2007/2008 Annual Inspection Report

GRAND-WHITE LAKES LANDBRIDGE PROTECTION PROJECT (ME-19)

State Project Number ME-19
Priority Project List 10

April 4, 2008
Cameron Parish

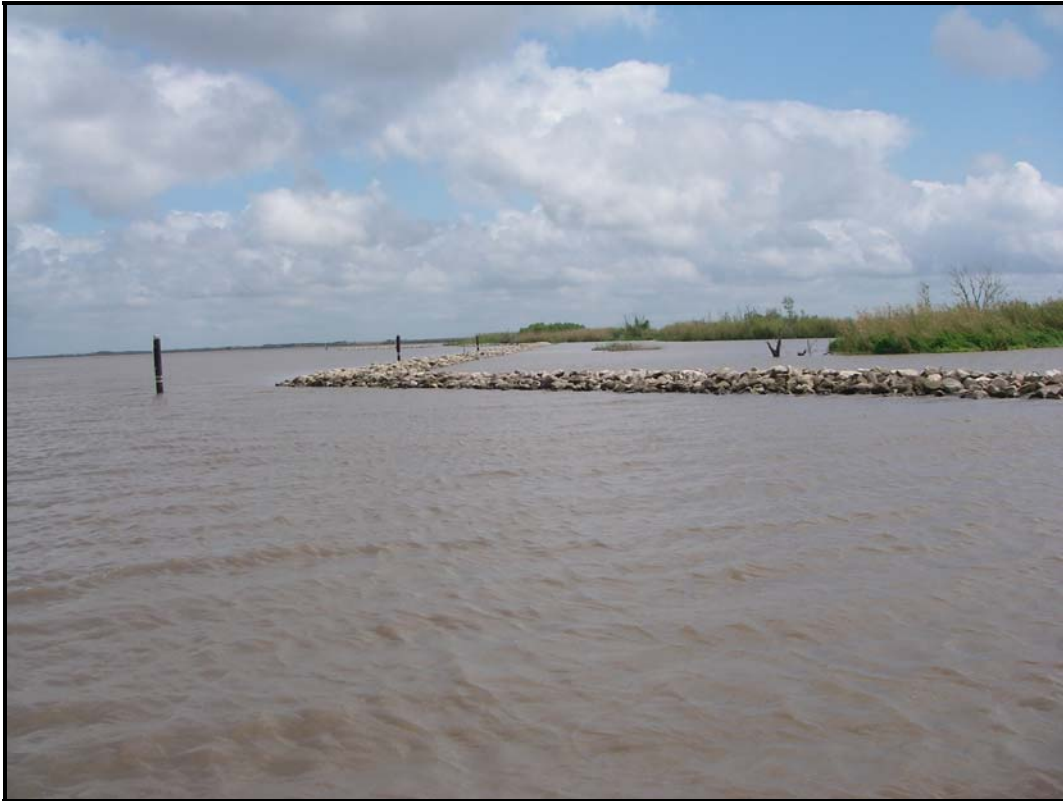
The foreshore rock dike feature is in excellent condition. No maintenance is required at this time. (Photos: Appendix B, Photos 1 & 2)

Photo 1, Typical rock dike.

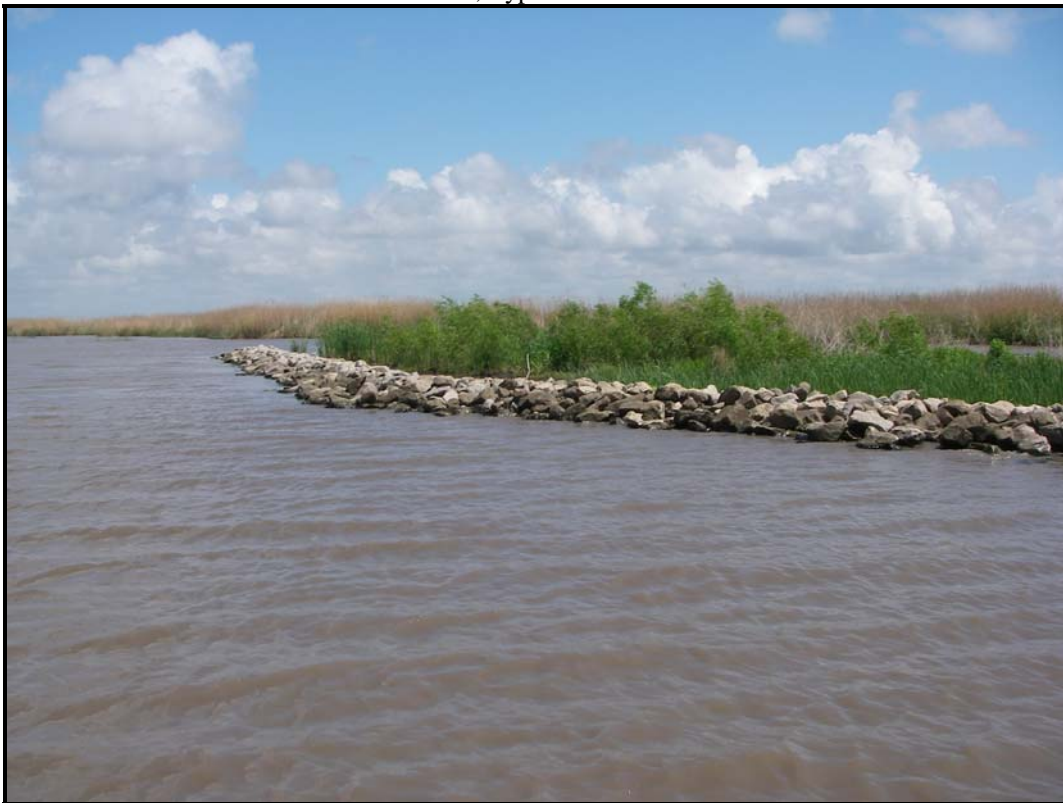
Photo 2, Rock foreshore dike.

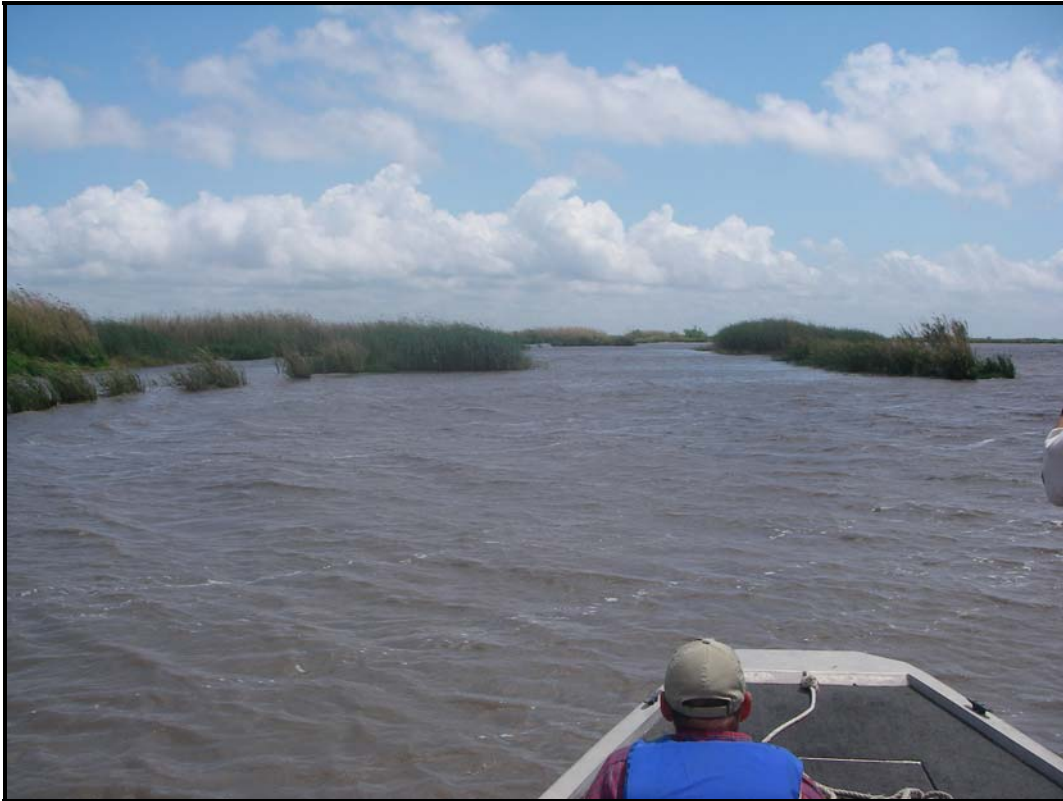
Marsh side and lake side earthen terraces along Collicon Lake continue to experience erosion, with the lake side sacrificial terraces being more severe. Original giant cutgrass plantings along the marsh side terraces were visible. (Photos: Appendix B, Photos 3 & 4)

Photo 3, Earthen terraces.

- Install 5,000 vegetative plantings on the Collicon Lake terraces.

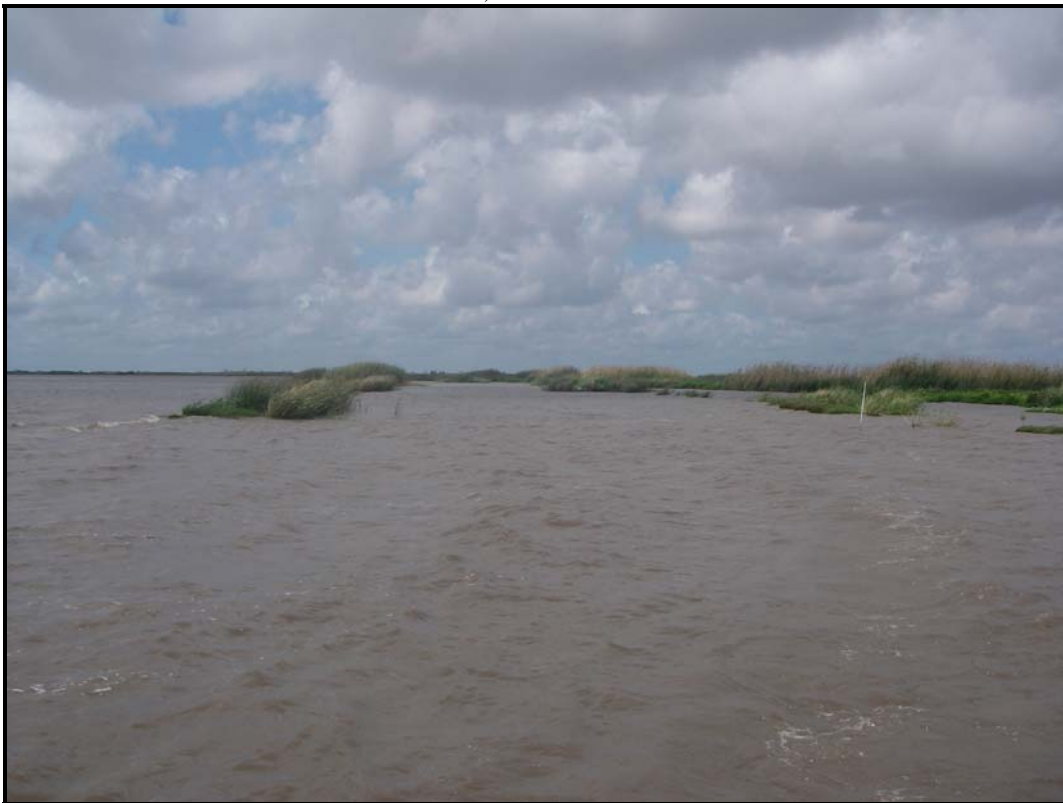
Photo 4, Earthen terraces
