**2011 Operations, Maintenance,
and Monitoring Report**

**Four-Mile Canal Terracing and
Sediment Trapping**

State Project Number TV-18
Priority Project List 9

October 2011
Vermilion Parish

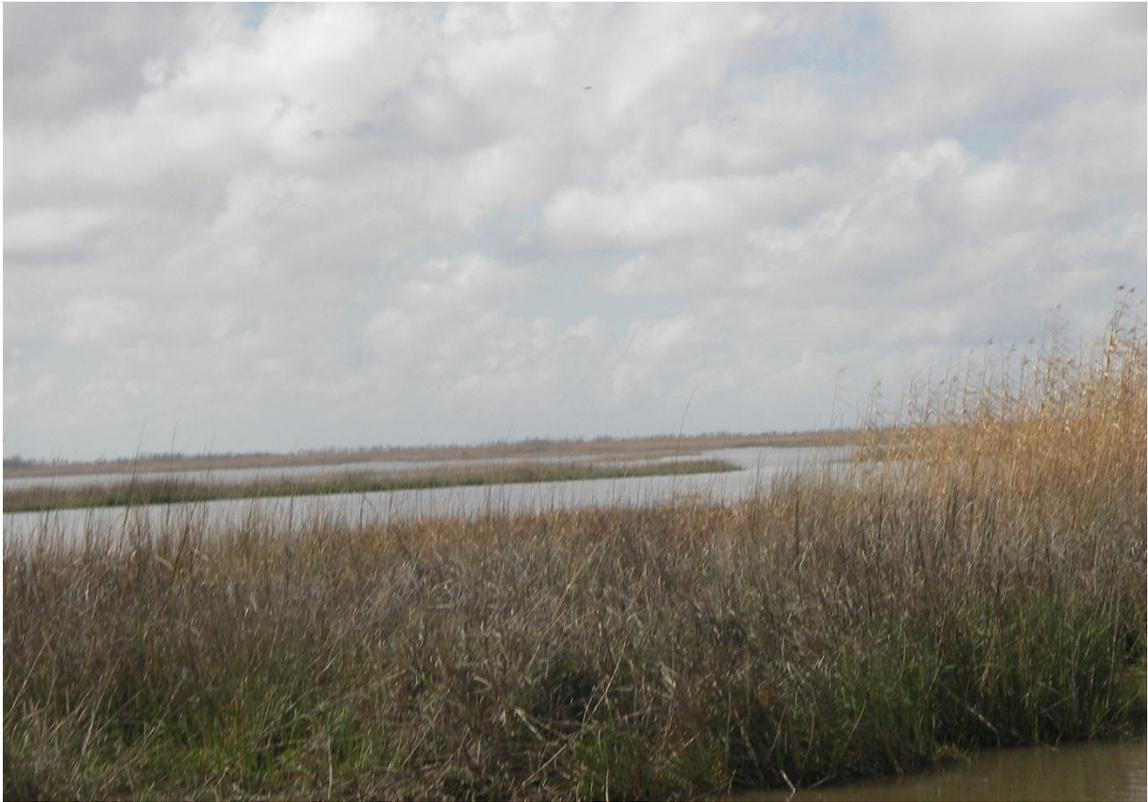
In Little White Lake, the 4th row of terraces continues to erode, but is still somewhat visible and breaking waves. The 3rd row is in fairly decent shape. The 1st and 2nd rows are in excellent condition. The channels are beginning to silt in. Future inspections will need to be done in a tunnel boat. Ducks were abundant in the area. The eastern terraces adjacent to the Four Mile Canal continue to erode as well as the western most terraces. Consideration is being given to armoring the open water along Four Mile Canal with rock in order to protect the remaining terraces. Boat wakes are severely damaging these terraces. Channels between the terraces are silting in. (Photos: Appendix B, Photo 1-4)

Photo No. 1—Little White Lake terraces

Permitting and installing approximately 5,200 LF of foreshore rock dike

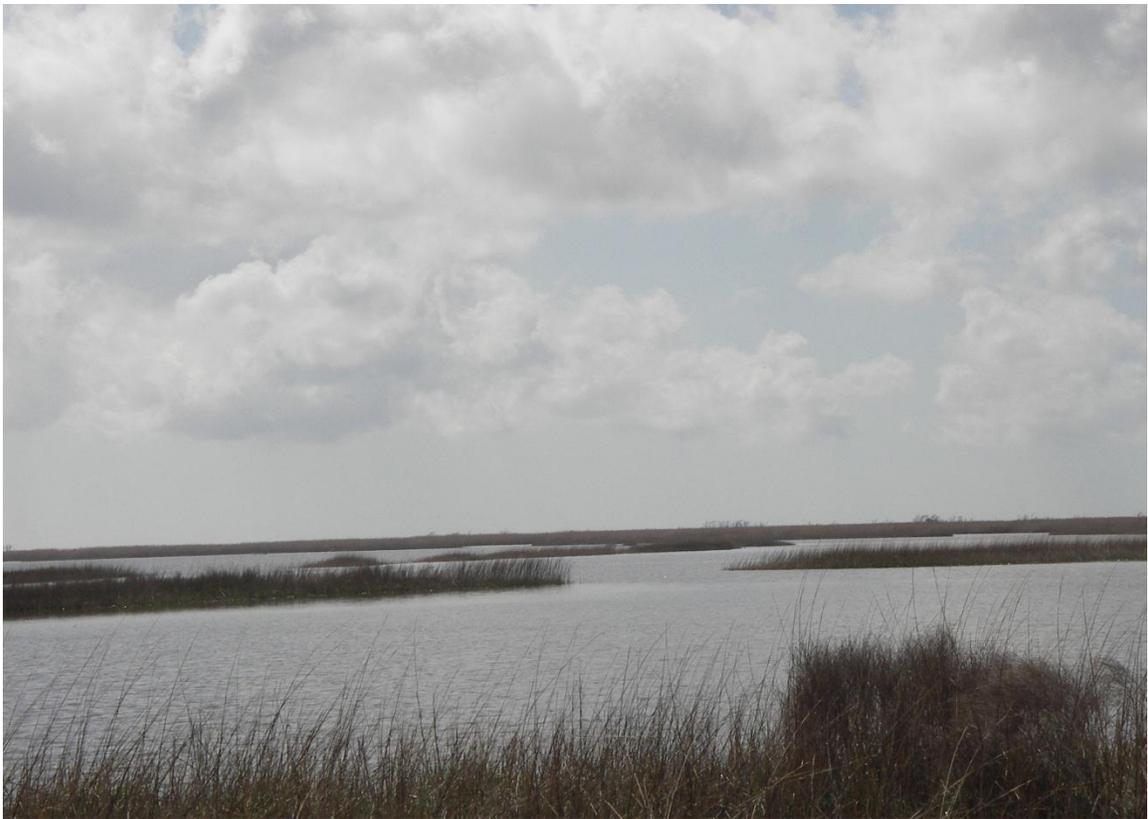
Photo No. 2—Little White Lake terraces

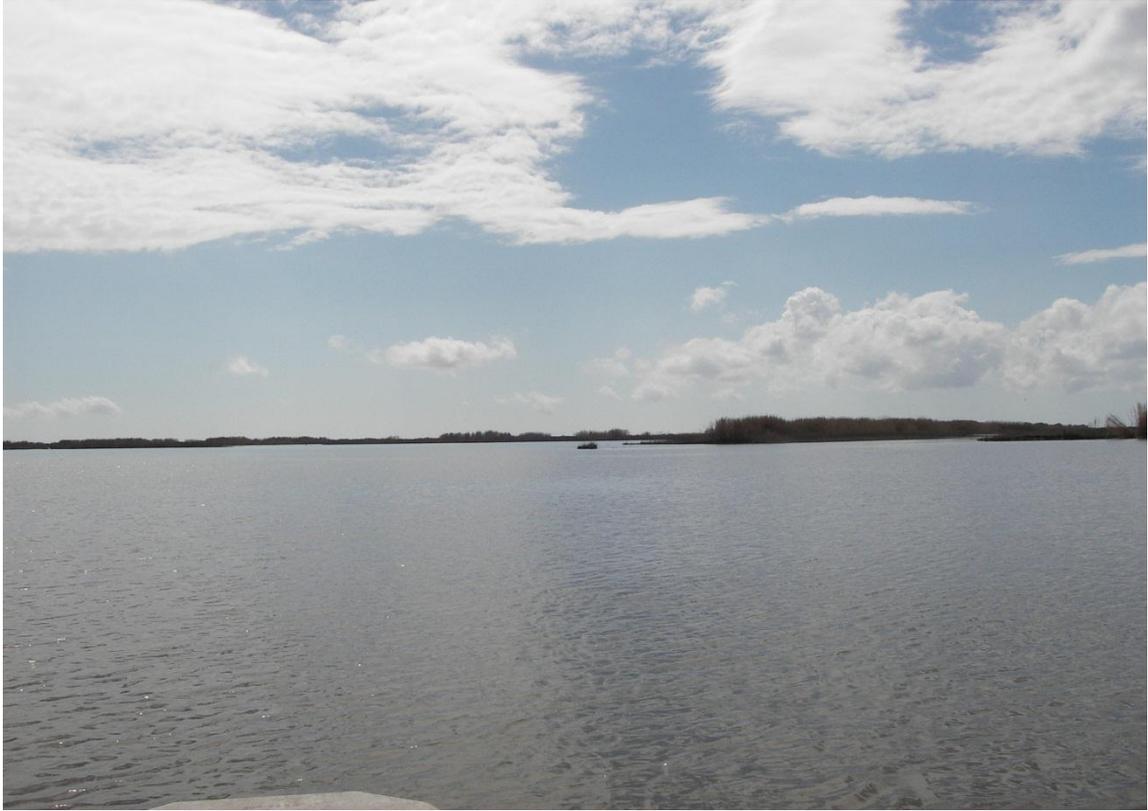
Photo 3—Four Mile Canal terraces

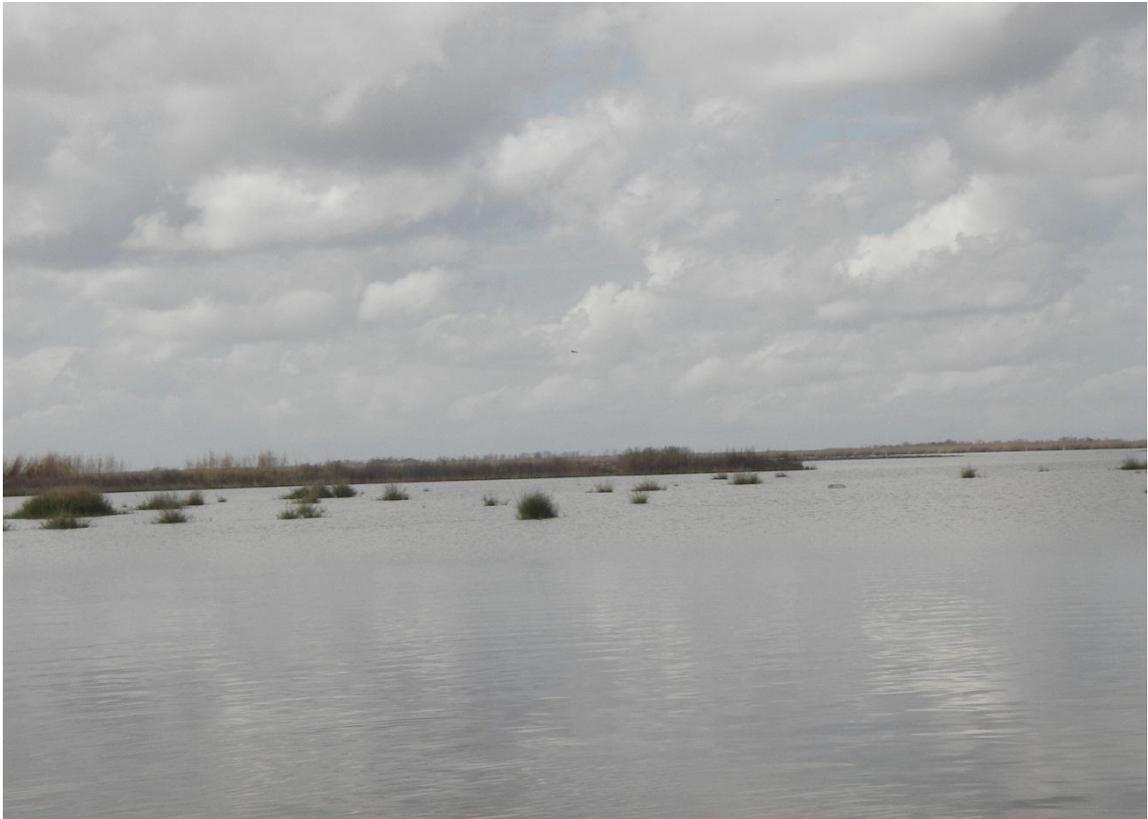
Vegetation is stable on terraces in both areas and is doing extremely well. Emergent vegetation is becoming established. No maintenance with regard to the plantings is needed at this time.

Photo 4—emergent vegetation within Four Mile Canal terraces
