**2010/2011 Annual Inspection  
Report**

**PECAN ISLAND TERRACING  
PROJECT  
(ME-14)**

State Project Number ME-14  
Priority Project List 7

June 10, 2011  
Vermilion Parish

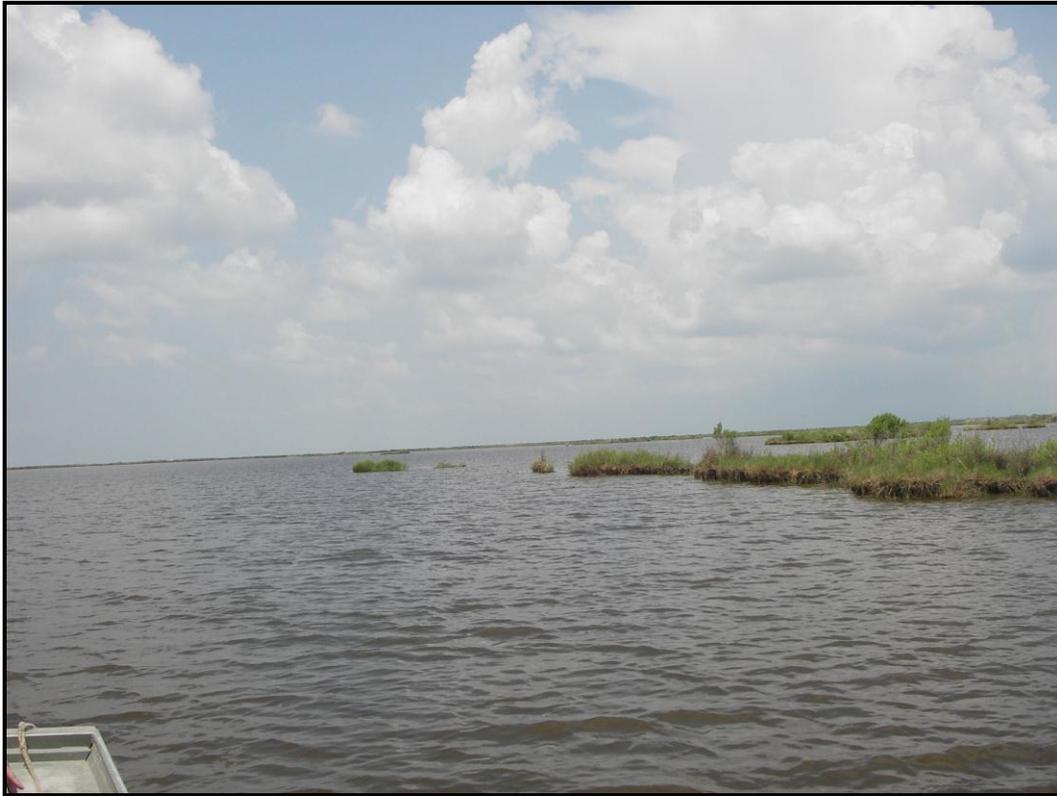
Overall the majority of the earthen terraces are in good condition and did not appear to suffer any major damage from Hurricane Ike. Previously noted erosion in past O&M Inspections of the southern sacrificial terraces has worsened. The southern sacrificial terraces are providing less protection for the interior earthen terraces than in previous years. (Photos: Appendix B, Photo 1)

**Photo No. 1,** Southern most earthen terrace showing erosion

Overall, the Pecan Island Terracing Project (ME-14) is functioning as designed and in good condition. The erosion of the southern sacrificial terraces will continued to be monitored. NOAA and OCPR have agreed to investigate possible erosion solutions for these sacrificial terraces, and if feasible will request additional funding for this maintenance event. Installation of a staff gauge in the vicinity is recommended. Maintenance items to be addressed in CY 2012:

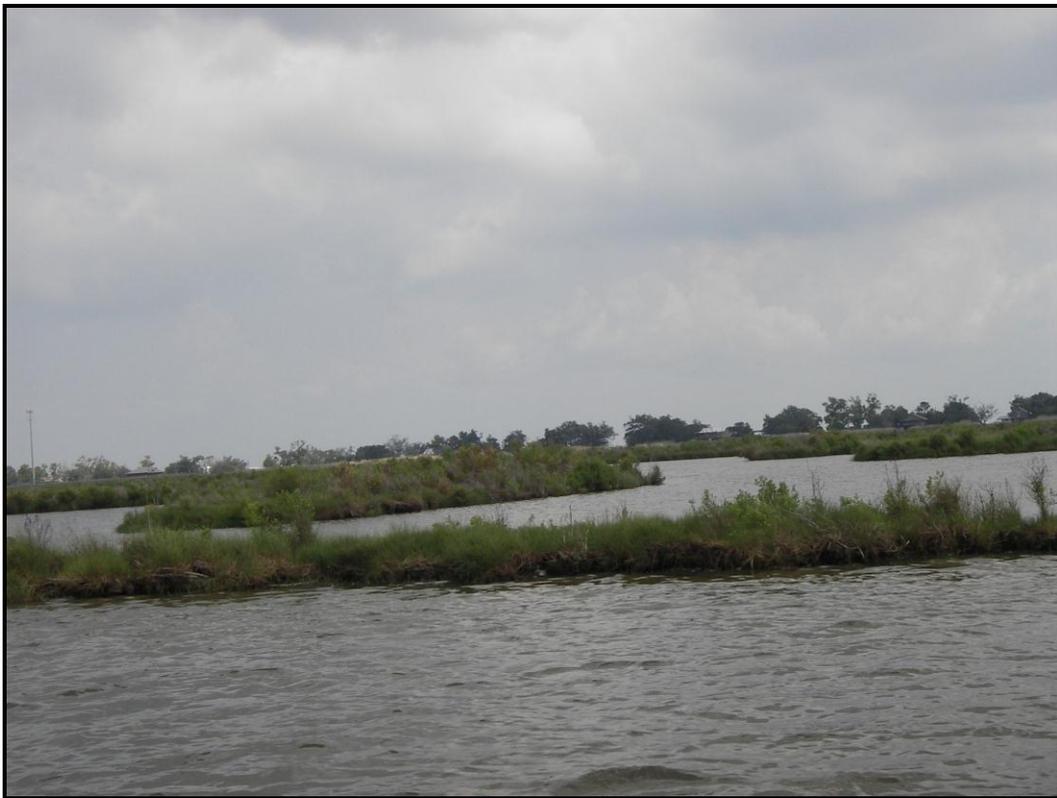
The tops of the terraces are approximately 50 per cent covered with vegetation. Species noted include *Spartina alterniflora*, *Juncus*, *Baccharis*, and *Spartina patens*. (Photos: Appendix B, Photo 2)

**Photo No. 2,** Typical terrace
