**2010/2011 Annual Inspection
Report**

**CAMERON PRAIRIE REFUGE
PROTECTION PROJECT
(ME-09)**

State Project Number ME-09
Priority Project List 1

March 24, 2011
Cameron Parish

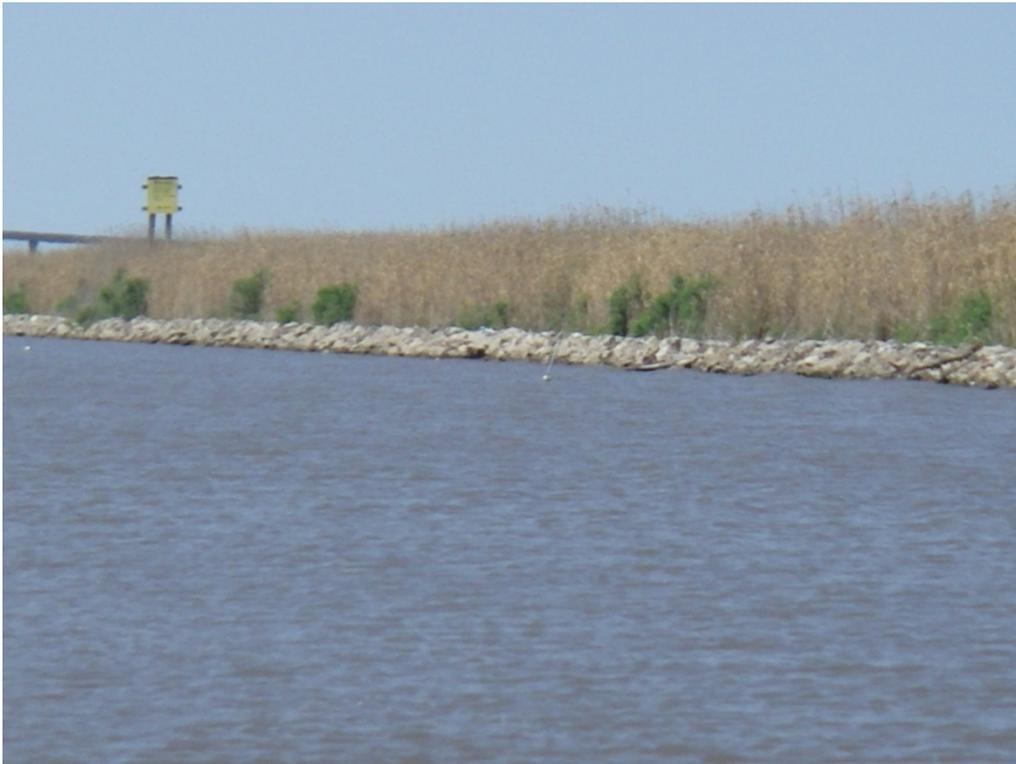
The foreshore rock dike is in excellent post construction condition. There is a short section of dike that is low with some displaced rock. Evidence of increased vegetation behind the foreshore rock dike was noted. No need for any maintenance in the foreseeable future however a staff gage is required. (Photos: Appendix B, Photo 1)

Photo No. 1, Typical rock dike

Item	Condition	Physical Damage	Corrosion	Photo #	Observations and Remarks
Steel Bulkhead / Caps	N/A				
Steel Grating	N/A				
Stop Logs	N/A				
Hardware	N/A				
Timber Piles	N/A				
Timber Wales	N/A				
Galv. Pile Caps	N/A				
Cables	N/A				
Signage / Supports	Good				
Rip Rap (fill) (foreshore dike)	Excellent			1	One area of dike is low with displaced rock.
Earthen Embankment	N/A

- Install staff gage along rock dike.
