**2011/2012 Annual Inspection
Report**

**CAMERON/CREOLE
WATERSHED HYDROLOGIC
RESTORATION PROJECT
(CS-17)**

State Project Number CS-17
Priority Project List 1

October 20, 2011
Cameron Parish

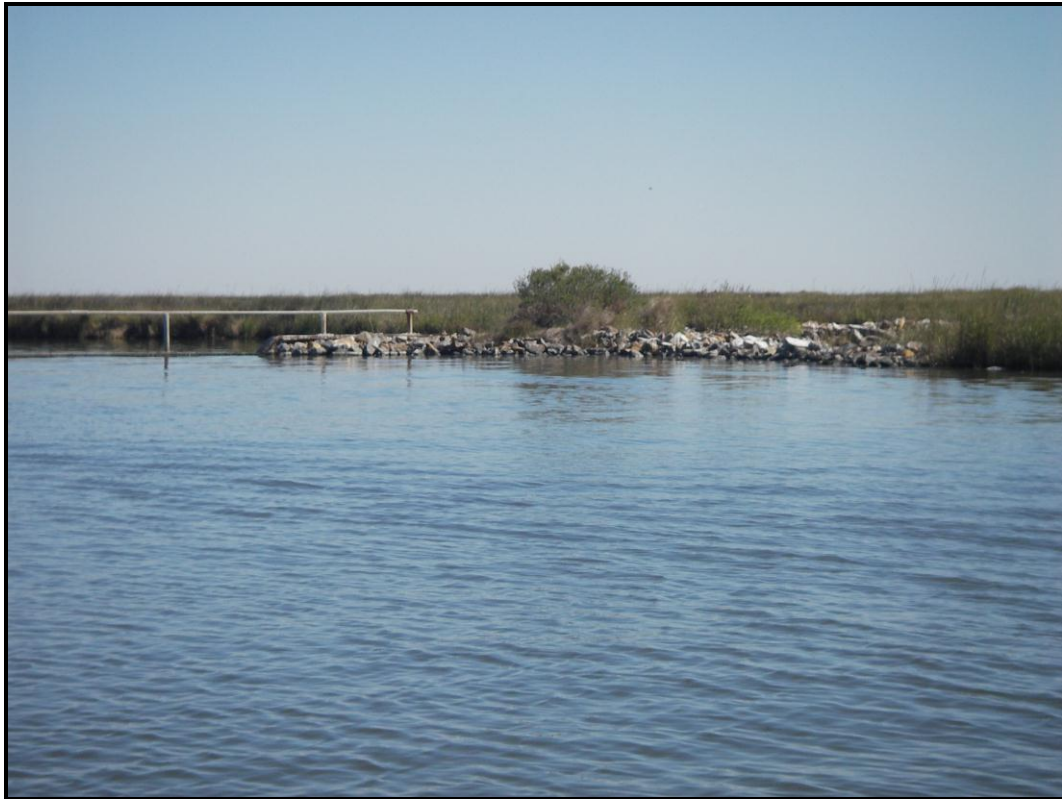
Overall this structure is in good condition. The west boat guide has been removed from the structure assumed to be by vandals. The east boat guide has been removed from the structure by Tal McCain and is currently at Lonnie Harper's Office. Warnings signs, swing gate and top rail are still visible. The recent maintenance event performed in 2009 to armor the ends of the sheet pile wall has been effective and looks in good condition. The sheet pile wall is showing signs of deterioration and will be monitored during future inspections. (Photos: Appendix B, Photos 1 -3).

Photo 1, Grand Bayou Weir, view of rock east side.

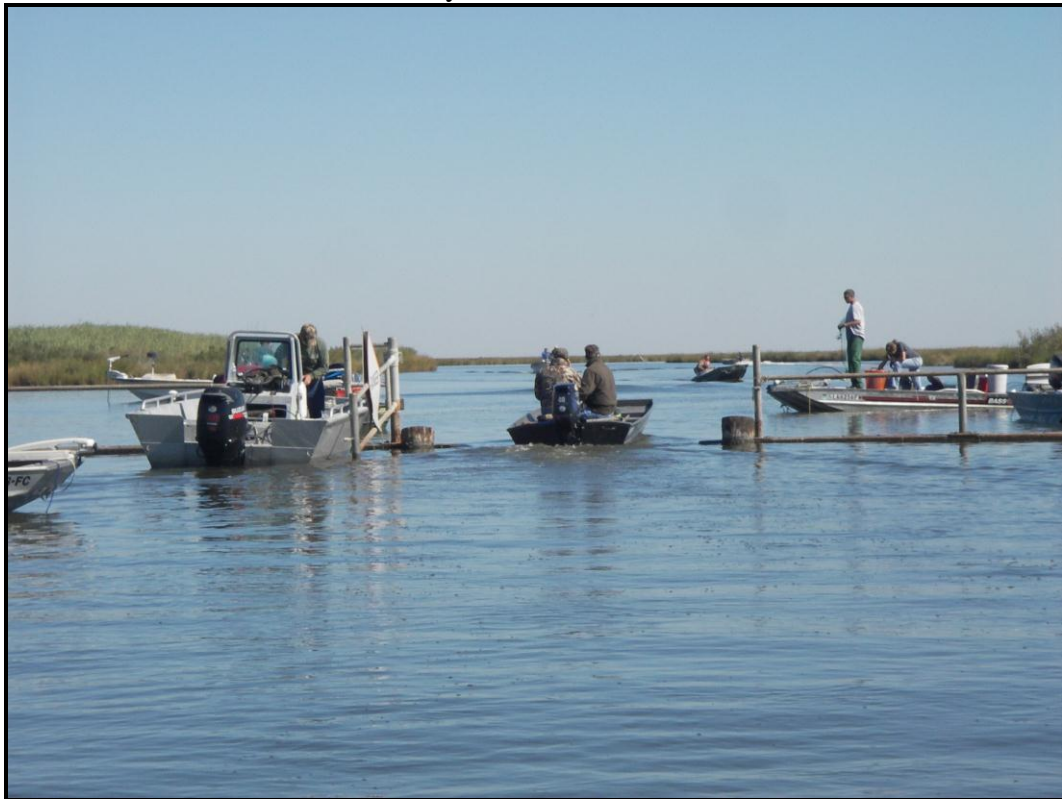
Photo 2, Grand Bayou Weir, close up view showing missing boat guides.

Item	Condition	Physical Damage	Corrosion	Photo #	Observations and Remarks
Steel Bulkhead / Caps	Fair			1	
Steel Grating	N/A				
Stop Logs	N/A				
Hardware	Fair				
Boat Guides	Fair			2	West boat guide missing. East boat guide removed and being held by Lonnie Harper's office.
Timber Wales	N/A				
Galv. Pile Caps	Fair				
Cables	N/A				
Signage /Supports	Good			1	
Rip Rap (Rock Armor)	Good			3	
Eathern Embankment	Good

Overall, the structures of the Cameron-Creole Watershed Project are still in fair condition and are functioning as designed. The west boat guide will be replaced in 2012 as part of a maintenance event for the Cameron-Creole CS-04a project.

12/13 Description: Replace boat guides at Grand Bayou

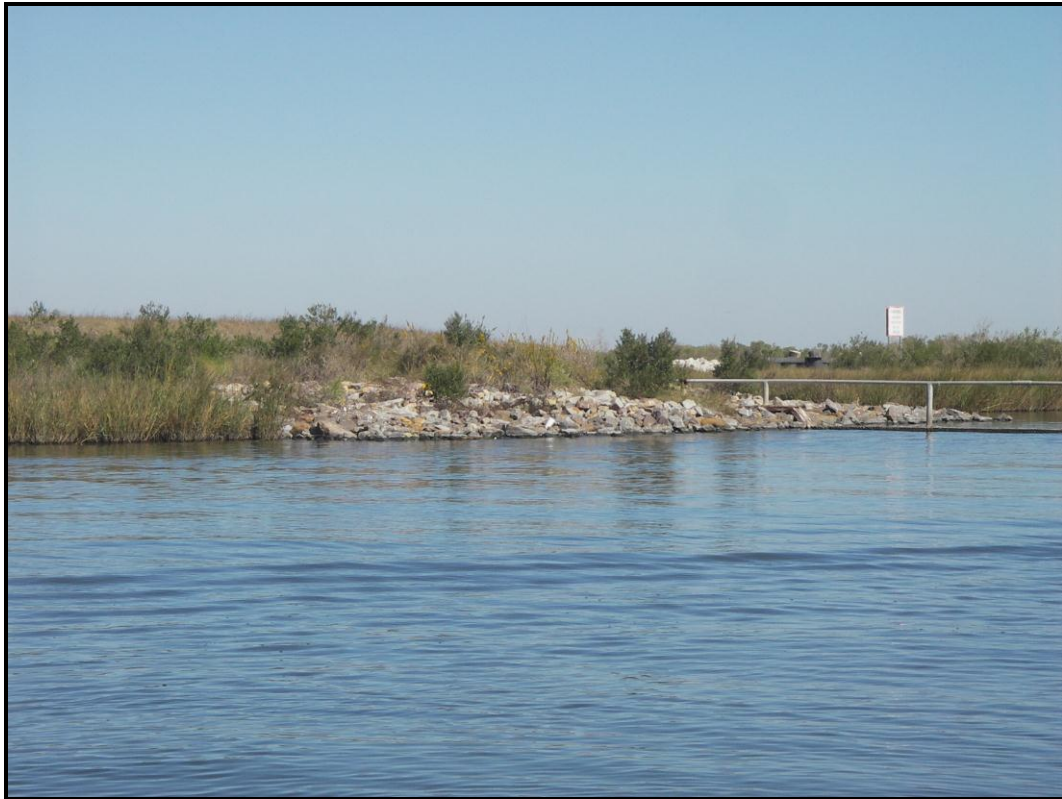
Photo 3, Grand Bayou Weir, view showing rock armor on west side.

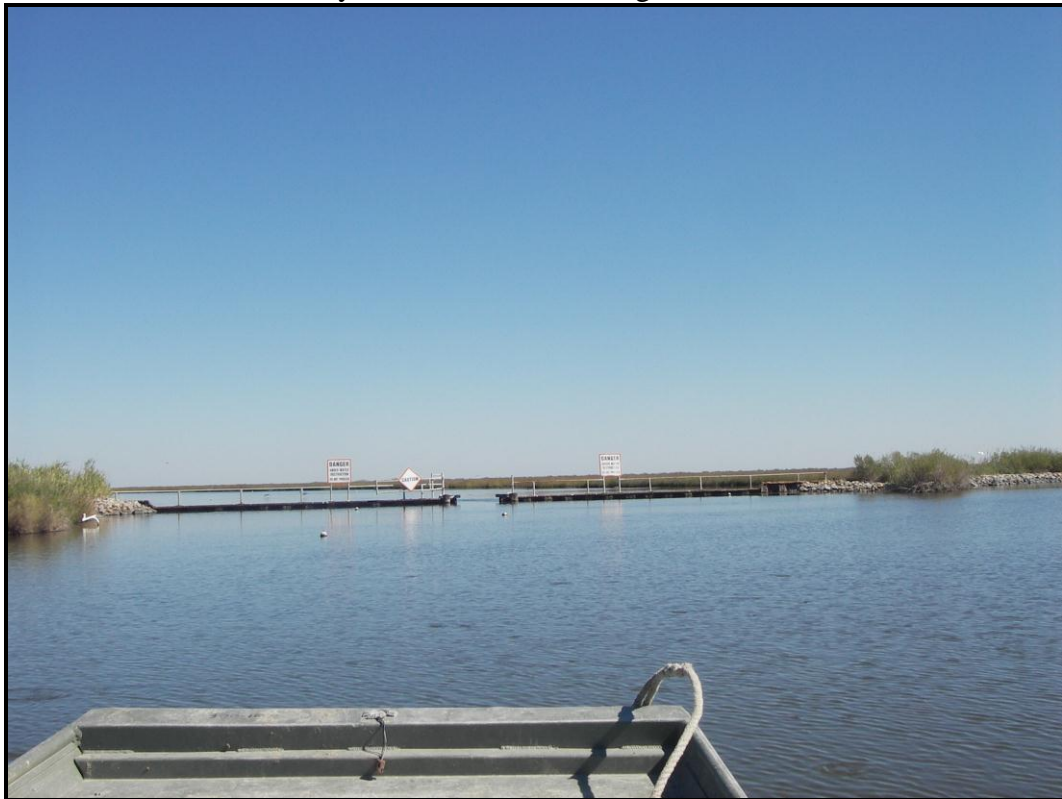
Overall the structure is in good condition. Both boat guides remain on the structure. Warning signs and top railing are still visible. The recent maintenance event performed in 2009 to armor the ends of the sheet pile wall has been effective and looks in good condition. The sheet pile wall is showing signs of deterioration and will be monitored during future inspections. (Photos: Appendix B, Photos 4-6).

Photo 4, Mangrove Weir, view looking north.

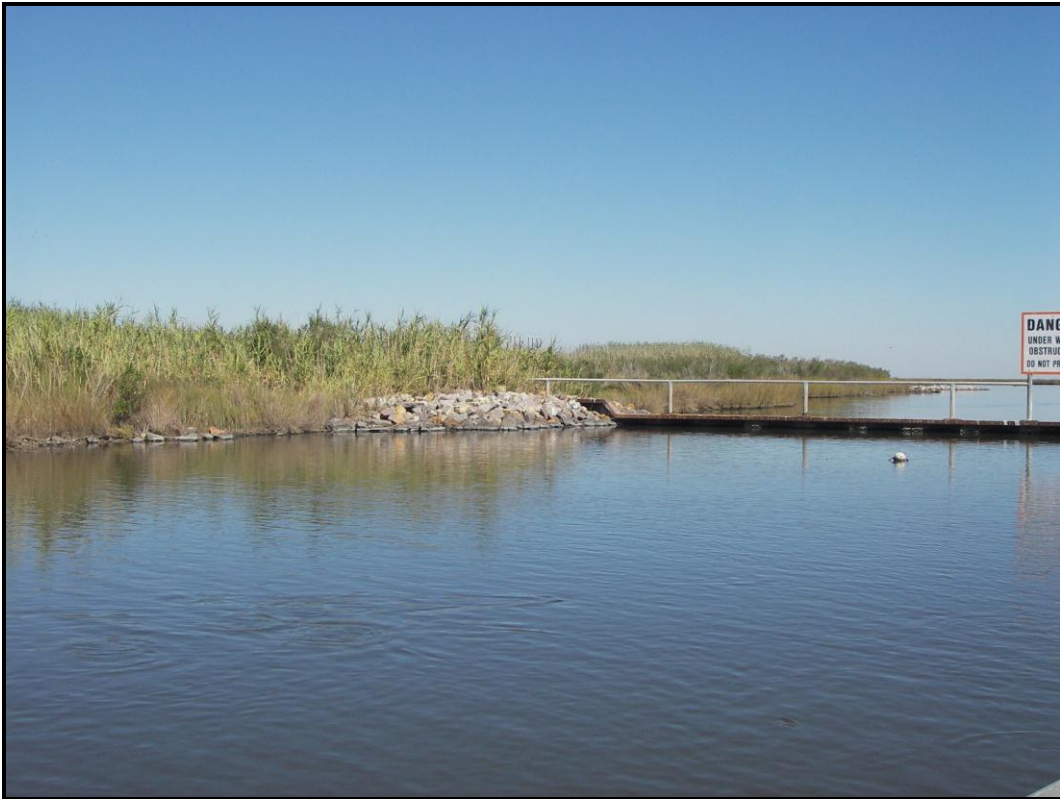
Photo No. 5, Mangrove Weir, view of rock armor west side.

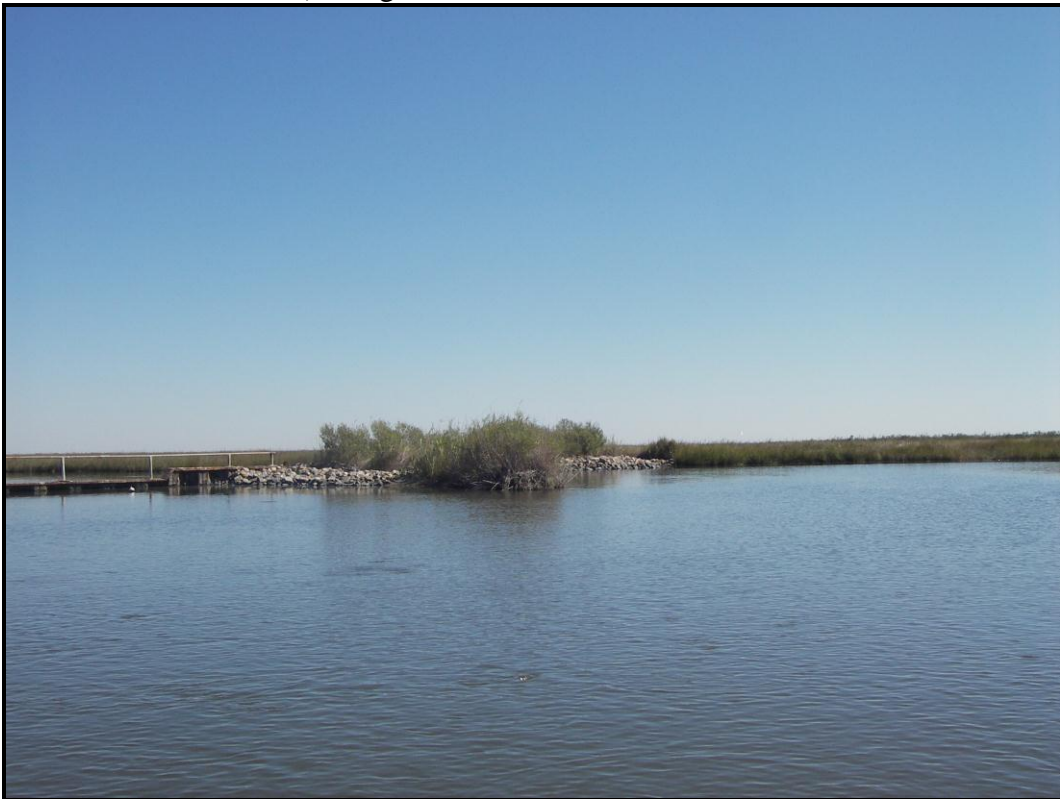
Photo No. 6, Mangrove Weir, view of sheet pile wall.
