**Coastal Protection and Restoration
Authority of Louisiana (CPRA)**

**2012/2013 Annual Inspection
Report**

**EAST SABINE LAKE
HYDROLOGIC RESTORATION
PROJECT (CS-32)**

October 11, 2012
Cameron Parish

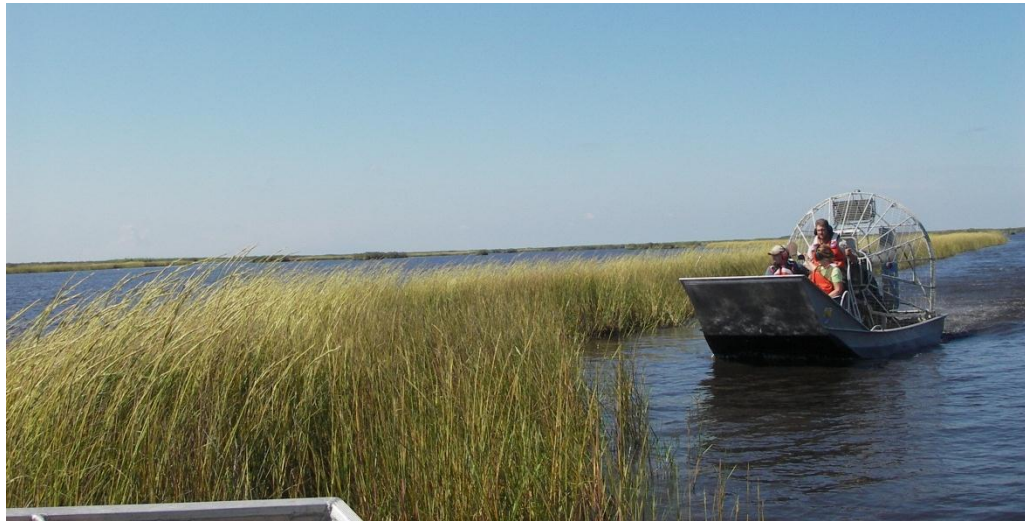
Overall the vegetation is in good condition. (Appendix B: Photo No. 1) From discussion with the team members after the site inspection it was estimated that approximately 90% coverage was present. At this time it doesn't appear that additional planting is required. The terraces are in good condition with somewhat more significant narrowing or settling of the terraces seen in CU1 than in CU1A. During this inspection, salinity and soil samples were collected by NRCS at four locations noted on the Terrace Field Site Map in Appendix A.

Photo No.1 –Typical Terrace in CU1A - Row 1 (Northern Most Row)

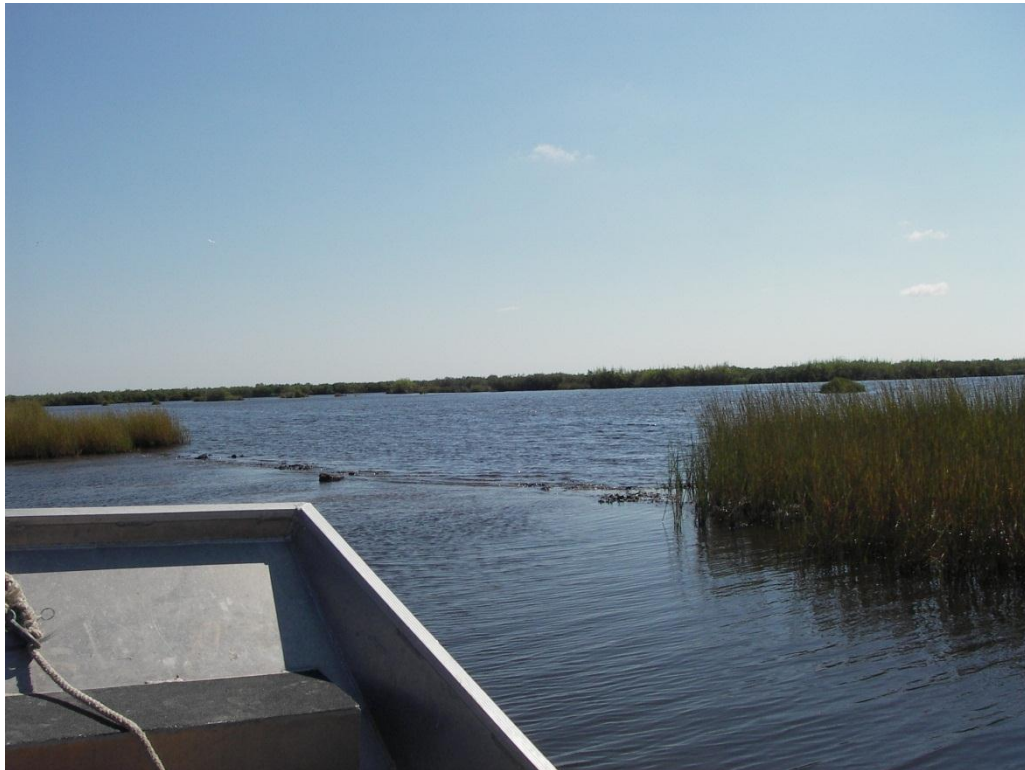
Typically the terraces are in good condition with slight narrowing or settling. On CU1A Rows 1-3 & 5 there were a few gaps where the terraces were bare with good vegetation on either side. (Appendix B: Photo No. 2) CU1A Rows 3, 7, & 8 show signs of narrowing where Row 8 has a cut bank on the south side. (Appendix B: Photo No. 4) There are a couple of segments on the west side of CU1A Row 10 that have been washed away by wave action. (Appendix B: Photo No. 5)

Photo No. 2 –CU1A Bare Segments

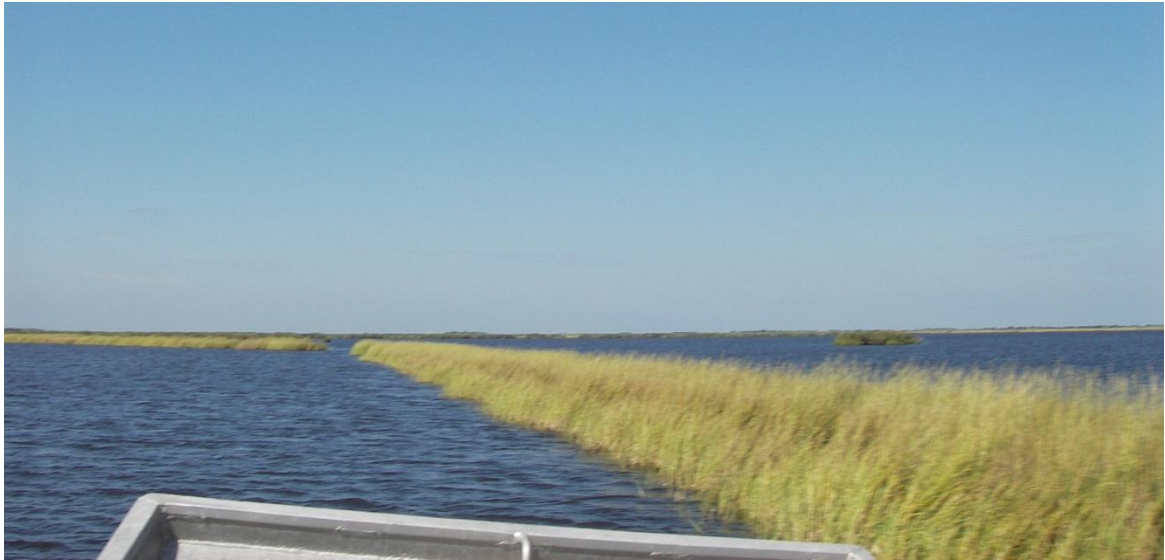
Photo No. 3 - CU1A Rows Slightly Narrowed with Good Vegetation

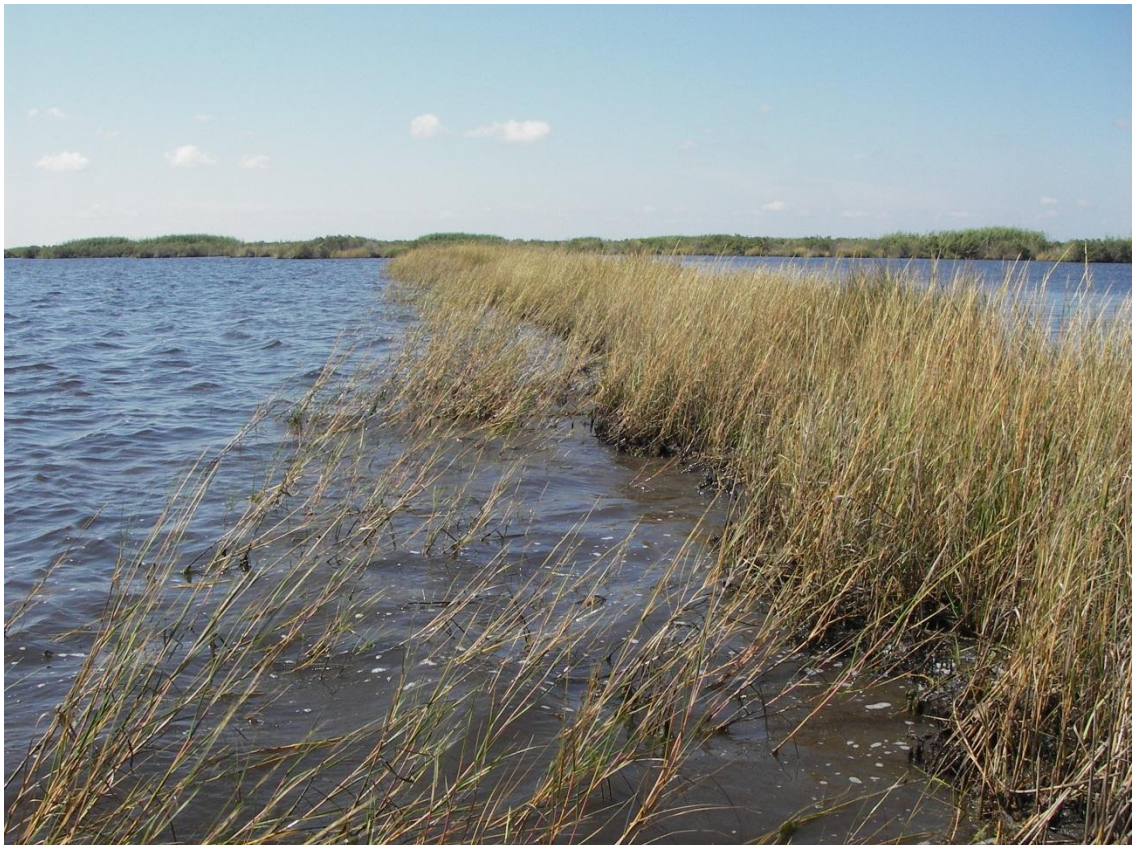
Photo No. 4 - CU1A Row 8 Cut Bank on South Side

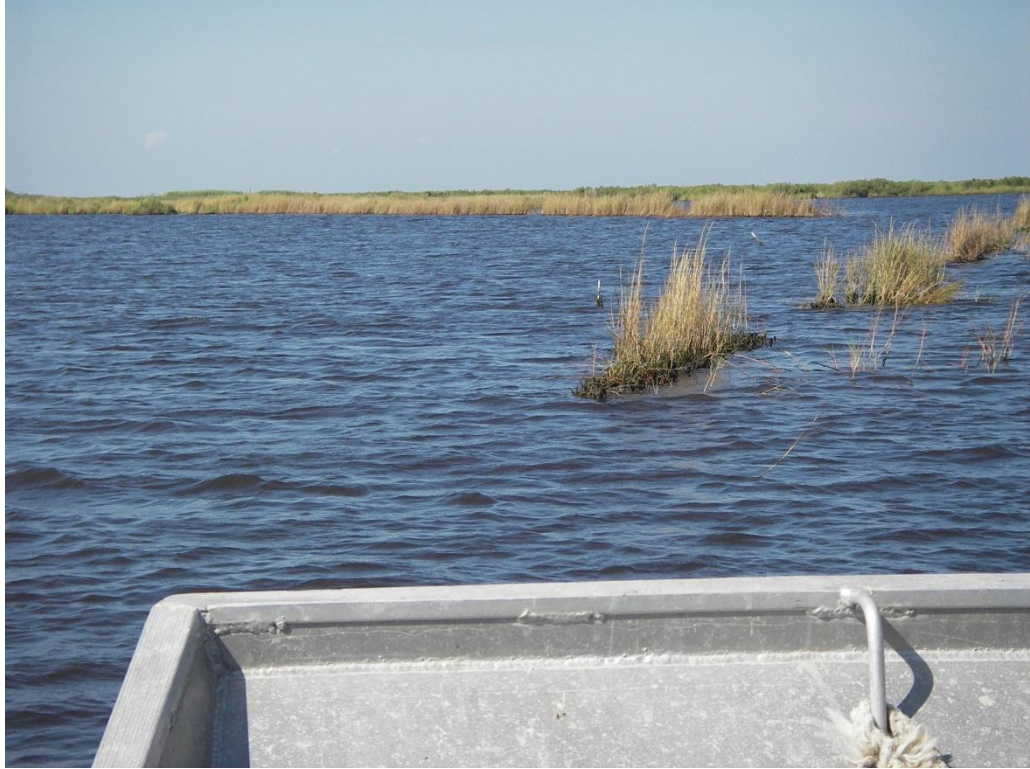
Photo No. 5 - CU1A Row 10 (Southern End of CU1A Terraces – West Side of Row)

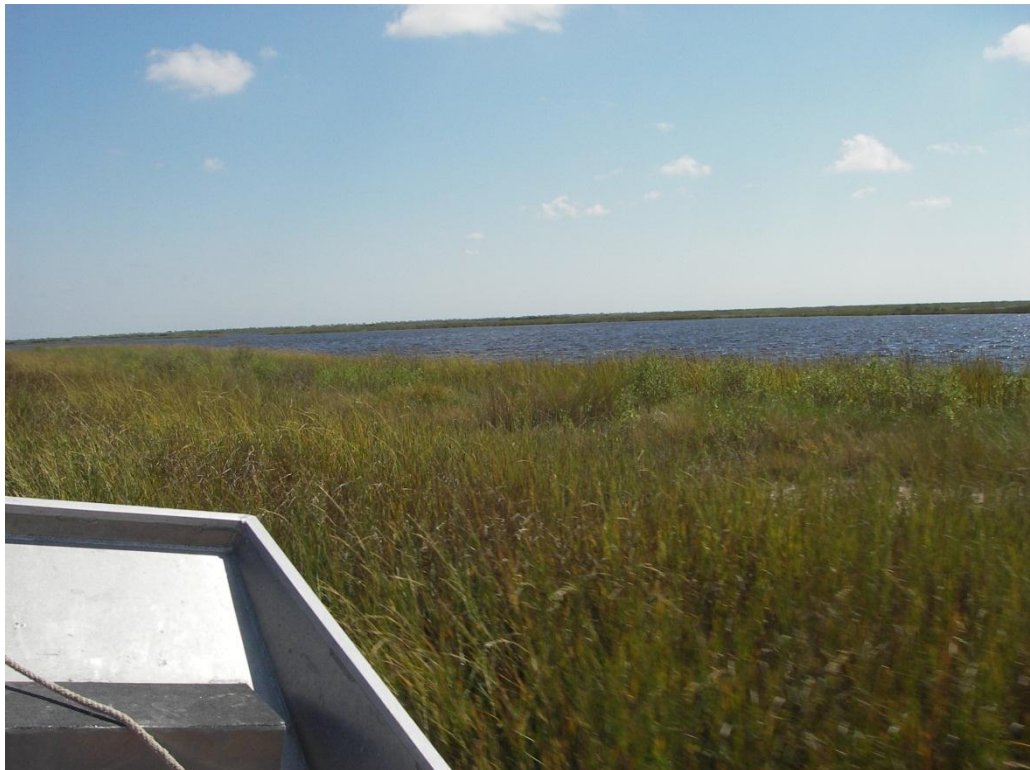
The southern end of CU1 tended to have narrower widths than the northern end of the terrace field. On Row 1B – Row 6, the terrace width and vegetation were in very good condition. (Appendix B: Photos No. 6) Narrowing of the terrace width has occurred on Rows 10, 12, & 13. (Appendix B: Photos No. 7) There were small segments of terraces with bare spots on Row 10 – Row 14A. Some locations were bare with vegetation on either side where as some locations were bare on the terrace crown with vegetation growth expanding outward into the water. (Appendix B: Photos No. 8)

Photo No. 6 - CU1 - Typical Terrace in Row1B-Row 6

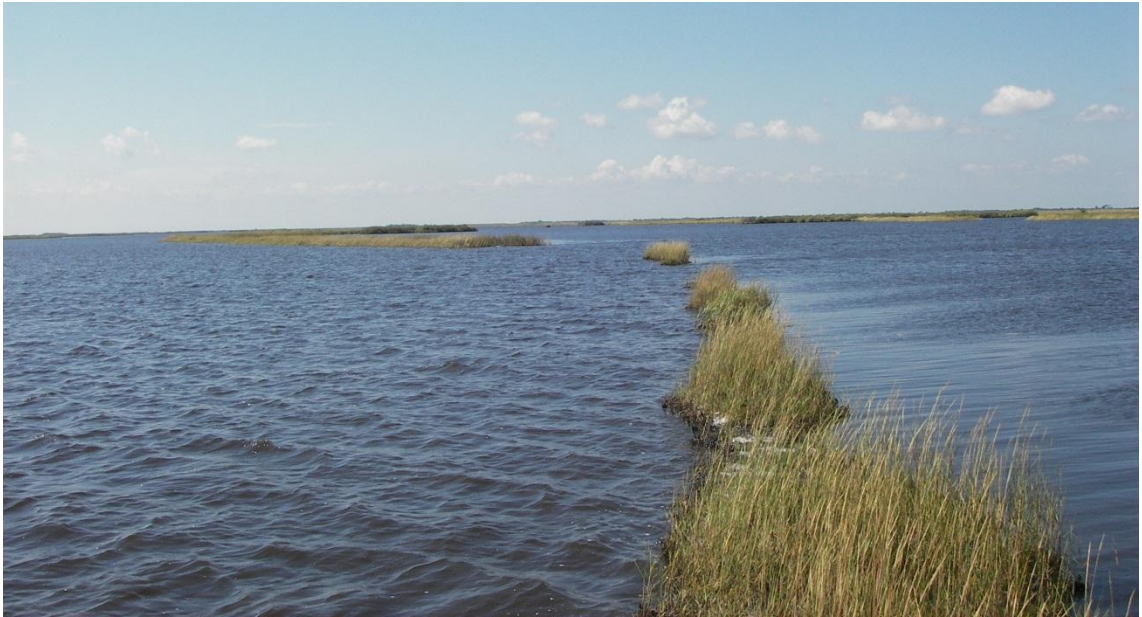
Photo No. 7 - CU1 – Narrowing Terrace Widths - Typical Terrace in Rows 10, 12, & 13

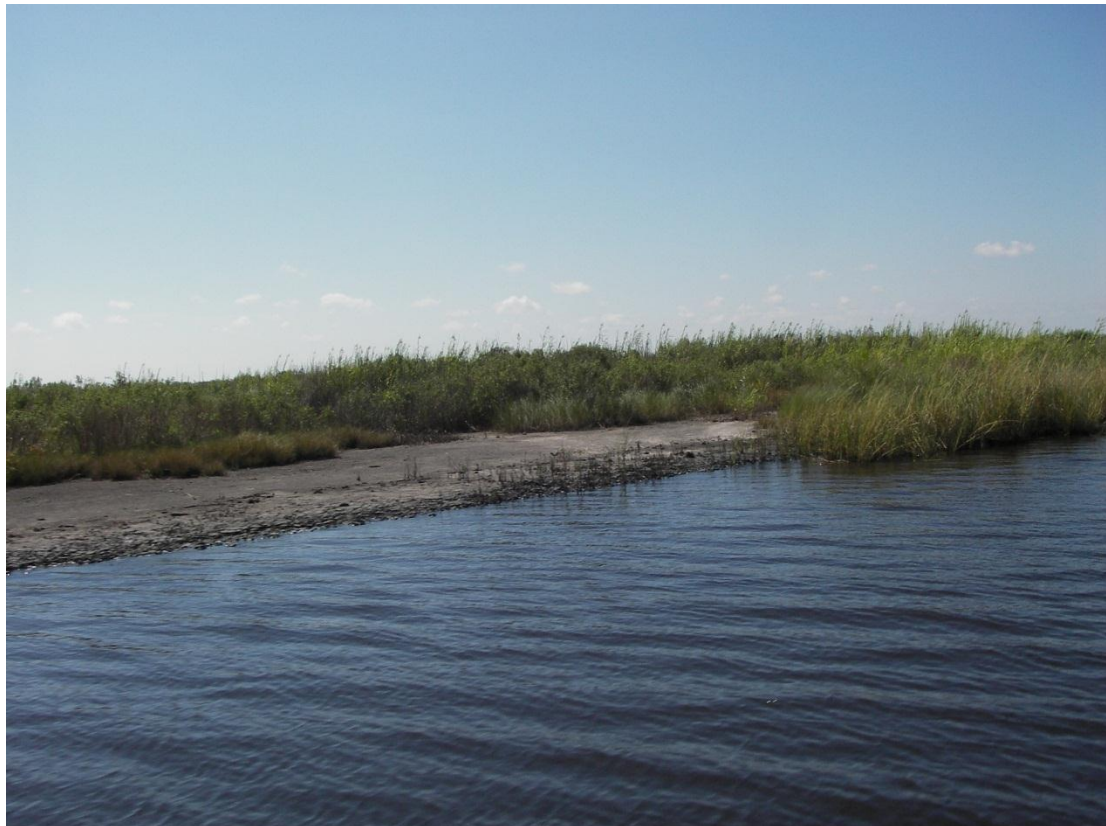
Photo No. 8 - CU1 – Typical Bare Spots in Row 10 - Row14A
