**State of Louisiana
Coastal Protection and Restoration Authority**

2015 Annual Inspection Report

Fritchie Marsh Restoration

State Project Number PO-06
Priority Project List 2

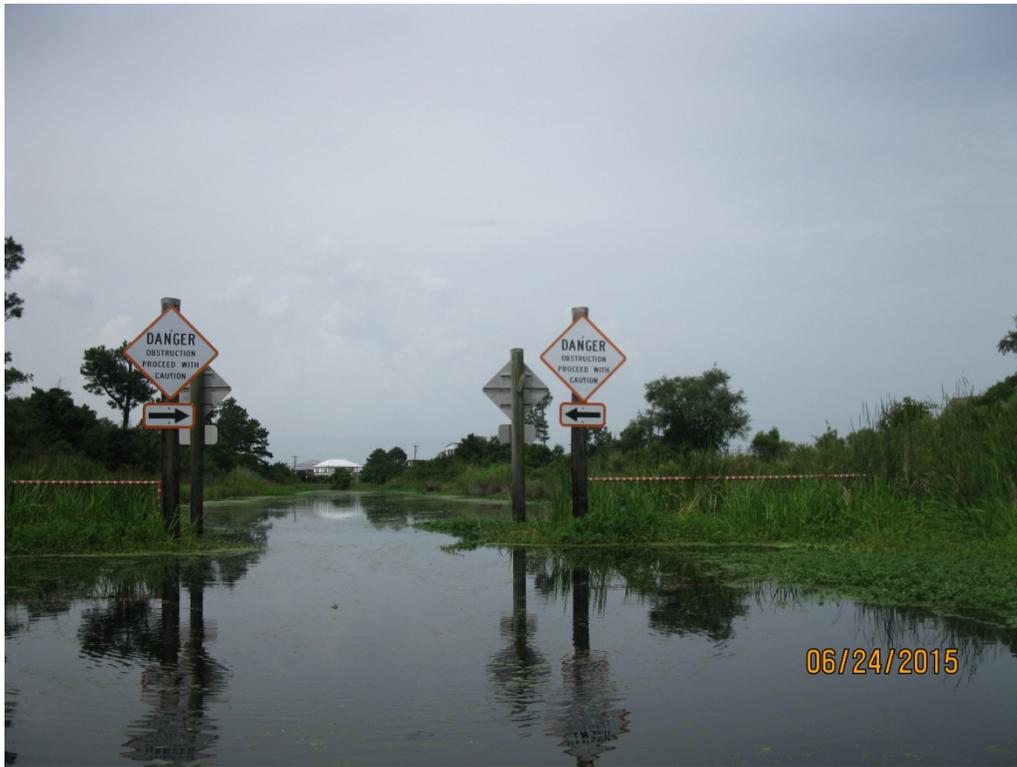
Photo 1: W-14 Weir and Warning Signs

The weir structure was fully submerged and partially surrounded by aquatic vegetation. The visible portion of the handrails appeared to be in good condition. The new warning signs were in very good condition. No maintenance is required in this area at this time.

Item	Condition	Physical Damage	Corrosion	Photo #	Observations and Remarks
Steel Bulkhead / Caps	Good	None	None	6	No significant defects noted.
Handrails, Grating, Hardware, etc.	Good	None	None	1	No significant defects noted.
Signage, Supports	Very Good	None	None	1	Signs and timber support piles appeared to be in very good condition.
Rock RipRap channel lining	Good	None		4	Good condition. Rip-rap covered by concrete debris on South bank.
W-14 Weir structure	See remarks	See remarks		1	Structure was fully submerged; flow visible.
W-14 diversion channel dredge	Good	None		2	Channel entrance is shallow but unobstructed. Emergent vegetation was present in outfall.
Salt Bayou dredging	See remarks	N/A		5	Boat access was not possible due to shallow depths in bayou. Inspection was performed from road embankment at Hwy 90. Water was observed flowing into the project area.
72" Diameter culvert	Good	None		4	No significant defects noted; water appeared to be flowing freely through culvert.

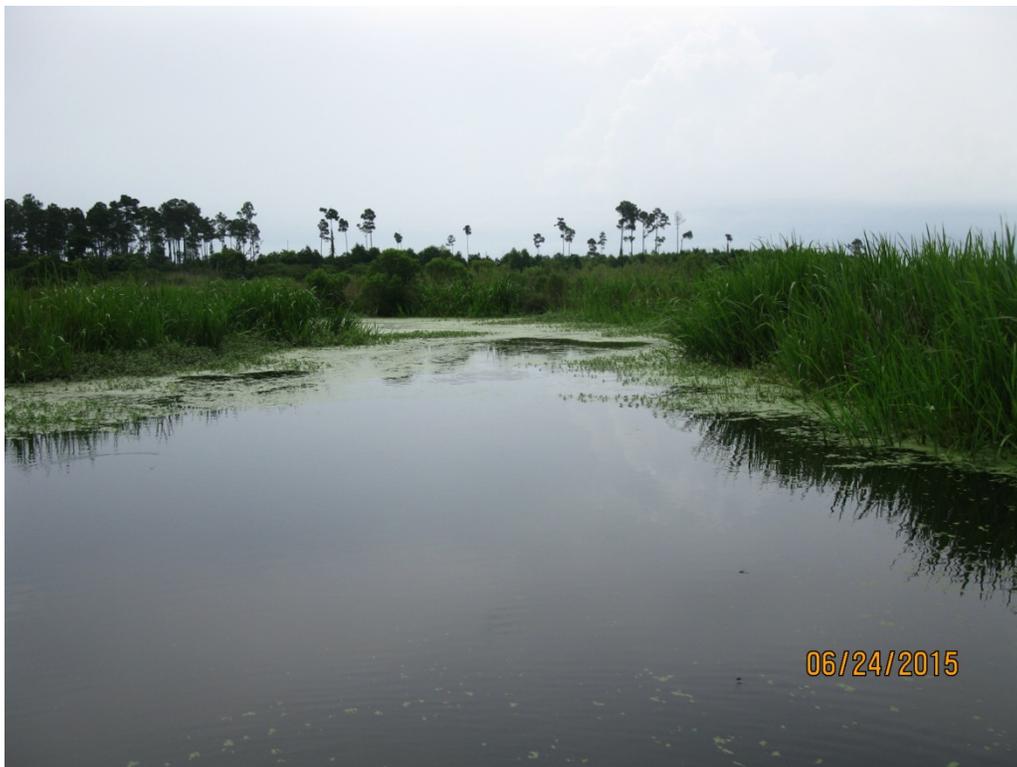
Photo 2: W-14 Diversion Canal

The channel inlet was free of obstructions. Emergent aquatic vegetation was present in the channel outfall. The diversion channel appeared to be functioning as designed.

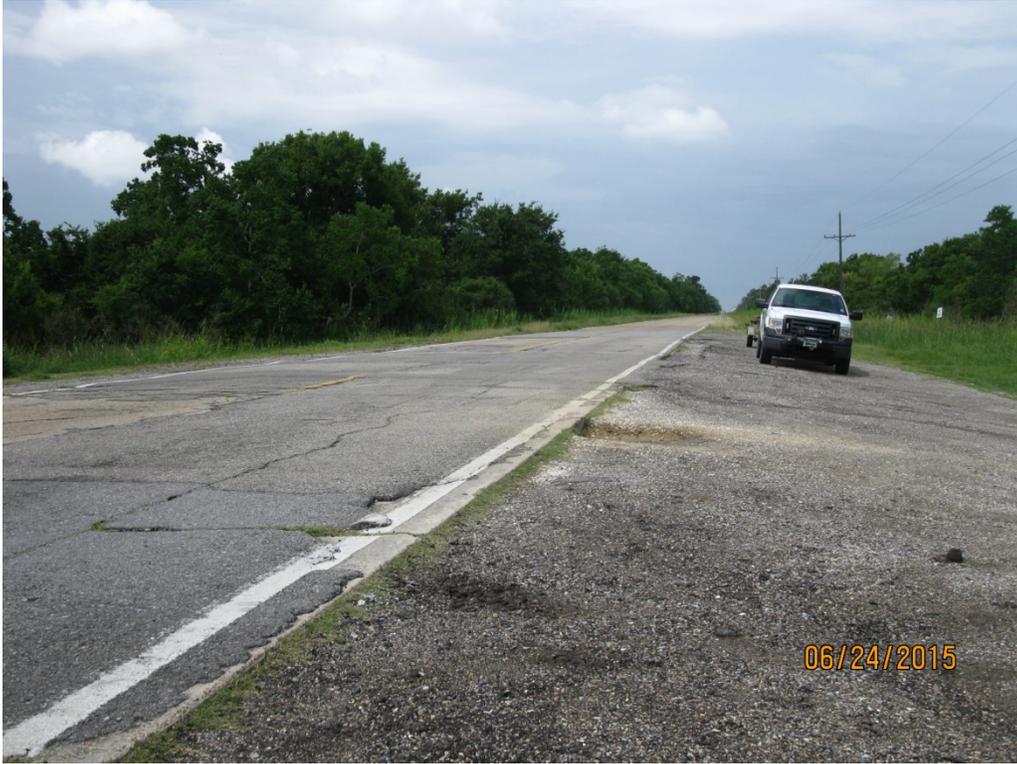
Photo 3: Hwy. 90 Road Surface Above Culverts

HWY 90 road surface	Good	None		3	No significant change since last inspection.

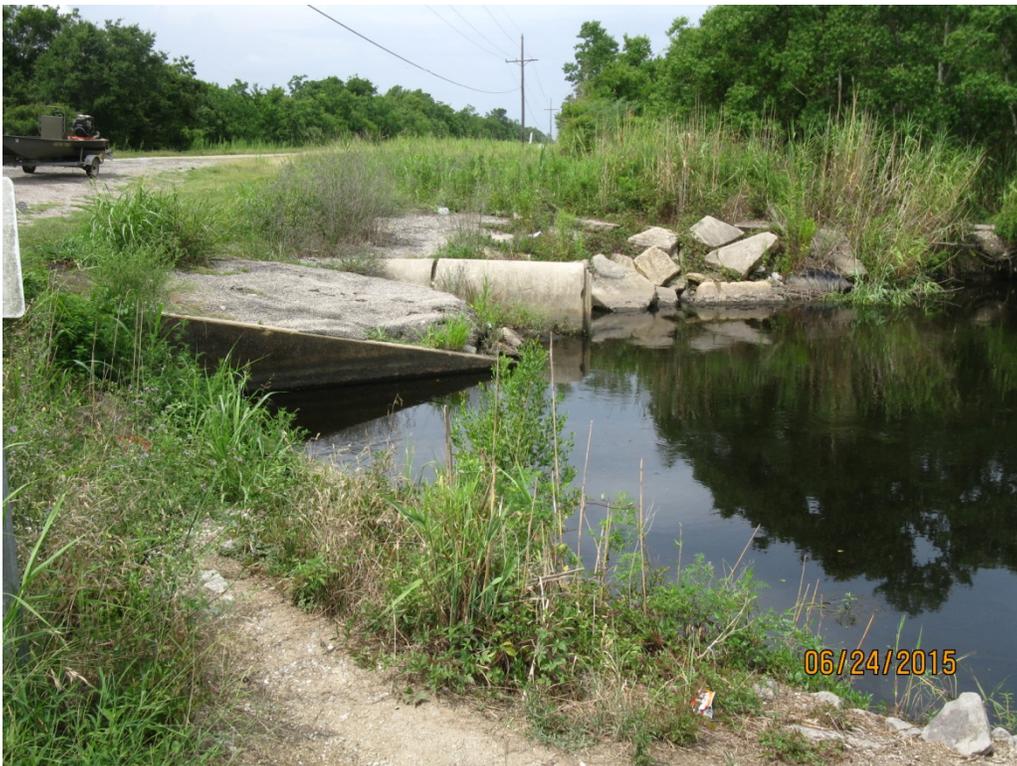
There is little change in this structure from the previous inspection. The bank scour reported in previous inspections did not appear to have progressed appreciably. The low area in the north bank, located approximately 150' west of the roadway centerline, still allows overbank flow of fresh water to enter the marsh during high water events. This area deserves continued observation during future inspections.

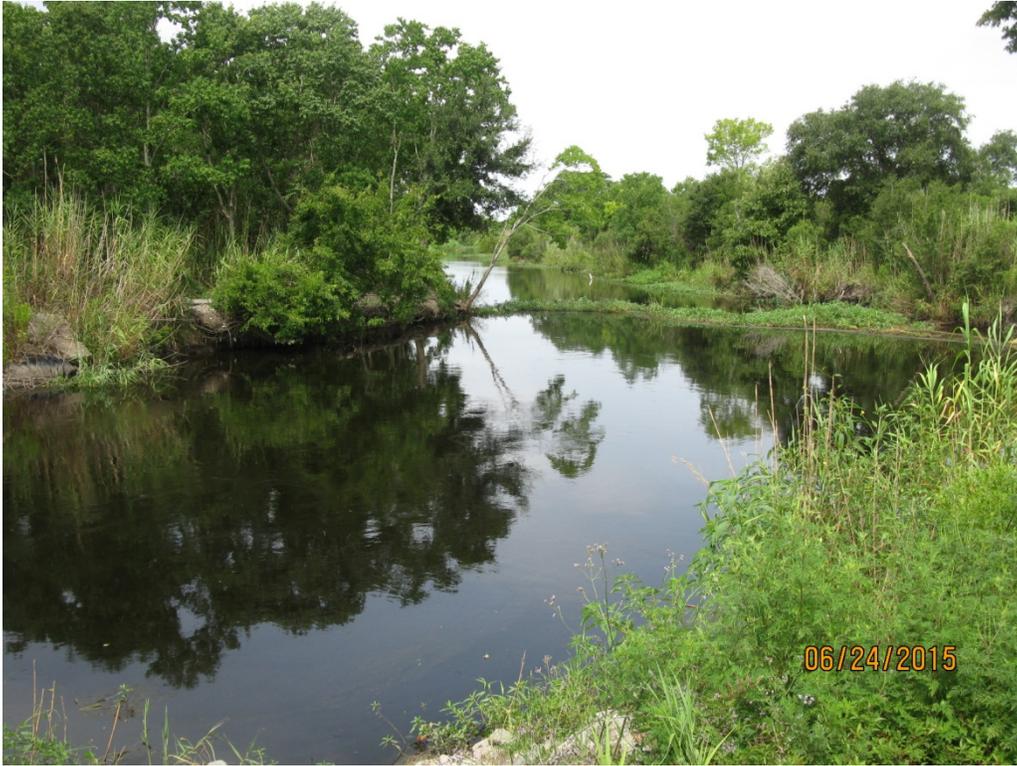
Photo 5: Salt Bayou Flowing into Project Area

Due to shallow water depths in Salt Bayou, the inspection team was not able to inspect this project feature by boat. Visual observation was performed from the Highway 90 shoulder adjacent to the culverts and revetment. The deadfall observed in the bayou last year appears to have been partially cleared, and water was flowing into the project area.
