2018 Annual Inspection Report

Hopedale Hydrologic Restoration

State Project Number PO-24
Priority Project List 8

September 25, 2018
St. Bernard Parish

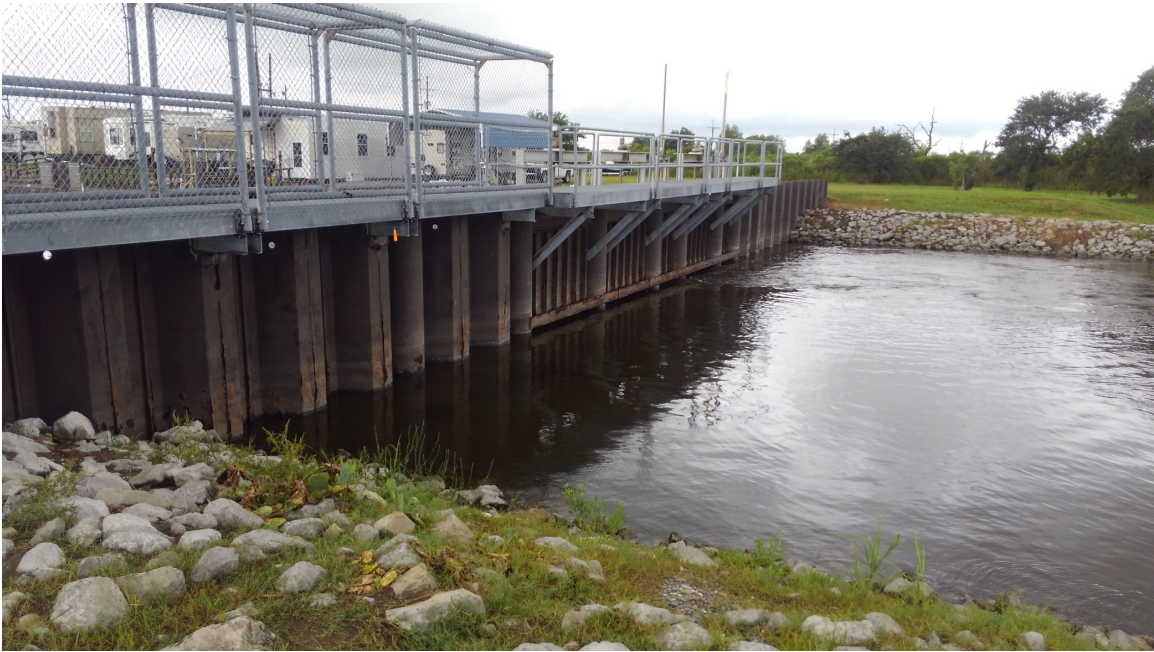
Hurricane Isaac passed through Southeast Louisiana on August 28, 2012. The only damage noted on this structure was a damaged stem cover on one of the Fish Gates.

Photo 1: Structure taken from Upstream Northeast Bank looking south

- Replace one vinyl gate stem cover.

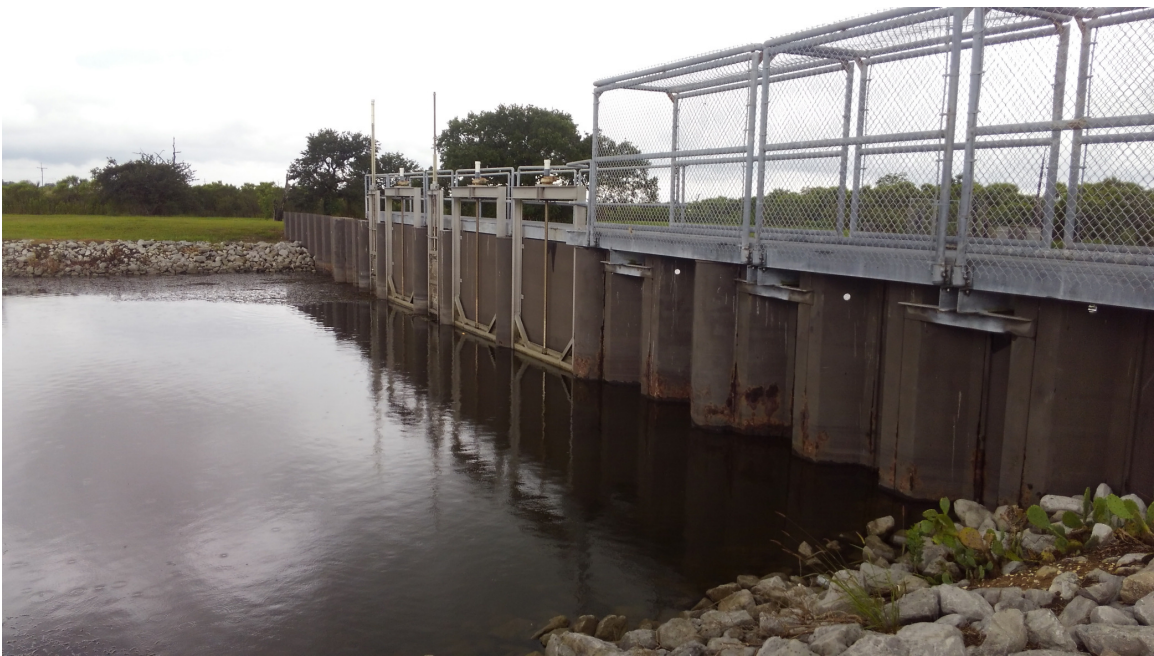
Photo 2: Gates taken from Downstream Northeast Bank looking west

Item	Condition	Physical Damage	Corrosion	Photo #	Observations and Remarks
Swing Gates 84" D	Good	None	None	1,2	
Fish Gates 24" x 84"	Good	None	None	1,2	One stem cover damaged in Hurricane Isaac.
Handrails Grating Hardware etc.	Good	None	None	1,2	
Galv. Pile Caps	Good	None	None		
Signage /Supports	Good	None	None		
Riprap	Good	None	None	1,2	
Silt/Fill	Good	None	None
