2017 Annual Inspection Report

**BRADY CANAL HYDROLOGIC
RESTORATION PROJECT (TE-28)**

State Project Number TE-28
Priority Project List 3

July 11, 2017
Terrebonne Parish

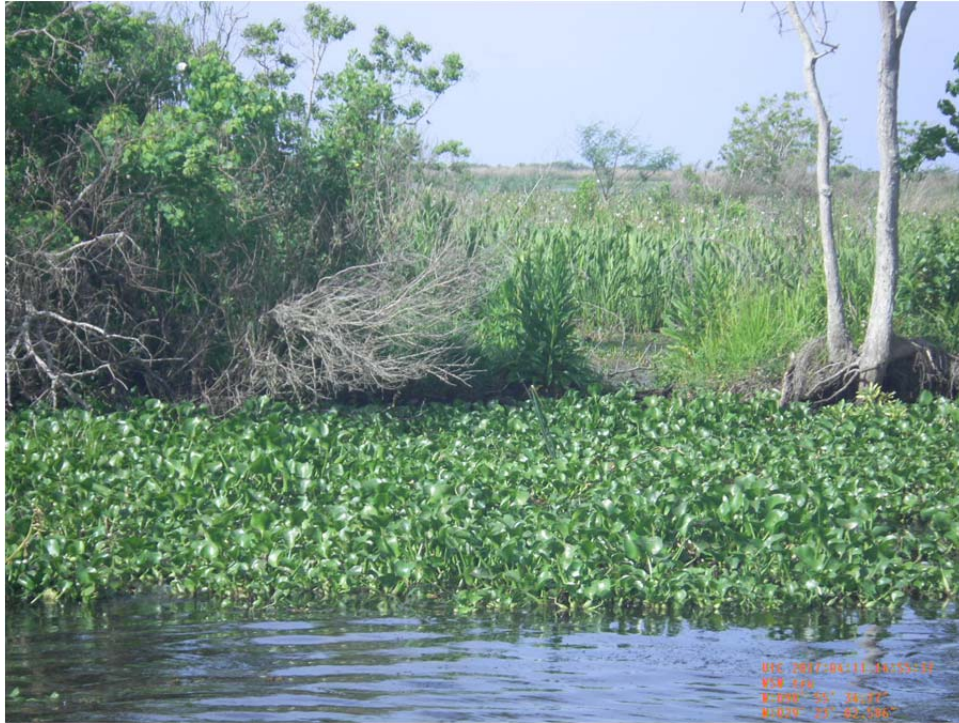
The inspection of the earthen embankments began with the west bank of Turtle Bayou (Appendix B, Photo 1) and progressed along Superior Canal, the dead end canal off of Superior Canal, Bayou Decade (Appendix B, Photos 4 - 8), Jug Lake (Appendix B, Photos 9, 10, 15, 19-21, 25 -27), through Voss Canal (Appendix B, Photo 24), Bayou Carencro (Appendix B, Photo 49-50), and concluded along Brady Canal at the Apache Camp location. The earthen embankments along Turtle Bayou and Superior Canal are in good condition. There are visual variations in the elevation and various vegetative species, but no noticeable breaches in the embankment. However, we did note a small breach, approximately 10' wide, in the bankline as reported on previous inspections (See Appendix B, Photos 1). We also noted a large breach along the west bank of Jug Lake between Structures 21 and 20. The breach appeared to be approximately 100' long and very shallow (See Appendix B, Photo 25 - 27). Earthen embankments along Bayou DeCade, Voss Canal and Carencro Bayou are in good condition with only a single breach noted along Carencro Bayou that was approximately 15' wide (See Appendix B, Photos 49 - 50). ConcoPhillips has indicated that they will repair this breach during their regular bank maintenance cycle.

Photo No.1 – view of small opening in the bank line along Turtle Bayou between Bayou De Cade and Superior Canal.

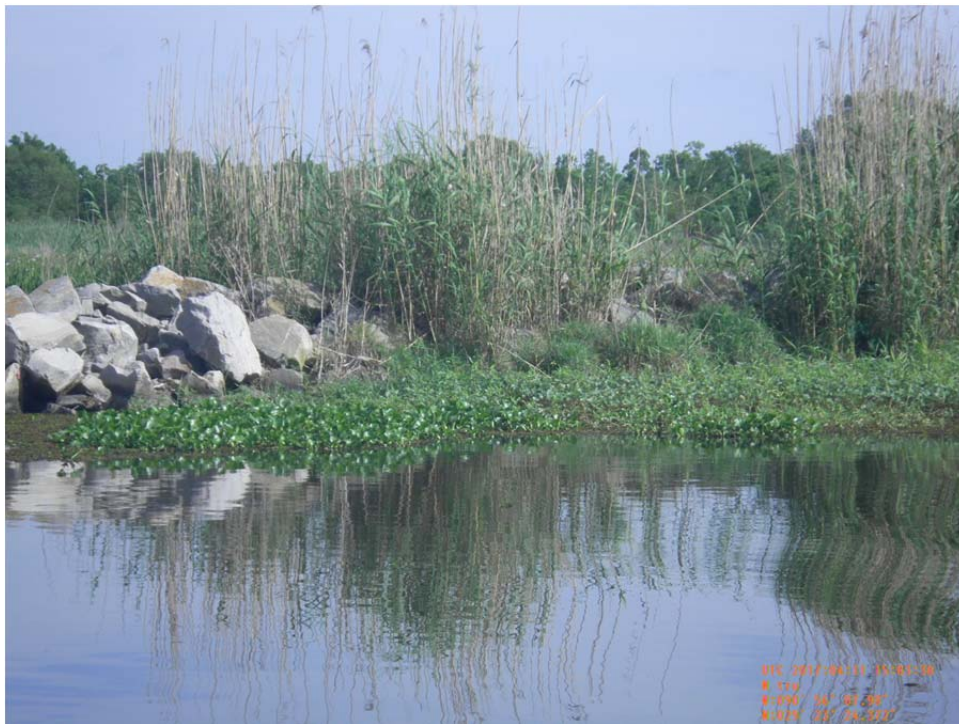
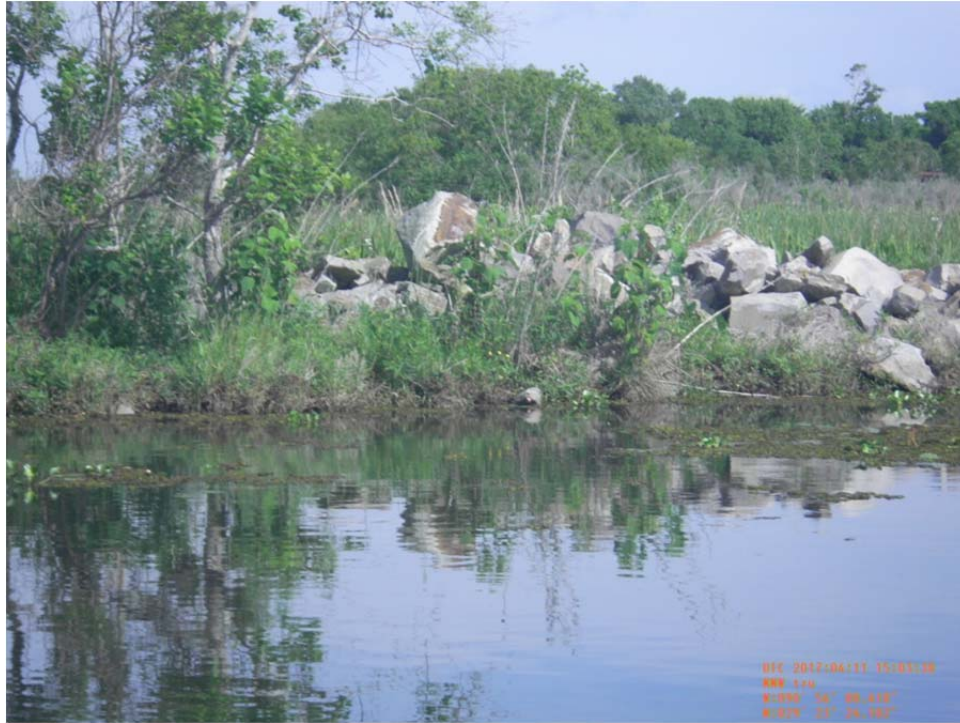
The rock plug known as "Breach 7" is located along an existing oil field access canal connected to Superior canal is in good condition. There was no observed settlement along the length of the embankment and no erosion or washouts around the embankment tie-ins. There are no recommendations for corrective action at this time, but it will continue to be monitored on future inspections. (See Appendix B, Photos 2-3)

Photo No.2 – view of bank tie-in of rock plug on the northeast side of the structure. This structure was completed in 2003 and is designated as Breach 7 on the project map.

Photo No.3 – view of bank tie-in of rock plug on the southwest side of the structure. This structure constructed in 2003 and is designated as Breach 7 repair on the project map.

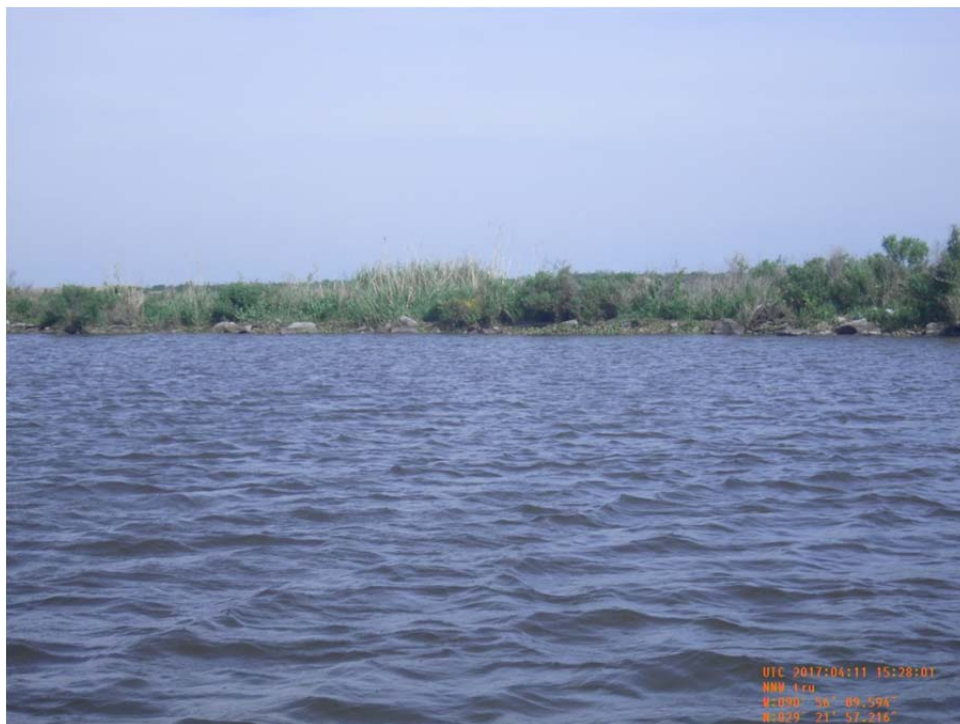
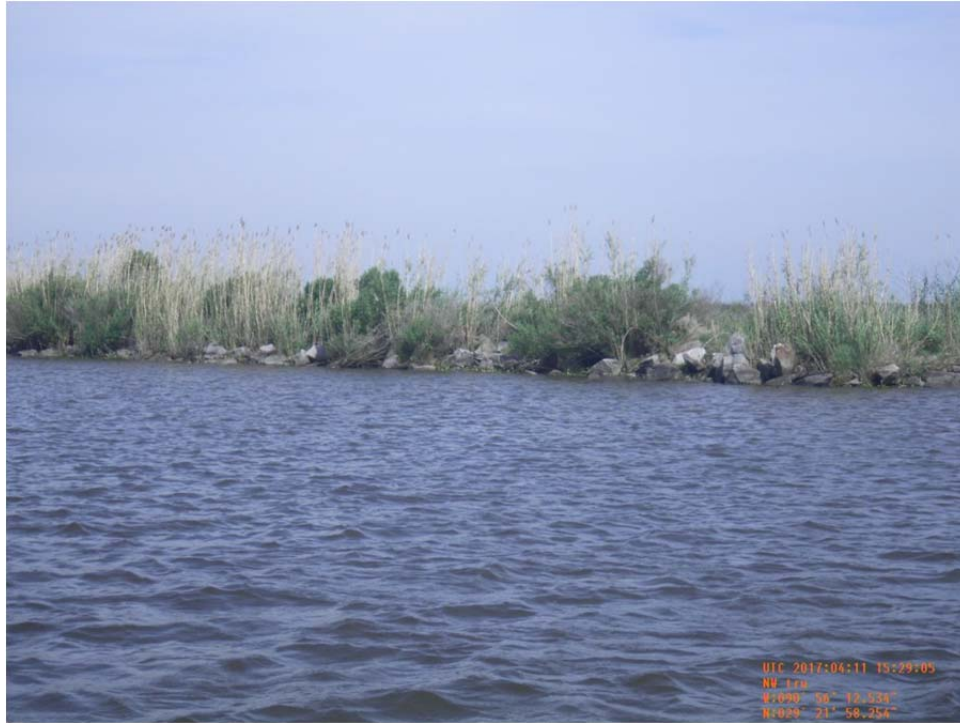
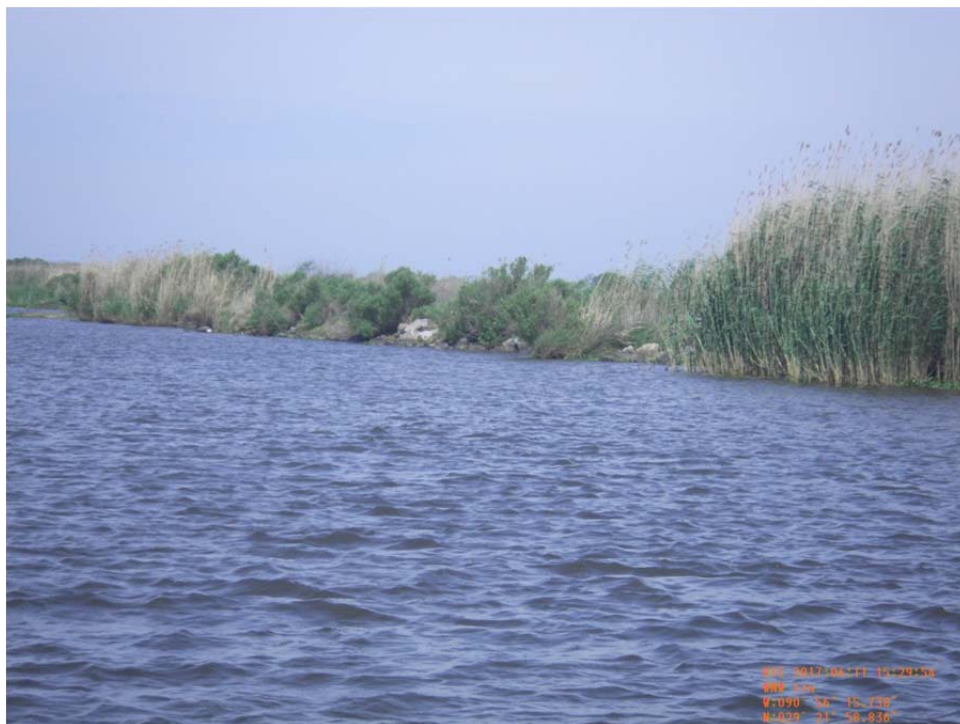
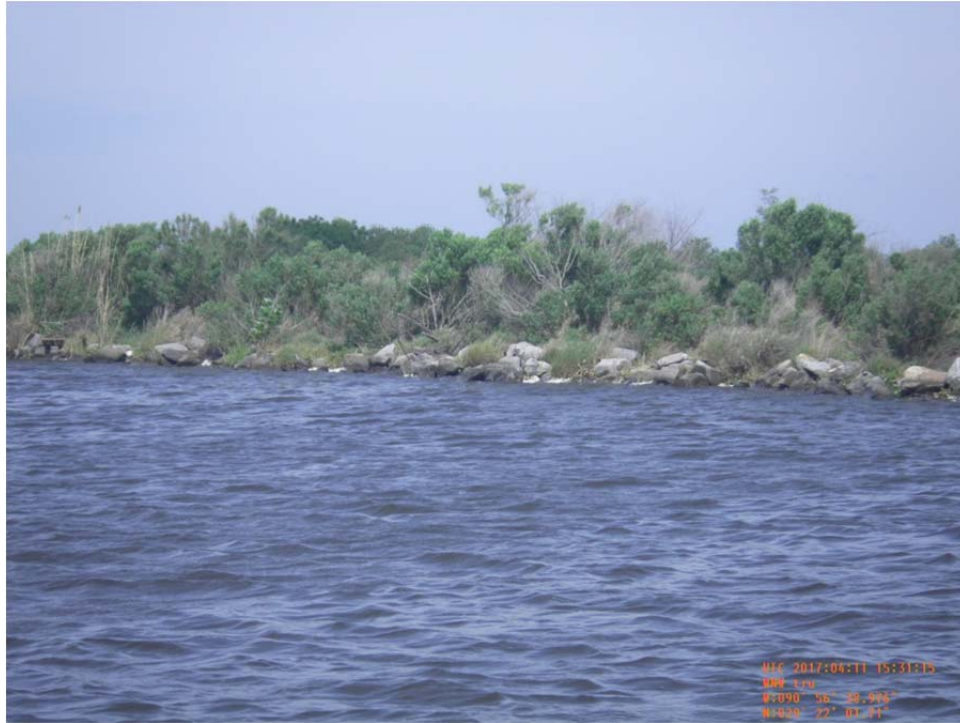
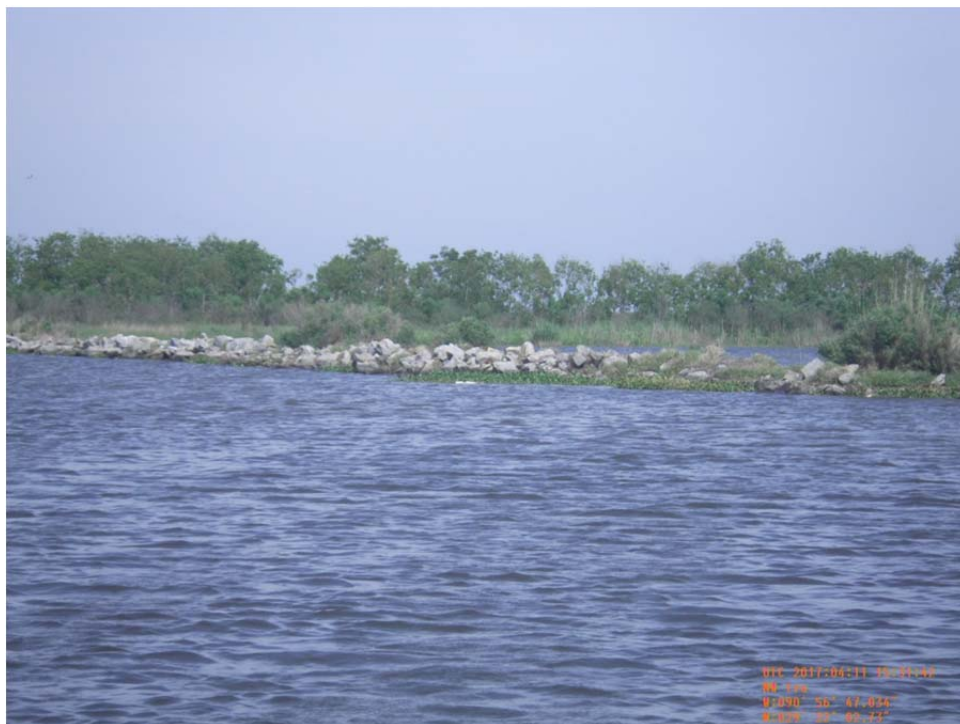
The rock armored embankments and rock dikes along the north bank of Bayou Decade (Appendix B, Photos 4-8) and Voss Canal (Photos 41-42, 44) are in good condition. The rock dike along Bayou Decade between Jug Lake and Turtle Bayou appear to be in fair condition with isolated low areas and moderate displacement of rock riprap. The earthen embankment with rock revetment west of Structure 7 along Bayou Decade appears to be in good condition

Photo No.4 – view of east section of the rock dike shoreline repair constructed in 2003 along the north bank of Bayou de Cade. This structure is designated as Breach 1-4 on the project map.

Photo No.5 – view of the rock dike shoreline repair (Breach Repair 1-4) located along the north bank of Bayou de Cade.

Photo No.6 – view of the rock dike shoreline repair (Breach Repair 1-4) located along the north bank of Bayou de Cade.

Photo No.7 – view of the rock dike shoreline repair (Breach Repair 1-4) located along the north bank of Bayou de Cade.

Photo No.8 – view of the rock dike shoreline repair (Breach Repair 1-4) located along the north bank of Bayou de Cade.

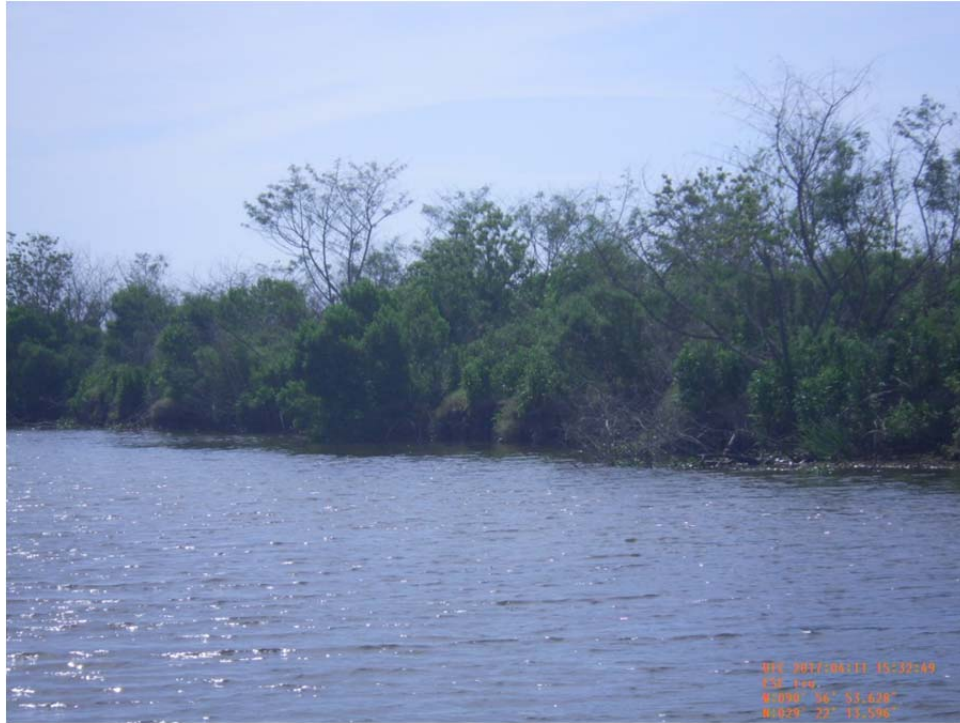
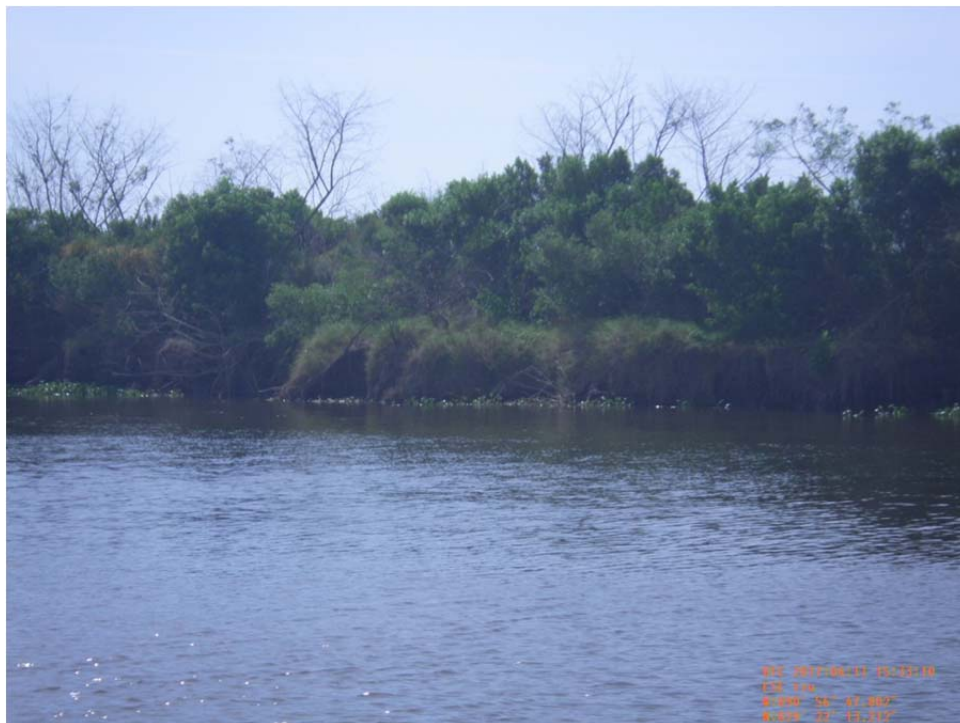
Photo No.9 – view of the earthen embankment along the south bank of Jug Lake.

Photo No.10 – view of the earthen embankment along the south bank of Jug Lake.

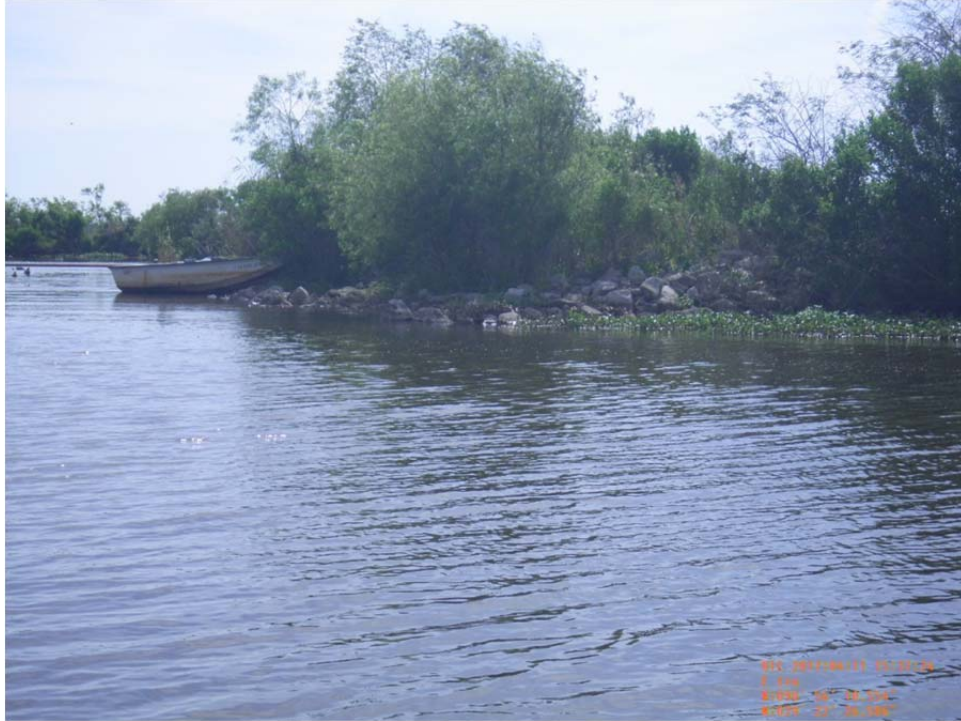
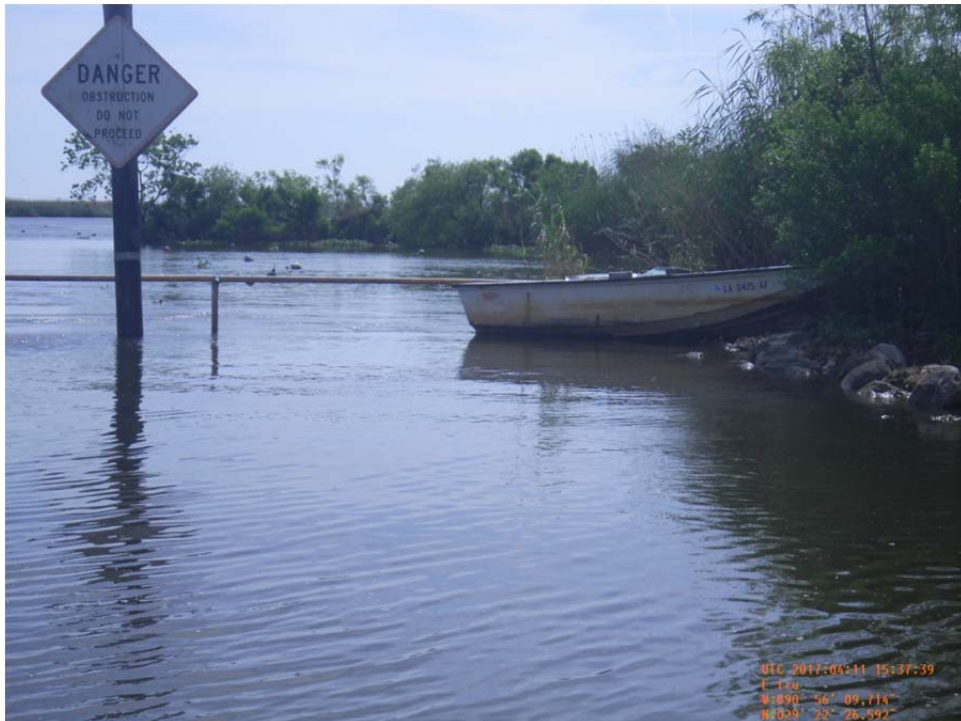
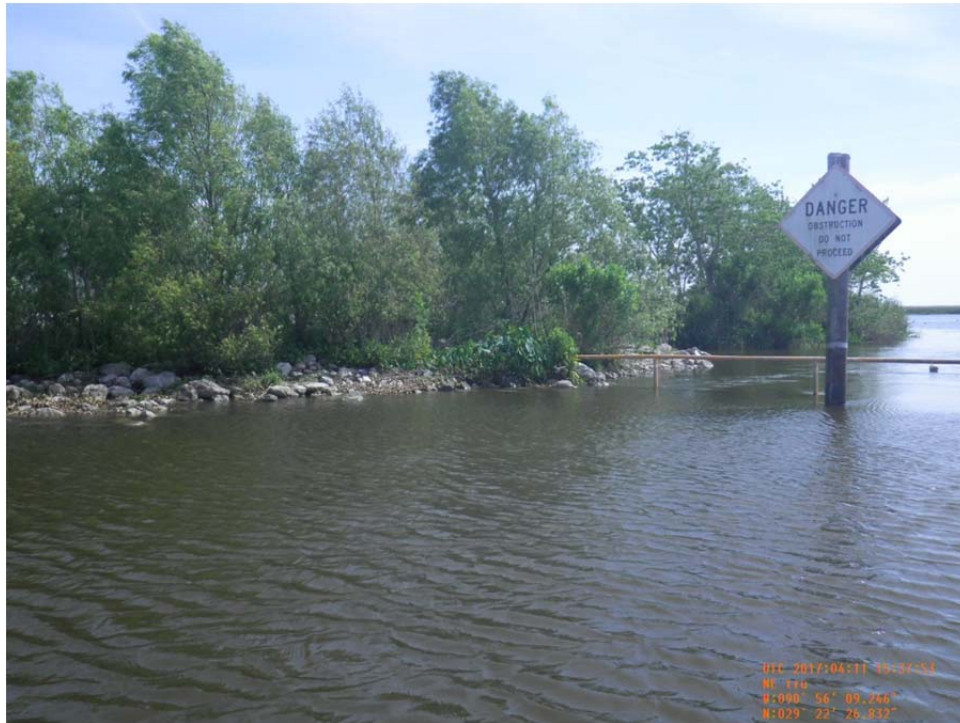
Overall, Structure 24 is in fair condition. There is no visible damage to the steel bulkhead, platform, or the warning signs and their timber supports. However, we did note that one section of the steel handrail had sheared at the welded seam. It is not clear whether the steel pipe had been intentionally cut or if the damage was caused by corrosion (Photo 14). The handrail is welded to the top of the steel bulkhead and does not affect the structure integrity of the weir. As noted on previous inspections, there was a hull of a small recreational fishing vessel is lodged against the structure. The hull doesn't seem to be causing any damage to the structure (Photo 12). As part of the 2012 Maintenance Project, Structure No. 24 had both of its embankment tie-ins refurbished and armored with rock riprap on both sides to prevent any further erosion around the ends of the structure. There has not been any visual settlement of the riprap following the completion of the maintenance project. Structure No. 24 has been restored to its original constructed condition and will not require maintenance. (See Appendix B, Photos 11 - 14)

Photo No.11 – view of the south bank rip rap tie-in of Structure 24.

Photo No.12 – view of the south bank rip rap tie-in of Structure 24 and abandoned boat hull.

Photo No.13 – view of the north bank rip rap tie-in of Structure 24.

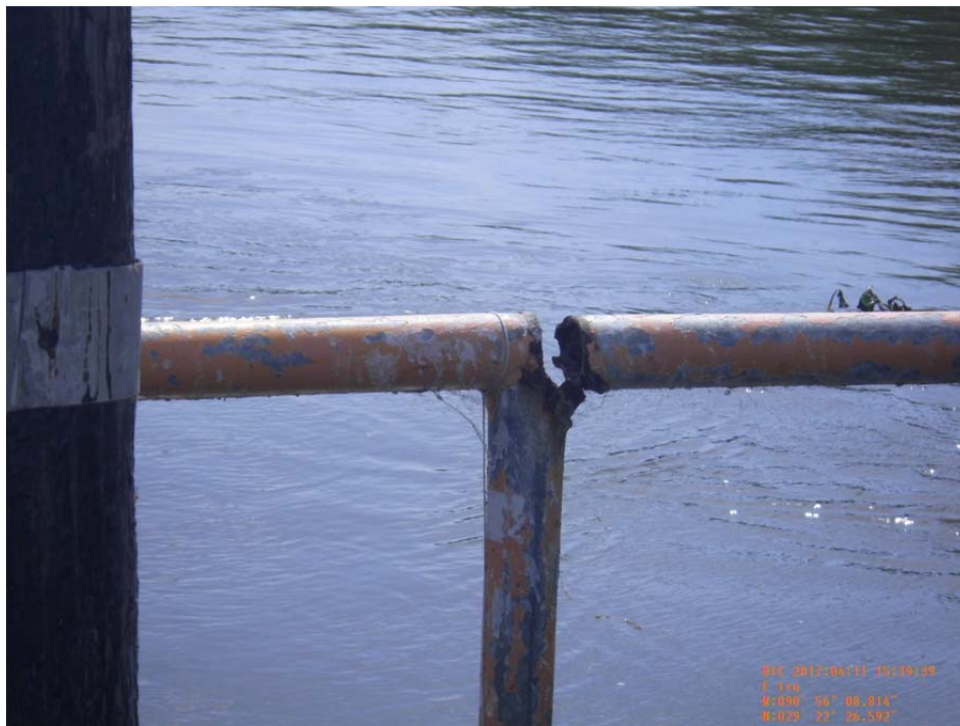
Photo No.14 – view of a break in the steel pipe hand rail on the south side of Structure 24.

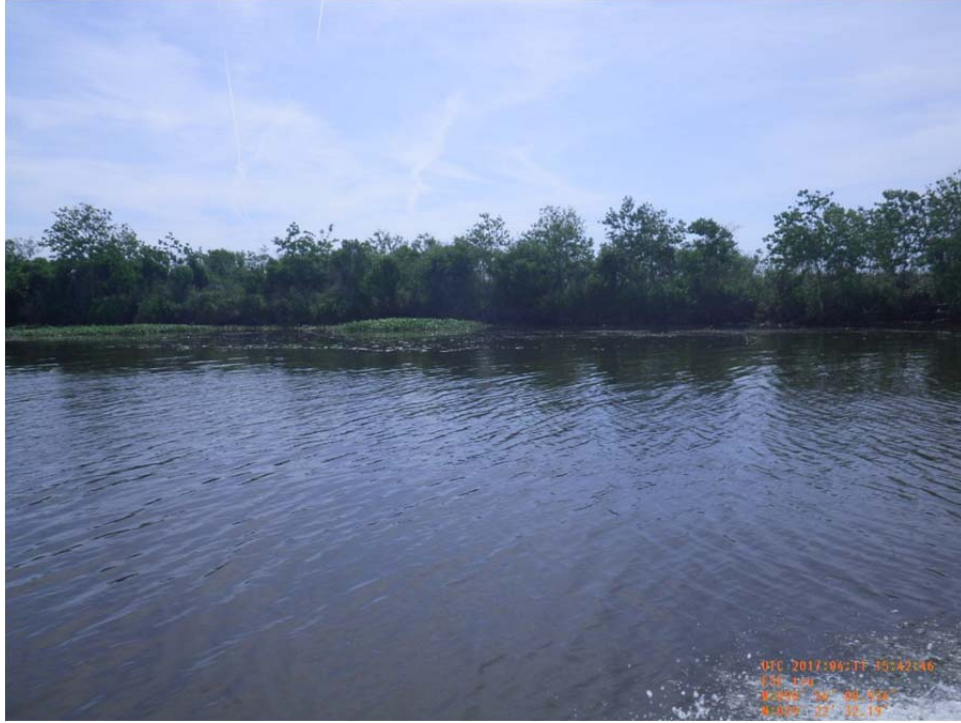
Photo No.15 – view of the earthen embankment along the south bank of Jug Lake between Structure 24 and 23.

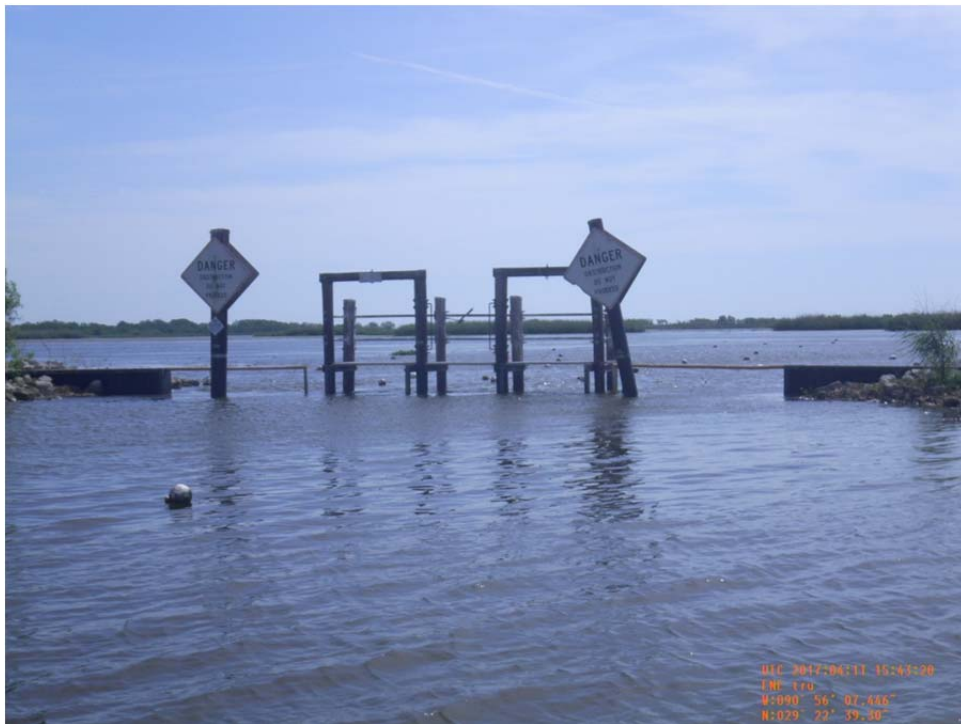
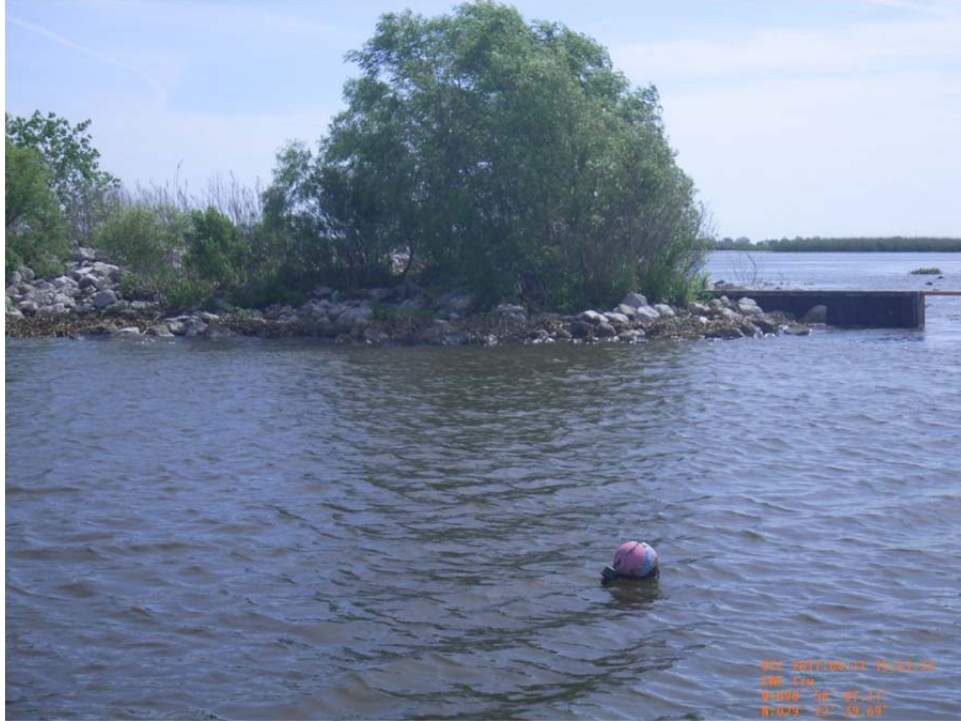
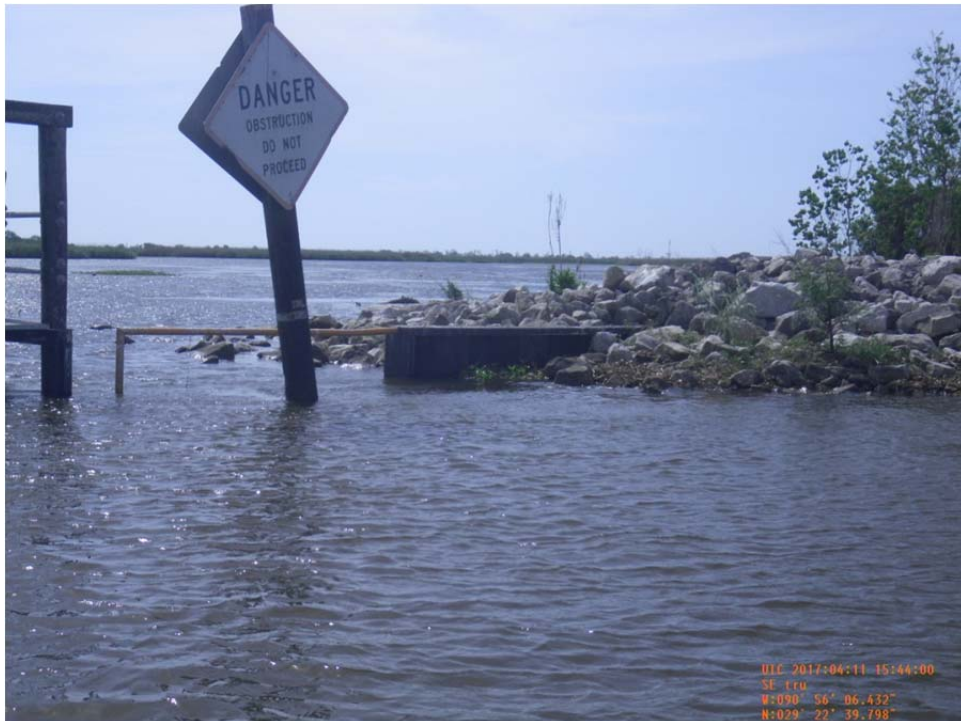
Structure 23 appears to be in good condition as well. There is no visible damage to the steel bulkhead, railings, platform, or the warning signs and their timber supports. As part of the 2012 Maintenance Project, Structure 23 had both of its embankment tie-ins refurbished and then armored with 50 linear feet of rock riprap in each direction to prevent any further erosion around the ends of the structure. There has not been any visual settlement of the riprap following the completion of the maintenance project. Structure 23 has been restored to its original constructed condition and will not require maintenance. (See Appendix B, Photos 16 - 18)

Photo No.16 – view of Structure 23 located along the east bank of Jug Lake.

Photo No. 17 – view of the north bank riprap tie-in of Structure.23.

Photo No. 18 – view of the south bank riprap tie-in of Structure 23.

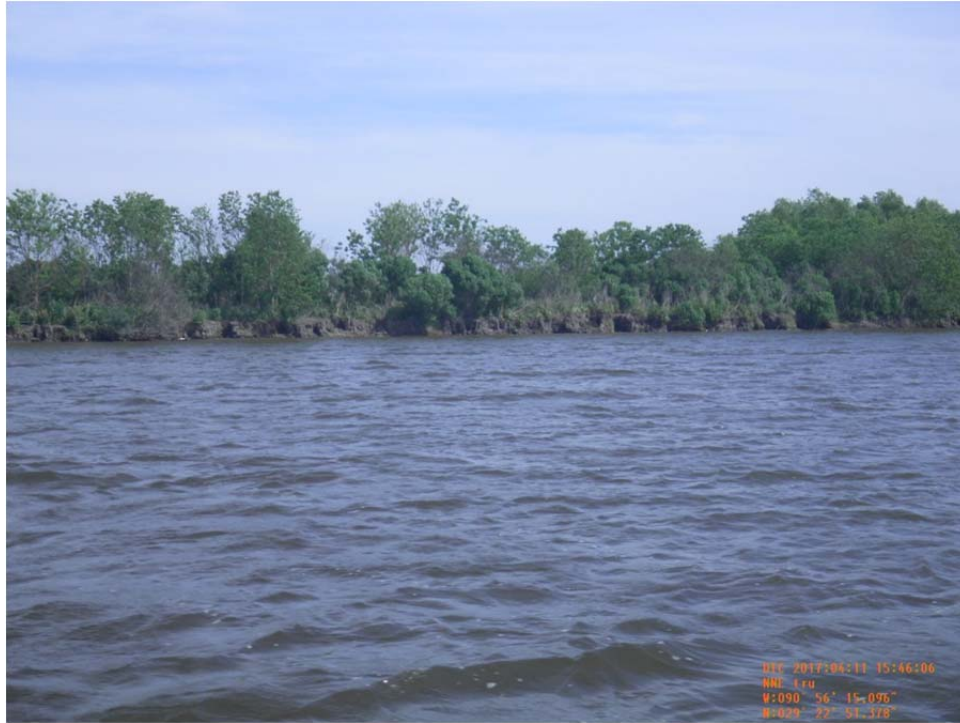
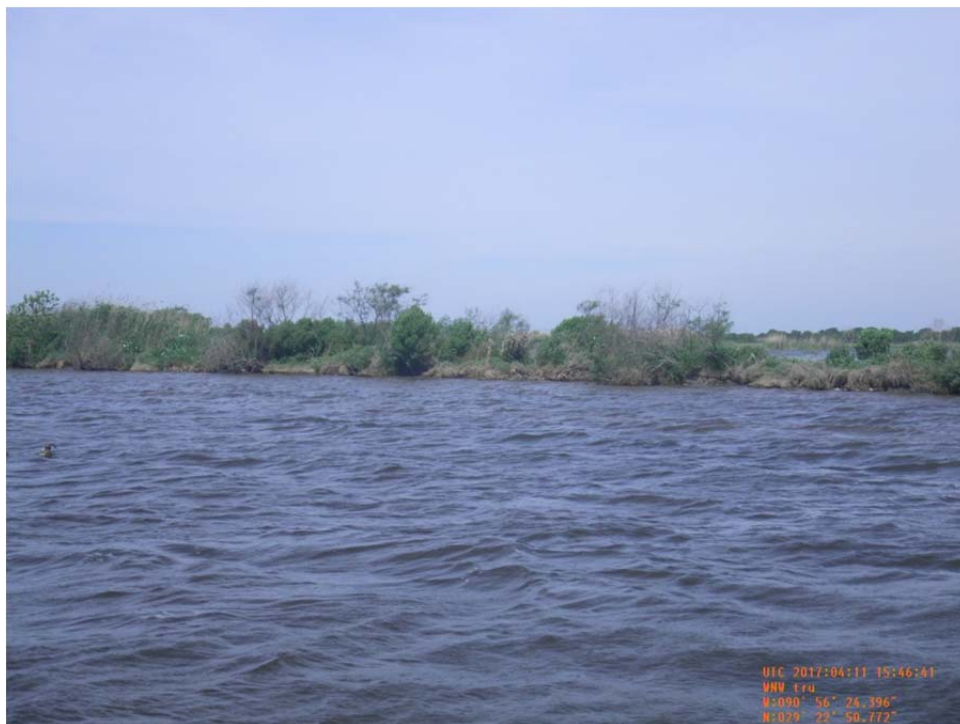
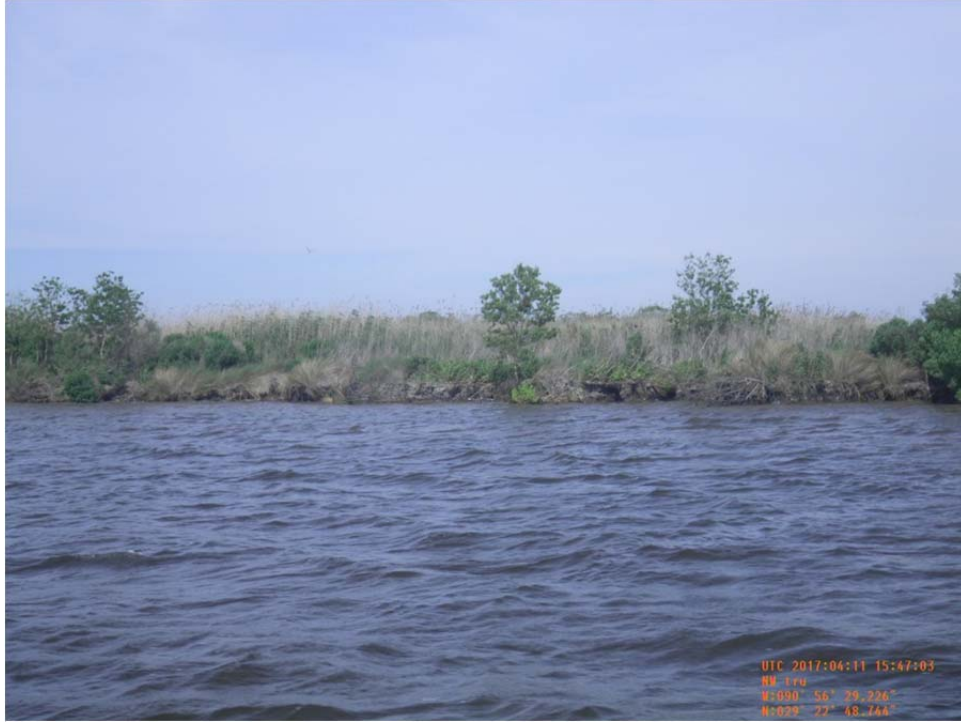
Photo No.19 – view of the earthen embankment along the north bank of Jug Lake east of Structure 21.

Photo No.20 – view of the earthen embankment along the north bank of Jug Lake east of Structure 21.

Photo No.21 – view of the earthen embankment along the north bank of Jug Lake east of Structure 21.

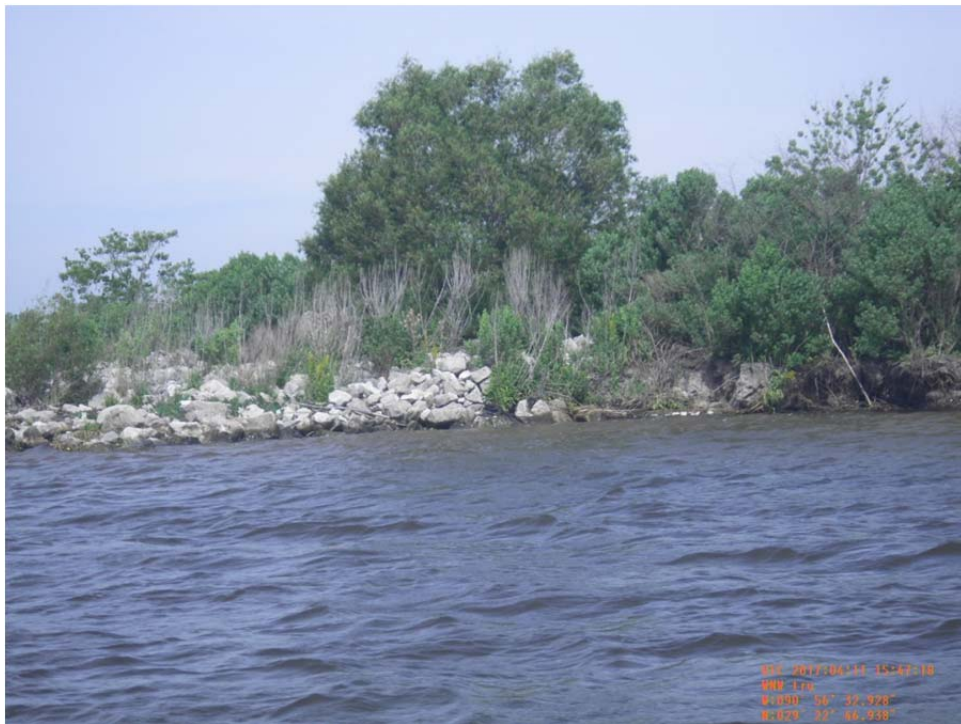
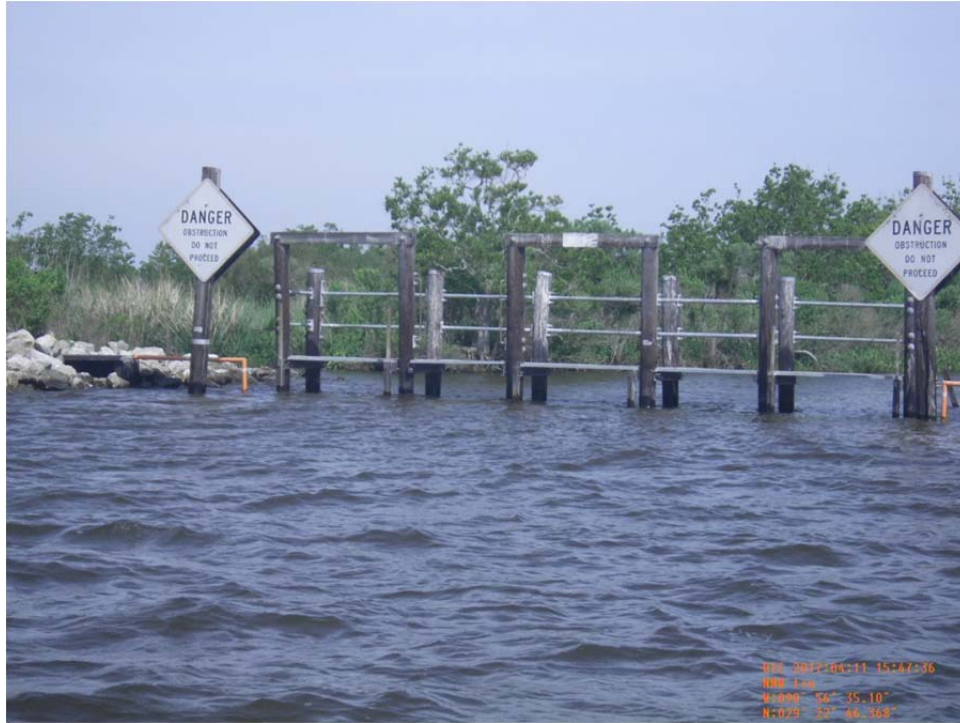
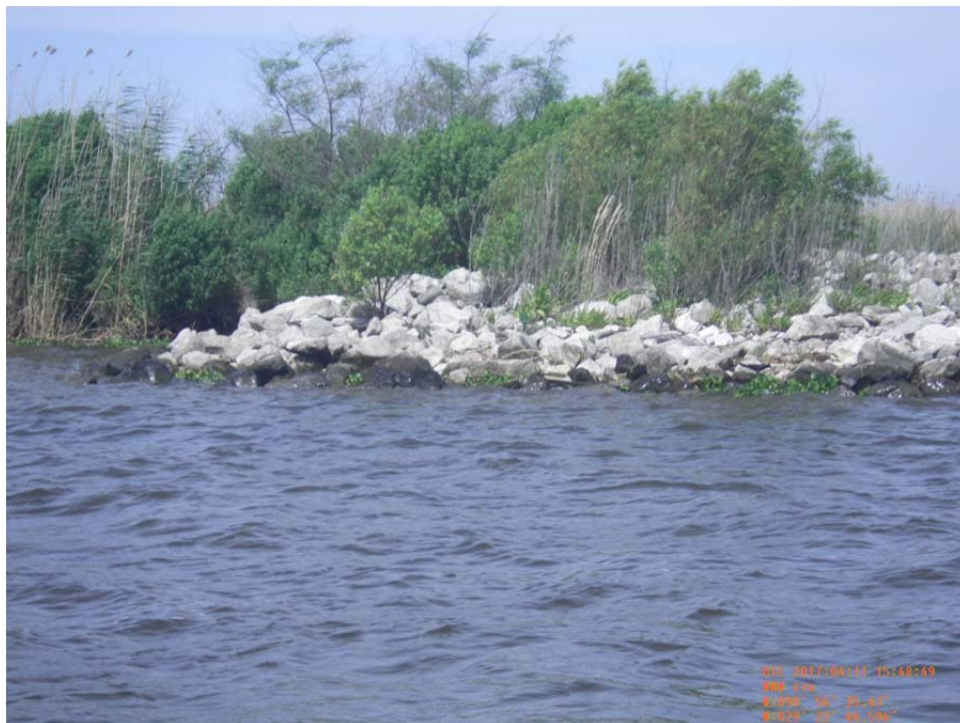
Overall, Structure 21 is in very good condition. There is no visible damage to the steel bulkhead, railings, platform or the warning signs and their timber supports. As part of the 2012 Maintenance Project, Structure 21 had both of its embankment tie-ins refurbished and then armored with 50 linear feet of rock riprap to prevent any further erosion around the ends of the structure. There has not been any visual settlement of the riprap following the completion of the maintenance project. Structure 21 will not require maintenance. (See Appendix B, Photos 22 - 24)

Photo No.22 – view of the north bank riprap tie-in on Structure 21.

Photo No.23 – view of the variable crest weir Structure 21.

Photo No.24 – view of the south bank riprap tie-in on Structure 21.

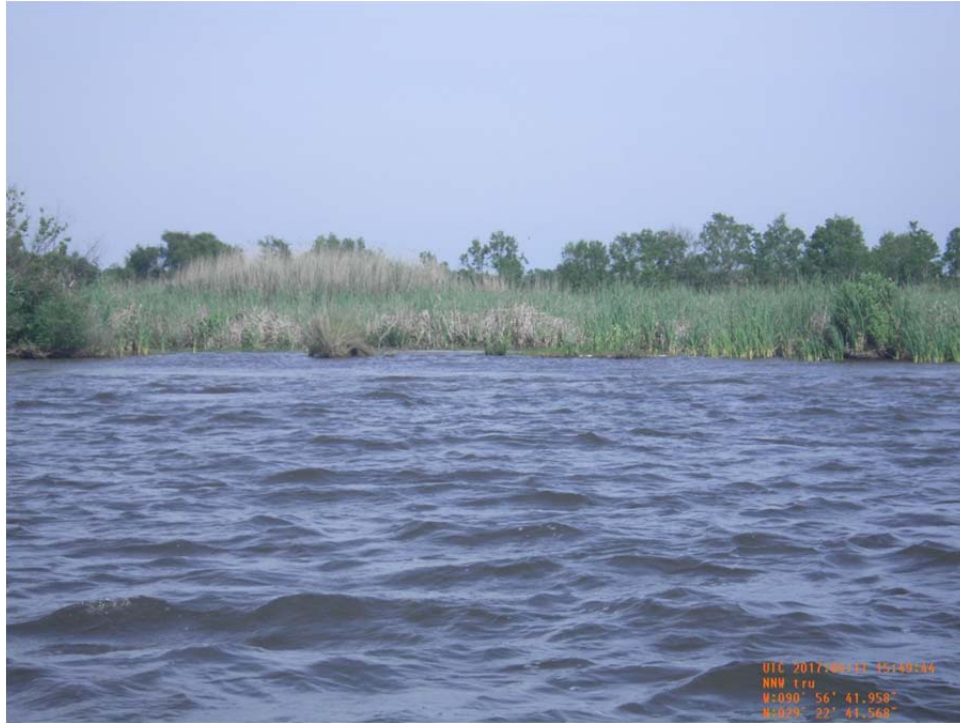
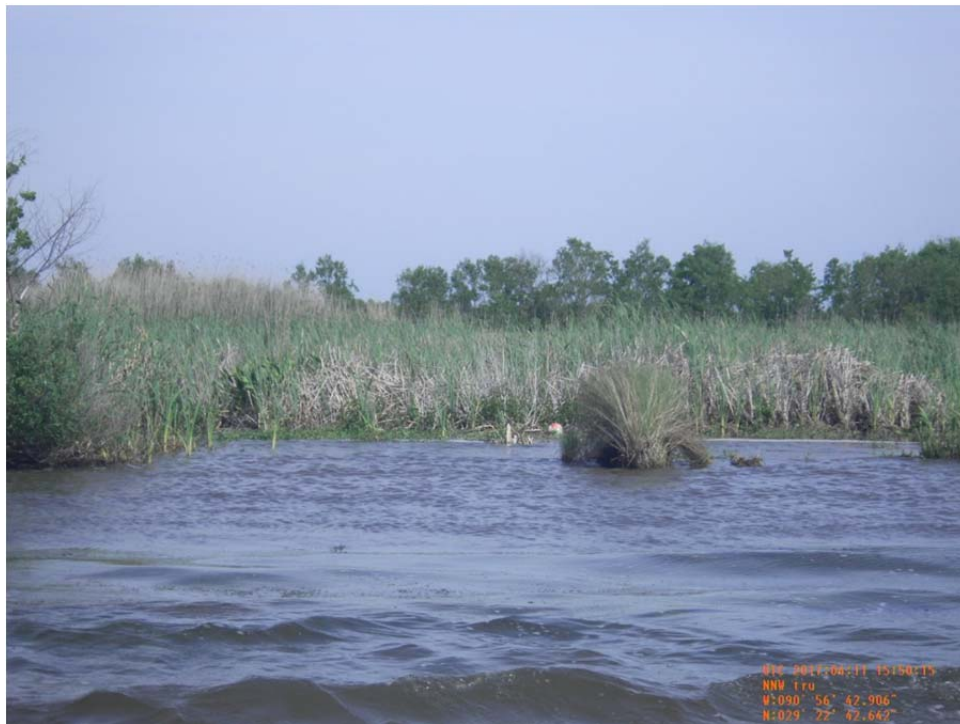
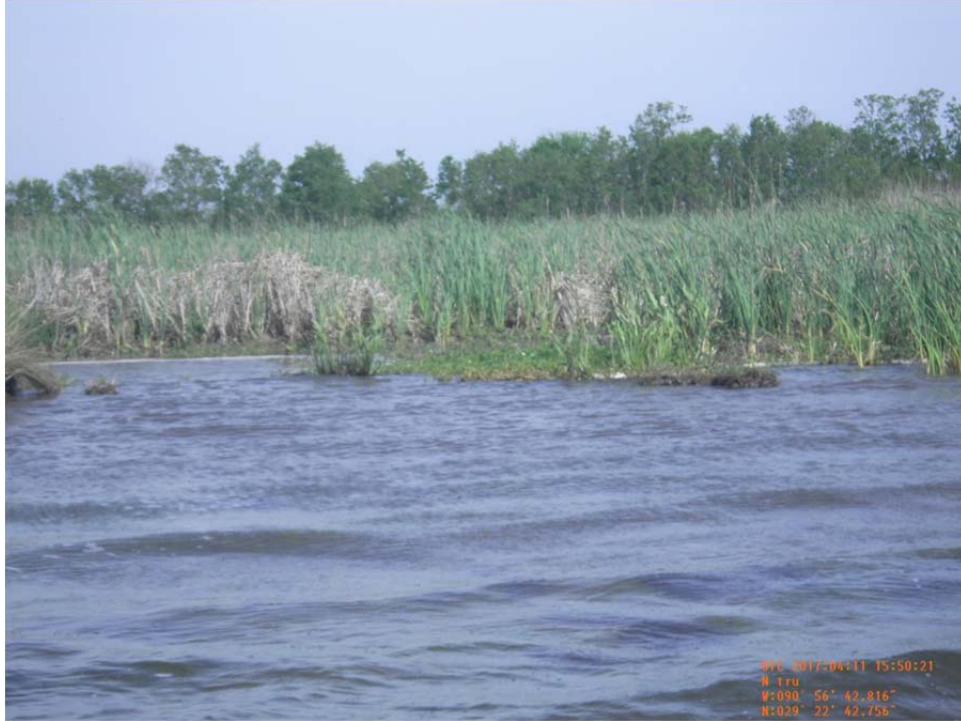
Photo No.25 – view of the existing shoreline along the north bank of Jug Lake between Structures 21 and 20.

Photo No.26 – view of the existing shoreline along the north bank of Jug Lake between Structures 21 and 20.

Photo No.27 – view of the existing shoreline along the north bank of Jug Lake between Structures 21 and 20.

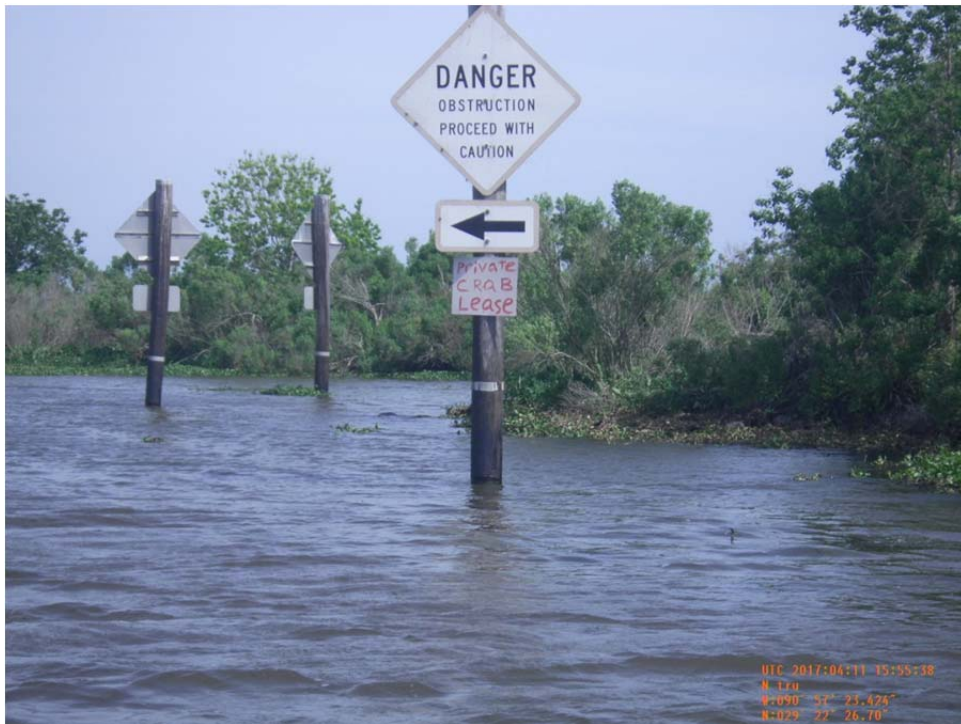
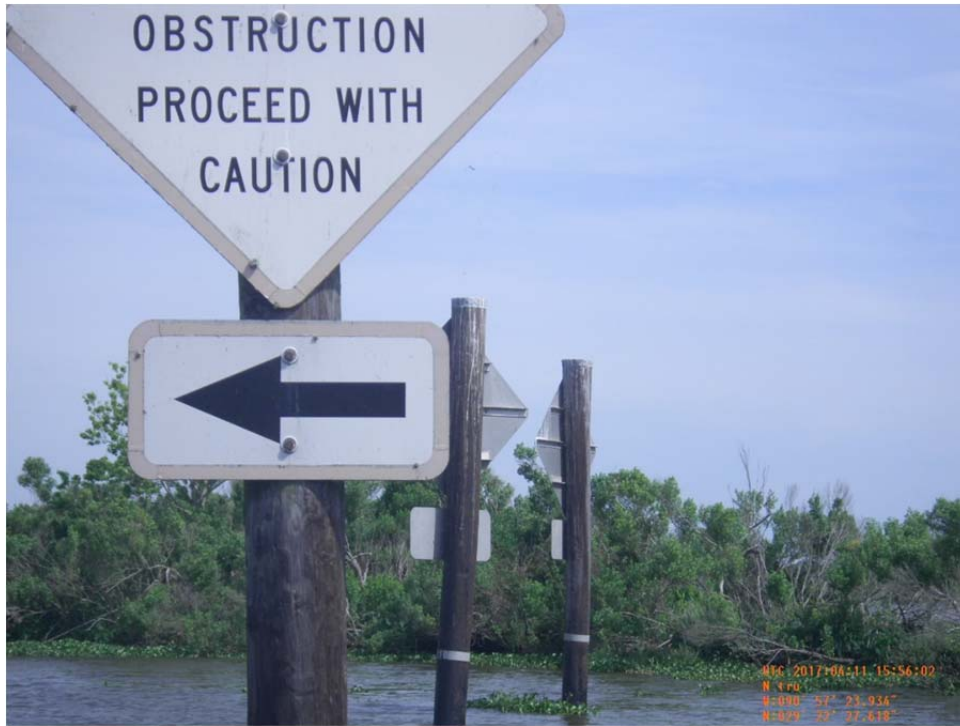
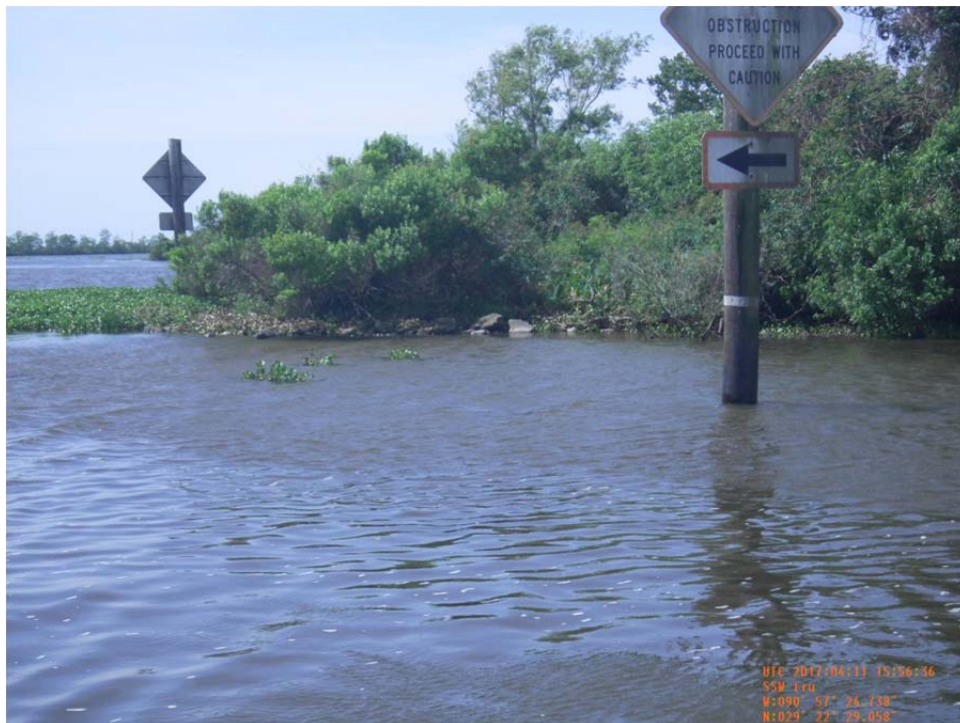
This structure is in good overall condition. As noted in previous annual inspections, there has been some settlement of the rock riprap on the bank tie-ins and submerged crest of the

structure. During the 2016 inspection, the depth of water at the center of the rock channel liner was approximately 8.5', which translates into crest elevation of -6.1' elevation. The water levels at the time of the inspection was +2.4' NAVD. From our calculations, Structure 20 has experienced approximately 1.35' settlement since the structure was constructed in 1998. All other warning signs and timber supports are in good condition. At this time, Structure 20 is in good condition and no maintenance will be required. (See Appendix B, Photo 28 - 30)

Photo No.28 – view of the north riprap to bank tie-in on Structure 20.

Photo No. 29 – view of warning signs at Structure 20

Photo No.30 – view of the south riprap to bank tie-in on Structure 20.
