2017 Annual Inspection Report

**BRADY CANAL HYDROLOGIC
RESTORATION PROJECT (TE-28)**

State Project Number TE-28
Priority Project List 3

July 11, 2017
Terrebonne Parish

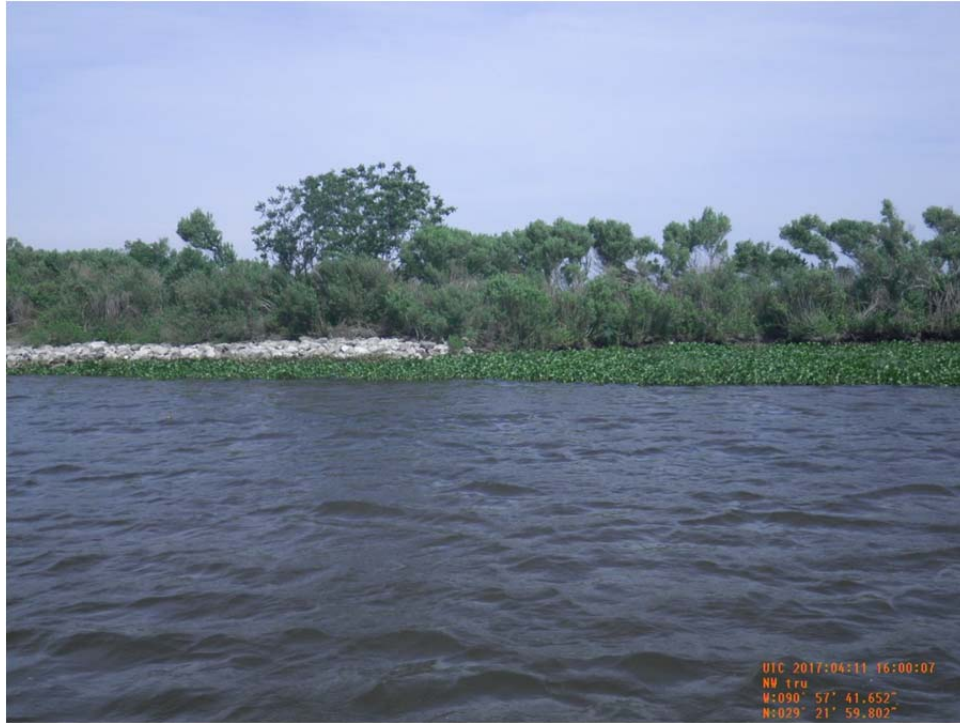
Photo No. 31 – view of the rock revetment along north bank of Bayou Decade west of Jug Lake.

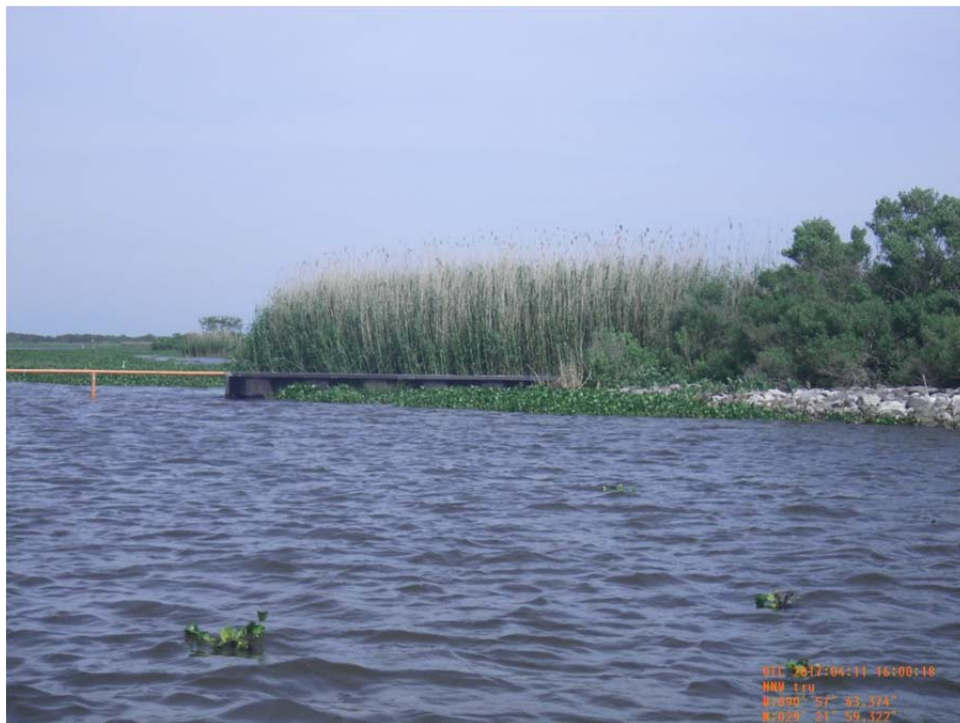
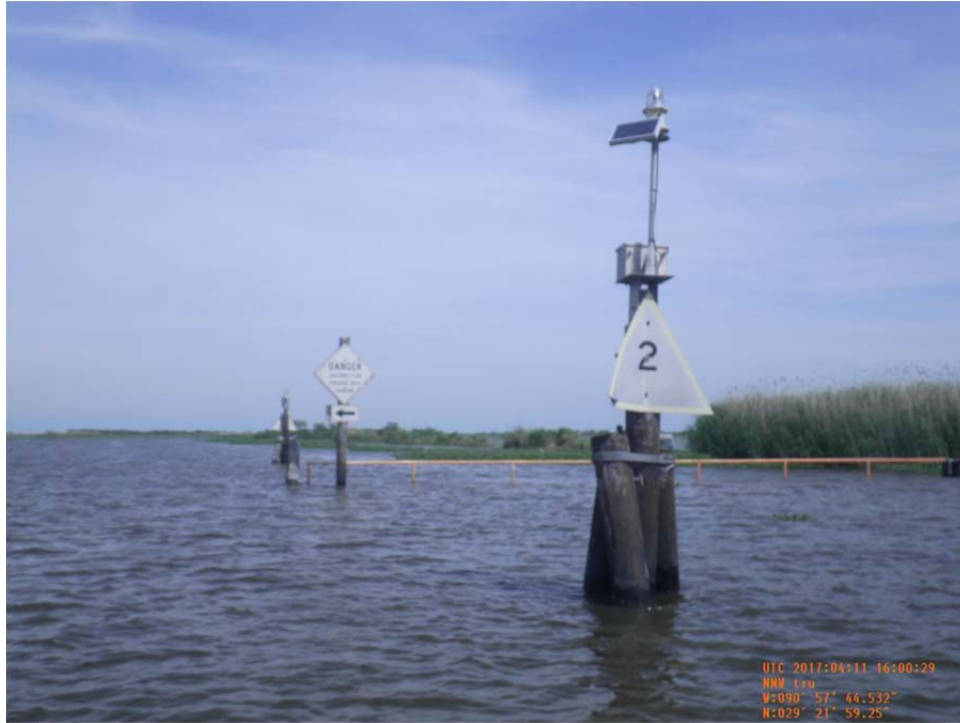
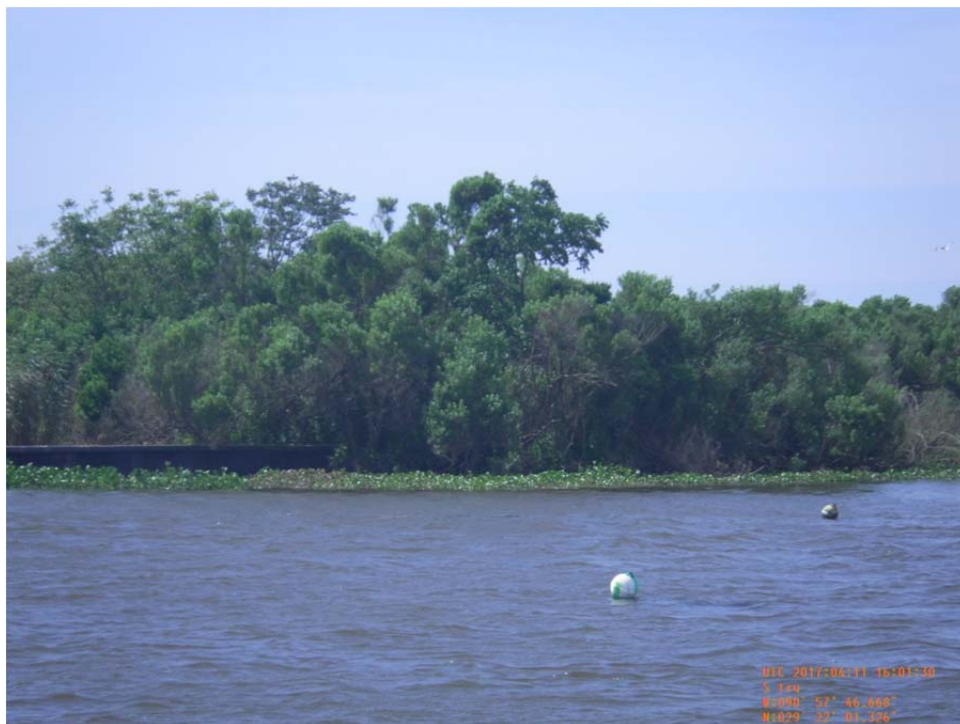
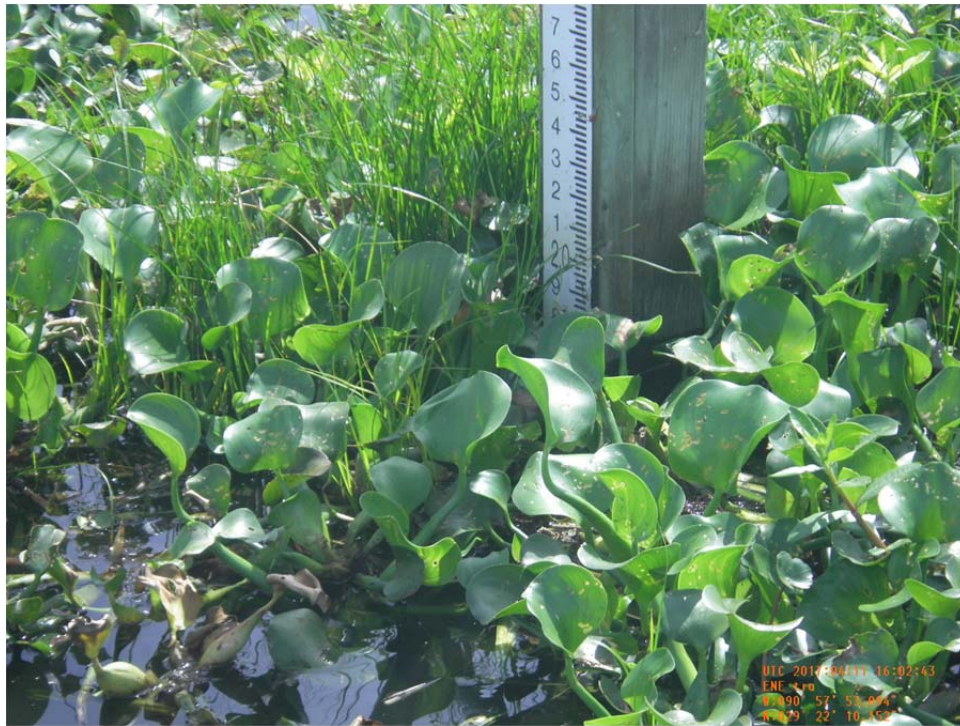
Structure 6 appears to be in good condition. The bank tie-ins are stable and there are no signs of erosion or breaching around the steel bulkhead or rock tie-ins. The timber navigational aid supports, signs and lights are visible and appear to be in good condition. The navigational aid structures are inspected quarterly through a state-wide contract with Pharo-Marine Automatic Power, Inc. and no major maintenance has been reported. The gauge reading from the CPRA continuous recorder, located just north of Structure 6 indicated that the water elevation was approximately +1.6' NAVD88 at 10:30 a.m. No maintenance will be required at Structure No.6. (See Appendix B, Photos 32 - 35)

Photo No.32- view of the steel sheetpile to bank tie-in on the east side of Structure 6.

Photo No. 33 – view of the warning signs and navigational aids at the entrance of the barge bay at Structure 6.

Photo No. 34 – view of the steel sheetpile to bank tie-in on the west end of Structure 6

Photo No. 35 – view of the staff gauge on the CRMS data recorder just north of Structure 6.

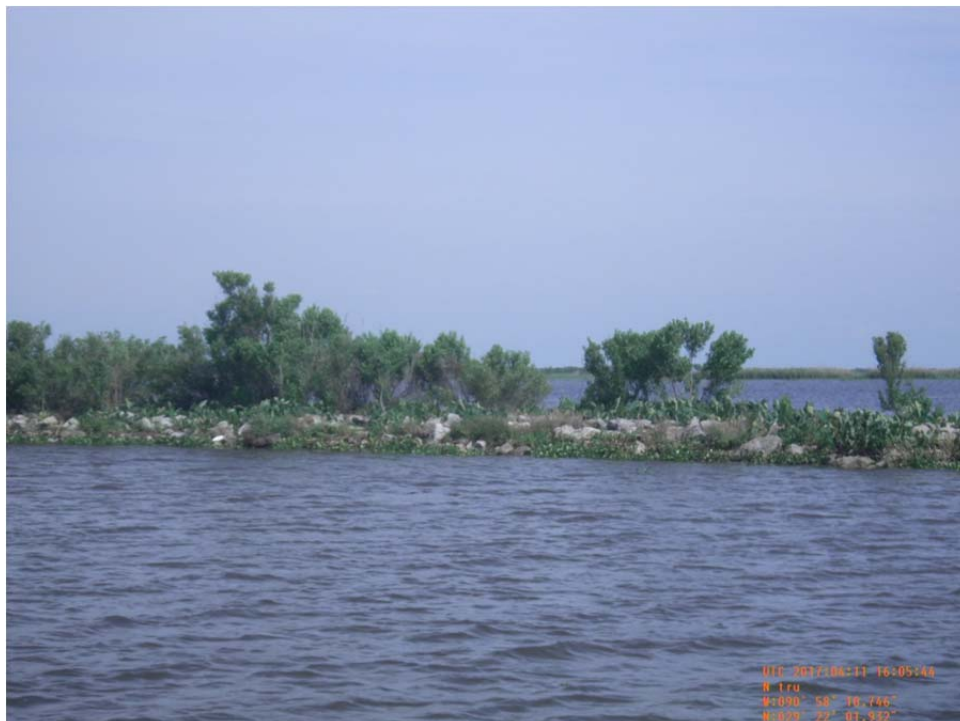
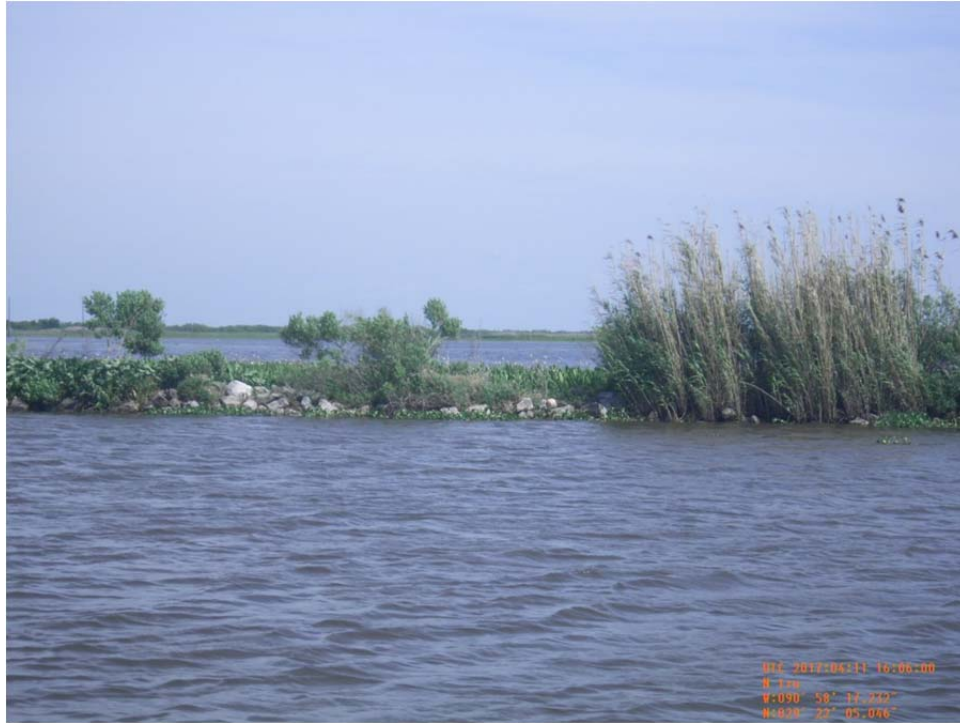
Photo No.36 – view of rock revetment along the north bank of Bayou de Cade between Structures 6 and 7.

Photo No.37 – view of rock revetment along the north bank of Bayou de Cade between Structures 6 and 7.

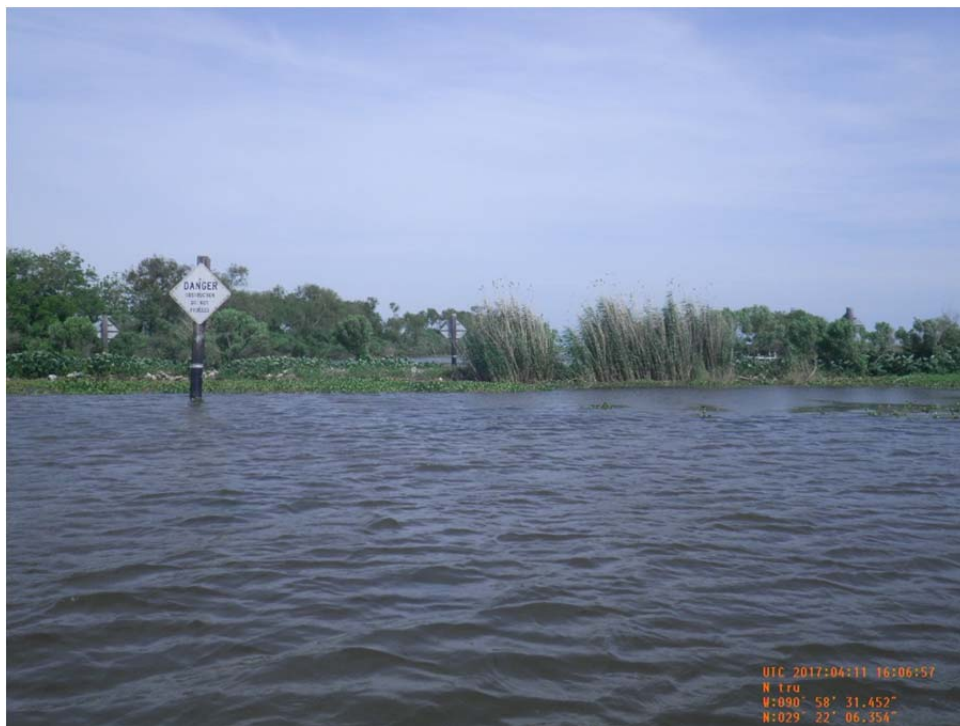
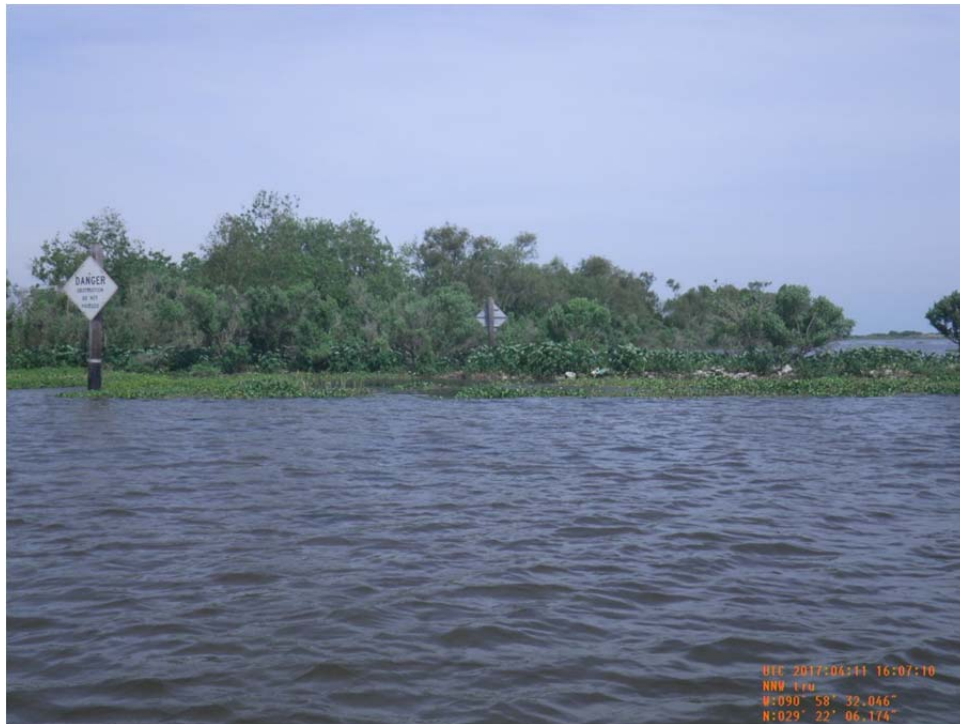
Structure 7 appears to be in good condition with no obvious settlement, breaches, or defects other than heavy vegetation on and around the rock plug. The warning signs and supports located on both sides of the structure are in good condition. Currently, there are no recommendations for maintenance (Appendix B, Photos 38 - 39).

Photo No.38 – view of rock plug 7 along the north bank of Bayou de Cade.

Photo No.39 – view of rock plug 7 along the north bank of Bayou de Cade.

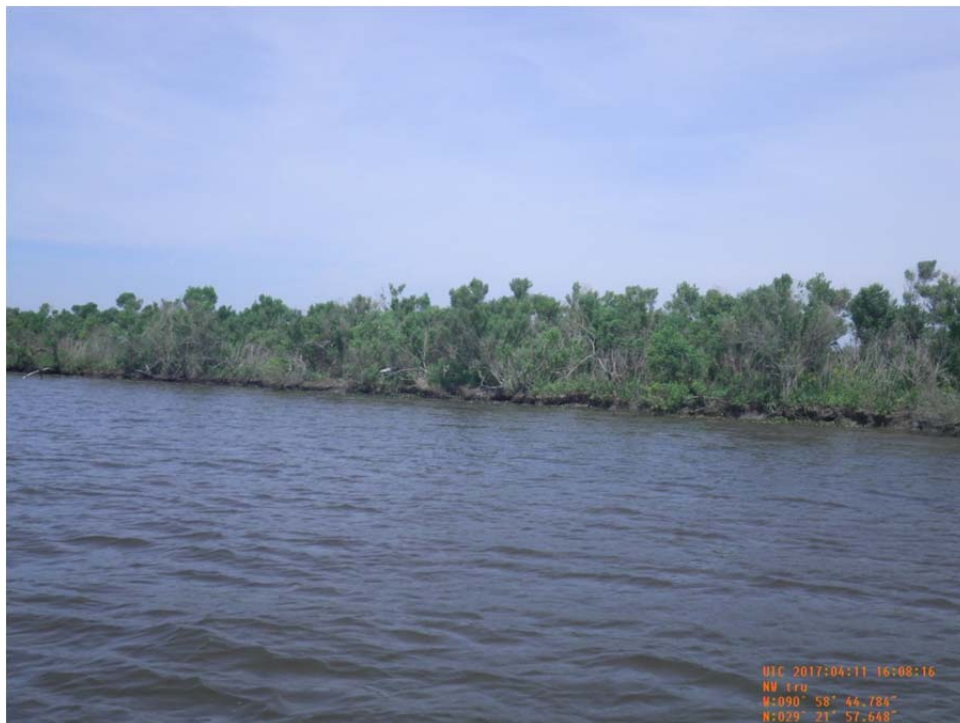
Photo No.40 – view of existing shoreline along the north bank of Bayou de Cade between Structure 7 and Voss Canal.

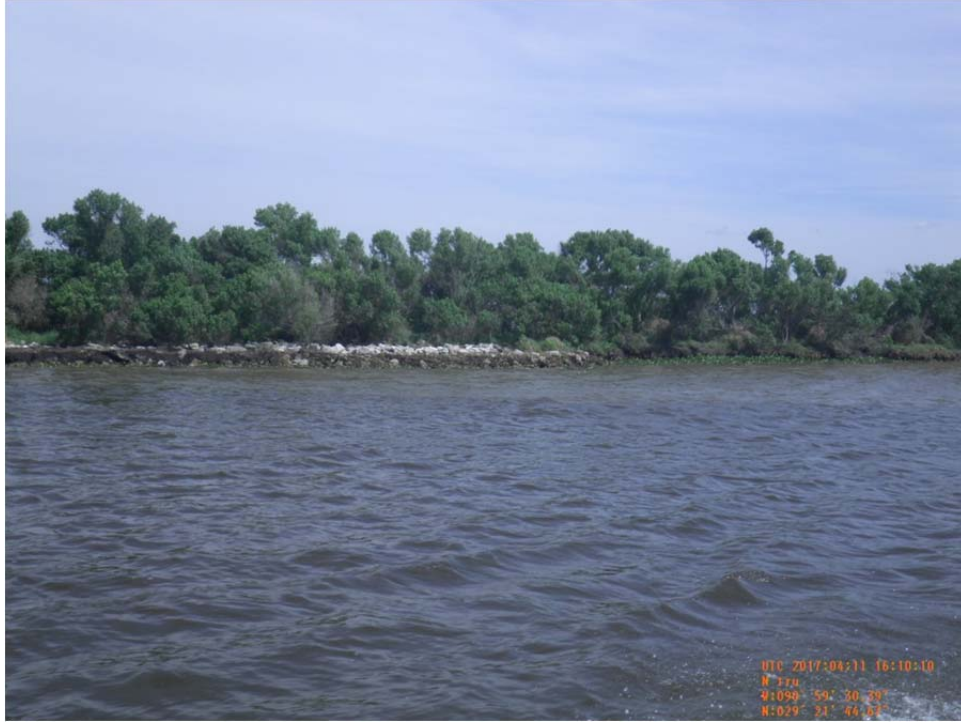
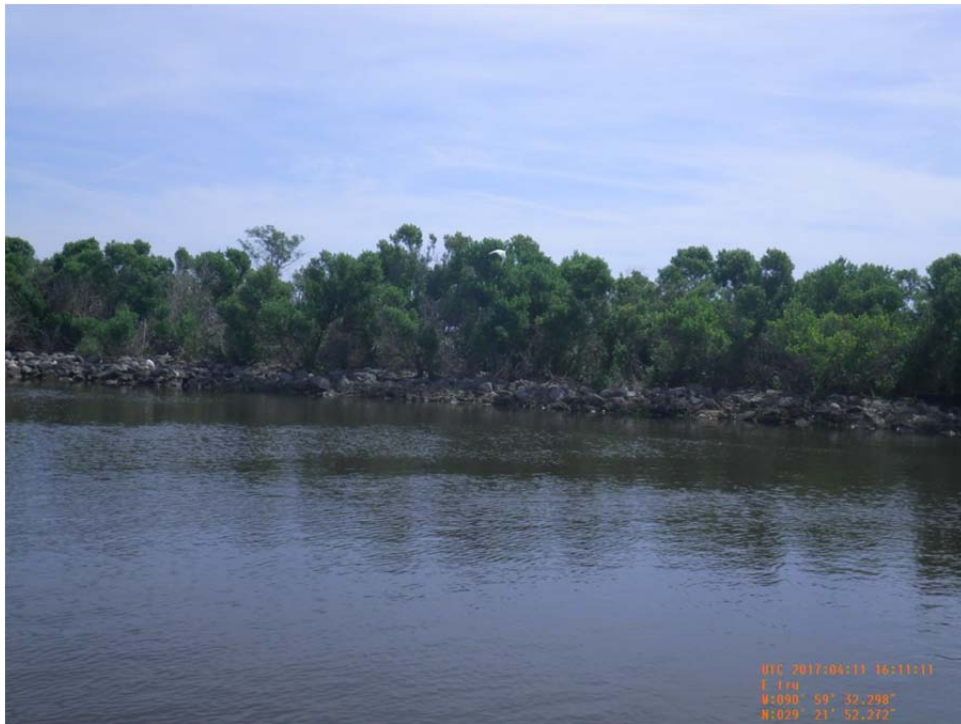
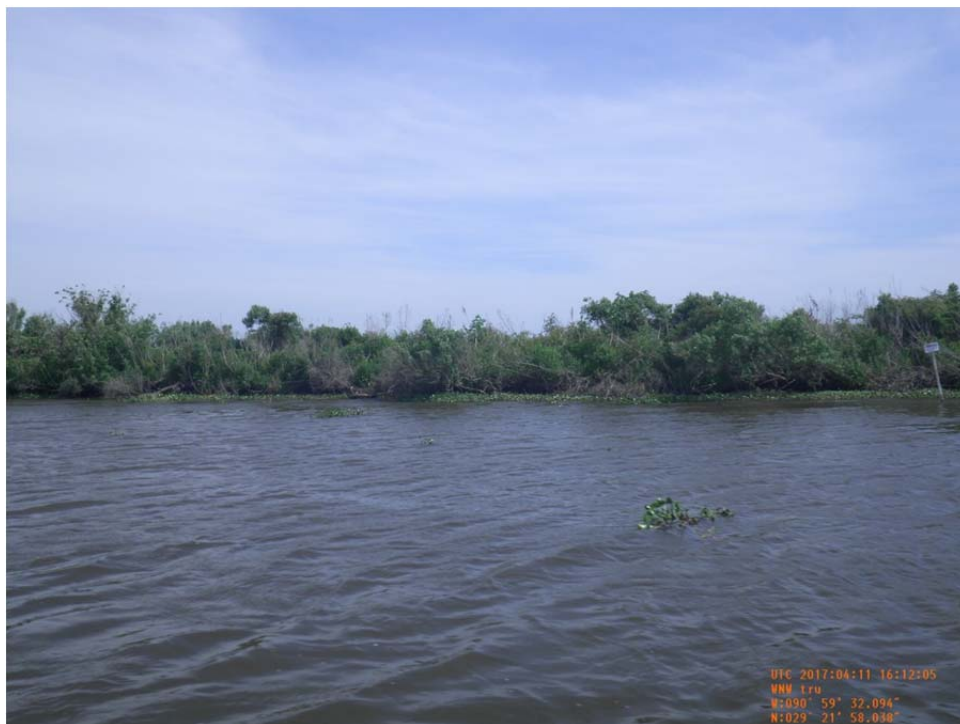
The rock armored embankments and rock dikes along the north bank of Bayou Decade (Appendix B, Photos 4-8) and Voss Canal (Photos 41-42, 44) are in good condition. The rock dike along Bayou Decade between Jug Lake and Turtle Bayou appear to be in fair condition with isolated low areas and moderate displacement of rock riprap. The earthen embankment with rock revetment west of Structure 7 along Bayou Decade appears to be in good condition

Photo No.41 – view of rock revetment along the north bank of Bayou de Cade at Voss Canal.

Photo No.42 – view of rock revetment along the east bank of Voss Canal south of Structure 10.

Photo No. 44- view of existing embankment along the east bank of Voss Canal .

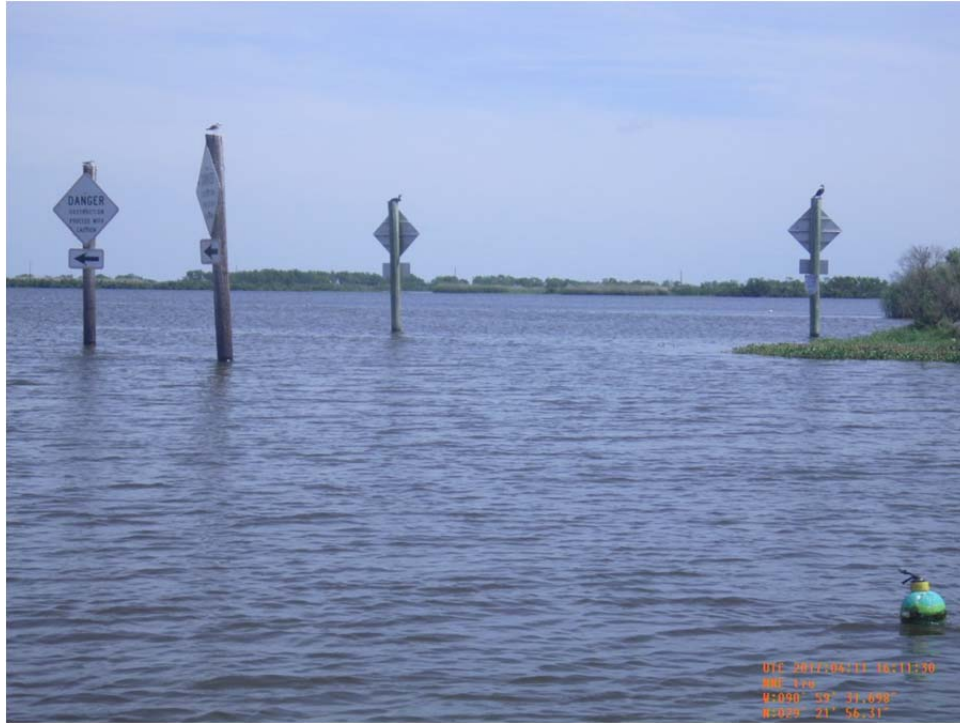
Structure 10 appears to be in fair condition. The rock tie-ins to the bank on both sides of the structure appear to be thin and were mostly submerged which is attributed to minor settlement and higher than normal water levels during the inspection. Depths along the center of the rock channel liner were not taken at the time of the inspection. The most recent water depths measurements taken in 2015 and 2016 revealed that the center elevation was approximately -5.5' NAVD. The constructed sill elevation was -4.75', indicating that structure has settled approximately 1 foot since it was constructed. All of the timber piling and warning signs appear to be in good condition (See Appendix B, Photo 43)

Photo No.43 – view of rock channel liner and warning signs at Structure 10 along the east bank of Voss Canal.

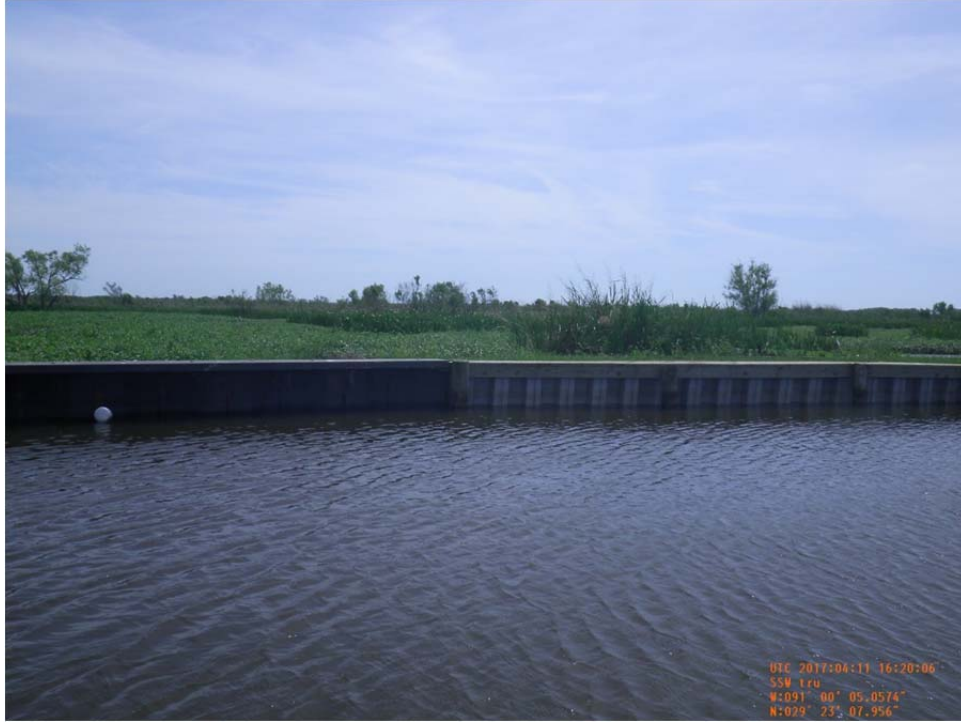
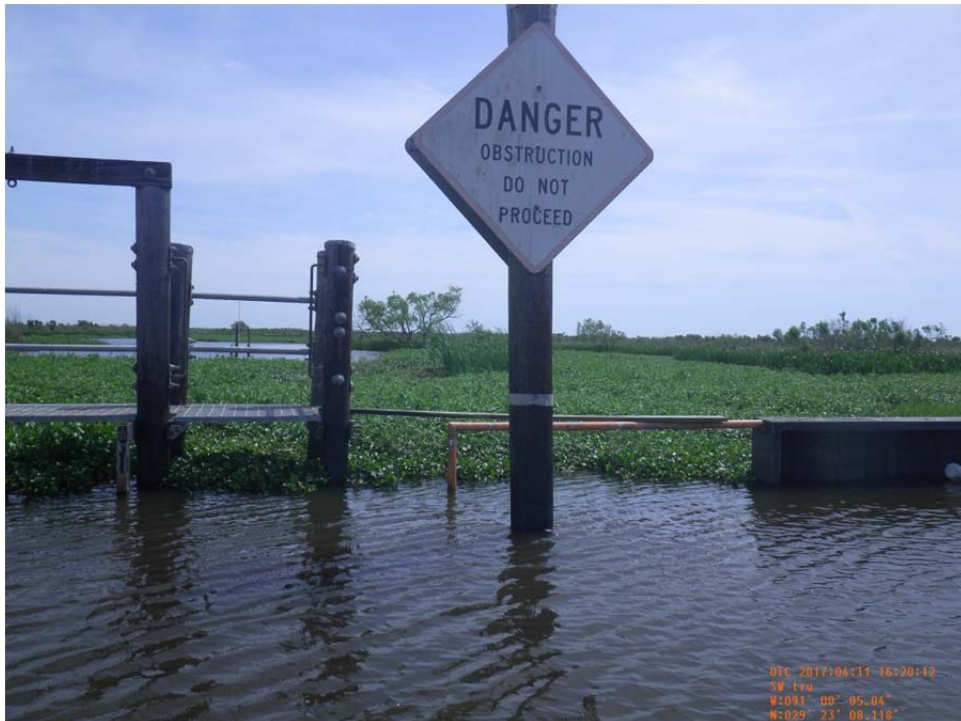
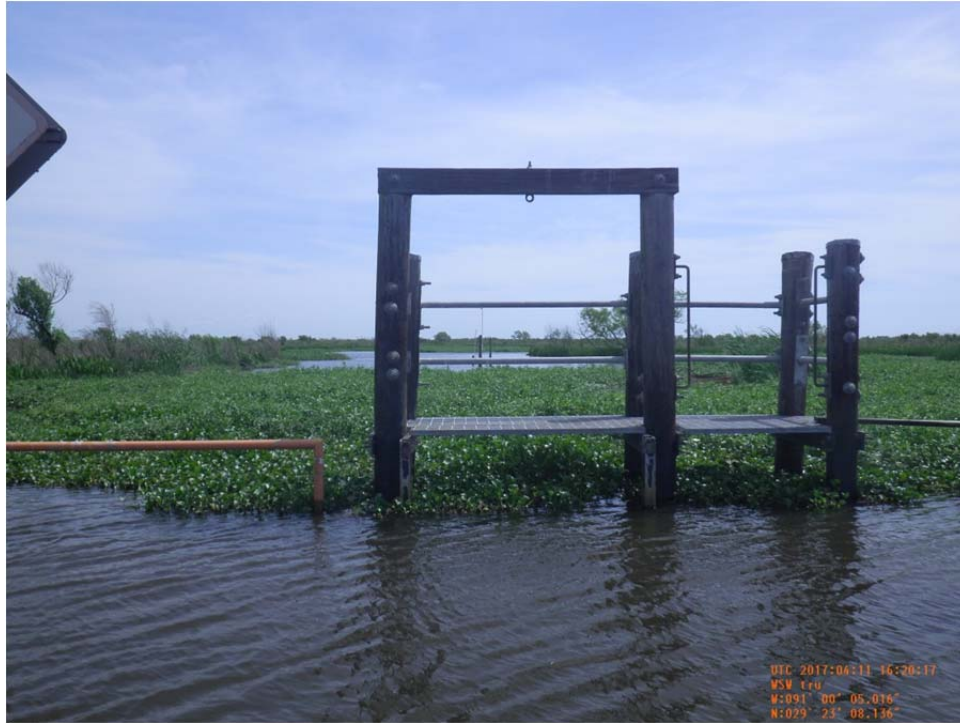
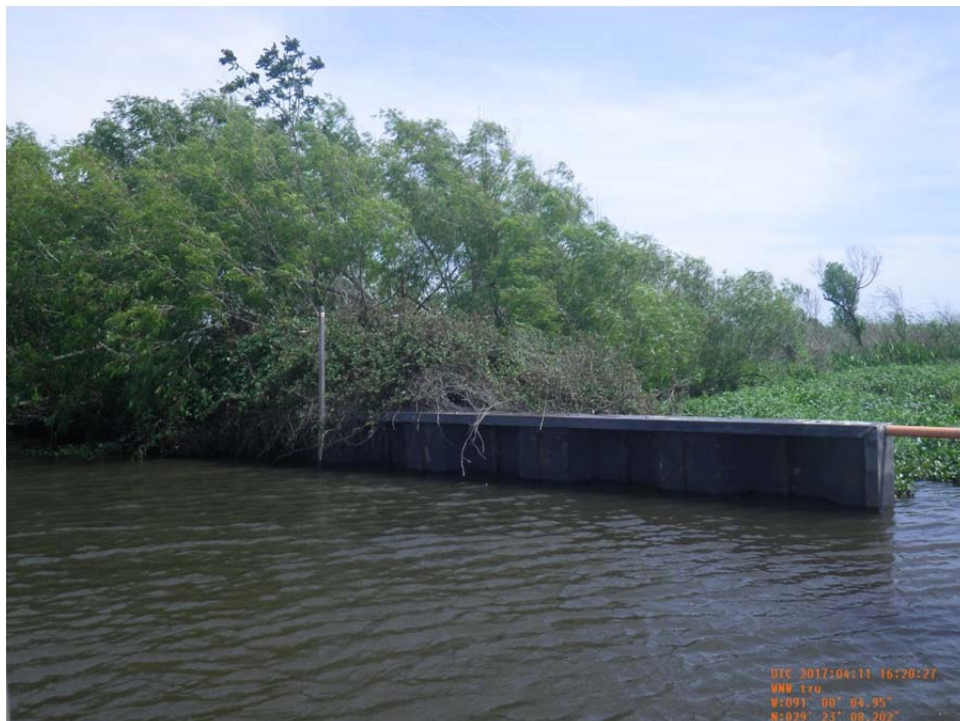
Structure 14 appears to be in fair condition. There was no visible damage to the railings, platform, steel bulkhead or warning signs. The bank tie-in on the north side of the structure is still thin with very little material between the existing bank and the steel bulkhead. The south side of the steel bulkhead connects to a vinyl bulkhead installed by the adjacent camp owner and is in good condition. ConocoPhillips has indicated that they are willing to assist the maintenance efforts by placing additional material on the north side of the structure during their regular maintenance cycle. Other than the erosion near the north end of the bulkhead, the structure remains in fair condition. (See Appendix B, Photos 45 - 48)

Photo No.45 – view of southern end of steel sheetpile wall at Structure 14.

Photo No.46 – view of variable crest weir structure 14 and interior marsh.

Photo No.47 – view of variable crest weir structure 14 and interior marsh.

Photo No.48 – view of northern end bank tie-in of steel sheetpile wall at Structure 14.

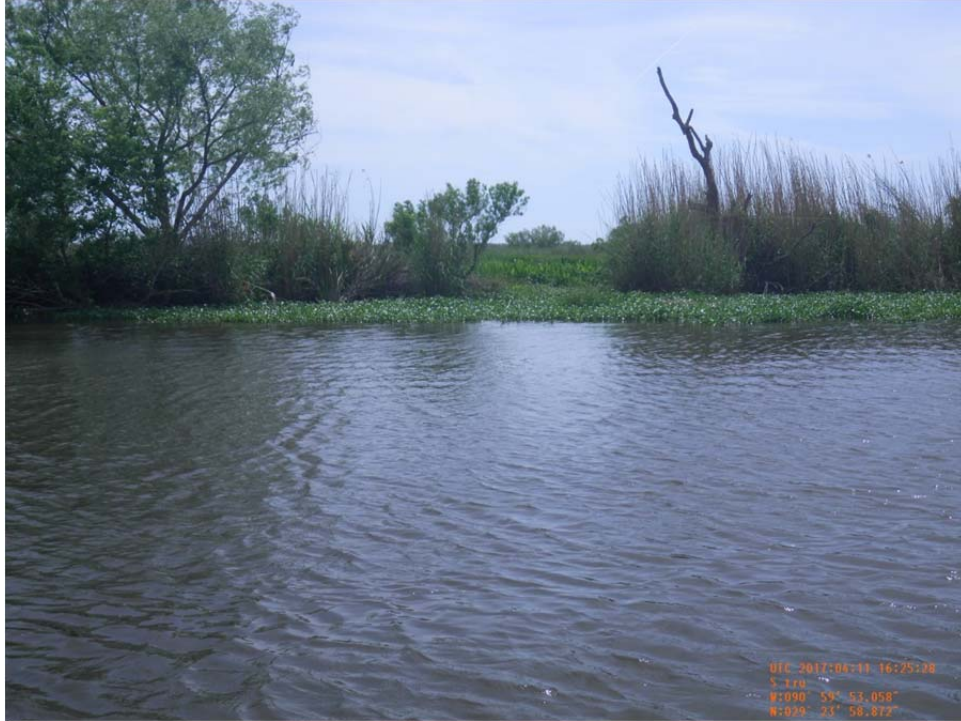
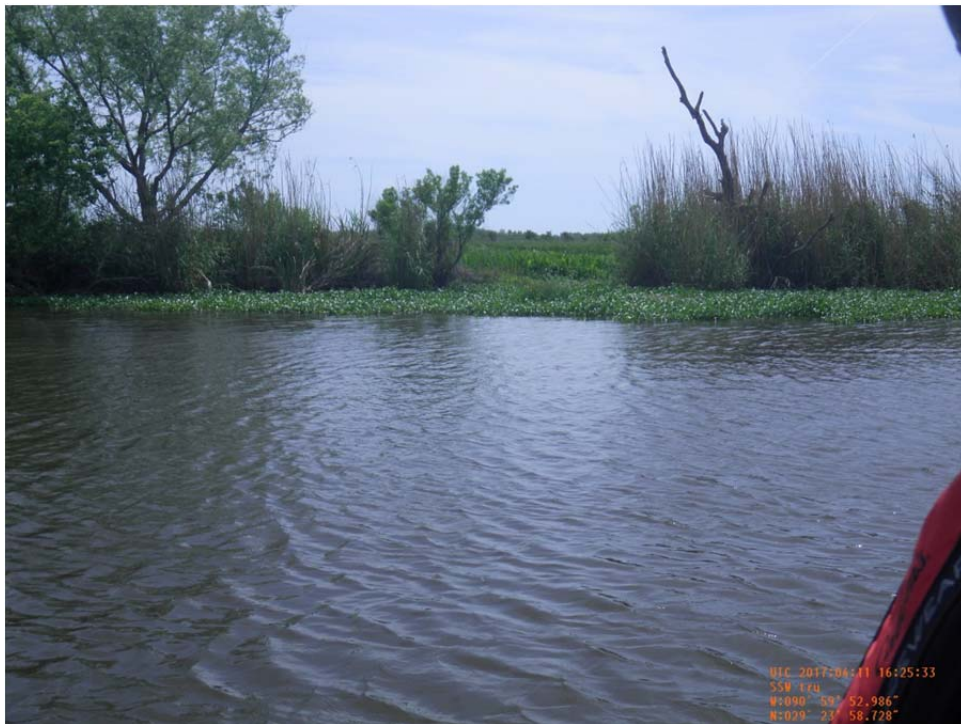
Photo No.49 – view of a breach in the overflow bank along Carencro Bayou north of Structure 14.

Photo No.50 – view of a breach in the overflow bank along Carencro Bayou north of Structure 14.

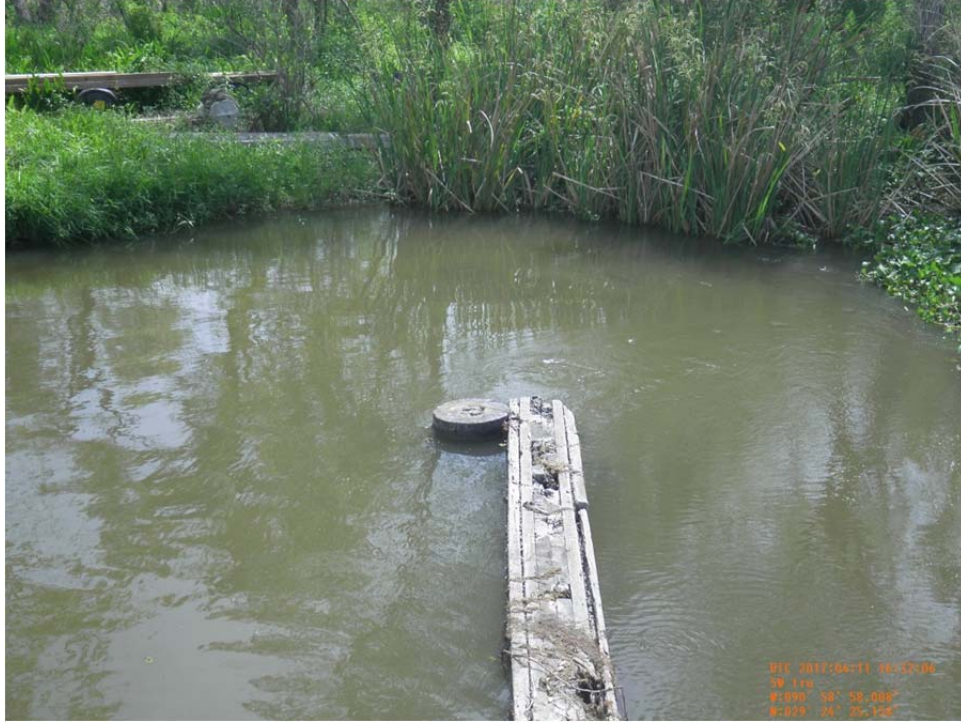
The timber bulkhead at the head of Brady Canal is an old existing oilfield structure that is not an original feature of the Brady Canal project. Over time, a small breach had developed on the southern end of the bulkhead. The breach was repaired during the 2012 Maintenance Project with rock riprap to close off the flow around the structure. The riprap material appeared to have settled below the top of the bulkhead just below the water surface. We do not believe that this requires immediate remedial action and will continue to monitor this location on future site visits. (See Appendix B, Photo 51)

Photo No.51 – view of the existing timber bulkhead along the oilfield canal at the intersection of Brady Canal and Carencro Bayou.
