**State of Louisiana
Coastal Protection and Restoration
Authority**

2017 Annual Inspection Report

**Penchant Basin Natural Resource
Plan, Increment No. 1 (TE-34)**

State Project Number TE-34
Priority Project List 6

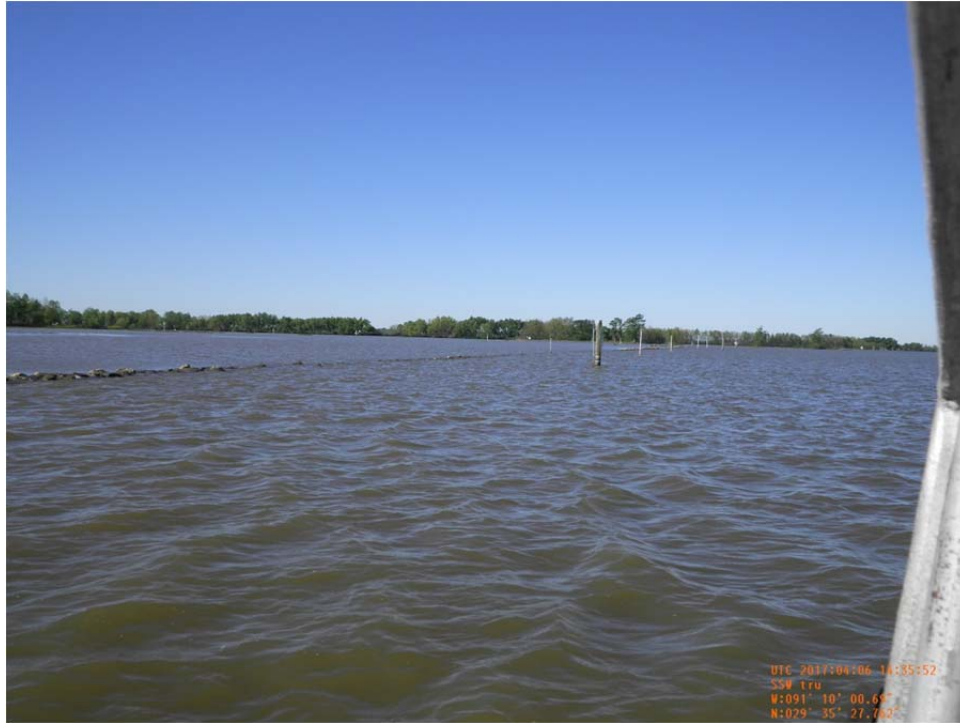
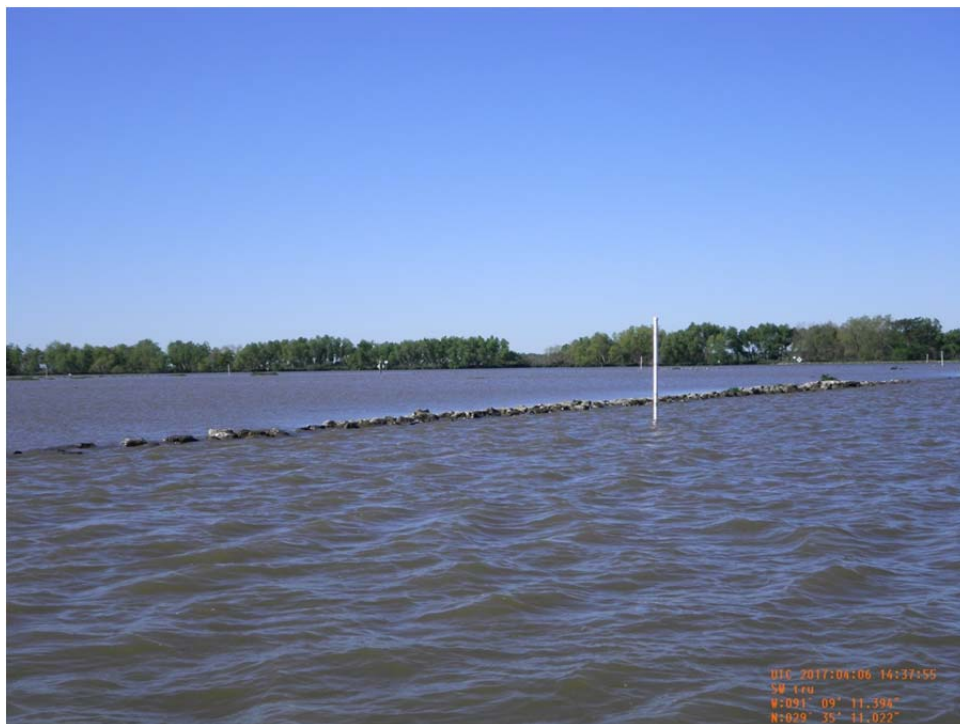
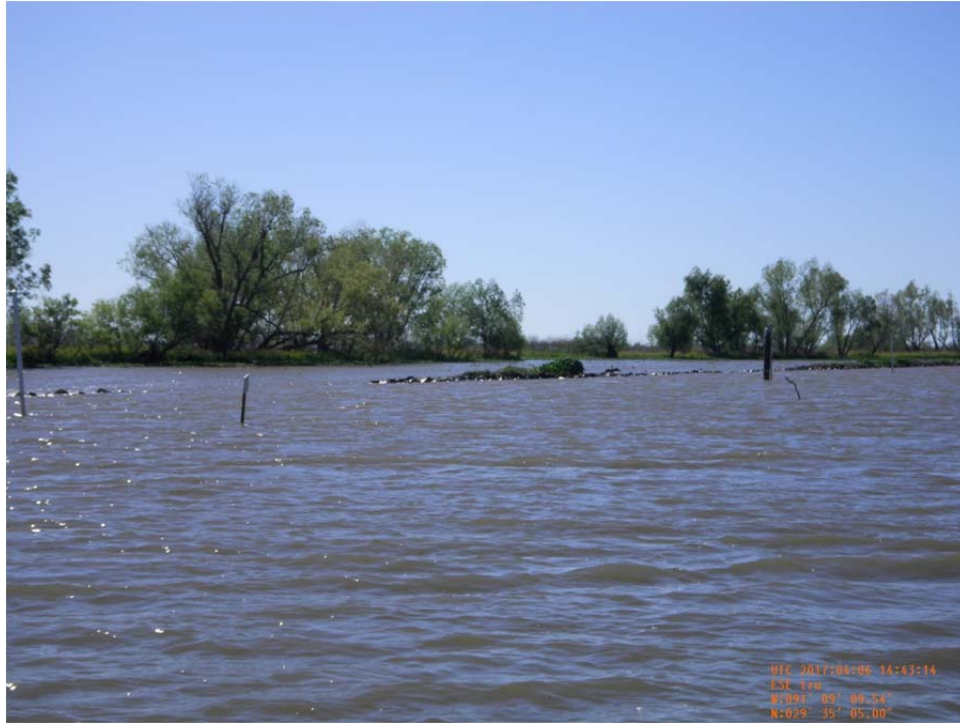
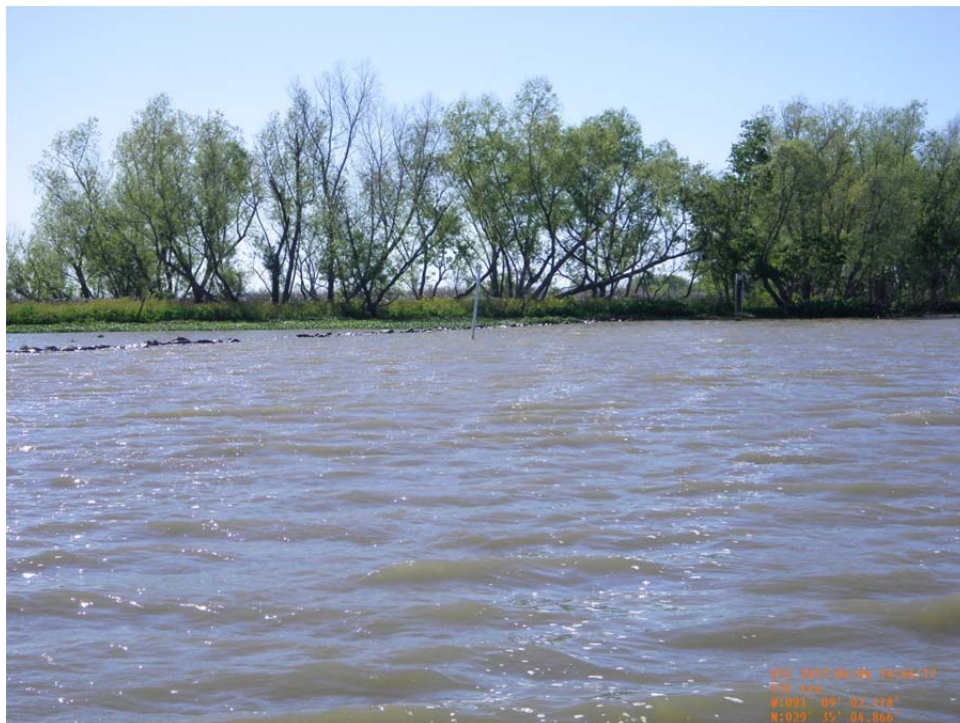
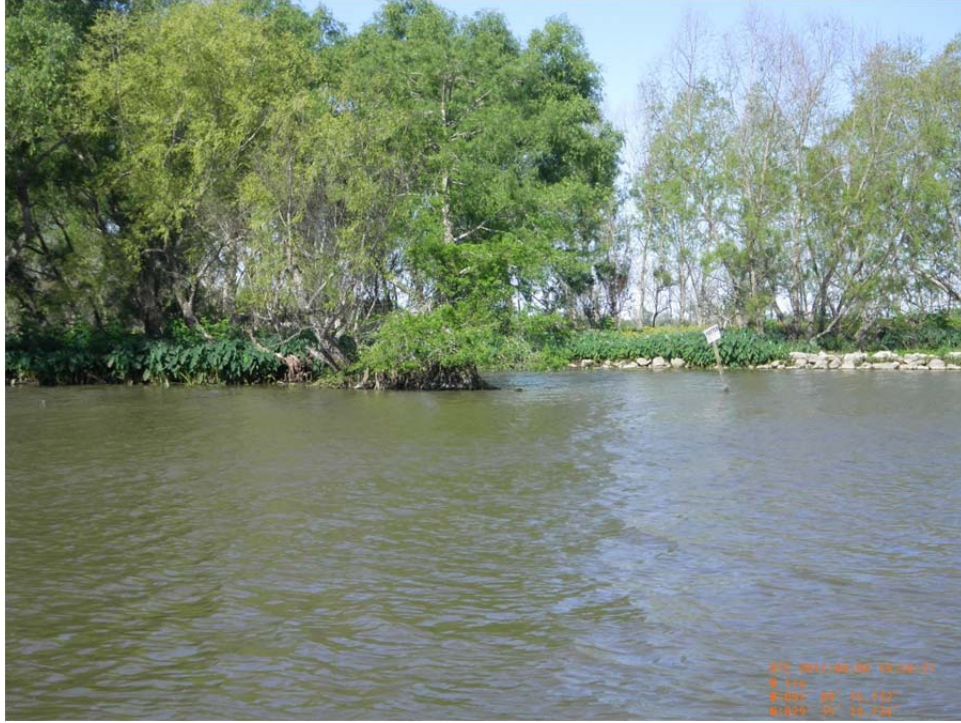
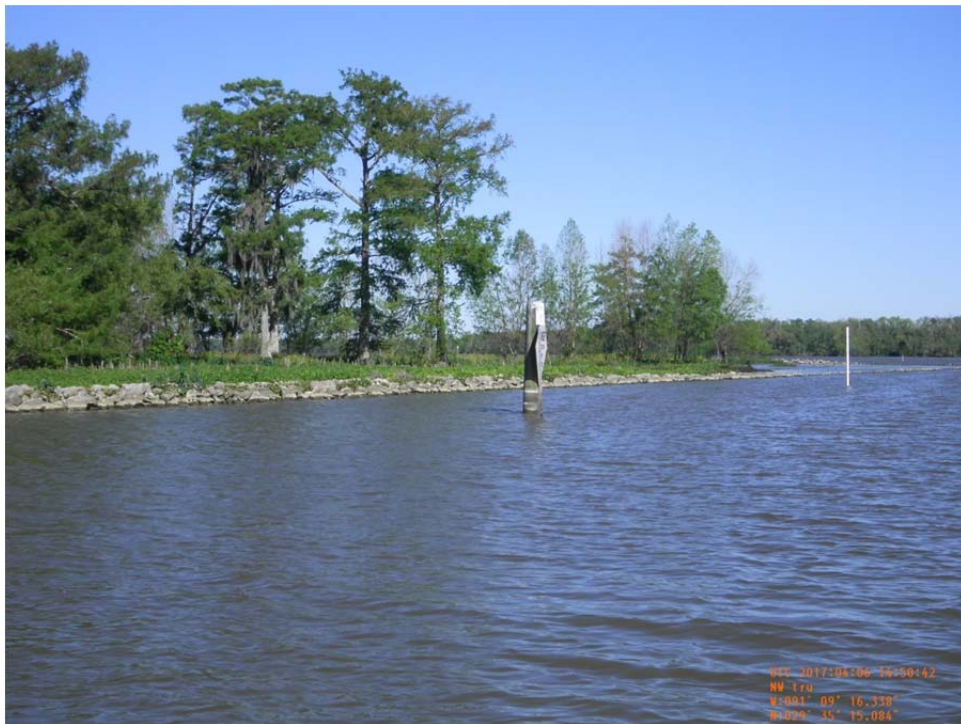
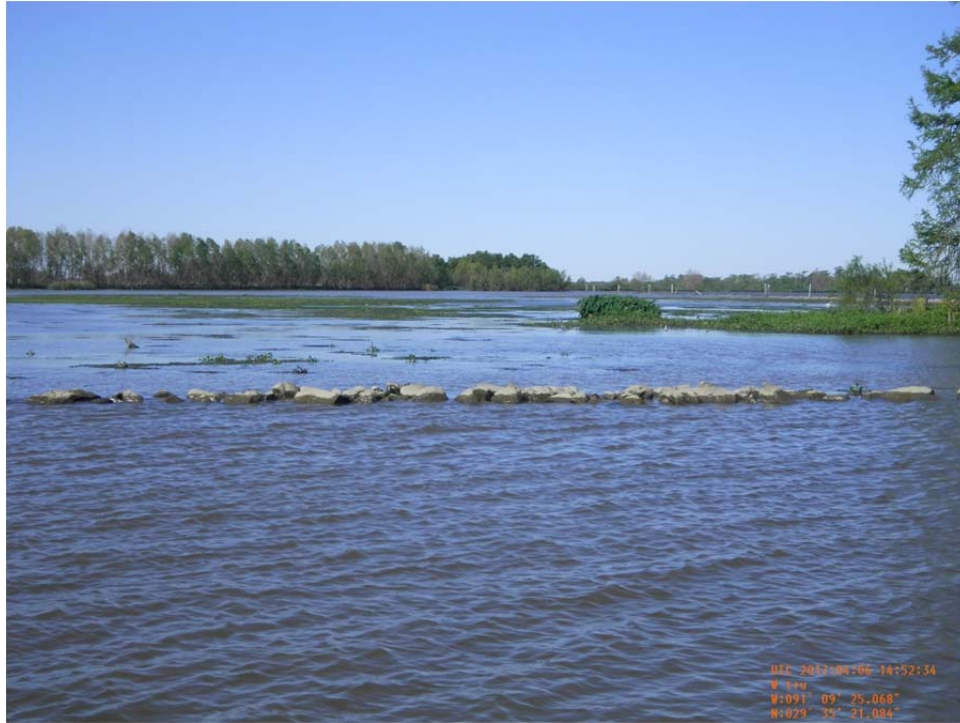
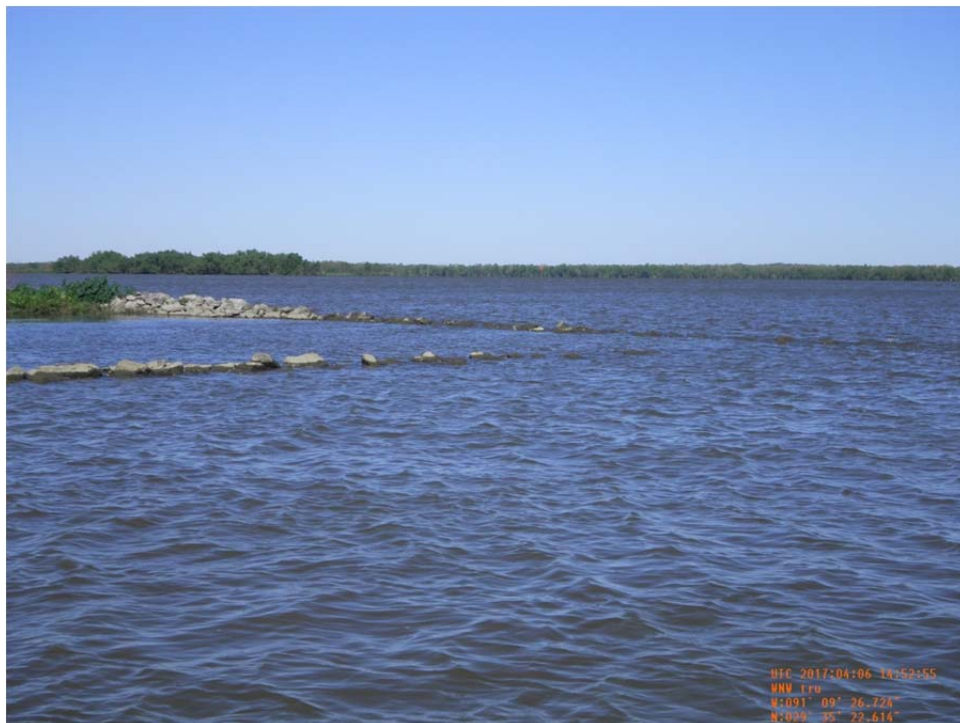
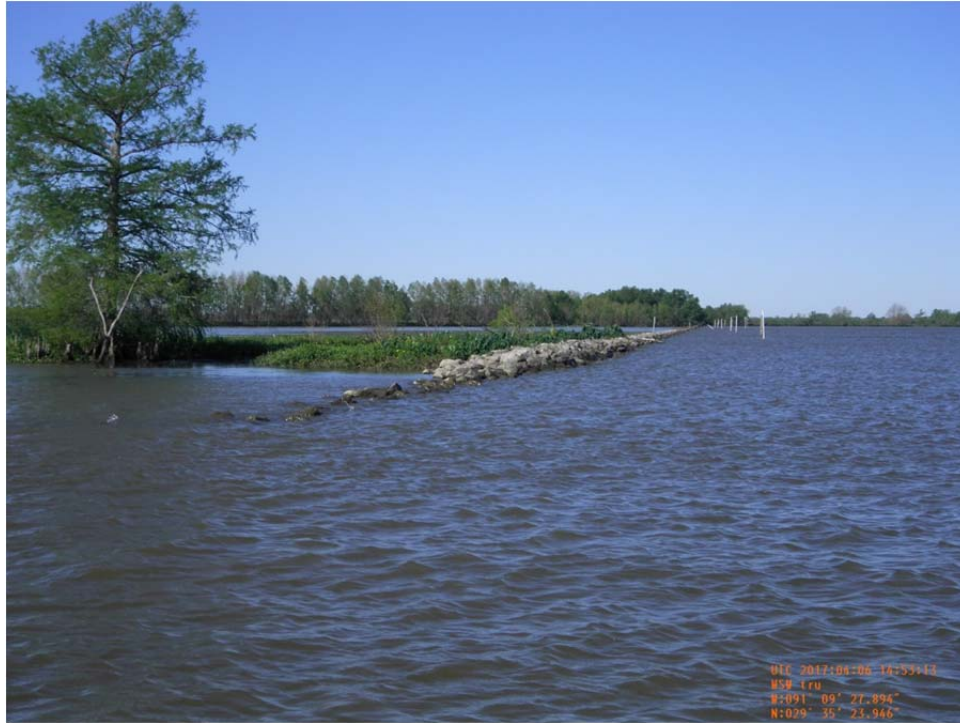
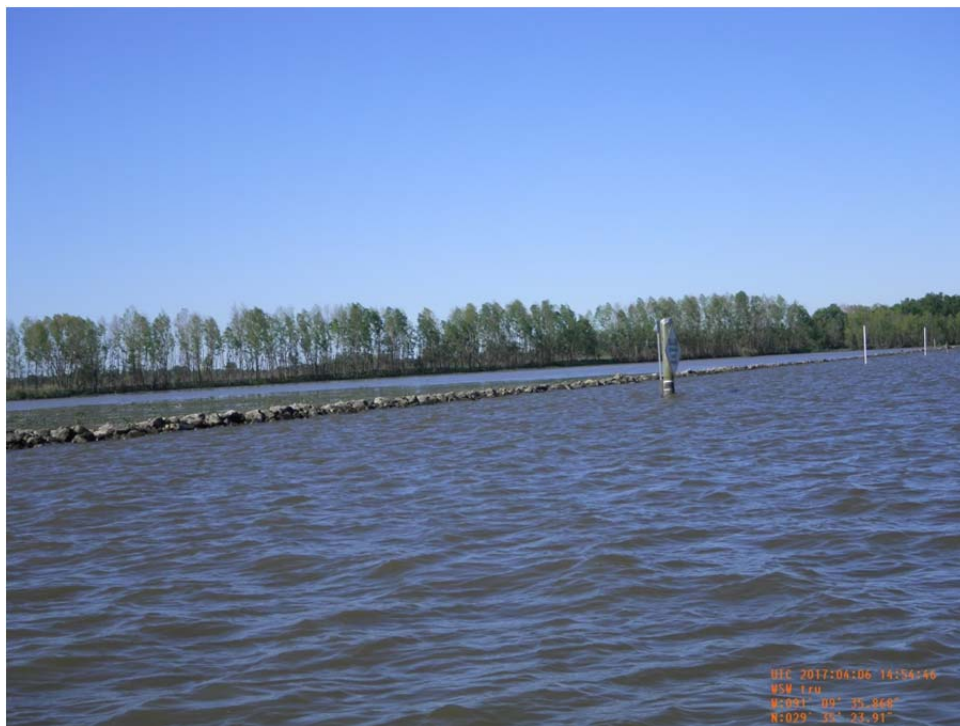
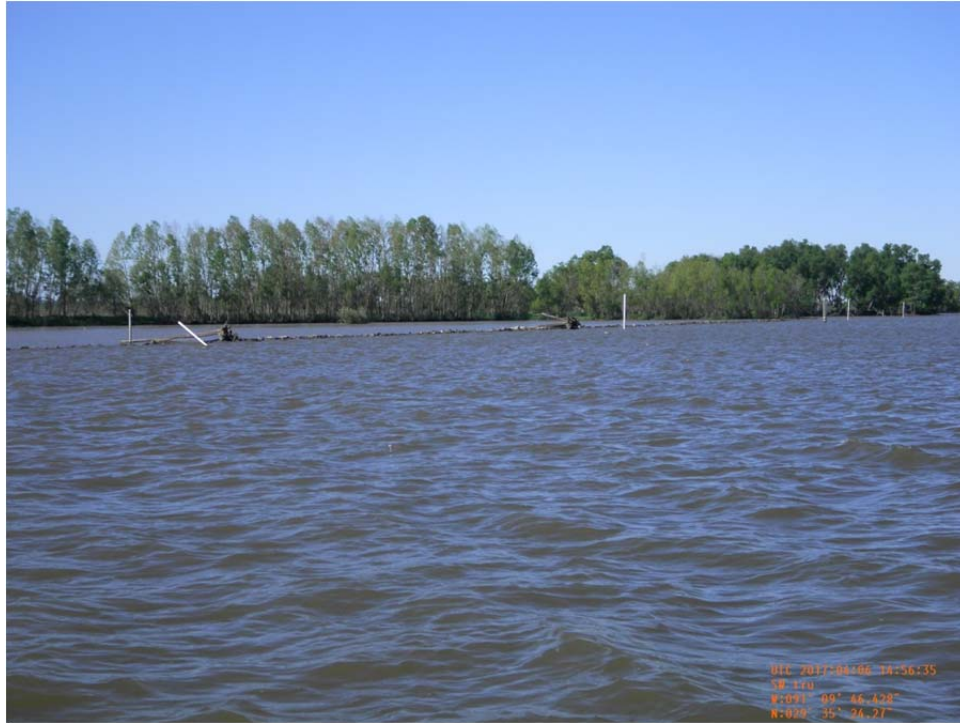
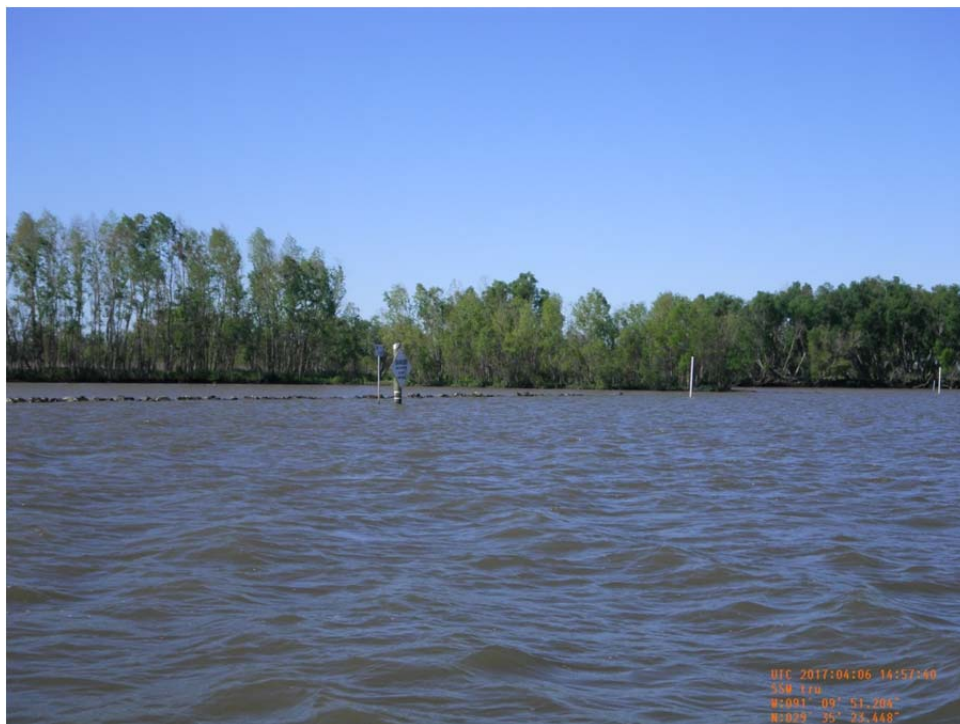
Upon arrival at the marsh creation sites and rock dike at Bayou Penchant near Bayou Chene, we noticed that the rock containment dike was barely visible, just above the water line with the majority of the marsh creation areas under water. (Appendix B, Photos 1 through 12)

No.1 – view of rock dike and marsh creation site on east side of Bayou Penchant along Bayou Chene.

Photo No.2 – view of rock dike and marsh creation site on east side of Bayou Penchant along Bayou Chene.

Photo No.3 – view of rock dike and marsh creation site along east bank of Bayou Penchant.

Photo No.4 – view of rock dike tie-in and marsh creation site on east side of Bayou Penchant.

Photo No. 5 – view or rock dike tie-in boundary for the marsh creation site on west side of Bayou Penchant.

Photo No.6 – view of rock dike and marsh creation site on the west side of Bayou Penchant.

Photo No.7 – view of the rock dike and marsh creation site on west side of Bayou Penchant.

Photo No.8 – view of rock dike and marsh creation site on west side of Bayou Penchant at the intersection of Bayou Chene.

Photo No.9 – view of the rock dike and marsh creation site on west side of Bayou Penchant along Bayou Chene.

Photo No.10 – view of rock dike and marsh creation site on west side of Bayou Penchant along Bayou Chene.

Photo No.11 – view of rock dike and marsh creation site on west side of Bayou Penchant along Bayou Chene.

Photo No.12 – view of rock dike and marsh creation site on west side of Bayou Penchant along Bayou Chene near the west tie-in.

concern on future inspections and recommend repairs at a later date should maintenance be required. The rock dike containment and fill areas near Bayou Penchant and Bayou Chene were in good to fair condition with minor to moderate settlement of the rock dike and uniform settlement of the both marsh platforms. This area is subject to seasonal high river stages which at times can cover the structures with several feet of water for extended periods of time. The impact of several feet of water over the disposal areas may have accelerated the consolidation of the marsh platform since construction was completed. It may be beneficial to pump additional material into the disposal areas sometimes in the future to raise the platform so that vegetation can take hold. Further discussions with NRCS will be required prior to pursuing action on marsh re-nourishment. We are also not recommending any action regarding the maintenance of the rock dike at this time. Although the rock containment dike has settled since construction, it is still providing protection of the marsh creation areas. The project team will continue to monitor the condition of the dike and fill areas and make appropriate recommendation for maintenance as needed.

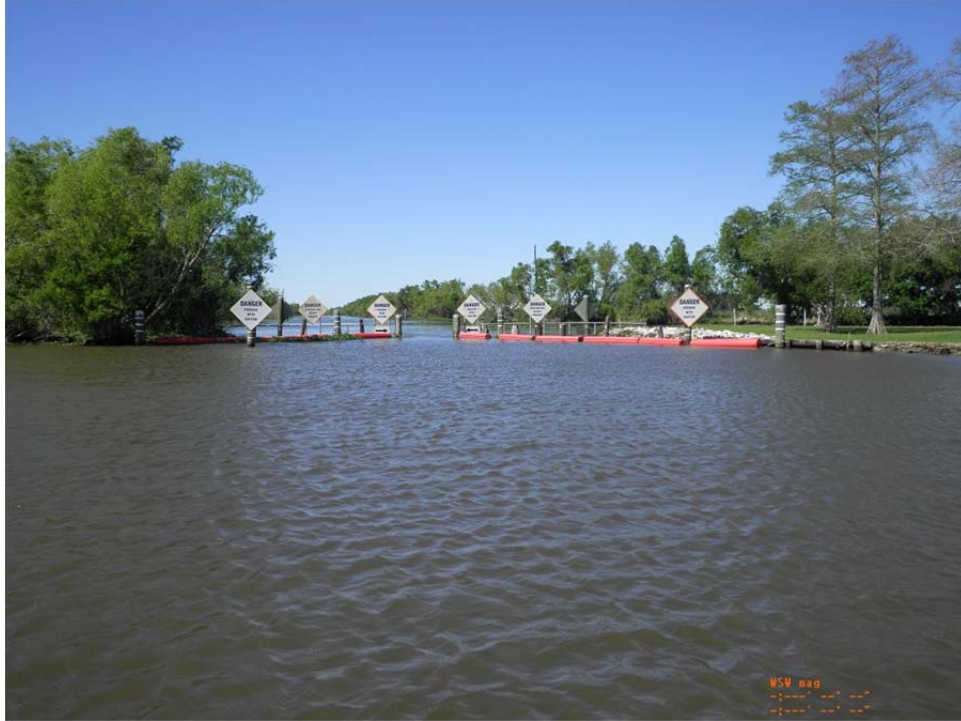
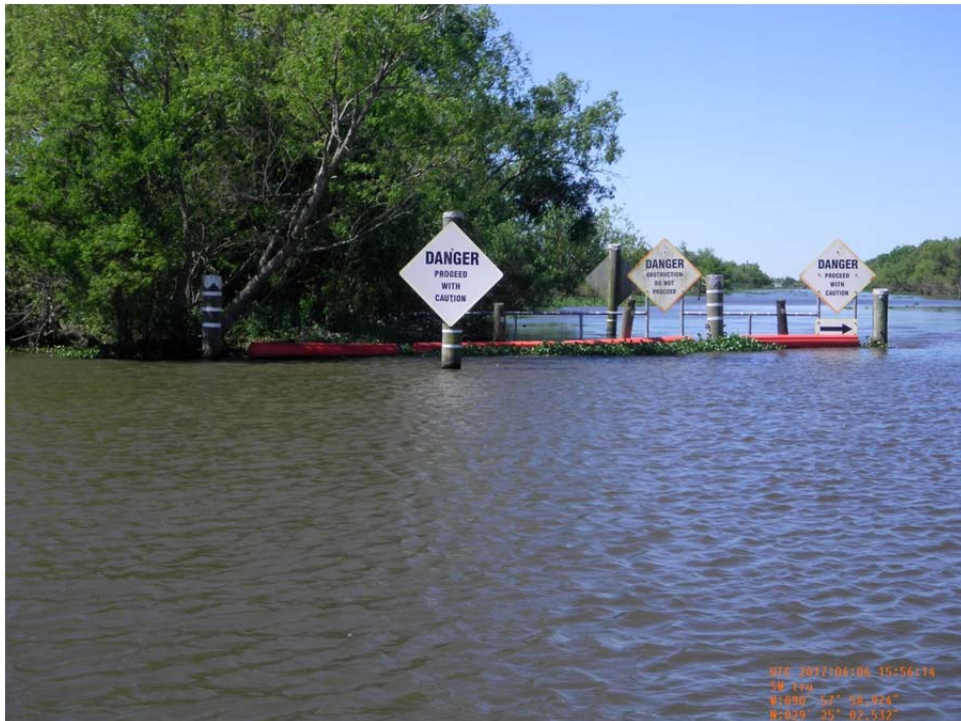
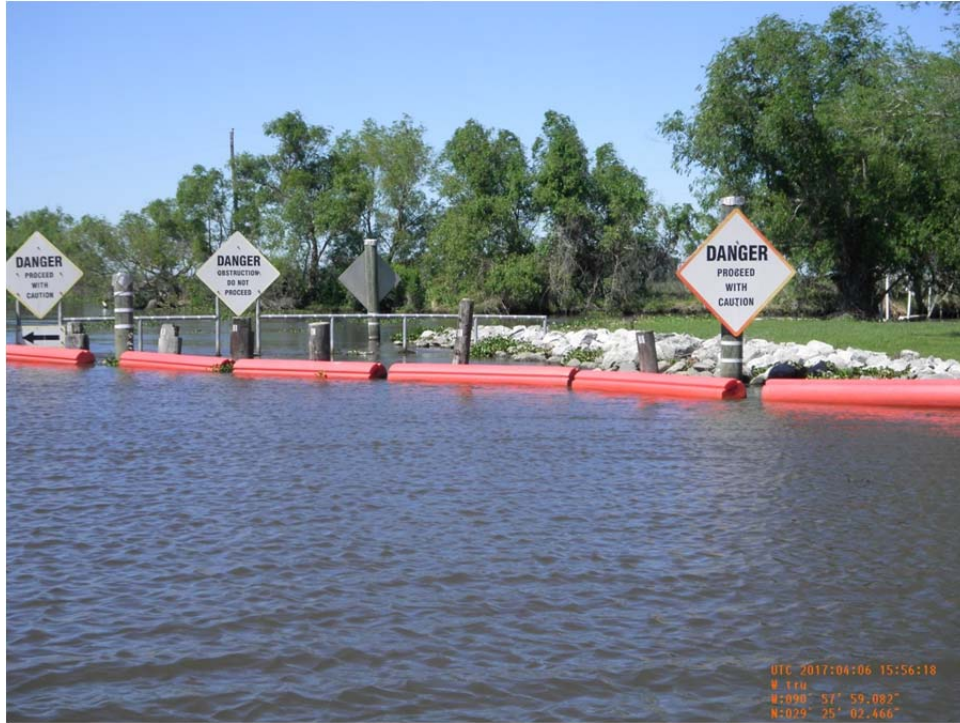
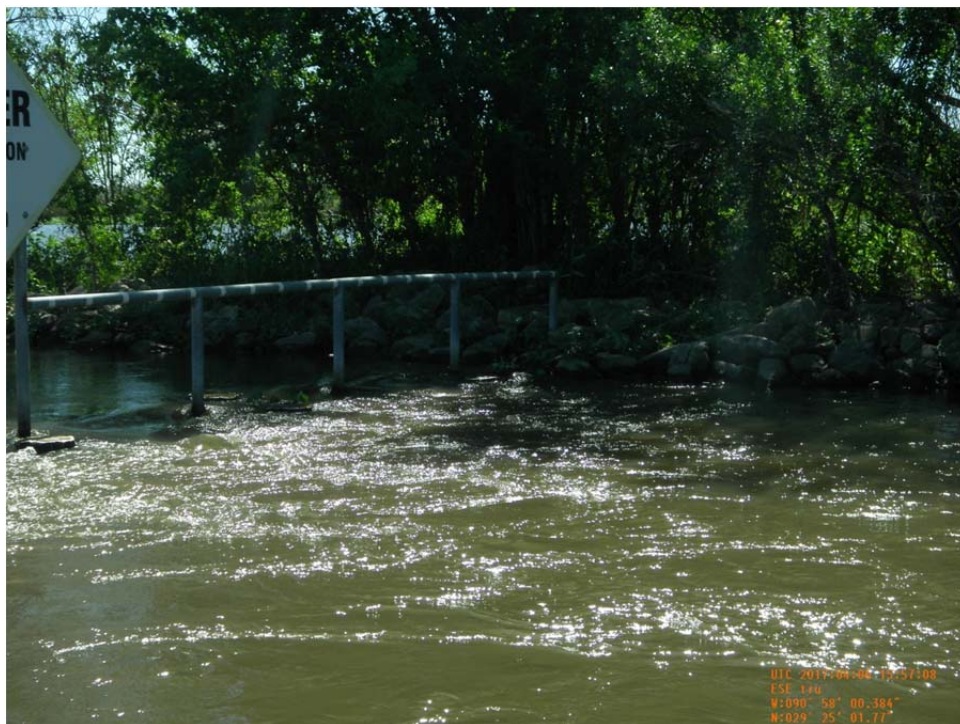
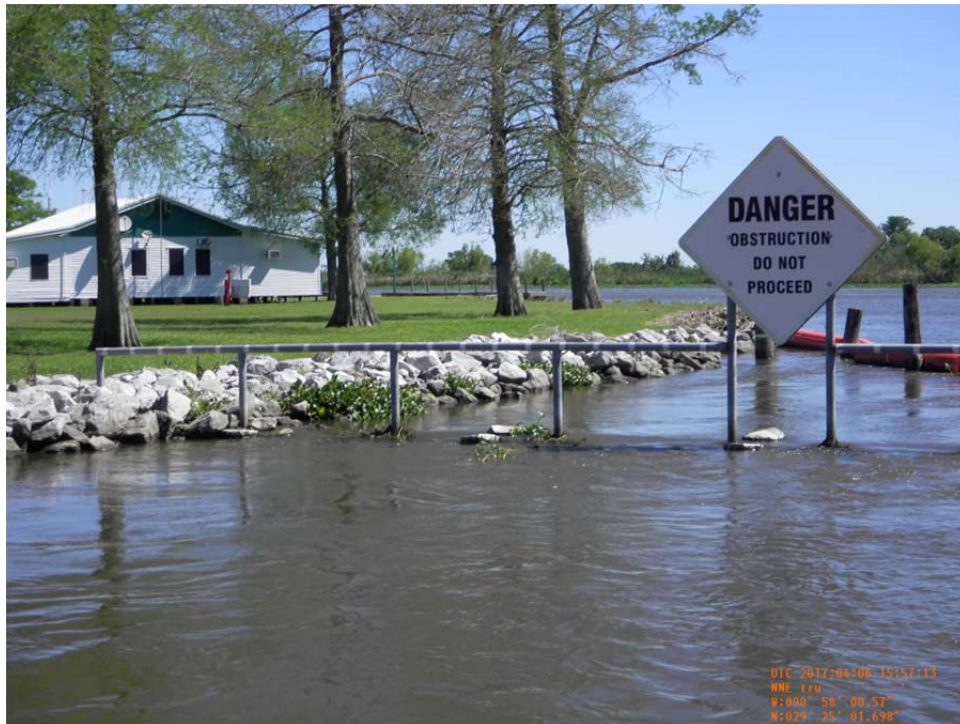
The fixed crest weir with a boat bay and flap-gates at the intersection of Brady Canal and Bayou Penchant was in good condition with no noticeable defects. The bank tie-ins were stable with no signs of erosion. The floating debris barrier installed to prevent build-up of vegetation against the structure was also in good condition. All signs and supports were in good condition as well. No maintenance will be required at this time. (Appendix B, Photos 13 through 17)

Photo No. 13 – view of Brady Canal Structure at the intersection of Bayou Penchant.

Photo No.14 – view of Brady Canal Structure, debris buoys and warning signs on southeast side of structure.

Photo No.15 – view of Brady Canal Structure, debris buoys and warning signs on northwest side of structure.

Photo No.16 – view of Brady Canal structure tie-in to the bank on the southeast side of the structure.

Photo No.17 – view of Brady Canal structure tie-in to the bank on the northwest side of the structure.

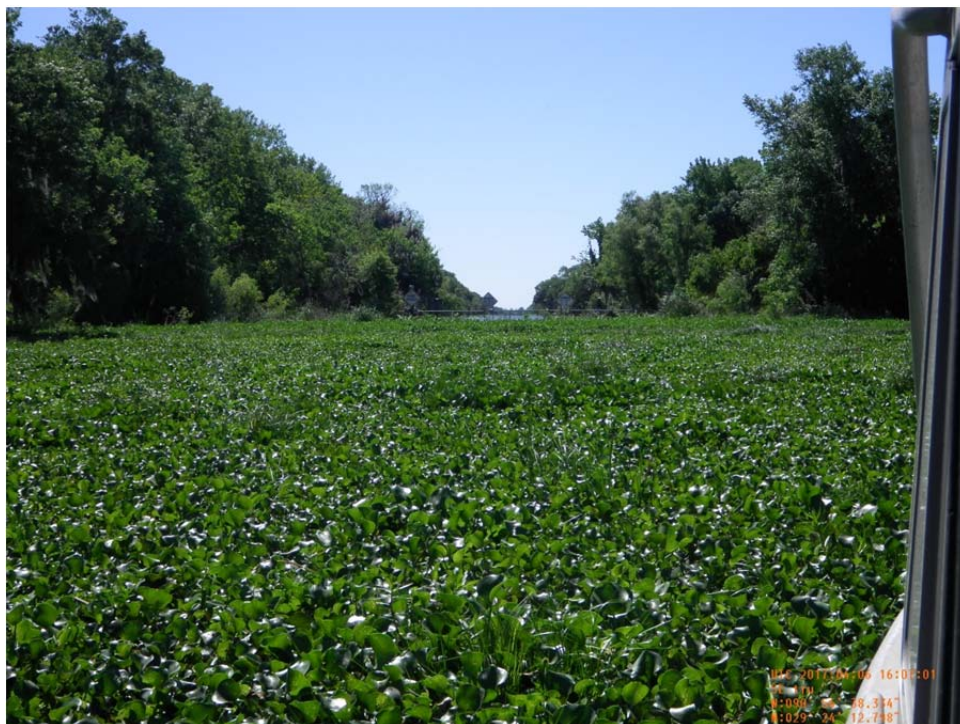
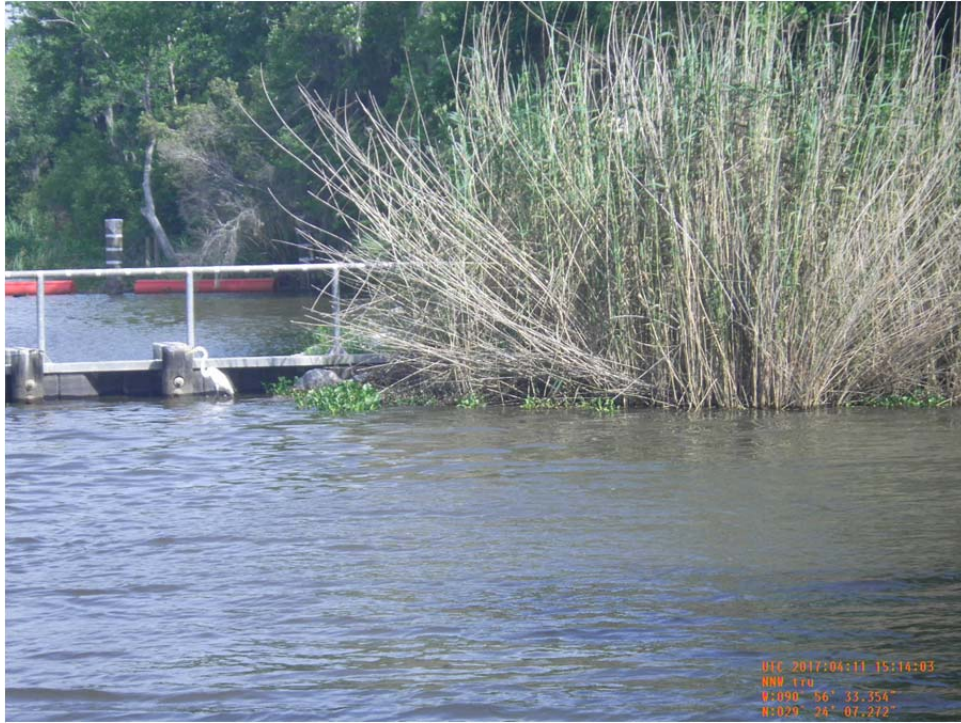
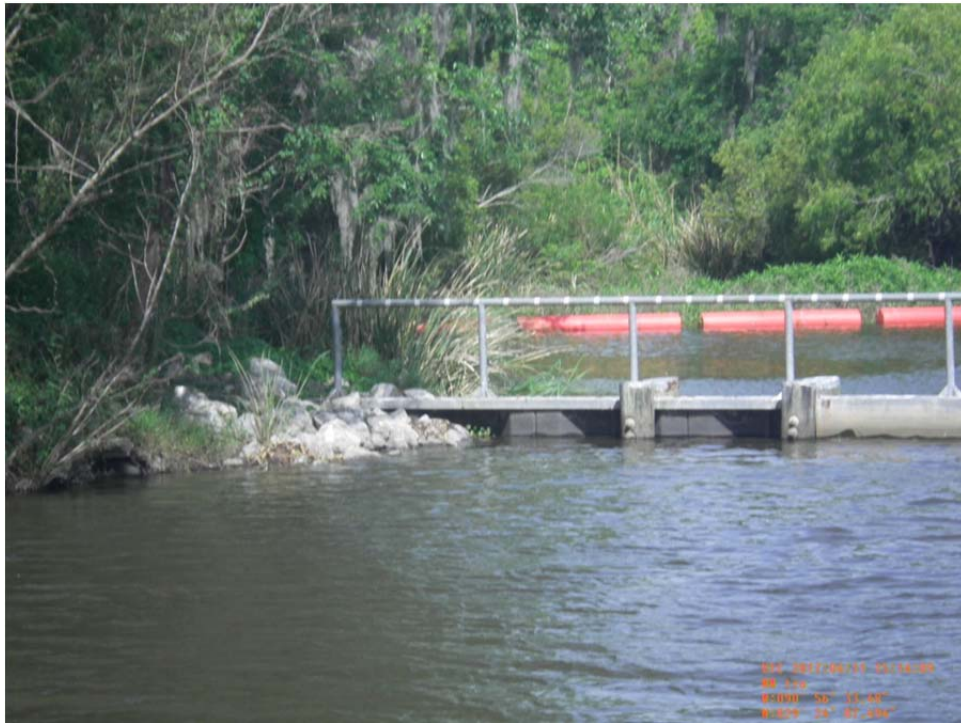
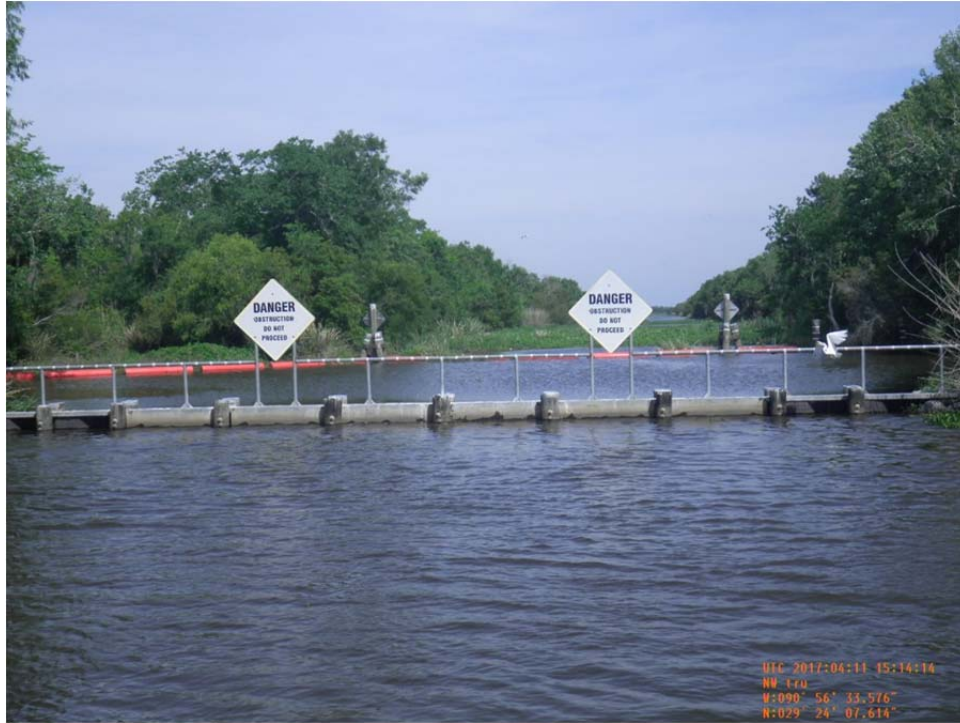
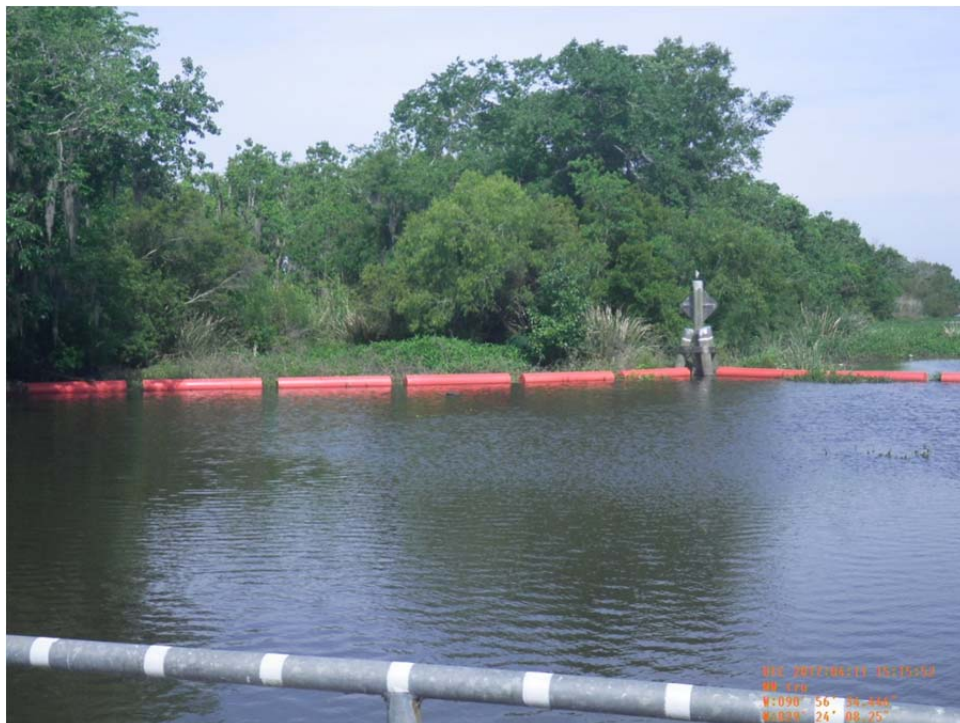
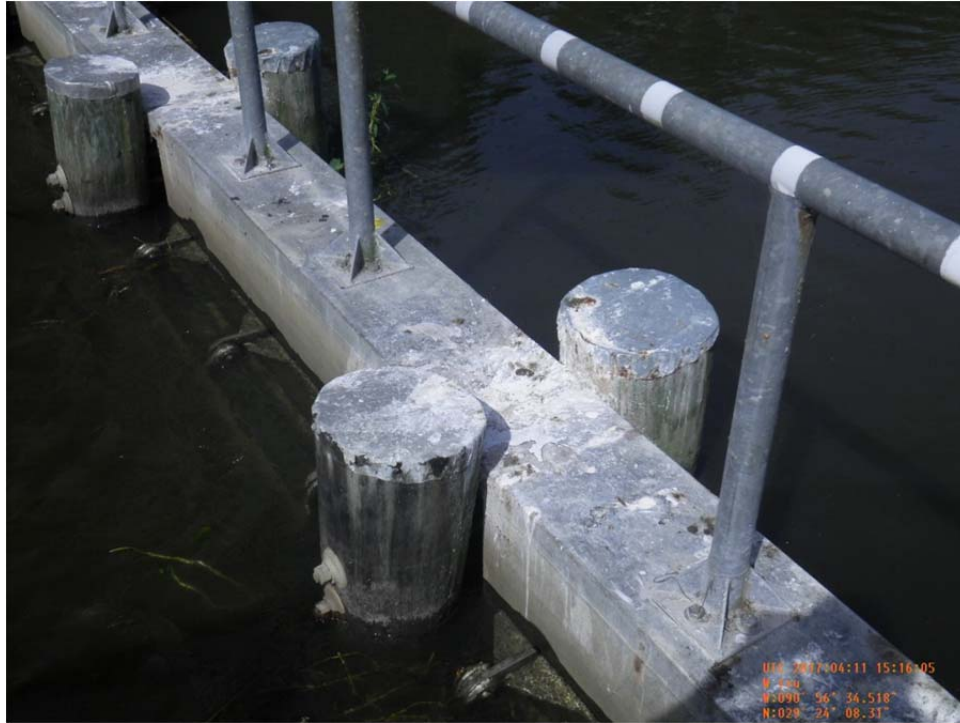
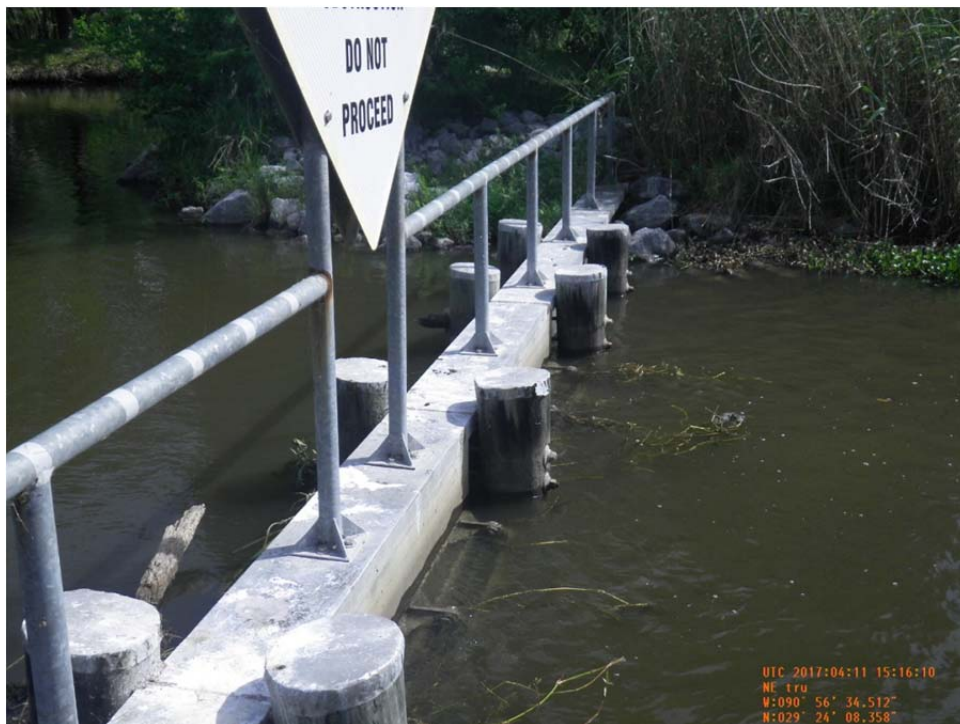
The fixed crest weir with flap-gates across Superior Canal was in good condition with no obvious defects or damage. The galvanized steel components, channel cap and sign supports all appeared to be in good condition. The rock armored bank tie-ins were also in good condition. The floating debris barrier installed on the north side of the structure was in good condition and working well. A large portion of the channel was clogged with water hyacinth north of the floating barrier. The warning signs were all intact without damage. The structure will not require maintenance at this time. (Appendix B, Photos 18 through 24)

Photo No.18 – view of Superior Canal on the north side of the Superior Canal structure showing vegetation that is being held back by the floating debris barrier.

Photo No.19 – view of the Superior Canal Structure and east bank tie-in from the south.

Photo No.20 – view of the Superior Canal Structure and the west bank tie-in from the south.

Photo No.21 – view of the Superior Canal Structure from the south side looking north.

Photo No.22 – view of the floating debris barrier on the north side of the Superior Canal Structure.

Photo No.23 – view of the channel cap, timber piling and flap-gates on the Superior Canal Structure.

Photo No.24 – view of the channel cap, timber pile supports and sign supports along the Superior Canal Structure.
