**State of Louisiana
Coastal Protection and Restoration
Authority**

2017 Annual Inspection Report

**Penchant Basin Natural Resource
Plan, Increment No. 1 (TE-34)**

State Project Number TE-34
Priority Project List 6

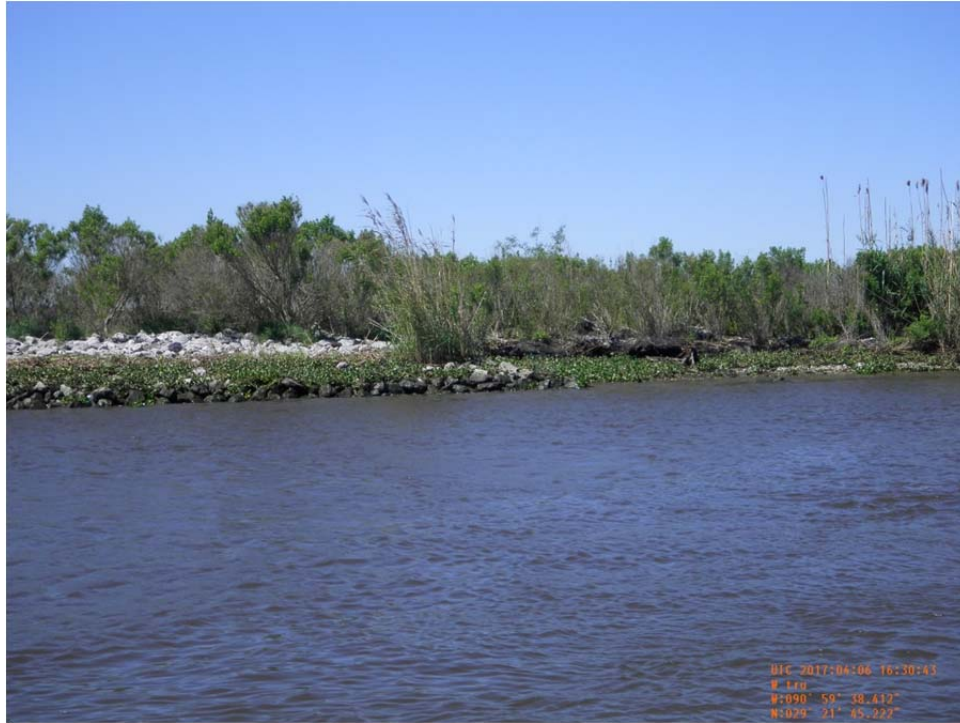
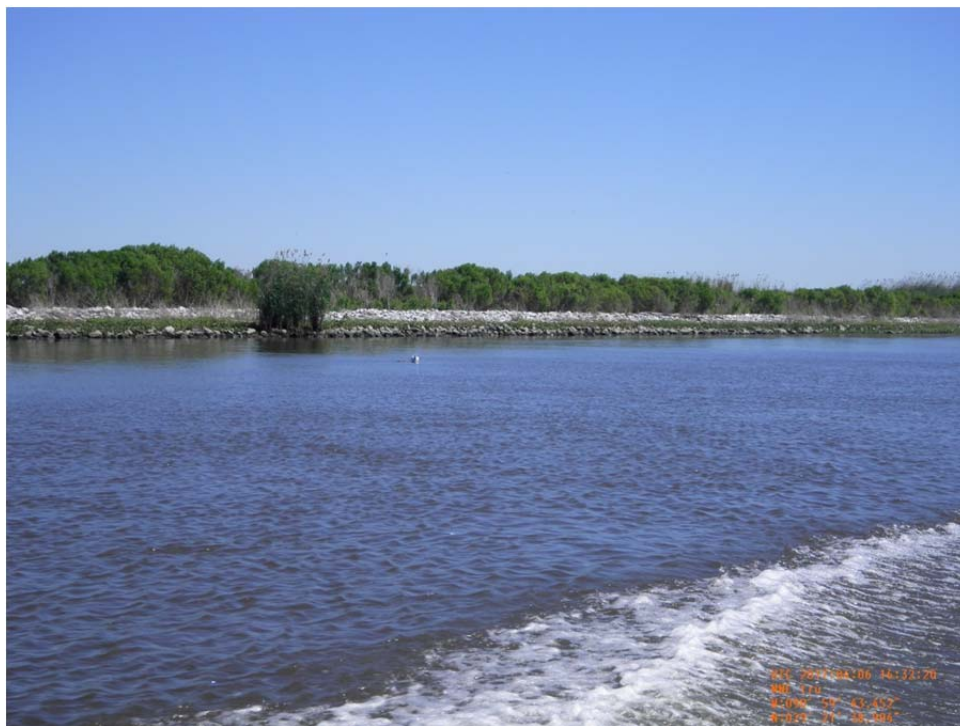
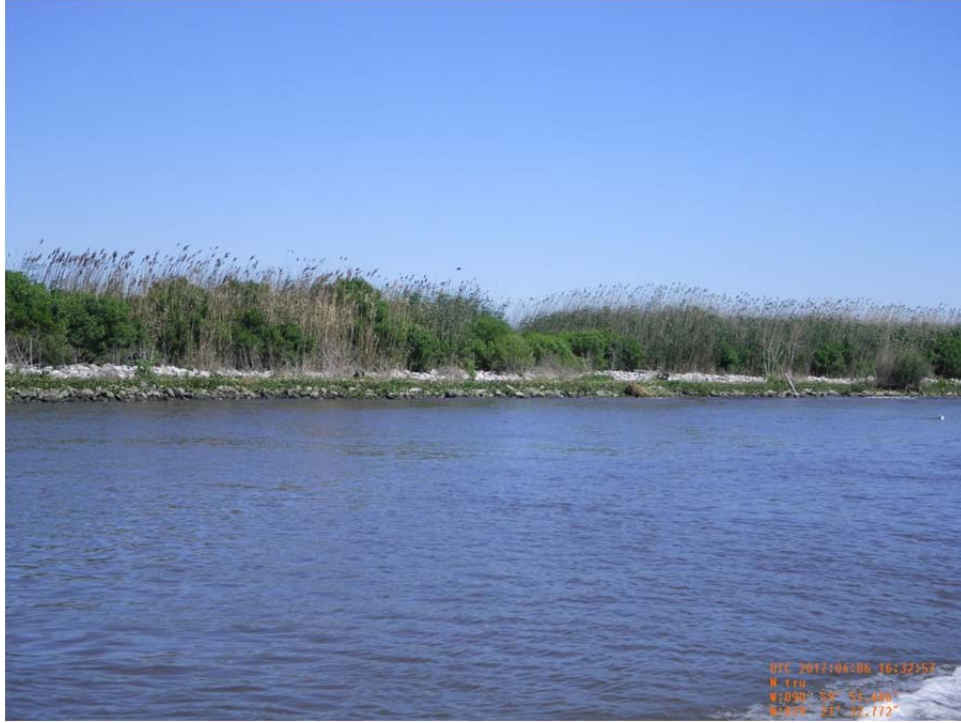
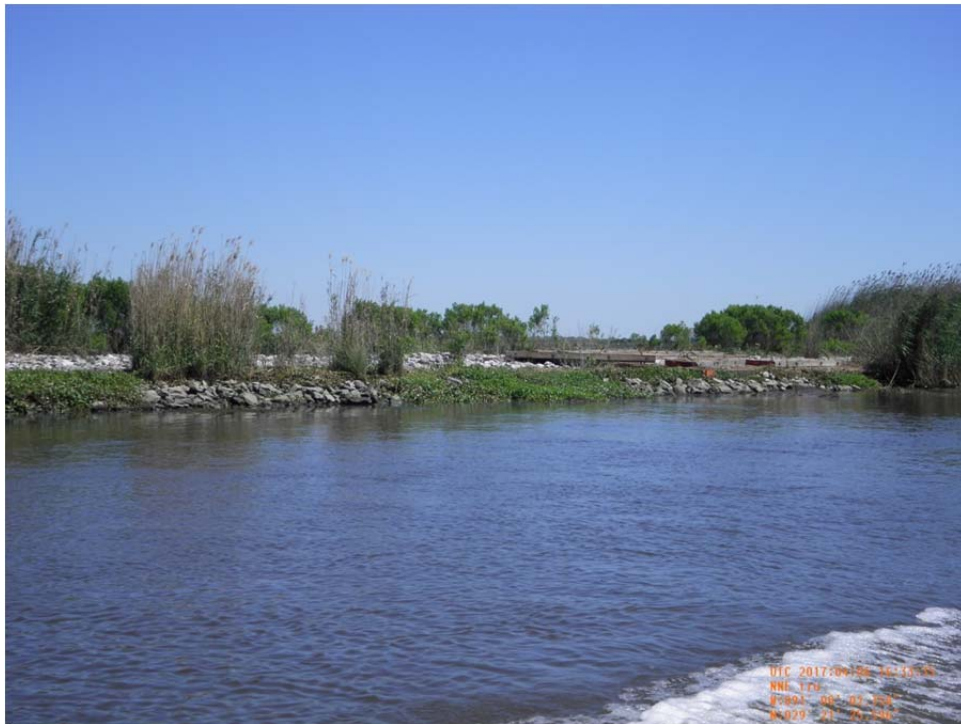
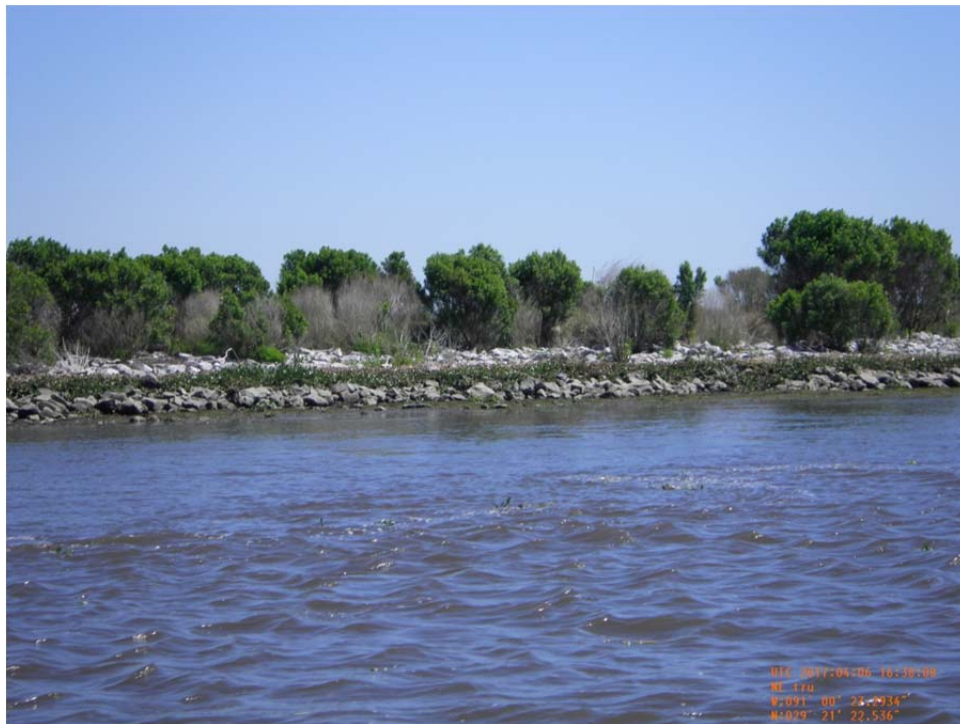
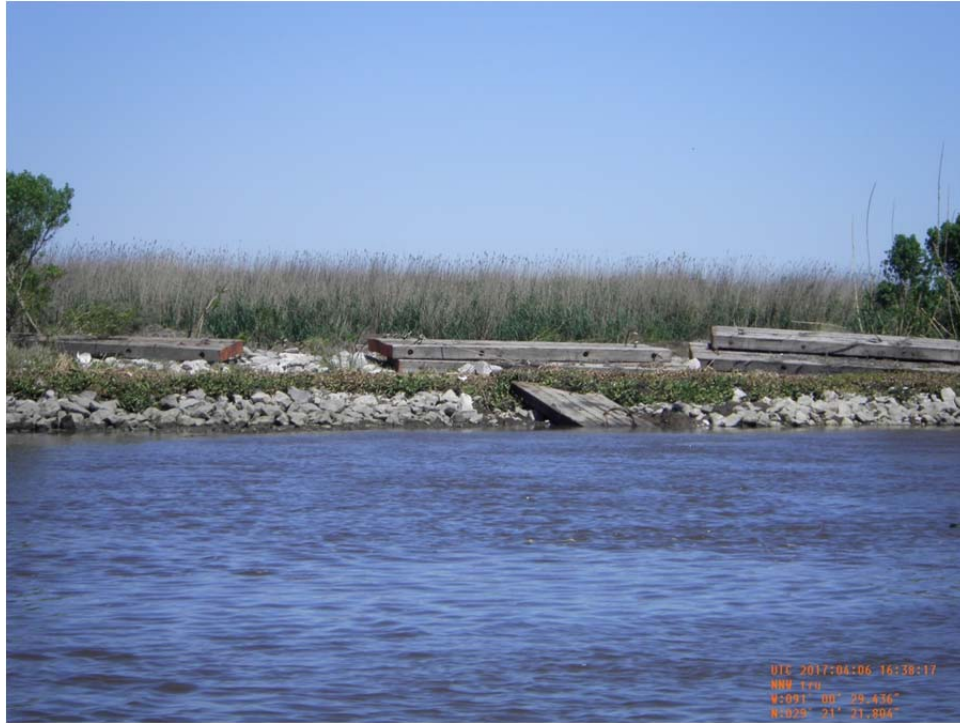
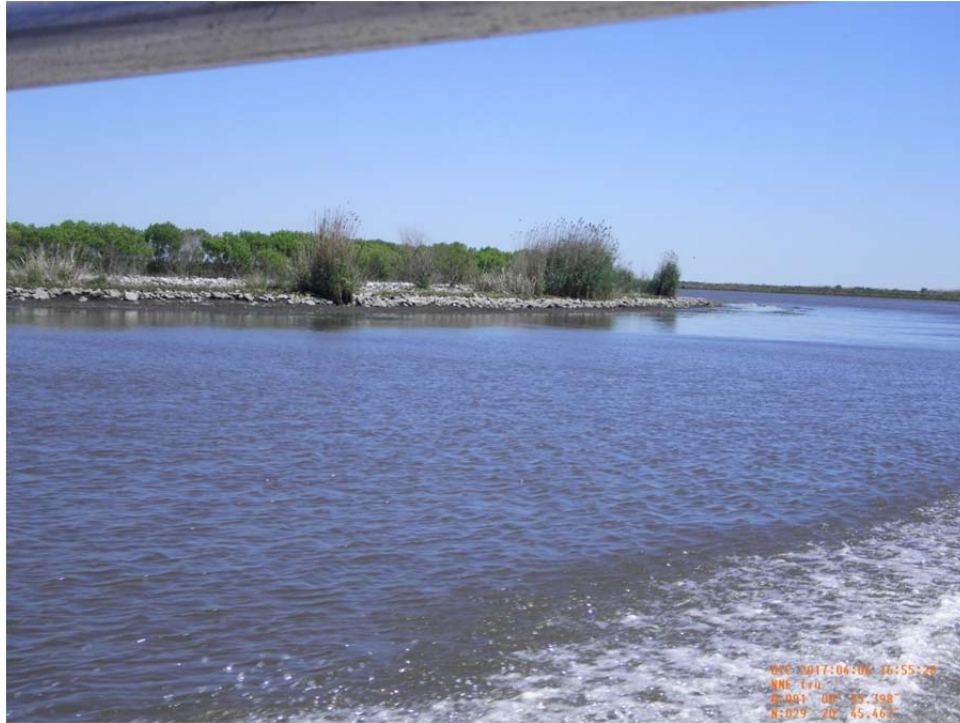
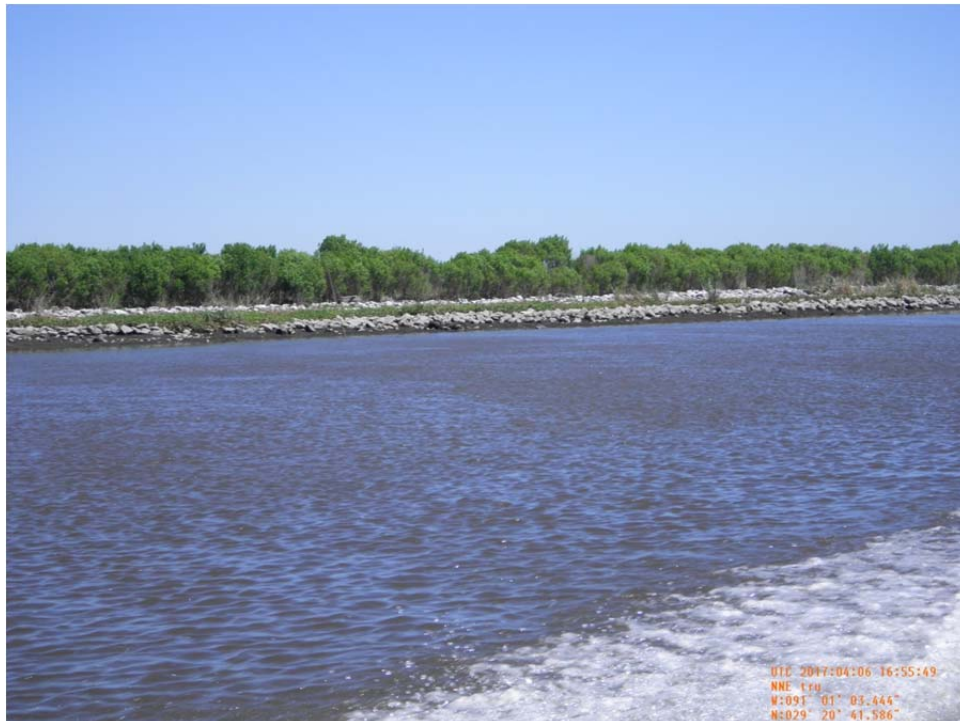
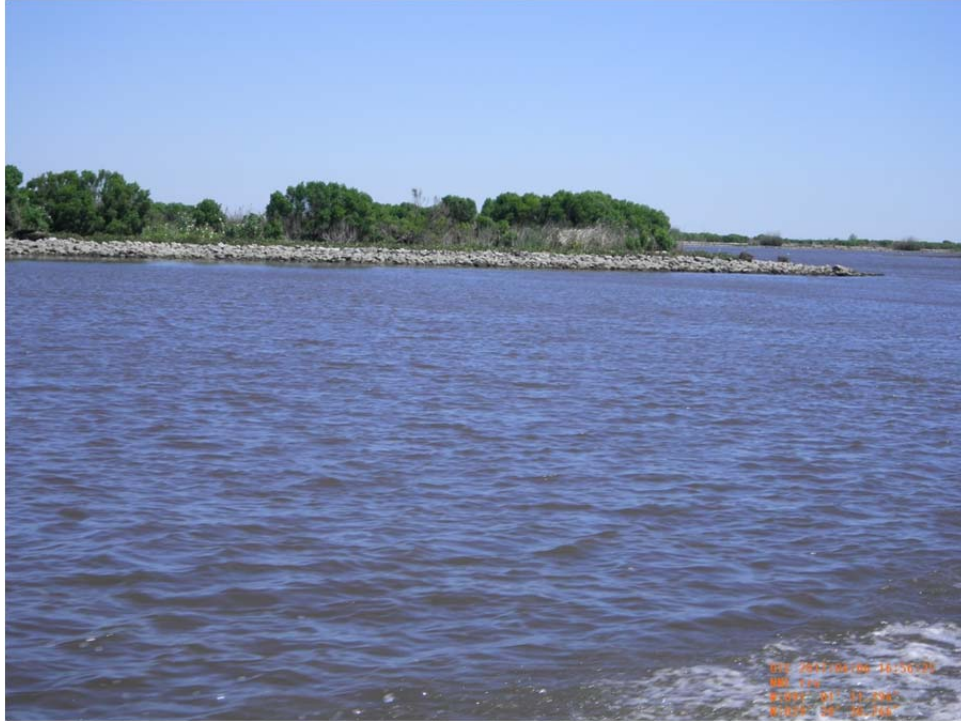
The rock armored revetment along the north bank of Bayou Decade was in good condition with only one minor flaw at the end of Reach 3 near Voss Canal. It appeared that earthen embankment was recently refurbished, but the material was placed without grading and was not uniform (Appendix B, Photo 25). The remaining reaches (Reach 1 and 2) were in good condition with only minor erosion around the southern beginning of Reach 1 near Lost Lake (Appendix B, Photos 44-45). The earthen embankment is well vegetated and the rock revetment is stable. No maintenance will be required at this time. (Appendix B, Photos 26 through 28, 32-33, 41-43)

Photo No. 25 – view of rock revetment near Sta. 39+11 (Reach 3) along west bank of Bayou de Cade.

Photo 26- view of rock revetment (Reach 3) along west bank of Bayou de Cade.

Photo 27- view of rock revetment (Reach 3) along west bank of Bayou de Cade.

Photo 28- view of rock revetment (Reach 3) along west bank of Bayou de Cade.

Photo 32- view of rock revetment (Reach 2) along west bank of Bayou de Cade.

Photo 33- view of rock revetment (Reach 2) along west bank of Bayou de Cade.

Photo 41- view of rock revetment (Reach 1) along west bank of Bayou de Cade.

Photo 42- view of rock revetment (Reach 1) along west bank of Bayou de Cade.

Photo 43- view of rock revetment (Reach 1) along west bank of Bayou de Cade.

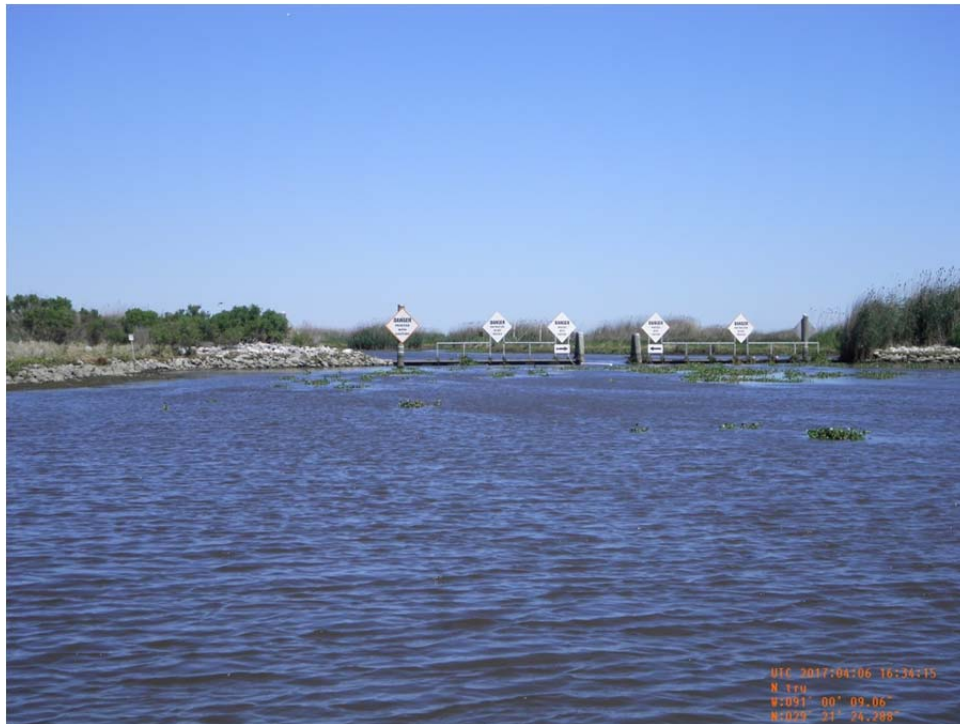
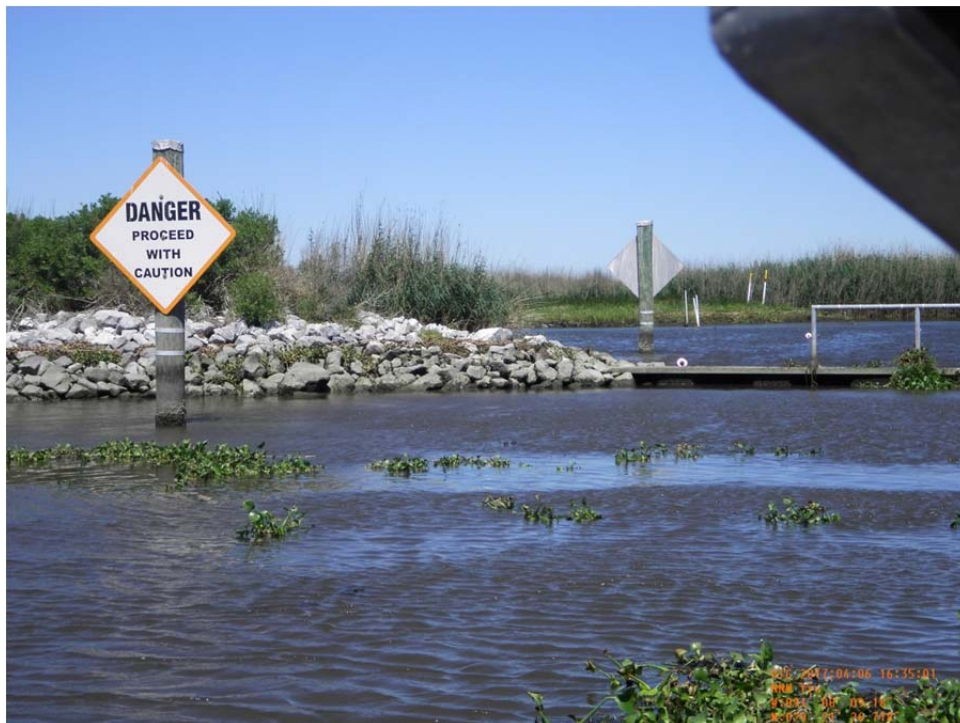
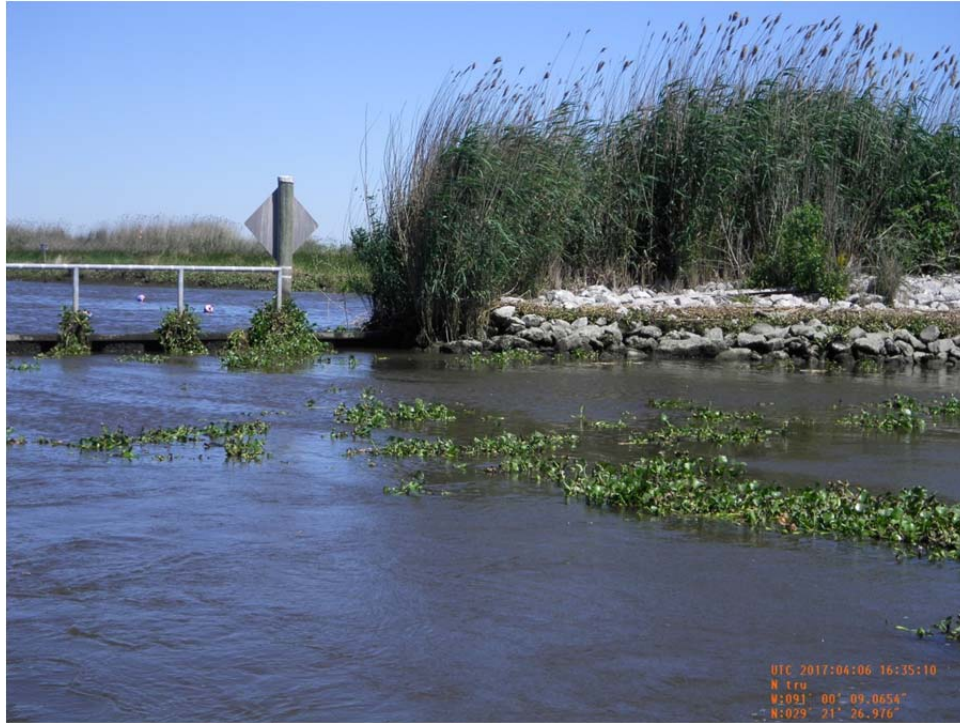
Structure No.4 appeared to be in very good condition with no evident damage or corrosion. The armored bank tie-ins were in good condition. The signs and supports were also in good condition. No maintenance is required at this time. (Appendix B, Photos 29 through 31)

Photo 29- view of steel sheetpile Weir No.4 along west bank of Bayou de Cade.

Photo 30- view of south bank tie-in of steel sheetpile Weir No.4 along west bank of Bayou de Cade.

Photo 31- view of north bank tie-in of steel sheetpile Weir No.4 along west bank of Bayou de Cade.

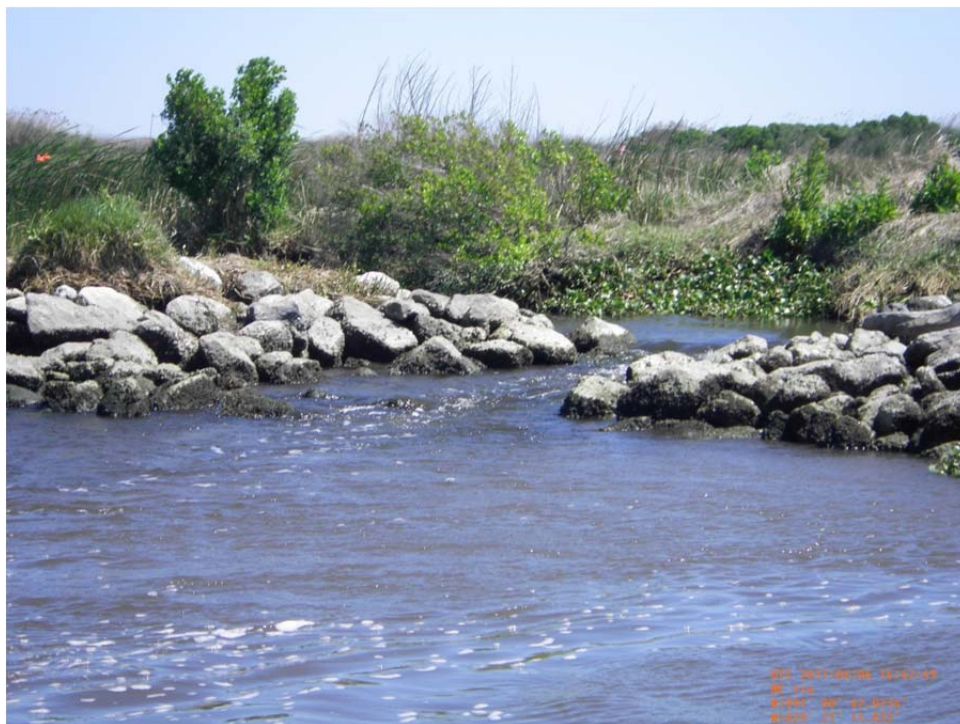
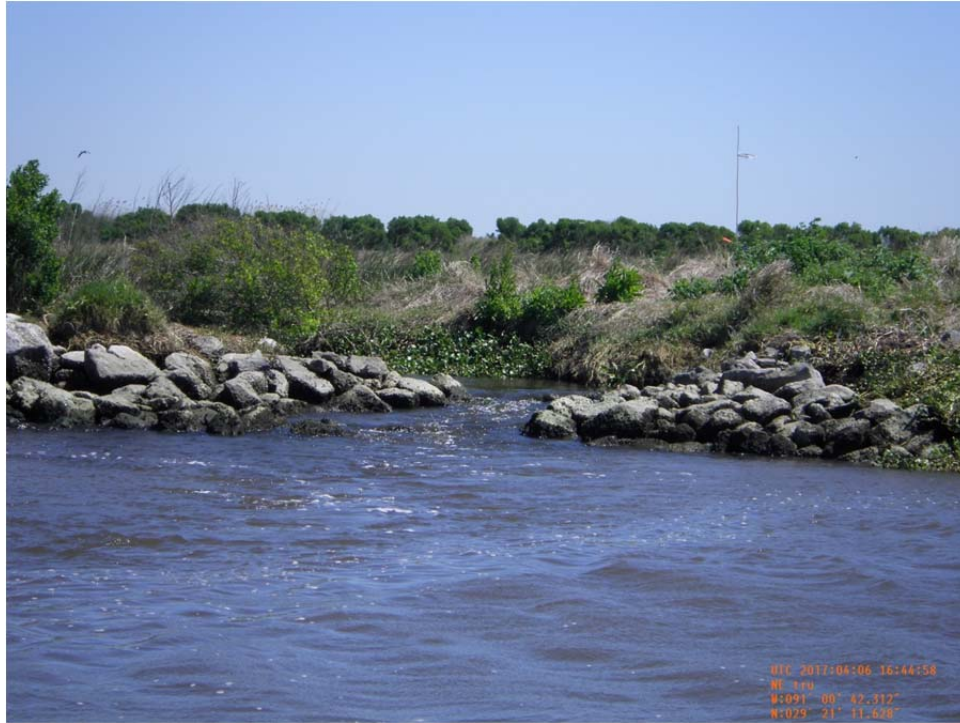
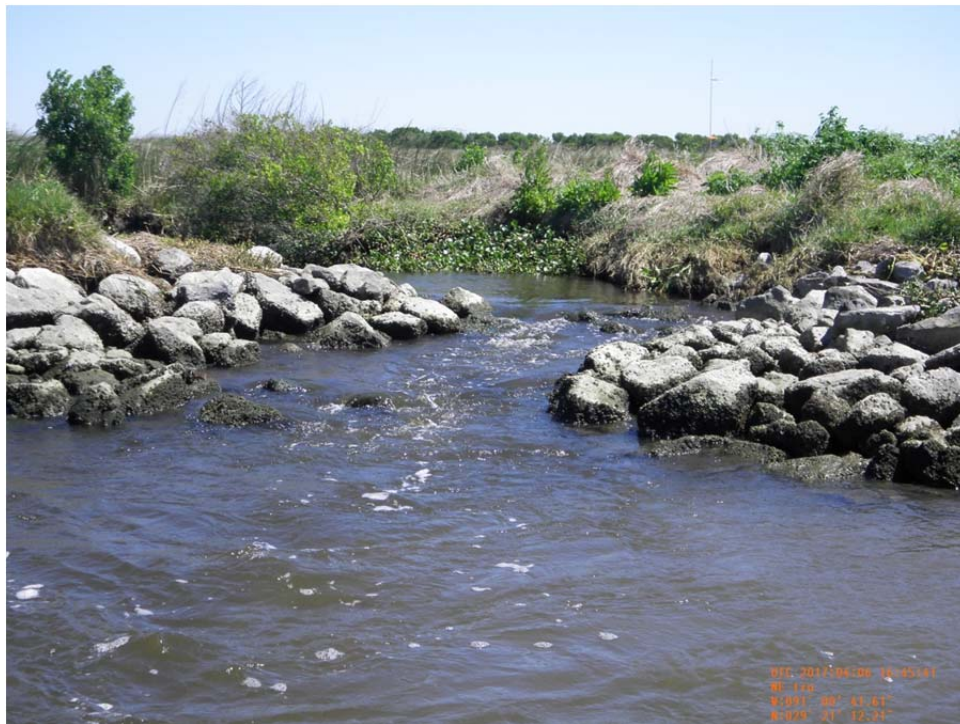
The fixed crest weir with boat bay closest to Lost Lake along the north bank of Bayou Decade was in good condition at the time of the inspection. On the north tie-in, it appeared that someone had cut the rock dike connecting the steel bulkhead to the bank revetment structure. The contractor, Weeks Marine, currently working on the Lost Lake Marsh Creation (TE-72) project has agreed to repair the rock dike at an estimated cost of approximately \$15,000. A change order has been issued to Weeks Marine and the work should be completed by the end of November 2017. There were also several long lengths of white PVC pipe in front of the structure that didn't appear to have a function and were not installed during construction of the project. It was later discovered that a fisherman placed the PVC pipe in front of the structure to block the water hyacinth from moving his crab traps around on the interior side of the marsh. The steel sheet piling and structural components were in good condition with no noticeable corrosion or damage. The signs and supports were in good condition as well. No maintenance will be required at this time. (Appendix B, Photos 34 and 40)

Photo 38- view of cut in rock dike tie-in on the north side steel sheetpile Weir No.5 along west bank of Bayou de Cade.

Photo 39- view of cut in rock dike tie-in on the north side steel sheetpile Weir No.5 along west bank of Bayou de Cade.

Photo 40- view of cut in rock dike tie-in on the north side steel sheetpile Weir No.5 along west bank of Bayou de Cade.

All features of the Penchant Basin Natural Resource Plan – Increment 1 were in good condition with only minor erosion at the Lost Lake near the beginning of Reach 1 and the end of Reach 3 near Voss Canal. There was also damage to the rock dike connecting the north side of Structure No. 5 to the revetment structure. The damage was intentionally done by the contractor, Weeks Marine, to benefit the ongoing construction of the Lost Lake Marsh Creation (TE-72) project. Weeks Marine has been notified by CPRA that we expect this area to be restored to its previous condition prior to demobilizing from the Lost Lake project. An inspection of the repairs shall be done prior to final payment for the Lost Lake Project. We will continue to monitor the areas of

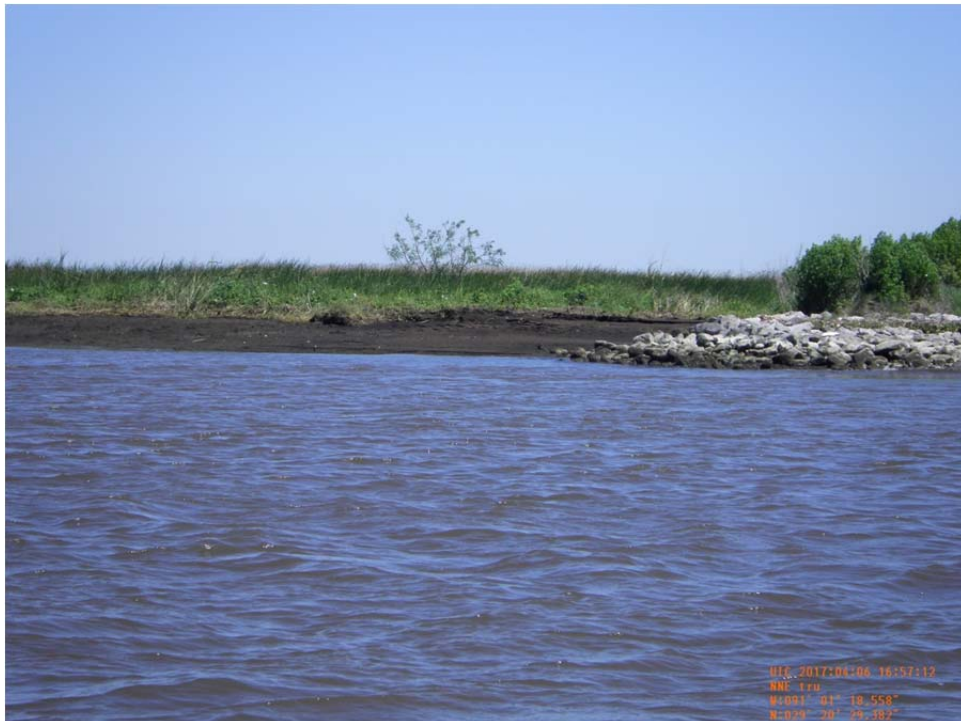
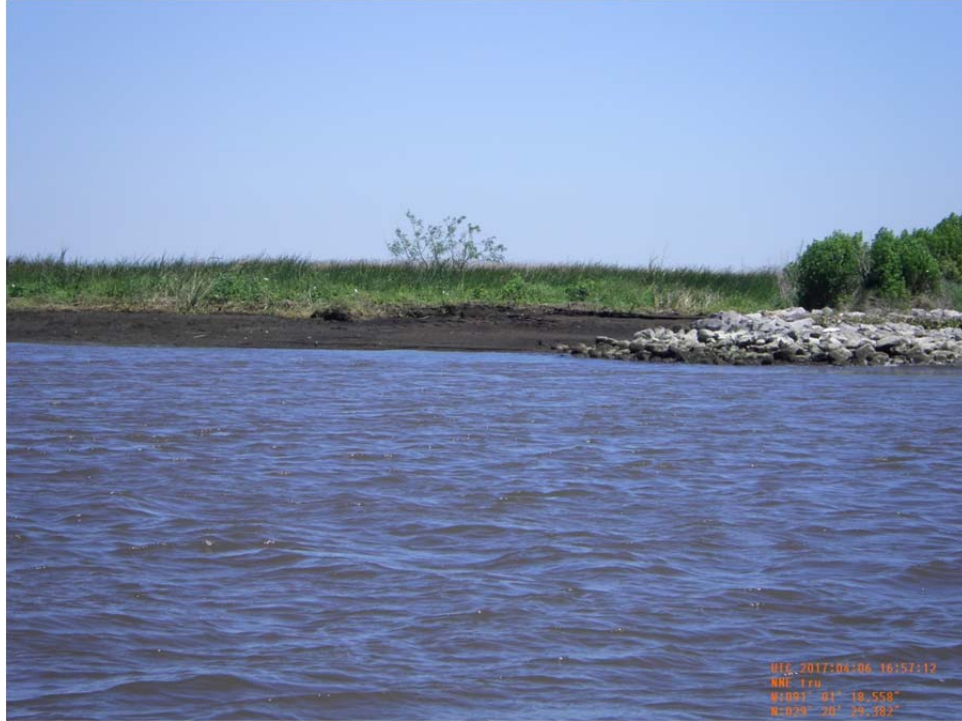
Photo 44- view of rock revetment at the beginning of Reach 1 along west bank of Bayou de Cade at Lost Lake.

Photo 45- view of rock revetment at the beginning of Reach 1 along west bank of Bayou de Cade at Lost Lake.

concern on future inspections and recommend repairs at a later date should maintenance be required. The rock dike containment and fill areas near Bayou Penchant and Bayou Chene were in good to fair condition with minor to moderate settlement of the rock dike and uniform settlement of the both marsh platforms. This area is subject to seasonal high river stages which at times can cover the structures with several feet of water for extended periods of time. The impact of several feet of water over the disposal areas may have accelerated the consolidation of the marsh platform since construction was completed. It may be beneficial to pump additional material into the disposal areas sometimes in the future to raise the platform so that vegetation can take hold. Further discussions with NRCS will be required prior to pursuing action on marsh re-nourishment. We are also not recommending any action regarding the maintenance of the rock dike at this time. Although the rock containment dike has settled since construction, it is still providing protection of the marsh creation areas. The project team will continue to monitor the condition of the dike and fill areas and make appropriate recommendation for maintenance as needed.
