**State of Louisiana
Coastal Protection and Restoration
Authority**

2013 Annual Inspection Report

**North Lake Mechant Landbridge
Restoration Project (TE-44)**

State Project Number TE-44
Priority Project List 10

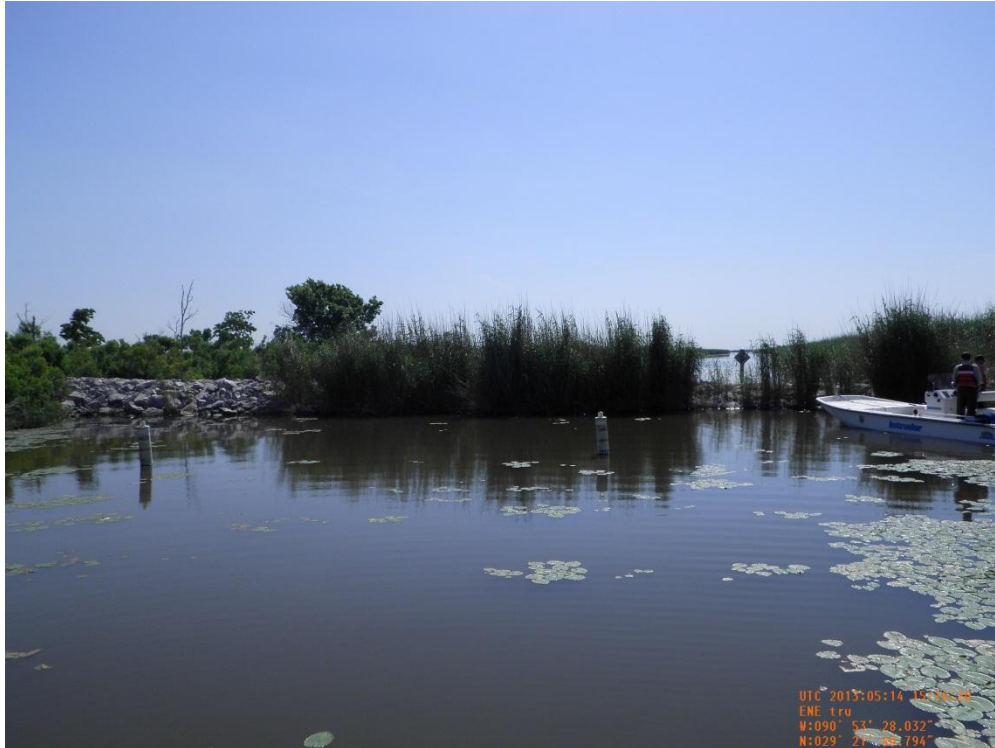
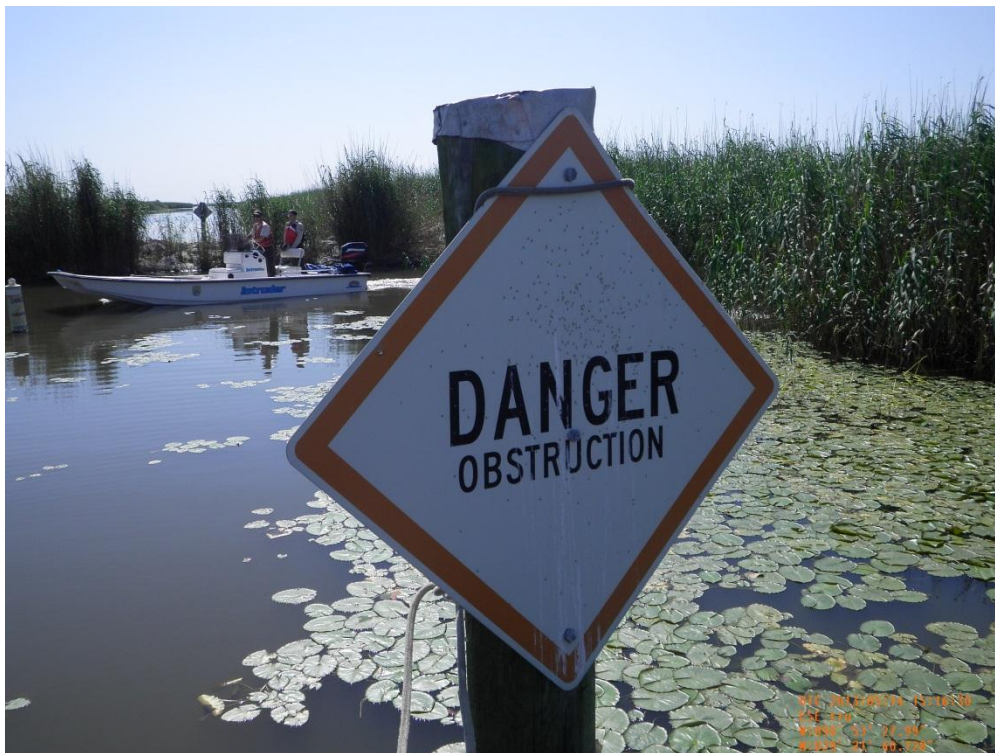
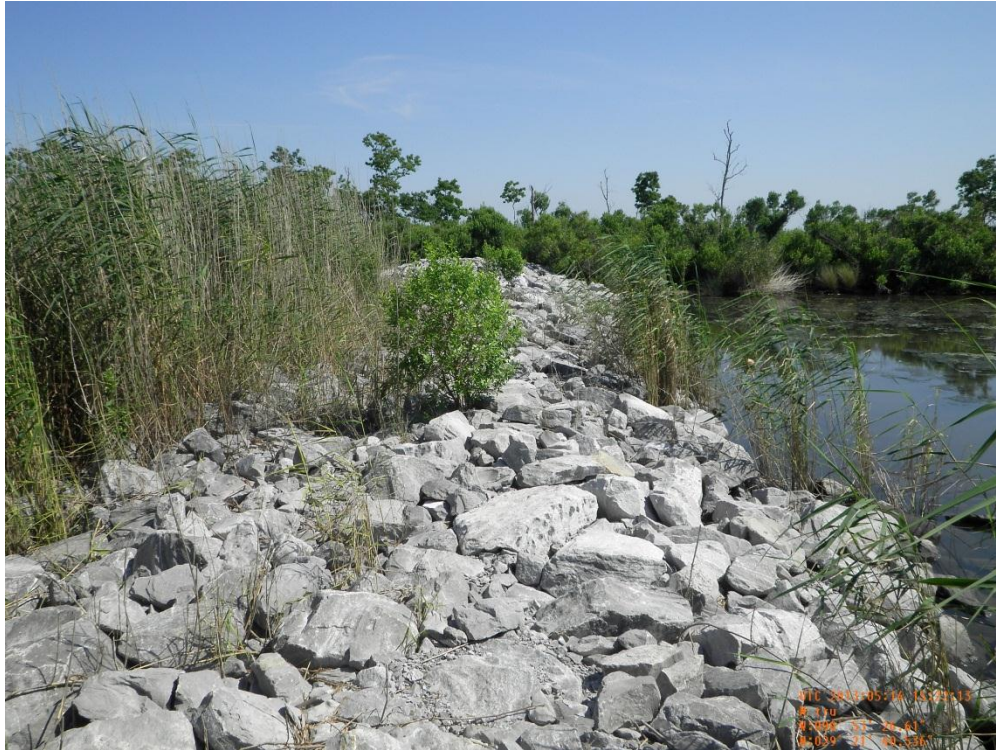
Rock plug 2 appears to be in good overall condition. During construction, the structure experienced some settlement of the rock riprap material and erosion causing a breach around its northern embankment tie-in. In order to repair this situation and prevent further breaching, extra rock riprap material was placed on this northern end of the structure raising its elevation. The as-built drawings indicate the north end was constructed to an elevation of approximately 5.5' NAVD with a gradual slope to the southern end at an elevation of approximately 3.0' NAVD. Our observations during the 2013 annual inspection are consistent with the as-built drawings, as the northern end is approximately 2.0'-3.0' higher in elevation than the southern end. The warning signs for the structure are up right and visible, but the southwest sign has been damaged by a shotgun. Overall this structure is in good condition. (See Appendix B, Photos 1 through 2, and Photo 5)

Photo 1: Overall view of Rock Plug 2 from the oilfield canal, looking east

Photo 2: Close up view of Rock Plug 2 warning sign and damage caused by vandals

Photo 5: View of Rock Plug 2 from on top of the structure, looking north

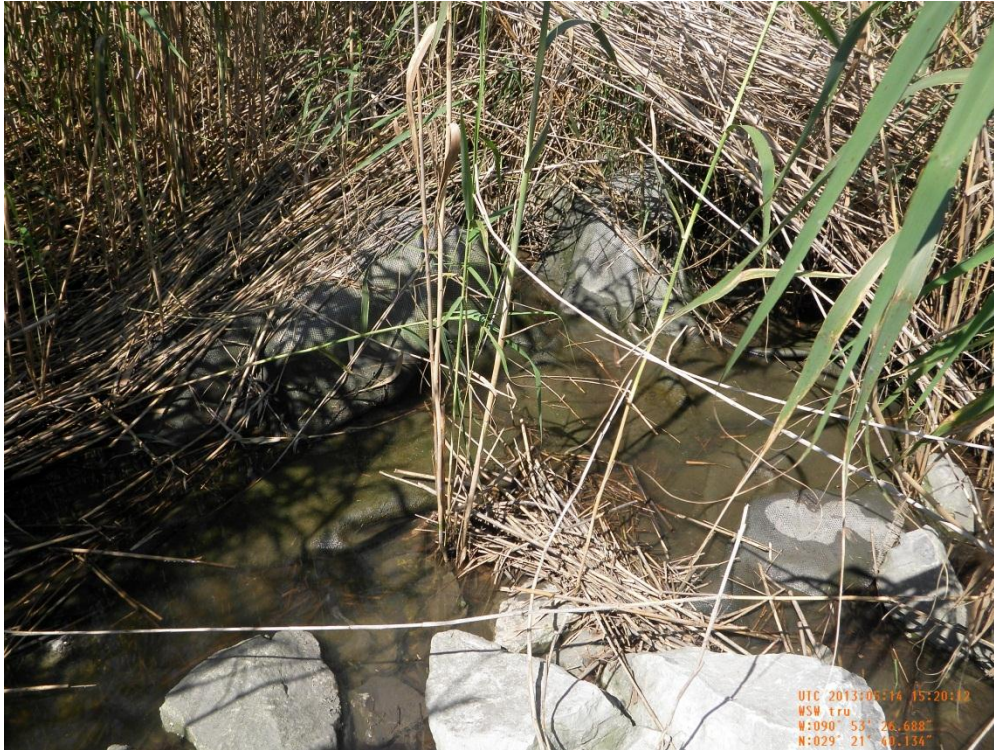
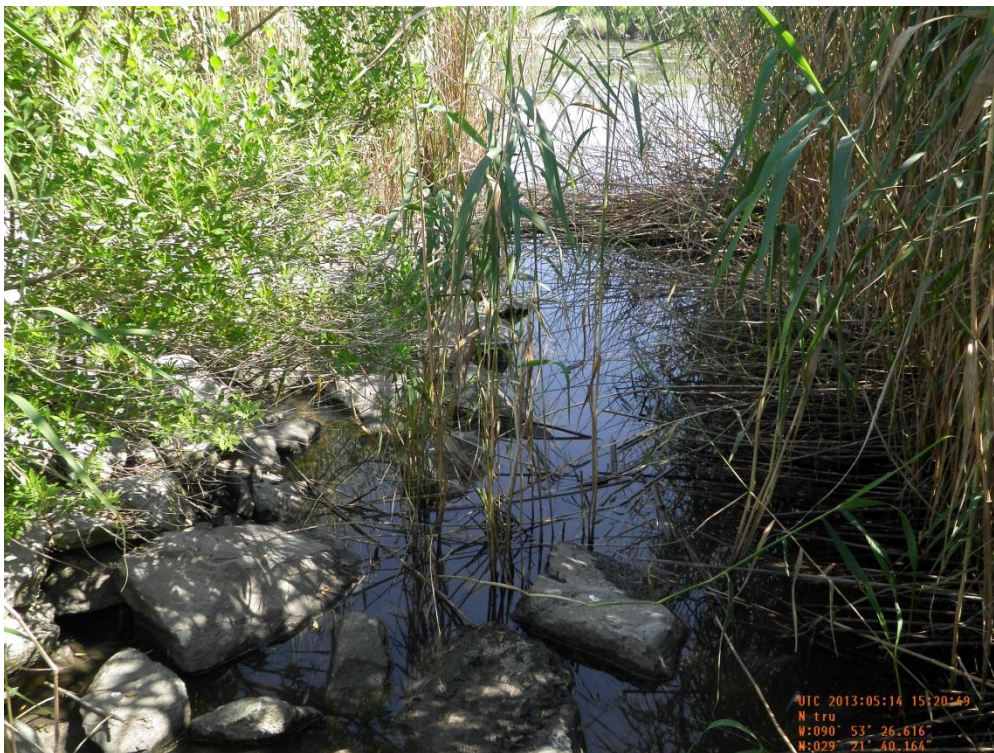
On the southern end of the structure, it appears the geofabric on which the rock riprap was placed was not properly trimmed to the edge of the structure. The excess of geofabric has prevented the native vegetation to grow around this end of the structure. With the lack of vegetation, standing water can be seen wrapping around the southern embankment tie-in. Although there was no flow of water around the structure observed during the inspection indicating a breach, this scenario would be plausible during an elevated tide or high water event. Due to the location of this structure and low volume of fill material, a repair of the embankment would be extremely expensive. Since this area does not pose an immediate threat, there are no recommendations for corrective action at this time, but CPRA will continue to monitor this location and would like to begin conversation with USFWS to discuss the feasibility of repairing this location.

Photo 3: View of standing water and untrimmed geo-fabric on the southern end of Rock Plug 2

Photo 4: View of standing water and untrimmed geo-fabric on the southern end of Rock Plug 2

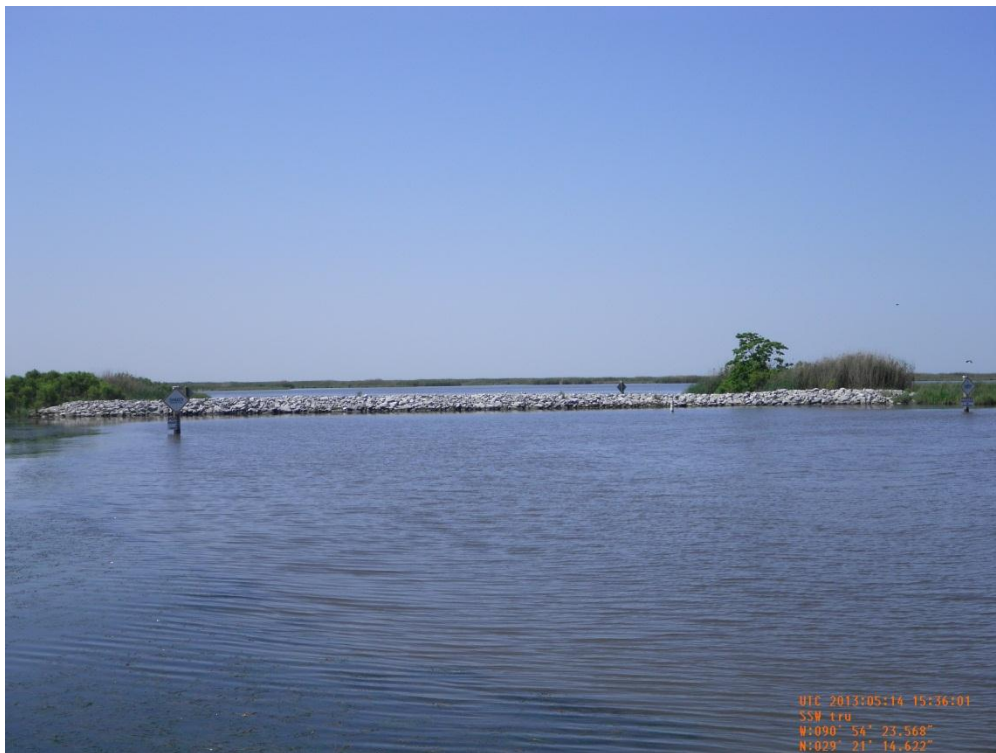
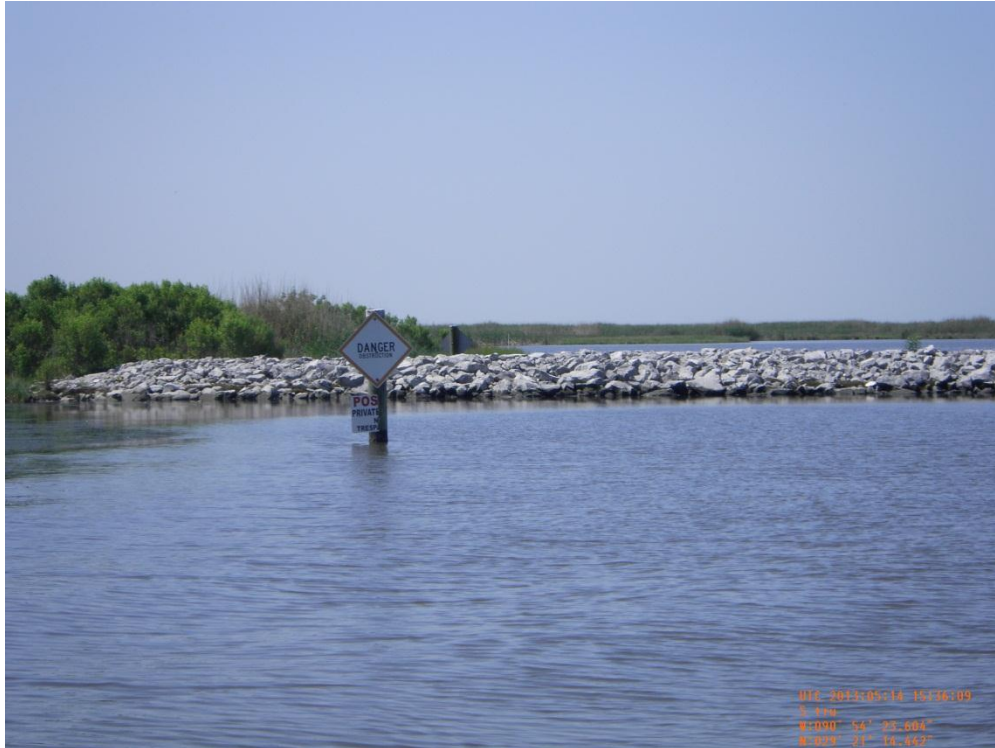
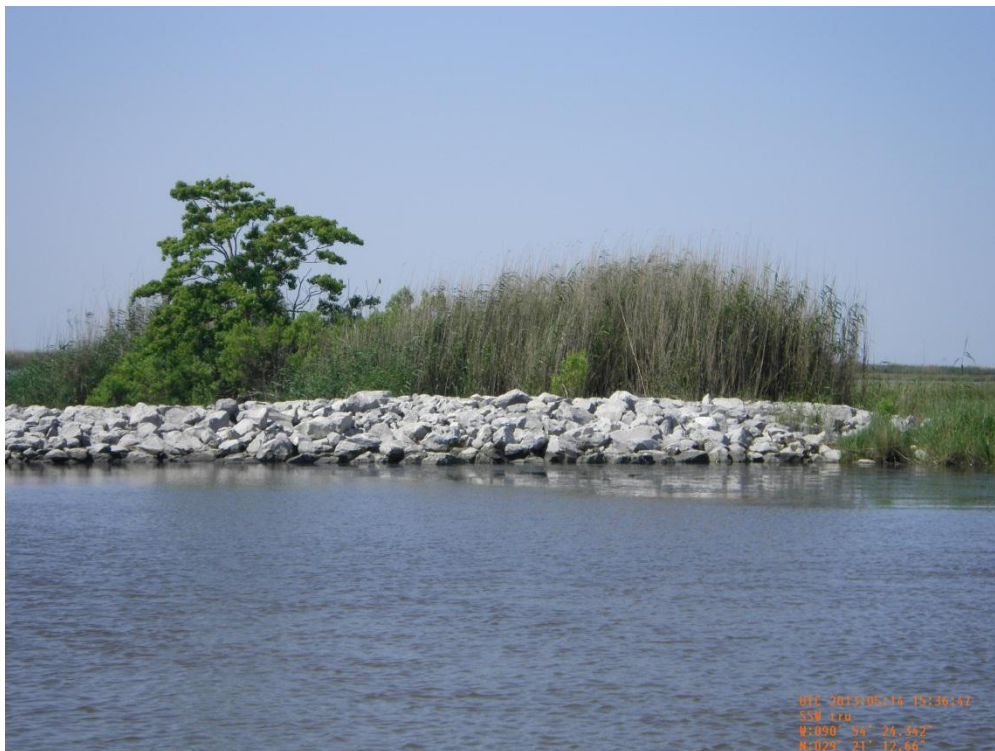
The Rock Plug 1 structure located along the south bank of Small Bayou LaPointe appeared to be in very good condition. There is no observable settlement since the end of construction and there is no evidence of erosion or washouts around the embankment tie-ins. The rock plug is still functioning as designed; therefore there are no recommendations for corrective action at this time. (See Appendix B, Photos 6 through 8)

Photo 6: Overall view of Rock Plug 1, looking south

Photo 7: View of the eastern embankment tie-in and warning sign of Rock Plug 1, looking south

Photo 8: View of the western embankment tie-in of Rock Plug 1, looking south

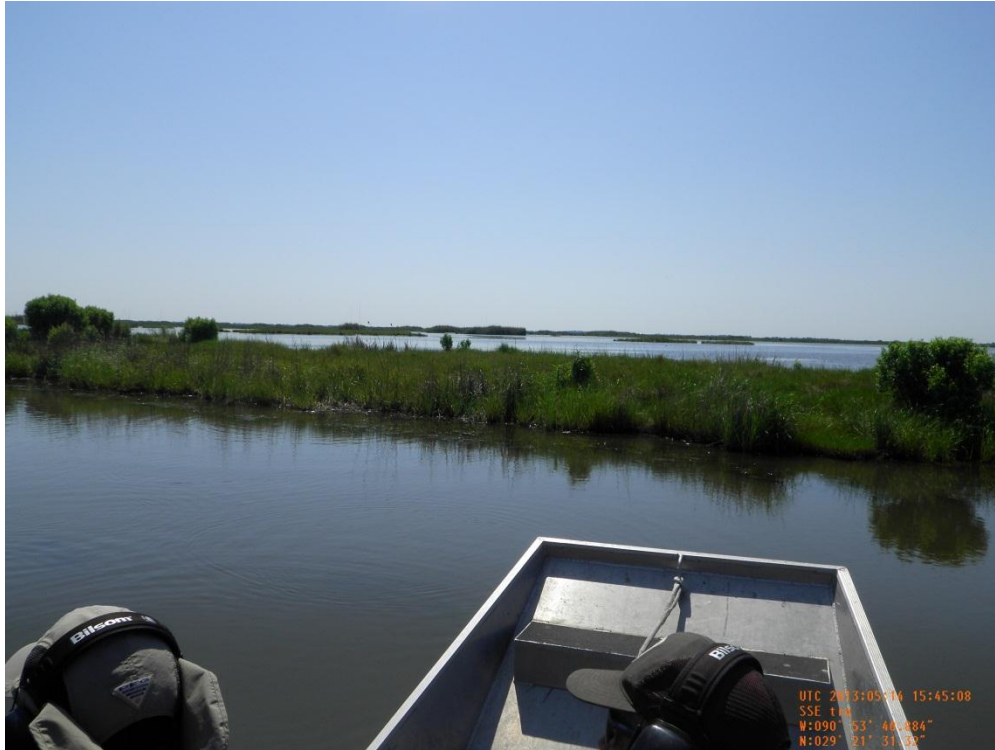
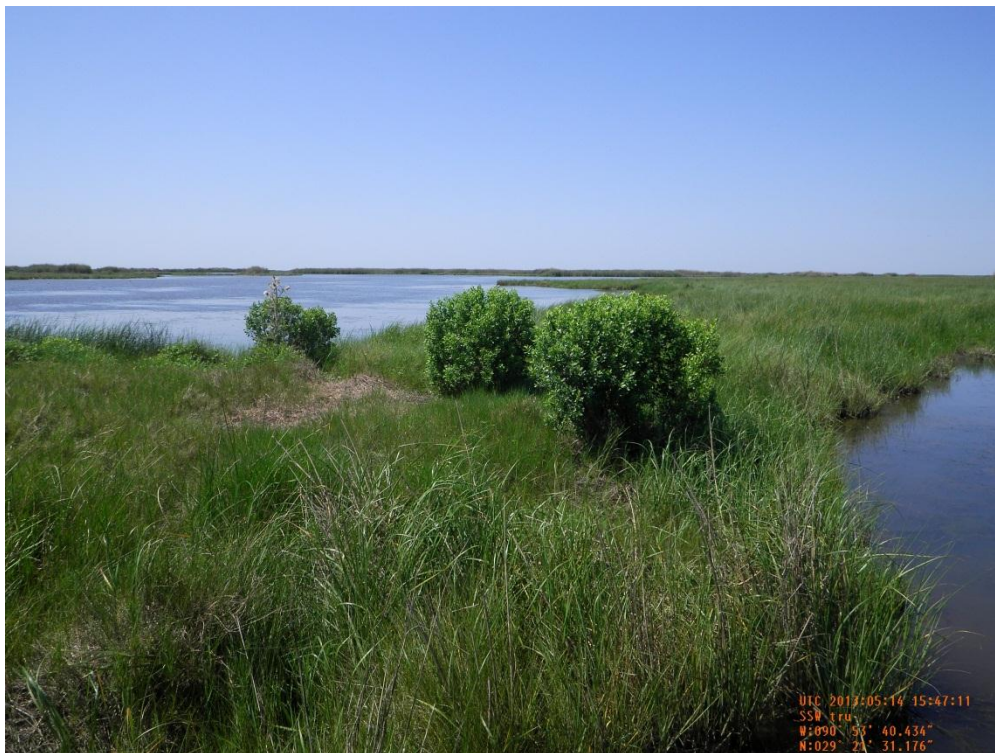
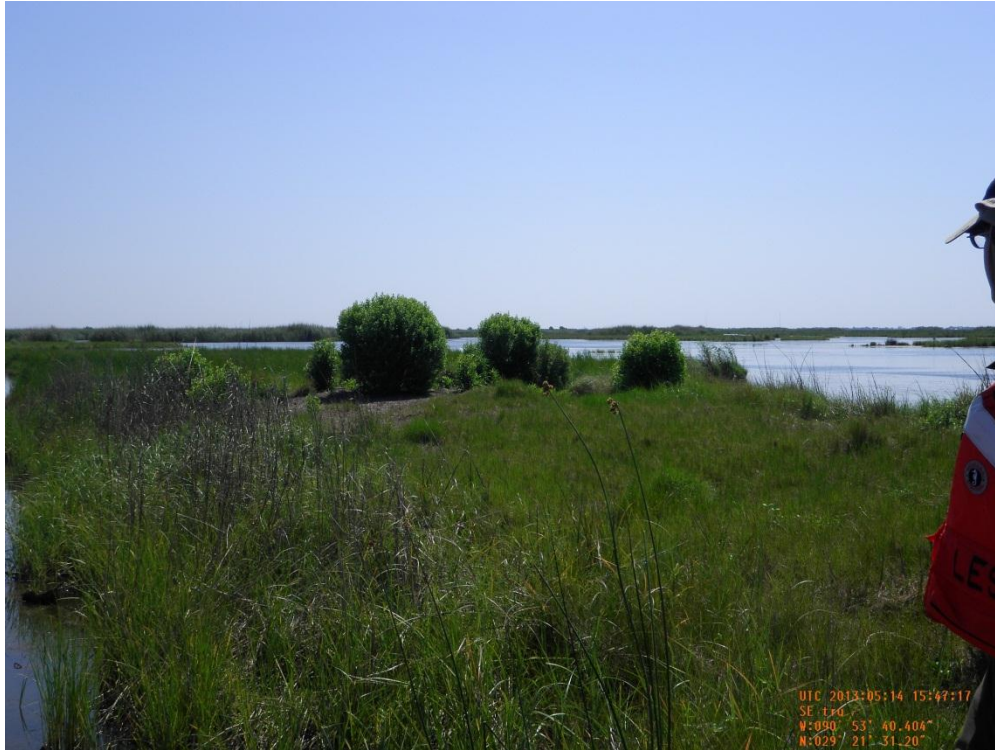
The Earthen Plug 2 structure located along the southern edge of Small Bayou LaPointe is difficult to access and difficult to locate now that the structure is fully vegetated. Besides the slightly higher elevation than the adjacent marsh, the structure doesn't have any identifying characteristics. This structure is in good overall condition with no observed settlement or erosion of the plug. Also, there is no evidence of washouts around the structures embankment tie-ins. There are no recommendations for maintenance at this time. (See Appendix B, Photos 9 through 11)

Photo 9: Overall view of Earthen Plug 2 from Small Bayou Lapointe, looking east

Photo 10: View of the western embankment tie-in of Earthen Plug 2, looking west

Photo 11: View of the eastern embankment tie-in of Earthen Plug 2, looking east

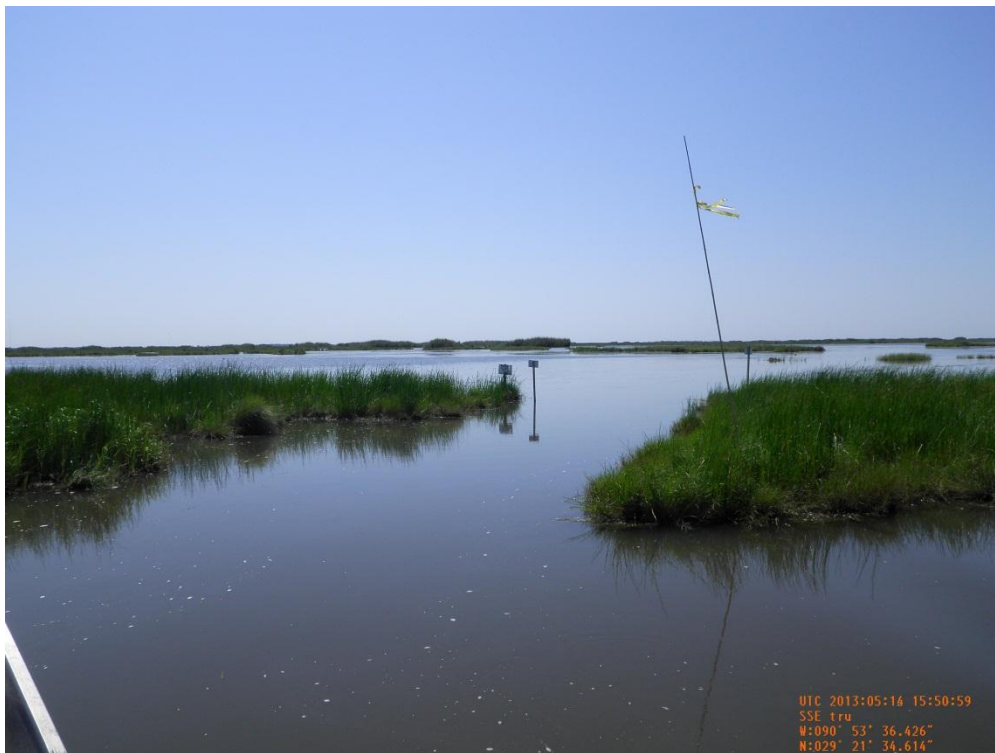
There was a breach identified during this year's annual inspection in the southern bank of Small Bayou LaPointe located approximately 400 feet north east of Earthen Plug 2. This is

a new breach, and at the time of this report, it remains breached. Once repaired, this breach will be referred to as Earthen Plug 5. (See appendix B, Photo 12)

Photo 12: View of a breach in the southern bank of Small Bayou Lapointe, looking south. It is located between Earthen Plug 2 and Rock Plug 2.

General Breach Repairs: Since the project was completed, we have noticed that the earthen embankments along the Small Bayou Lapointe Ridge are thin and endanger of breaching (very little marsh protecting the ridge). Below are estimated costs for refurbishing sections of the embankment. At this time, the specific areas have not been identified. For 2013/2014, we are assuming that approximately 500 linear feet of embankment will require refurbishment.

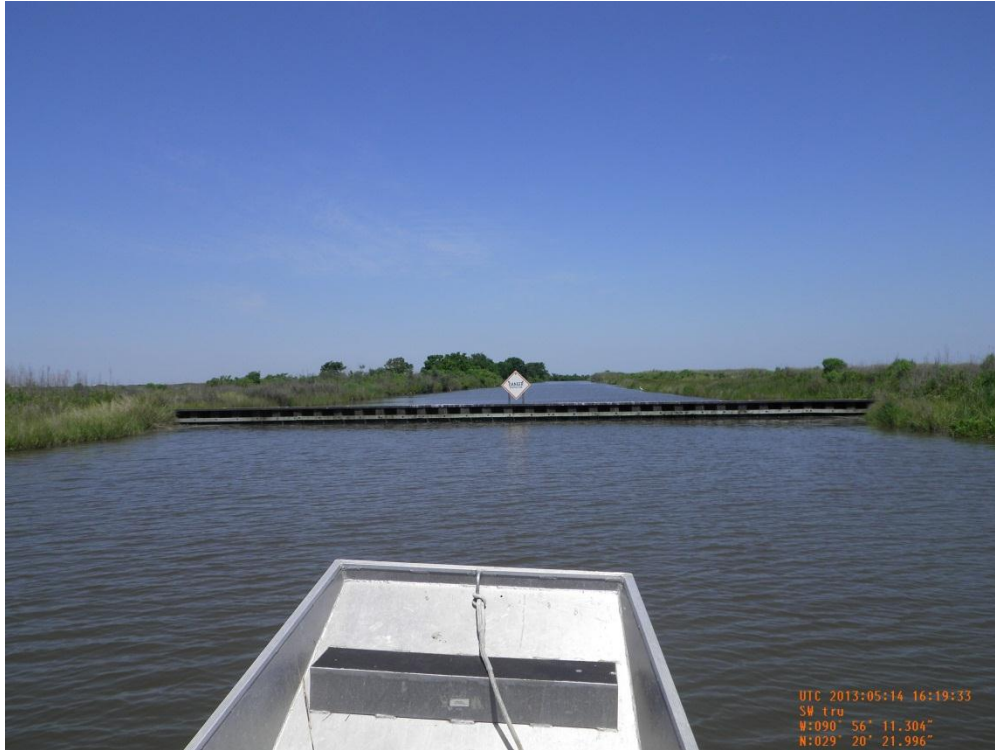
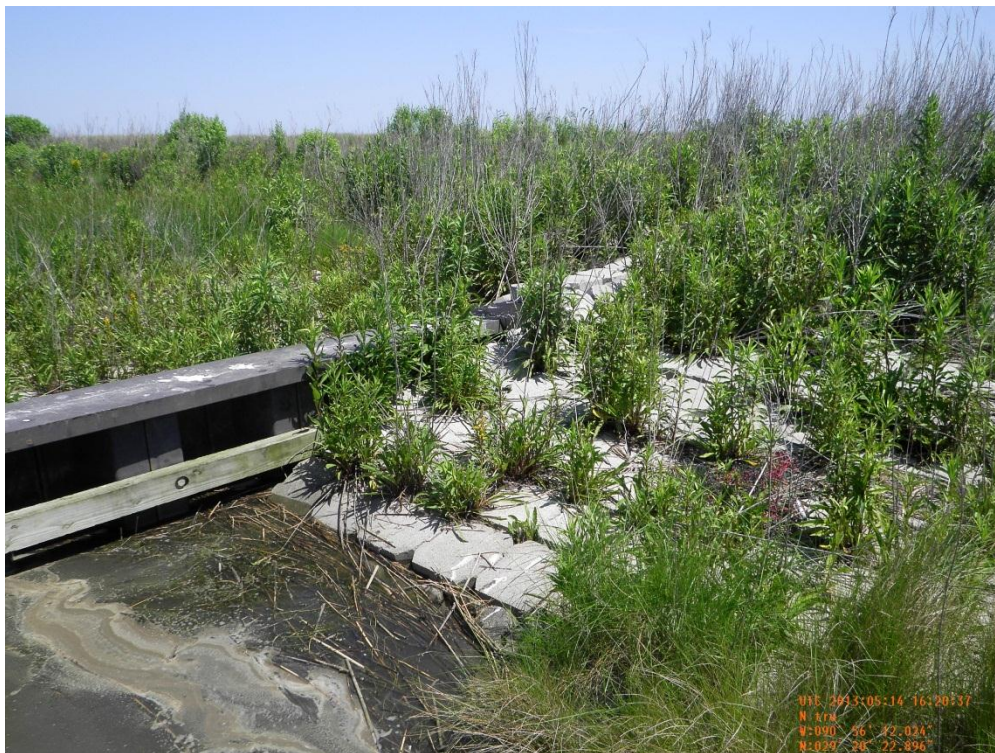
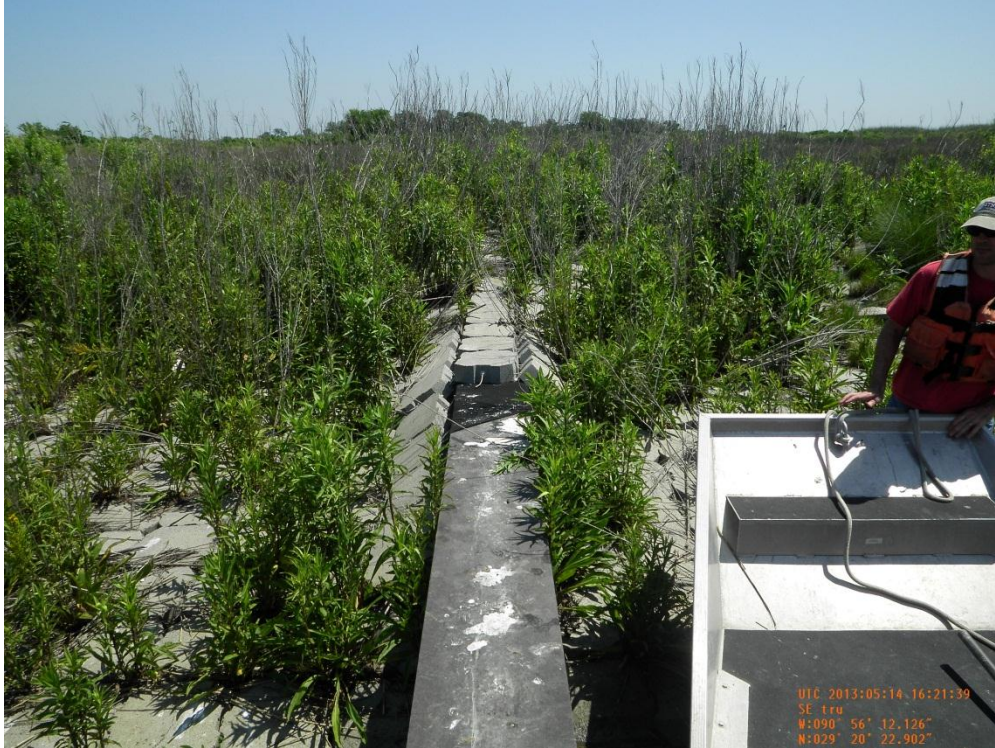
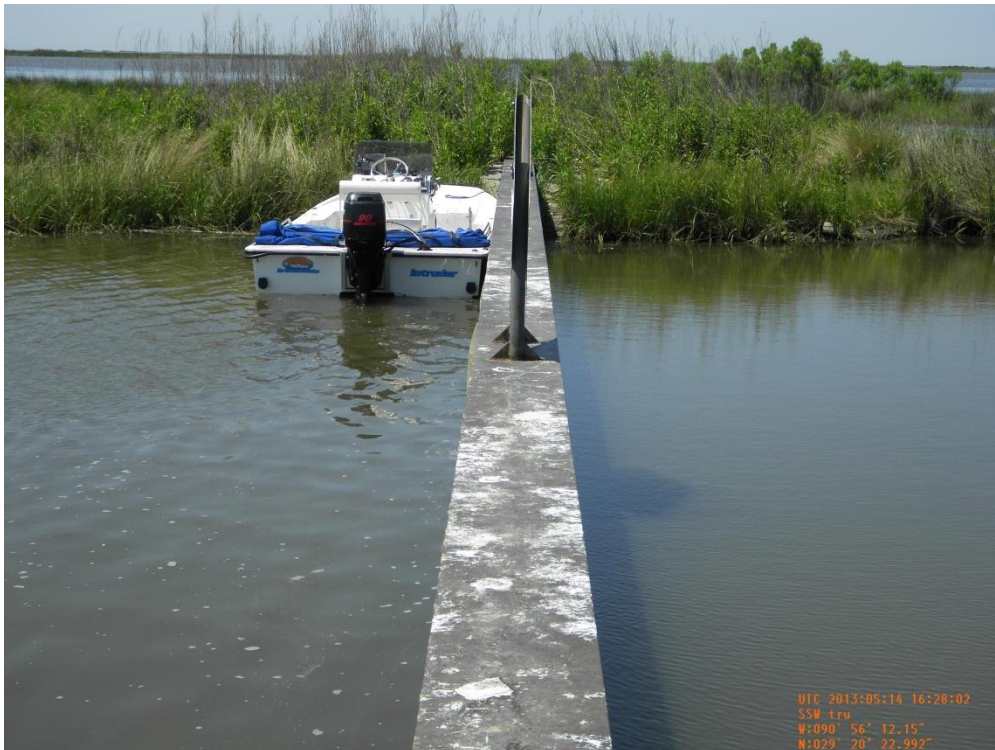
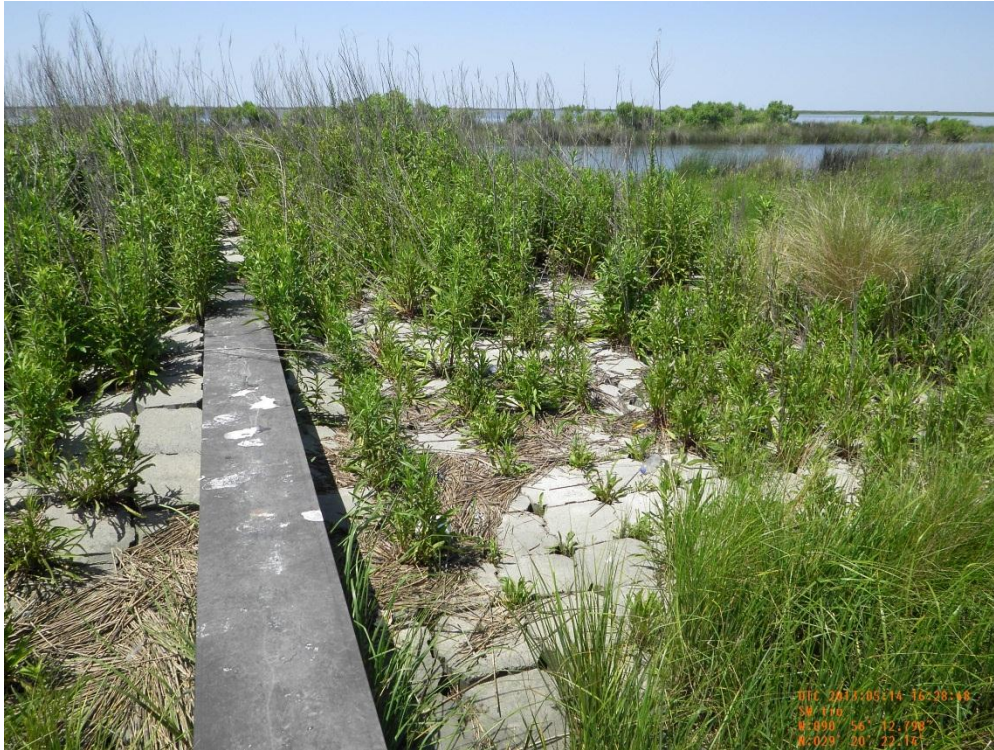
Sheet Pile Plug No. 3 appears to be in good overall condition. The sheet pile and top cap showed no signs of damage or excessive corrosion, and the embankment tie-ins had no signs of erosion or washouts. Photo comparison from previous annual inspections display the articulated concrete mat used to armor the embankment tie-ins are stable with no signs of settlement. In addition, the warning signs were intact and visible. There are no recommendations for corrective action at this time. (See Appendix B, Photos 13 through 17)

Photo 13: Overall view of Sheetpile Plug 3, looking northwest

Photo 14: View of the articulated concrete mat used on the northeastern embankment tie-in of Sheetpile Plug 3

Photo 15: View of the articulated concrete mat used on the northeastern embankment tie-in on Sheetpile Plug 3 from on top of the structure

Photo 16: View along Sheetpile Plug 3 from on top of the structure, looking southwest

Photo 17: View of the articulated concrete mat used on the southwestern embankment tie-in on Sheetpile Plug 3 from on top of the structure

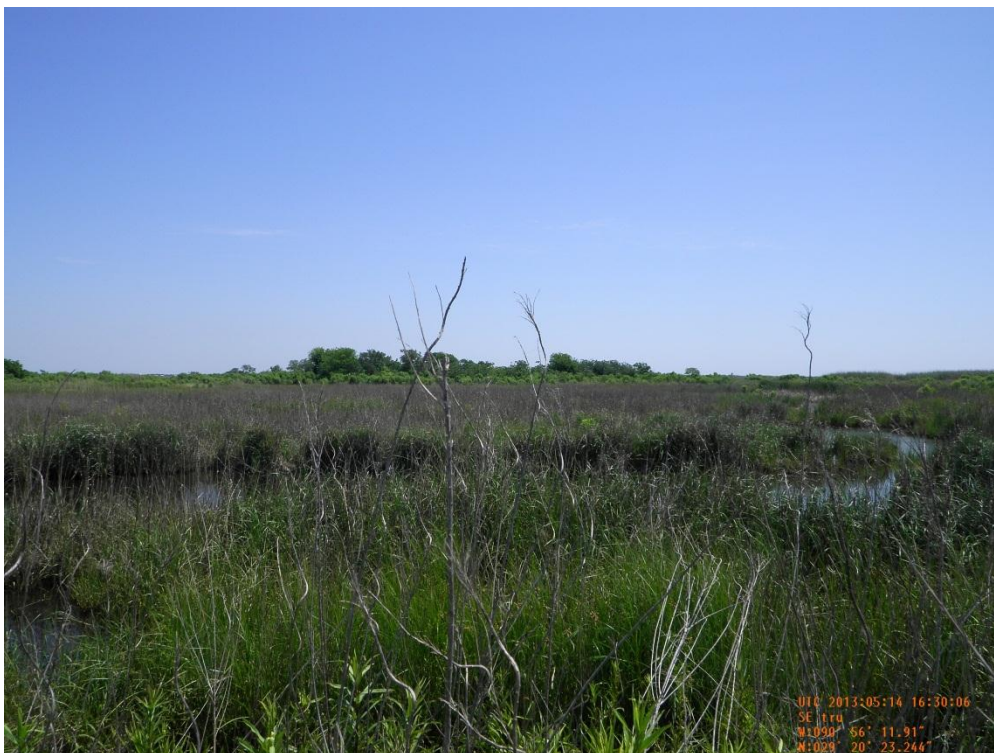
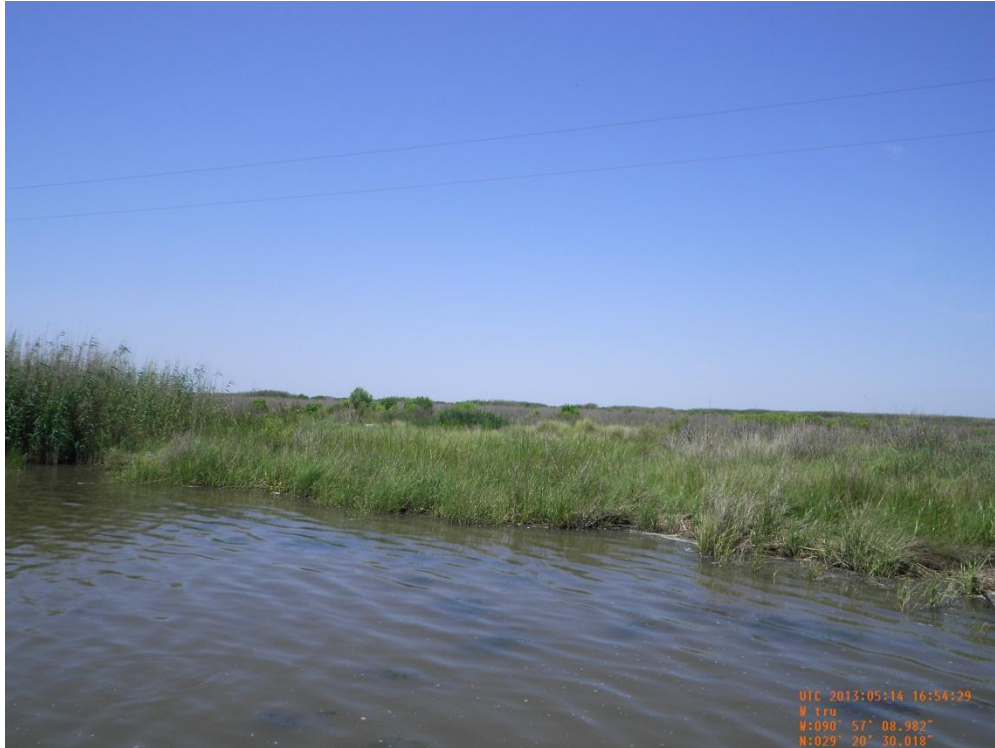
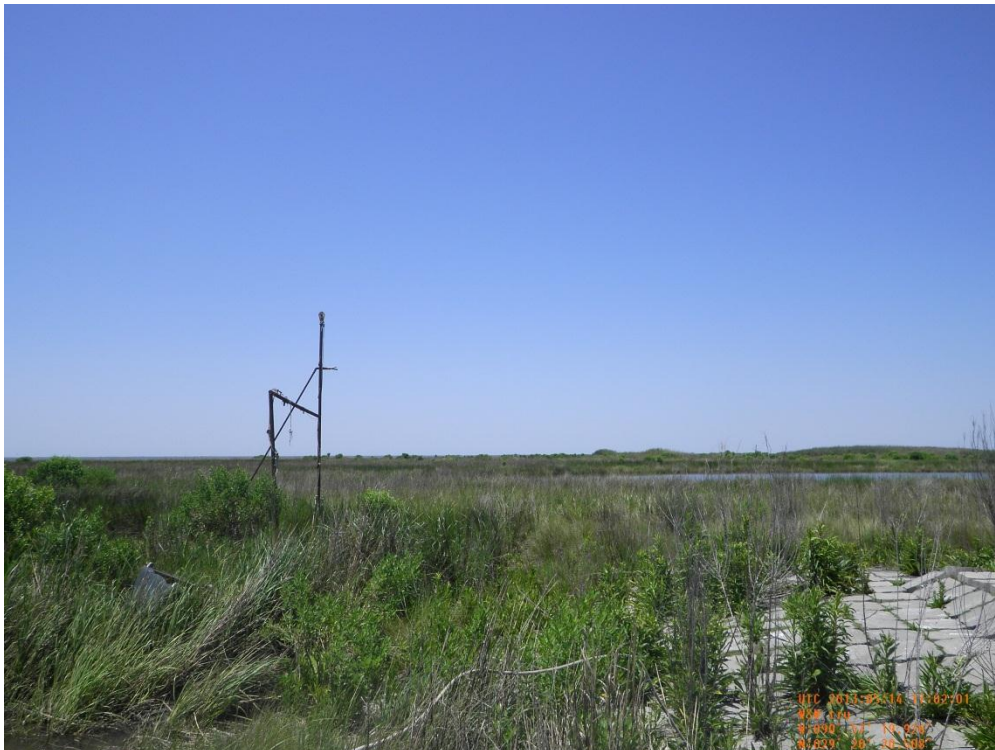
of the airboat, we were able to see the interior of Fill Areas 2A, 2-3, 4, and 5. There are no signs of extreme settlement of the fill material, as the elevation of the dredged material remains fairly consistent with the typical spikes in elevation where the dredge pipe was located during construction. Overall the fill areas appear to be in very good condition and there are no recommendations for corrective actions at this time. (See Appendix B, Photos 18, 25 and 30)

Photo 18: View of Fill Area 7 from Sheetpile Plug 3, looking northeast

Photo 25: View of Fill Area 5 from the western bank of Bayou Raccourci, looking west

Photo 30: View of Fill Area 4 from the Sheetpile Weir, looking west

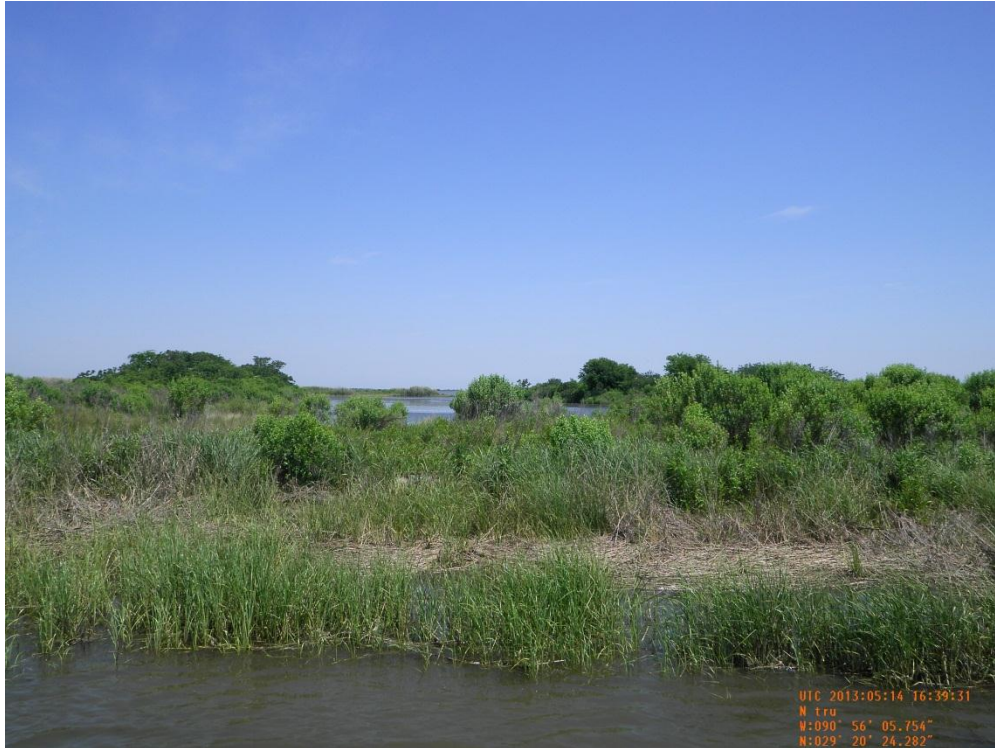
The Earthen Plug 3 structure appears to be in good condition. This structure located between fill areas 7 & 8 appears to be fully vegetated with none of the original construction material visible from the airboat. This structure also has no observed settlement or erosion of the plug and no signs of erosion around the embankment tie-ins. There are no recommendations for corrective actions at this time. (See Appendix B, Photo 19)

Photo 19: Overall view of Earthen Plug 3, looking northwest

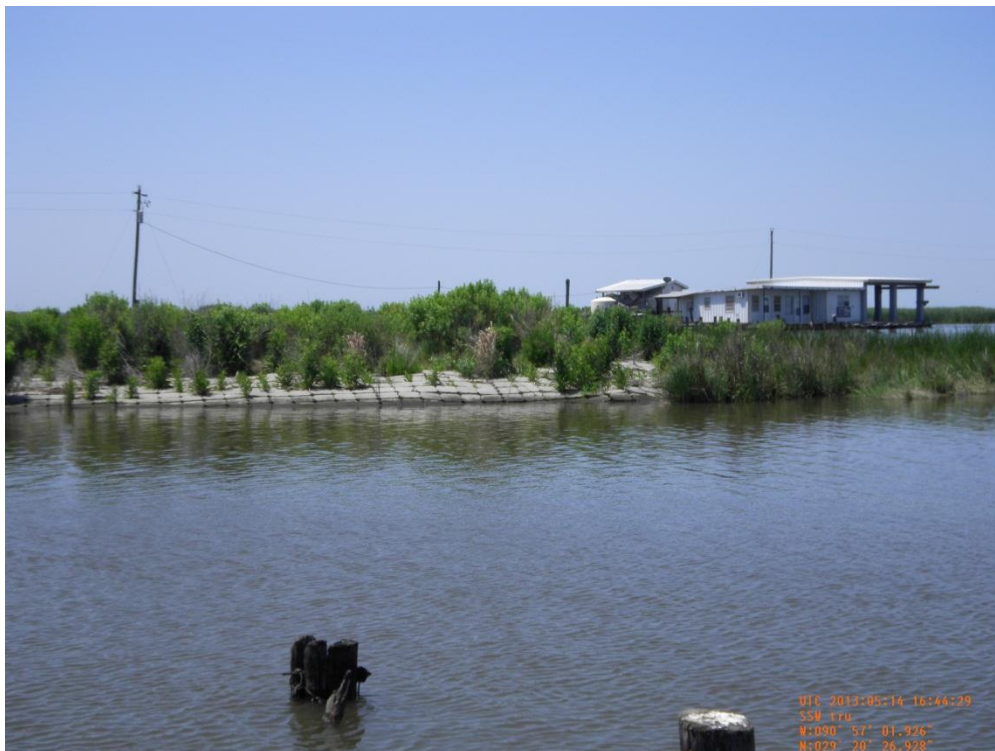
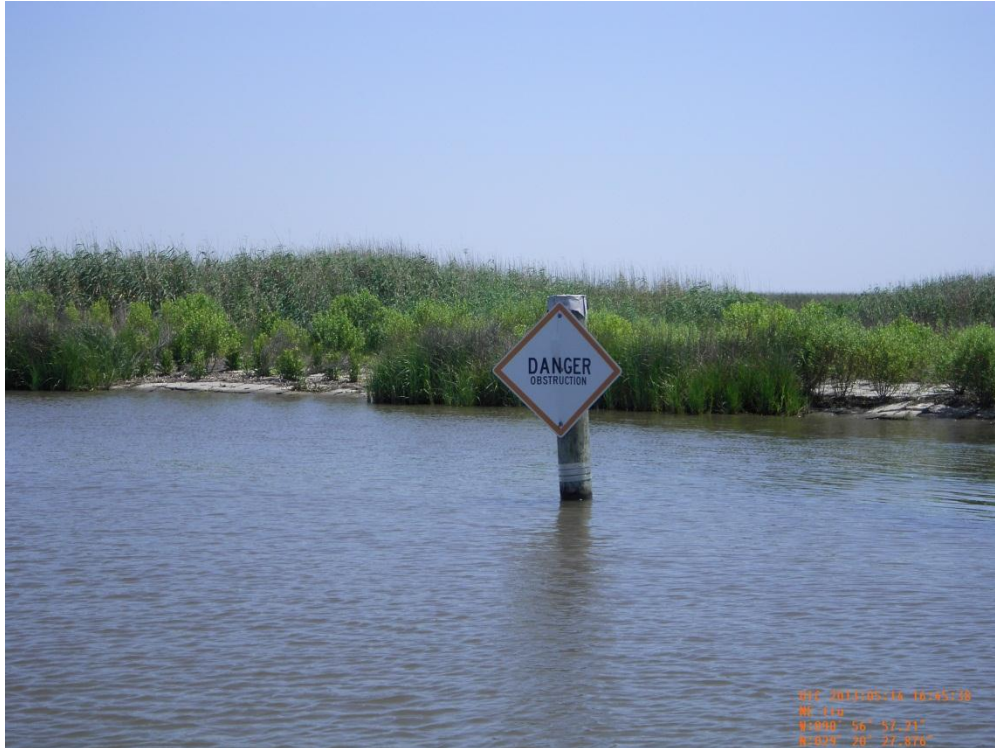
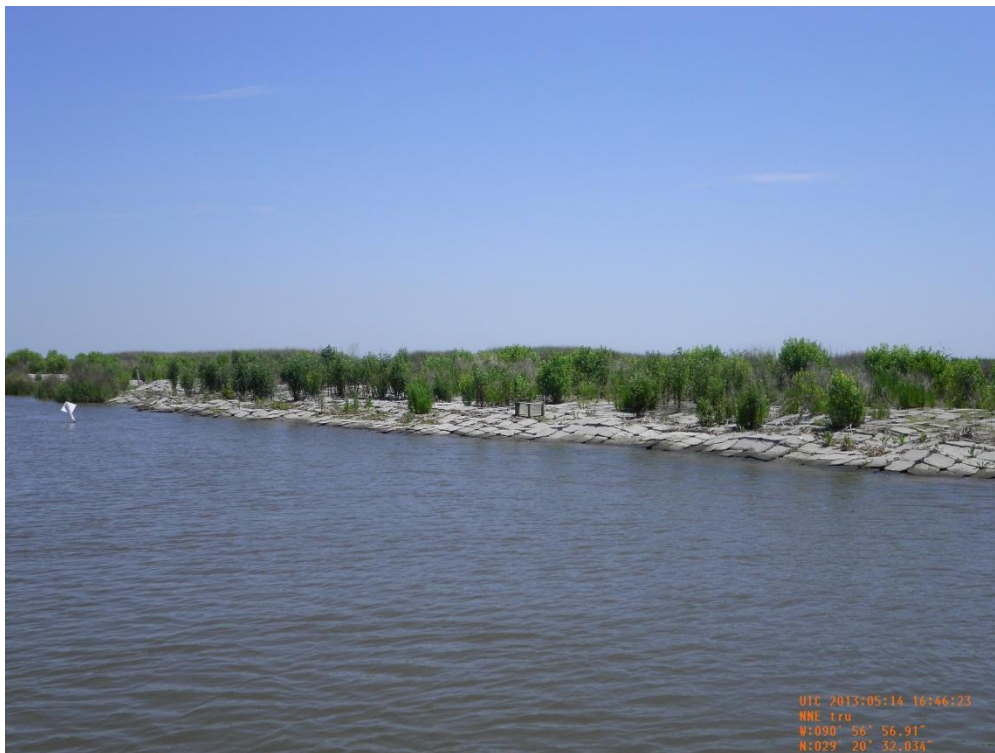
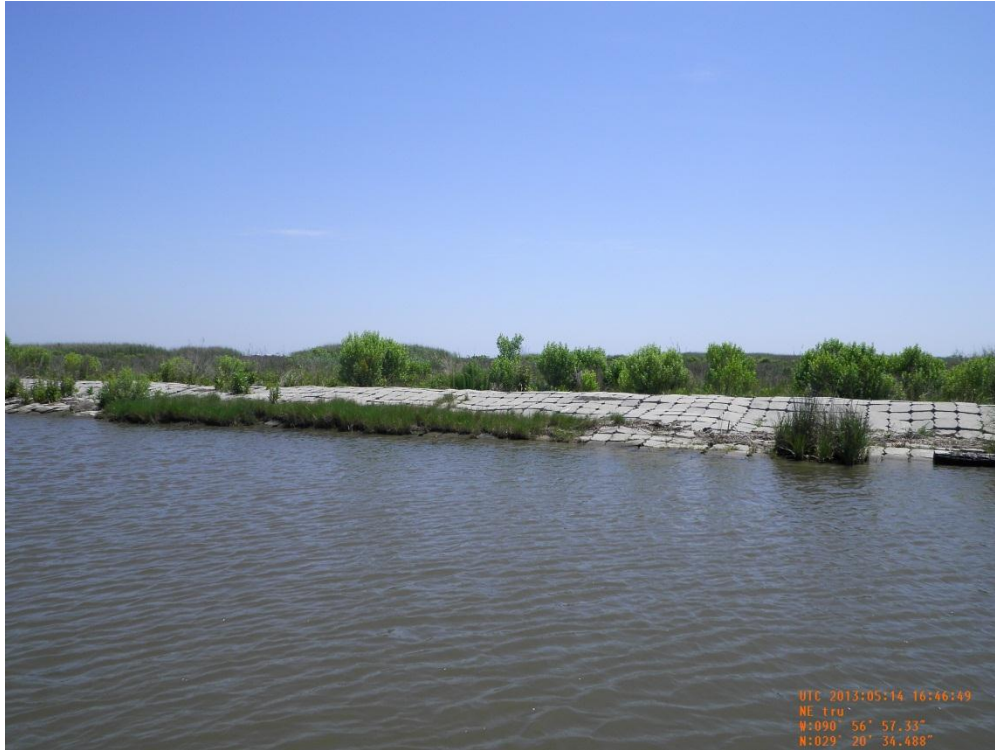
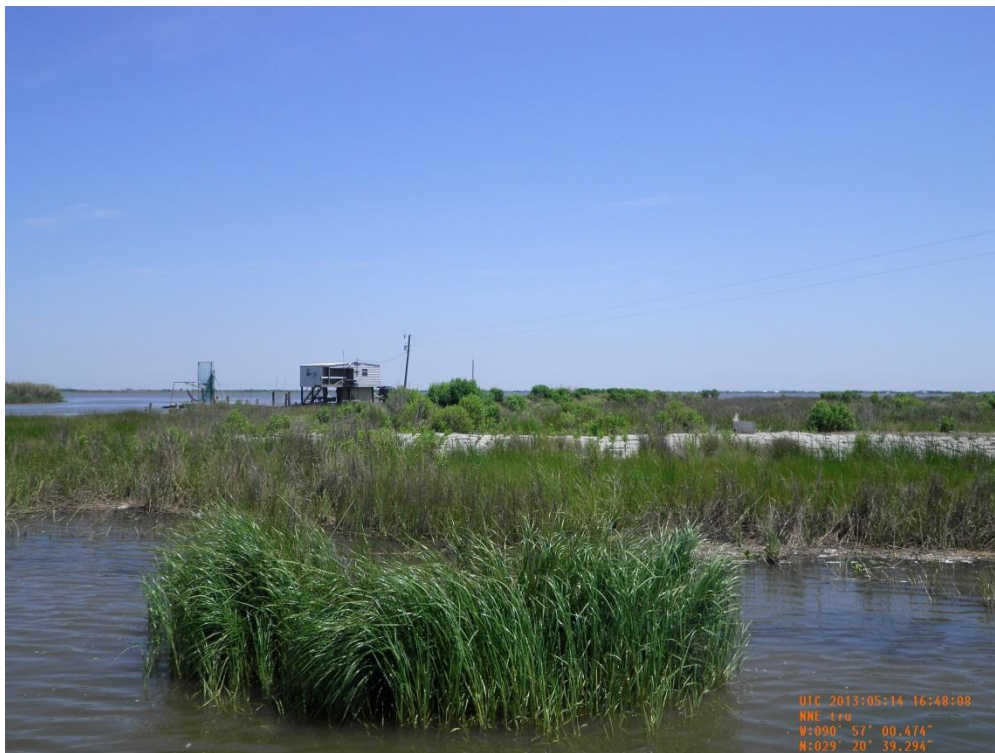
The Armored Earthen Dike on the west bank of Bayou Raccourci appears to be in good overall condition. The warning sign and its support timber show no signs of damage. The articulated concrete mats are still coupled by the copolymer rope with vegetation emerging through the seams and in front of the concrete mats. As expected, there is some variation in height along the length of the armored earthen dike. This is believed to be caused by a difference in dredged material settling at different rates under the weight of the articulated concrete mats in addition to placement of the mats on earthen material that was not fully compacted. Although there are some slight variations in elevation, the armored earthen dike is still performing as designed; therefore, there are no recommendations for corrective actions at this time. (See appendix B, Photos 20 through 24)

Photo 20: View of the articulated concrete mats along the southern end of Bayou Raccourci

Photo 21: View of the warning signs in front of the articulated concrete mats along Bayou Raccourci

Photo 22: View of the articulated concrete mats along the eastern bank of Bayou Raccourci, looking east

Photo 23: View of the articulated concrete mats along the eastern bank of Bayou Raccourci, looking east

Photo 24: View of the articulated concrete mats along the northern end of Bayou Raccourci
