**State of Louisiana
Coastal Protection and Restoration
Authority**

2013 Annual Inspection Report

**North Lake Mechant Landbridge
Restoration Project (TE-44)**

State Project Number TE-44
Priority Project List 10

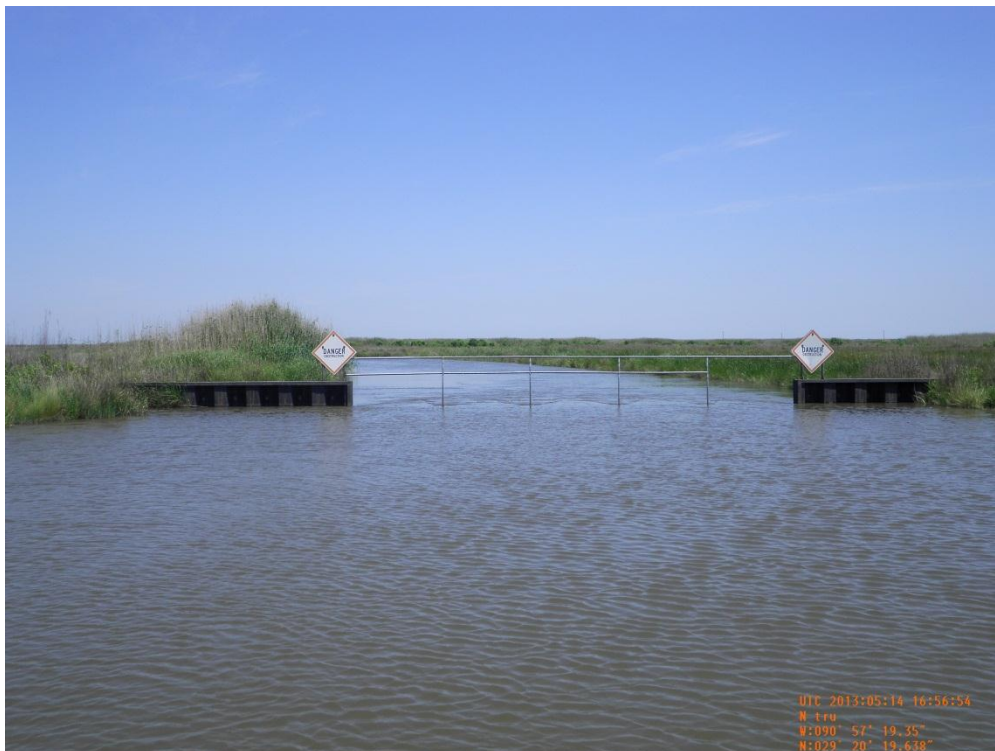
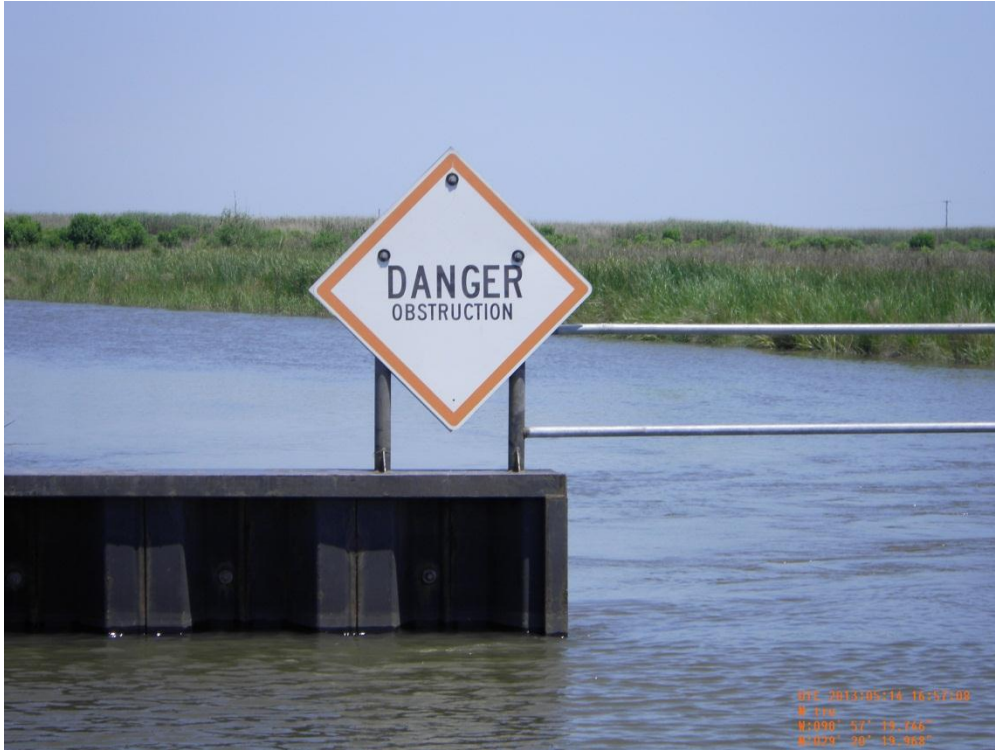
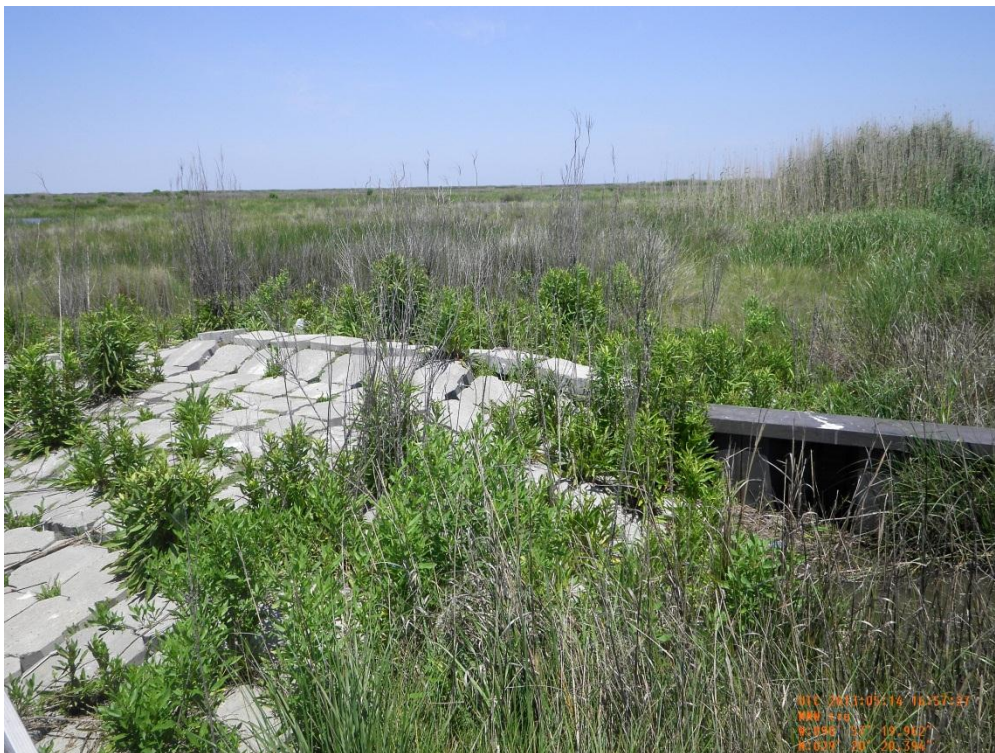
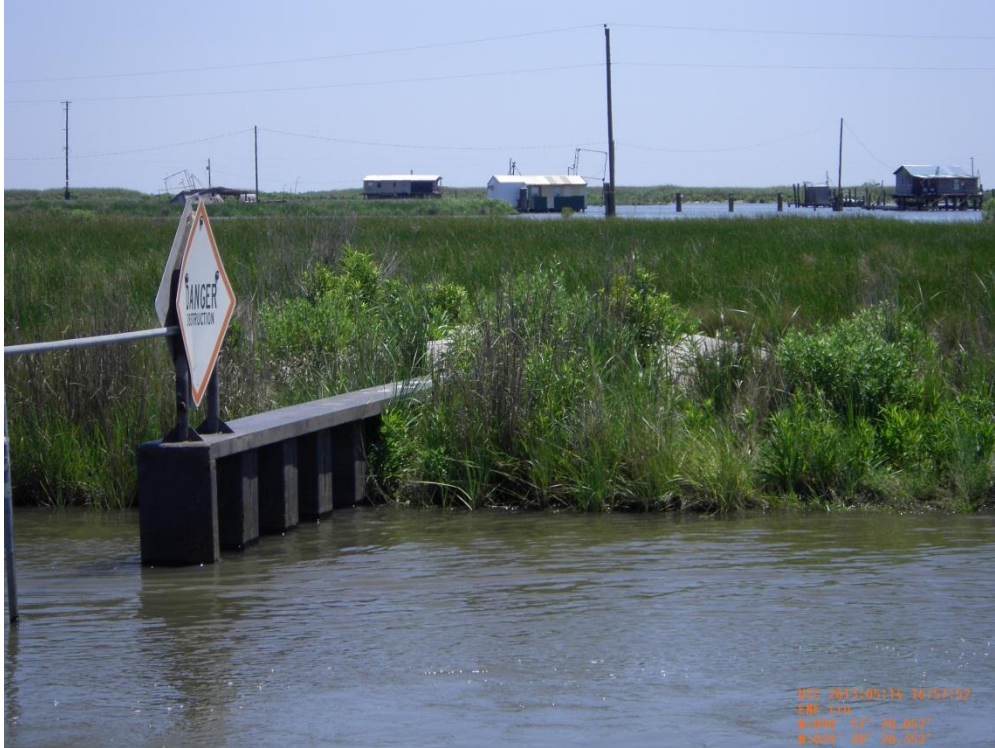
The Sheetpile Weir structure appears to be in good overall condition. There are no signs of excessive corrosion or damage to the sheet pile or top cap. There appears to be no erosion or washouts around the embankment tie-ins. Photo comparison from previous annual inspections display the articulated concrete mat used to armor the embankment tie-ins are stable with no signs of settlement. The warning signs and supports are also in good condition. There are no recommendations for corrective action at this time. (See Appendix B, Photos 26 through 29)

Photo 26: Overall view of the Sheetpile Weir replacement, looking north

Photo 27: Close-up view of the warning signs on top of the Sheetpile Weir, looking north

Photo 28: View of the articulated concrete mat used on the western embankment tie-in of the Sheetpile Weir, looking northwest

Photo 29: View of the articulated concrete mat used on the eastern embankment tie-in of the Sheetpile Weir, looking northeast

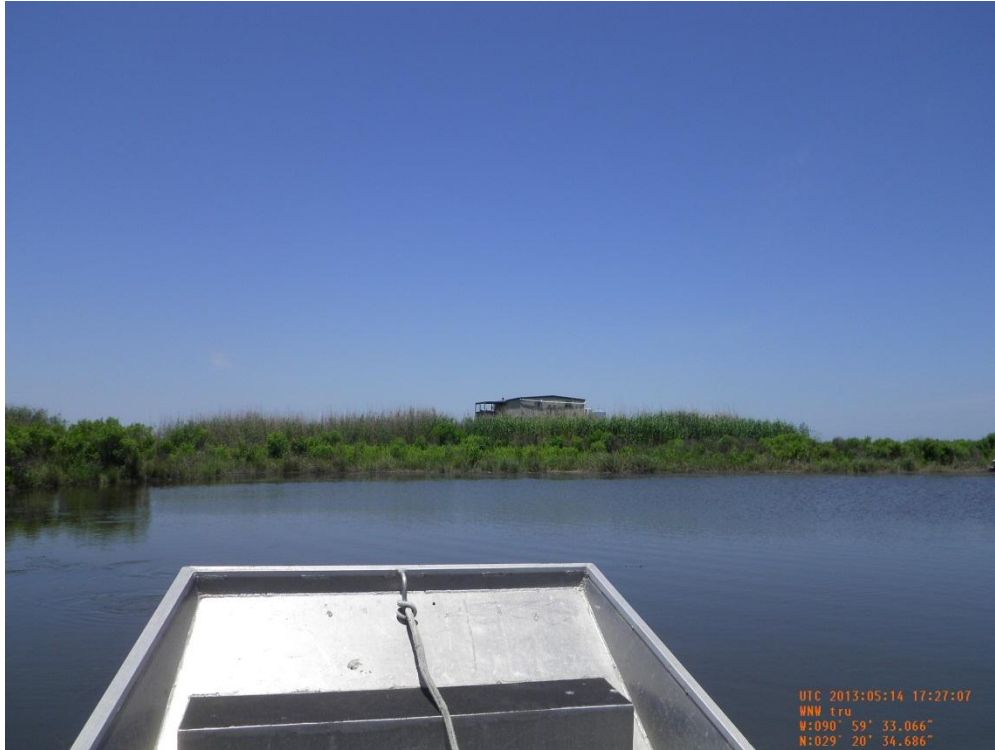
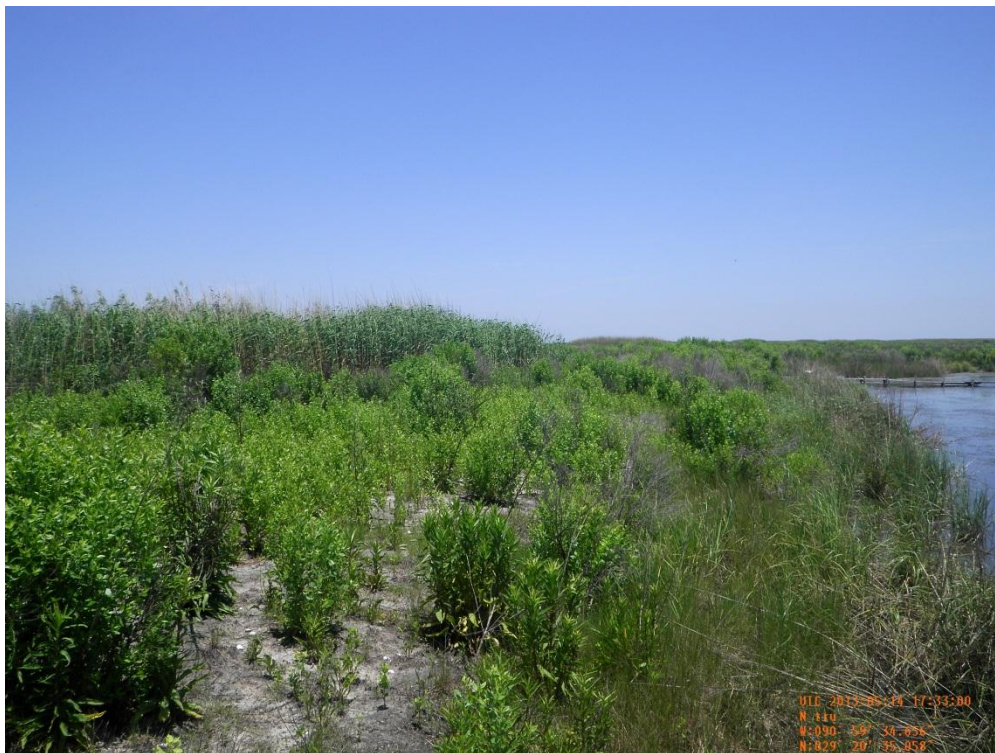
The Earthen Plug 1 structure located on the eastern edge of Lake Pagie appeared to be in good overall condition. The plug was viewed from the “Y” canal and from directly on top of the structure at the southern embankment tie-in. It appears to be densely vegetated with no signs of erosion or washout around the embankment tie-ins. Earthen Plug 1 is in good shape and there are no recommendations for corrective action at this time. (See Appendix B, Photo 31 through 32)

Photo 31: Overall view of Earthen Plug 1 from the Y canal, looking northwest

Photo 32: View along Earthen Plug 1 from on top of the plug, looking north

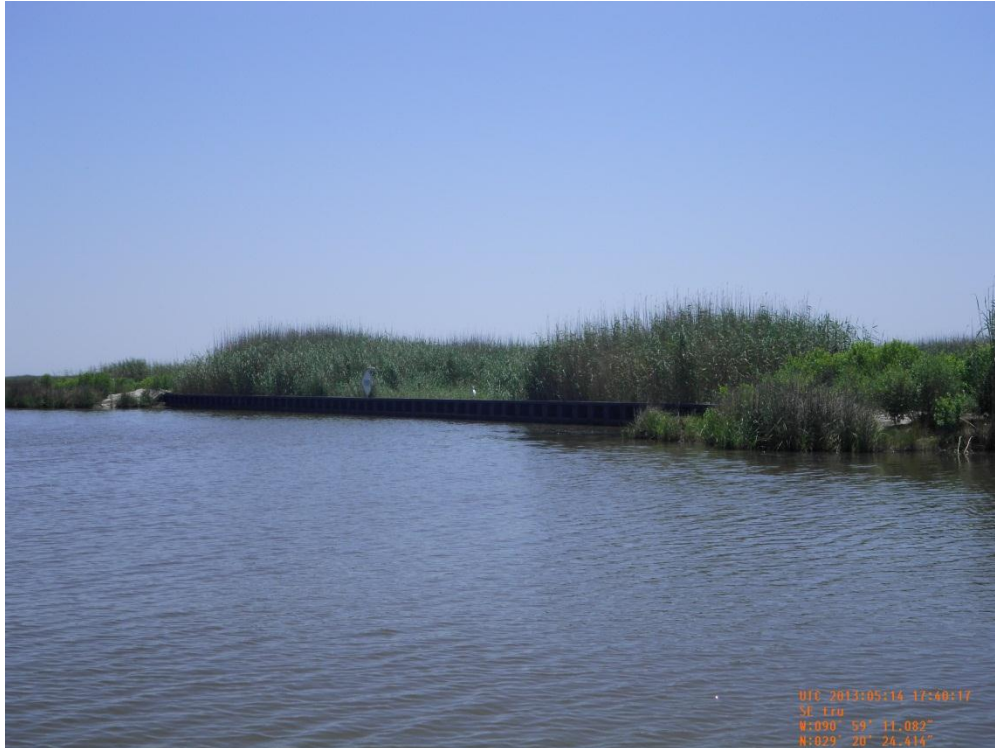
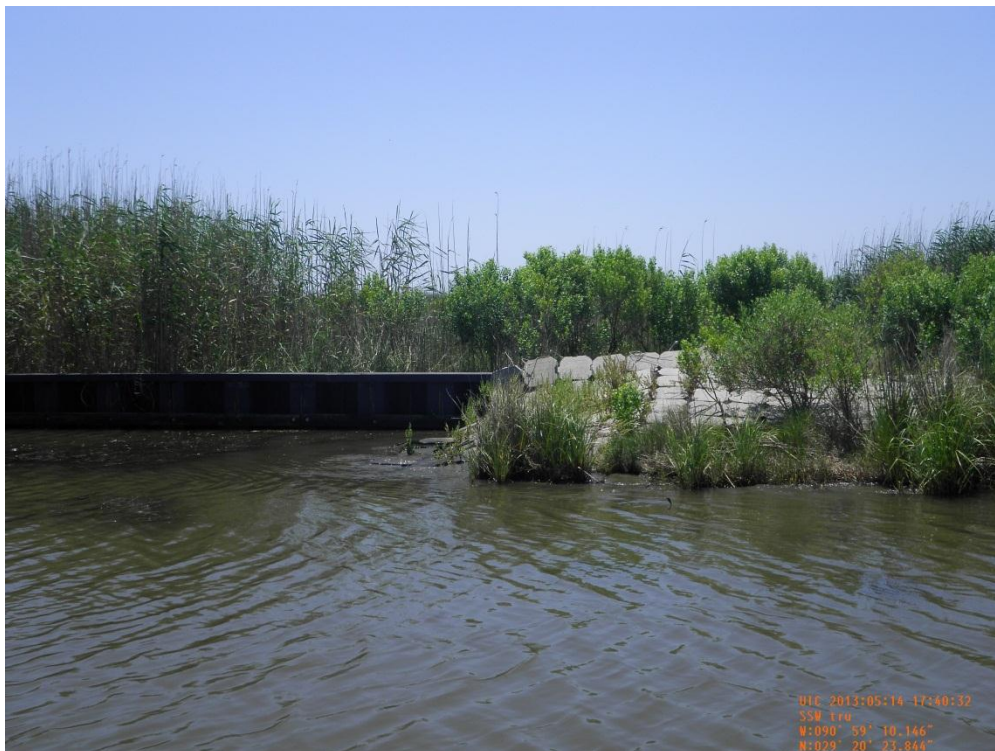
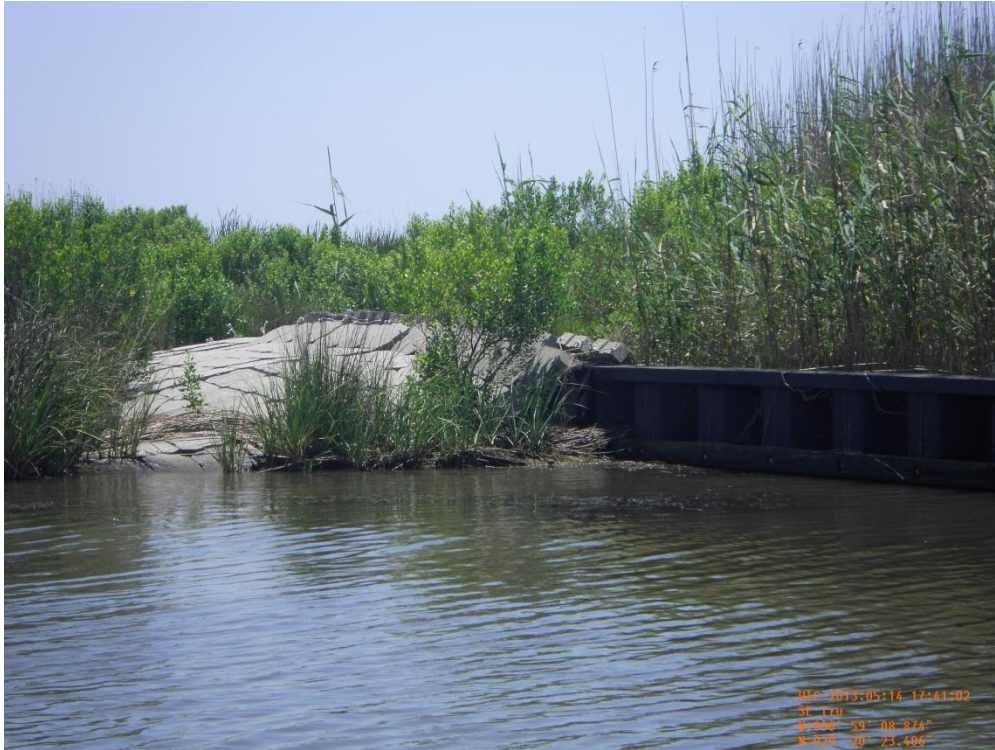
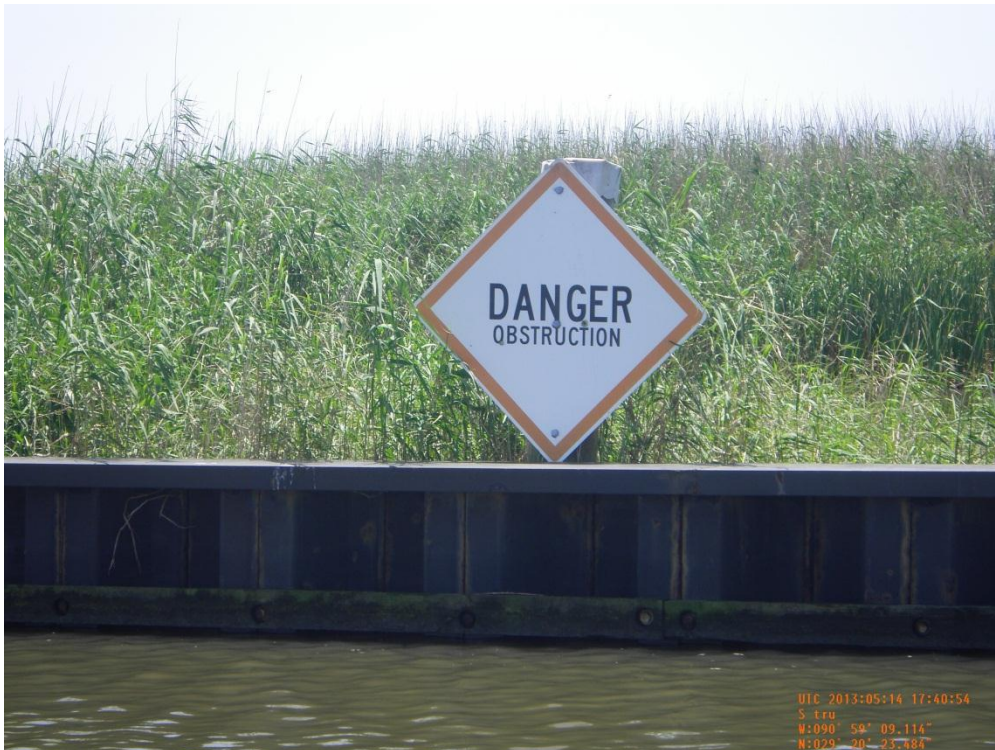
Sheet pile plug 1 is in good condition. There are no signs of settlement or excessive corrosion of the sheet pile, cap, warning signs and supports. The embankment tie-ins are armored with articulated concrete mats and also show no signs of settlement or erosion around its ends. The structure appears to be stable and functioning as intended. There are no recommendations for corrective actions at this time. (See Appendix B, Photos 33 through 36)

Photo 33: Overall view of Sheetpile Plug 1 from the Y canal. Looking south

Photo 34: View of the articulated concrete mats used on the western embankment tie-in of Sheetpile Plug 1, looking south

Photo 35: View of the articulated concrete mats used on the eastern embankment tie-in of Sheetpile Plug 1, looking south

Photo 36: View of the warning sign installed on top of Sheetpile Plug 1, looking south

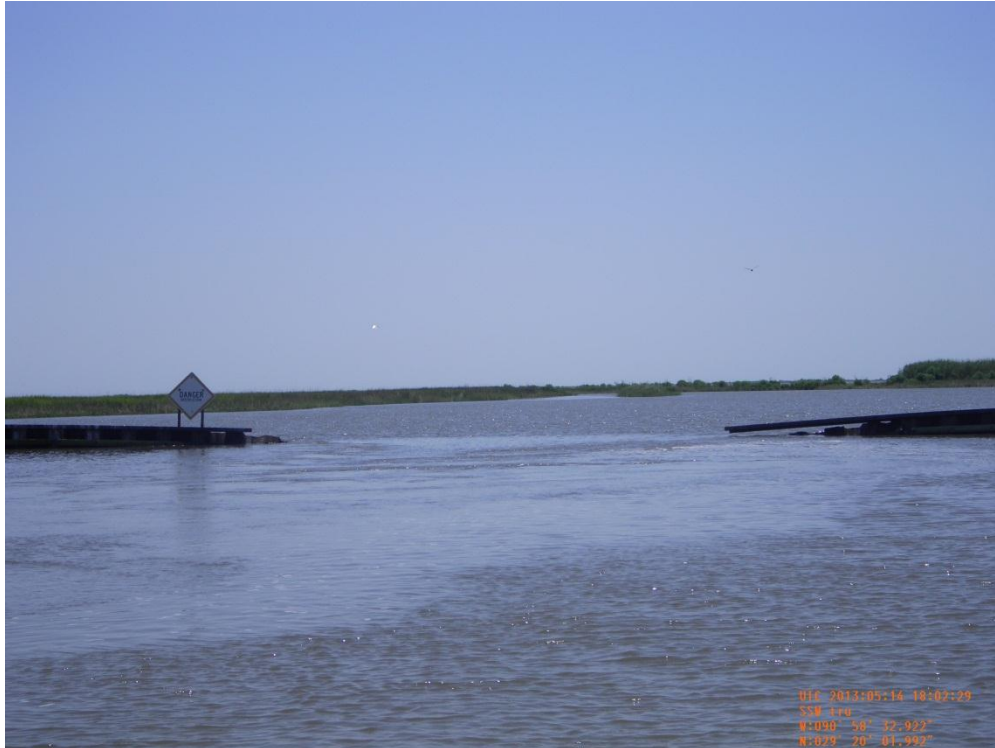
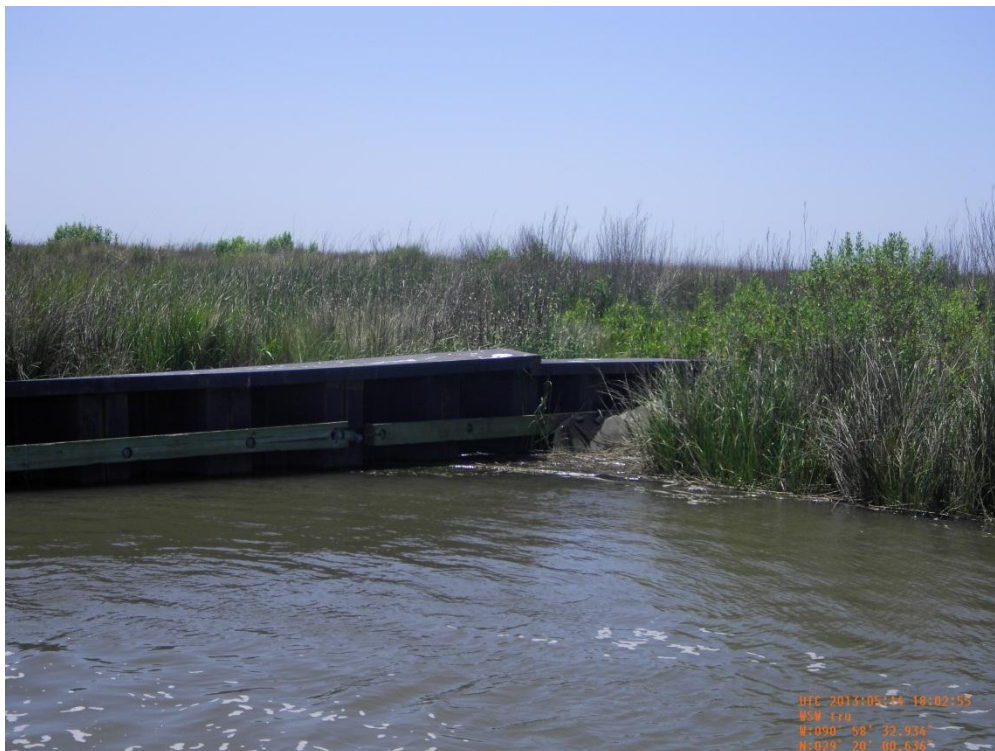
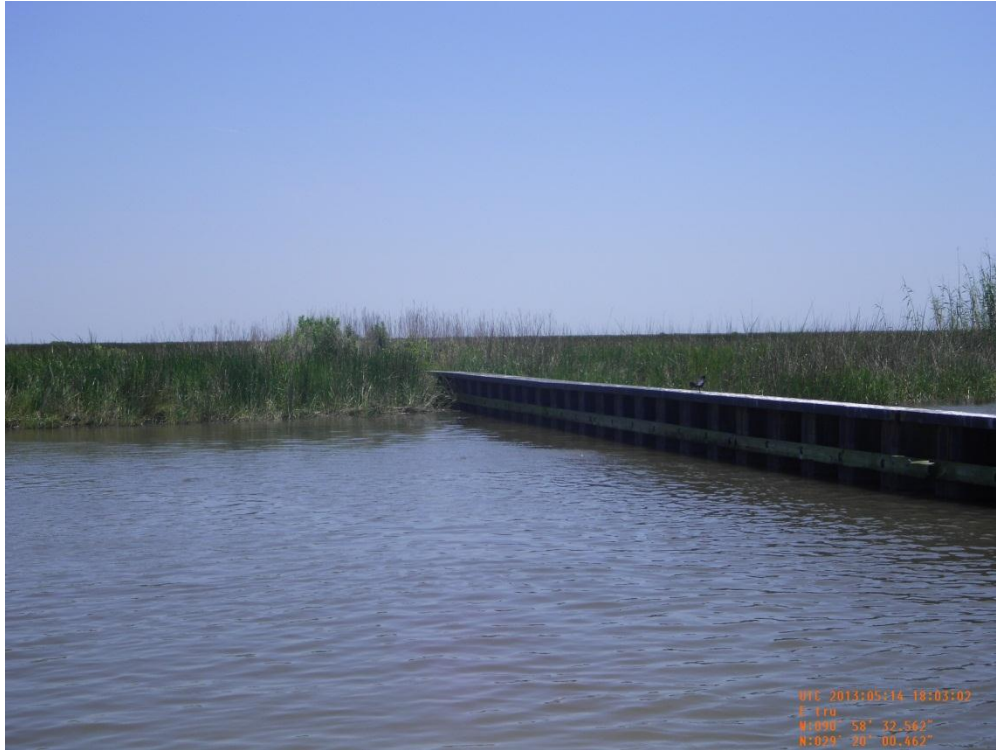
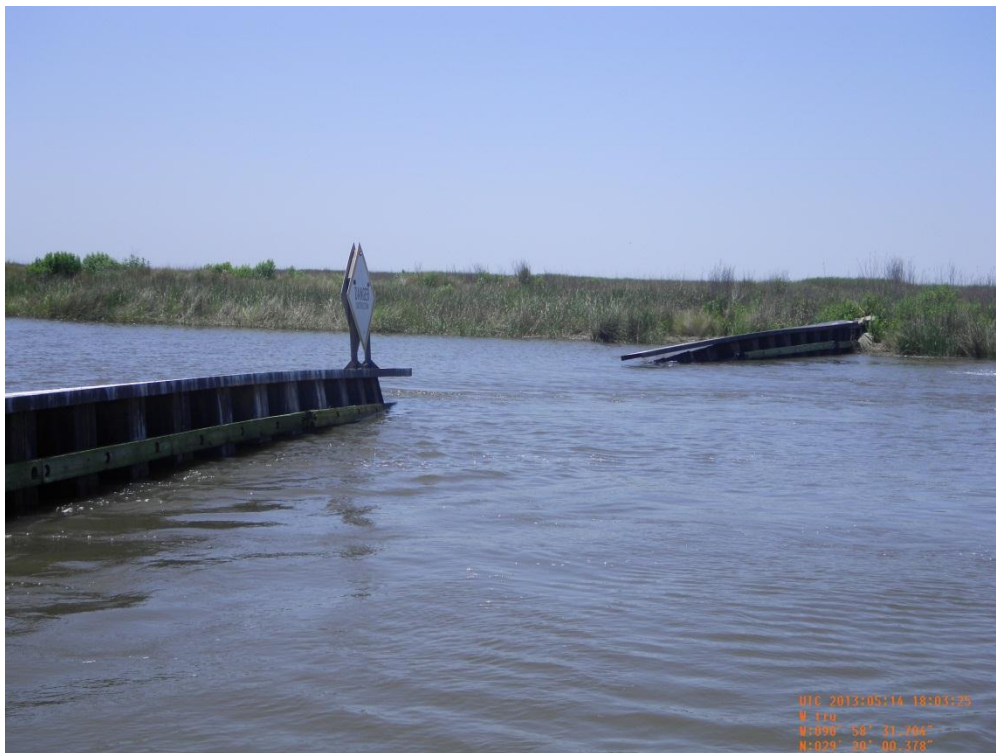
The Sheetpile Plug 2 suffered catastrophic structural damage due to Hurricane Isaac in August 2012. It appears a large water level differential during the storm caused the free standing structure to fail and fall over. A section of the top cap is missing and the sheet pile is bent below the water line allowing water to pass through/over the structure. Sheetpile Plug 2 is damaged in such a way that there are minimal options for repairing the structure, it must be removed and then replaced. CPRA has initiated a claim with the Federal Emergency Management Agency (FEMA) as the structure was damaged during a natural disaster. As of June 2013, CPRA has provided FEMA personnel with design plans, replacement estimates, supporting documentation, and site visits to help advance the claims procedure and are currently waiting a response from FEMA claims processing. (See Appendix B, Photos 37 through 40)

Photo 37: View of structural damage to Sheetpile Plug 2 caused by Hurricane Isaac, looking south

Photo 38: View of western embankment tie-in of Sheetpile Plug 2, looking west

Photo 39: View of eastern embankment tie-in of Sheetpile Plug 2, looking east

Photo 40: View of structural damage to Sheetpile Plug 2 caused by Hurricane Isaac, looking west

Steel Sheetpile Removal/Replacement (Sheet Pile Plug No.2):

(Construction based on additional 10' tip elevation on steel sheet pile and the lateral supports (vertical and batter H-piles) at 20' centers)

Considering the extent of damage to the Steel Sheetpile Plug No.2, CPRA has submitted a claim to the Federal Emergency Management Agency (FEMA) for assistance in funding of corrective actions under Hurricane Isaac.
