**Coastal Protection and Restoration Authority (CPRA)**

## **2023 Operations, Maintenance, and Monitoring Report**

# Four Mile Canal Terracing and Sediment Trapping

State Project Number TV-0018 Priority Project List #9

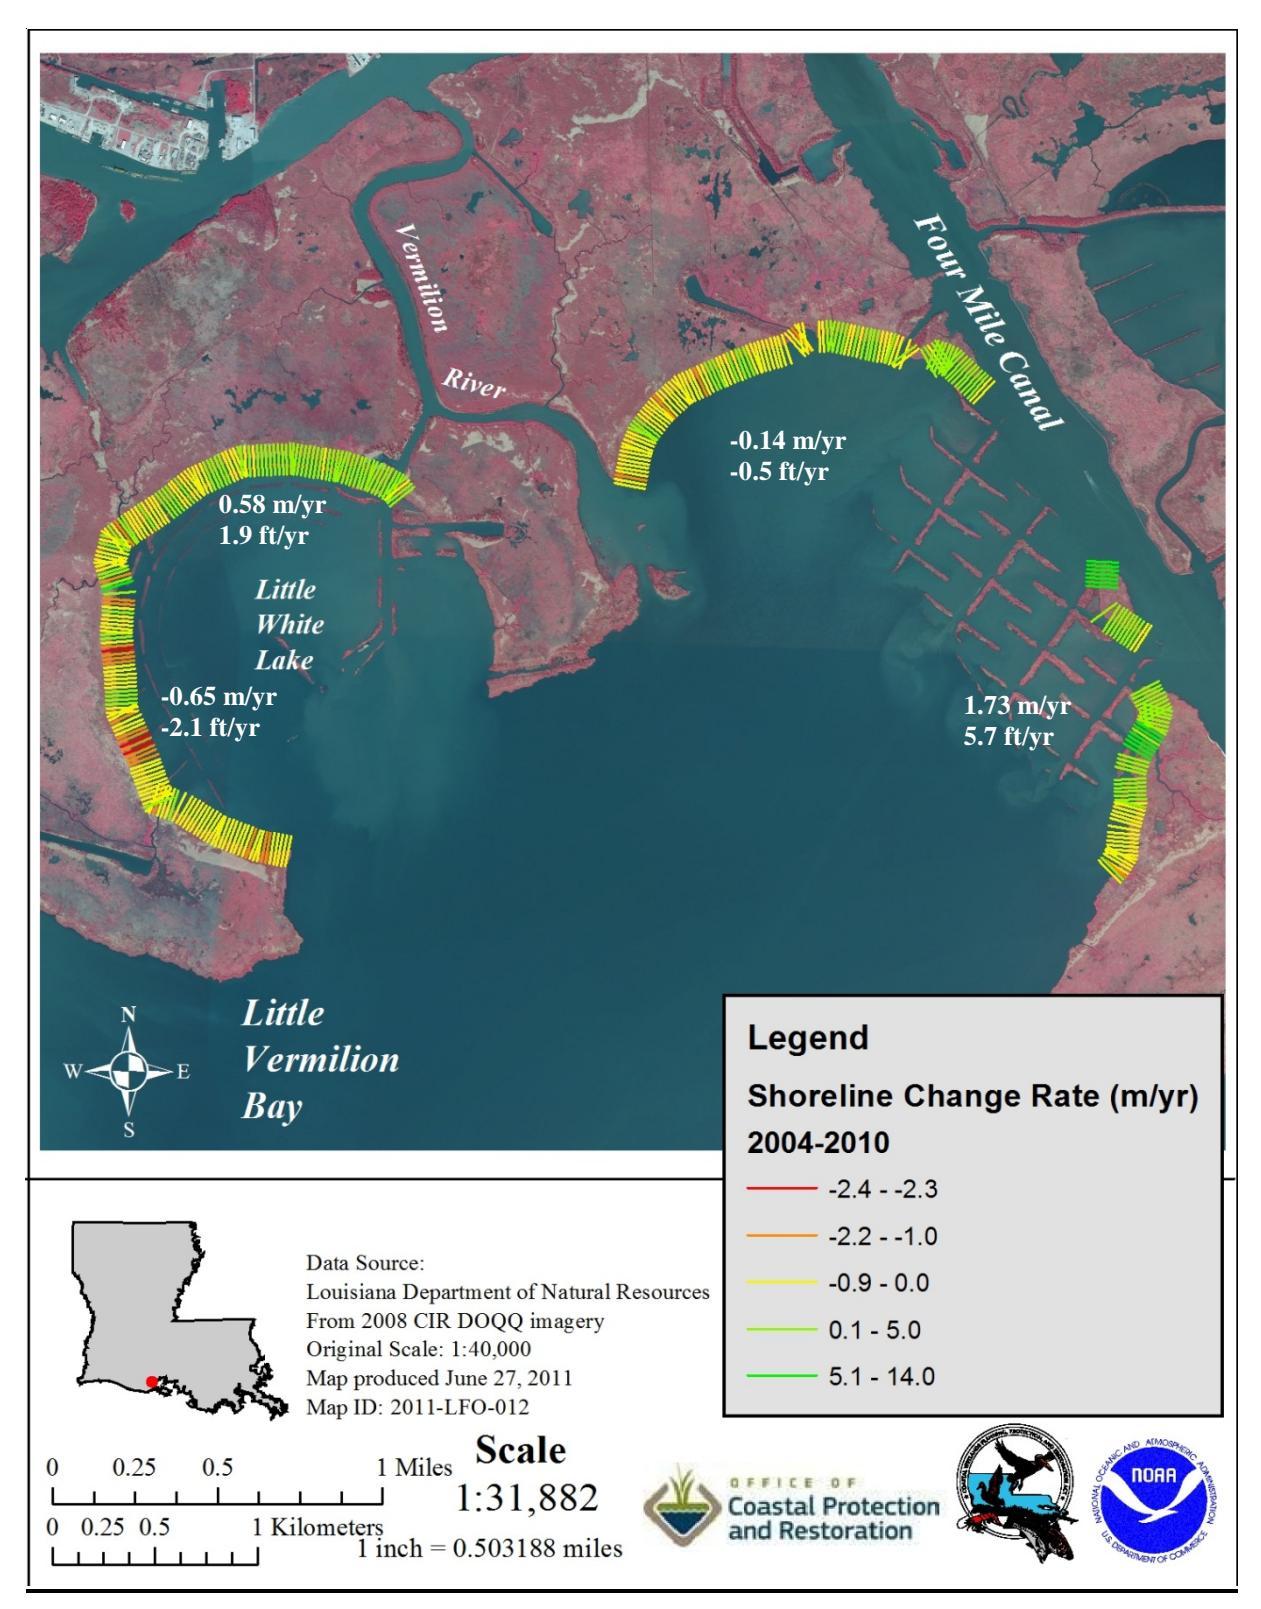
DGPS shoreline surveys were performed in June 2004 and June 2010 (Figure 5, Table 1), with a final shoreline survey in 2022 (Figure 6, Table 2). On average the shoreline erosion rate in Little White Lake was 0.00 m/yr from 2004–2010 and +0.78 m/yr (+2.55 ft/yr) from 2010–2022. There was consistent loss on the west side where the outer terraces had eroded with -0.65 m/yr (-2.1 ft/yr) from 2004–2010 and -0.43 m/yr (-1.43 ft/yr) from 2010–2022. Conversely, there was consistent gain on the more protected north side of Little White Lake with +0.58 m/yr (+1.9 ft/yr) from 2004–2010 and +2.67 m/yr (+8.77 ft/yr) from 2010-2022. In combination with its more protected location, the gain in the northern Little White Lake area may be due to trapped sediment from upstream alluvium and storm events. The more rapid recent increase is so drastic because it captures the connection of the innermost terrace to the existing shoreline.

The average shoreline change rate for the Little Vermilion Bay area was +0.58 m/yr (+1.9 ft/yr) from 2004–2010 and -0.39 m/yr (-1.27 ft/yr) from 2010–2022. There was more gain on the protected south side than the unprotected northern shore from 2004–2010, with +1.73 m/yr (+5.7 ft/yr) in the south and 0.14 m/yr (-0.5 ft/yr) in the north. The positive shore movement in the south appears to be due in part to sediment deposition trapped behind the terraces from Hurricanes Katrina, Rita and Gustav. The positive effect of these storms appears to be gradually counteracted by erosional forces from 4-mile Canal. Shoreline movement in the Little Vermilion Bay area was slightly negative from 2010–2022, with -0.24 m/yr (-0.78 ft/yr) in the south and -0.48 m/yr (-1.56 ft/yr) in the north.

**Figure 5.** Four Mile Canal Terracing and Sediment Trapping DGPS shoreline change rates (m/yr) from 2004 to 2010.

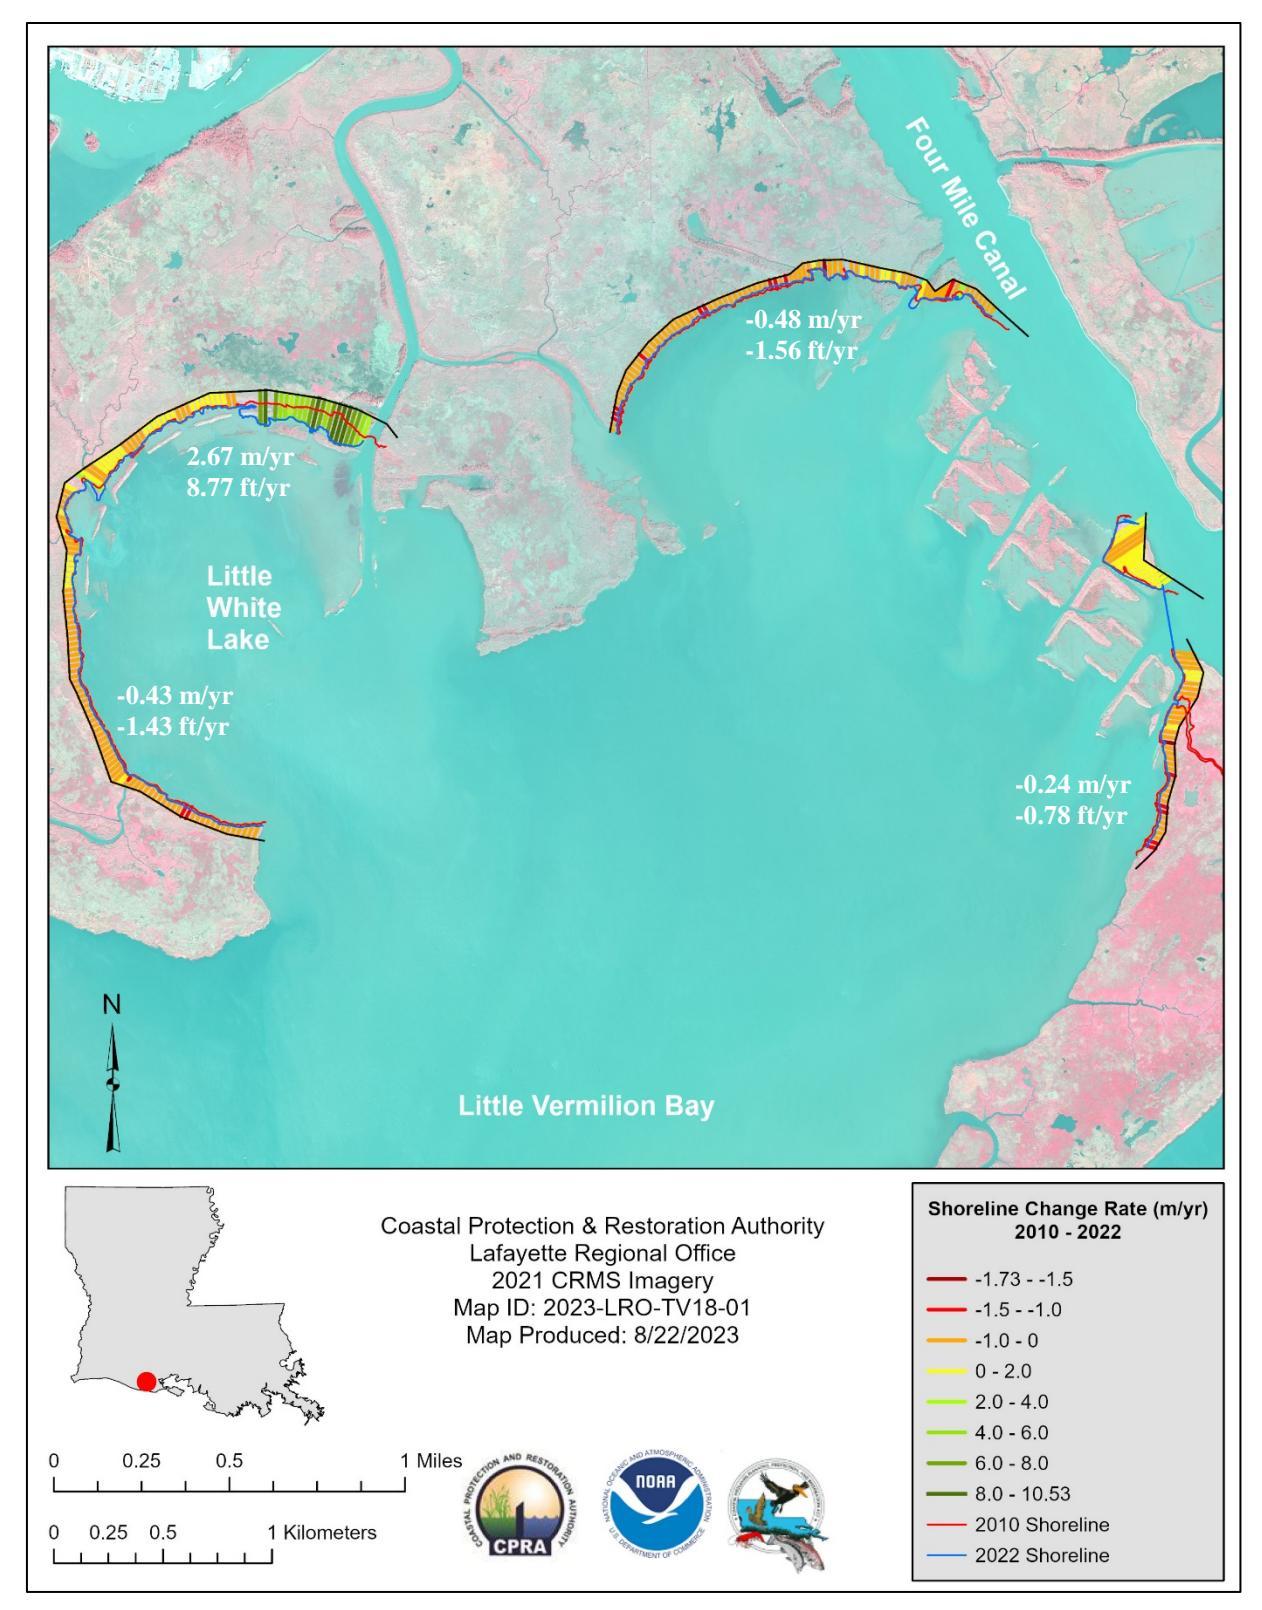
**Figure 6.** Four Mile Canal Terracing and Sediment Trapping DGPS shoreline change rates (m/yr) from 2010 to 2022.

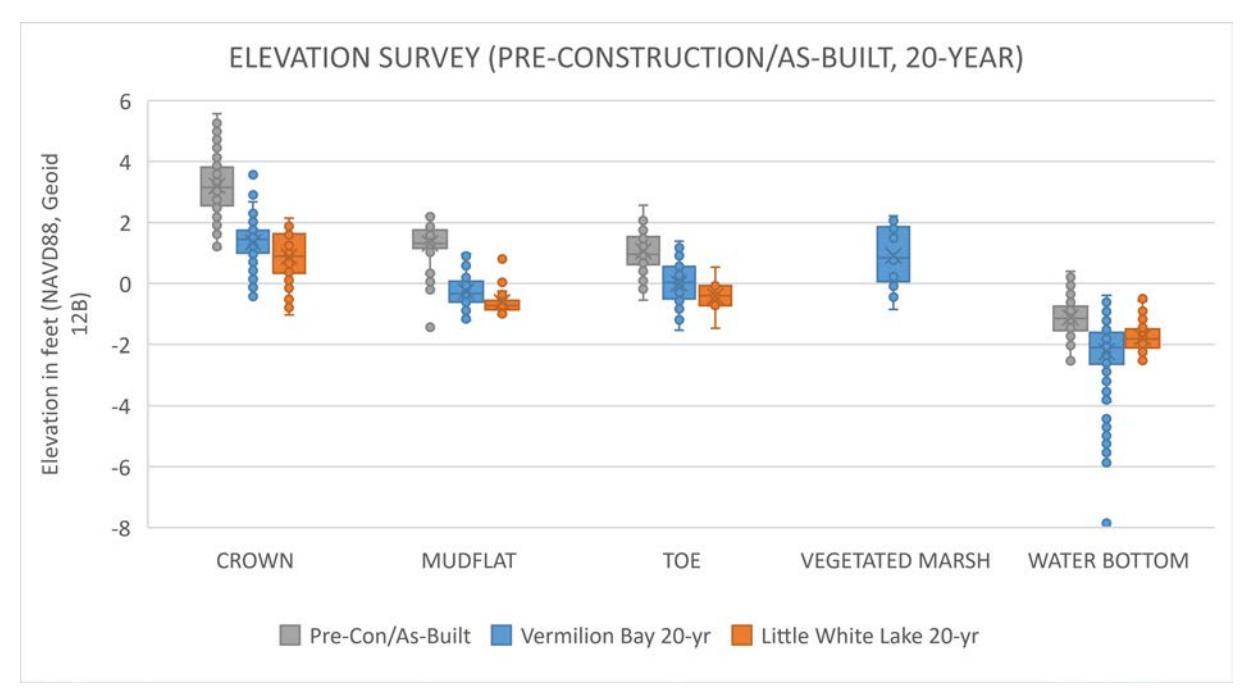
Elevation loss was observed across all elevation survey classes across the 20-year project life. Terrace crown is the only elevation survey class that was had a positive elevation mean value for both Little White Lake (0.88 ft., NAVD88 Geoid 12B) and Vermilion Bay (1.34 ft., NAVD88 Geoid 12B) at the end of project life. Those mean elevation values are comparable to that of natural vegetated marsh in Vermilion Bay captured in 2023 (0.92 ft., NAVD88 Geoid 12B). Mean water bottom elevation loss was the least drastic of all survey classes, with the lowest elevations occurring in Vermilion Bay project area (Figures 11 and 12).

**Figure 11.** Elevation survey data collected in 2003 and 2023 within the T/V 18 project area at Little White Lake and Vermilion Bay.

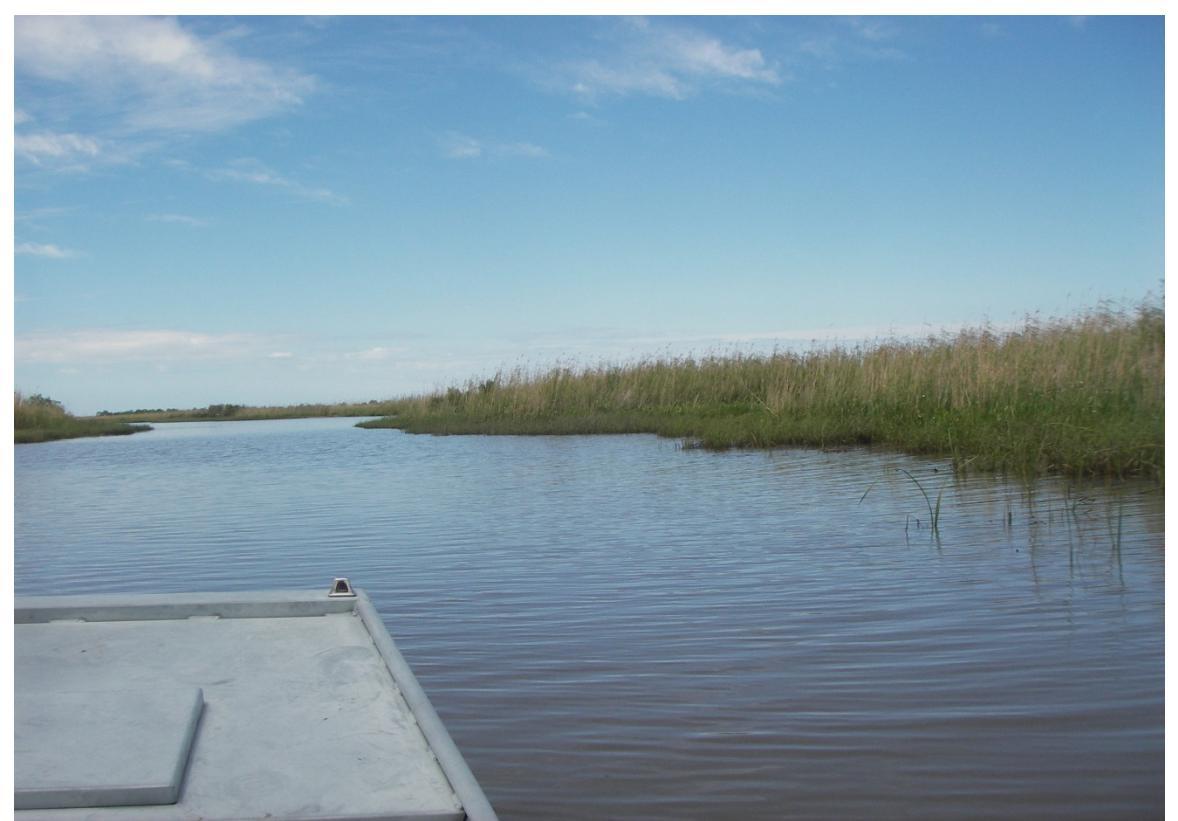
During the 2016 observation, water depths at the entrance to the terrace field in Little White Lake had continued to shallow. The 3rd row of terraces had fewer terraces visible, while the 2nd row had continued to suffer effects of the waves. The 1st row remains in excellent condition. The eastern terraces adjacent to the Four Mile Canal continue to erode as well as the western most terraces. The boat wakes continue to damage these terraces. Interior terraces were inspected on this trip and found to be in excellent condition. Vegetation between the terraces in both fields is expanding. (Photos: Appendix B, Photos 1-4)

Photo 1: Little White Lake Terraces, Interior Row (April 2016)

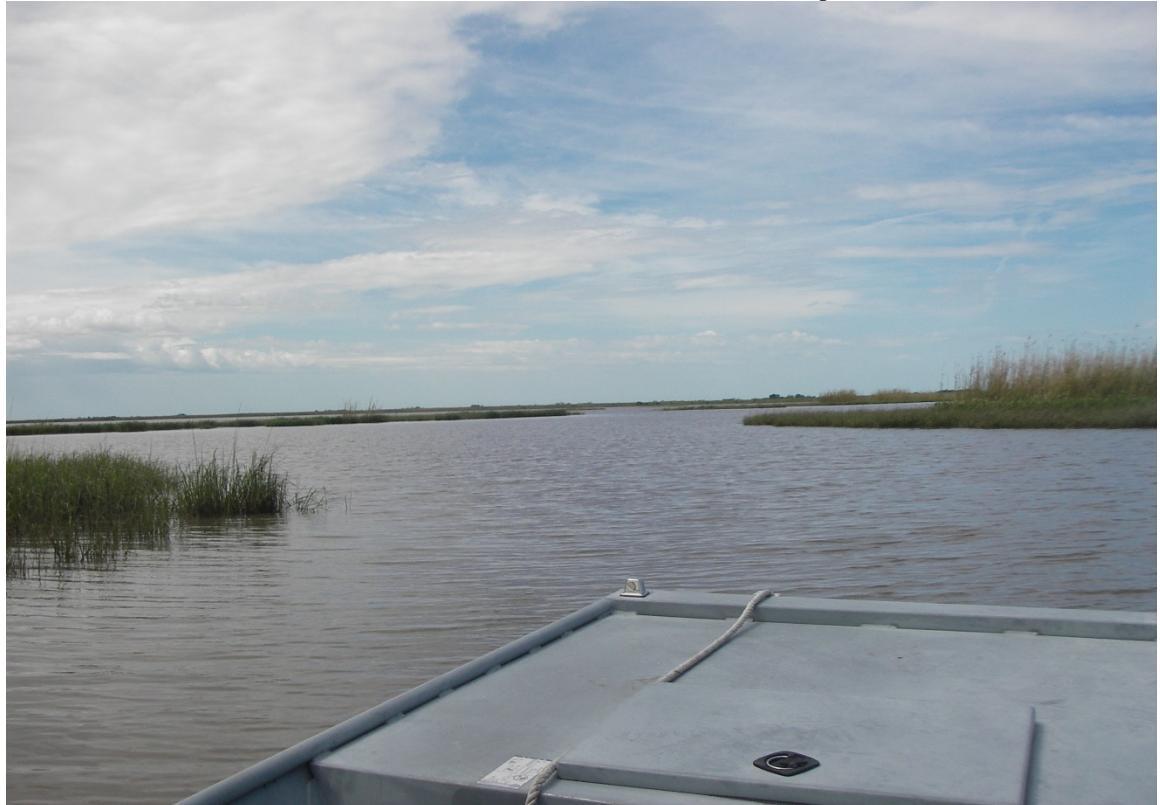
Photo 2: Little White Lake Terraces, 2<sup>nd</sup> Row (April 2016)

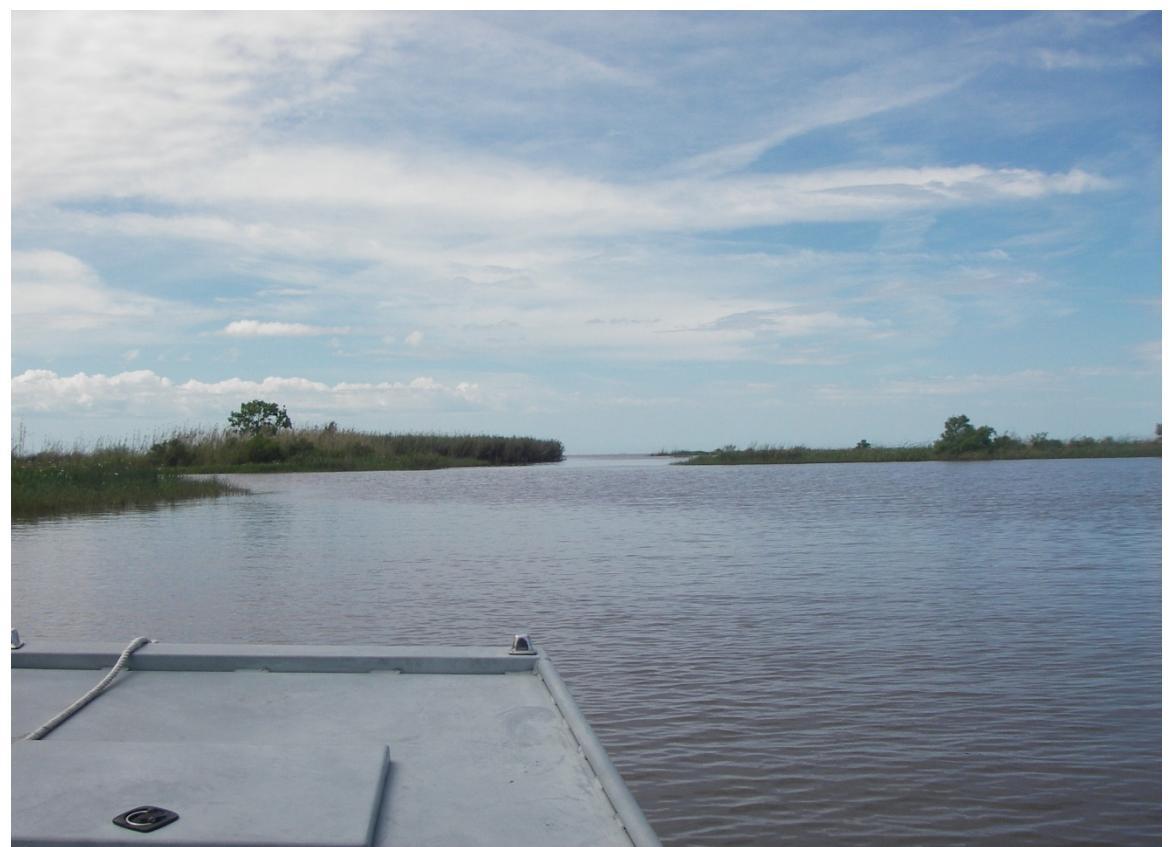
Photo 3: Four Mile Canal Terraces (April 2016)

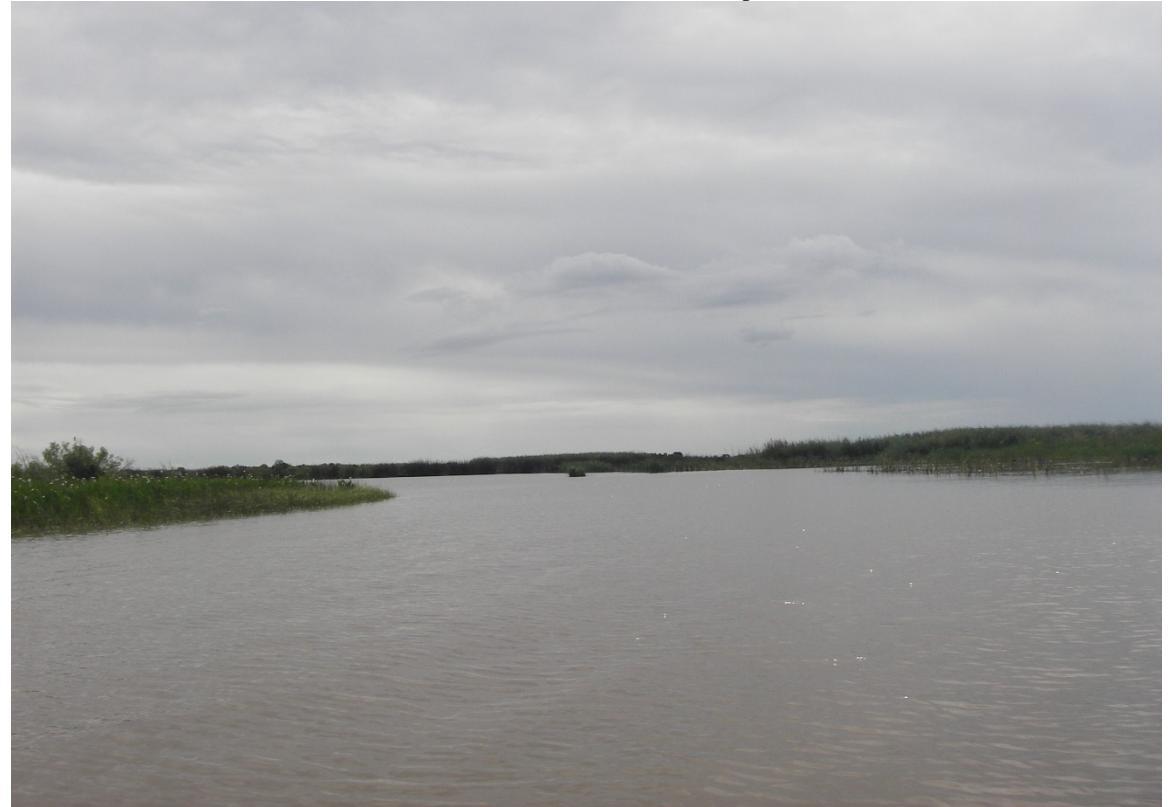
Photo 4: Emergent Vegetation Within Four Mile Canal Terraces (April 2016)

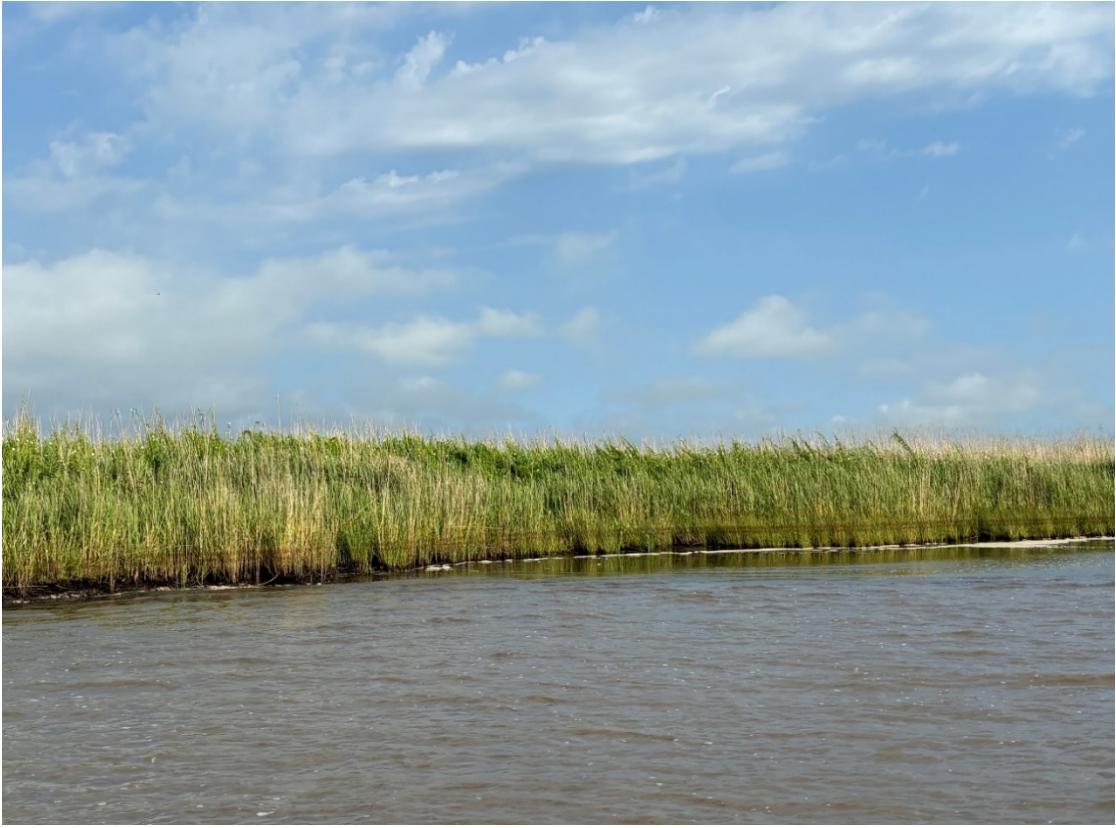
Since that time, the 2024 observation revealed continued deterioration of the interior rows of terraces at Little White Lake, with only the 1<sup>st</sup> row of terraces remaining visible. Water depths were noticeably very shallow in portions of Little White Lake approaching the historic lake rim, indicating a likely shallowing aided by restoration efforts of the TV-0018 project. Advanced erosion was noted on the east side of the Four Mile Canal project area, though locations of shell hash deposits were noted nearby. (Photos: Appendix B, Photos 5-8)

Photo 5: Little White Lake Terraces (May 2024)

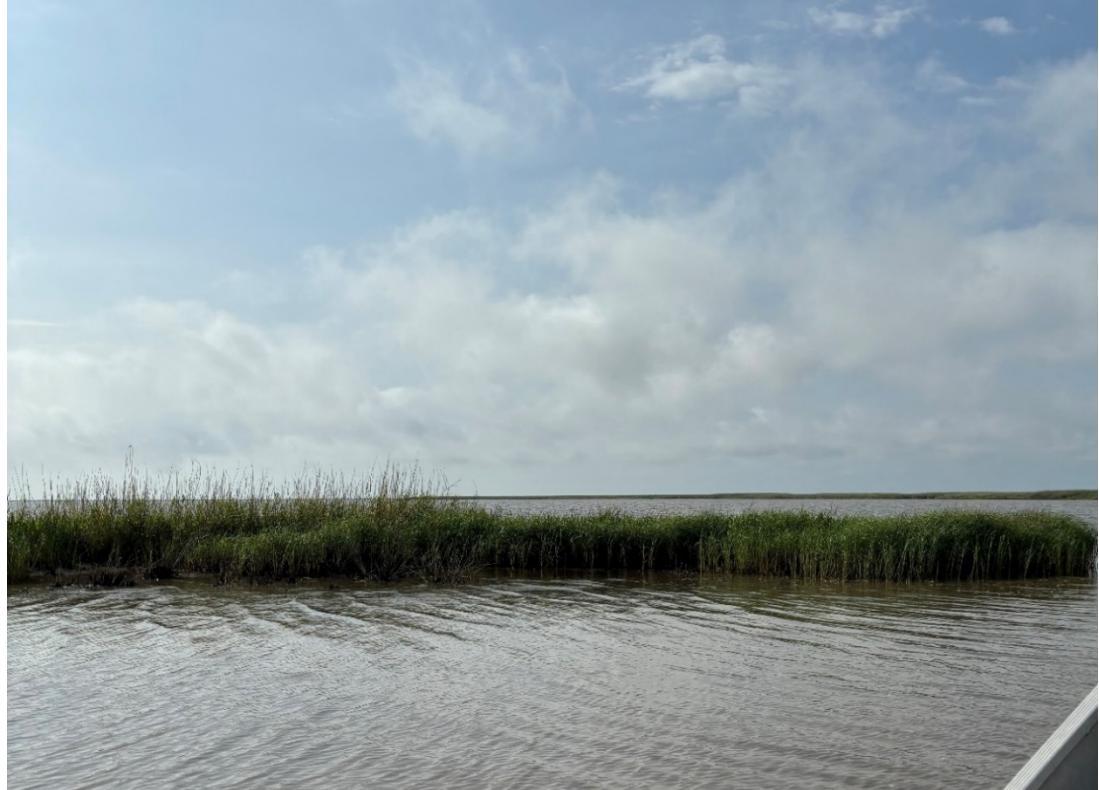
Photo 6: Little White Lake Terraces (May 2024)

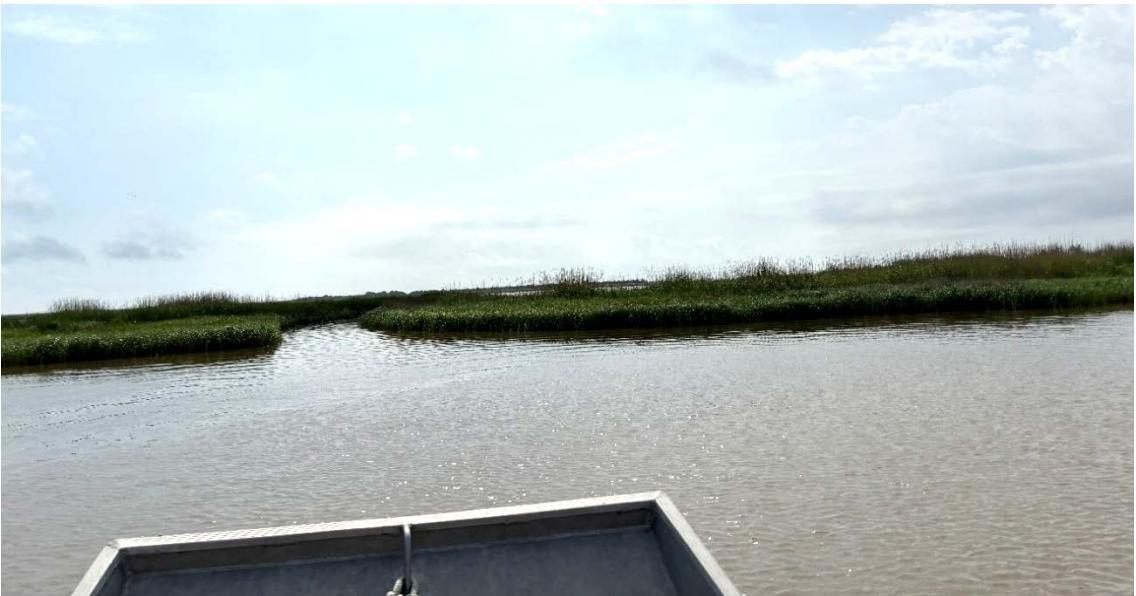
Photo 7: Four Mile Canal Terraces (May 2024)

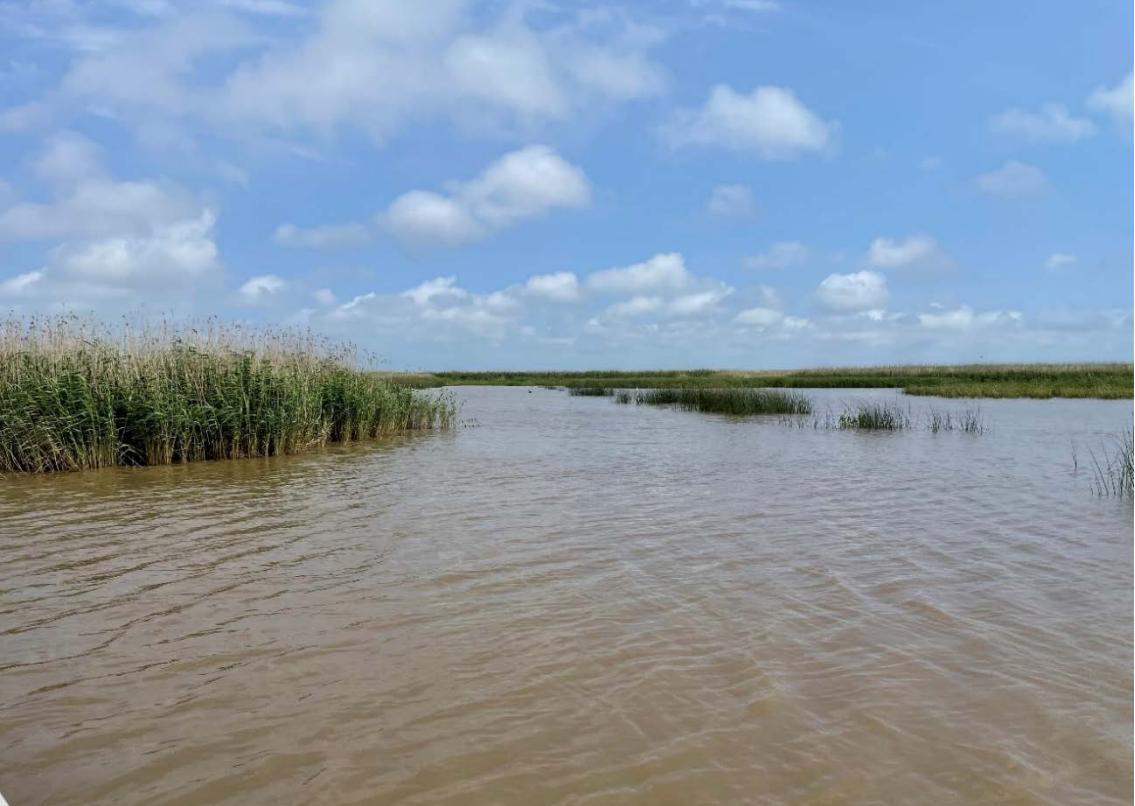
**Photo** 8: Emergent Vegetation within Four Mile Canal Terraces (May 2024)
