# East Mud Lake Marsh Management (CS-20)

## Project Status

**Project Type:** Marsh Management

**PPL #:** 2

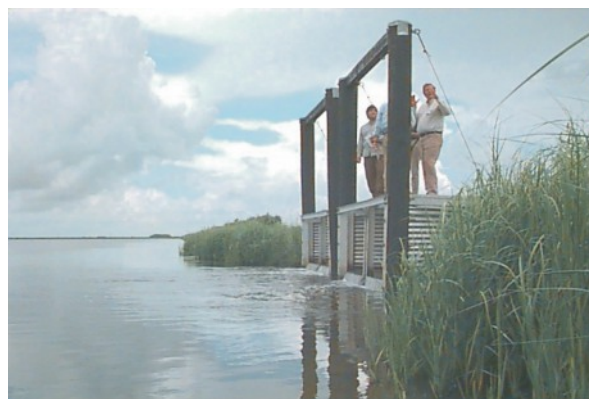
A gate in operation. A healthy stand of cordgrass protects the gate's flanks.

The project was designed to stabilize salinity and water levels while ensuring the movement of commercial fish species into and out of the project area. Earthen plugs, flapgated culverts, variable crest culverts, and gated culverts were constructed and can be used to manage the flow of water into and out of the project area. In treatment unit 1, the structures have slots allowing ingress and egress of commercial fish species. Treatment unit 2 structures have drawdown capabilities, encouraging shallow water areas to revert to emergent vegetation. In both treatment units, the structures are closed when salinities exceed 15 parts per thousand (ppt).

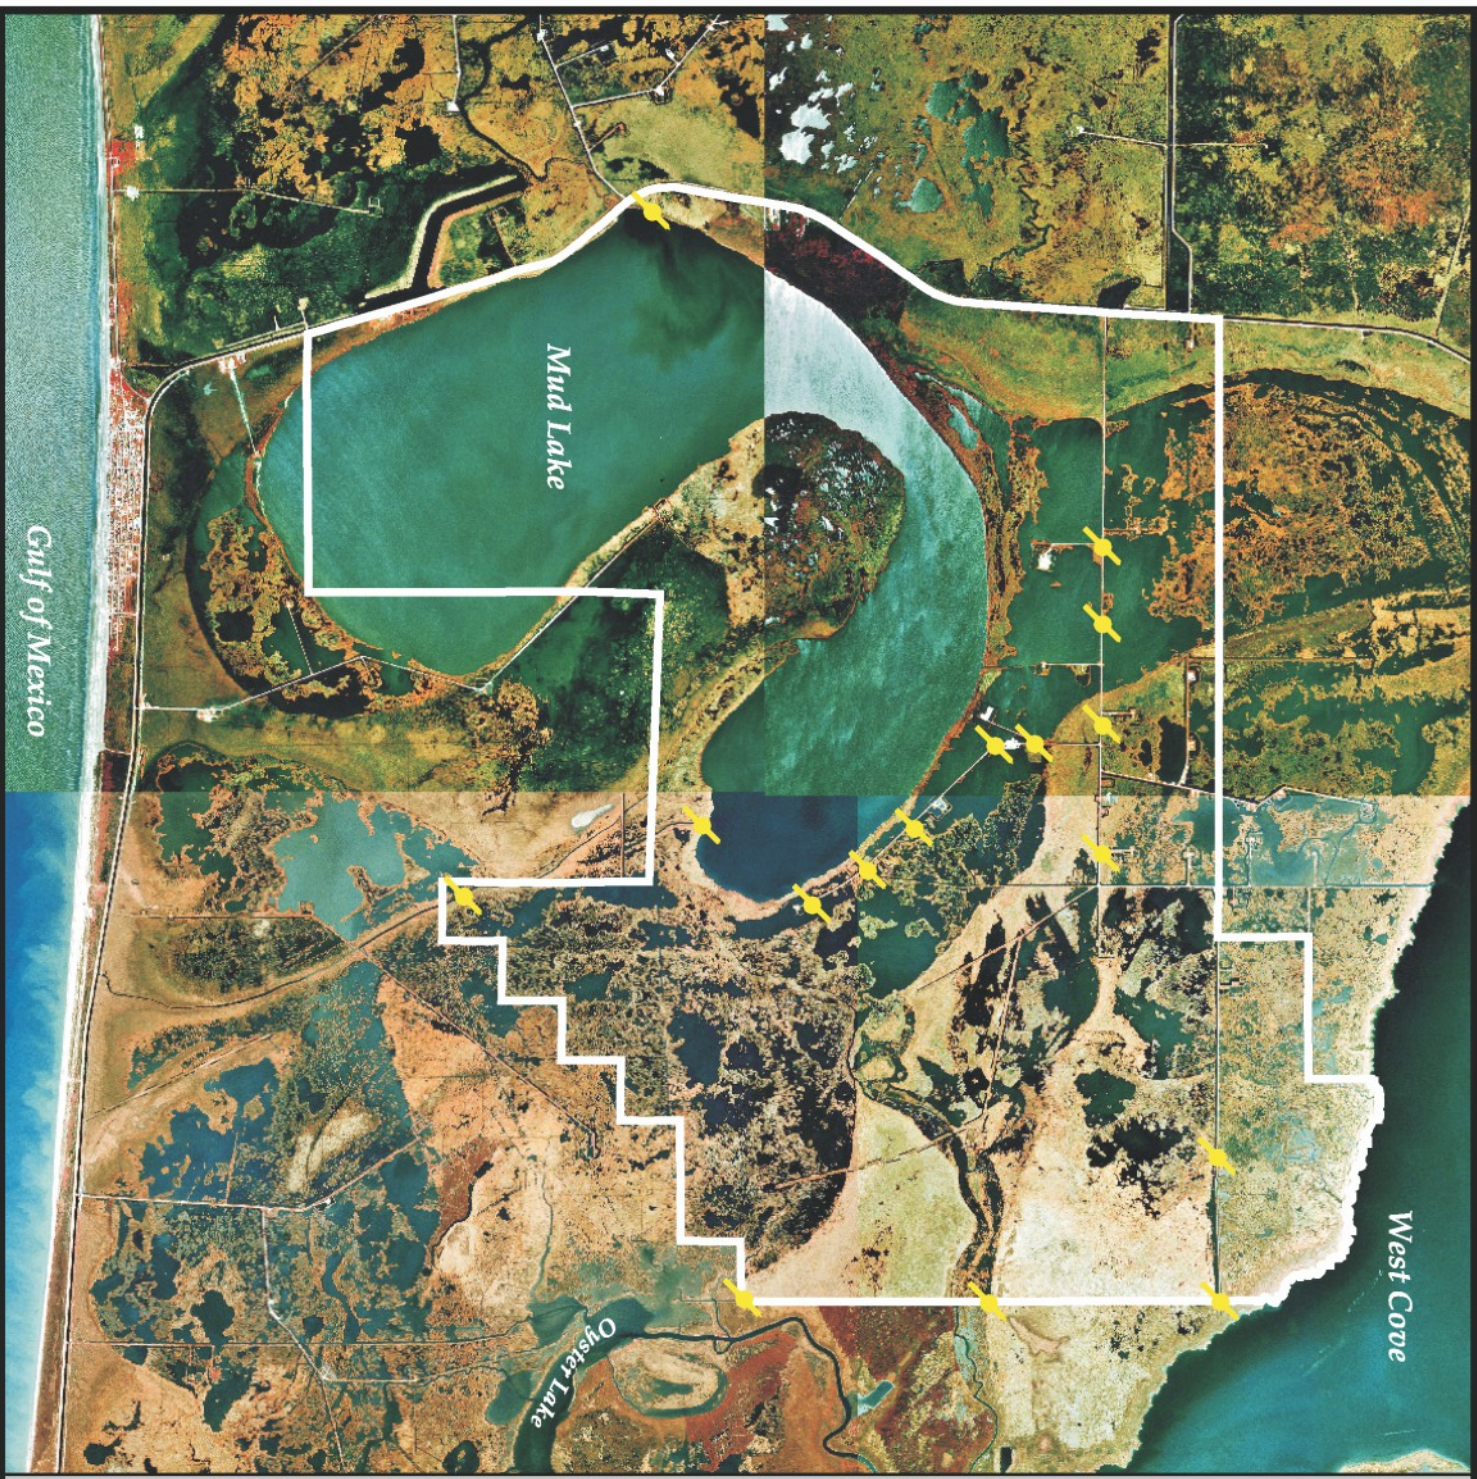
# East Mud Lake Marsh Management (CS-20)

Water Control Structure
-

Project Boundary
