**2004 Operations, Maintenance,
and Monitoring Report**

Perry Ridge West Bank Stabilization

State Project Number CS-30
Priority Project List 9

May 2004
Calcasieu Parish

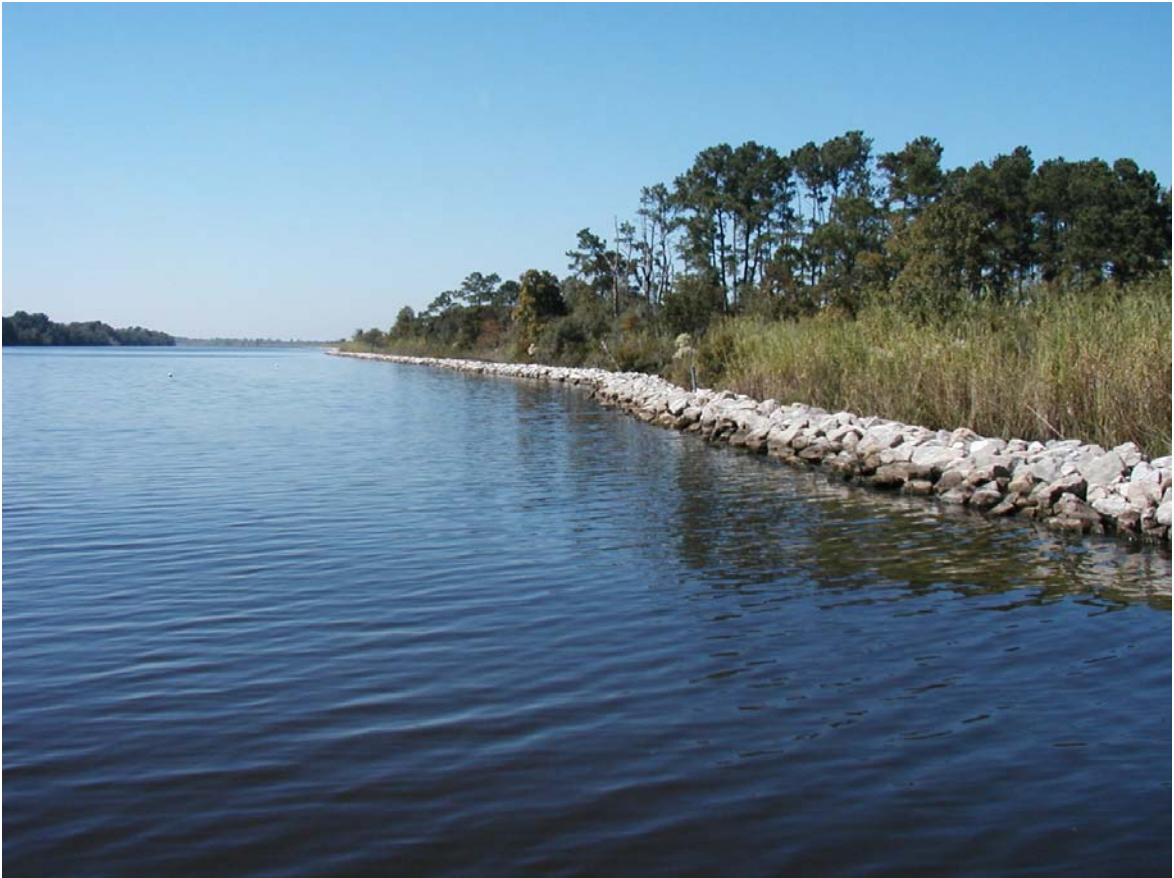
The dike is in excellent condition. No apparent need for any maintenance at this time.

Figure 4. View of the Perry Ridge West rock dike taken October 21, 2003. The photograph is facing west.

In order to evaluate dike settlement, stability of the rock structure, toe scour, and any vertical accretion on the land side of the rock structure, a structural assessment survey performed by a licensed engineering/ land surveying firm is recommended within the first 5 years of construction . The date of assessment survey is to be agreed upon by the state and federal sponsor at the annual maintenance inspection.

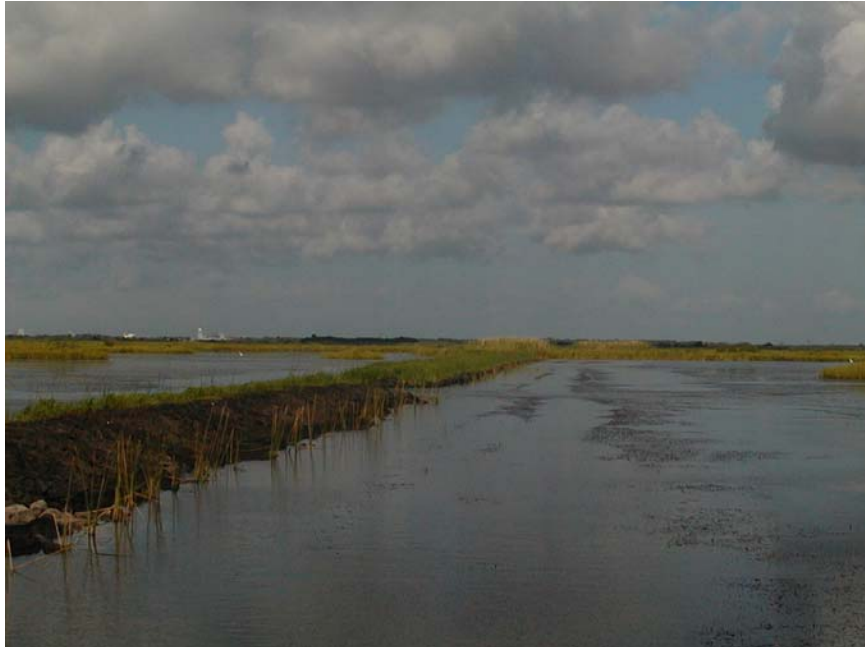
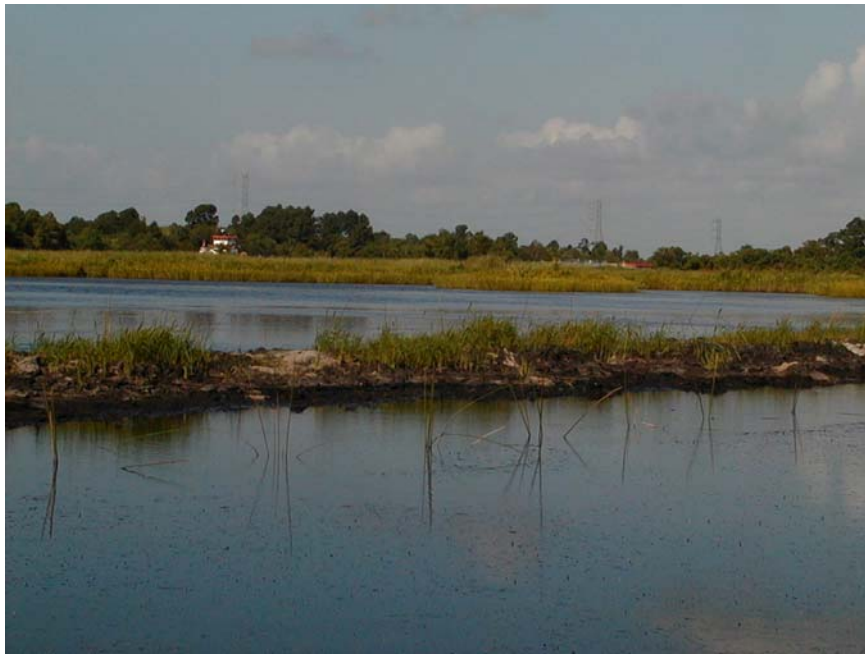
The plantings are in excellent shape at this time. They cover the terraces and are green and healthy.

Figure 5. Views of the *Schoenoplectus californicus* plantings taken July 2002. The photograph on the top is facing southwest, and on the bottom is facing south.
