CAMERON PRAIRIE REFUGE PROTECTION (ME-09)

ME-09-MSPR-0297-3

PROGRESS REPORT No. 3

August 3, 1994 to June 13, 1997

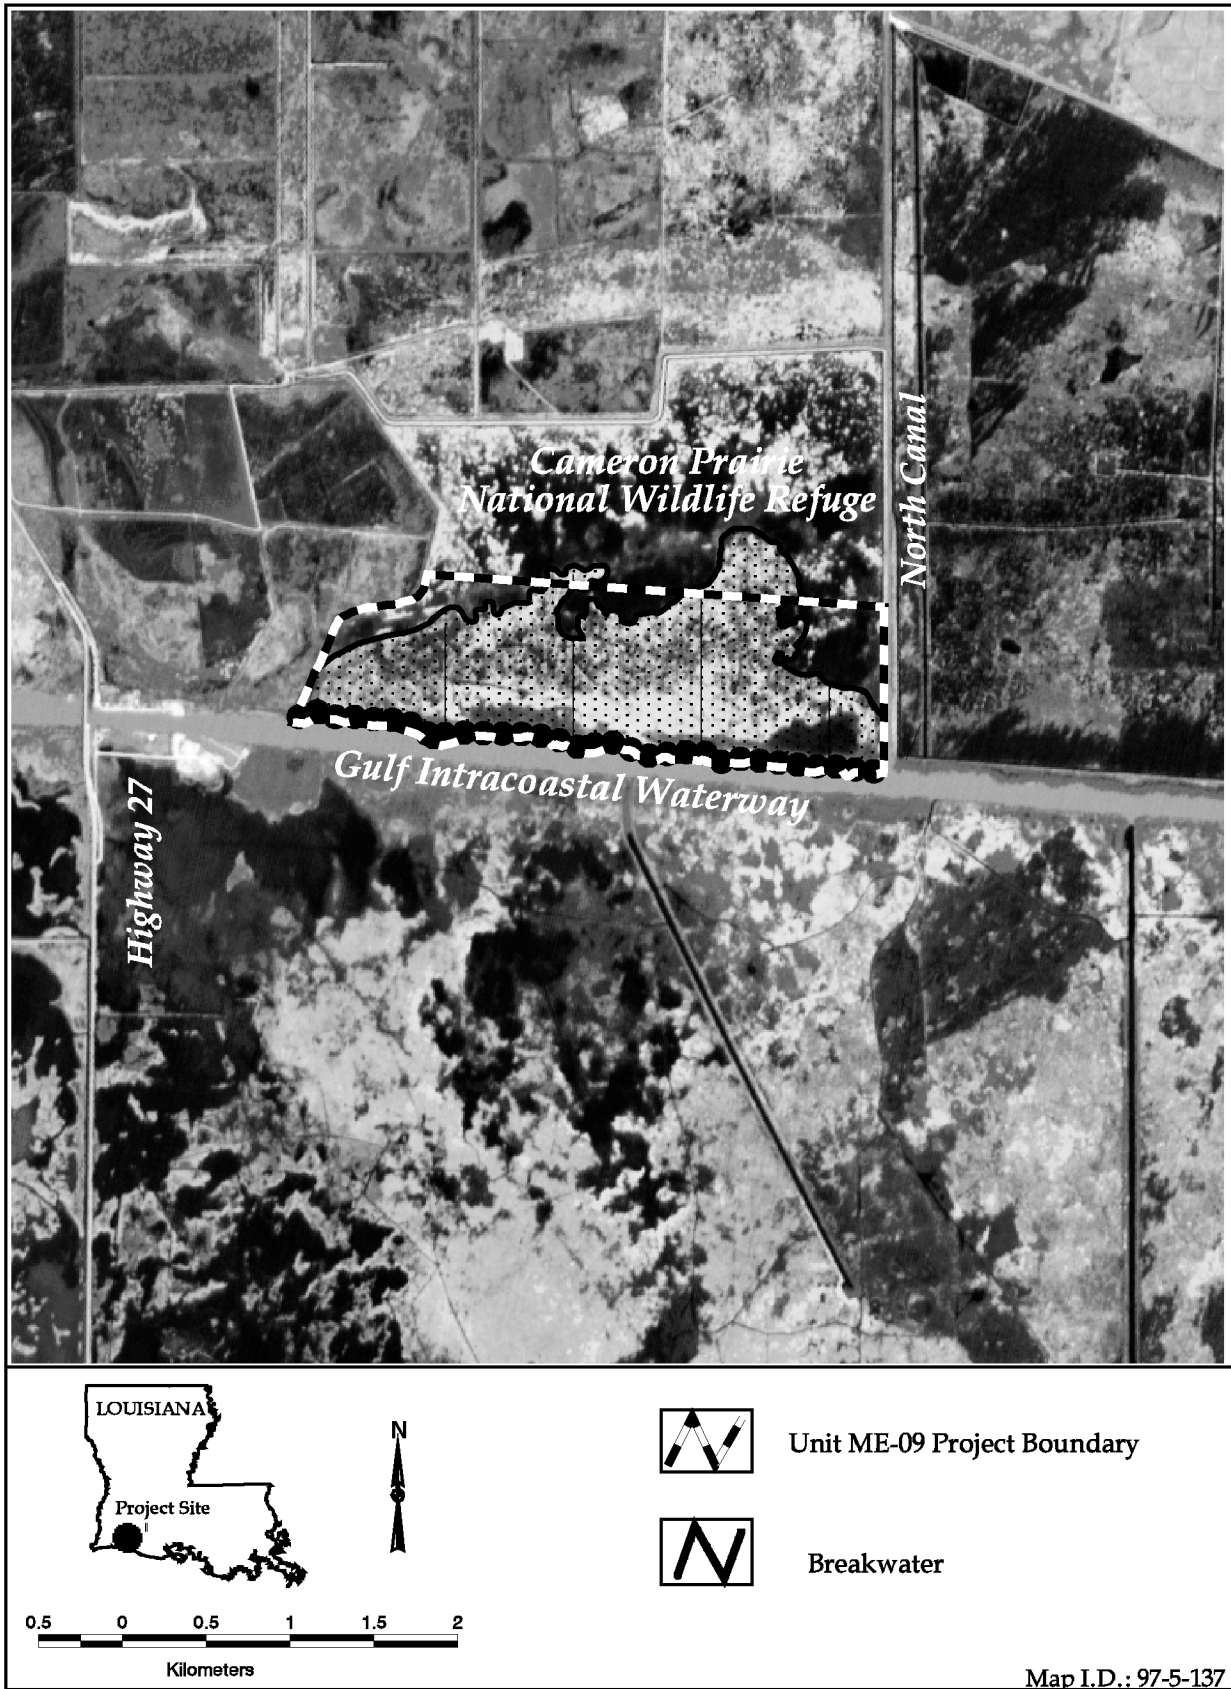
Figure 1. Cameron Prairie Refuge project location and features.

The Cameron Prairie Refuge Protection project is located in north-central Cameron Parish within the Cameron Prairie National Wildlife Refuge (figure 1) and encompasses 350 acres of highly organic freshwater wetlands (U.S. Fish and Wildlife Service 1991). The Gulf Intracoastal Waterway (GIWW) borders the project area to the south and threatens to breach into the refuge. Wave action caused by boat traffic within the GIWW has eroded most of the spoil banks that protect the refuge, allowing the high-energy and salinity waters of the GIWW to enter the project area. The resulting wave energy and saltwater intrusion destroys the fragile interior freshwater wetlands (Cameron Prairie National Wildlife Refuge 1991). In August 1994, a 13,200-ft rock breakwater was constructed 0-50 ft from (and parallel to) the northern bank of the GIWW in 3 to 4 ft of water. The purpose of the breakwater was to prevent the encroachment of the GIWW into the project area by preventing the waves caused by boat traffic from overtopping and eroding the remaining spoil bank.

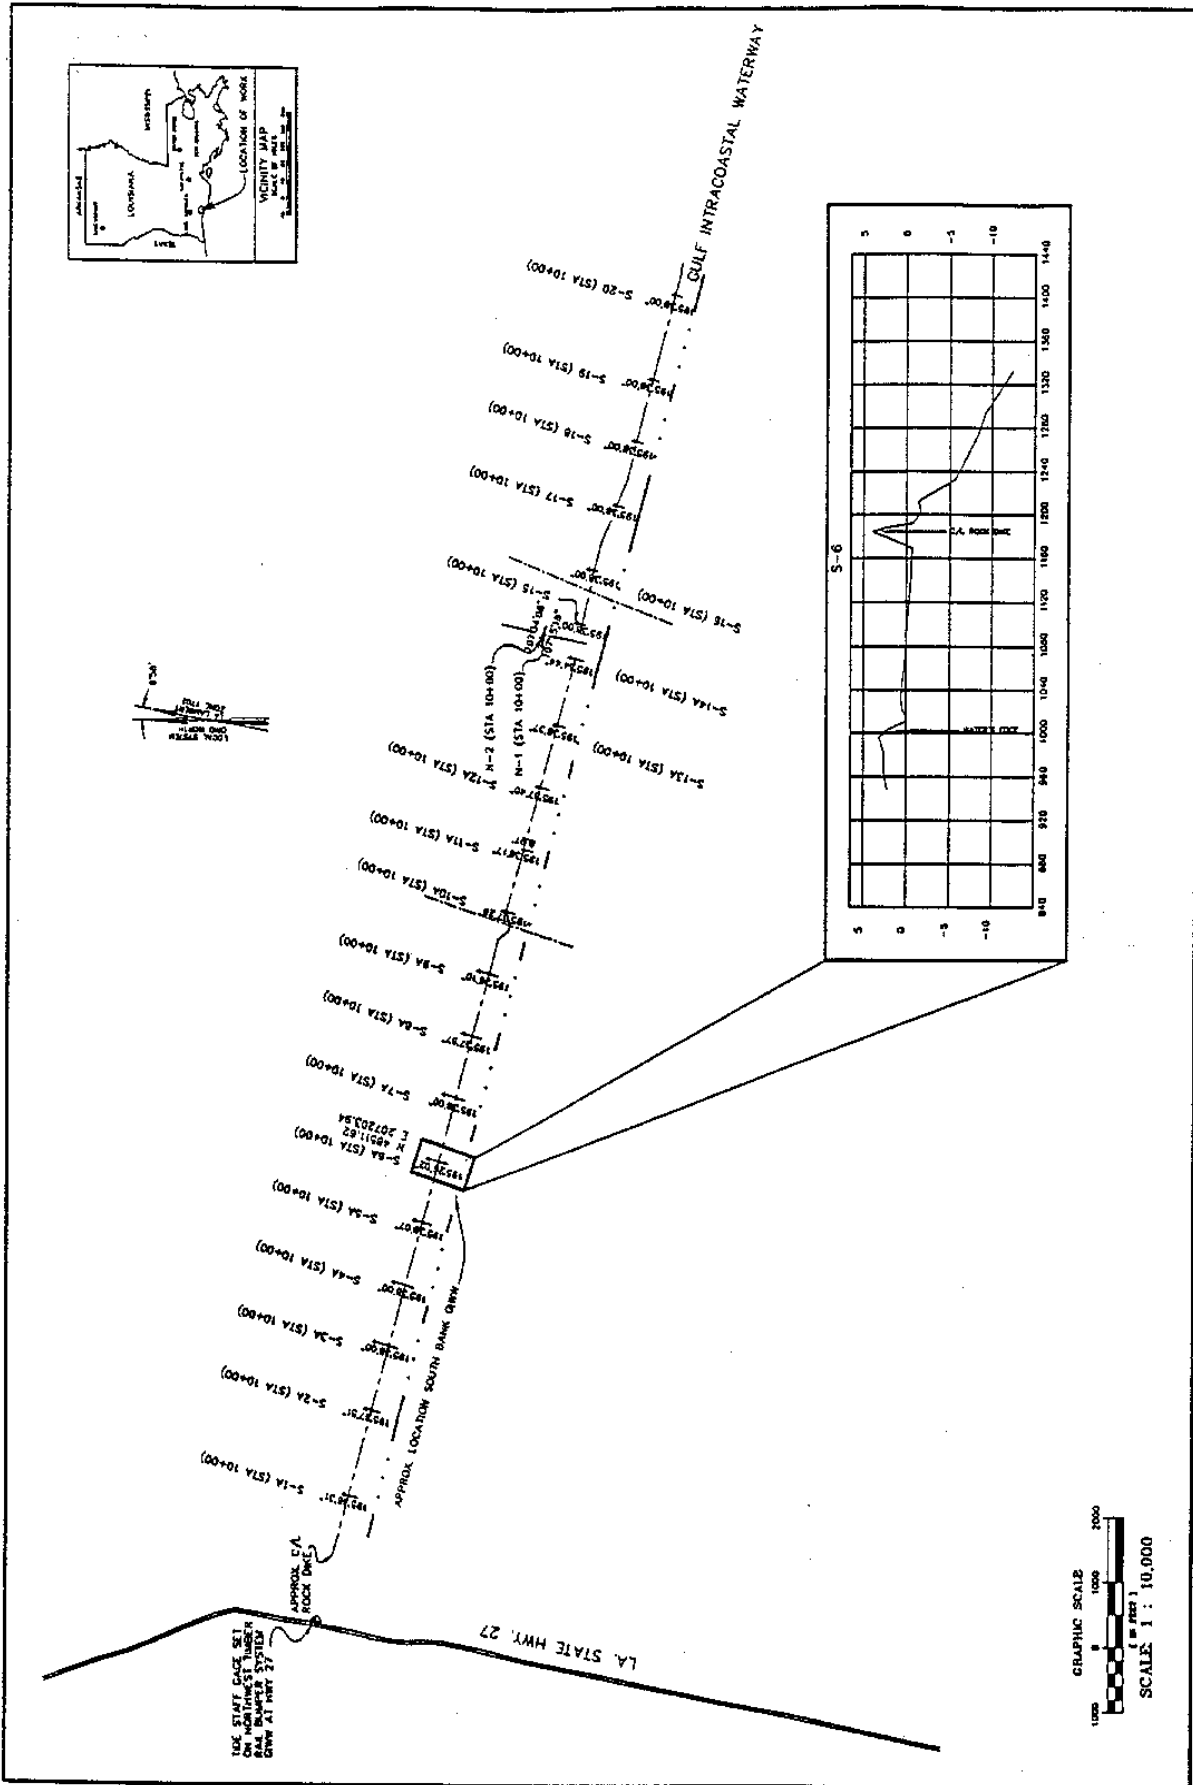
Figure 2. Cross-sectional survey locations with a typical elevational profile

Although not required by the monitoring plan, an elevation survey of the breakwater was completed in March 1995 to measure sediment deposition behind the breakwater and the relative position of the shoreline. Thirteen cross-sections were taken every 1,000 ft along the entire breakwater. Each cross-section consisted of elevations taken every 10 ft from approximately 40 ft behind the vegetated marsh edge to approximately 100 ft past the center line of the rock breakwater. The location of the cross-sections and a typical elevational profile is provided in figure 2. A completed set of the elevation survey data is located in the Louisiana Department of Natural Resources Abbeville field office. The baseline survey data will be compared to future data sets for interpretation and evaluation of breakwater performance in maintaining the original shoreline.
