**State of Louisiana  
Department of Natural Resources  
Coastal Restoration Division and  
Coastal Engineering Division**

**2007 Operations, Maintenance,  
and Monitoring Report**

**Sabine Refuge Marsh Creation**

State Project Number CS-28  
Priority Project List 8

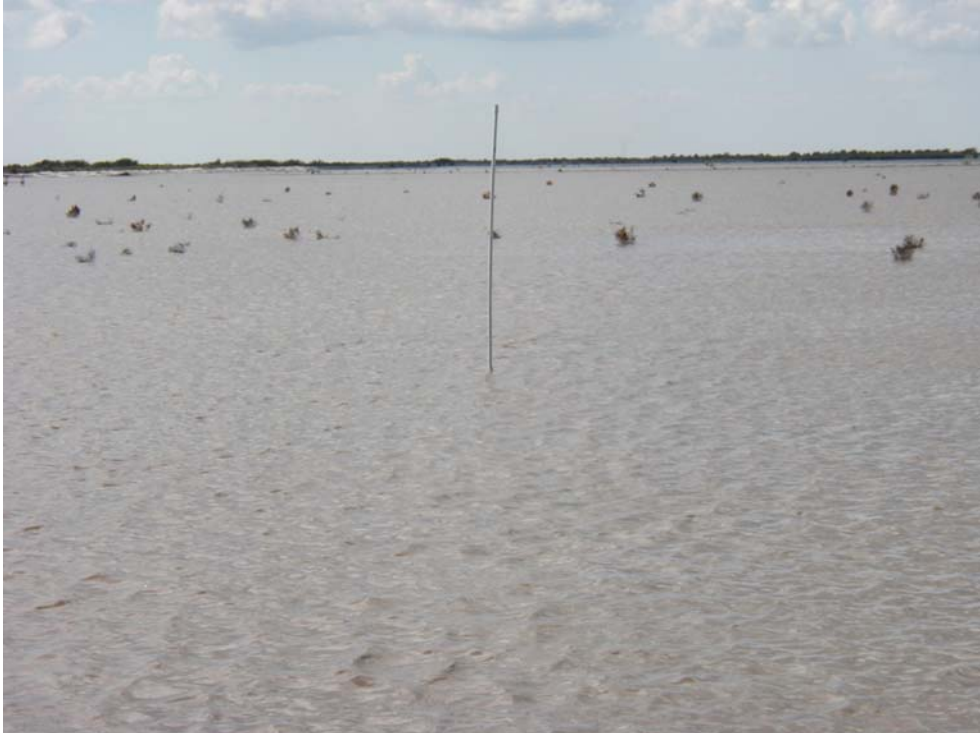
**Figure 5.** Photograph of vegetation station (CS28-205) in the Cycle I deposition area at time of establishment (September 2002). The plants in the background are *Salicornia bigelovii*.

Vegetation stations were established in the dredge cell constructed in 2002 (Cycle I) after construction. At the time of station establishment, the area was still an un-vegetated mudflat (figure 5). The Cycle I stations were revisited in 2004 (figure 6) and again after Hurricane Rita in 2005 and 2006 (figures 7, 8 and 9) as part of a regional post-hurricane survey (see Appendix A for complete survey results). In 2004, two species were present in the dredge construction area, *Spartina alterniflora* and *Schoenoplectus robustus* (table 1). *Spartina alterniflora* had been planted along the edges post-construction in 2002. Total cover had increased from 0 to 52% in the constructed marsh by 2004 (figure 10). Comparisons to the vegetative assemblages in the adjacent, natural marsh revealed that cover in the constructed marsh was approaching levels in the natural marsh (figure 10), although the constructed marsh was a monoculture of *Spartina alterniflora* while the natural marsh was dominated by *Distichlis spicata* and *Spartina patens* and had 3 to 4 species per plot with a maximum of 6 (figure 11). Vegetation height in the constructed marsh was much higher than in the natural marsh due to differences in growth habit of dominant vegetation (figure 12). The dredge material contains mineral-rich clays that *Spartina alterniflora* was likely responding to (although there are no data to assess this assertion).

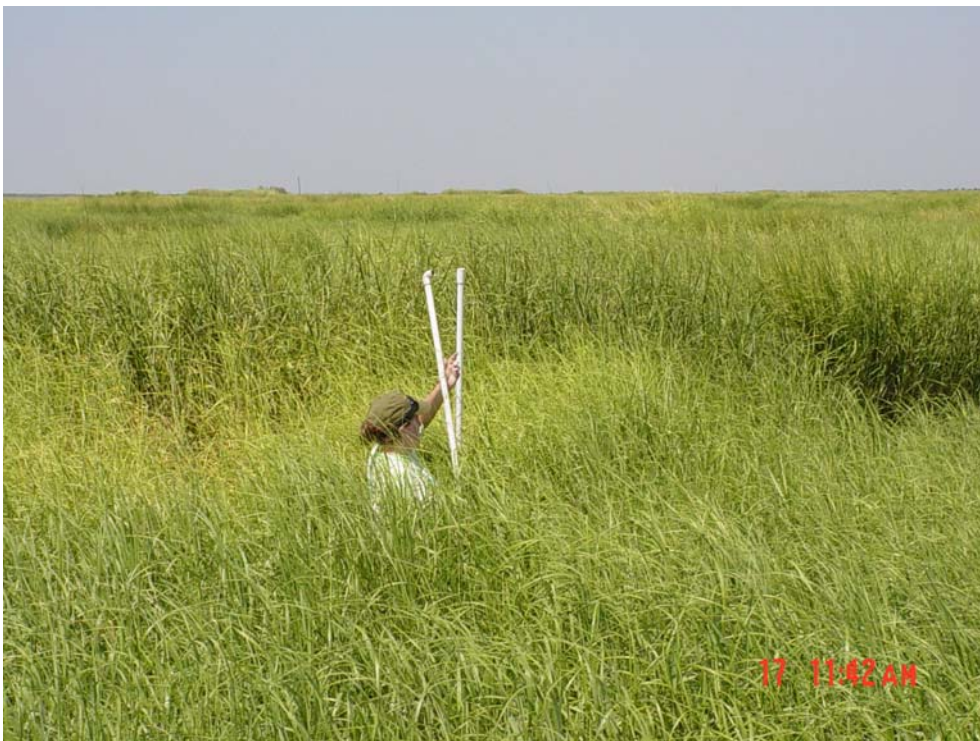
**Figure 6.** Photograph of vegetation station (CS28-205) in the Cycle I deposition two years after construction (August 2004).

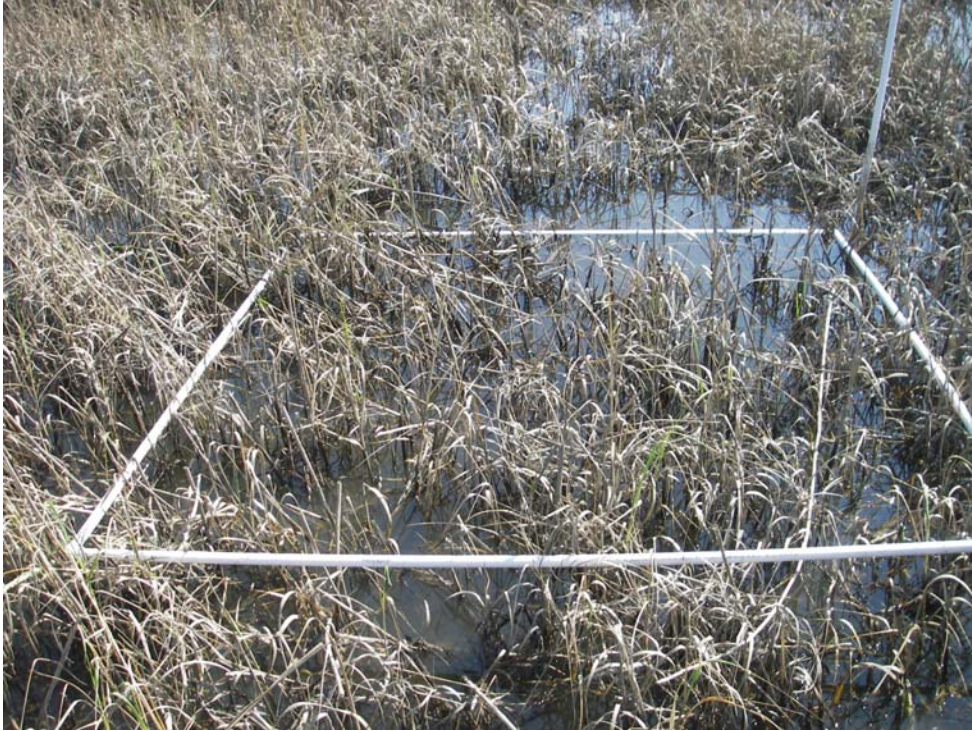
**Figure 7.** Photograph of vegetation station (CS28-200) in the Cycle I deposition area six weeks after Hurricane Rita and three years after construction (October 2005).

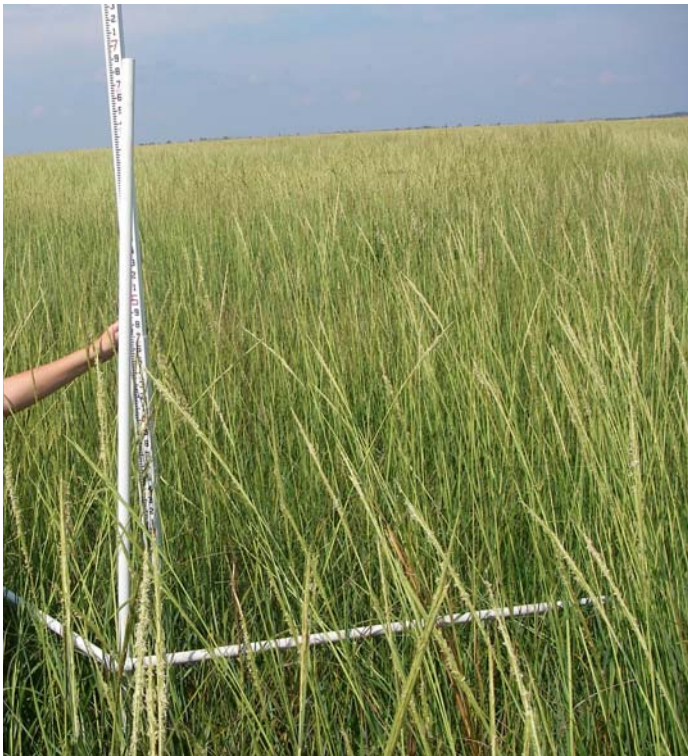
**Figure 8.** Photograph of vegetation station (CS28-206) in the Cycle I deposition area one year after Hurricane Rita and four years after construction (September 2006).

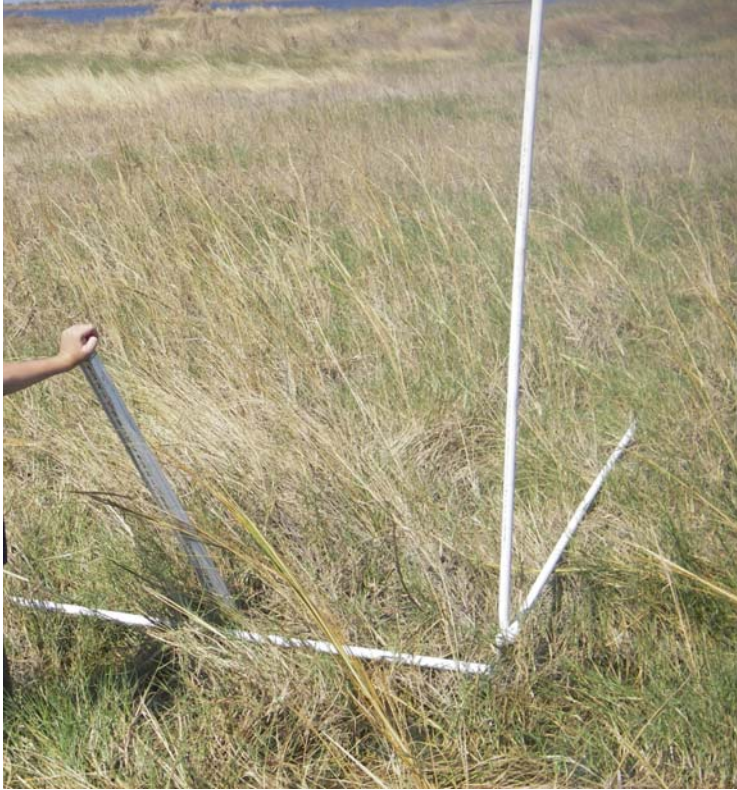
**Figure 9.** Photograph of vegetation station (CS28-150) in the reference area six weeks after Hurricane Rita and three years after construction (October 2005).

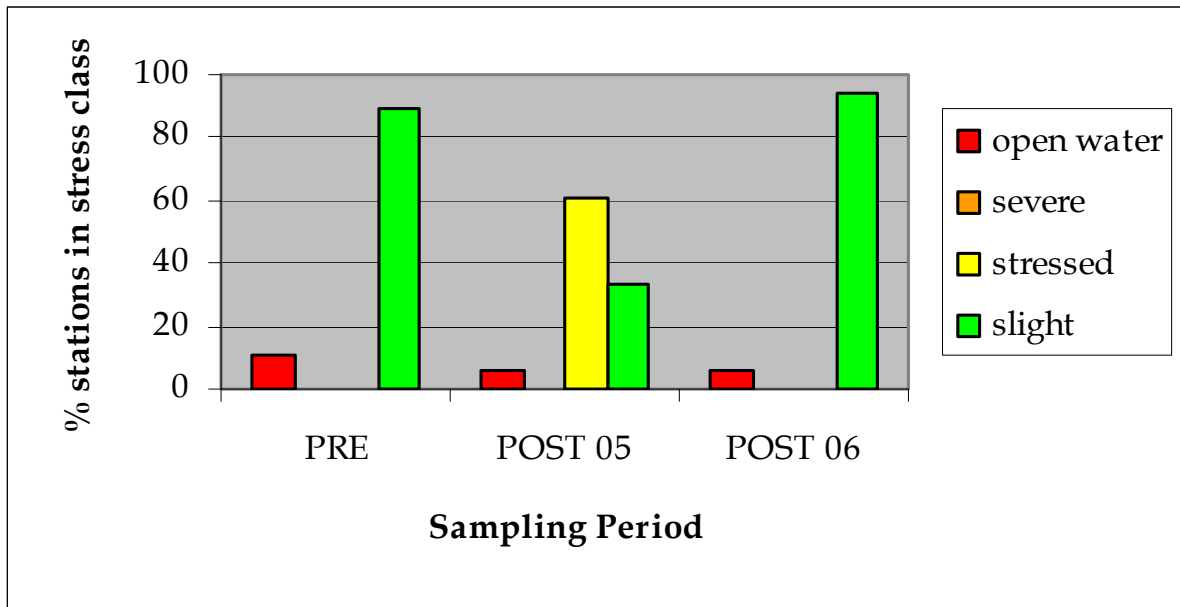
**Figure 13.** Percent of CS-28 vegetation stations in each stress class before and after Hurricane Rita (n=23).
