**2007 Operations, Maintenance,
and Monitoring Report**

**Holly Beach Sand Management
Project**

State Project Number CS-31
Priority Project List 11

August 2007
Cameron Parish

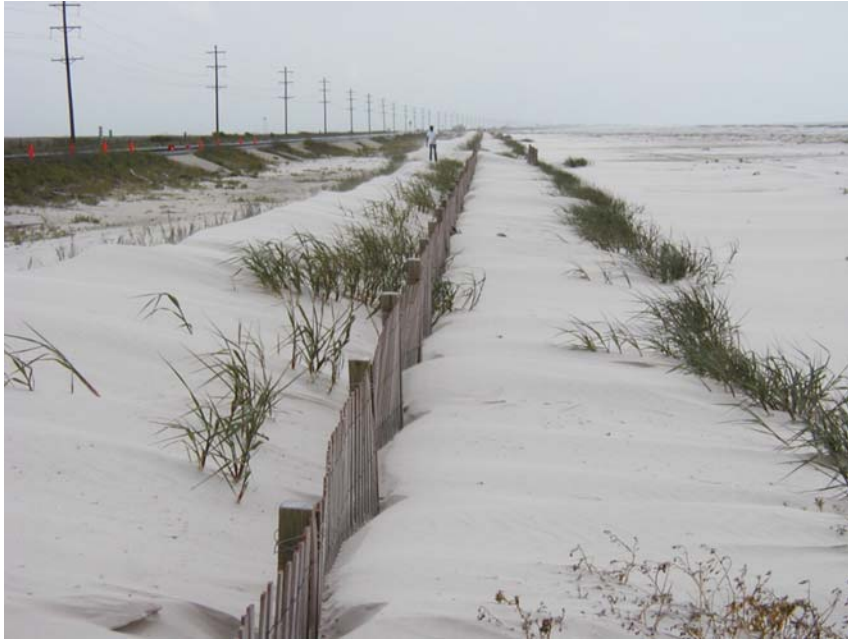
Figure 7a. View of the sand fencing and vegetation plantings at Station CS31-108 taken in April 2004. Note the dune formation almost covering the fences. The photograph is facing east.

Data were collected on October 6, 2003, April 20, 2004, and October 12, 2004 (Table 1, figures 7 & 8). Mean percent survival and mean percent cover in the fall of 2003 were 82.5 and 13.07, respectively. In the spring of 2004 mean percent survival was 81.1% and mean percent cover was 26.7%. Mean percent survival dropped to 76.7% in the fall of 2004, while mean percent cover increased to 46.4% (figure 8). Many of the original plants were actually covered by the dune that formed behind the fences. The dunes were becoming colonized by both *Panicum amarum* and other species as well. The last scheduled monitoring of the vegetation plantings occurred in the fall of 2004. As documented in the inspection report though, the plantings were severely impacted by Hurricane Rita and were replanted by the La. Dept. of Agriculture and Forestry. No monitoring is scheduled for the new plantings. The condition of the vegetation plantings and dunes will be documented using O&M surveys.

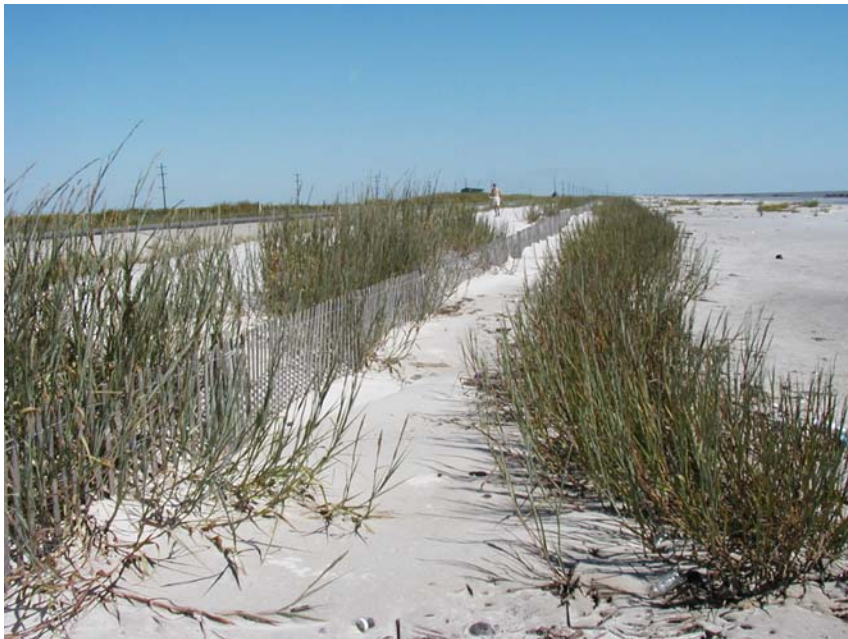
Figure 7b. View of the sand fencing and vegetation plantings at Station CS31-150 taken in October 2004. The photograph is facing east.

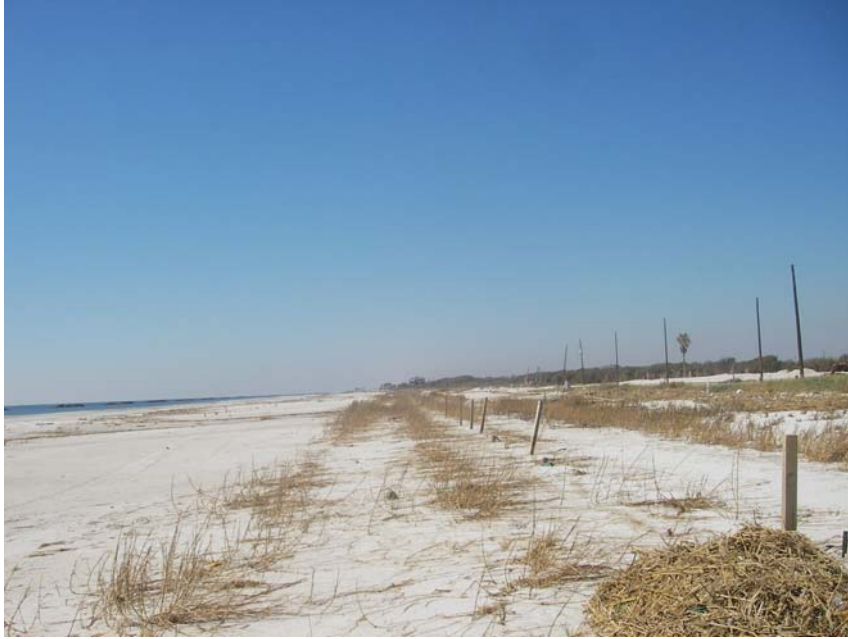
Figure 7c. View of a section of the sand fencing and vegetation plantings taken October 2005. The photograph is facing west.

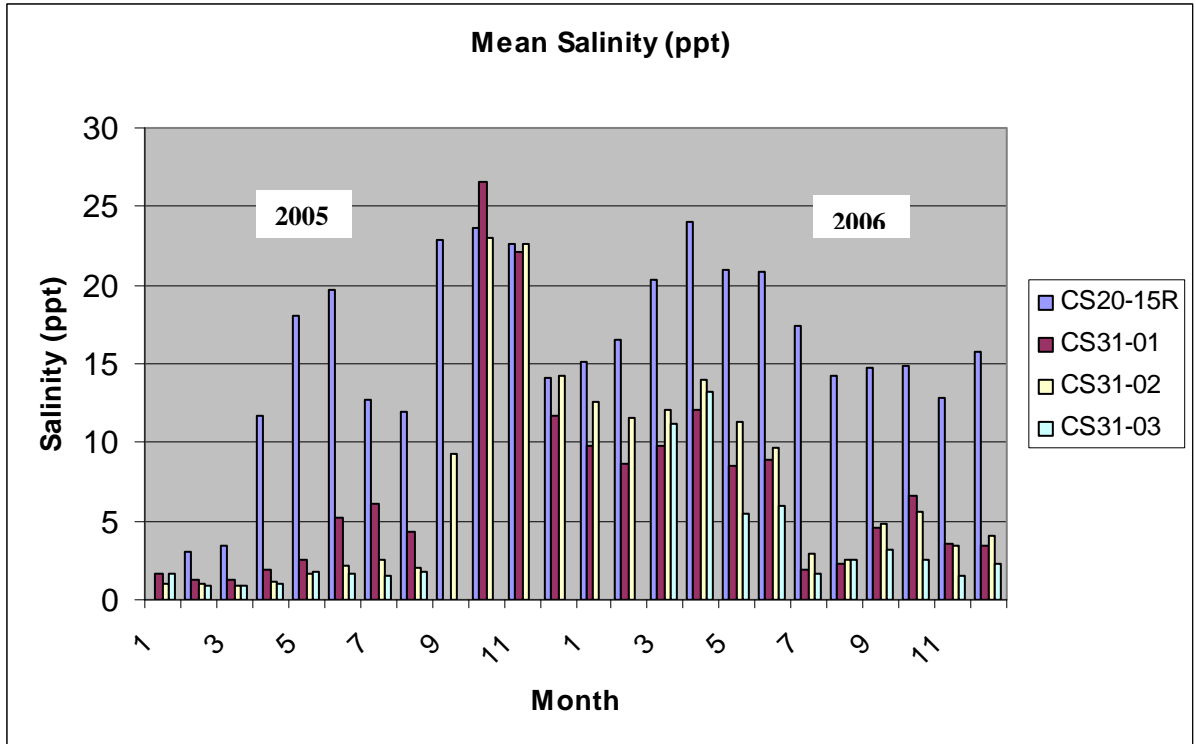
Figure 13. Monthly means at CS-31 project area stations and CS20-05R for years 2005 and 2006.

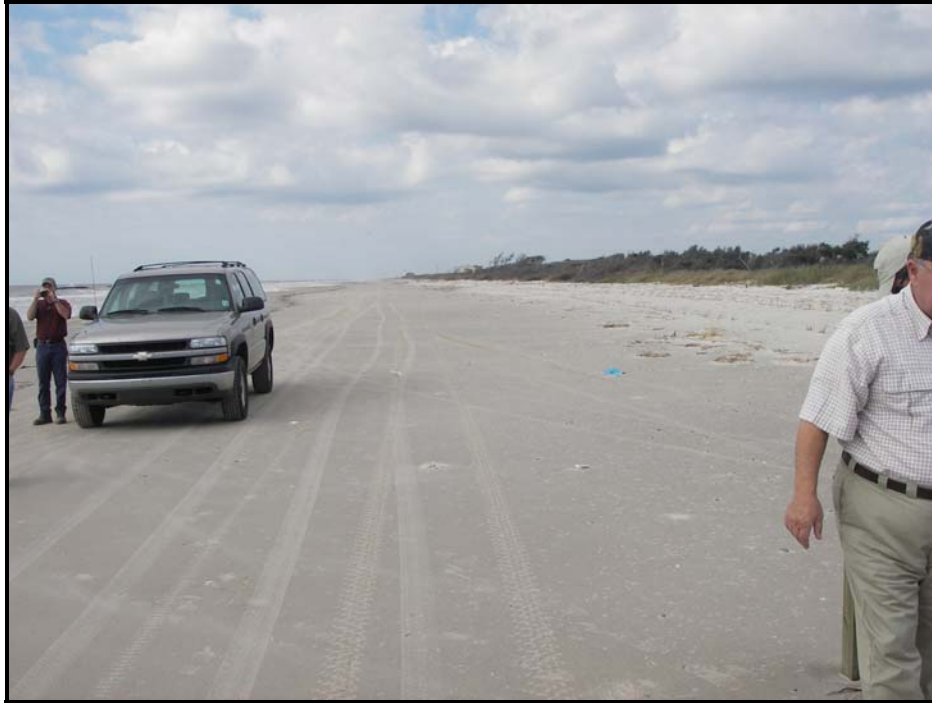
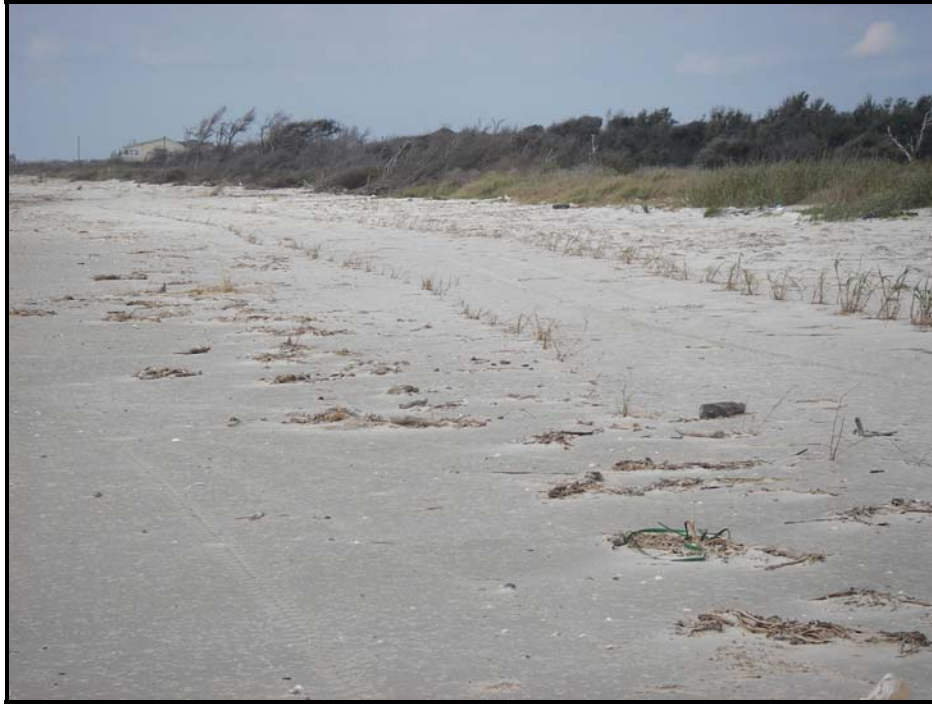
The entire reach of the 28,000 linear feet of the beach fill area appeared very clean and was without significant areas of scattered debris. Recent strong southerly winds and extremely high tides pushed most of the small debris against the high bank or roadside embankment, or carried same away via westerly currents. The sand fill was judged to be in excellent shape, considering the severity of Hurricane Rita, with the majority of the “plateau area” that was initially constructed still in place. Post-Rita surveys and cross sections were performed and compared to pre-Rita surveys. The results indicate that an approximate quantity of 427,000 cubic yards of sand material have been removed by Rita. Beyond the western end of the project, we observed that some significant amounts of sand material had been deposited onto areas adjacent to the beach. Also, the prevailing westerly currents have deposited sand along the coast west of the original project boundary as per visual observation and recent 2005 aerial photography. The original “vegetative plantings” portion of the project was severely impacted by Hurricane Rita and has since been partially replanted at no cost to LDNR by the Louisiana Department of Agriculture and Forestry. The recent high water event has caused the new plants to become

somewhat stressed, but over time they are expected to recover. (Photos: Appendix B, Photos 1 and 2).

Photo 1, View of sand enhancement project, looking west beyond project limits. (10-30-2006)

Photo 2, Close up view of beach head with vegetative plants in background. (10-30-2006)

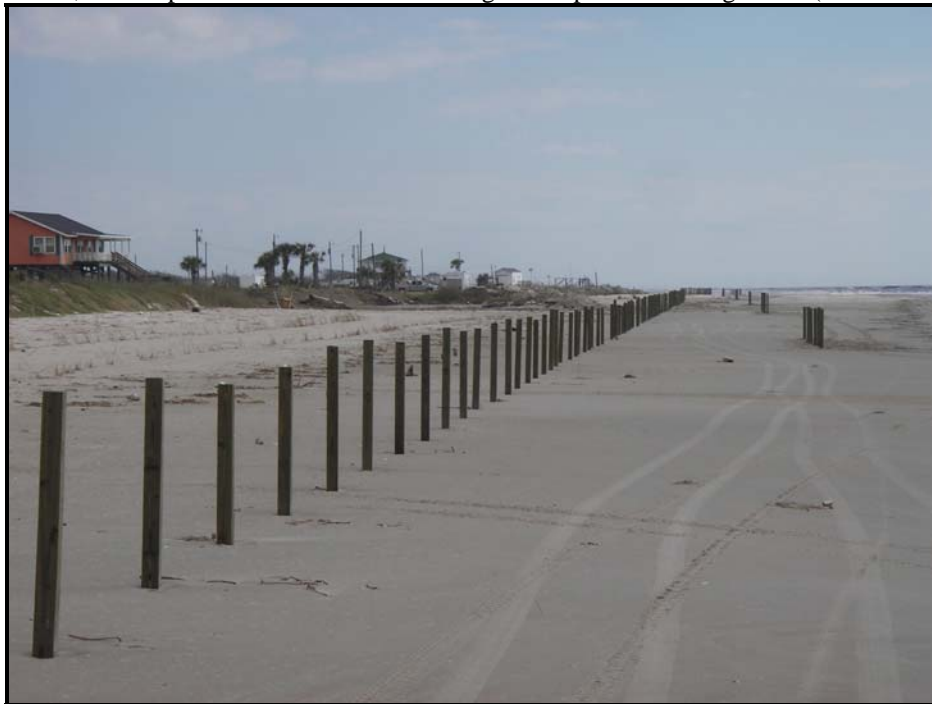
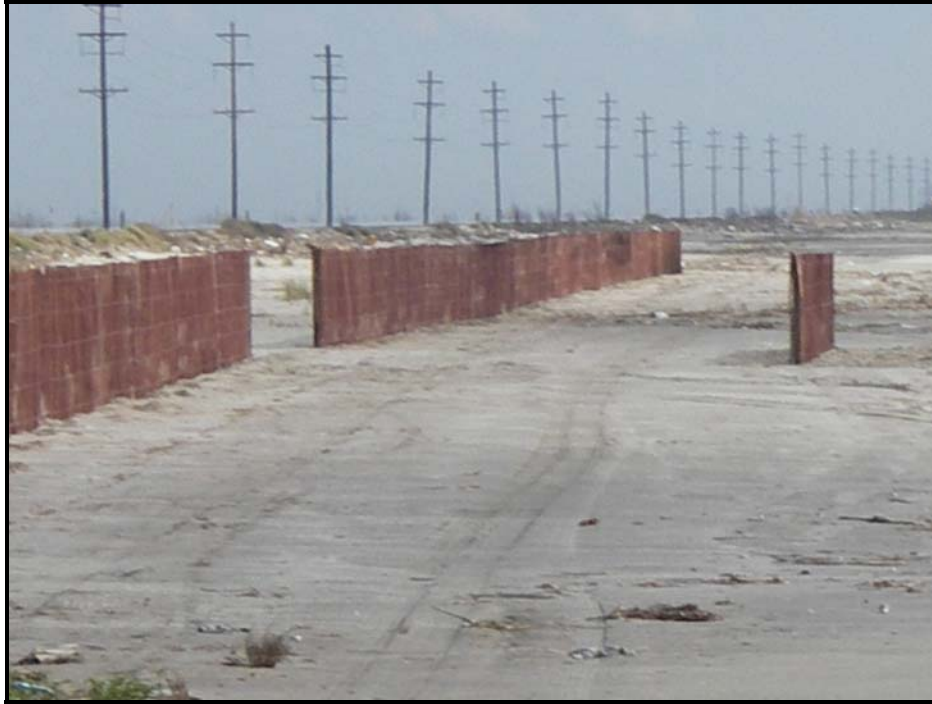
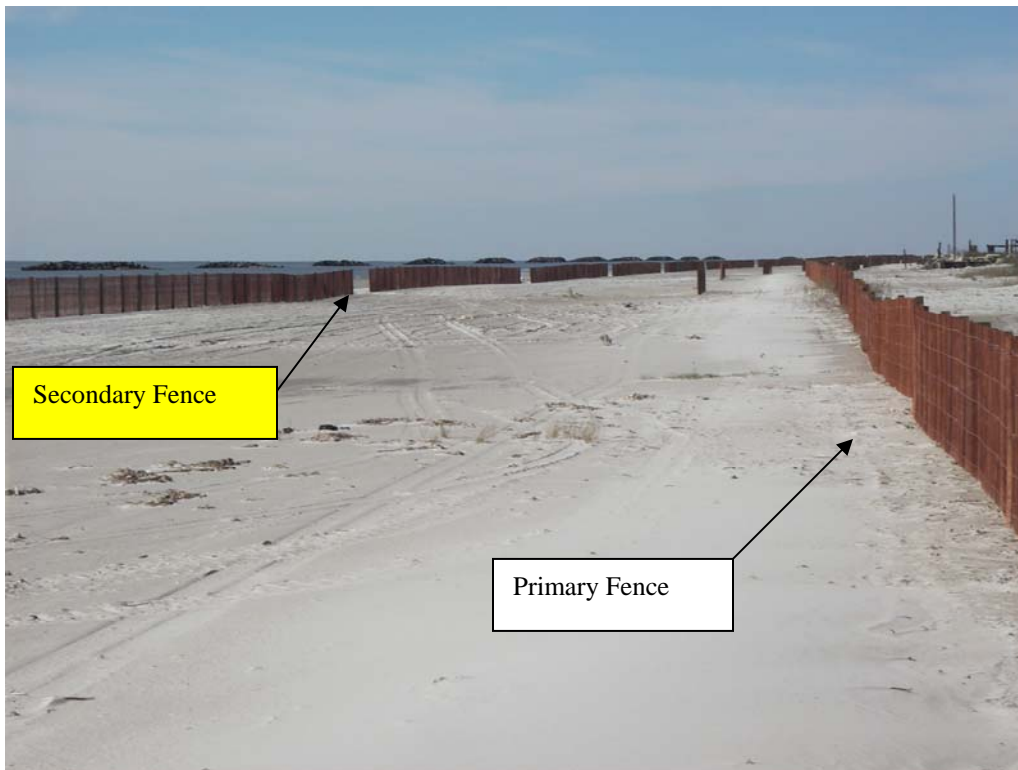
The entire initially installed sand fence was destroyed by Hurricane Rita and a Sand Fence Repair Maintenance Project to replace 46,000 linear feet is currently underway as noted in Section II. d. below. The contractor has removed all of the existing fence posts, wire, and debris for offsite removal. Approximately 1,200 posts of the initial fence were salvaged for reuse on the new fence. All of the posts have been installed for the primary fence alignment, and at the time of this inspection, the contractor was starting to hang new sand fence material starting at the eastern end of the project. The secondary fence alignment has been partially staked out. The contract time ends on March 12, 2007; however, the contractor completed the project on November 27, 2006. (Photos: Appendix B, Photos 3, 4, and 5).

Photo 3, View of fence posts installed along primary fence alignment. (10-30-2006)

Photo 4, Start of new fence installation, east end of project. (10-30-2006)

Photo 5, View of primary and secondary fence alignments, looking west. (12-1-2006)

Item	Condition	Physical Damage	Corrosion	Photo #	Observations and Remarks
Steel Bulkhead / Caps	N/A				
Steel Grating	N/A				
Stop Logs	N/A				
Hardware	N/A				
Timber Piles	N/A				
Timber Wales	N/A				
Galv. Pile Caps	N/A				
Sand Fencing	Good			3, 4, & 5	Fencing is being completely replaced from Hurricane RITA damage. Work completed on November 27, 2006.
Signage / Supports	N/A				
Sand (fill)	N/A				
Earthen Embankment	N/A

Note: This maintenance project was completed on November 27, 2006. The final quantity of sand fence installed was 46,239 linear feet.
