**2007 Operations, Maintenance,
and Monitoring Report**

**Freshwater Bayou Wetland
Protection**

State Project Number ME-04
Priority Project List 2

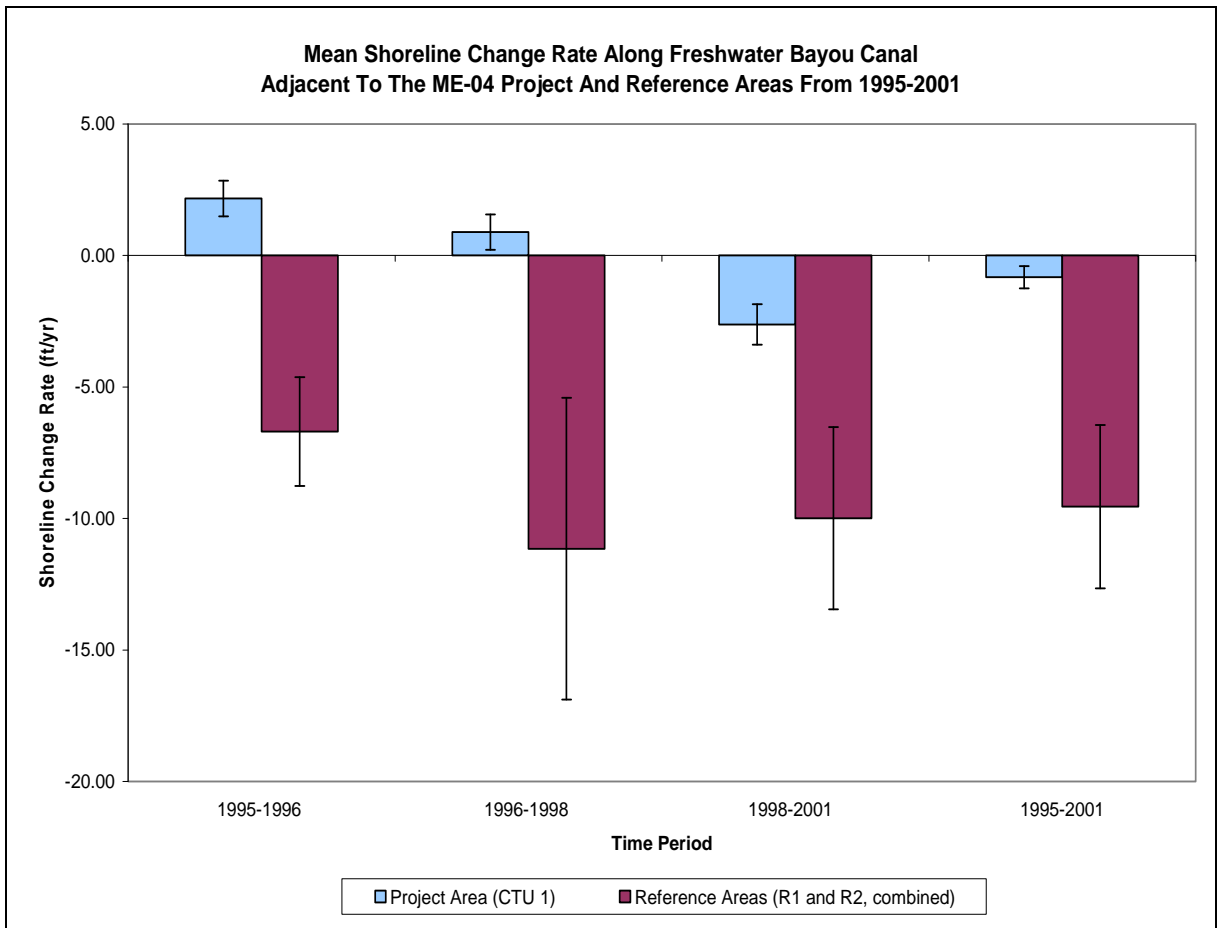
The project area shoreline prograded an average of 2.17 ft/yr (0.66 m/yr) between June 1995 and July 1996 (figure 8), and an average of 0.89 ft/yr (0.27 m/yr) between August 1996 and February 1998, but eroded an average of -2.62 ft/yr (-0.80 m/yr) between March 1998 and May 2001 (figure 8). Overall, the average shoreline change rate on the west canal bank behind the rock dike was -0.83 ft/yr (-0.25 m/yr) between June 1995 and May 2001.

Conversely, erosion was documented at all six reference area monitoring stations on each survey conducted, averaging -6.69 ft/yr (-2.04 m/yr) between April 1995 and July 1996, -11.15 ft/yr (-3.40 m/yr) between August 1996 and February 1998, and -9.99 ft/yr (-3.05 m/yr)

Figure 8. Mean shoreline change rate along Freshwater Bayou Canal adjacent to the ME-04 project and reference areas from 1995 to 2001.

between March 1998 and May 2001 (figure 8). Overall, the average shoreline change rate along the two reference areas on the east canal bank was -9.55 ft/yr (-3.03 m/yr) between June 1995 and May 2001.

Shoreline along the west bank of FBC in the project area has benefited from the construction of the rock dike, as indicated by the significantly reduced erosion rates relative to the reference areas. However, the rate of erosion increases when the elevation of the rock material sinks below the originally constructed top elevation, as noted in 2001. Maintenance events in 2002 and 2005 lifted the rock dike back to the prescribed elevations.

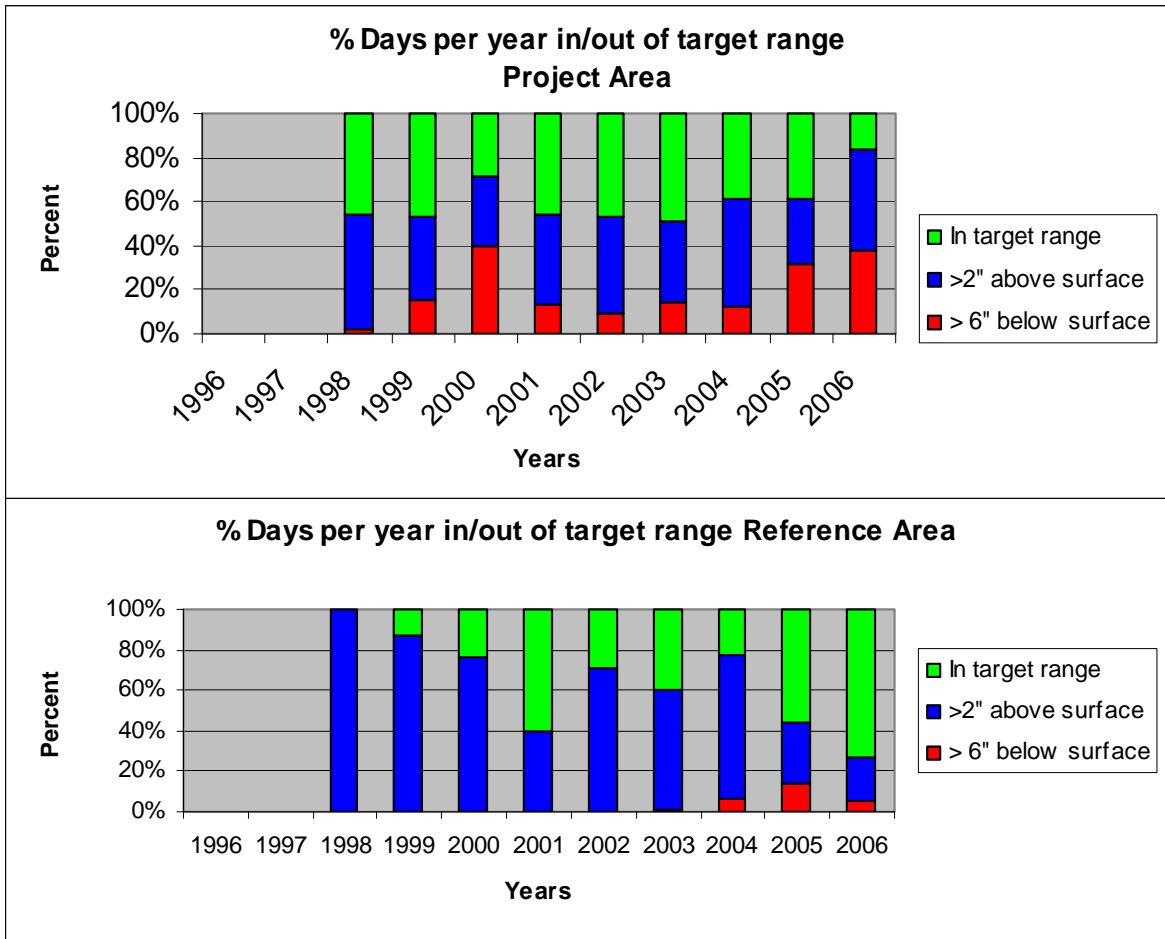
The goal to reduce water levels to within the target range of 6 in (15 cm) below to 2 in (5 cm) above marsh level was not met. Water levels in the project area were within the target range less than 50% of the year during 10 years of data collection. However, project area water levels were within the target range a greater percentage of time than the reference area in all post-construction years except 2001, 2005, and 2006 (figure 9).

In general, when reference area water levels were out of the target range, they tended to be greater than 2" above the marsh surface. Project area water levels were greater than 6" below marsh surface more often than reference stations. This would be expected since two of the reference area stations are located along major waterways and are subject to higher tidal amplitude, while the three project area stations are located in interior marsh areas influenced by water control structures. Water levels were higher during all years in the project area compared to the reference area.

Figure 9. Percentage of days per year water levels were inside and outside of target range within the project and reference areas.

The ME-04 project does not appear to be effective in keeping water levels within the desired range since project area stations stayed within range less than half the time during all years, and project area water levels were higher than the reference area. Salinity stayed within the target range at project area stations for most years, but this cannot be attributed to project features since the reference stations were generally within 10% of project stations. Salinity spikes observed have been associated with periods of droughts and tropical storm or hurricane activity.

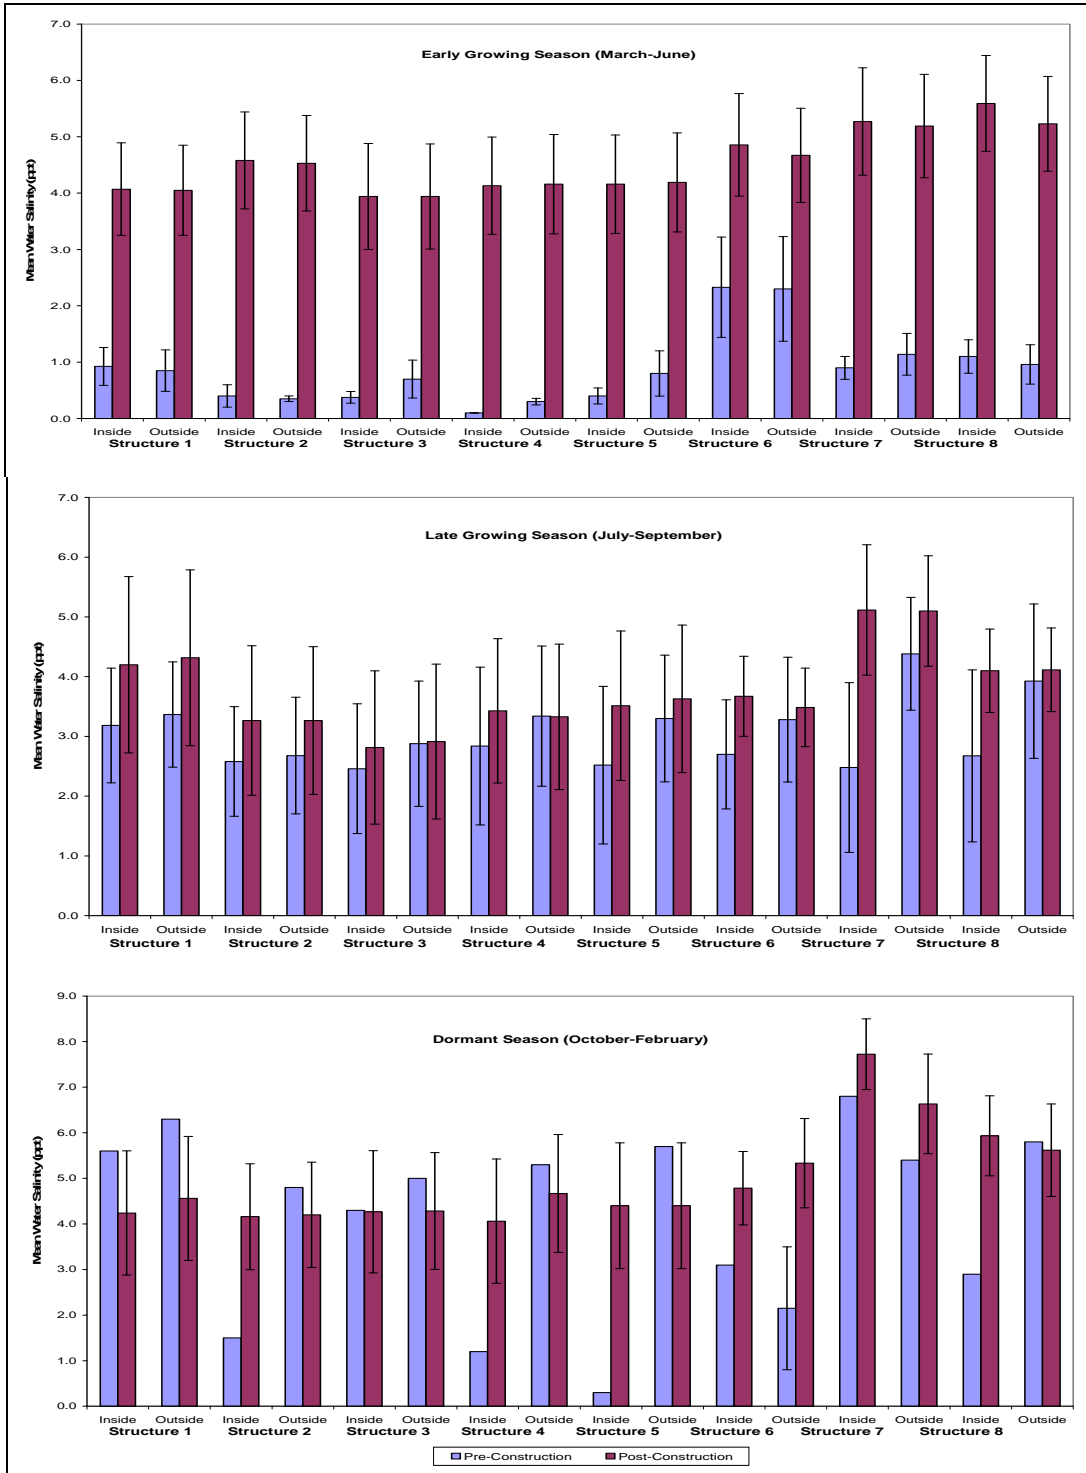
Mean monthly water salinity (ppt) calculated from discrete monthly salinity readings taken at monitoring stations throughout the project area, surrounding canals, and reference areas R2 and R3 shows a general trend of increasing salinity from west to east (figures 11, 12, and 13). Discrete monthly water salinity readings taken at the eight CWPPRA structure sites do show that water salinity "inside" and "outside" of the structures was higher during the post-construction period than during the pre-construction period at all eight structures (figure 14).

Figure 14. Comparison of mean seasonal water salinity (ppt) inside and outside of the eight CWPPRA structures at ME-04 during the pre-construction (March 1996-September 1998) vs. the post-construction (October 1998-May 2002) time periods. Error bars represent ± 1 standard error.

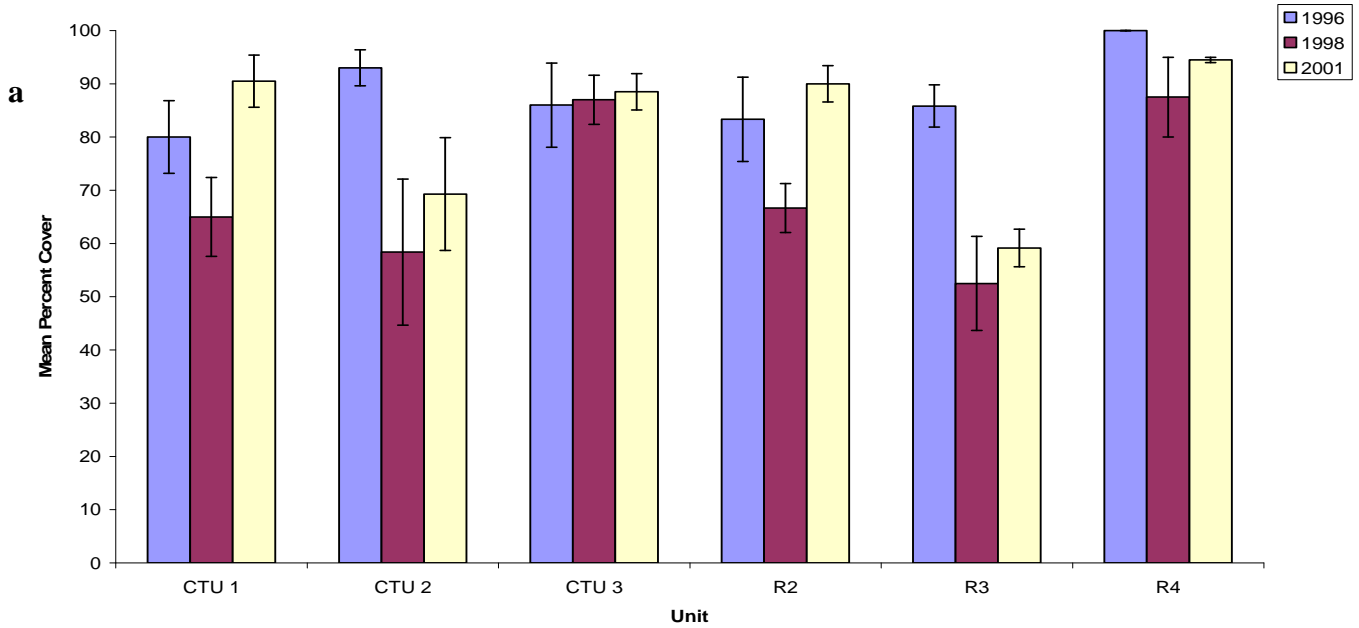
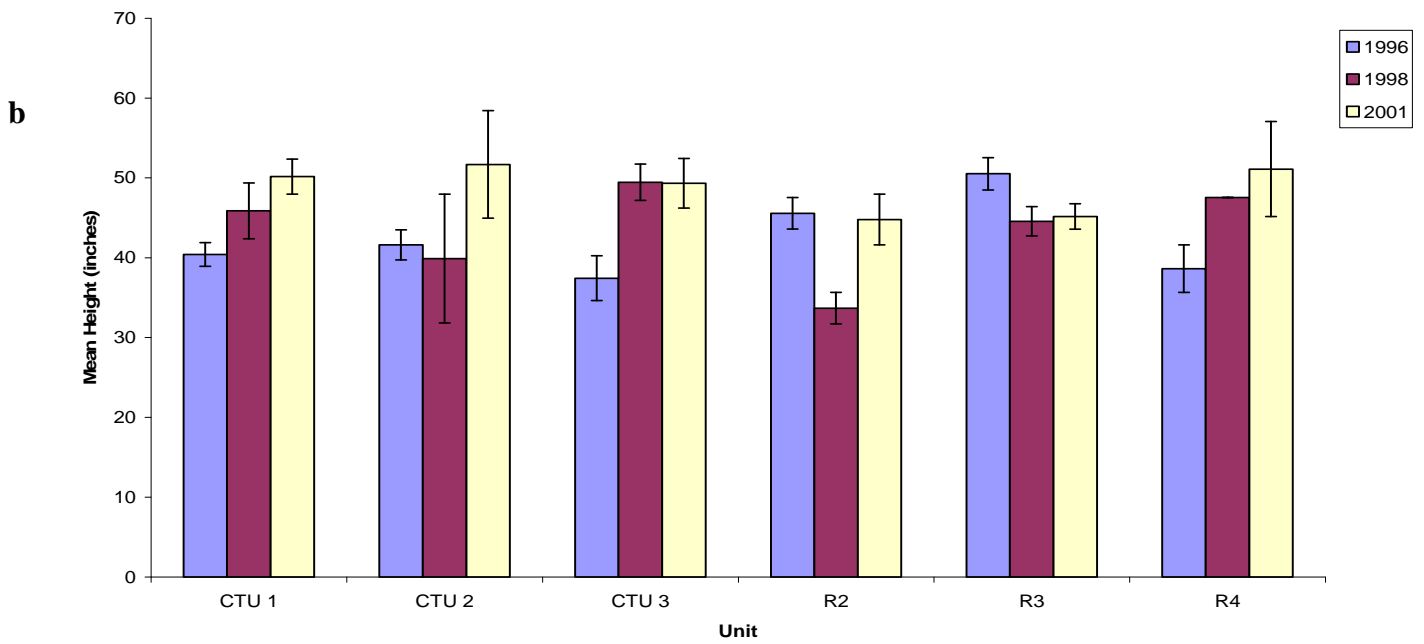
Total percent cover decreased from 1996 to 1998 in all units except CTU 3, where cover remained about the same (figure 15a). Total percent cover then increased from 1998 to 2001 in all units except R3 where cover continued to decrease. Mean height of the tallest dominant increased from 1996 to 2001 in all units in the project area (CTU 1, CTU 2, and CTU 3) and in R4 (figure 15b). Mean height decreased between 1996 and 2001 in R3 and remained about the same in R2. The dominant species in each unit remained the same for all years throughout the project. In CTU 1, CTU 3, R2, and R4 the dominant species was *Spartina patens*. In CTU 2 the dominant species was *Panicum hemitomon*, with *Spartina patens* and *Sagittaria lancifolia* as co-dominants. In R3 the dominant species was *Sagittaria lancifolia*.

Figures 15a-b. a) Mean total percent cover in the project and reference areas, separated by unit. b) Mean plant height in the project and reference areas, separated by unit.

Between 1996 and 2001 there was little or no increase of total vegetation cover or height at monitoring stations within the project area. Habitat analysis indicates that intermediate and brackish marsh has overtaken former areas of fresh marsh in the southeastern part of the ME-04 project area. Vegetation does not appear to be benefiting from the ME-04 project.

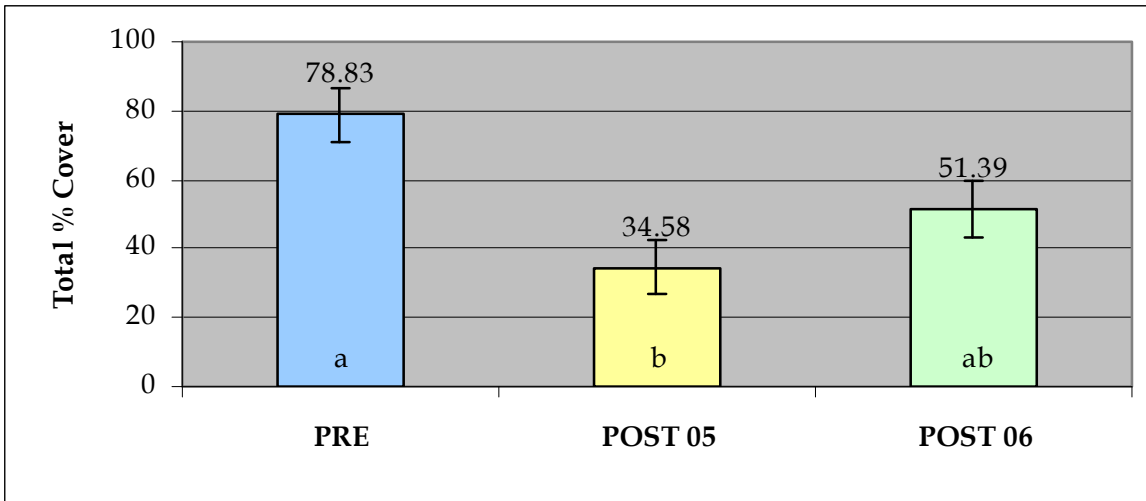
In the ME-04 project area, 18 stations were randomly chosen from the available stations. In the last sampling before Rita (2001), the vegetation was vigorous and only slightly stressed (figure 16). The slightly stressed category dropped to 10% in 2005, but recovered to 58 % in 2006. In 2005, 25% of the stations were severely stressed and 50 % were stressed. By 2006, the percent of severely stressed stations had dropped to 10% (one station) and the stressed category dropped to 21%. Species richness was lower in 2005, but essentially recovered to pre-storm levels by 2006 (figure 17). Total cover was reduced from 75% in 2001 to 35% in 2005, and had not recovered by 2006 with 51% (figure 18).

Figure 18. Total % Cover of vegetation at ME-04 Pre and Post Hurricane Rita. LS Mean ± SE (n=23 stations). $F_{2, 68}=7.68$, $p=0.0012$. Levels connected by the same letter are not significantly different.

Vegetation in the project area was severely impacted by Hurricane Rita and is slowly recovering, although species assemblages are reverting to more salt tolerant species.

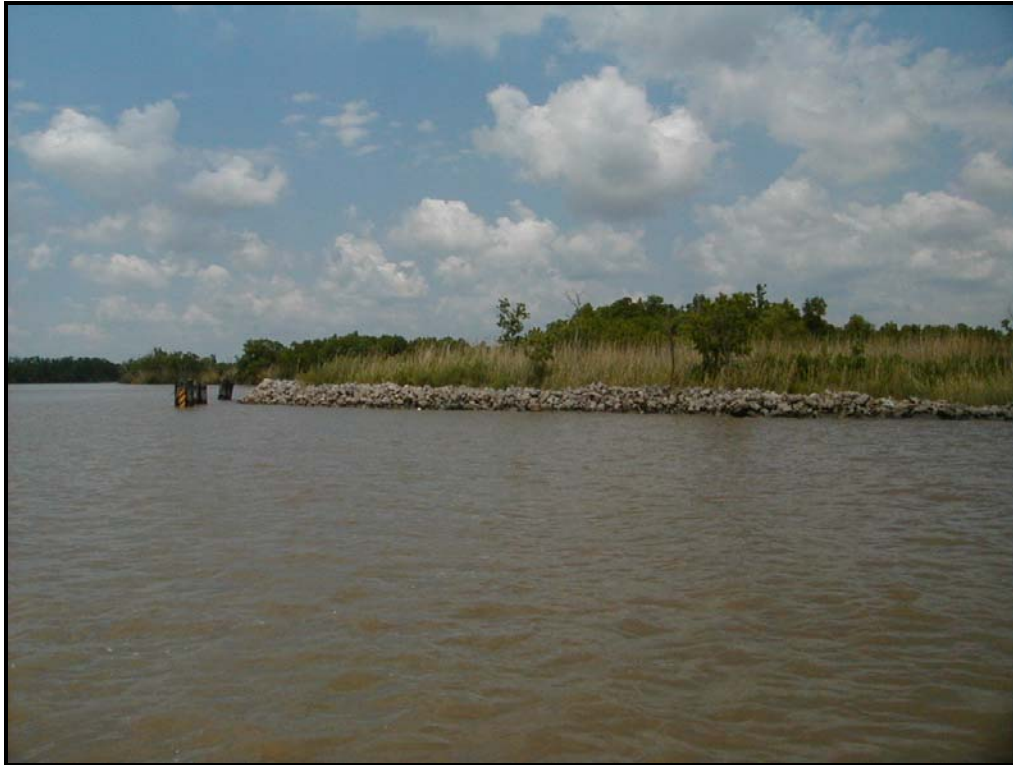
Photo 1, Typical rock dike

The inspection revealed the 11,420 linear feet of foreshore dike repaired in the 2005 maintenance project is in good condition. The additional 2,000 linear feet of foreshore rock dike (identified in the 2003/2004 O & M Inspection as being below elevation 4.0' NAVD, but above elevation 2.0' NAVD), has not deteriorated further and was not addressed due to budget limitations. (Photos: Appendix B, Photos 1 and 2)

Overall the Freshwater Bayou Wetland Protection Project structural components are in good condition. The 2,000 linear feet of foreshore dike mentioned above will continue to be monitored for deterioration during future annual inspections.
