**2007 Operations, Maintenance  
and Monitoring Report**

**CHANDELEUR ISLANDS MARSH  
RESTORATION**

State Project Number PO-27  
Priority Project List 9

July 19, 2007  
Orleans Parish

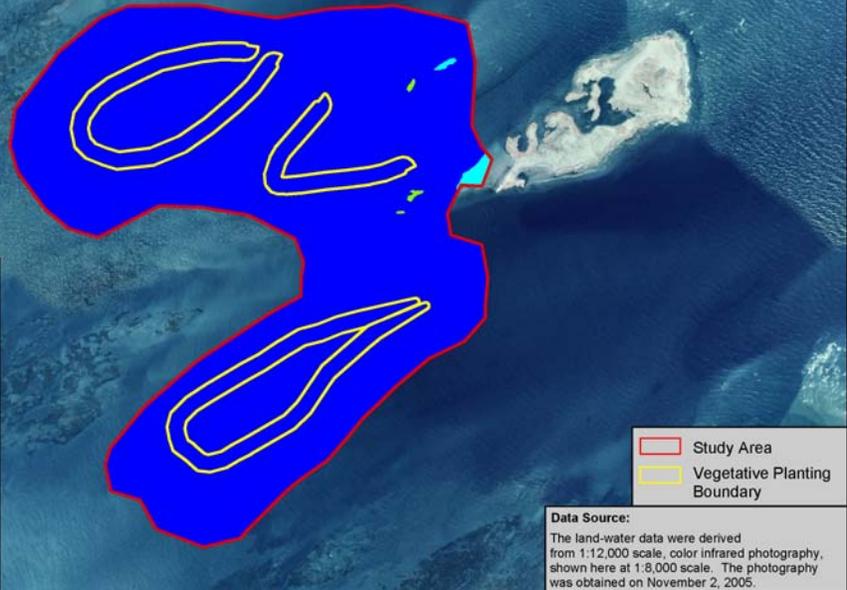
Class	Site Acres
Water	117.0
Irregularly Exposed	0.4
Regularly Flooded	0.1
Irregularly Flooded	0.0
Land	0.0
<b>Total</b>	<b>117.5</b>

Marsh restoration strategies at the Chandeleur Islands Marsh Restoration (PO-27) project area included vegetative plantings of smooth cordgrass (*Spartina alterniflora*) at 10 overwash fan sites. The Double Cut study area is one of these sites. All areas characterized by emergent vegetation, wetland forest, or scrub-shrub were classified as land, while open water, unvegetated mudflats, and aquatic beds were classified as water. In addition, tidal water regime modifiers based on time and duration of flooding were included. Irregularly flooded areas were classified as tidal water that floods land surface less often than daily. Irregularly exposed areas were classified as land surface that is exposed by tides less often than daily. Regularly flooded areas were classified as tidal water that alternately floods and exposes the land surface at least once daily. Due to tidal fluctuation, water classes are based on water levels at the time of flight. The water regime classification is modified from "Classification of wetlands and deepwater habitats of the United States" (Cowardin and others, 1979).

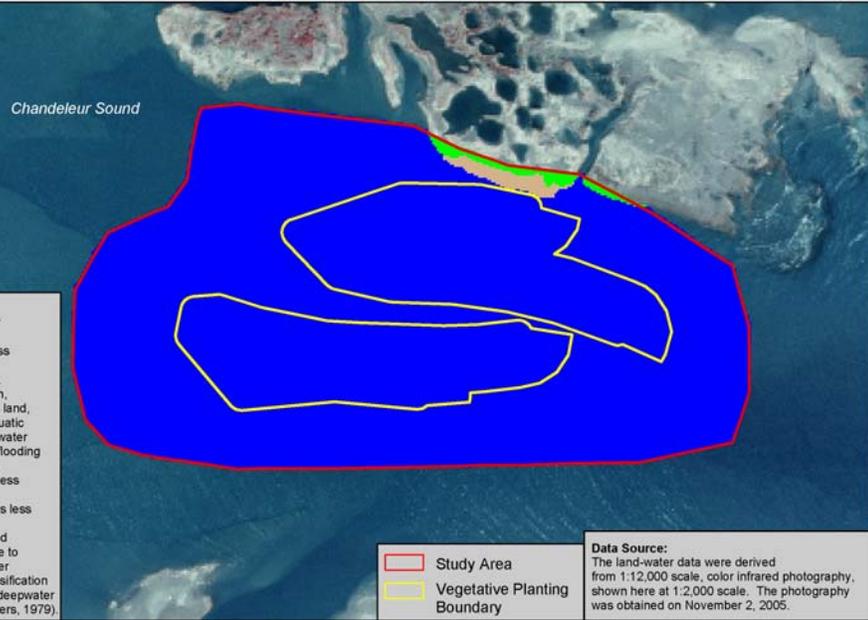
Class	Site Acres
Water	9.9
Irregularly Exposed	0.0
Regularly Flooded	0.1
Irregularly Flooded	0.0
Land	0.1
<b>Total</b>	<b>10.1</b>

**Project Information:**  
Marsh restoration strategies at the Chandealeur Islands Marsh Restoration (PO-27) project area included vegetative plantings of smooth cordgrass (*Spartina alterniflora*) at 10 overwash fan sites. The Teddy Bear study area is one of these sites. All areas characterized by emergent vegetation, wetland forest, or scrub-shrub were classified as land, while open water, unvegetated mudflats, and aquatic beds were classified as water. In addition, tidal water regime modifiers based on time and duration of flooding were included. Irregularly flooded areas were classified as tidal water that floods land surface less often than daily. Irregularly exposed areas were classified as land surface that is exposed by tides less often than daily. Regularly flooded areas were classified as tidal water that alternately floods and exposes the land surface at least once daily. Due to tidal fluctuation, water classes are based on water levels at the time of flight. The water regime classification is modified from "Classification of wetlands and deepwater habitats of the United States" (Cowardin and others, 1979).

The Little Teddy Bear site had a decrease in mean percent cover of 28% after Hurricane Ivan, which was the highest decrease of all the sites. However, this site still had the second highest total plant coverage out of all the sites. The mean percent cover within vegetated plots decreased from 56.8 to 32.2% after the storm and the mean percent cover across all plots decreased from 52.1 to 24.2%. Three plots were unvegetated, compared to only one before the storm. At this site, we observed significant scour along the edges of the vegetated areas, but the plants seemed to have survived fairly well despite a large overwash breach in the island. Like the Tripletail site, the decrease in percent coverage was caused by a combination of scour at the edges of the planting lobe and dieback of the plants within the lobe interior. It is unclear whether the storm accelerated the browning and thinning of the plants associated with seasonal dieback. The percent cover of vegetation plot PO27020104, which is located on the southern edge of the planting lobe, was reduced from 30% cover before the storm to 0% cover after the storm due to a cut which formed along the southern edge of the plantings. There were indications in some areas that the plants were effective in retaining sand and reducing scour. The area surrounding plot PO27020203 consisted of thick, scattered clumps of *S. alterniflora* the week before the storm. Although this area experienced heavy scour of surface sand during the storm, many of these clumps remained intact. Storm overwash deposits resulted in the formation of a new bare sand lobe near the original planting area.

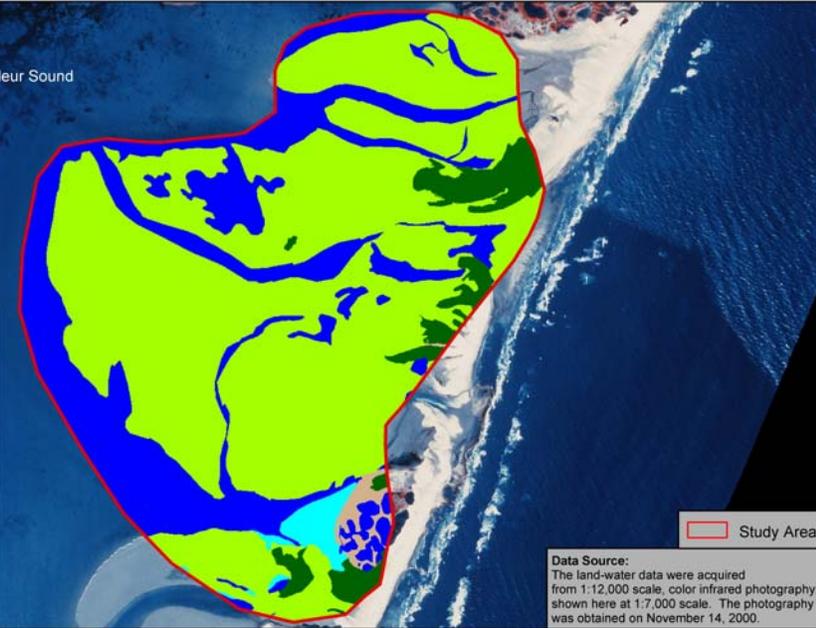
Class	Site Acres
Water	32.4
Irregularly Exposed	2.1
Regularly Flooded	83.4
Irregularly Flooded	6.7
Land	1.4
<b>Total</b>	<b>126.0</b>

**Project Information:**  
Marsh restoration strategies at the Chandeleur Islands Marsh Restoration (PO-27) project area included vegetative plantings of smooth cordgrass (*Spartina alterniflora*) at 10 overwash fan sites. The Spool study area is one of these sites. All areas characterized by emergent vegetation, wetland forest, or scrub-shrub were classified as land, while open water, unvegetated mudflats, and aquatic beds were classified as water. In addition, tidal water regime modifiers based on time and duration of flooding were included. Irregularly flooded areas were classified as tidal water that floods land surface less often than daily. Irregularly exposed areas were classified as land surface that is exposed by tides less often than daily. Regularly flooded areas were classified as tidal water that alternately floods and exposes the land surface at least once daily. Due to tidal fluxuation, water classes are based on water levels at the time of flight. The water regime classification is modified from "Classification of wetlands and deepwater habitats of the United States" (Cowardin and others, 1979).

**Data Source:**  
The land-water data were acquired from 1:12,000 scale, color infrared photography, shown here at 1:7,000 scale. The photography was obtained on November 14, 2000.

Like Redfish Point, the Spool site had been affected by overwash events even before the passage of Hurricane Ivan. Overwash impacts from Hurricane Ivan were evident at the Spool site, but were not as severe as those observed at the Redfish Point site. The week before the storm, only 9 of the 20 plots contained *S. alterniflora*. Fortunately, eight plots were still vegetated after the storm. The mean percent cover within vegetated plots decreased from 33.2% to 21.6% and the mean percent cover across all plots decreased from 14.9% to 8.7% after the storm. Some burial of the plants was observed immediately after the storm along with significant scour within the planting sites. Some plots which were formerly on unvegetated sand flats were now located in newly formed cuts. One cut formed almost directly in the center of the main planting lobe through the area where plots 40302 and 40306 are located. Very little of the beach remained at this site following Hurricane Ivan and new overwash lobes had formed on the backside of the island near the plantings. As seen at the other sites, the vegetation that remained was generally brown and less dense than during the September survey.

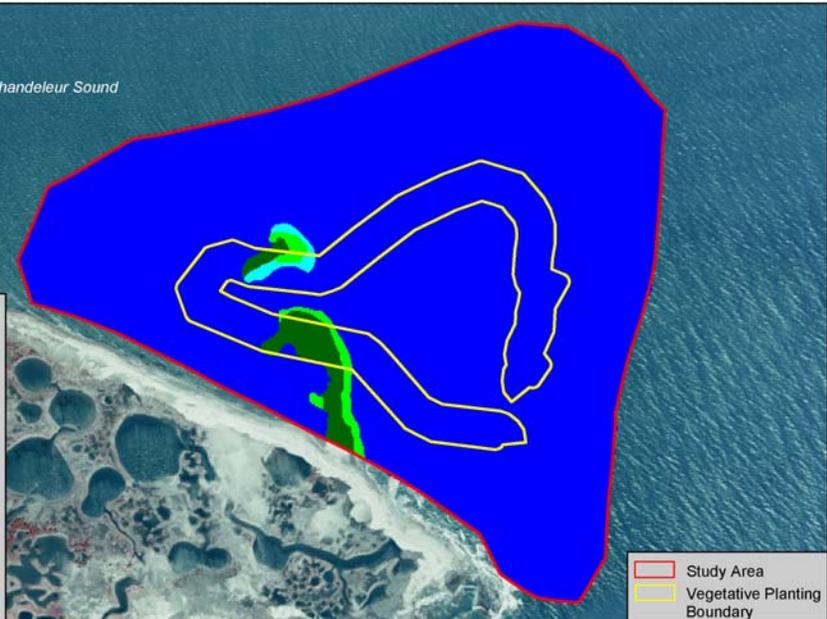
**Data Source:**  
The land-water data were derived from 1:12,000 scale, color infrared photography, shown here at 1:3,500 scale. The photography was obtained on November 2, 2005.

**Project Information:**  
Marsh restoration strategies at the Chandeleur Islands Marsh Restoration (PO-27) project area included vegetative plantings of smooth cordgrass (*Spartina alterniflora*) at 10 overwash fan sites. The Monkey Bayou North study area is one of these sites. All areas characterized by emergent vegetation, wetland forest, or scrub-shrub were classified as land, while open water, unvegetated mudflats, and aquatic beds were classified as water. In addition, tidal water regime modifiers based on time and duration of flooding were included. Irregularly flooded areas were classified as tidal water that floods land surface less often than daily. Irregularly exposed areas were classified as land surface that is exposed by tides less often than daily. Regularly flooded areas were classified as tidal water that alternately floods and exposes the land surface at least once daily. Due to tidal fluctuation, water classes are based on water levels at the time of flight. The water regime classification is modified from "Classification of wetlands and deepwater habitats of the United States" (Cowardin and others, 1979).

The North Monkey Bayou site was severely impacted by Hurricane Ivan. The week before the storm, 8 out of the 12 plots contained *S. alterniflora* compared to only 3 after the storm. The beach at this site had almost completely disappeared and much of the outer edges of the planting lobe had washed away. The original planted lobe has been cut into two pieces consisting of one larger lobe that was roughly at the center of the original lobe and a separate smaller lobe to the south. The loss of plants at this site was mostly due to direct damage from Hurricane Ivan through overwash scour. Despite the loss of vegetated plots at this site, the mean percent cover within the remaining vegetated plots was the highest out of all the sites. The mean percent cover within vegetated plots actually increased from 49.8% to 53.3% after the storm. Where the plants remained, they were still generally more dense and in better condition than at the other sites. The mean percent cover across all plots, however, decreased from 33.2% to 13.3% due to the loss of vegetated plots. Although the remaining plants continued to thrive at this site, much of the remaining area would have been too far below mean tide to revegetate.

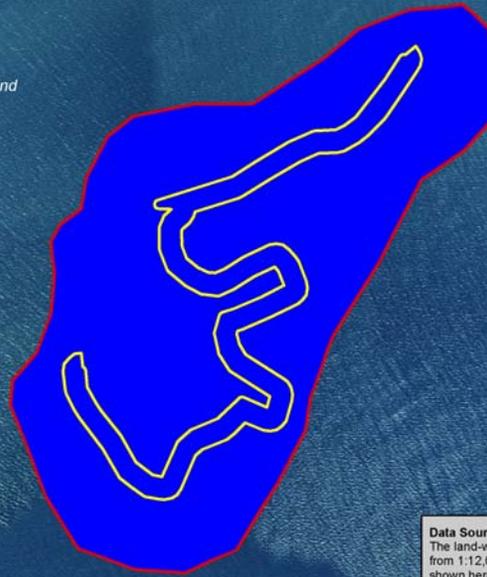
Class	Site Acres
Water	68.7
Irregularly Exposed	0.0
Regularly Flooded	0.0
Irregularly Flooded	0.0
Land	0.0
<b>Total</b>	<b>68.7</b>

**Data Source:**  
The land-water data were derived from 1:12,000 scale, color infrared photography, shown here at 1:6,000 scale. The photography was obtained on November 2, 2005.
