**WAVE HEIGHT MEASUREMENTS AT THE RACCOON ISLAND
BREAK WATERS DEMONSTRATION (TE-29) PROJECT:
REPORT ON JULY 1998 FIELD DEPLOYMENT**

Gregory W. Stone, Ph.D.
Associate Professor

Coastal Studies Institute
336 Howe-Russell Geoscience Complex
Louisiana State University
Baton Rouge, LA 70803

September 25, 1998

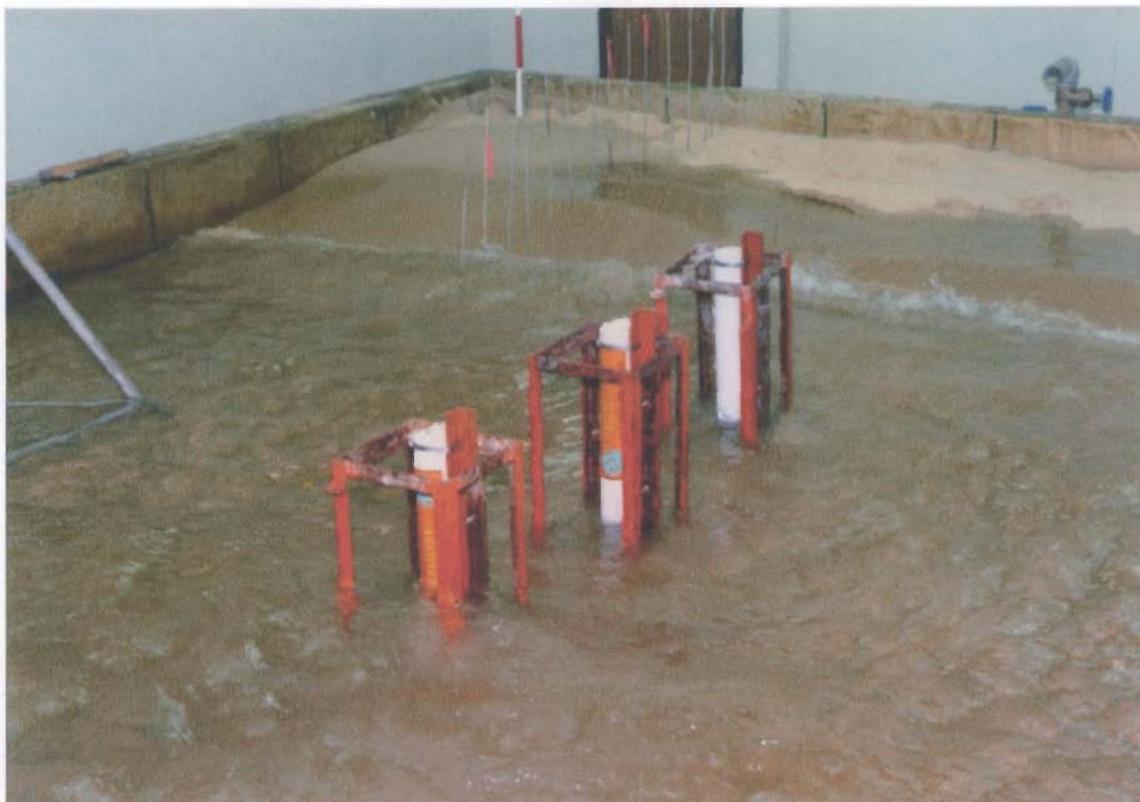
Plate 1. The pressure transducer array used in the Raccoon Island breakwater study. The pressure sensors and solid-state recorders are housed in a water-tight casing and are being tested in the Coastal Studies Institute's Wave Simulation Facility.

package, suitable for underwater deployment. An example of the laboratory test of the pressure sensor array is shown in Plate 1. The instrument packages are capable of sampling at a high frequency of 4 Hz.

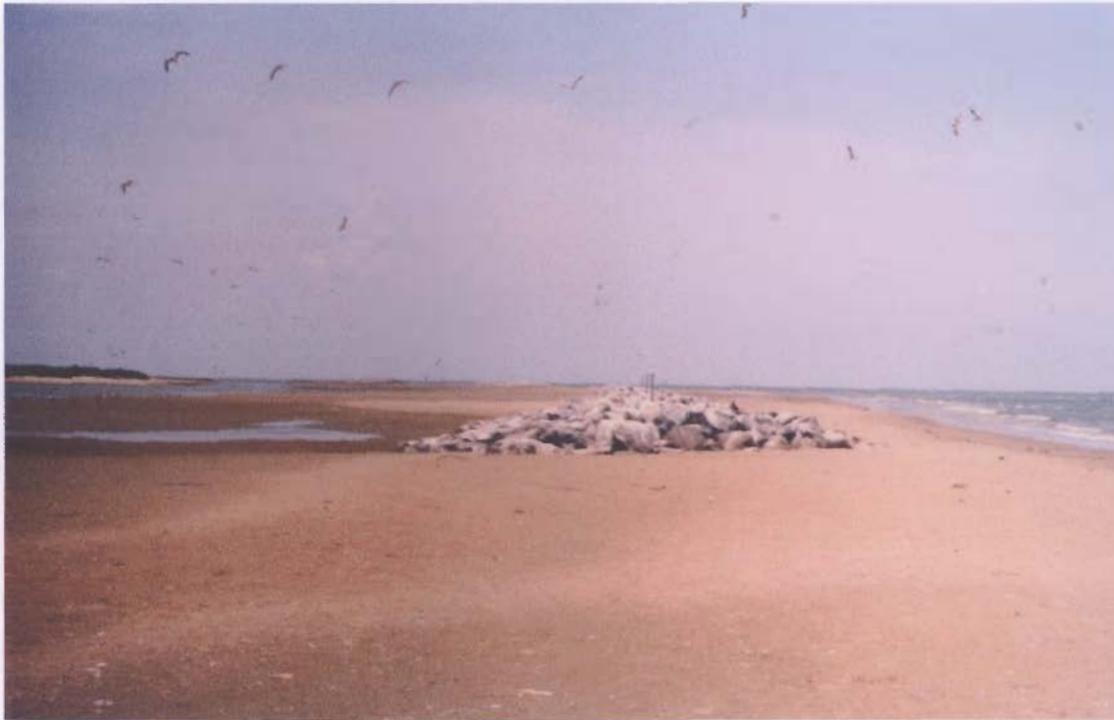
Plate 2. The breakwaters #6, #5, #4, and #3 were surrounded by an emerged sand body and the structures were not directly exposed to wave action. Photograph looking east, July 31, 1998.

Wave diffraction around the tips of the breakwaters and wave breaking were almost completely absent during the July 1998 measurements due to the emerged sand body in the vicinity of the breakwaters. This contrasted significantly with the field conditions encountered during the October 1997 and March 1998 measurements. Incident wave propagation from the Gulf was negligible along the Raccoon Island shoreline during the

July 1998 measurements. Little to no wave activity was observed landward of breakwaters #6, #5, #4, and #3.

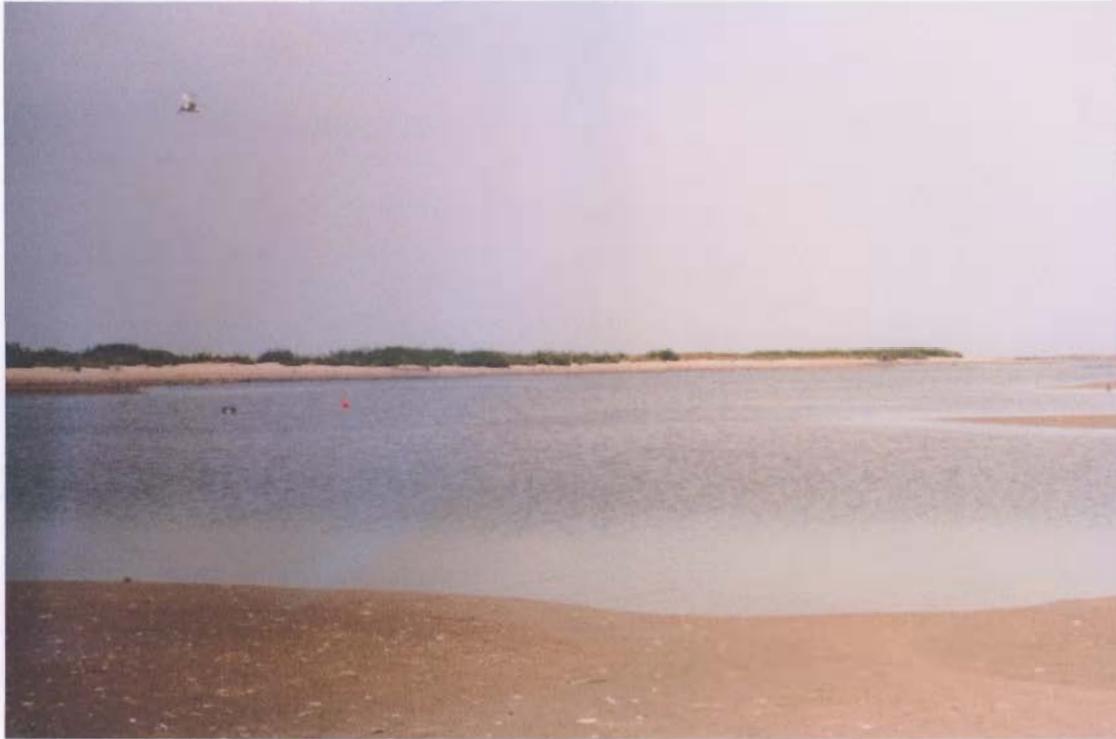
Plate 3. Photograph showing negligible wave action landward of breakwaters #6 and #5 and at the adjacent Raccoon Island shoreline. Note the shallow water and emergence of part of the wave gage. Photograph looking northeast, July 31, 1998.

Hydrodynamic conditions landward of the breakwaters and at the Raccoon Island shoreline have changed substantially due to the emergence of the sand body in the gaps between breakwaters. Waves during fairweather conditions were entirely dissipated by the emerged sand body adjacent to the breakwaters. Wave breaking was not observed at the shoreline landward of the breakwaters (Plate 3).

It is noteworthy that in contrast to conditions encountered during the October 1997 and March 1998 measurements, waves landward of the breakwaters during the July 1998 measurements were locally wind generated as opposed to having propagated across the shelf. Due to low wind speeds encountered during the July 1998 measurements, practically no waves were observed landward of the breakwaters (Plate 3), landward of the center and the gaps.

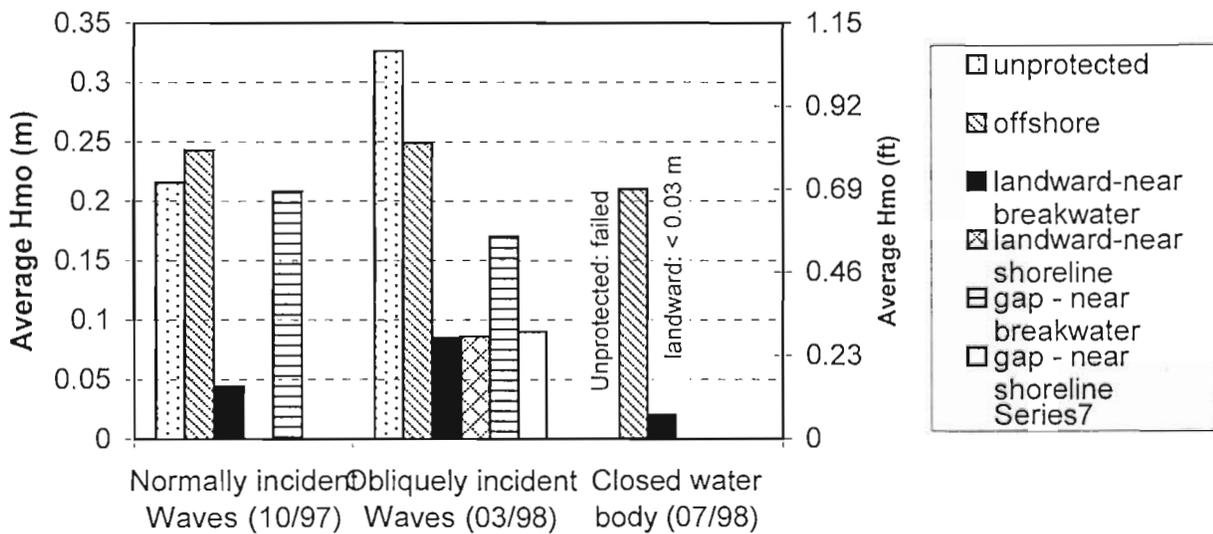
Figure 2. Comparison of significant wave heights at different locations for October 1997, March 1998, and July 1998 deployments.

Significant wave heights measured at the offshore site ranged from 0.19 m (0.62 ft) to 0.26 m (0.85 ft) with an average of 0.21 m (0.69 ft) (Figure 2). Wave conditions remained reasonably constant throughout the day (Figure 3). Similar wave heights were observed visually at the control site. Landward of the breakwaters, the average water

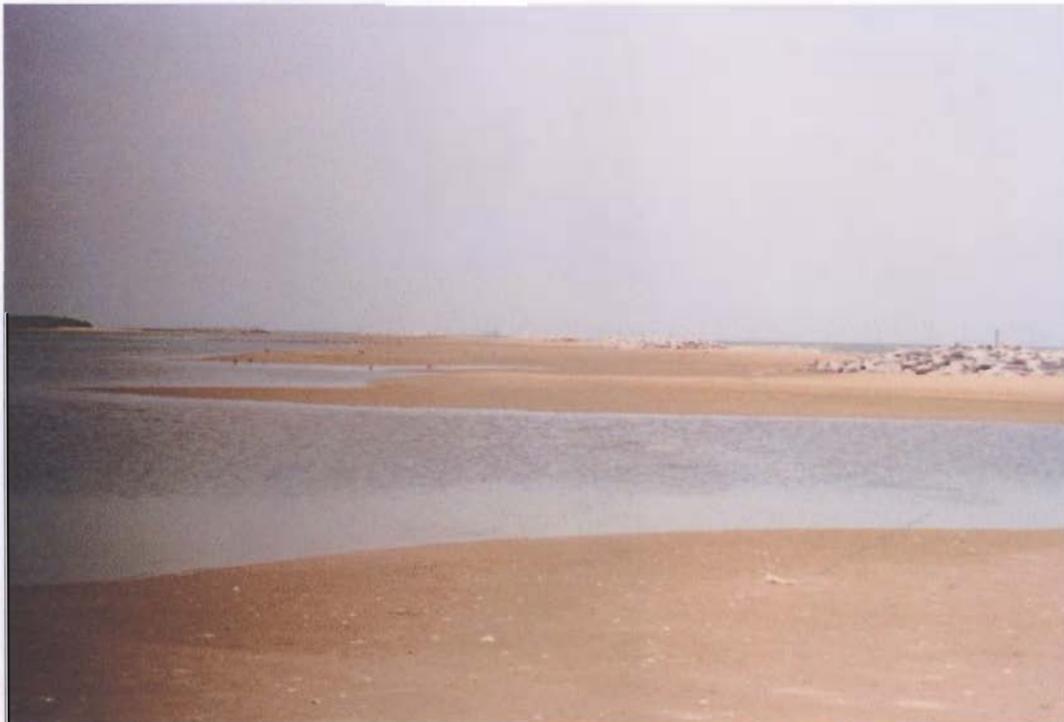
Plate 4. Photograph showing emerged sand body extending from breakwater #6 through #3 resulting in an enclosed shallow water body landward of the breakwaters. Photograph looking east, July 31, 1998.

Between March 1998 and July 1998, most sand accumulation occurred in the gaps between the breakwater segments, resulting in an expansive emerged sand body. A large amount of sand accumulation was measured in the vicinity of the shoreline landward of the center of breakwater #7, resulting in salient growth (Plate 6). Slight shoreline retreat and volume loss were measured immediately east of the salient, i.e., landward of breakwater #6. Approximately 29 and 26 m³/m sand accumulation were measured between the gaps of breakwaters #6 and #5 and breakwater #5 and #4, respectively. It is worthy of note that this amount of accumulation was measured between the center of the breakwater relative to the vegetation line. Since a significant amount of sand has accumulated seaward of the breakwaters, the actual amount of sand accumulation in the nearshore system is significantly greater (Plates 2 and 4).

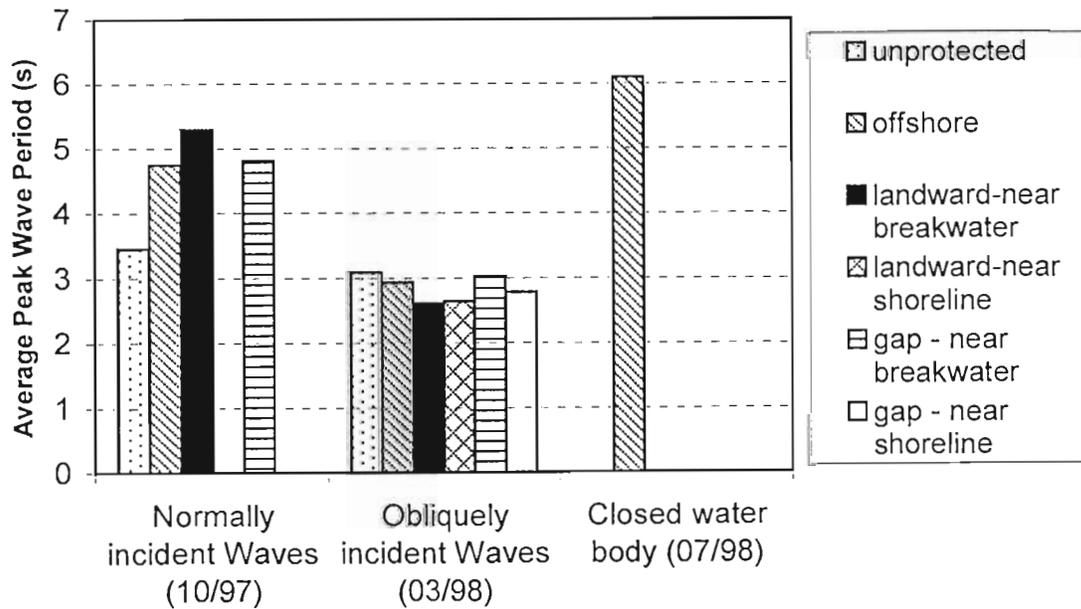
Figure 4. Comparison of peak wave periods at different locations.

Peak wave period, also referred to as dominant wave period or period of maximum wave energy, is defined as the wave period corresponding to the center frequency of the frequency band with the maximum non-directional spectral density. It is generally accepted that permeable rubble-mound breakwaters, such as those at the study site, function somewhat similar to a low-pass filter in that they reduce higher frequency waves more effectively than their lower frequency counterparts (SPM, 1984). This low-pass effect was apparent during the normally incident wave conditions encountered in October 1997 (Figure 4). The average peak wave period measured landward of the center of the breakwaters was considerably longer than those at other sites, especially that at the unprotected site. Differences in peak wave period were minimal during the oblique incident wave conditions (Figures 4 and 5) encountered during the March 1998 measurements.

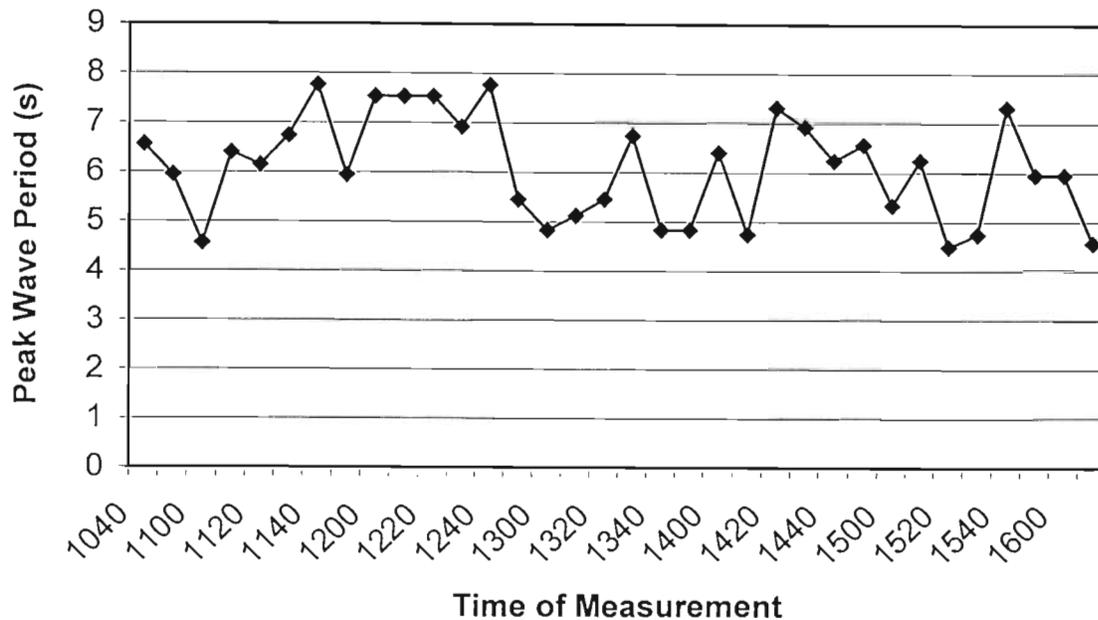
Figure 5. Measured peak wave period during July 1998. Note the relatively long period averaging 6 s indicating swell-dominated conditions.

During the July 1998 measurement, the offshore wave periods were much longer than those encountered during the previous two measurements, indicating swell-dominated conditions as opposed to wind-sea dominated conditions. Peak wave period cannot be determined reliably from the landward gage due to the shallow water and low signal strength as discussed earlier. Visual observations indicated that the ripples landward of the breakwaters were locally generated.

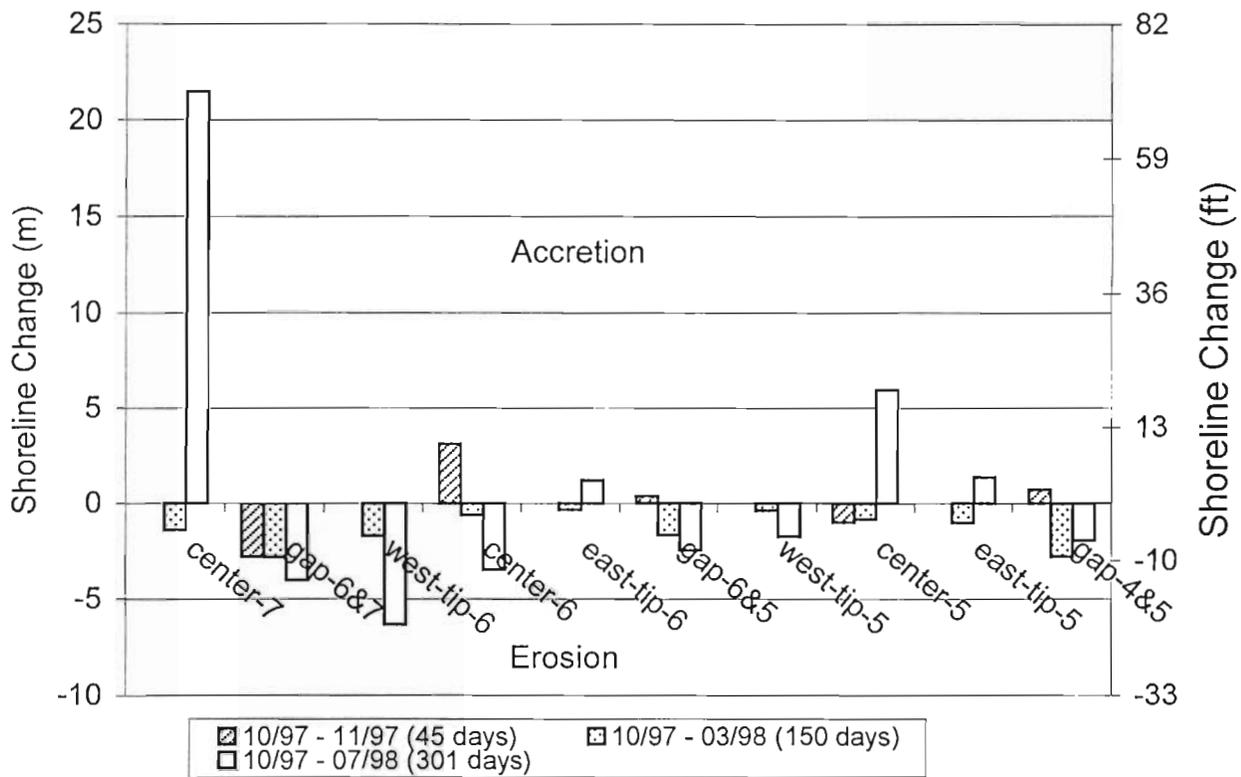
Figure 6. Shoreline change during October 1997 to November 1997, October 1997 to March 1998, and October 1997 to July 1998, respectively. Note the overall small magnitude of change, when compared to the amount of sand that had been accumulating across the entire profile (Figure 7). Transects across the tips of the breakwaters were not surveyed in November 1997.

A considerably different shoreline change pattern was measured from the July 1998 survey (Figure 6). The most dramatic change at the shoreline is the approximate 22 m

(72 ft) gain landward of the center of breakwater #7. Sand accumulation at breakwater #7 is apparently related to the impoundment of longshore sediment transport. In addition, the closure of the gaps between adjacent breakwaters may be increasing the trapping efficiency at the westernmost structure by further reducing the amount of wave energy arriving at the downdrift shoreline (during westerly wind and/or incident waves propagating from the west). The shoreline landward of the gap between breakwaters #7 and #6, and landward of breakwater #6 experienced 3 m (10 ft) to 6 m (20 ft) of shoreline retreat during the 301 days between October 1997 to July 1998. Except for a near 6 m (20 ft) shoreline gain measured landward of the center of breakwater #5, shoreline changes at all the other locations were small. Similar to the findings from the March 1998 survey, the overall changes in the vicinity of the shoreline were of much lower magnitude when compared to the changes across the entire profile and in the vicinity of the breakwaters.

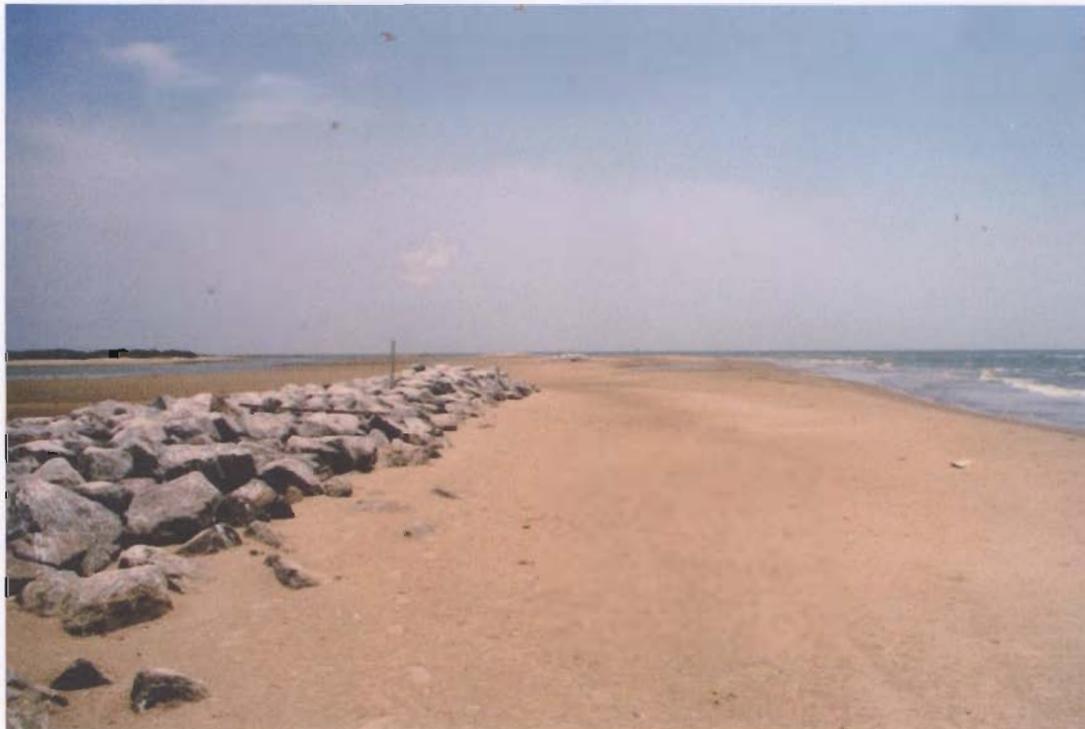
Plate 5. Sand accumulation seaward of the breakwaters, July 31, 1998. Photograph was taken looking east.

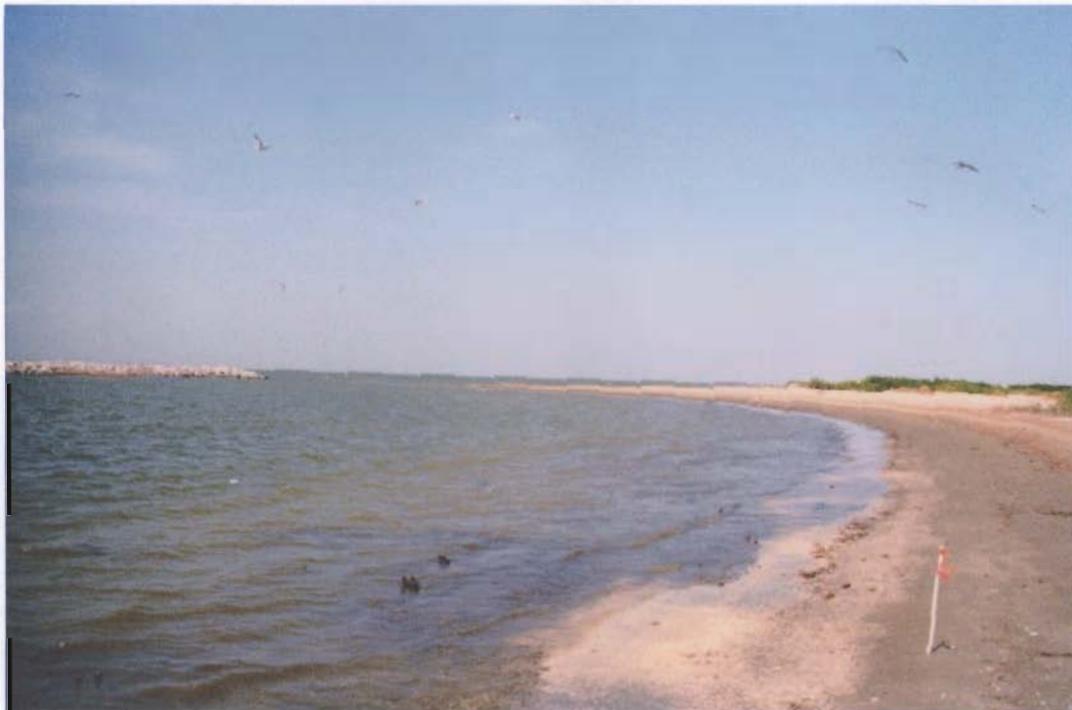
Plate 6. Development of a salient landward of the westernmost breakwater (#7), July 31, 1998.

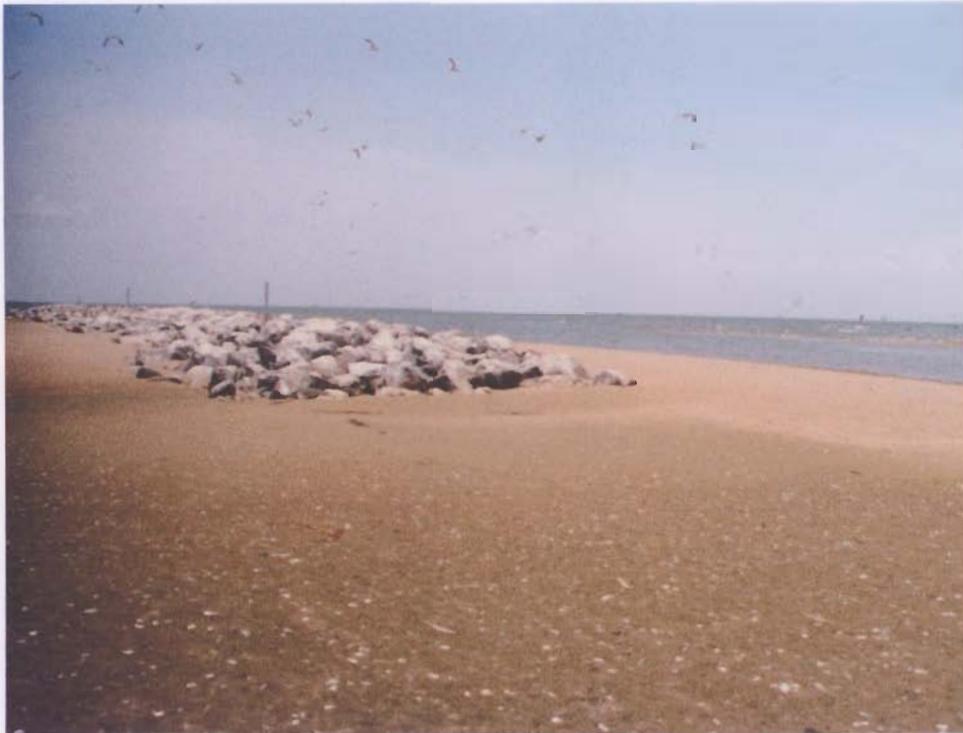
Plate 7. Shoaling of an offshore sand body south of the recently deposited beach seaward of breakwater #3, July 31, 1998. Photograph taken looking to the east.

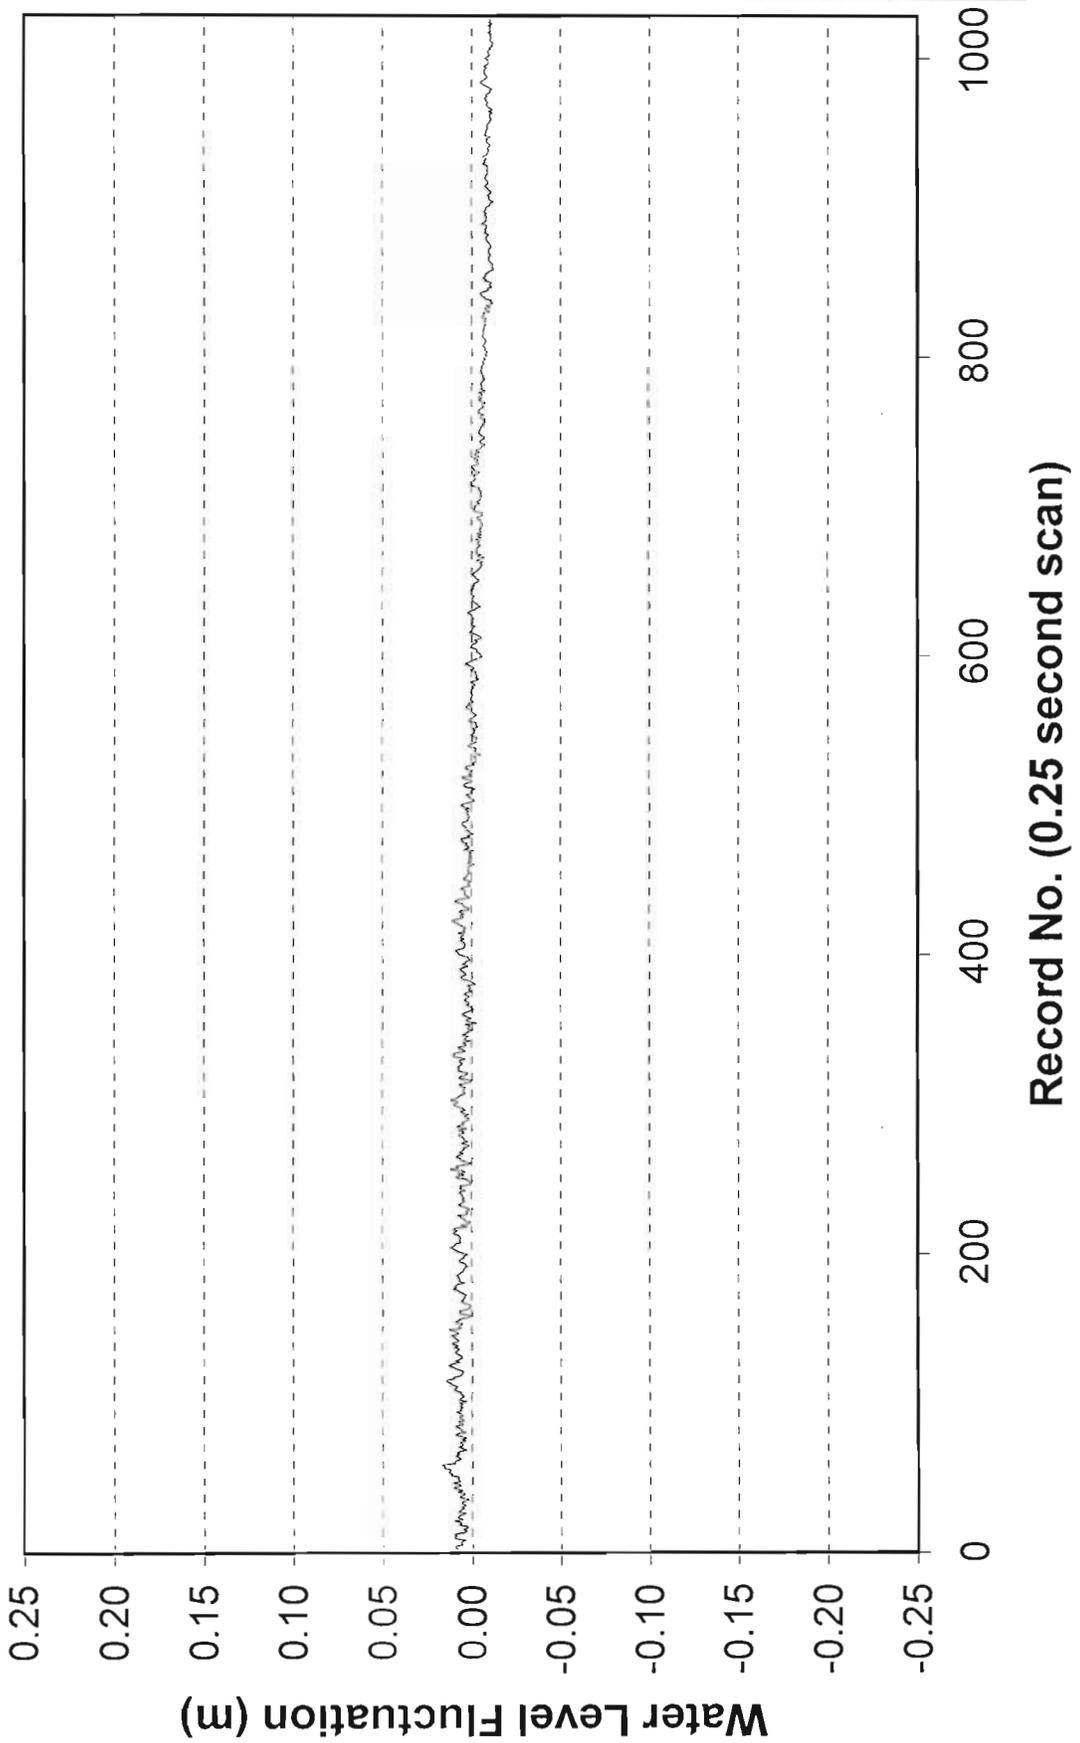
Water Level Fluctuations-Landward of Center (Site B): 12:00

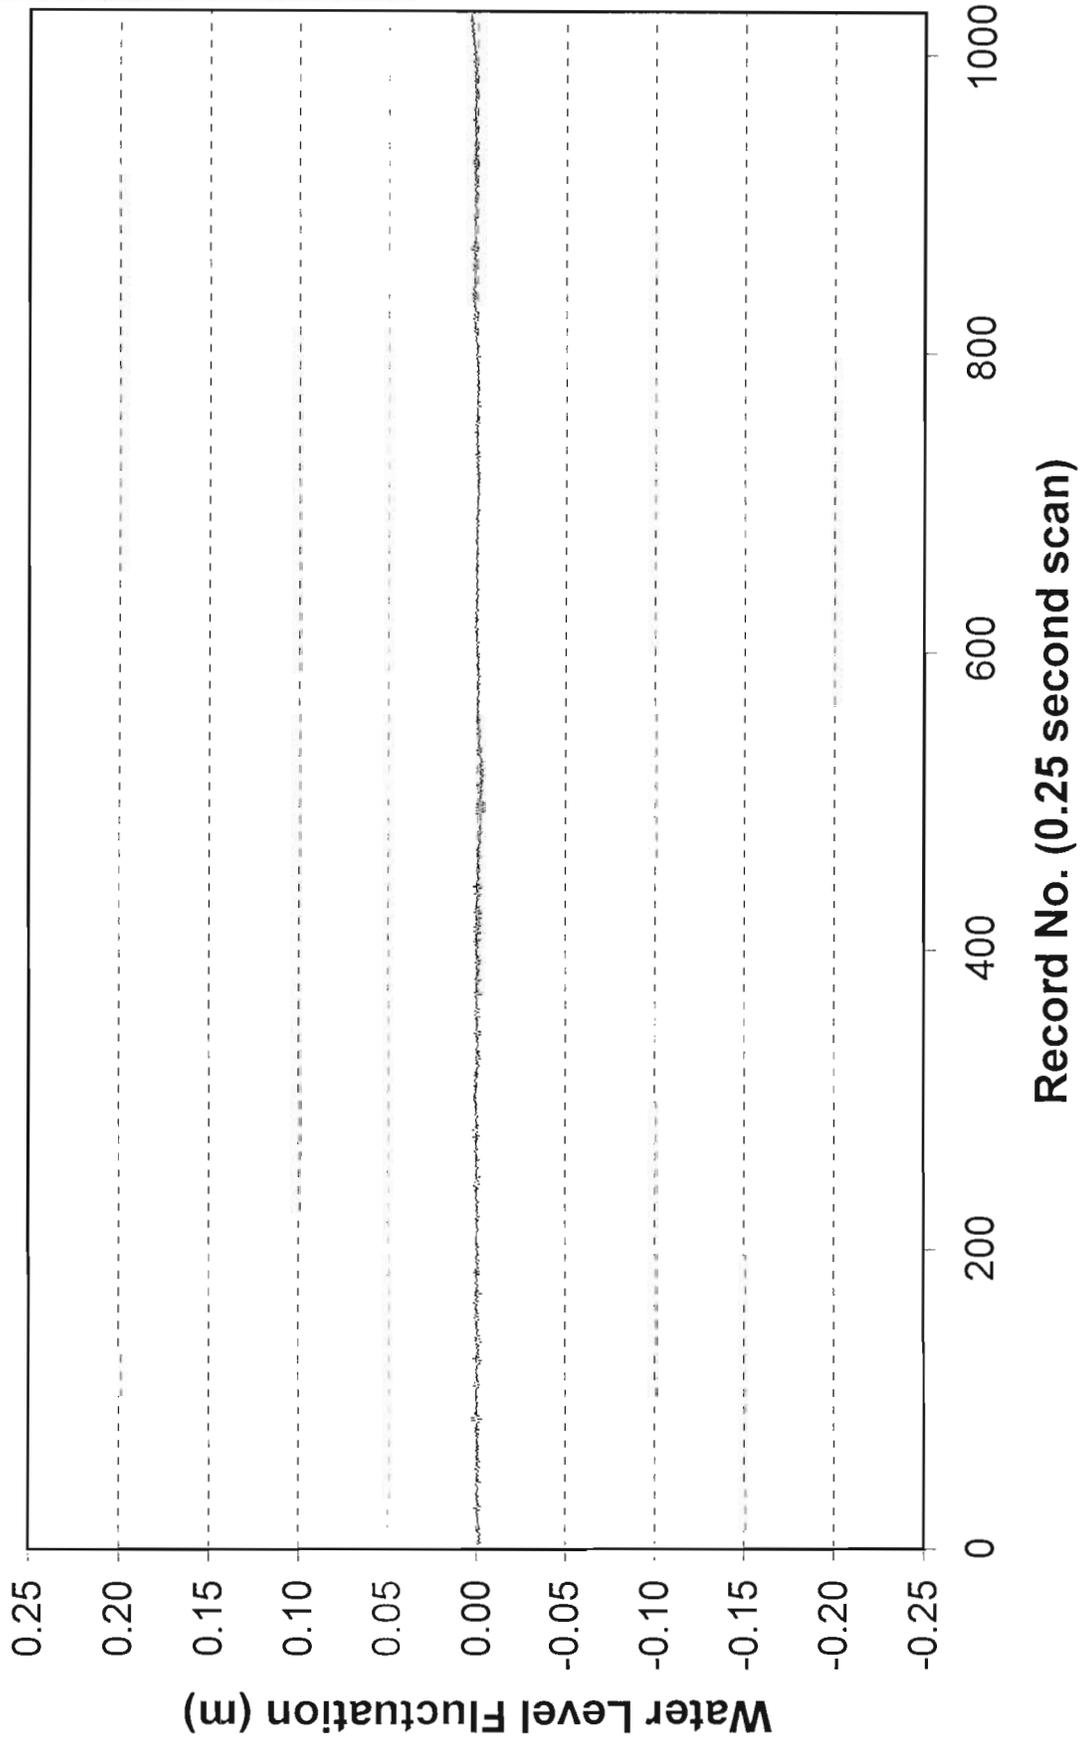
Water Level Fluctuations-Landward of Gap (Site E): 12:00

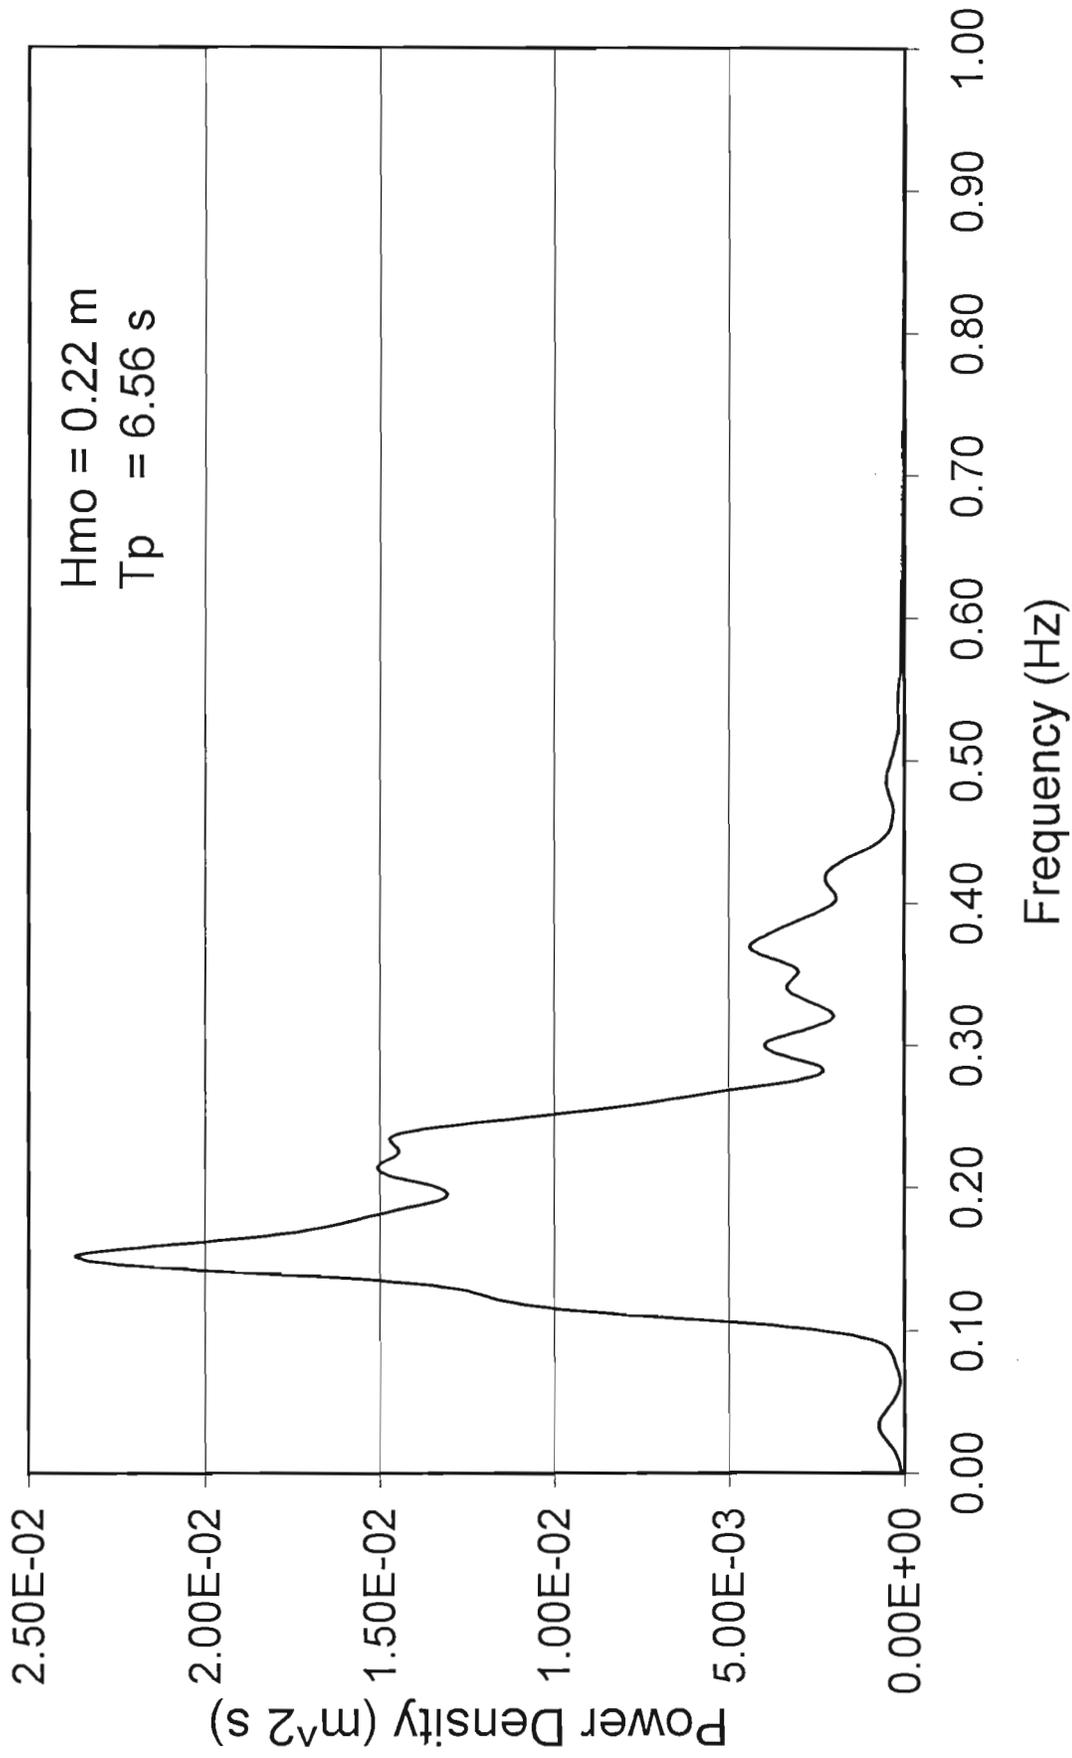
$H_{mo} = 0.222 \text{ m}$

$T_p = 6.56 \text{ s}$

Wave spectra measured during July 1998 deployment. Spectral distributions obtained from the inside measurements were not reliable due to the very shallow water and low signal strength and low signal-to-noise ratio

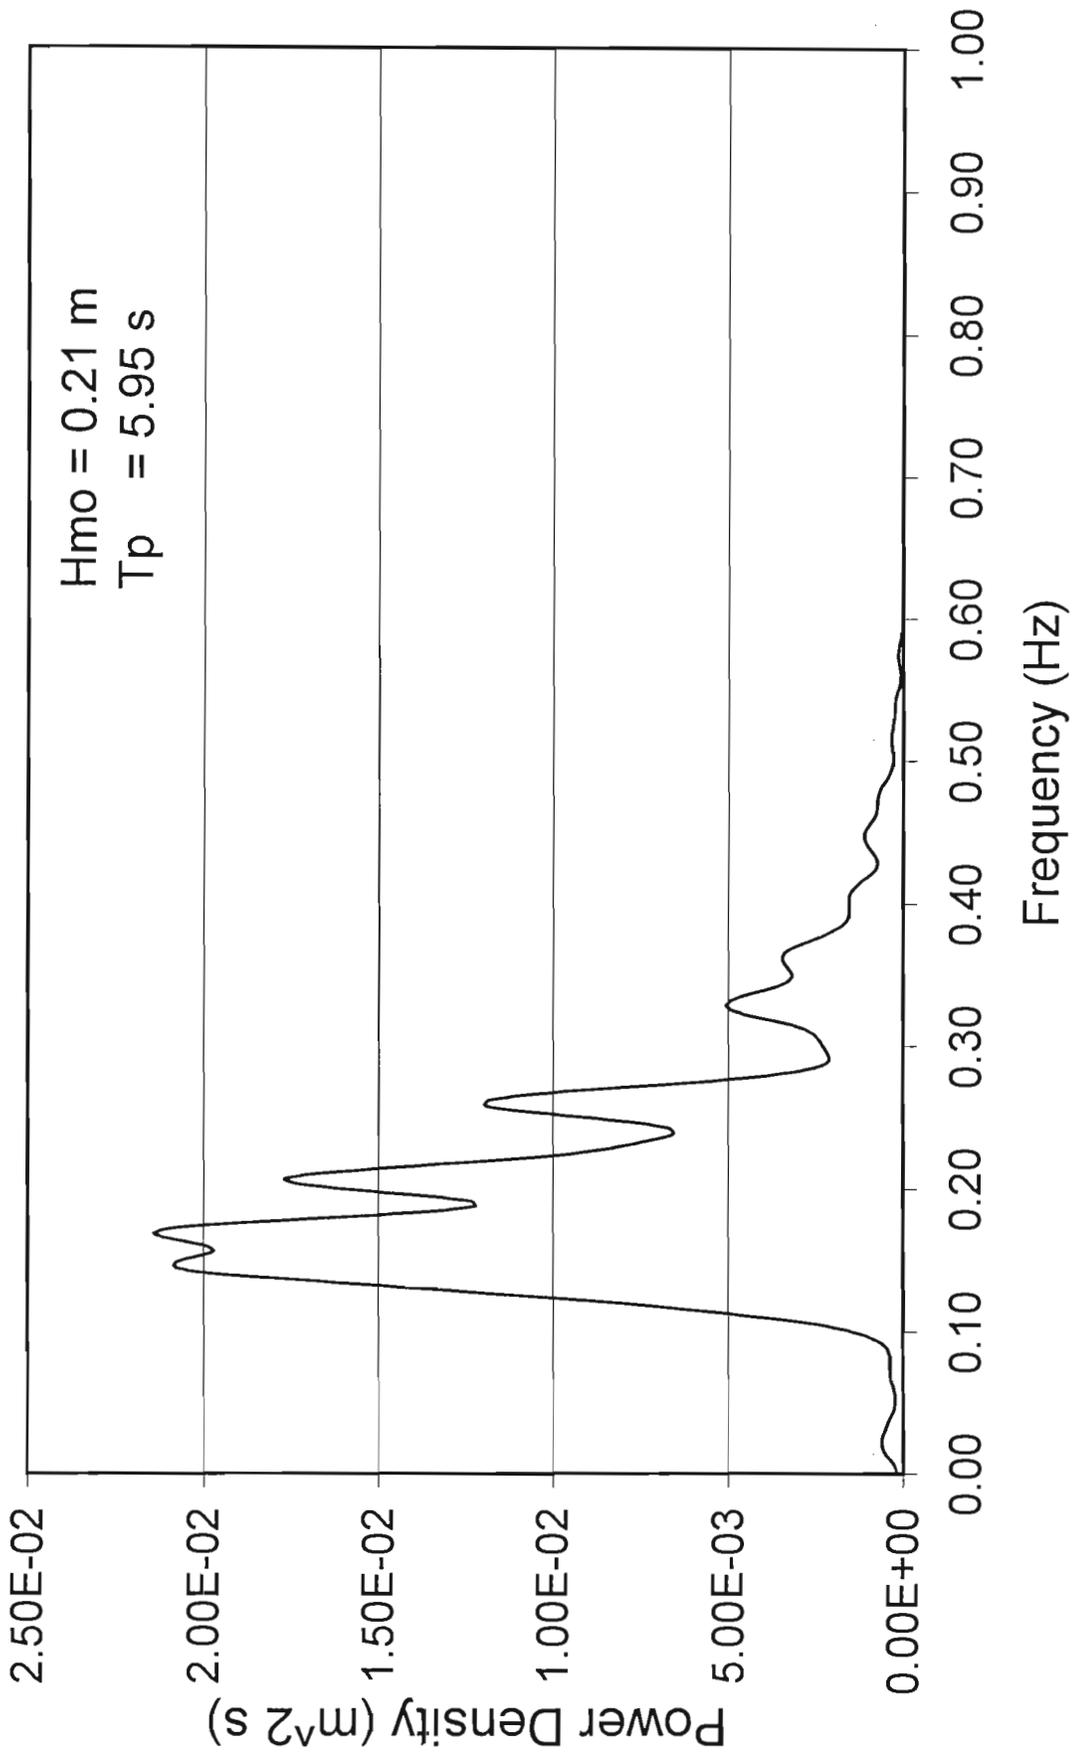
Power Spectra - 07/31/98 - 10:50 -- Offshore

Hmo = 0.21 m
Tp = 5.95 s

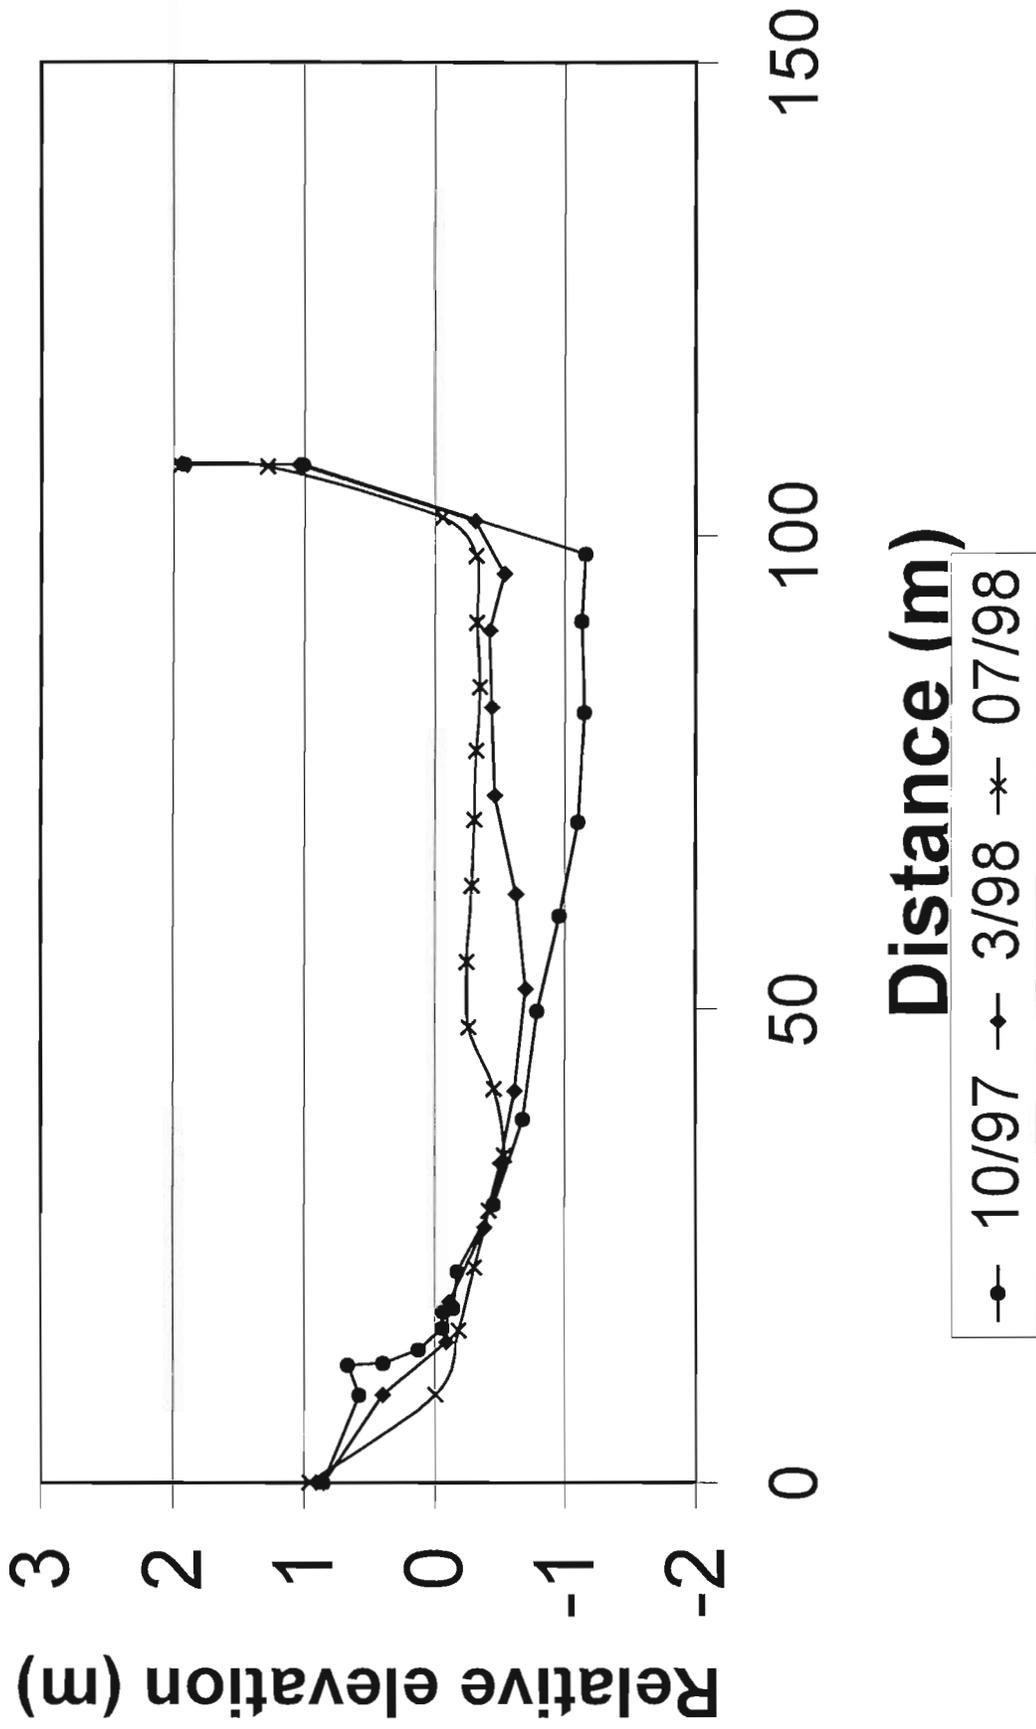
Behind West End of Breakwater - 6

Time-series of beach profiles (profile locations are shown in Figure 1): Upper figures are in metric units; lower figures are in English units.

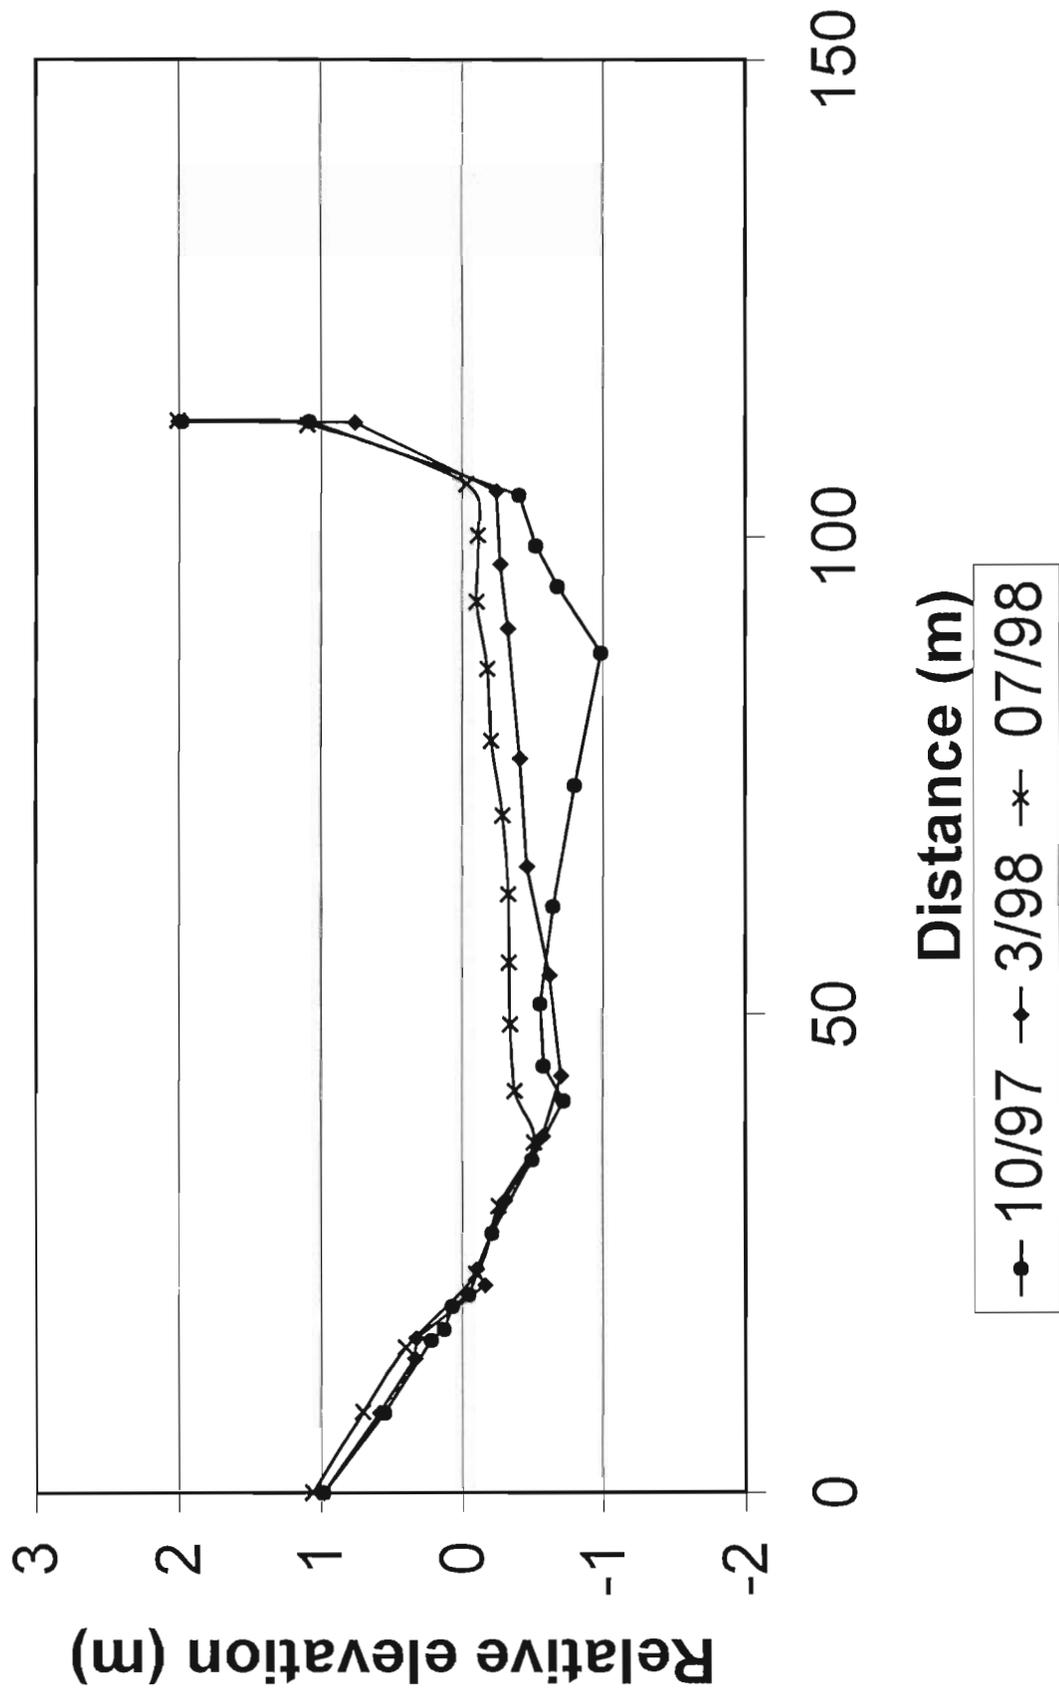
Behind the east end of Breakwater - 6
