**WAVE HEIGHT MEASUREMENTS AT THE RACCOON ISLAND
BREAK WATERS DEMONSTRATION (TE-29) PROJECT:
REPORT ON JULY 1998 FIELD DEPLOYMENT**

Gregory W. Stone, Ph.D.
Associate Professor

Coastal Studies Institute
336 Howe-Russell Geoscience Complex
Louisiana State University
Baton Rouge, LA 70803

September 25, 1998

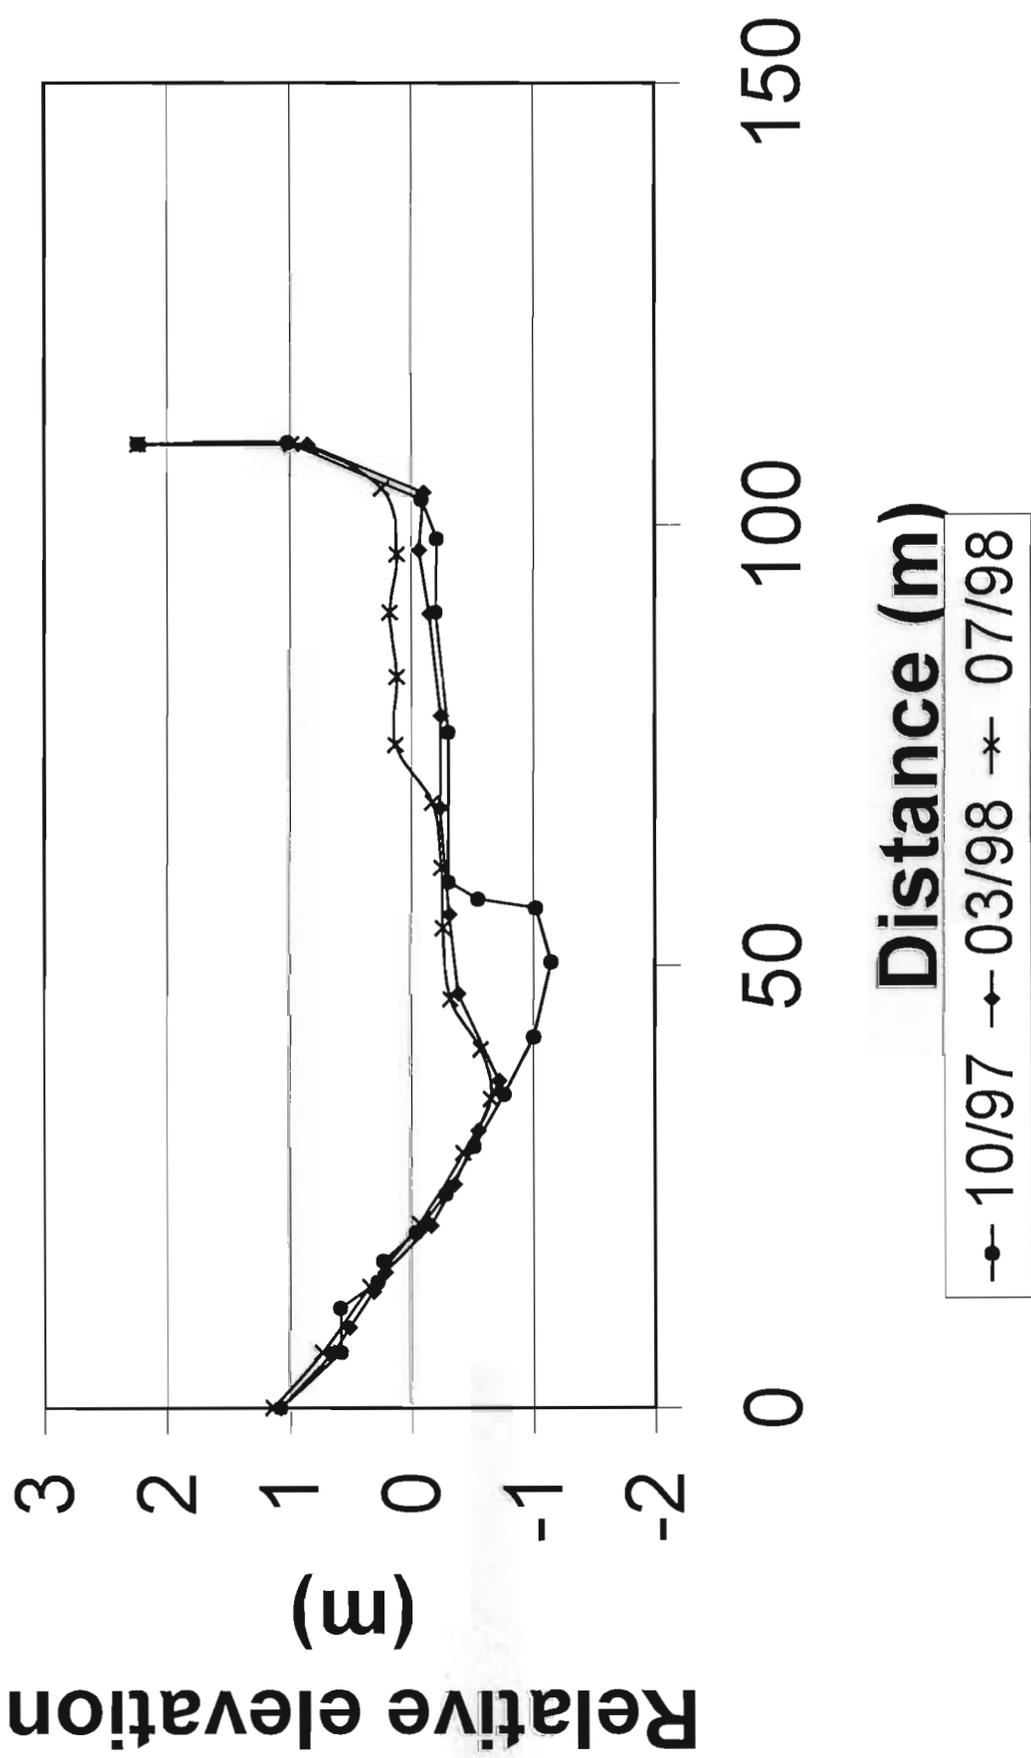
Behind the east end of Breakwater - 5

Time-series of beach profiles (profile locations are shown in Figure 1): Upper figures are in metric units; lower figures are in English units.

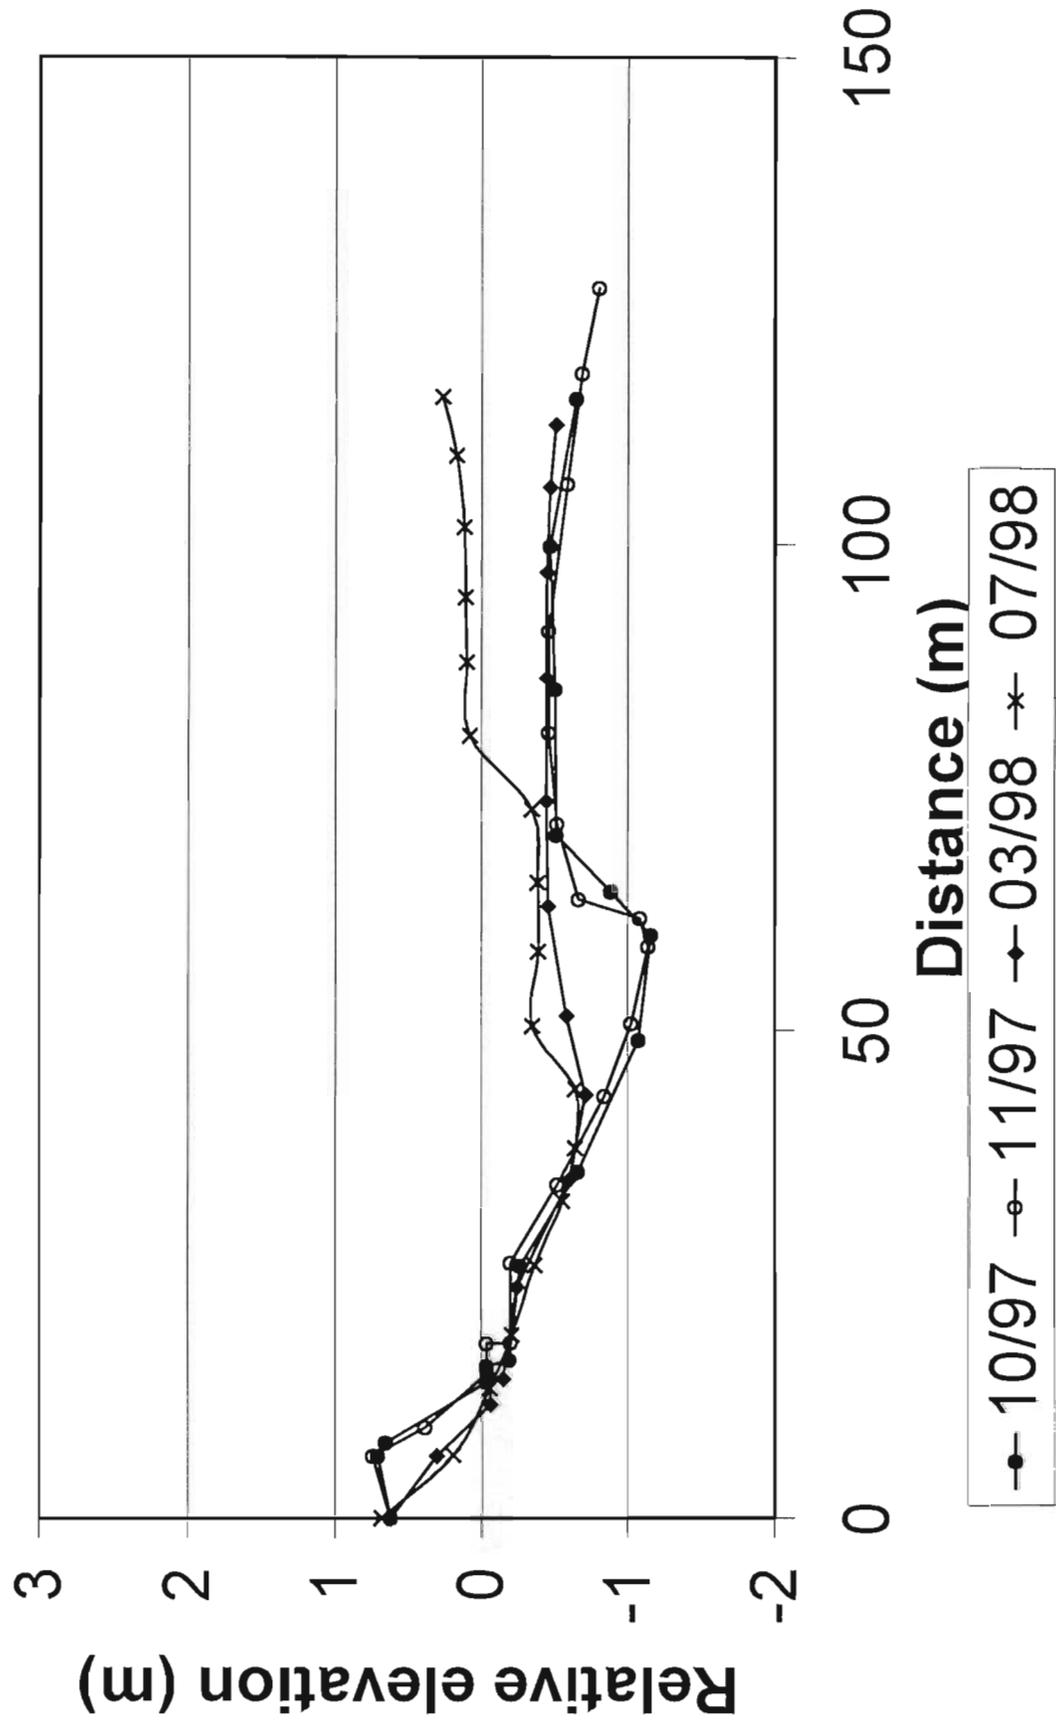
Between Breakwaters - 5 & 4

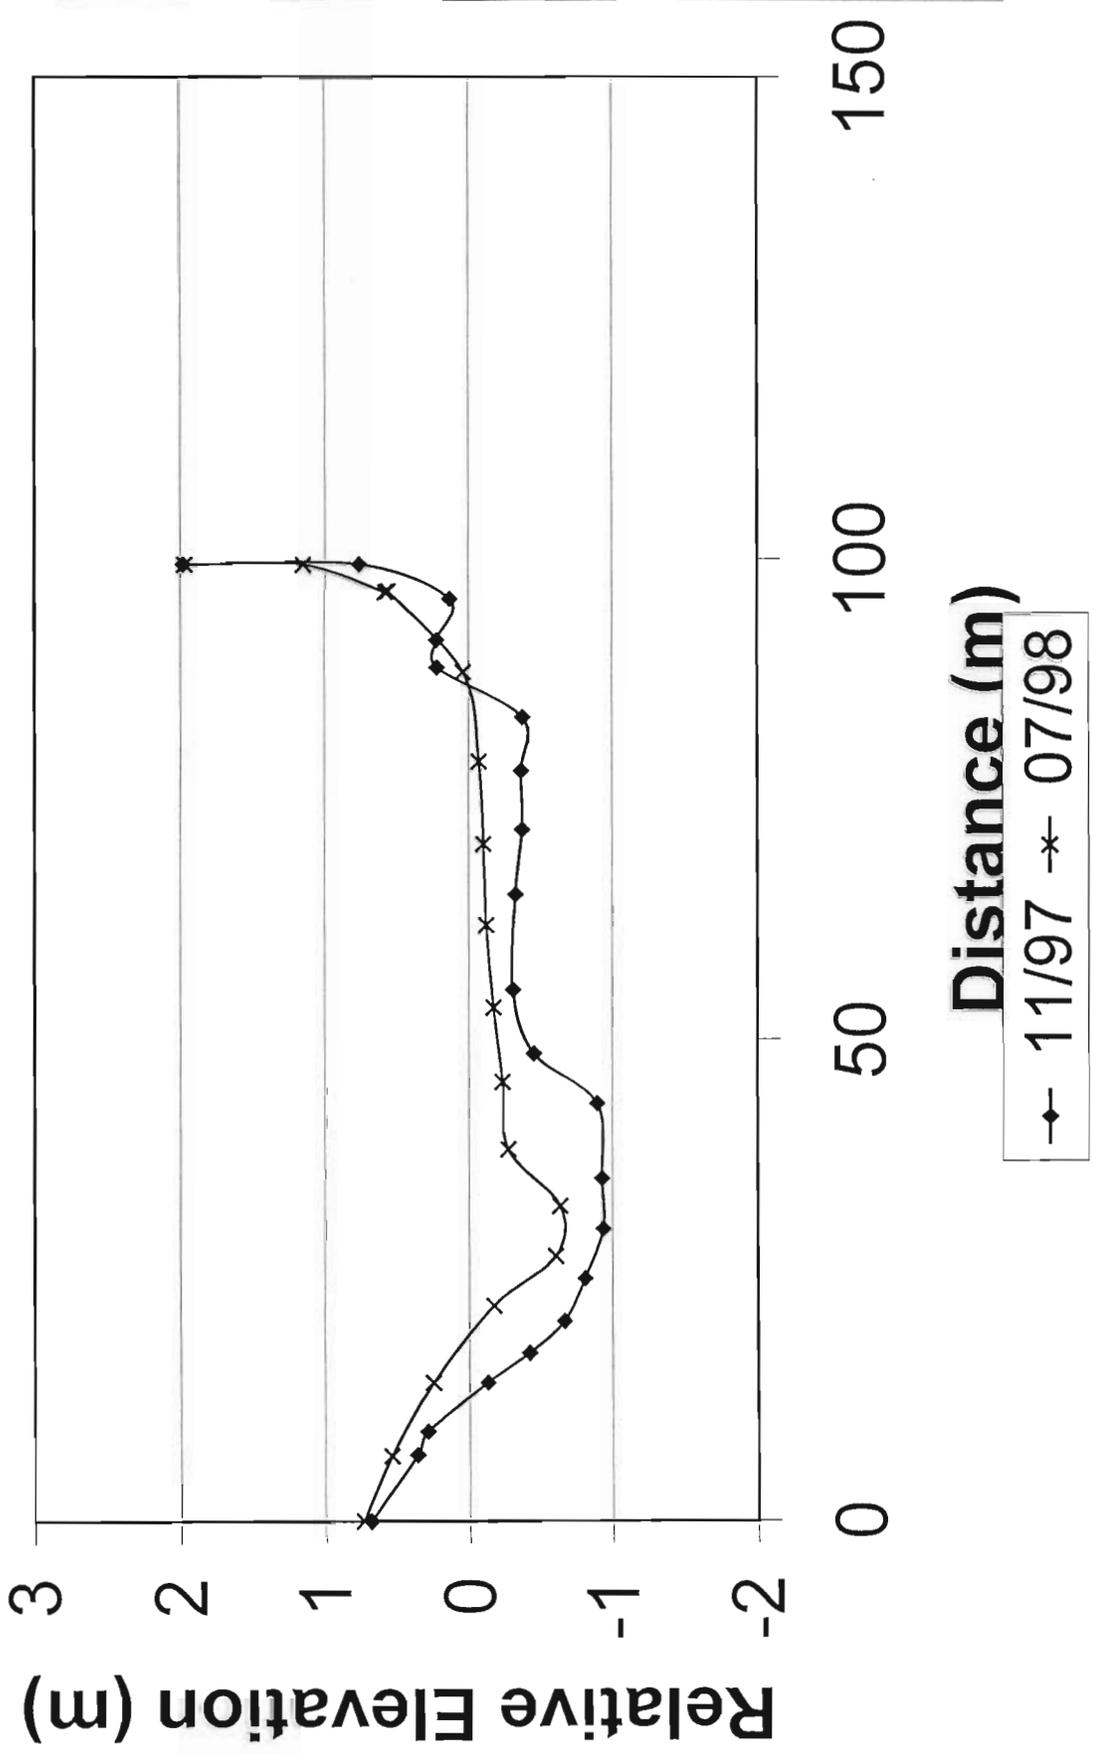
Behind Breakwater 4
