Monitoring Series No. ME-09- MSTY-0202-2

COMPREHENSIVE REPORT NO. 2  
For the period July 28, 1997 to August 2, 2001

**CAMERON PRAIRIE REFUGE PROTECTION  
ME-09 (ME-09)**

**First Priority List Shoreline Protection Project  
of the Coastal Wetlands Planning, Protection, and Restoration Act  
(Public Law 101-646)**

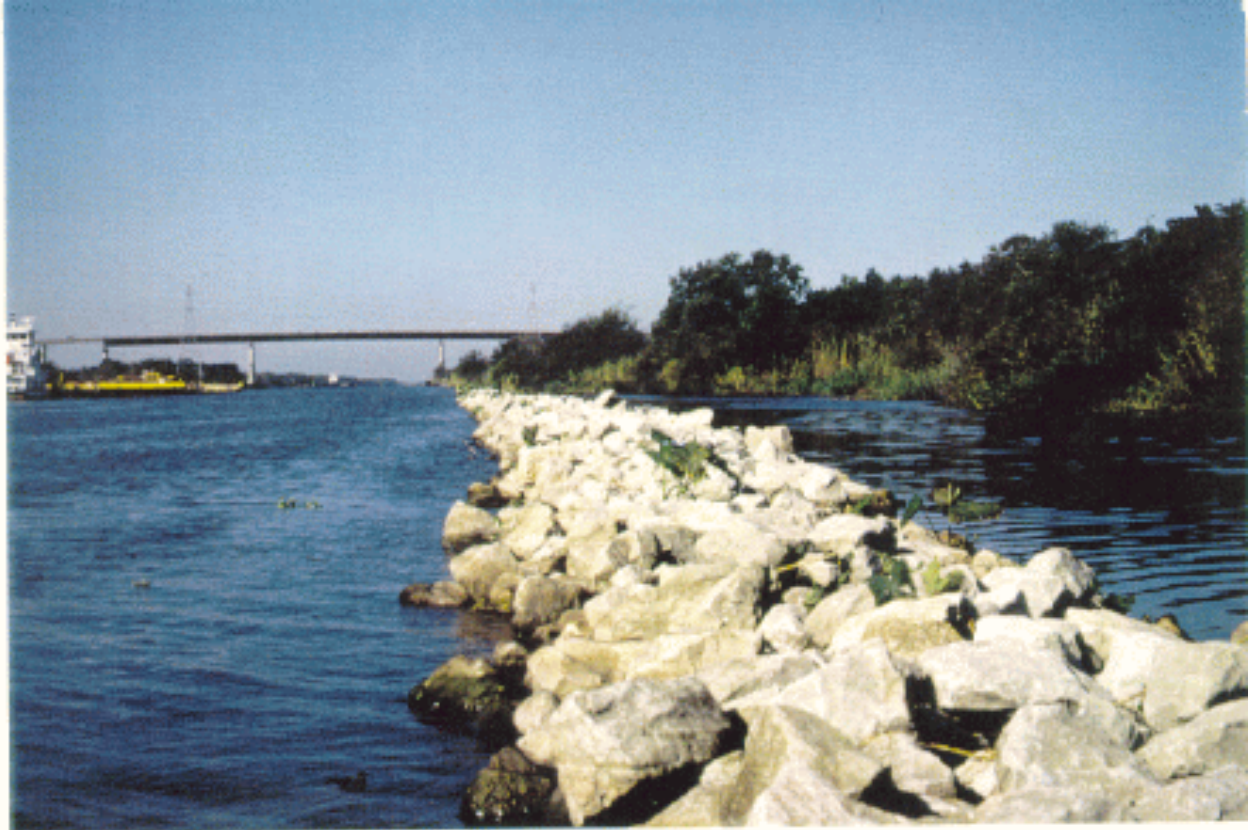
Rock breakwaters have been designed to prevent shoreline erosion and allow sediment accretion behind the structure through wave overtopping. A similar shoreline protection project along the GIWW at Clear Marais (CS-22) has resulted in observed sediment buildup between the rock dike and original shoreline (Miller 2001). The Cameron Prairie Refuge Protection project (ME-09) is designed to prevent further erosion of the existing spoil bank, and protect the existing freshwater wetlands from saltwater intrusion. Construction of approximately 13,200 ft (4,023 m) of free-standing, continuous rock breakwater was completed in August 1994 (figure 2) (Courville 1997). The breakwater was constructed using limestone rubble in the 125-275 lb. range placed above a layer of geotextile fabric (to prevent settling). No settlement plates were installed for this project.

**Figure 2.** Photograph of the Cameron Prairie Refuge Protection (ME-09) project following construction in August 1994, illustrating the shoreline of the GIWW and the installed rock breakwater.

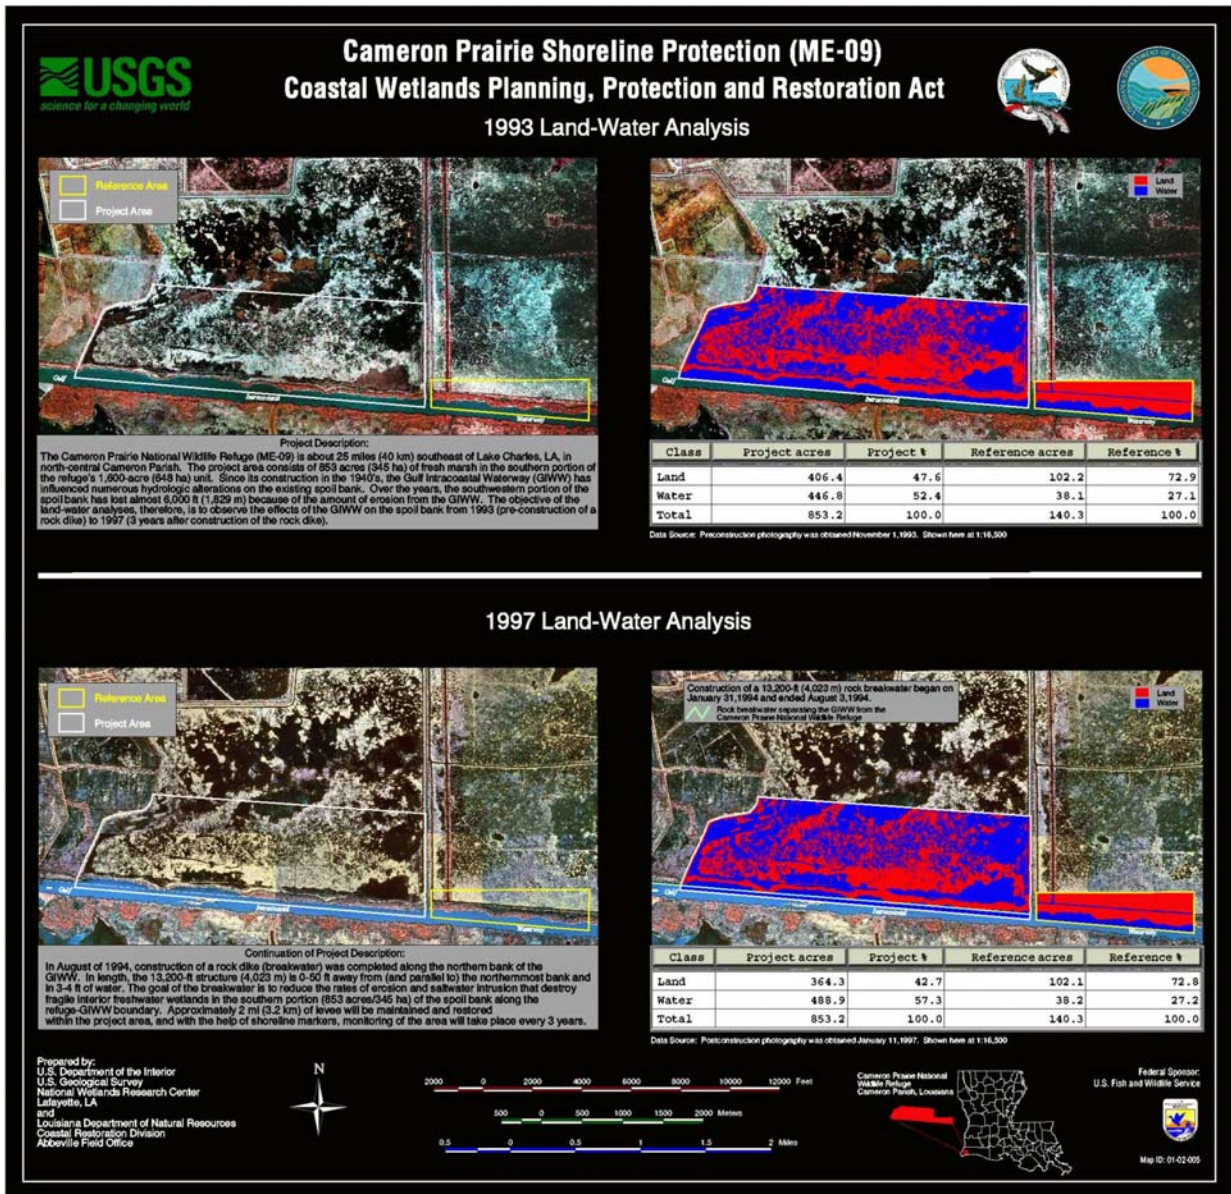
The findings of the unsupervised GIS classification for the project and reference area land and water analysis are illustrated in figure 3 for the preconstruction and post-construction project and reference area land to water analyses. Overall, the 853 acre (345 ha) project area showed a 4.93% increase in water. By comparison, the 140 acre (57 ha) reference area experienced a 0.09% increase in water. This rate of loss in the project area equates to approximately 13.3 acres/yr (5.4 ha/yr) and only slight loss of land (0.1 acre [0.04 ha]) in the reference area during the 38 month study period. Although there was an apparent net loss of land within the project area, the GIS analysis revealed noticeable new vegetation present in the central portion of the project area, between the rock breakwater and the shoreline (figure 3).

**Figure 3.** Cameron Prairie Refuge Protection (ME-09) GIS analysis of project and reference area preconstruction (1993) and post-construction (1997) aerial photography.

Analysis of Aerial Photography- Color-infrared aerial photography (1:12,000 scale) for the project and reference areas was obtained prior to construction on November 1, 1993 and post-construction on January 11, 1997 (Figure 3). A subsequent post-construction acquisition is also scheduled for 2009. Upon completion of the flights, the photography was checked for flight accuracy, color correctness, and clarity. The duplicate photography was prepared for scanning and analysis; the original film was archived. The photography was scanned and converted into a digital Tagged Image File Format (TIFF) file for mosaicking and georeferencing and will be used to document changes in marsh gain and loss rates over time in the project and reference areas.

GIS land and water analysis comparing preconstruction and post-construction photography revealed only small changes in the reference area; the project area showed a marked increase in the ratio of water to land. However, three principal difficulties were associated with the interpretation of this photography. First, during the acquisition of the post-construction photography, the project area contained standing water, which and submersed some of the emergent vegetation within the project area. These conditions may have contributed to the apparent increase in water in the analyzed portion of the project area. Second, the preconstruction photography showed large sections of floating vegetation throughout the project area and in canals within the reference area. Due to difficulties in distinguishing floating from rooted vegetation, some degree of classification error is expected. Finally, the post-construction flight was delayed until January 1997 because of unsatisfactory weather conditions. This possibly resulted in apparent vegetation differences in based on seasonality and senescence of some vegetation and may not be a true indication of land changes within the project area. Differences measured in the photography may be a reflection of time of year rather than project effects. Quality control by the USGS-NWRC photointerpreters helped to minimize these factors, however, interpretation of these results must be cautious due to these possible sources of error.

The analysis of the preconstruction and post-construction aerial photography, which exhibited an apparent loss of land between 1993 and 1997 in the project area, may not be the function of actual land loss within the project area. Such an apparent change could result from water level and/or seasonal differences in vegetative cover and not be the result of subsidence or erosional processes. The lack of any significant land loss in the reference area could reflect the stability of the interior marsh of this area, which is also still protected from the waters of the GIWW by a spoil bank created during the channel's construction. However, the continued erosion of the shoreline along the GIWW in this area at the current rate (4.1 ft/yr; 1.2 m/yr) could cause drastic land loss in the near future, once the remaining section of spoil bank has been compromised or breached. Tremendous increases in erosion rates for the shoreline itself would also be expected due to the more fragile nature of the interior marsh. Survey marker hubs for the reference area have already been relocated twice due the rapid erosion of the shoreline and another relocation will most likely be required following the next scheduled shoreline change survey. Thus, the project has demonstrated significant effects in preventing shoreline erosion along this section of the GIWW and has been extremely effective in damping the wave energy responsible for the previously measured rates of erosion present in the project area. Boat wakes from vessels traveling along the GIWW are assumed to be the main source of energy eroding the spoil bank.

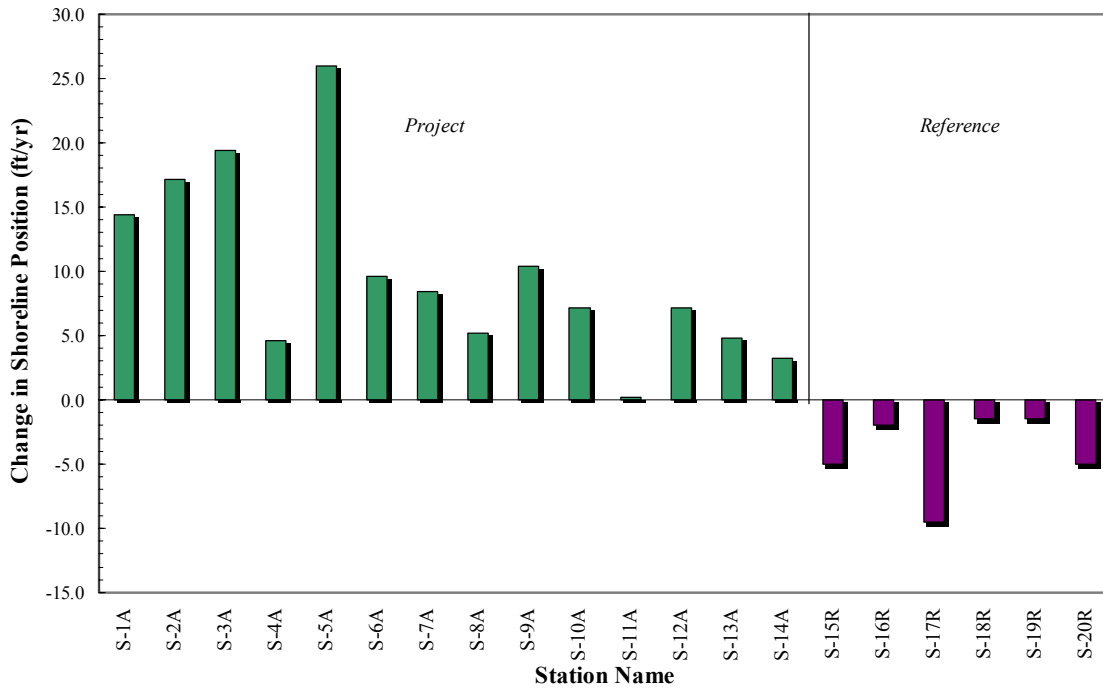
**Figure 5a.** Cameron Prairie Refuge Protection (ME-09) shoreline position change. Rates are calculated (in ft/yr) for the period 1995-2000.

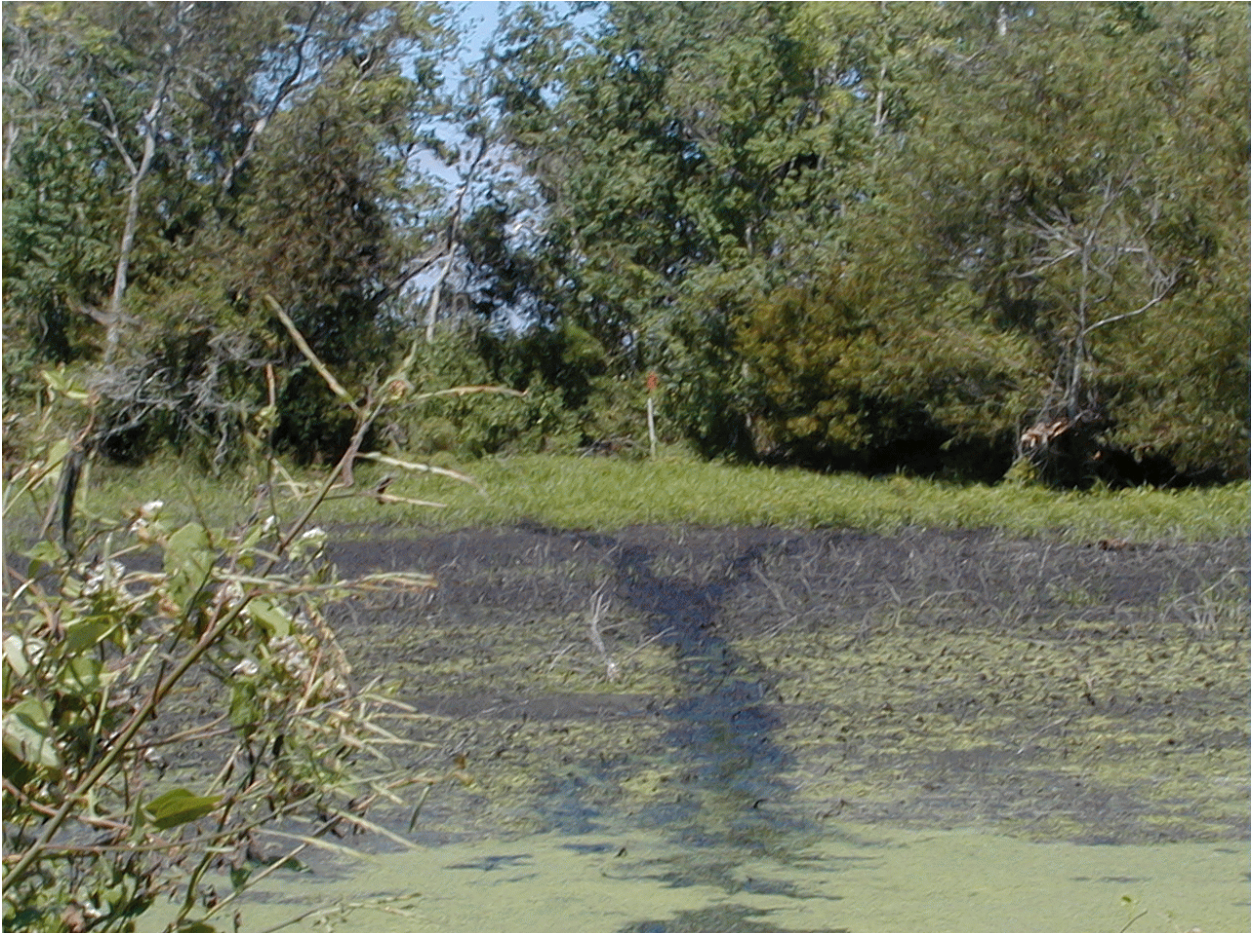
Considerable shoreline advance at most of the project stations behind the rock dike was also observed (figure 6). It is important to note that the shoreline advanced observed, as well as any future advance, will be restricted to the area behind the rock breakwater. In some areas vegetation is bordering the rock dike. However, in the areas where the rock dike is approximately 200 ft (60.96 m) away from the shoreline, progradation of the shoreline will require more time because the amount of sediment needed to fill this area is great. During the summer months, *Eichhornia crassipes* (Mart.) Solms (water hyacinth) (United States Department of Agriculture-Natural Resources Conservation Service 2001) fill these large open water areas which further reduces the amount of wave action reaching the shoreline (Courville 1997). The project area shoreline appears to be stable and the rock dike seems to be in good condition at this time, according to observations made by CRD personnel in 1997 and 2000. No breaches of the levee were found.

**Figure 6.** Photograph of the Cameron Prairie Refuge Protection (ME-09) project 6 years following construction in September 2000, showing shoreline advance between the rock breakwater and original shoreline at project station 11.

The goals and objectives of the monitoring plan appear to have been met thus far. The project has been effective in preventing erosion of the CPNWR southern boundary along the GIWW. Shoreline progradation averaging 9.8 ft/yr (3.0m/yr) was measured within the project area, whereas shoreline retreat averaging 4.1 ft/yr (1.2 m/yr) was observed along the unprotected reference area shoreline. Scheduled shoreline change surveys (for years 2003, 2006, 2009, and 2012), and subsequent monitoring reports will provide further monitoring documentation for this shoreline protection project (Miller 1994). Future inspections of the project area by CRD engineers will be conducted at regular intervals to document the condition of the rock breakwater and any required maintenance.
