FRESHWATER BAYOU WETLANDS (ME-04)

I. INTRODUCTION

I.1. Project Description

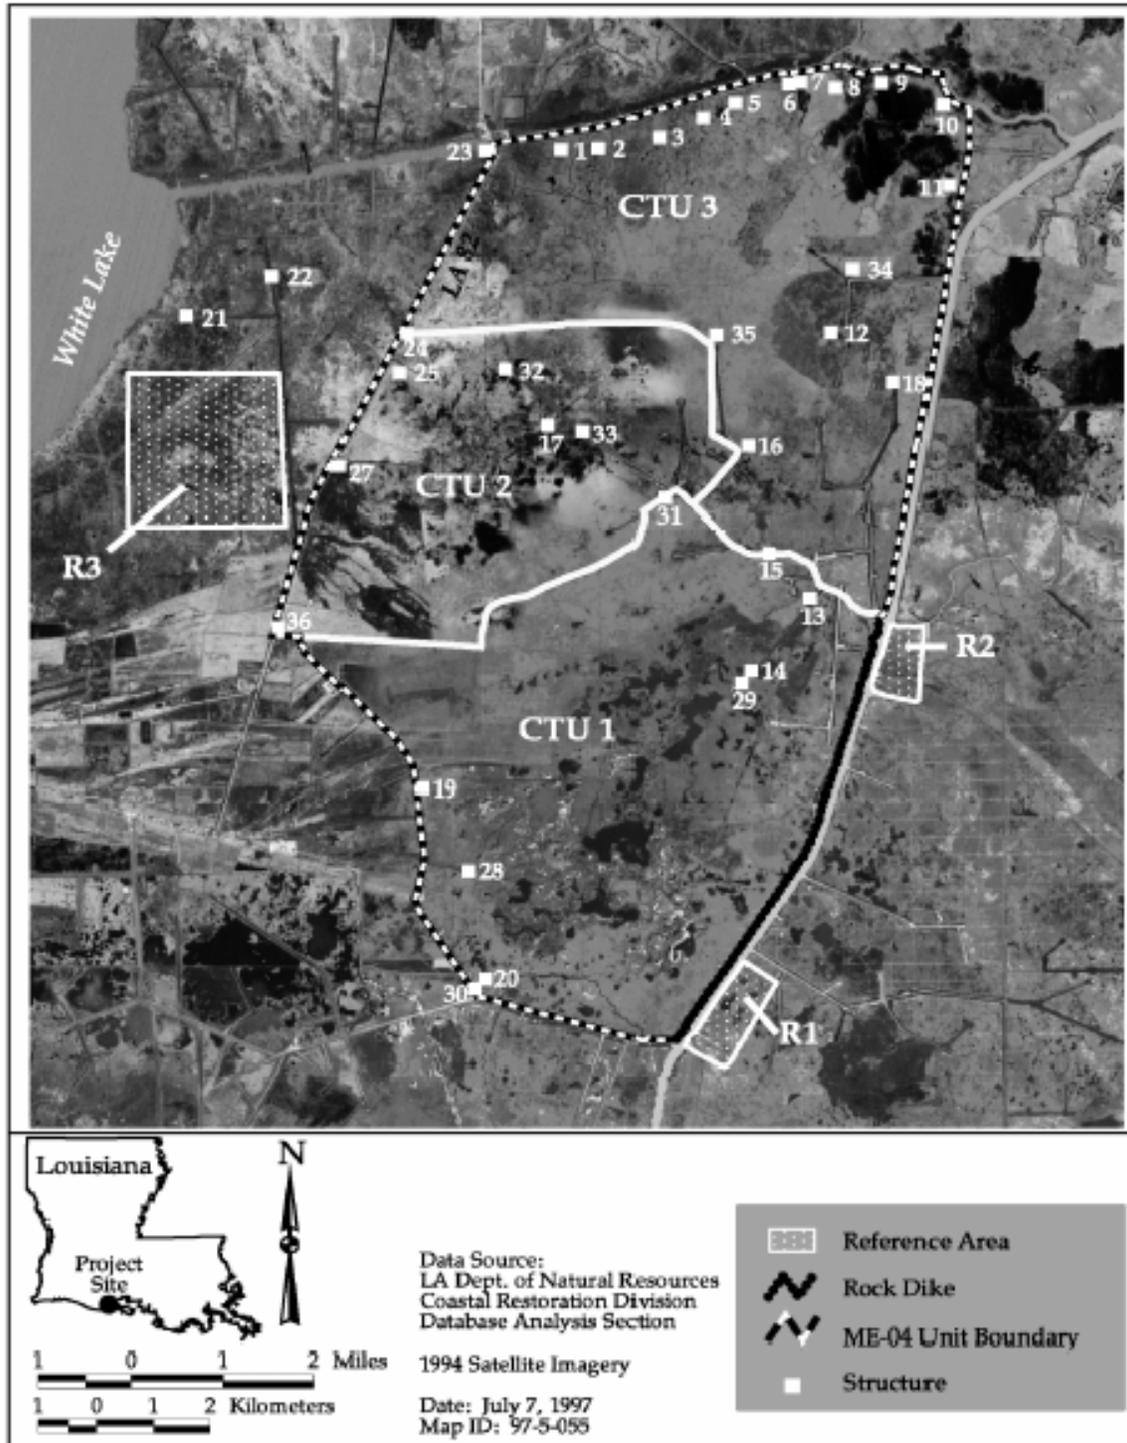
Figure 1. Project location and features.

Freshwater Bayou Wetlands is a second year CWPPRA project (figure 1). It was implemented in two phases because of the availability of rock from an emergency authorization to dismantle Wax Lake Outlet weir. Phase 1 involved the construction of a rock dike for shoreline protection; phase 2 involves the structures on the hydrologic restoration aspect of the project. Pursuant to a Task Force decision on April 14, 1998 the original monitoring plan was reduced in scope due to budgetary constraints.

The Monitoring Progress Report No. 5 for the period of January 31, 1995 to October 01, 1999 shows a boundary on the 33,292 acre area as bounded on the north by Schooner Bayou, on the west by Louisiana Highway 82, on the south by Humble Canal and on the east by Freshwater Bayou Canal. The removal of pump-off area - Sections 34, and 35 and part of Sec. 1 along the southwestern area - is indicated on the map.

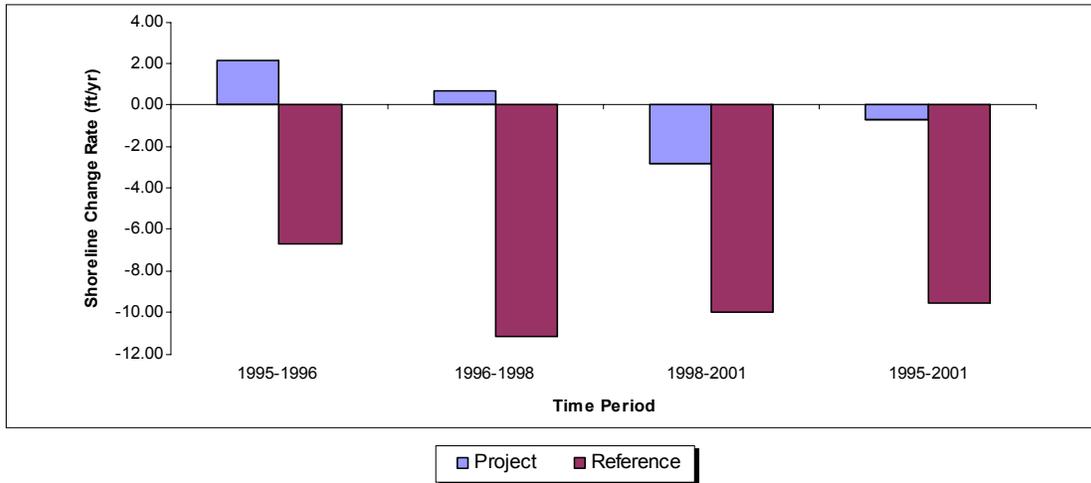
Figure 2. Shoreline erosion rates along Freshwater Bayou Canal in project and reference areas.

The project area shoreline prograded an average of 2.17 ft/yr (0.66 m/yr) between June 1995 and July 1996, and an average of 0.89 ft/yr (0.27 m/yr) between August 1996 and February 1998, but eroded an average of -2.62 ft/yr (-0.80 m/yr) between March 1998 and May 2001 (figure 2). Overall, the average shoreline change rate on the west canal bank behind the rock dike was -0.83 ft/yr (-0.25 m/yr) between June 1995 and May 2001 (figure 2).

Conversely, erosion was documented at all six reference area monitoring stations on each survey conducted, averaging -6.69 ft/yr (-2.04 m/yr) between April 1995 and July 1996, -11.15 ft/yr (-3.40 m/yr) between August 1996 and February 1998, and -9.99 ft/yr (-3.05 m/yr) between March 1998 and May 2001 (figure 2). Overall, the average shoreline change rate along the two reference areas on the east canal bank was -9.95 ft/yr (-3.03 m/yr) between June 1995 and May 2001 (figure 2).

These data indicate that the ME-04 project rock dike has successfully prevented or significantly reduced wave erosion of the protected segment of canal bank for the entire period of record, as compared to the unprotected reference area shoreline segments, particularly between April 1995 and February 1998 (figure 2). These data support the conclusion that the ME-04 project has met its specific goal of reducing shoreline erosion along the west bank of Freshwater Bayou Canal behind the ME-04 project rock dike. However, although the ME-04 rock dike has met its specific goal of reducing shoreline erosion along the west bank of Freshwater Bayou Canal behind the dike, monitoring data indicate that its effectiveness steadily decreased over this time period. This was in large part due to the substandard nature of the original construction material used, and the logistics of implementing a cost-effective maintenance lift to the structure, as explained elsewhere (see section III.3).
