2010 Operations, Maintenance, and Monitoring Report

East Mud Lake Marsh Management (CS-20)

State Project Number CS-20
Priority Project List 2

December, 2010
Cameron Parish

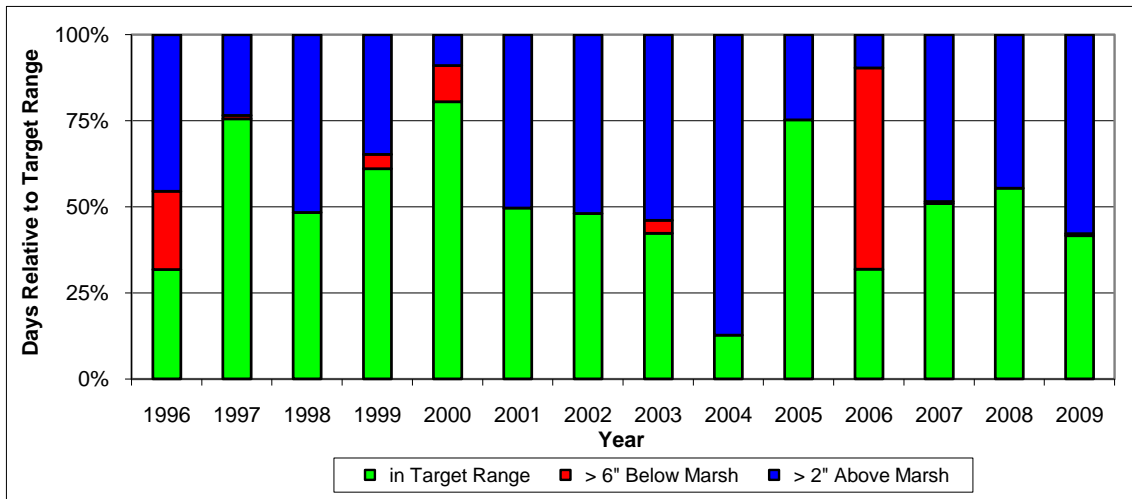
Figure 9. Percent days per year at CS20-07 in CTU 1 of water levels relative to target range (2'' above to 6'' below marsh level) since construction. Marsh level is averaged at 1.01 ft NAVD.

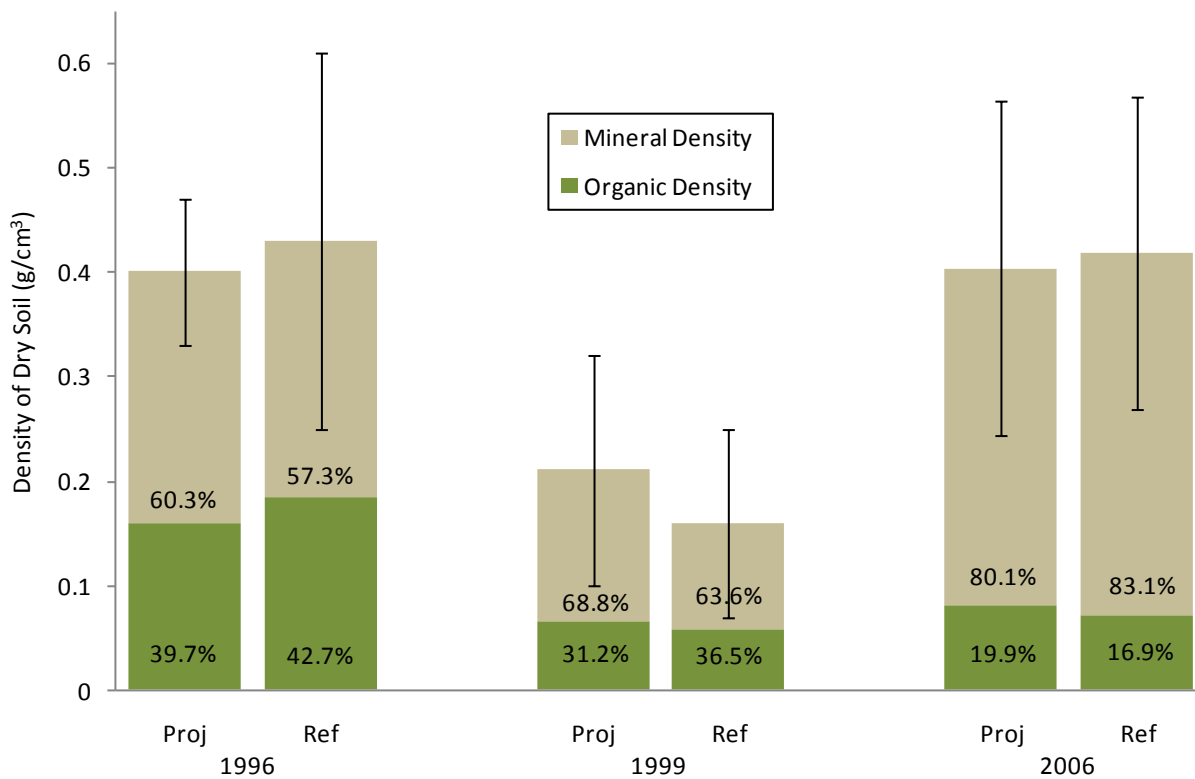
Figure 14. Bulk (full column), organic, and mineral density of dry soil (g/cm^3) of the top 10 cm from Proj ($n=25$) and Ref ($n=20$) sites collected preconstruction (1996), postconstruction (1999), and post Hurricane Rita (2006). Values are means of densities (columns) and mineral and organic percentages (text on bars); error bars are standard deviations of bulk density.

Soils: Project (CTU 2) and reference (REF 2) areas were similar to one another in terms of bulk density (BD) and organic components (density [OD] and percentage [%OM]) as surface soils (top 10 cm) changed over the three sampling periods (figures 14). From 1996-1999 (pre- to post-construction), BD decreased about 55% with a slighter decrease of about 20% in %OM during the drought and flooding events. A net loss in soil organic matter typically occurs when organic matter decomposition outpaces production (root productivity)/accumulation (sedimentation) (Nyman and DeLaune 1990). From 1999 to 2006 (pre- to post Hurricane Rita), BD sharply doubled with a proportional increase in mineral density (note decrease in %OM) resulting from the large sediment input during the storm surge of Hurricane Rita in 2005. Although OD increased, the soils converted from organic (>30% OM) to mineral (<30% OM) after Hurricane Rita. Soil properties are scheduled to be collected in 2012.

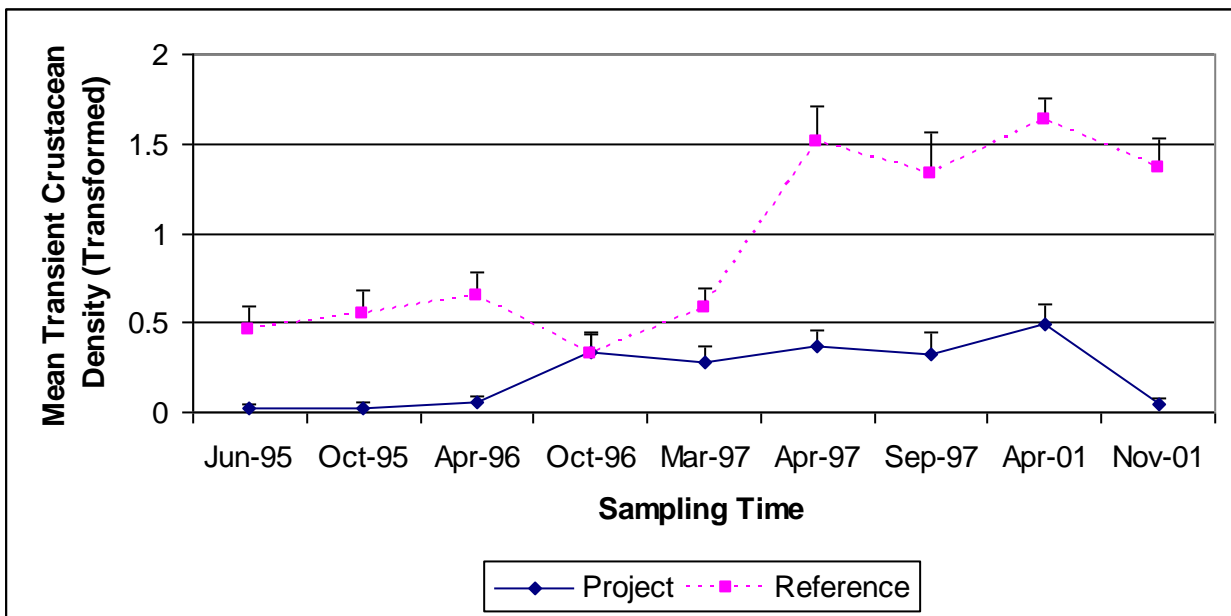
Figure 16. Transformed mean density per square meter of transient crustacean species collected in the East Mud Lake (CS-20) project and reference areas at sampling dates between June 1995 and November 2001.

Before and after project construction, transient fishes and crustaceans were generally more abundant in the reference area (REF 2) than the project area (CTU 2) (figures 15 and 16) while resident fishes and crustaceans were generally more abundant in the project area than the reference area (figures 17 and 18). This likely indicates a previous and present access restriction for transient species to the project area caused by ring levees which is more suitable habitat for resident species. Fisheries species densities were temporally variable in both areas, and despite a trend toward higher crustacean densities after project construction in both areas, the project did not have a significant effect on total fisheries species densities. Although transient crustacean densities did increase significantly postconstruction in the project area, there was a much greater significant postconstruction increase in the reference area in total, transient, and resident crustacean densities, which means that even if the project effects contributed to an increase in animal numbers it was overshadowed by other (likely natural) causes.

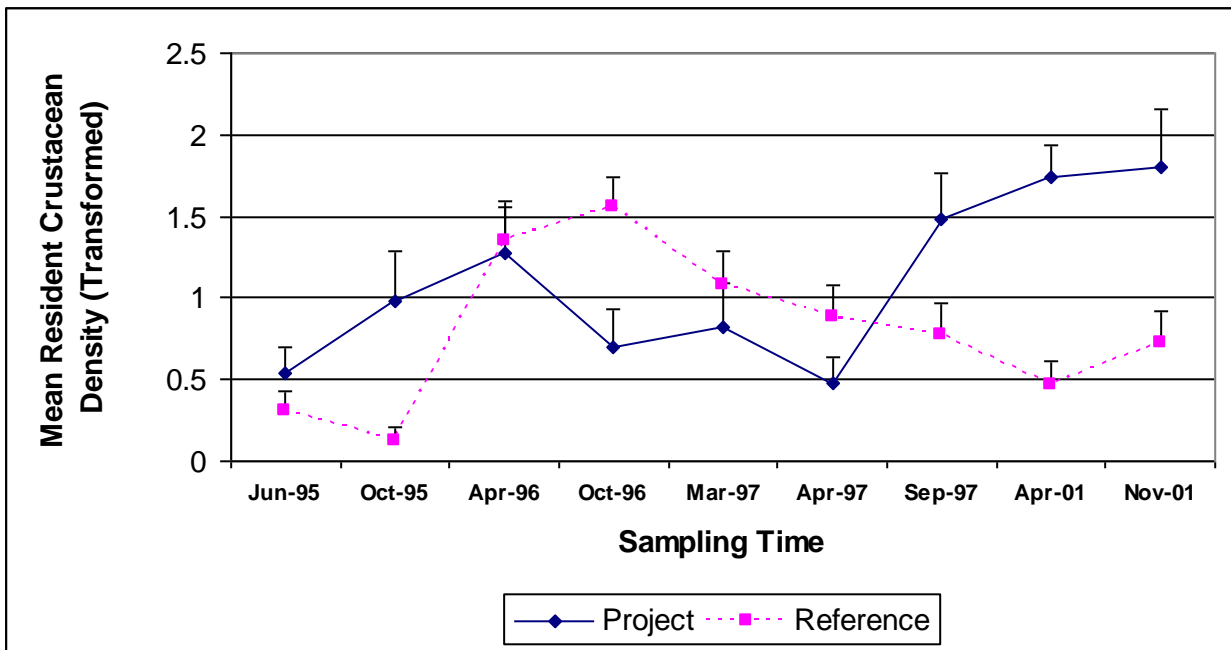
Figure 18. Transformed mean density per square meter of resident crustacean species collected in the East Mud Lake (CS-20) project and reference areas at sampling dates between June 1995 and November 2001.
