**2011/2012 Annual Inspection  
Report**

**PERRY RIDGE SHORELINE  
PROTECTION PROJECT (CS-24)**

State Project Number CS-24  
Priority Project List 4

May 24, 2012  
Calcasieu Parish

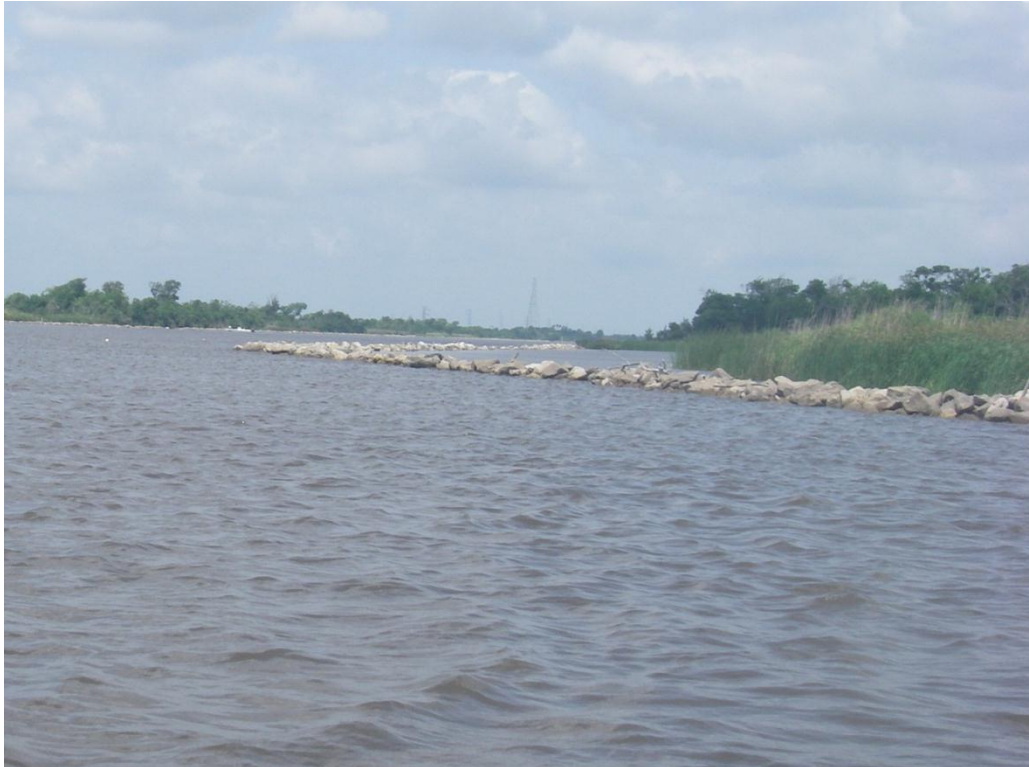
**Photo No.1, Typical Rock Dike**

The dike is in good condition with a few low areas below constructed elevation. One 50 foot gap was noted where the dike was disturbed by a barge. Visible signs of accretion are occurring behind the rock dike. No maintenance is recommended at this time. (Photos: Appendix B, Photo 1-3)
