**2007 Operations,  
Maintenance, and Monitoring  
Report**

**Jonathan Davis Wetland  
Protection**

State Project Number BA-20  
Priority Project List 2

July 30, 2007  
Jefferson Parish

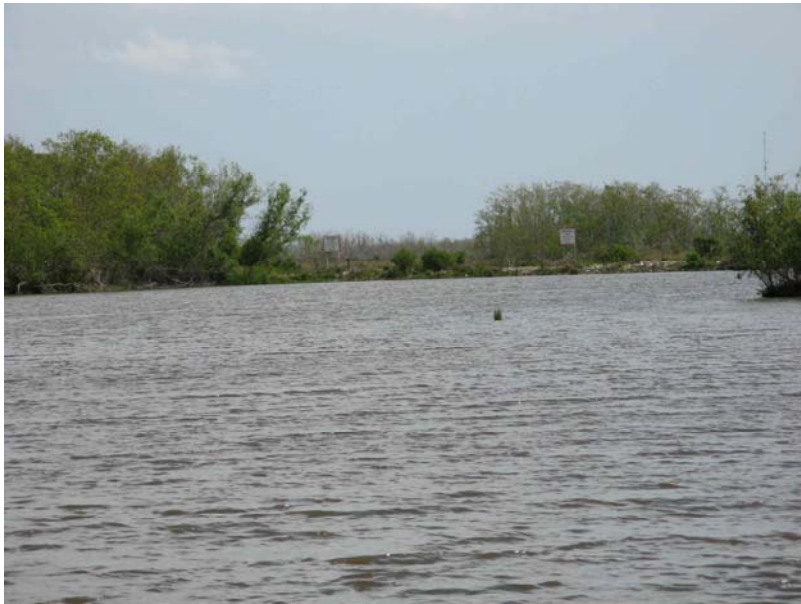
Photo 2  
Structure #14  
CU #1

Upon a visual inspection, we noticed a large breach on the west side of the structure (Photos 2 and 3). Due to poor soil conditions, this structure has experienced significant settlement problems since the time it was constructed. Several attempts were made during construction to stabilize the structure by placing several lifts of rock, but the structure continued to settle. The maintenance work for this structure will be performed during the construction of Construction Unit 4 (CU4), which is expected to begin in the summer of 2007.

The repairs noted at each structure will be included in the plans for Construction Unit 4.

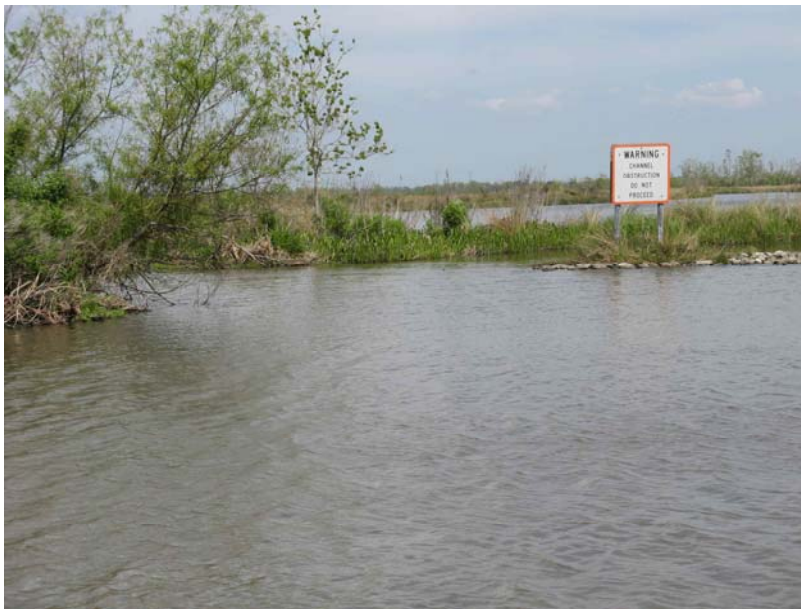
Photo 3  
Breach on west side of Structure #14

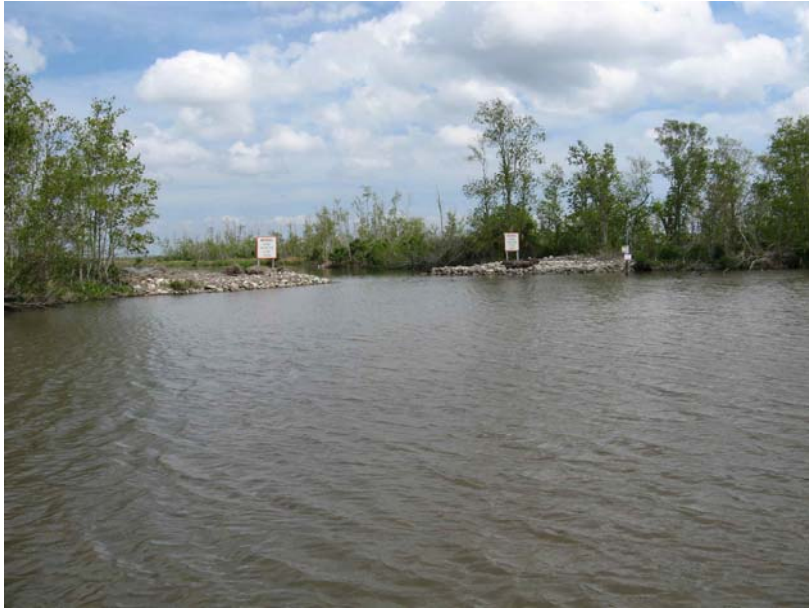
Photo 4  
Structure #15  
CU #1

Structure No. 15 appeared to be in good condition at the time of inspection, with little or no noticeable settlement of the rock weir (Photo 4). Signs and supports were also in good condition. The original design of this structure was modified to include a boat bay to accommodate oilfield activities and navigation on the interior marsh of the structure. During the construction of CU4, this structure will be modified so that it represents the original design more accurately. Construction Unit 4 (CU4) is scheduled to begin in the summer of 2007.

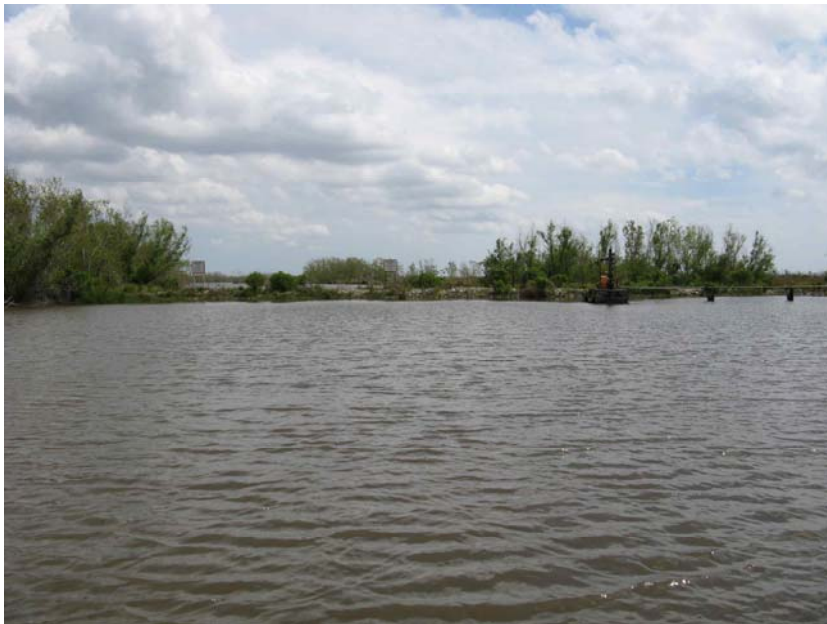
Photo 5  
Structure #16  
CU #1

Structure 16 appeared to be in good condition with the exception of a low area on the south side of the channel plug (Photo 5). The maintenance work for this structure will be performed during the construction of Construction Unit 4 (CU4), which is scheduled to begin in the summer of 2007.

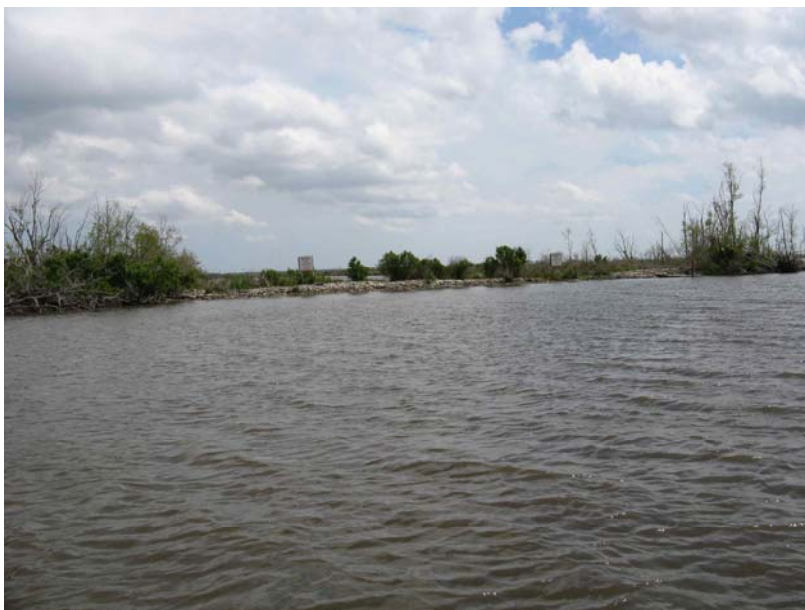
Photo 6  
Structure #17  
CU #1

During the inspection, we observed significant settlement near the warning sign on the south side of the structure and just east of the warning sign on the north side of the structure (Photos 6 and 7). The maintenance of this structure will be performed during the construction of Construction Unit 4 (CU4), which is scheduled to begin in the summer of 2007.

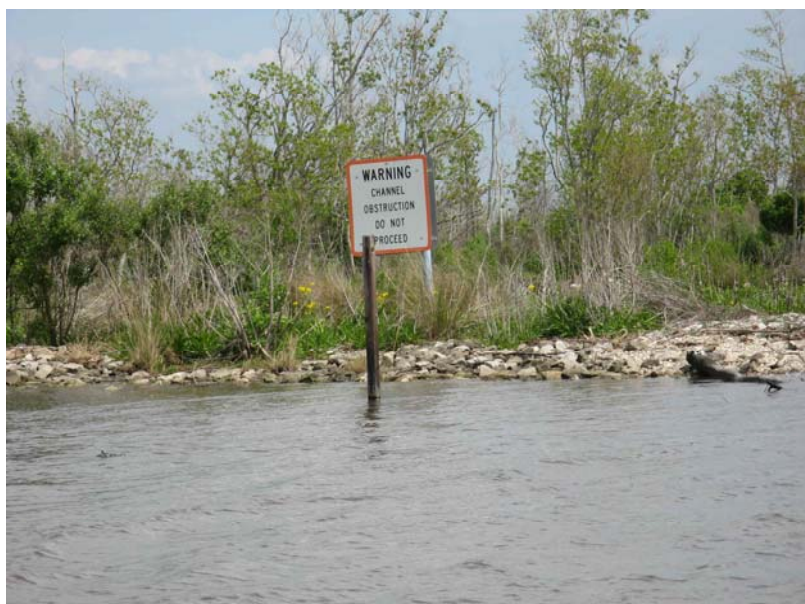
Photo 7  
Low area in Structure #17

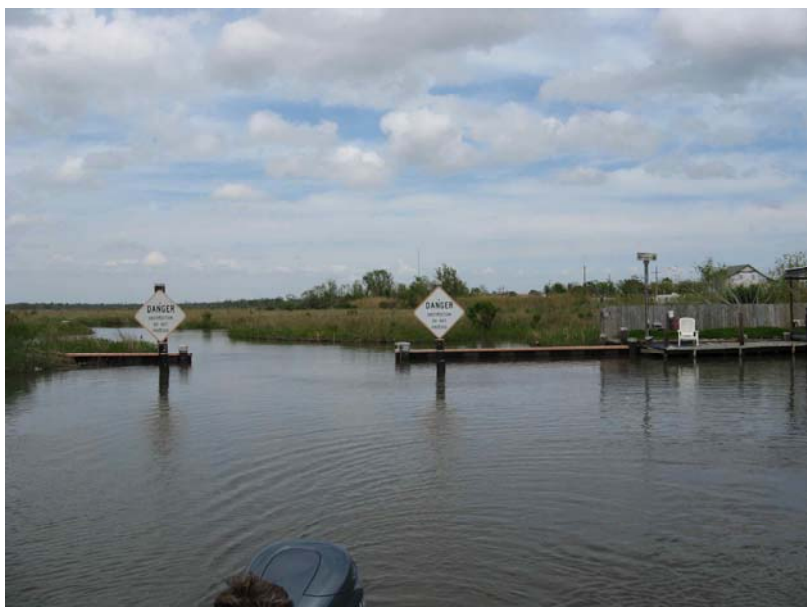
Photo 9  
Structure #22  
CU # 2

The structure itself appears to be in good condition along with the signs, supports, and sheet pile caps (Photo 9). LDNR and NRCS agree that this structure will require no work at this time.

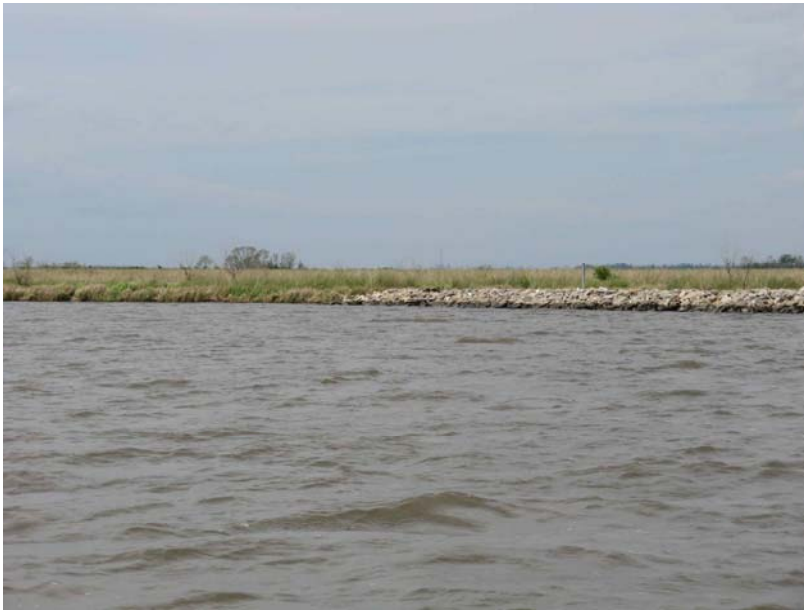
The rock dike along the northern shore of Bayou Rigolettes appeared to be in

good condition with a few signs of settlement (Photo 10). Maintenance work will not be needed at this time.

Photo 10  
West end of Bayou Rigolets Rock Dike  
CU # 2

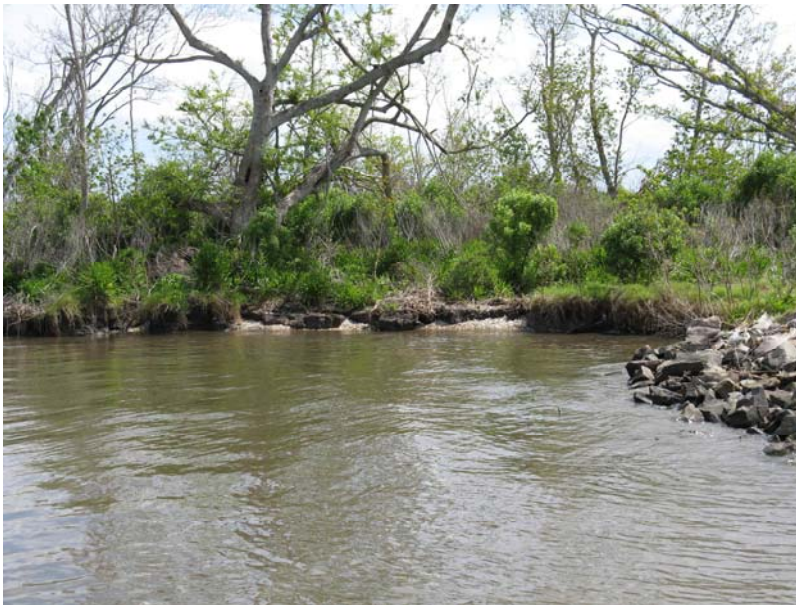
The Bayou Perot Bank Stabilization was in good condition. There was some slight erosion at the western most portion of the structure (Photo 11). There was also some settlement between Sta. 90+00 and 92+00 (Photo 12). The maintenance work for this structure will be performed during the construction of Construction Unit 4 (CU4) which is scheduled to begin construction in the summer of 2007 (Photo 12).

Photo 11  
Bank erosion at west end of  
Bayou Perot Rock Dike
