**2014 Operations, Maintenance, and
Monitoring Report**

**Sabine Refuge Marsh Creation
Cycles - 1 and 3**

State Project Number CS-28
Priority Project List 8

June 2014
Cameron Parish

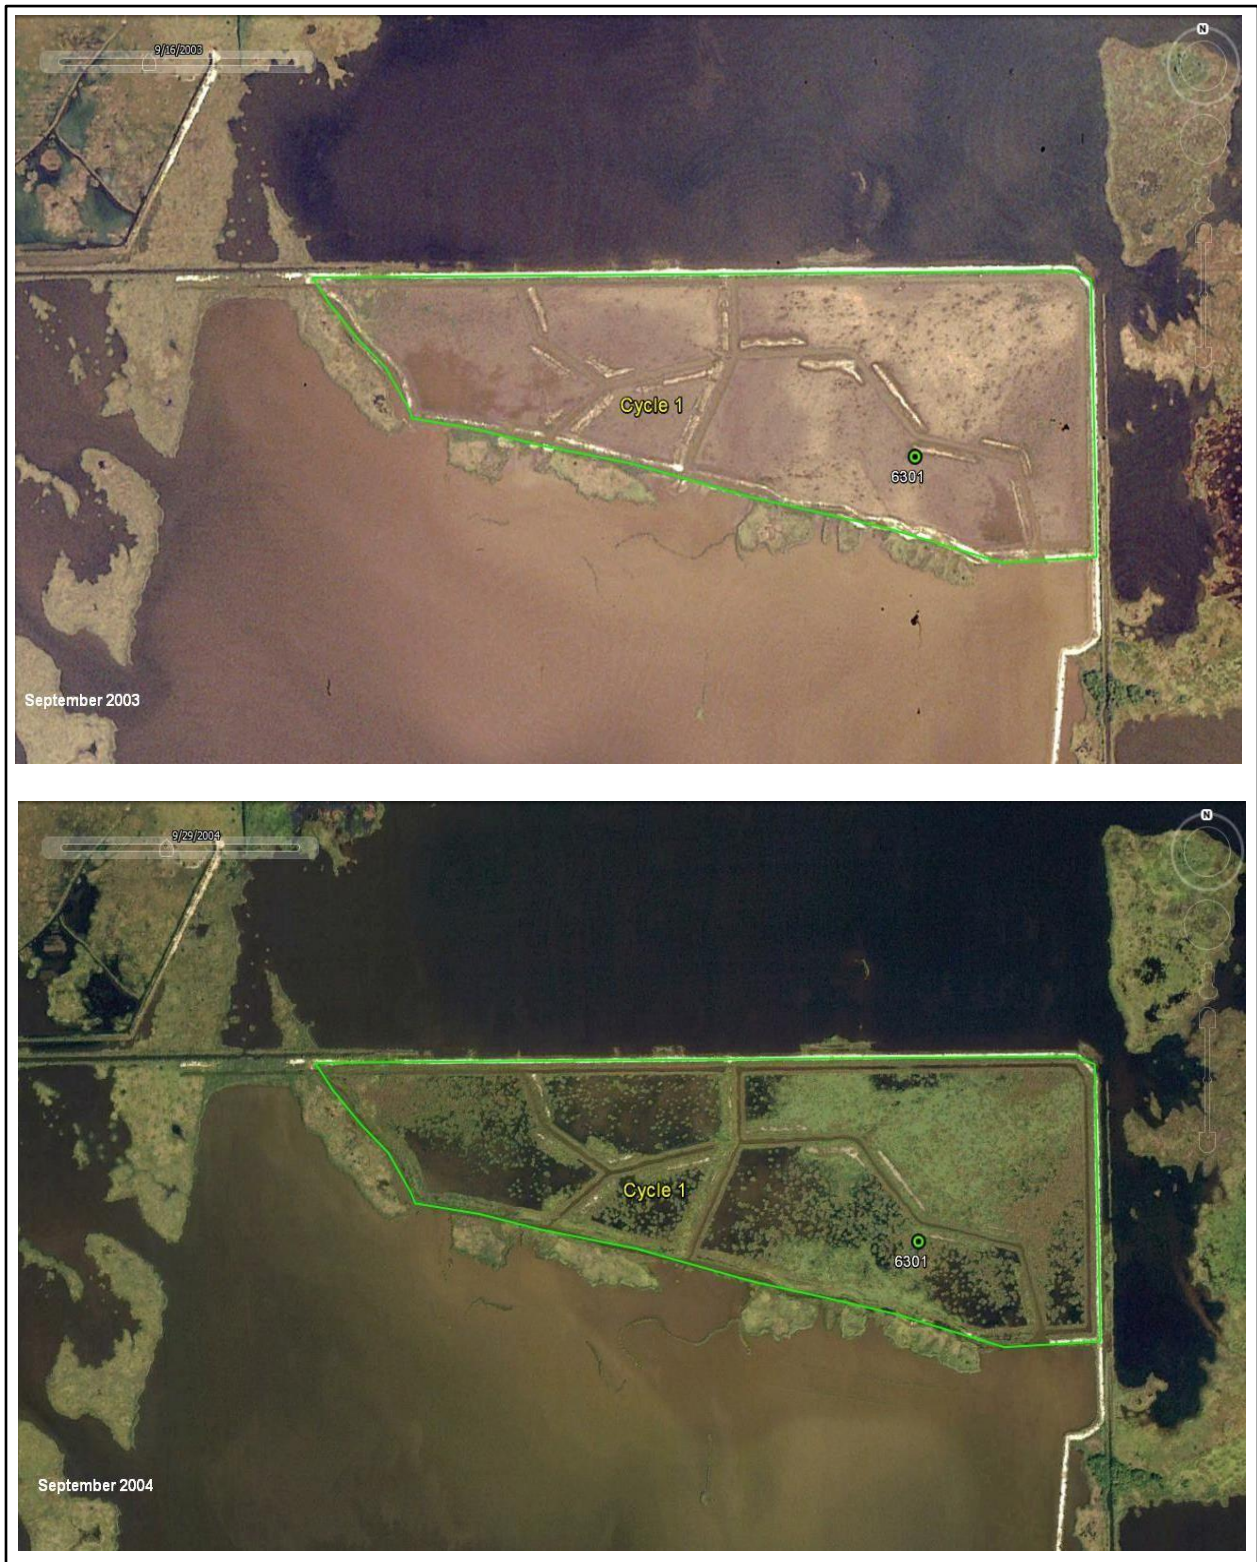
Figure 4a and 4b. Visual vegetation change in cycle 1 as seen from Google-Earth imagery in September 2003 and September 2004.

Land: Water aerial photography was captured and analyzed in 2002 and 2009 (Figures 2 and 3). The Cycle 1 fill area had 171 acres of vegetated land eight years after construction in 2009 (86% of the 200 acre cell). The remaining 29 acres consisted of previously existing land, trenasses, and 4 acres of unvegetated dredged material (Figure 3). It is clear from Google Earth Imagery that the Cycle 1 area was scarcely vegetated in September 2003 (2.75 years after construction), and that vegetation had emerged and began to spread by September 2004 (3.75 years after construction) (Figure 4a and 4b).

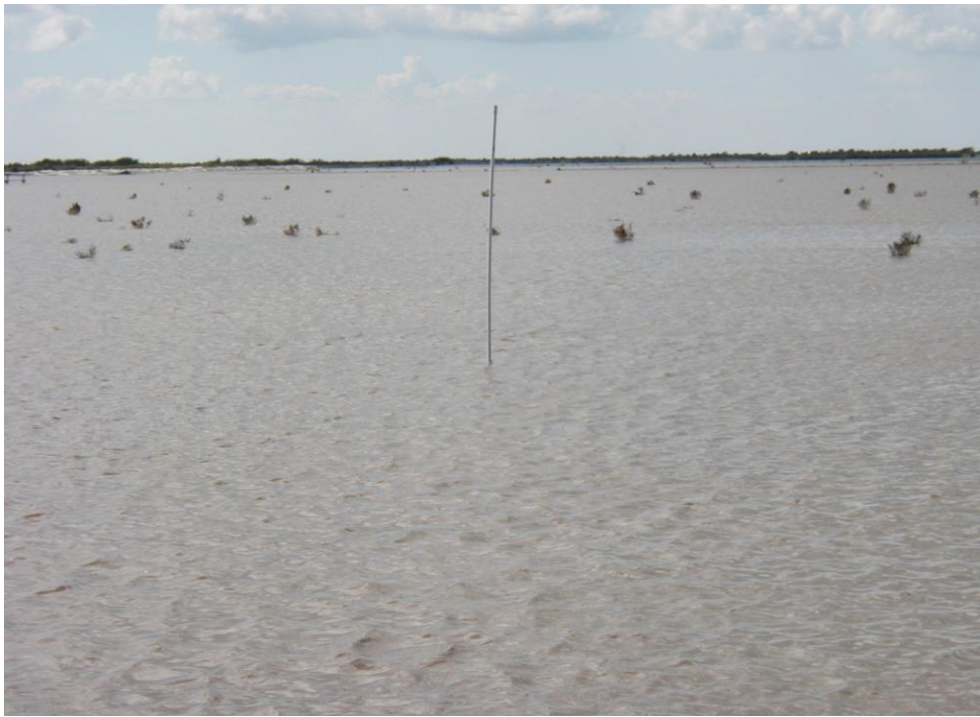
Figure 6. Photograph of vegetation station (CS28-205) in the Cycle 1 deposition area at time of establishment (September, 2002; 1.75 years after construction). The plants in the background are the succulent *Salicornia bigelovii*.

Vegetation stations were established in Cycle 1 post construction in 2002 while the cell was still a mudflat (Figure 6). *Spartina alterniflora* was planted along the edges of Cycle 1 in 2002. By 2004, the Cycle 1 area was dominated by *Spartina alterniflora* over five feet tall (Figure 7). The dredged material probably contained mineral rich clays that *S. alterniflora* was responding to. Hurricane Rita impacted Cycle 1 vegetation significantly (Figure 8). The immediate hurricane impact was much stronger in the project area than in the reference area (Figures 8-9). Both the Cycle 1 area and the reference area had recovered from the Hurricane a year later (Figures 10a and 10b).

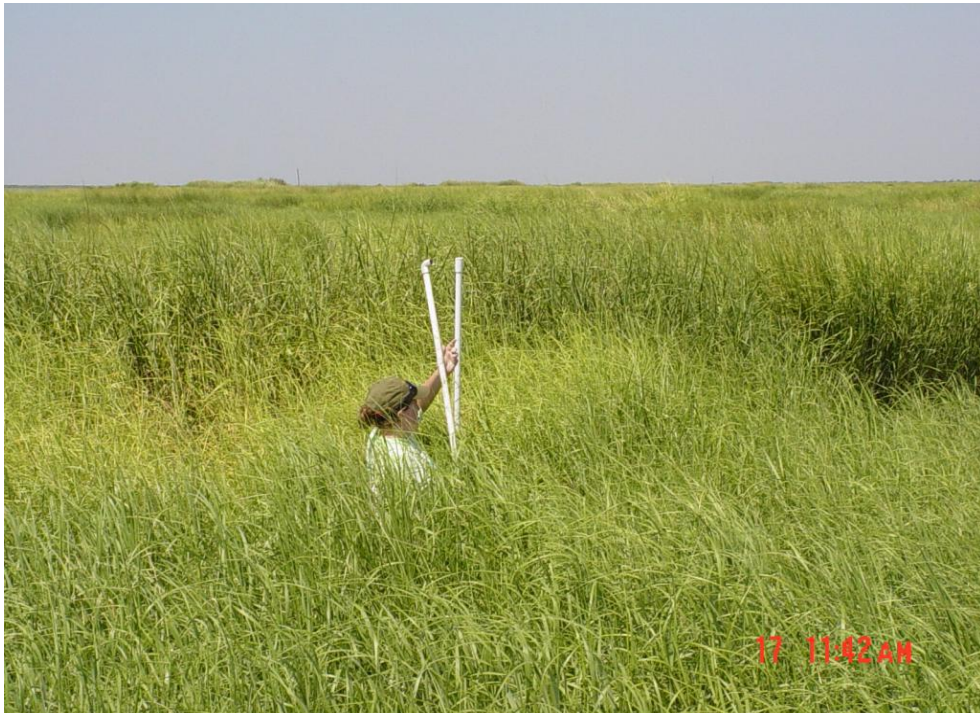
Figure 7. Photograph of vegetation station (CS28-205) in the Cycle 1 deposition area 3.7 years after construction (August, 2004).

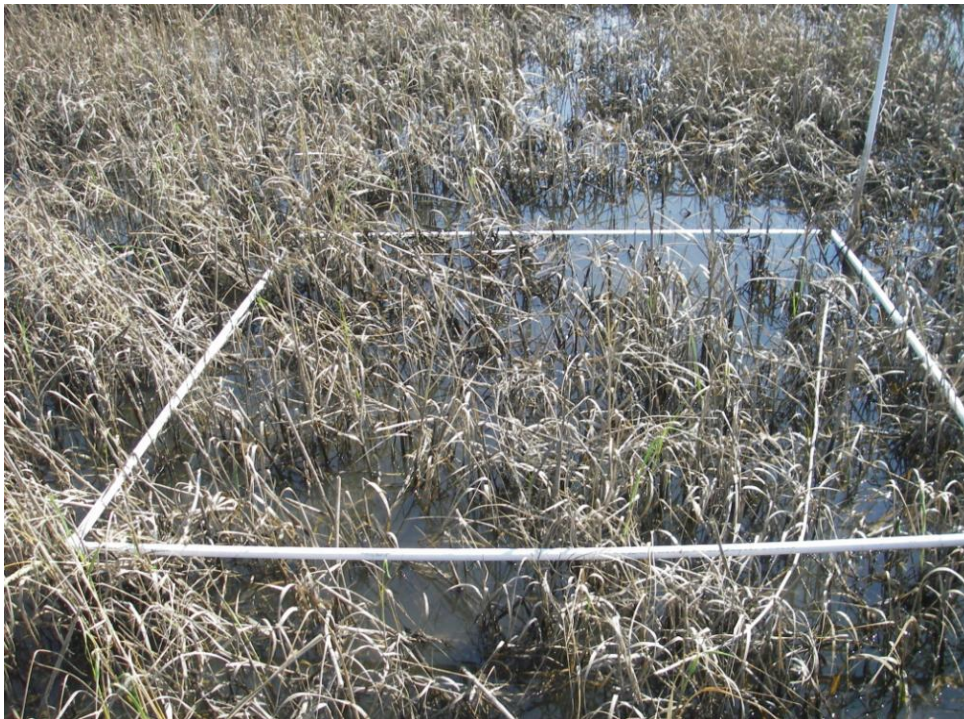
Figure 8. Photograph of vegetation station (CS28-200) in the Cycle 1 deposition area six weeks after Hurricane Rita and 4.8 years after construction (October, 2005).

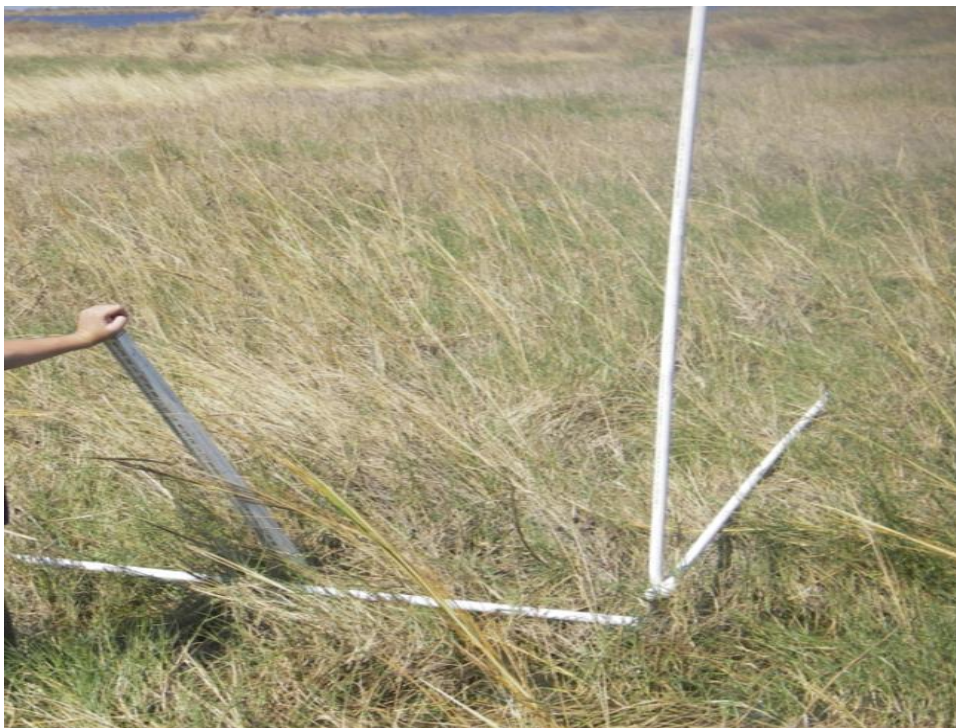
Figure 9. Photograph of vegetation station (CS28-150) in the reference area six weeks after Hurricane Rita (October, 2005).

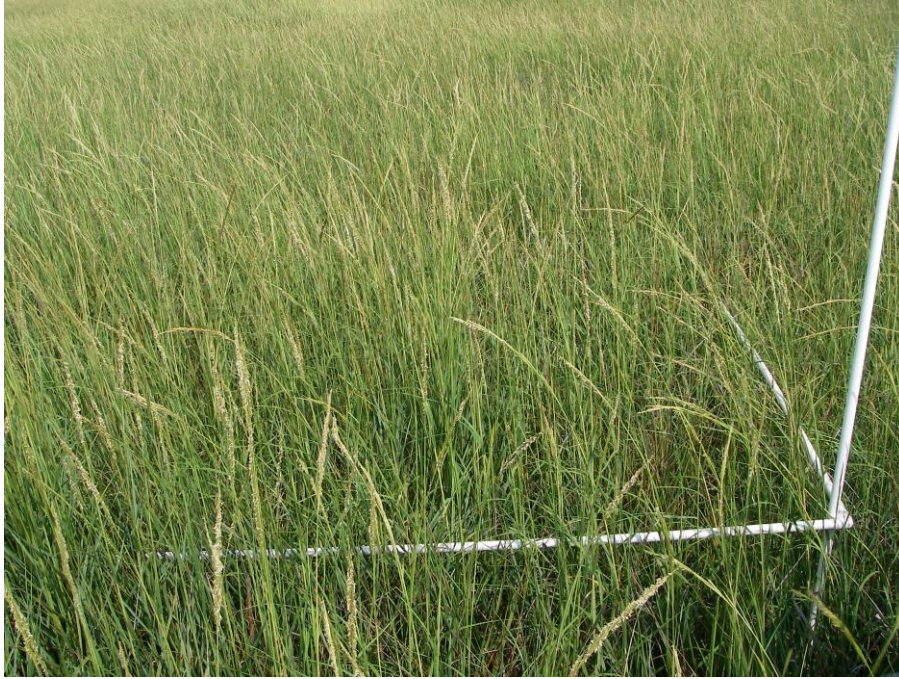
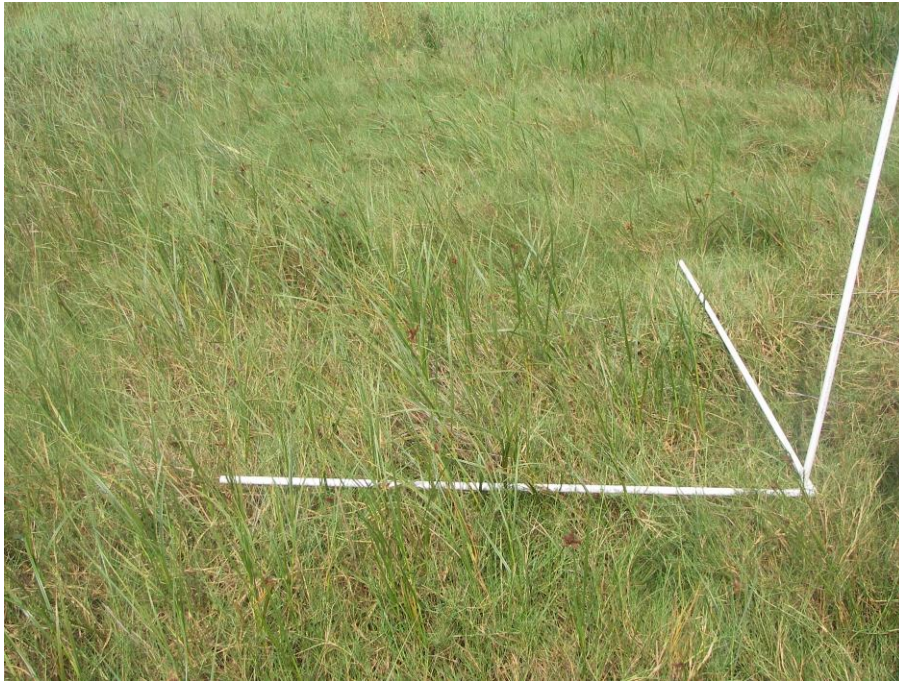
Figure 10a and 10b. Photographs of vegetation stations in October 2006 1.1 years after Hurricane Rita. Top: Cycle 1 station (CS28-205) Bottom: Reference station (CS28-150)

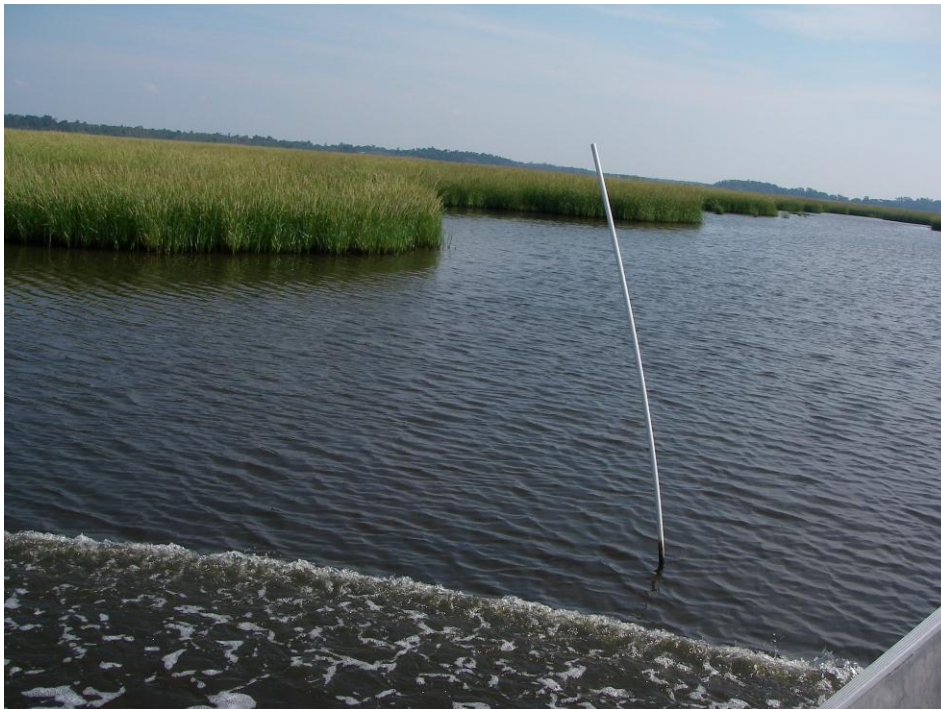
Figure 11. Photograph of vegetation station (CS28-307) in the Cycle 3 deposition area 3.25 years after construction (August, 2010).

Cycle 3 was constructed in 2007 and had begun to vegetate on the southern end but still had open water areas on the northern end (Figure 11) until vegetation crept northward in 2012 (5 years post construction),(Figure 12). Prior to the first measurements in 2008 natural re-vegetation can be seen growing within the Cycle 3 project area (Figure 13).

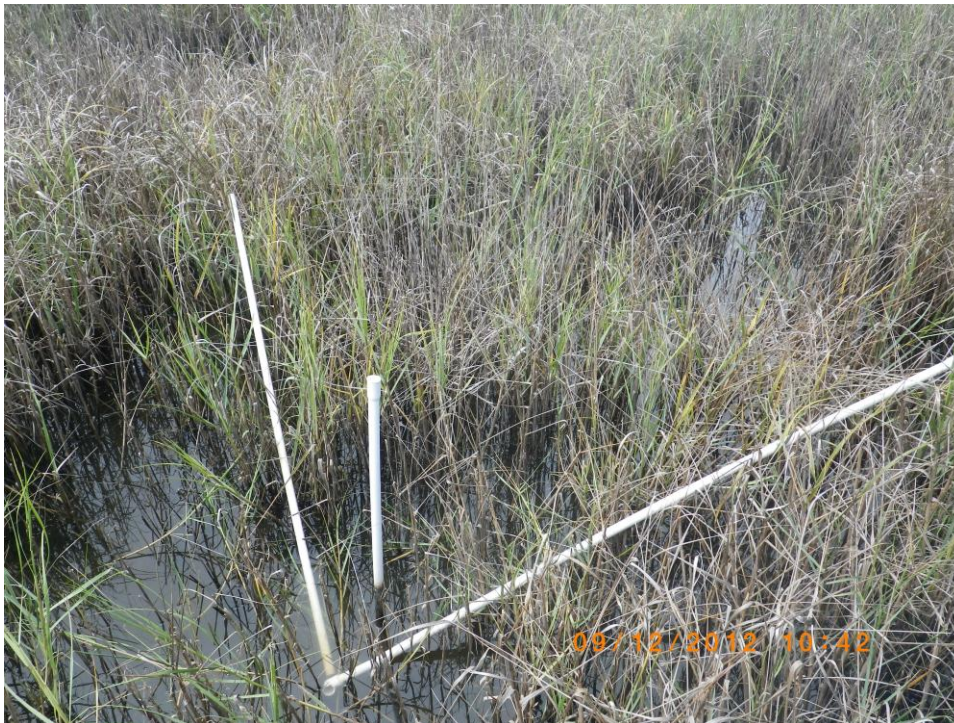
Figure 12. Photograph of vegetation station (CS28-307) in the Cycle 3 deposition area 5.3 years after construction (September, 2012).

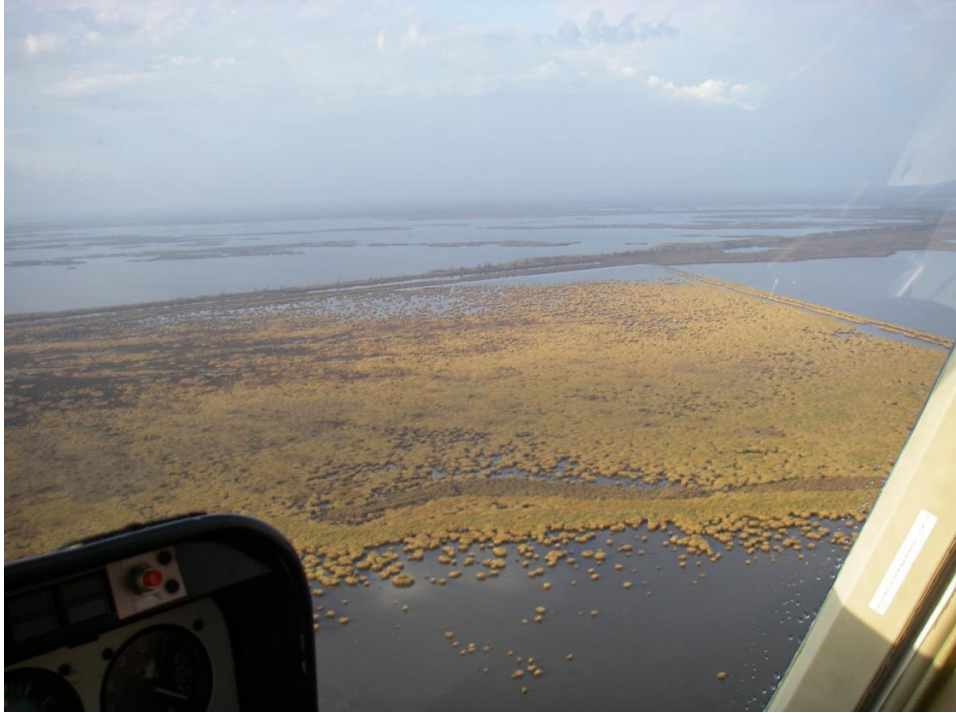
Figure 13. Cycle 3 as seen from the air in October 2008, 1.4 years after construction.

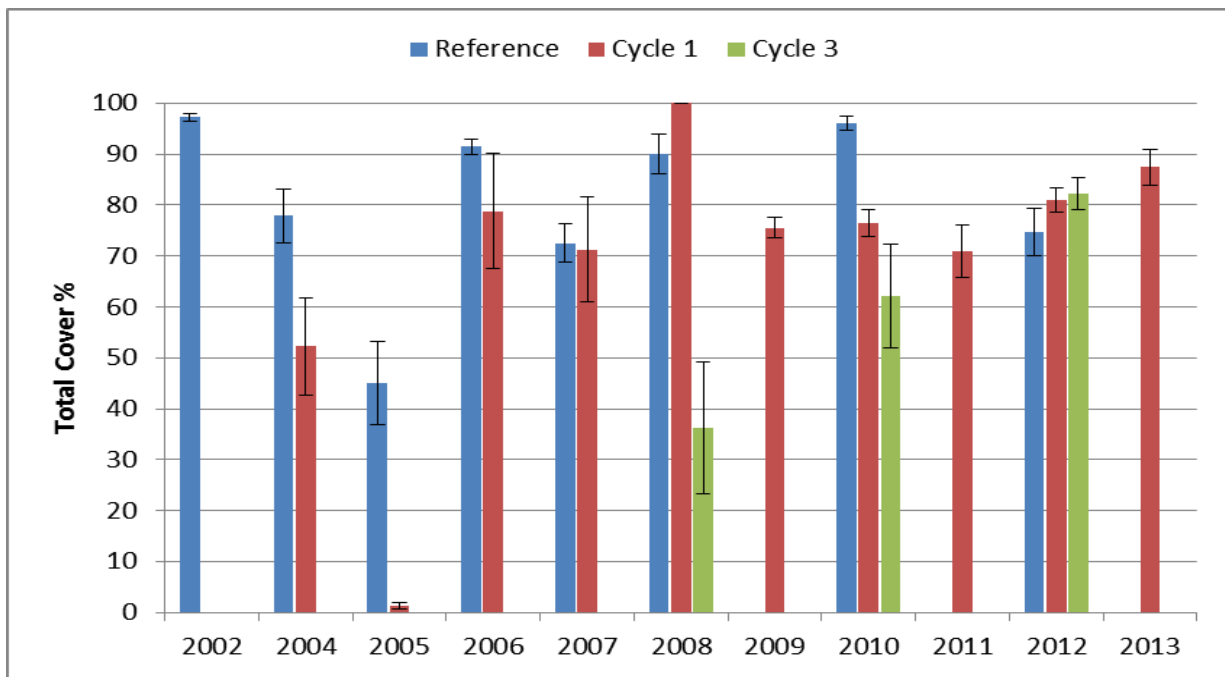
Figure 14. Total percent cover of emergent vegetation in the CS-28 project cycles and reference area. Mean \pm SE. Note that beginning in 2009, Cycle 1 data is from CRMS6301.

The Cycle 1 deposition area recovered quickly from Hurricane Rita in total cover (Figure 14), height of dominant species (Figure 15), and continued to slowly increase in species richness (Figure 16).

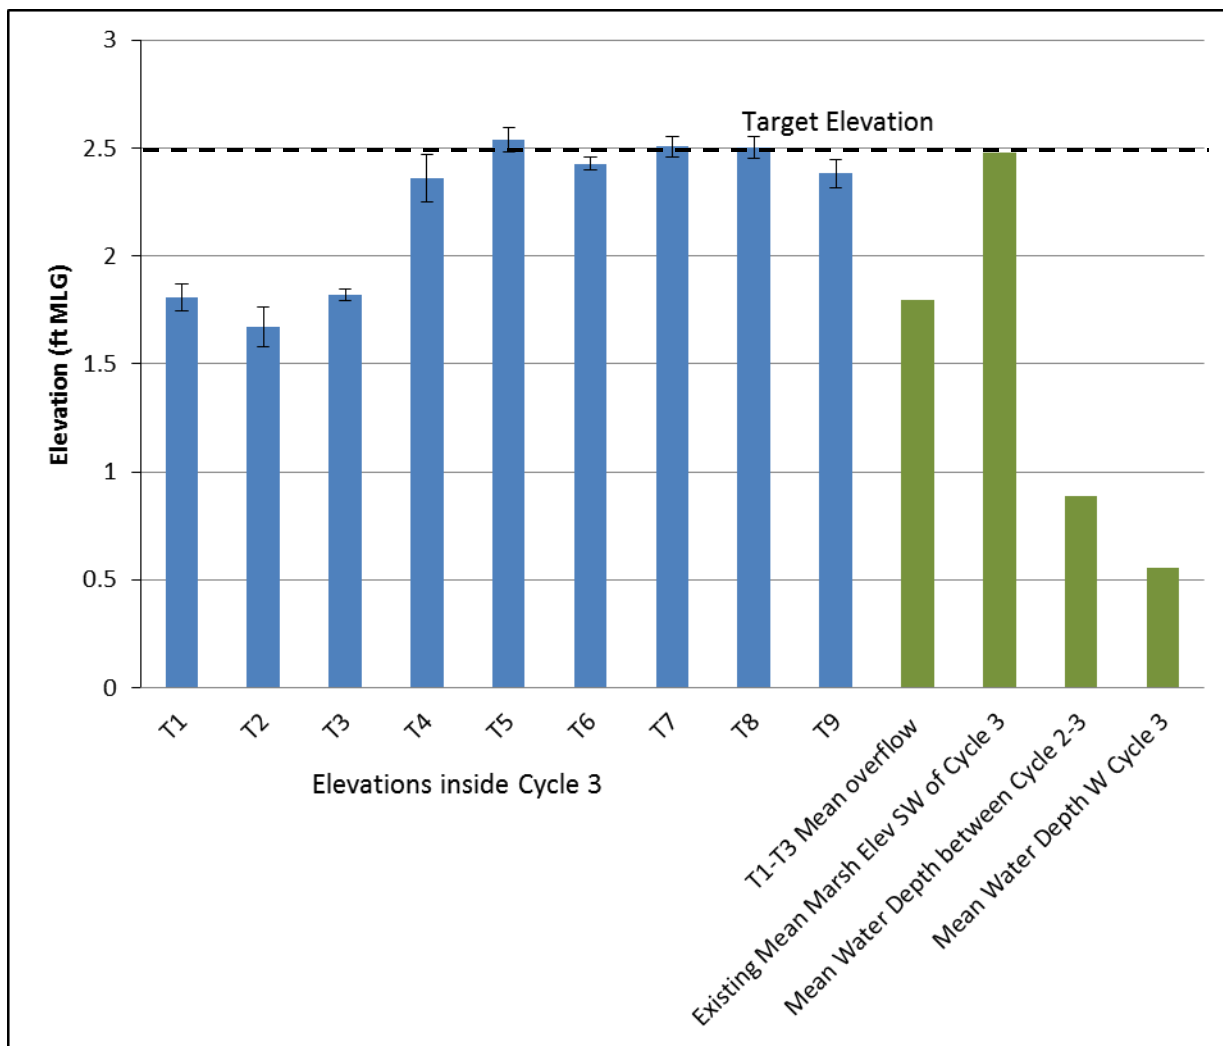
Figure 19. Mean marsh elevations of the nine survey transects, overflow area, existing marsh and water depth within and around the Cycle 3 containment area. Elevations were collected in Geoid 12A and converted to MLG.

Cycle 3 was pumped to between 2.6 and 4.2 ft MLG (1.3 and 2.9 ft NAVD 88(Geoid 99)) and was measured to be between 1.7 and 2.5 ft MLG (0.4 and 1.3 ft NAVD 88(Geoid 99)) in the 2013 survey at year 6. The Cycle 3 area is below the target elevation in the northern 3 of 9 transects surveyed in 2013 (Figures 18 and 19).

The 2013 survey extended into the existing marsh west of Cycle 3 and into the Cycle 2 mudflat located east of Cycle 3. The Cycle 2 overflow created 118 acres which are 1.8 ft MLG (0.5 ft NAVD 88(Geoid 99)) and the pre-existing marsh is 2.5 ft MLG (1.2 ft NAVD 88(Geoid 99)), (Figures 19 and 20).

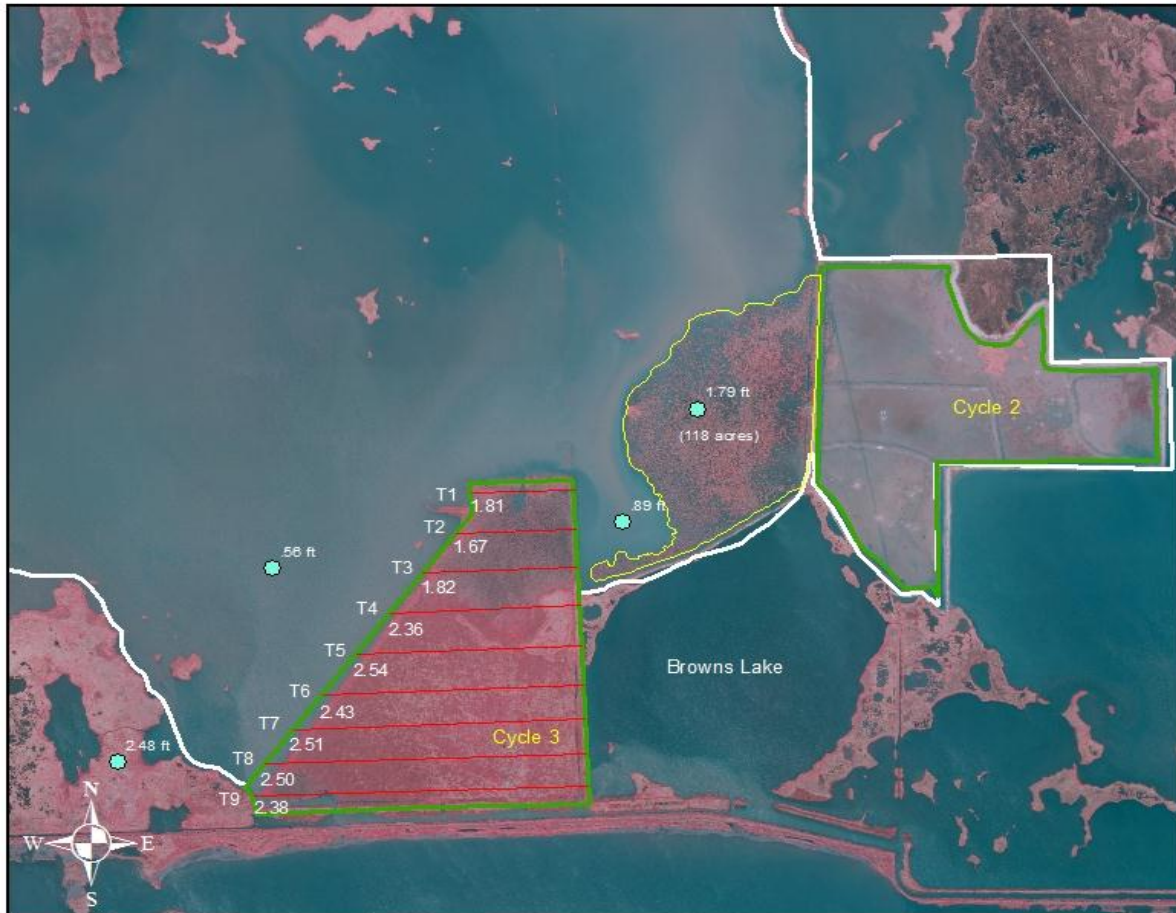
Figure 20. Google map depicting transects, spillover, water bottom and mean marsh elevations (ft MLG) within and around the Cycle 3 containment area.
