2008 Operations, Maintenance, and Monitoring Report

WHISKEY ISLAND RESTORATION

State Project Number TE-27 Priority Project List 3

May 2008 Terrebonne Parish

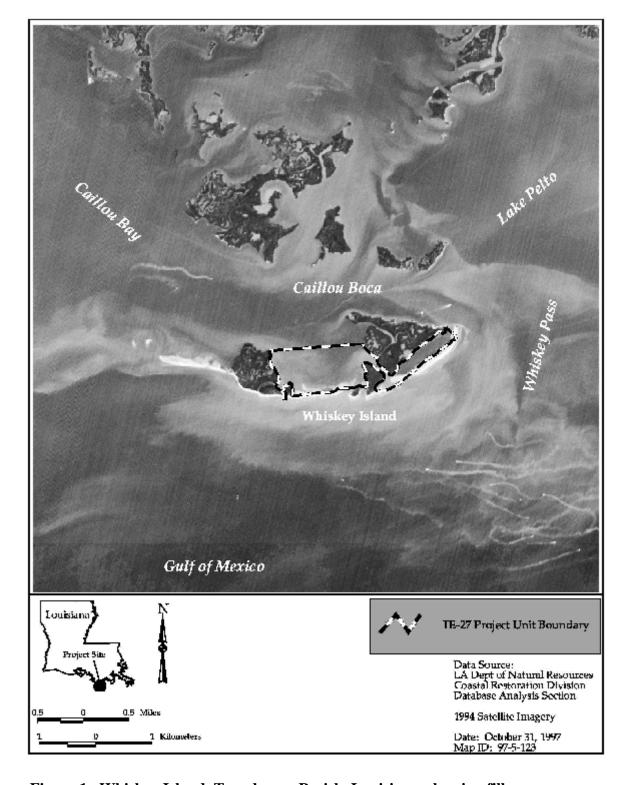
Figure 1. Whiskey Island, Terrebonne Parish, Louisiana, showing fill area.

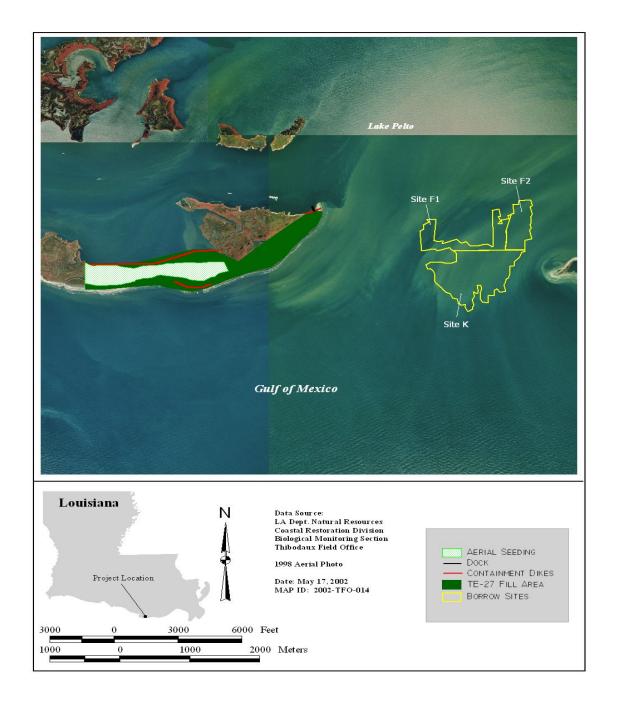
Figure 2. Project construction area, associated structures, and borrow sites for the Whiskey Island Restoration (TE-27) project.

The Whiskey Island Restoration (TE-27) project was constructed through the Coastal Wetlands, Planning, Protection, and Restoration Act (CWPPRA, Public Law 101-646, Title III) and is administered by the U.S. Environmental Protection Agency (EPA) and the Office of Coastal Protection and Restoration of Louisiana (OCPR, formerly the Louisiana Department of Natural Resources, Office of Coastal Restoration and Management). The project included the creation of approximately 355 acres (177 ha) of supratidal (beach, dune, barrier flat) and intertidal (beach, marsh) habitat using sediments dredged from Whiskey Pass (figure 2). Target elevations ranged from +1 ft (0.3 m) to +4 ft (1.2 m) North American Vertical Datum of 1988 (NAVD 88). Vegetation was planted along the artificial fill surface to establish a protective cover that would facilitate fill stabilization as well as minimize wind-Planted vegetation included Spartina alterniflora (smooth cordgrass), driven transport. Spartina patens (marshhay cordgrass), Panicum amarum (bitter panicum), and Avicennia germinans (black mangrove). Construction of the Whiskey Island Restoration project commenced in February 1998 and was completed in the spring of 1999. The first phase of construction included hydraulic dredging of sediments from Whiskey Pass using a 30" Cutter Head Suction Dredge (7,200 hp) and Booster Pump Barge and was completed in late summer Approximately 2.9 million yd³ (2.2 million m³) of sediment were dredged from Whiskey Pass (borrow area) and placed on Whiskey Island (figure 2). Most of the dredged material was placed landward of the gulfside beach to restore the back-barrier portion of the island. Some material, however, was pumped onto the existing beach along the central portion of the island, in the vicinity of several breaches, as well as along the eastern section of the island near Coupe Nouvelle (figure 2).

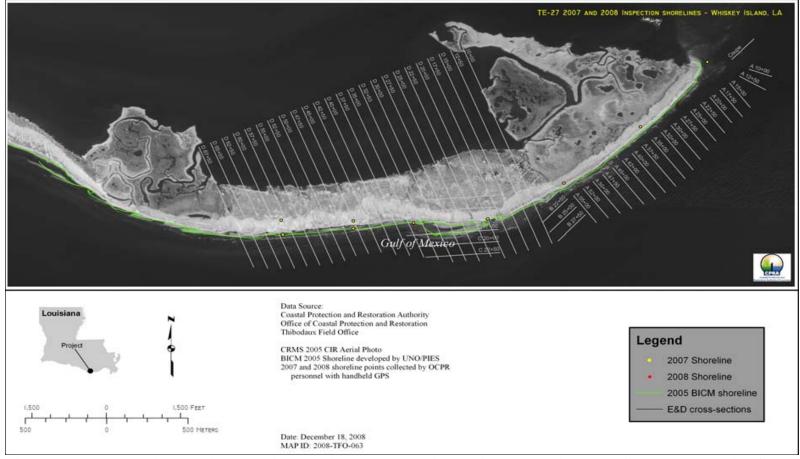
Figure 3. 2007 shoreline positions obtained during the annual inspection along with the BICM 2005 shoreline for the Whiskey Island (TE-27) project.

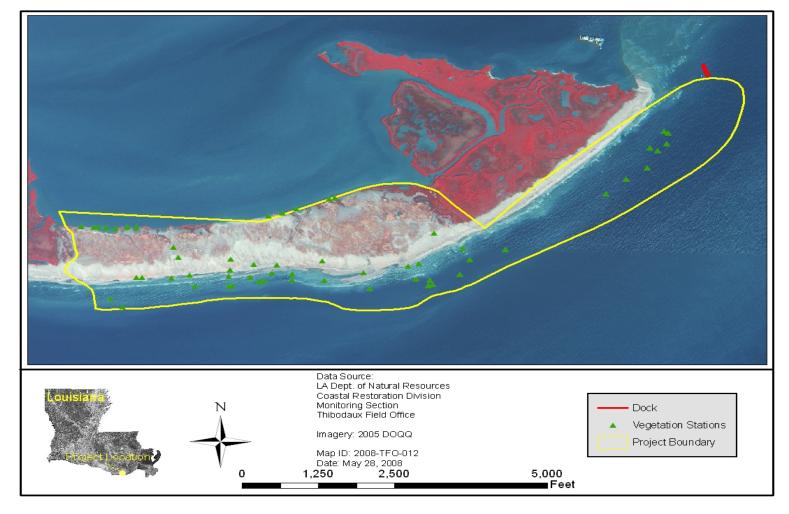
Figure 4. Vegetation sampling stations established prior to 2007 consumed by erosion at Whiskey Island Restoration (TE-27) project.

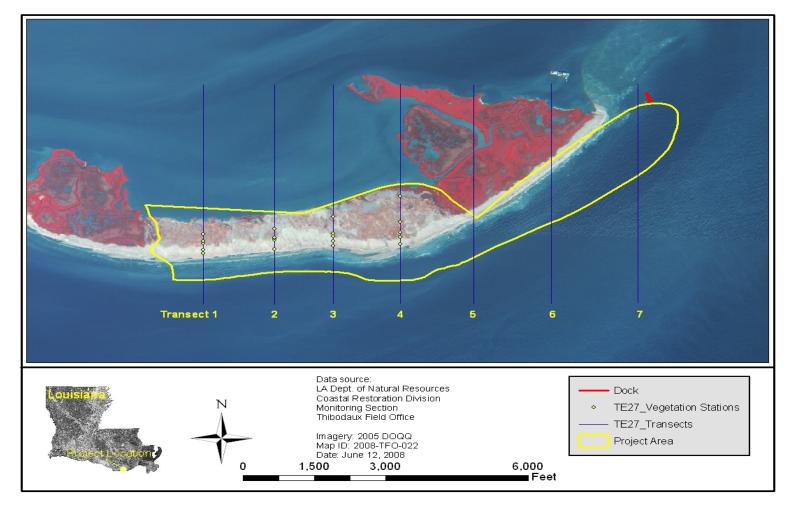
Figure 5. Vegetation transects and plots for the 2007 sampling scheme at the Whiskey Island Restoration (TE-27) project.

region for transects 1-4. A total of 20 stations were sampled. Transects 5-7 were not sampled due to the lack of emergent vegetation along the transects within the project boundary. Mangroves were present along the transects outside of the project boundary.

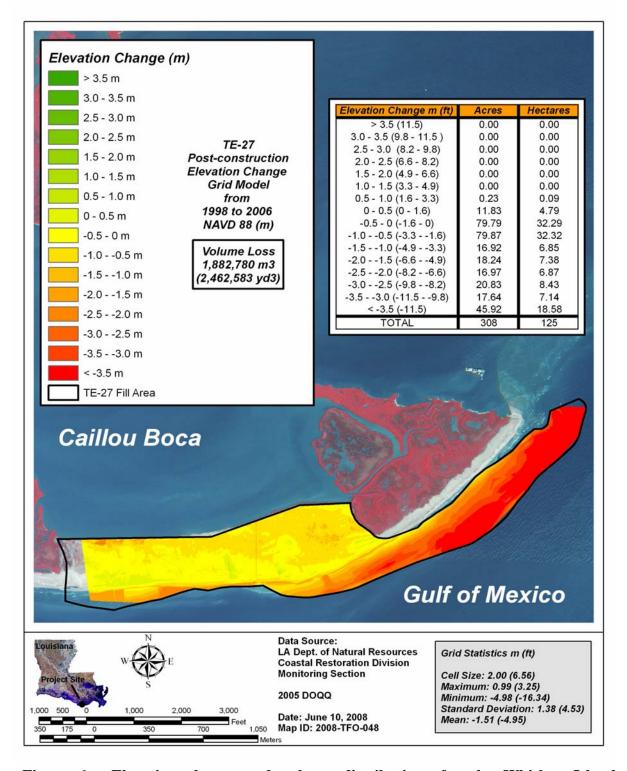
Dramatic changes have occurred to the Whiskey Island Restoration (TE-27) project fill area since construction was completed in 1998. Elevation change and volume distributions for the TE-27 fill area are shown in figure 6 (1998-2006). Elevation change and volume distributions for 1997-1998, 1998-2000, and 2000-2006 are provided in Appendix B. Approximately, 1,978,079 yd³ (1,512,350 m³) of sediment were deposited during construction in 1998. In the post-construction period, sediment volume in the fill area decreased by 19% from 1998 to 2000 and 116% from 2000 to 2006. The total sediment volume loss in the fill area from 1998 to 2006 was approximately 2, 462, 583 yd³ (1,882,780 m³), a 125% reduction in volume.

The primary cause for this large sediment loss inside the fill area is the rapid northwestern movement of the eastern part of Whiskey Island leaving an estimated 135 acres (55 ha) subaqueous. Moreover, segments of Whiskey Island have transgressed over 1000 ft (305 m) since construction. Although the volume in the fill area has decreased considerably, portions of the sand and sediment resources were conserved outside the fill area. The well documented westward drifting longshore transport (Stone and Zhang 2001; Georgiou et al. 2005; Peyronnin 1962) and tropical storm induced shoreline erosion (Peyronnin 1962; Stone et al. 1997; Stone et al. 1993; Georgiou et al. 2005) probably produced the change in shoreline position. West and Dearmond (2004) and Georgiou et al. (2005) reported volume losses on Whiskey Island after the passage of Tropical Storm Isidore and Hurricane Lilli in 2002. Hurricane Katrina (August 2005) and Hurricane Rita (September 2005) also altered the geomorphology of Whiskey Island by causing shoreline transgressions in the fill area (Barras 2006).

Figure 6. Elevation change and volume distributions for the Whiskey Island Restoration (TE-27) project fill area

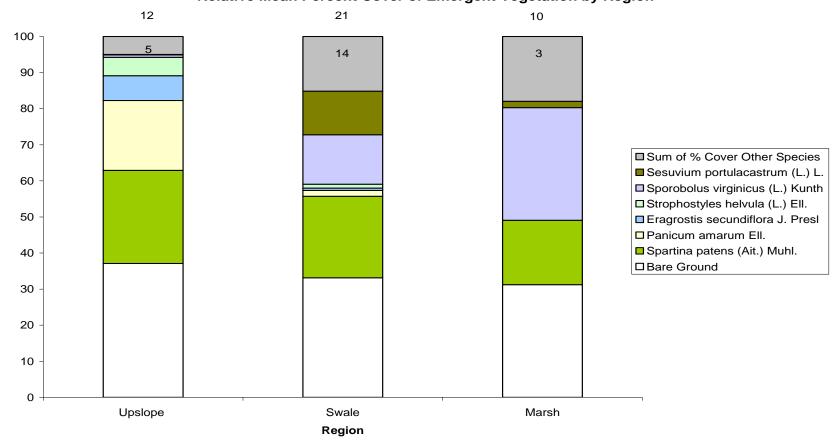
The upslope region of Whiskey Island contained 12 different plant species, including bare ground (figure 7). Bare ground was treated as an individual species and assigned a cover value. The swale region showed the most diversity with 21 total species and the marsh region contained 10 total species (sample size was 1 station), both regions including bare ground. The relative mean percent cover of bare ground was 37.09 on the upslope, 33.12 on the platform and 31.22 percent on the marsh region.

Figure 7. Relative mean percent cover of emergent vegetation by region in October 2007 showing the number of species grouped in the "Other" category and the total number of species found.

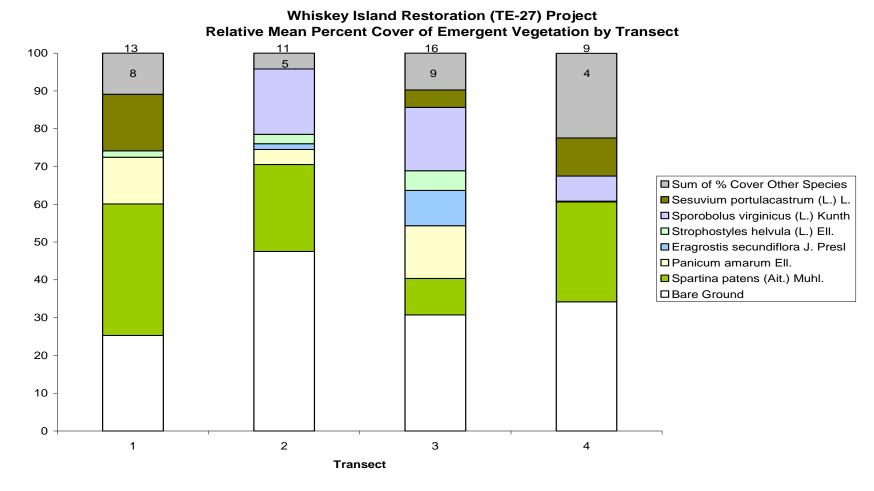
The relative mean percent cover per transect refers to the percent cover of an individual species, measured in five plots, across an entire transect, through the 3 different regions of Whiskey Island. Transect 3 exhibited the most diversity as it contained 16 species including bare ground (figure 8). A total of twenty-nine (29) species were identified in or within 15 feet of the vegetation sampling plots on Whiskey Island.

Figure 8. Relative mean percent cover of emergent vegetation by transect in October 2007 showing the number of species grouped in the "Other" category and the total number of species found.

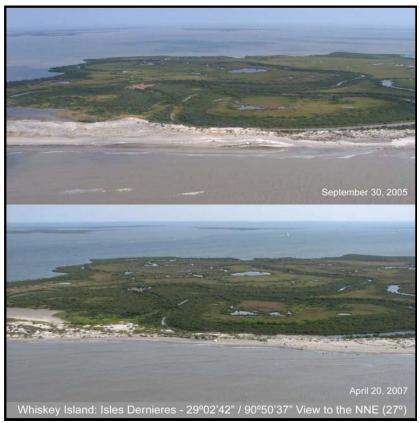
BICM oblique aerial photos of western marshes of Whiskey Island in 2005 (post-Katrina and Rita) and 2007. (Photos courtesy of UNO/PIES)

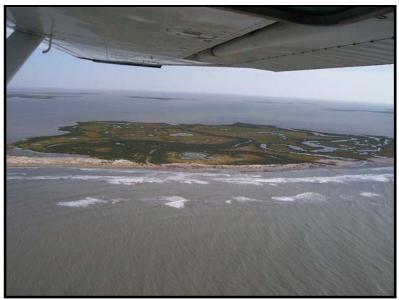
- 1. Overall, the island showed shoreline erosion as the only damage. No breaches were observed and the dune feature did roll back in most instances where widths were wide enough to capture the sediment. Also, vegetation was salt burned, but these features are natural and should recover with rains and time.

OCPR oblique aerial photos of western marshes of Whiskey Island on September 24, 2008 (post-Ike).

- 3. Repairs of hurricane impacts to the dune and beach features of the CWPPRA project would be completed through hydraulic dredging of appropriate sediment to replace that lost through shoreline erosion. With approximately 102 ft² of sediment removed from 3,601 ft of beach, we would need to replace 13,603 yd³ of sediment.

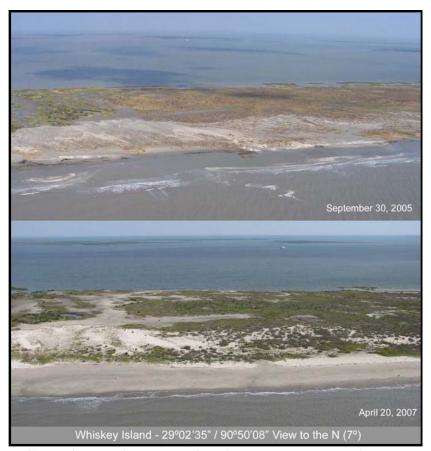
BICM oblique aerial photos of Whiskey Island near station D67+50 in 2005 (post-Katrina and Rita) and 2007. (Photos courtesy of UNO/PIES)

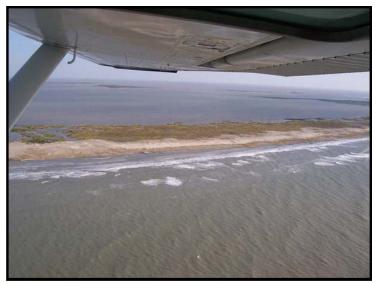
OCPR oblique aerial photos of Whiskey Island near station D67+50 on September 24, 2008 (post-Ike).

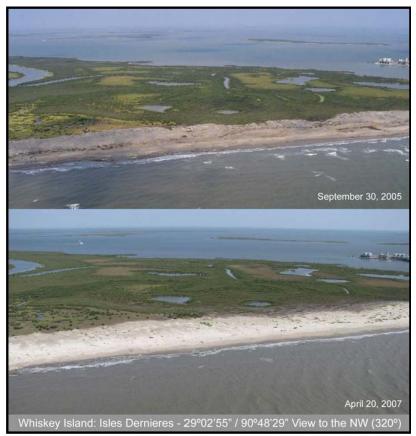
BICM oblique aerial photos of eastern marshes of Whiskey Island in 2005 (post-Katrina and Rita) and 2007. (Photos courtesy of UNO/PIES)

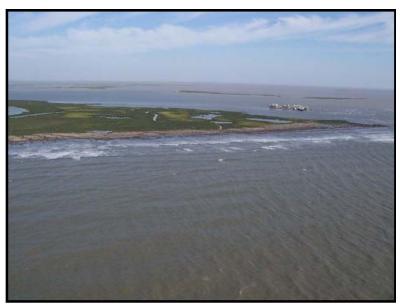
OCPR oblique aerial photos of eastern marshes of Whiskey Island on September 24, 2008 (post-Ike).

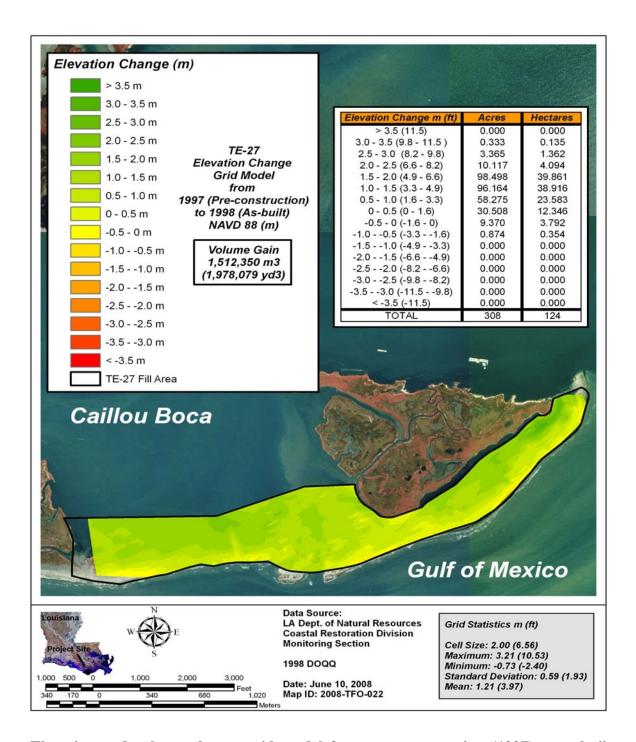
Elevation and volume change grid model from pre-construction (1997) to as-built (1998) at the Whiskey Island Restoration (TE-27) project.

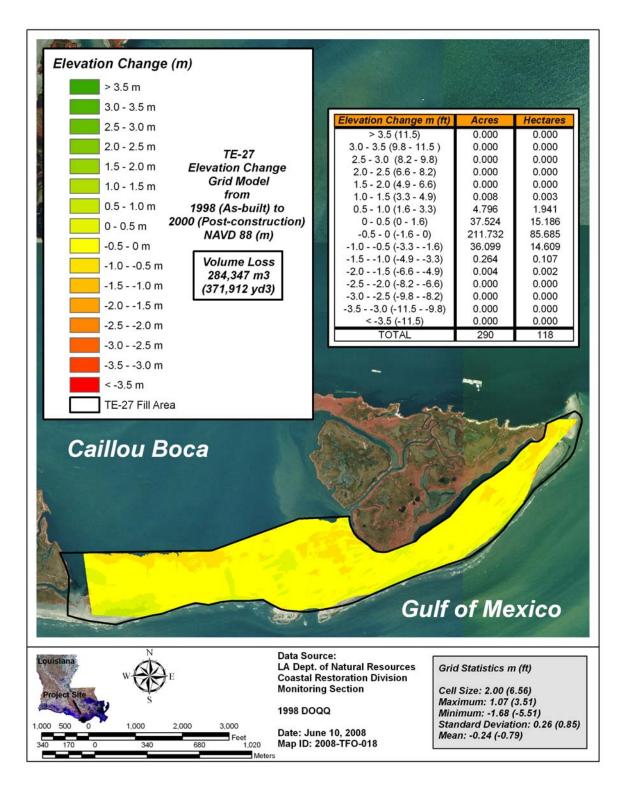
Elevation and volume change grid model from as-built (1998) to post-construction (2000) at the Whiskey Island Restoration (TE-27) project.

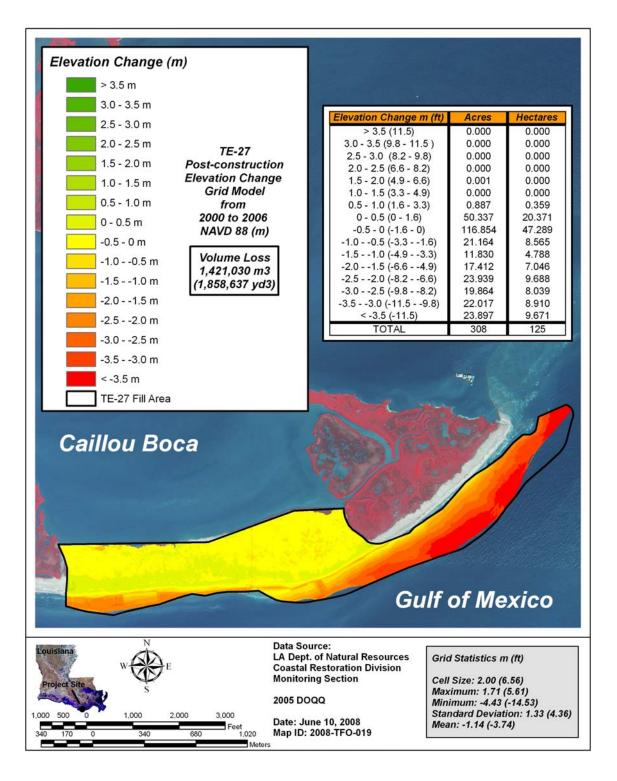
Post-construction elevation and volume change grid model from 2000 to 2006 at the Whiskey Island Restoration (TE-27) project.

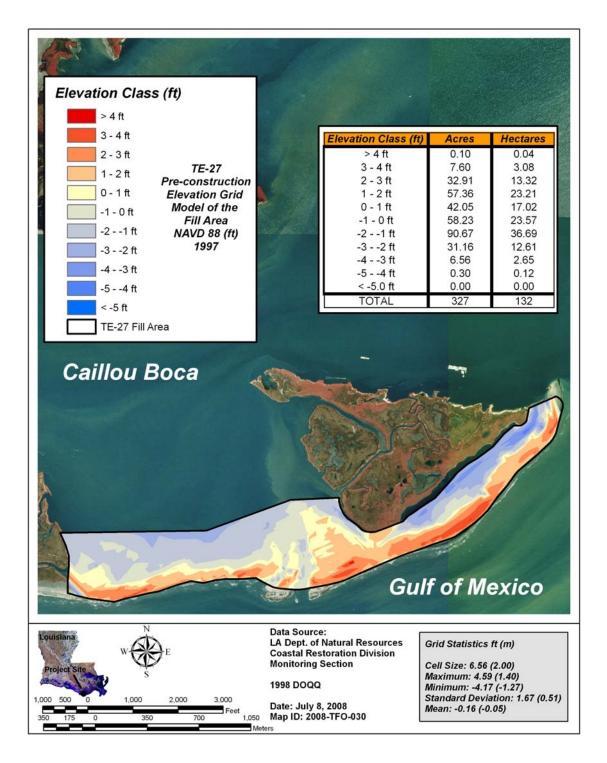
Elevation grid models for the 1997, 1998, 2000, and 2006 surveys are featured in Appendix C. The pre-construction (1997) elevation grid model shows a minimum elevation of -1.27 m (4.16 ft) and a maximum elevation of 1.40 m (4.59 ft). The asbuilt (1998) model shows a minimum elevation of 0.21 m (0.68 ft) and a maximum elevation of 2.23 m (7.31 ft). The 2000 elevation grid model shows a minimum elevation of -0.49 m (1.60 ft) and a maximum elevation of 1.82 m (5.97 ft). The 2006 elevation grid model shows a minimum elevation of -3.57 m (11.71 ft) and a maximum elevation of 1.67 m (5.47 ft).

Pre-construction (1997) elevation grid model at the Whiskey Island Restoration (TE-27) project.

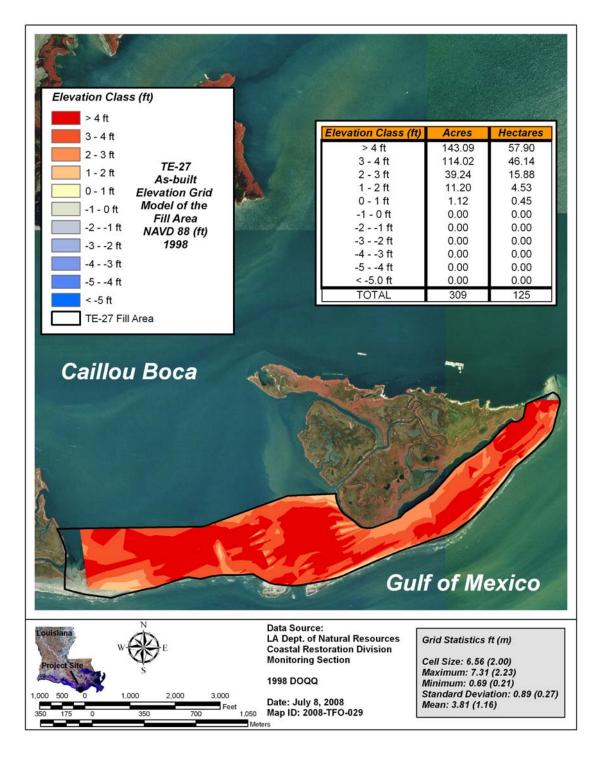
As-built (1998) elevation grid model at the Whiskey Island Restoration (TE-27) project.

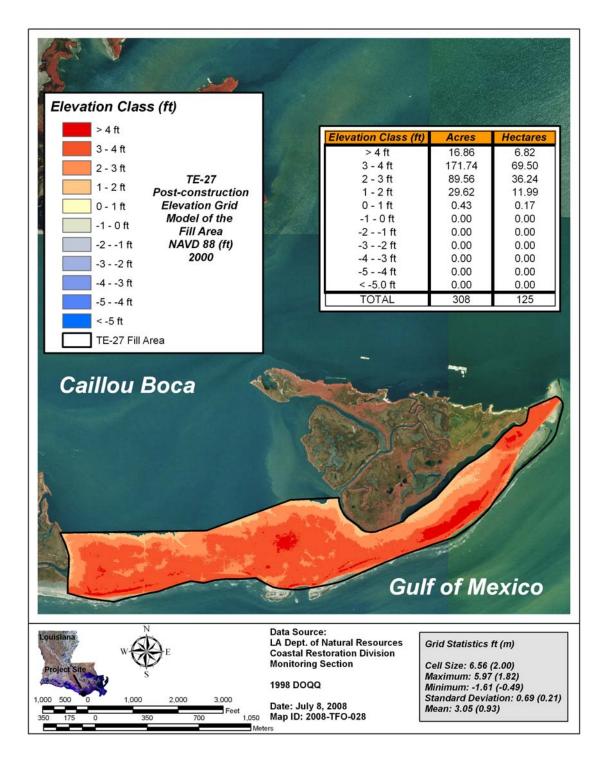
Post-construction (2000) elevation grid model at the Whiskey Island Restoration (TE-27) project.

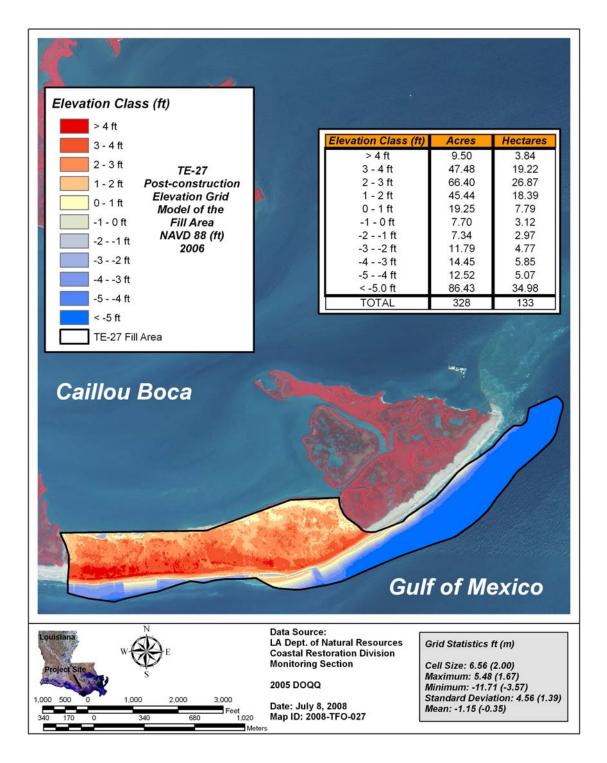
Post-construction (2006) elevation grid model at the Whiskey Island Restoration (TE-27) project.
