CS-11b

Sweet/Willow Lake Hydrologic Restoration Summary Data and Graphics

Sweet/Willow Lake Hydrologic Restoration (CS-11b)

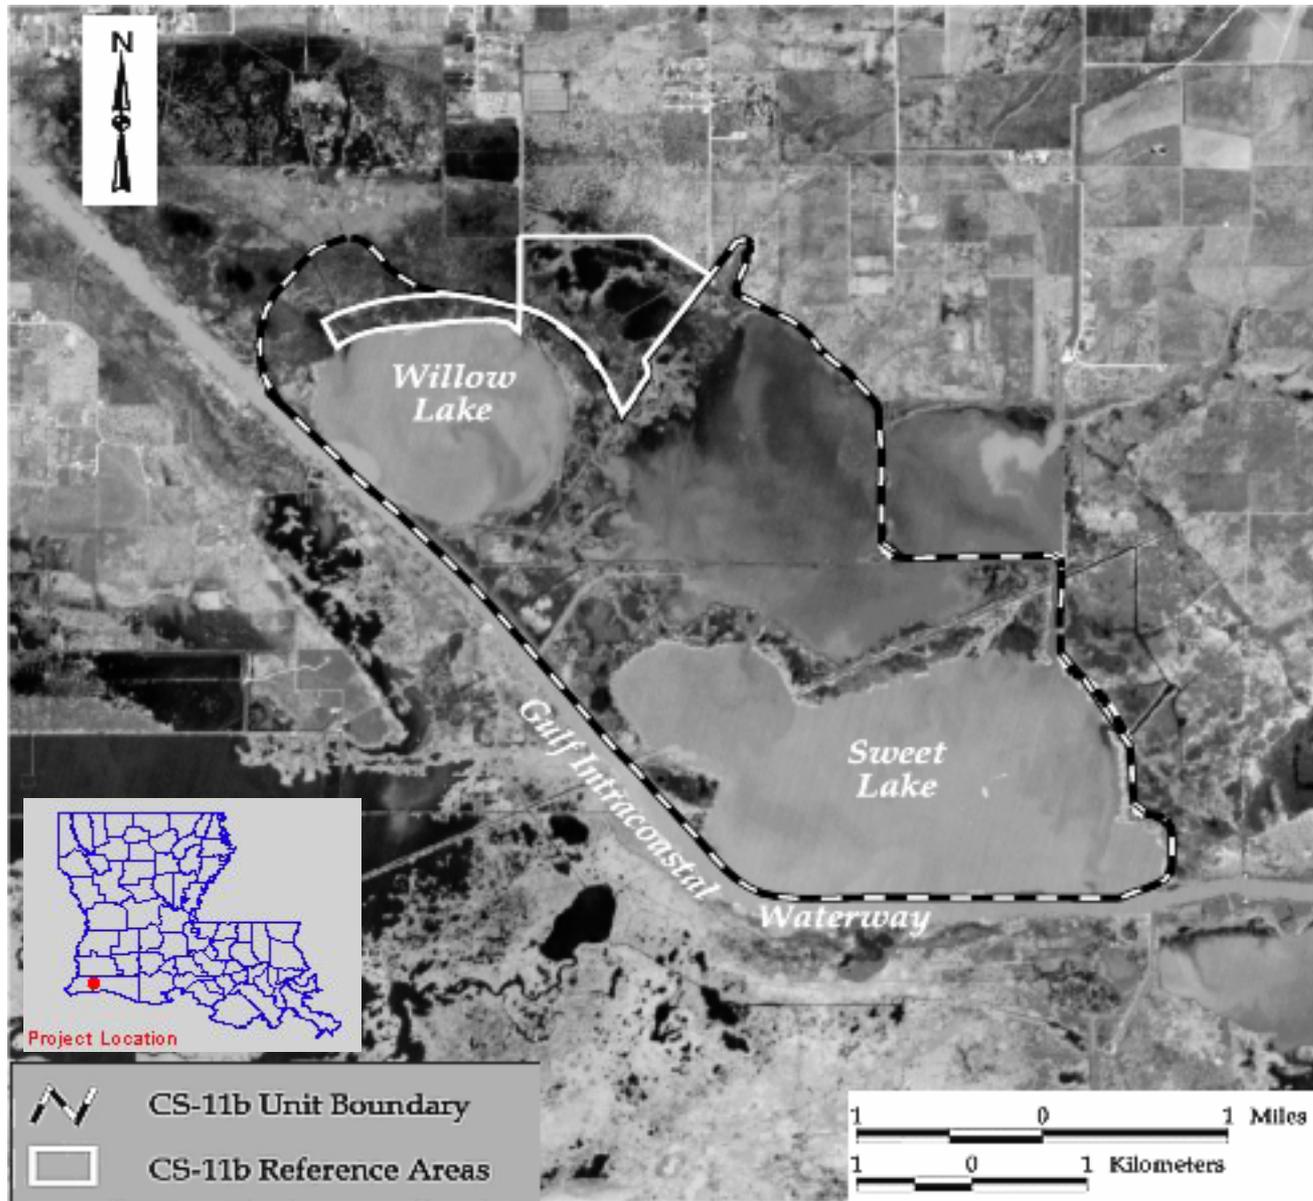
Figure 1. 1994 Sweet/Willow Lake Hydrologic Restoration (CS-11b) project and reference features.

The Sweet Lake/Willow Lake shoreline protection project is composed of approximately 6,000 ac (2,428 ha) of open water and freshwater wetlands surrounding Sweet Lake and Willow Lake in northeastern Cameron Parish (figure 1). The project area is bounded on the south and west by the Gulf Intracoastal Waterway (GIWW), and on the north and east by Pleistocene prairie formations along La. Hwy. 384 and La. Hwy. 27.

Shoreline Change: To document shoreline movement along the Sweet Lake shoreline, GPS surveys of unobstructed sections of shoreline adjacent to the *S. californicus* plantings were conducted in 2001 at the vegetative edge of the bank to document the position of the shoreline. Future shoreline surveys will be conducted, post-construction in 2004, 2009, and 2016. A similar survey will be conducted concurrently along a 1-mi (1.6 km) long section of the north shoreline of Willow Lake in reference area 1 (figure 1) for use as a reference.

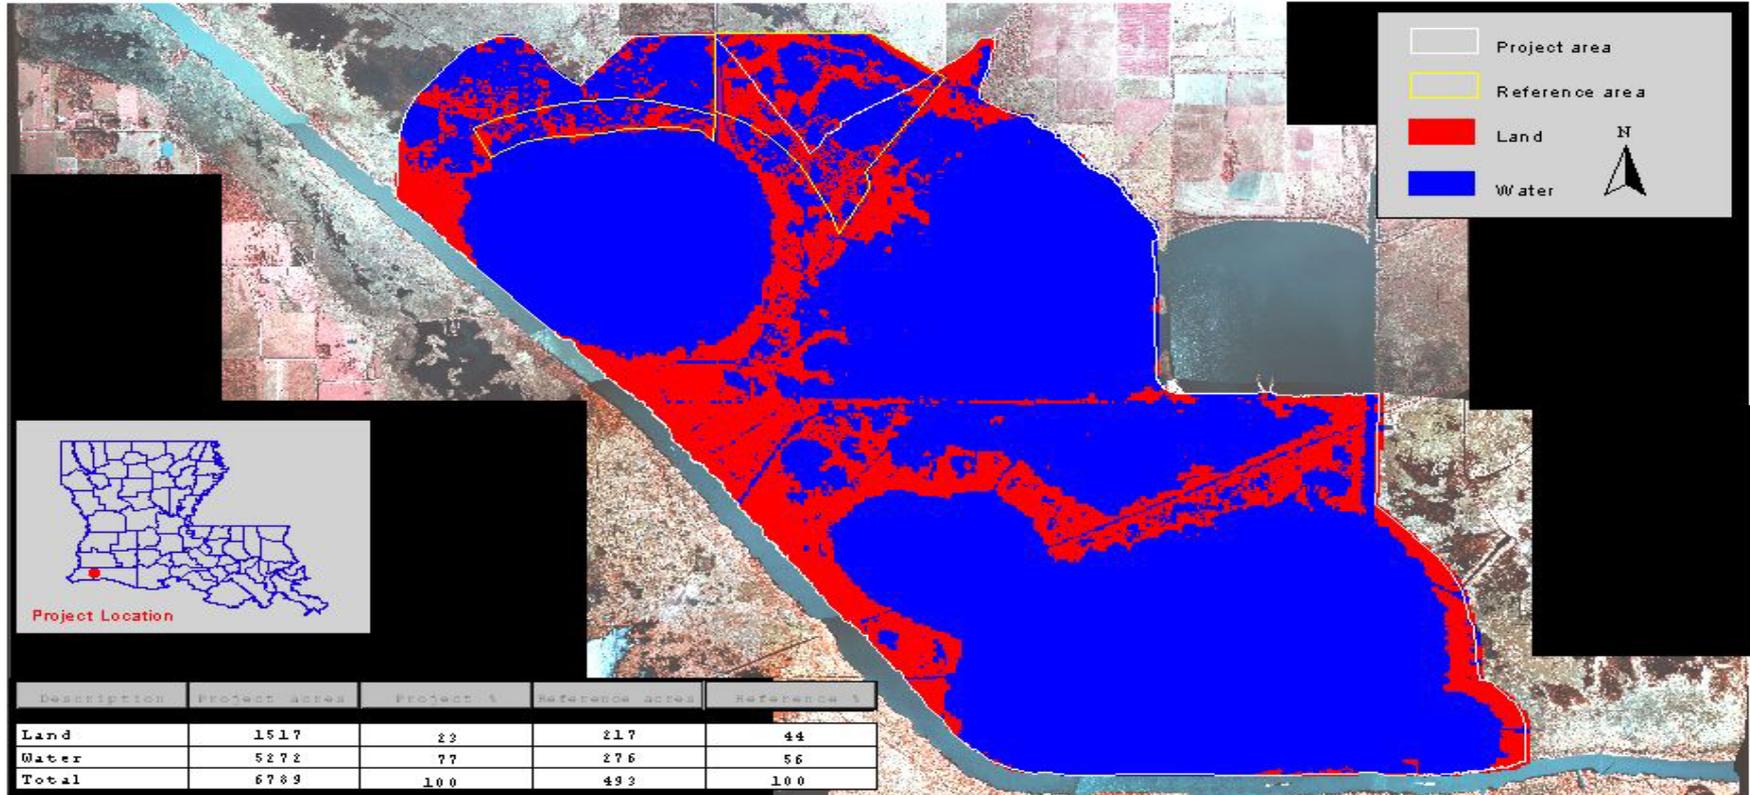
Figure 2. 1998 Land :Water Analysis of the Sweet/Willow Lake Hydrologic Restoration project and reference areas.

Source: The land-water analyses were derived from 1:12,000 scale color-infrared aerial photography acquired on December 17, 1998. Shown here at 1:51,000 scale.

Figure 2. 1998 land to water analysis of the Sweet/Willow Lake Hydrologic Restoration (CS-11b) project area.

- Pre-construction (1998) land:water classification indicate 23.0% land and 77.0% water within the project area versus 44.0% land and 56.0% water within reference area.

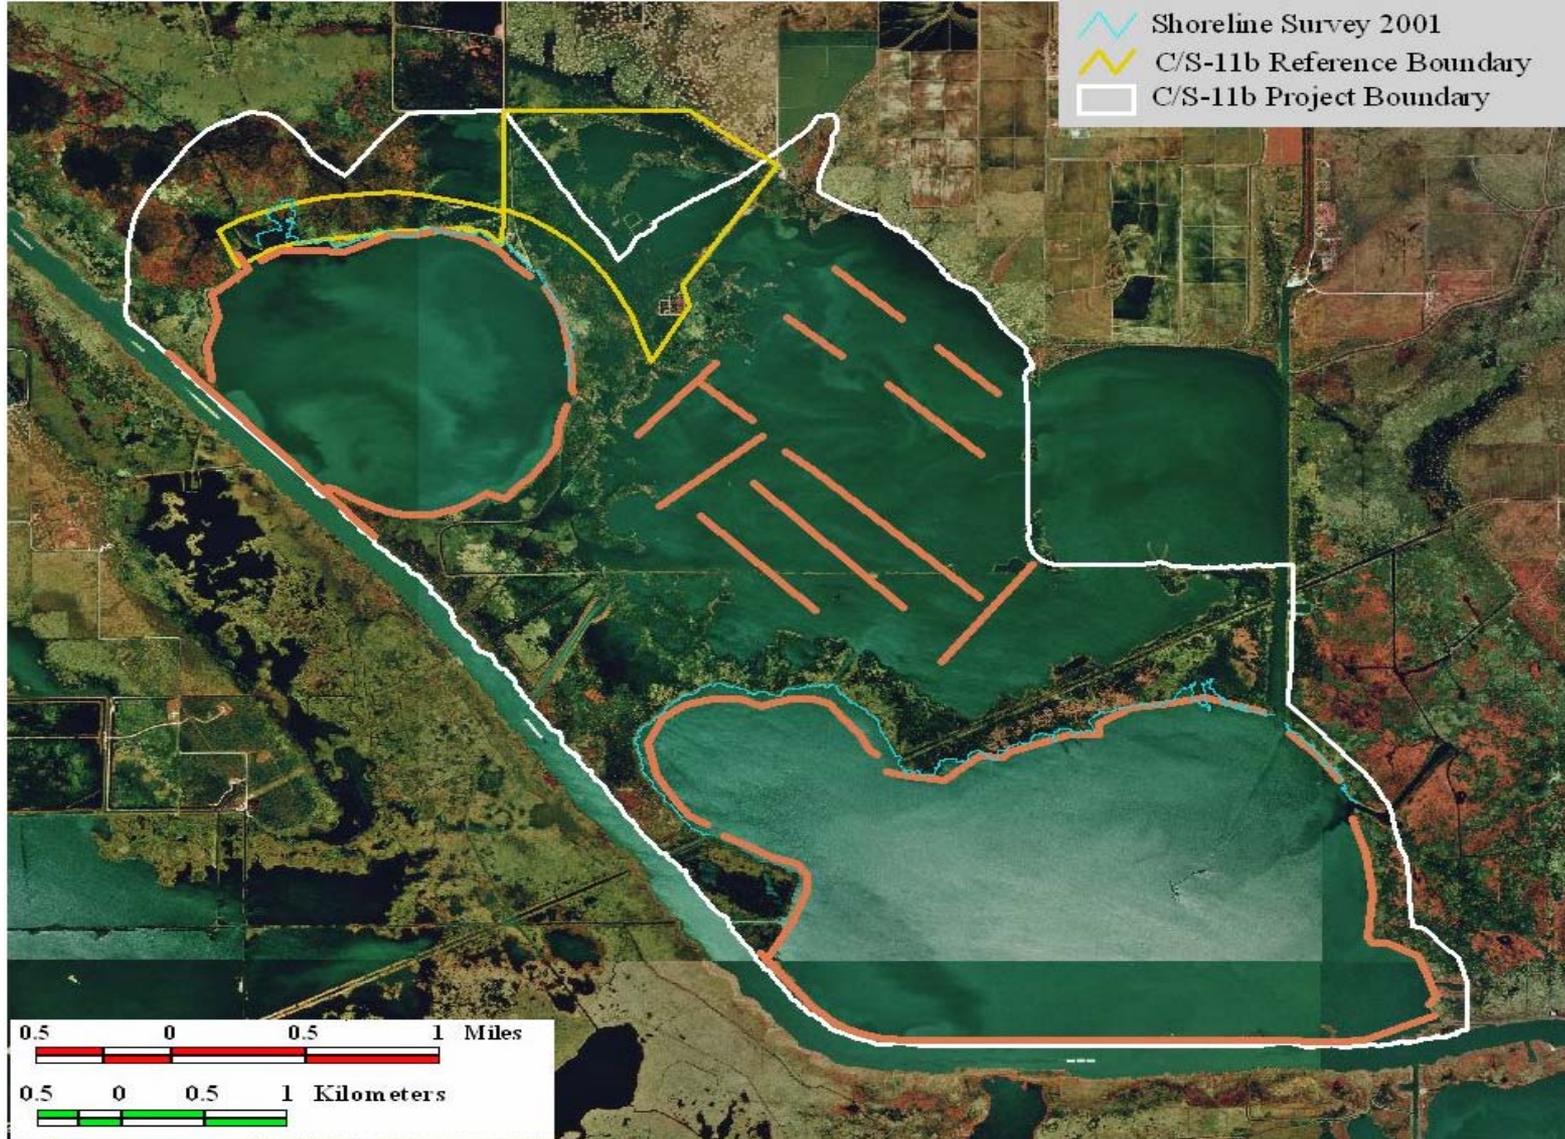
Figure 3. 2001 preconstruction DGPS survey of shoreline position in the Sweet/Willow Lake Hydrologic Restoration project area.

Figure 3. 2001 DGPS Shoreline survey of the Sweet/Willow Lake Hydrologic Restoration (CS-11b) project area and proposed location of the earthen terraces within the project area.

- Data were collected in August 2001 pre-construction. The data will be used to verify shoreline position over time.

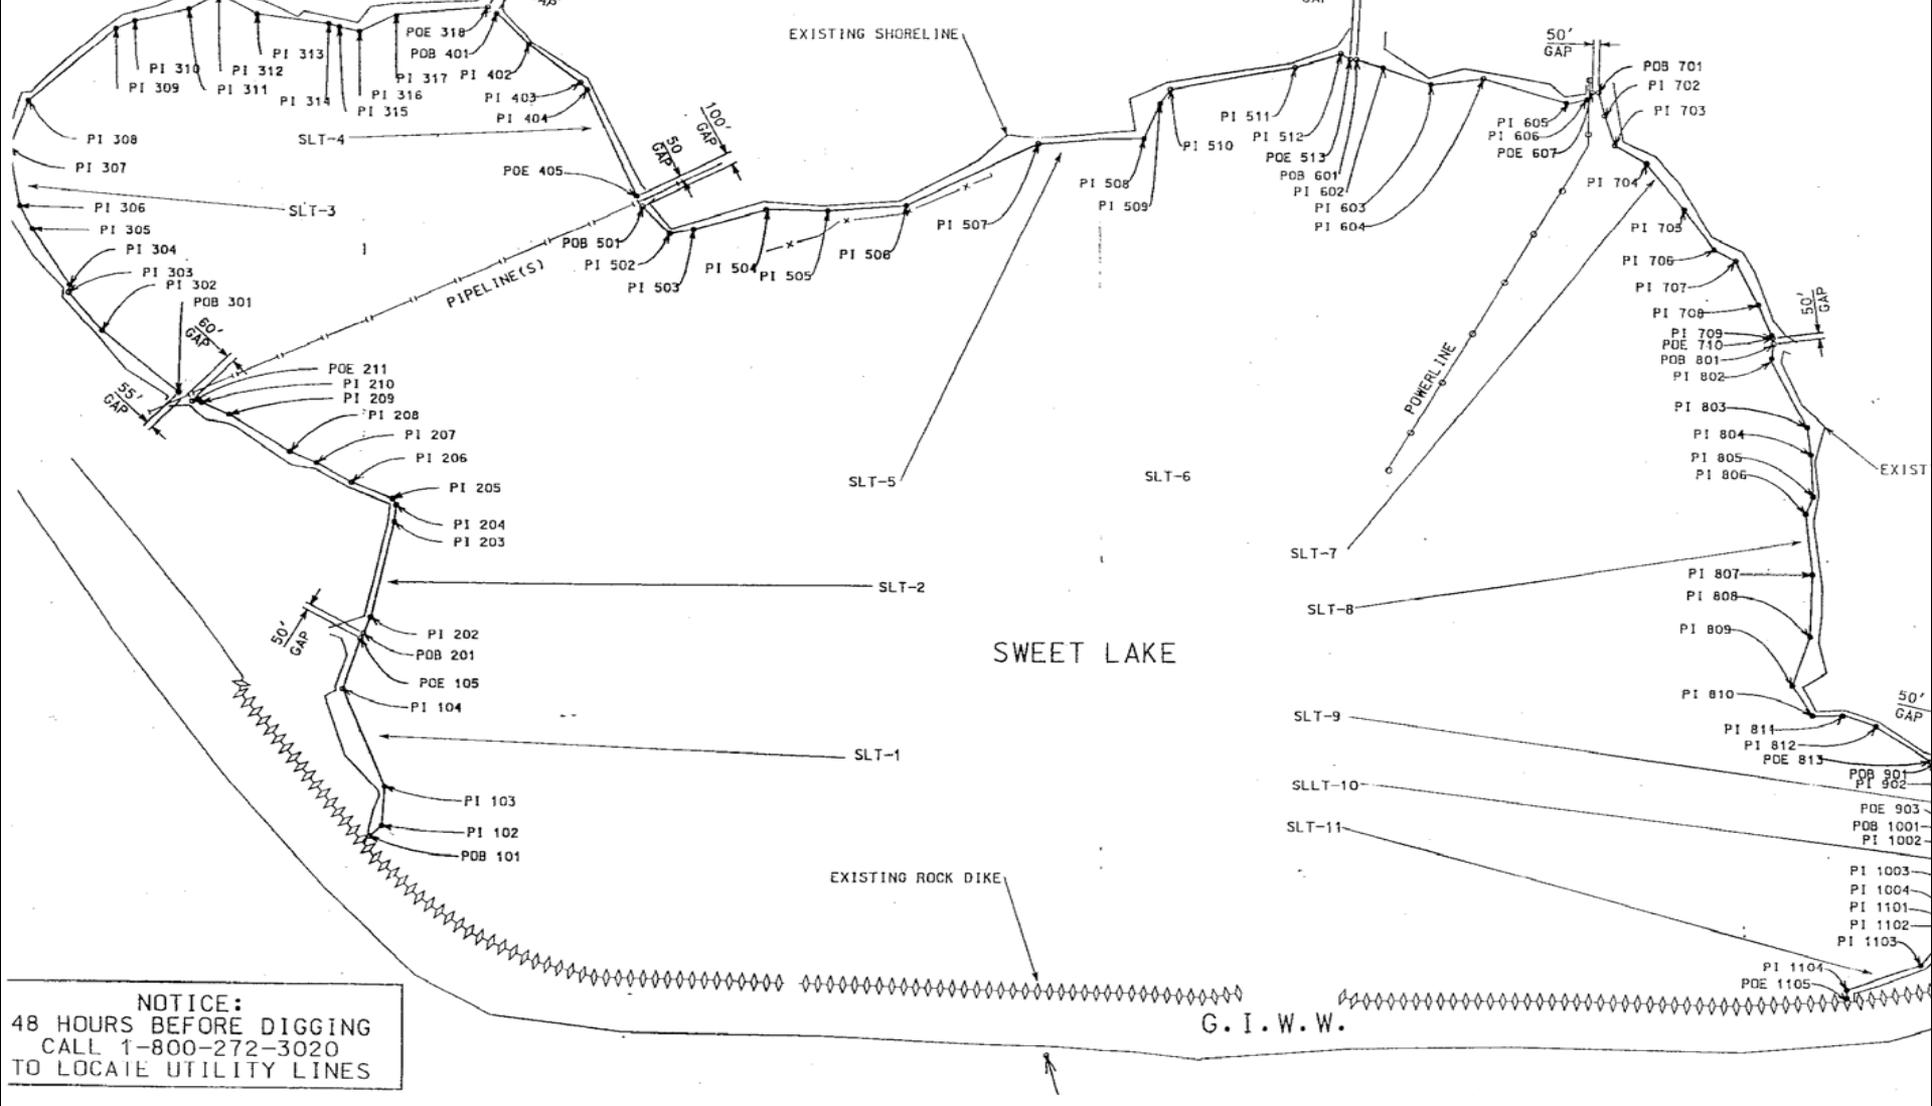
Figure 4. As-built project maps of Sweet Lake showing location of vegetative terraces.

Figure 4. As-built location of earthen terraces within the Sweet Lake area of the Sweet/Willow Lake Hydrologic Restoration (CS-11b) project area.

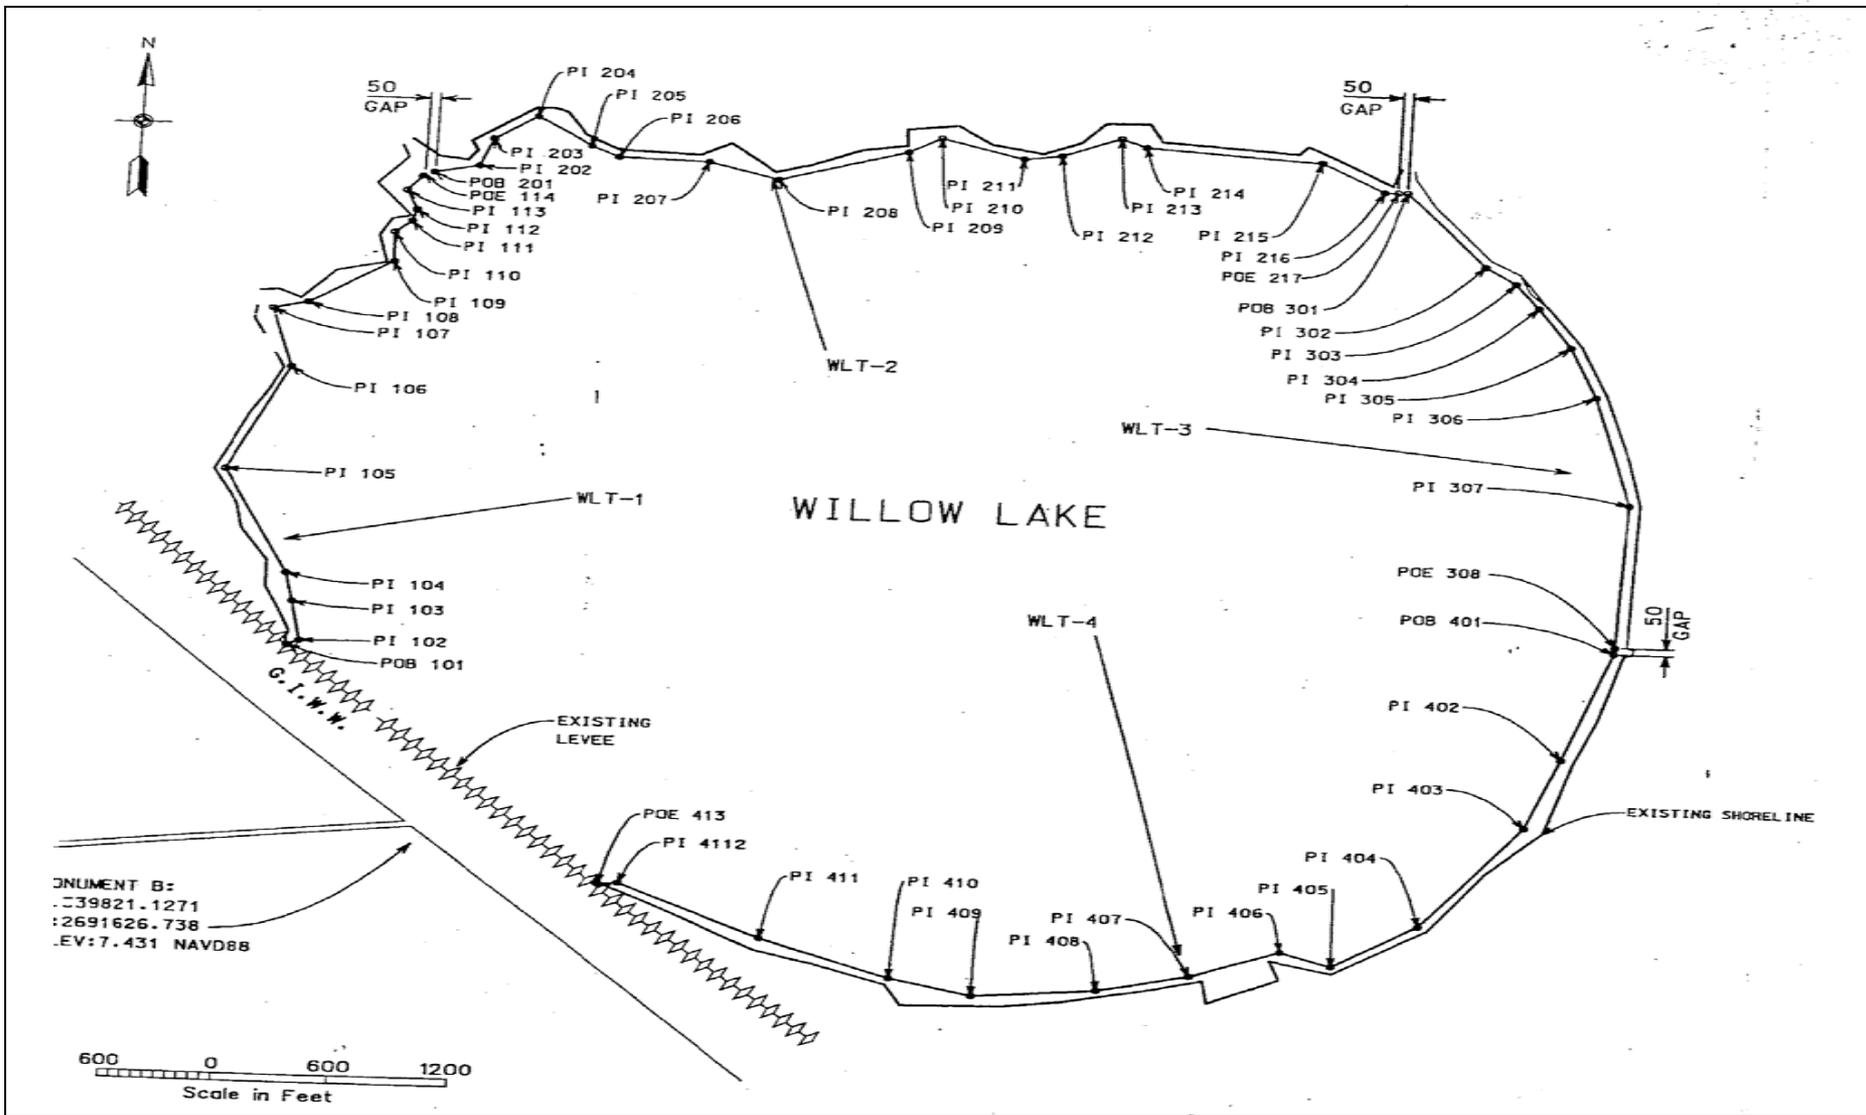
Figure 5. As-built project maps of Willow Lake showing location of vegetative terraces.

Figure 5. As-built location of earthen terraces within the Willow Lake area of the Sweet/Willow Lake Hydrologic Restoration (CS-11b) project area.

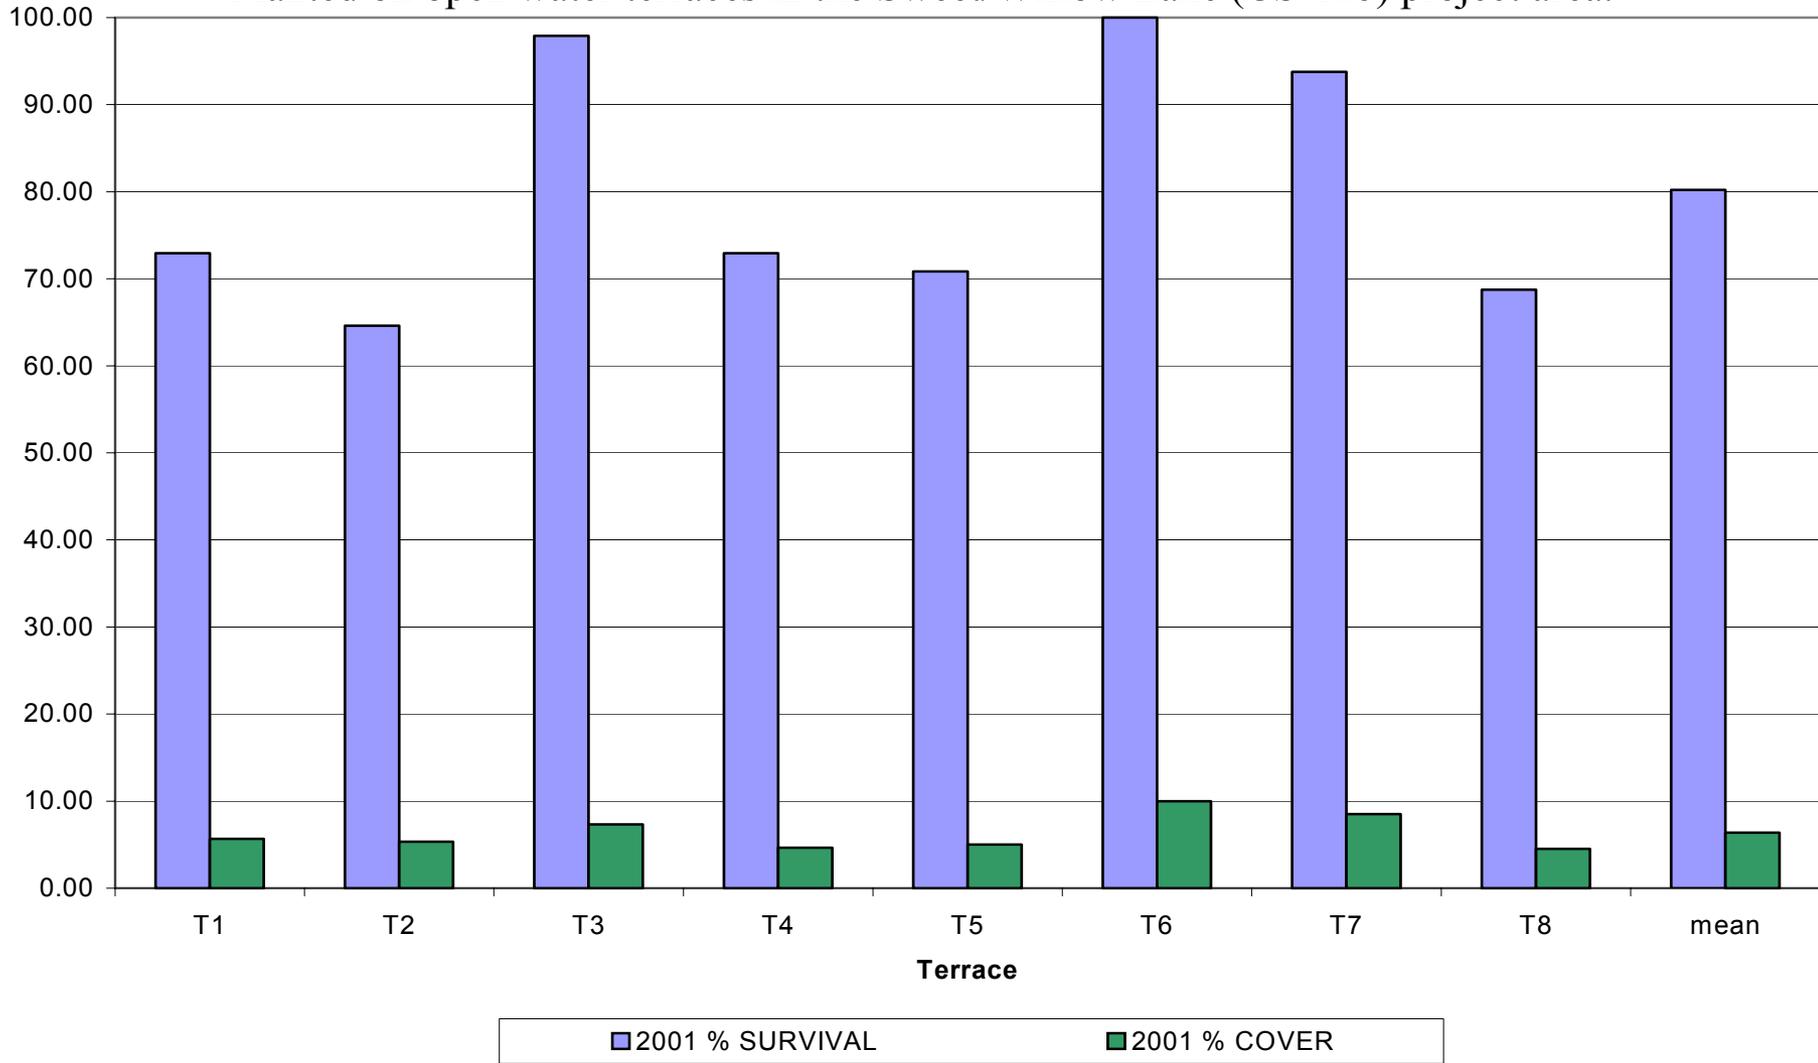
2001 % Survival and % Cover of *Zizaniopsis milaceae*
 Planted on open water terraces in the Sweet/Willow Lake (CS-11b) project area.

Figure 6. 2001 percent survival and percent cover of vegetative plantings on the open water terraces located in the Sweet/Willow Lake Hydrologic Restoration (CS-11b) project area.

- Data collected in December 2001 and November 2002 on open water terraces indicate that mean % survival has decreased from 80.21 to 33.72 percent.
- Data were collected in October 2002 on shoreline terraces along the Sweet Lake and Willow Lake perimeters. Sweet Lake and Willow Lake terraces had initial mean % survivals of 83.40 and 94.12 respectively.

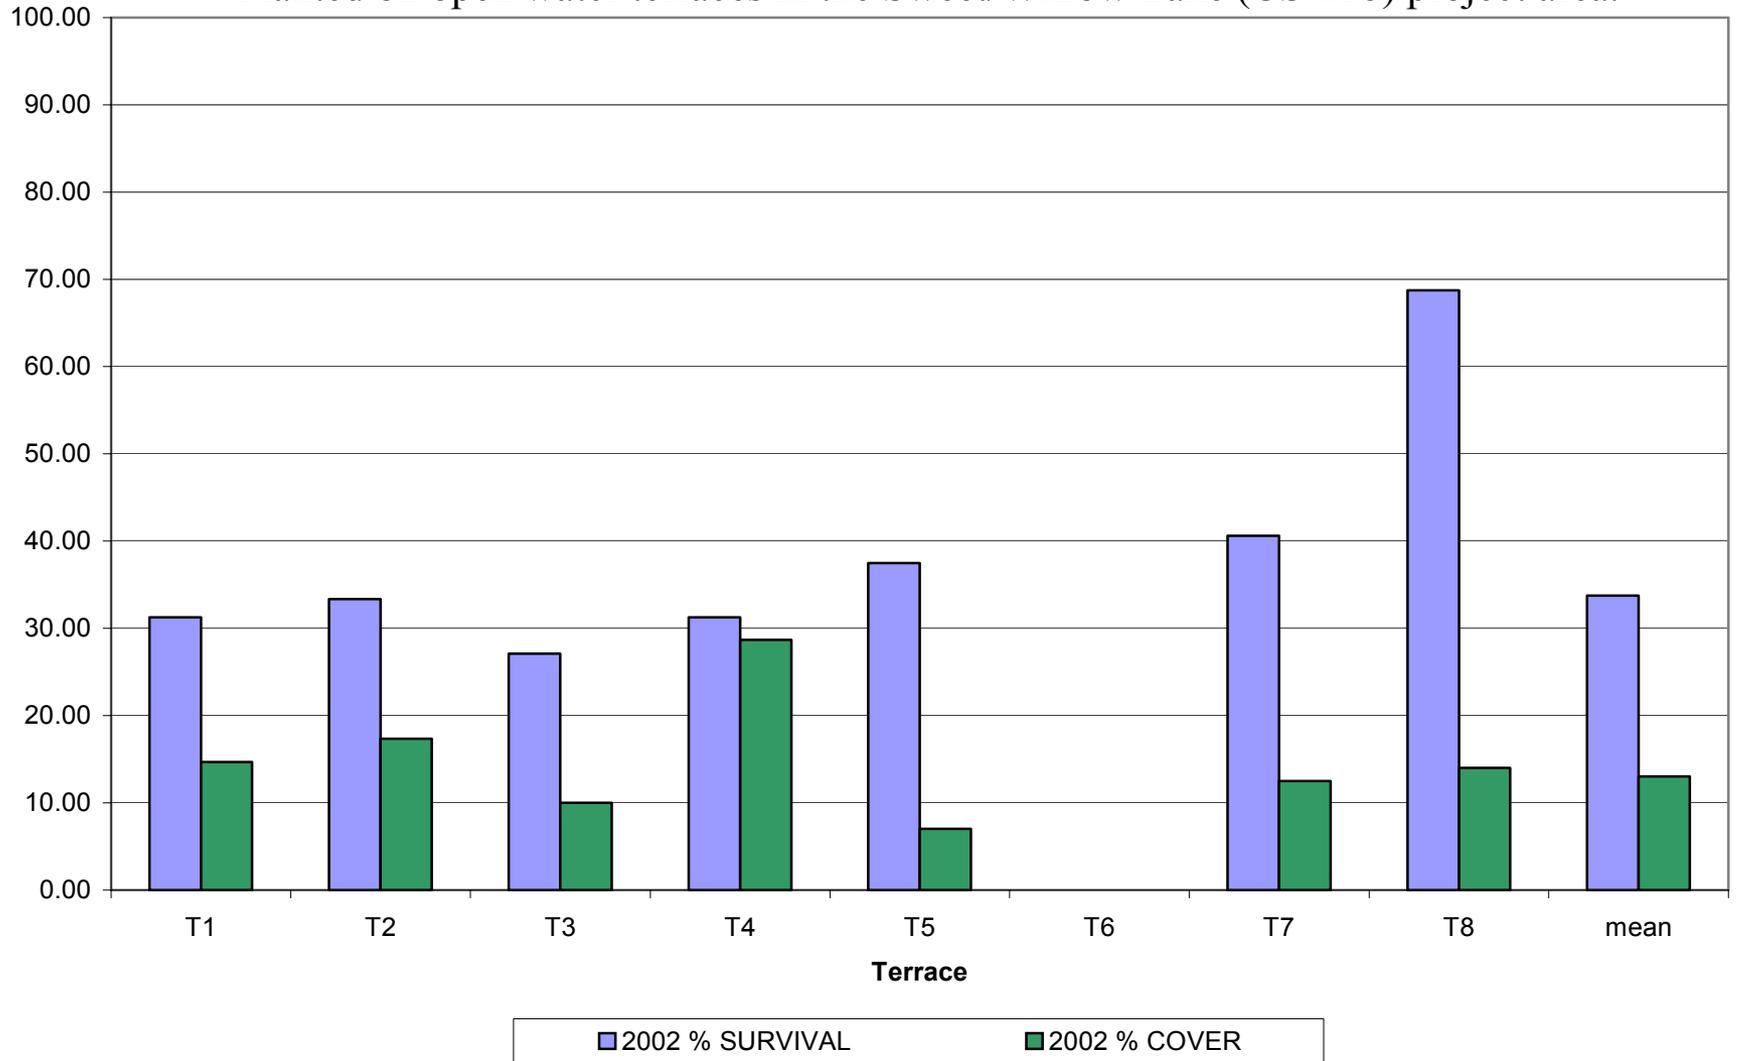
2002 % Survival and % Cover of *Zizaniopsis milaceae*
Planted on open water terraces in the Sweet/Willow Lake (CS-11b) project area.

Figure 7. 2002 percent survival and percent cover of vegetative plantings on the open water terraces located in the Sweet/Willow Lake Hydrologic Restoration (CS-11b) project area.

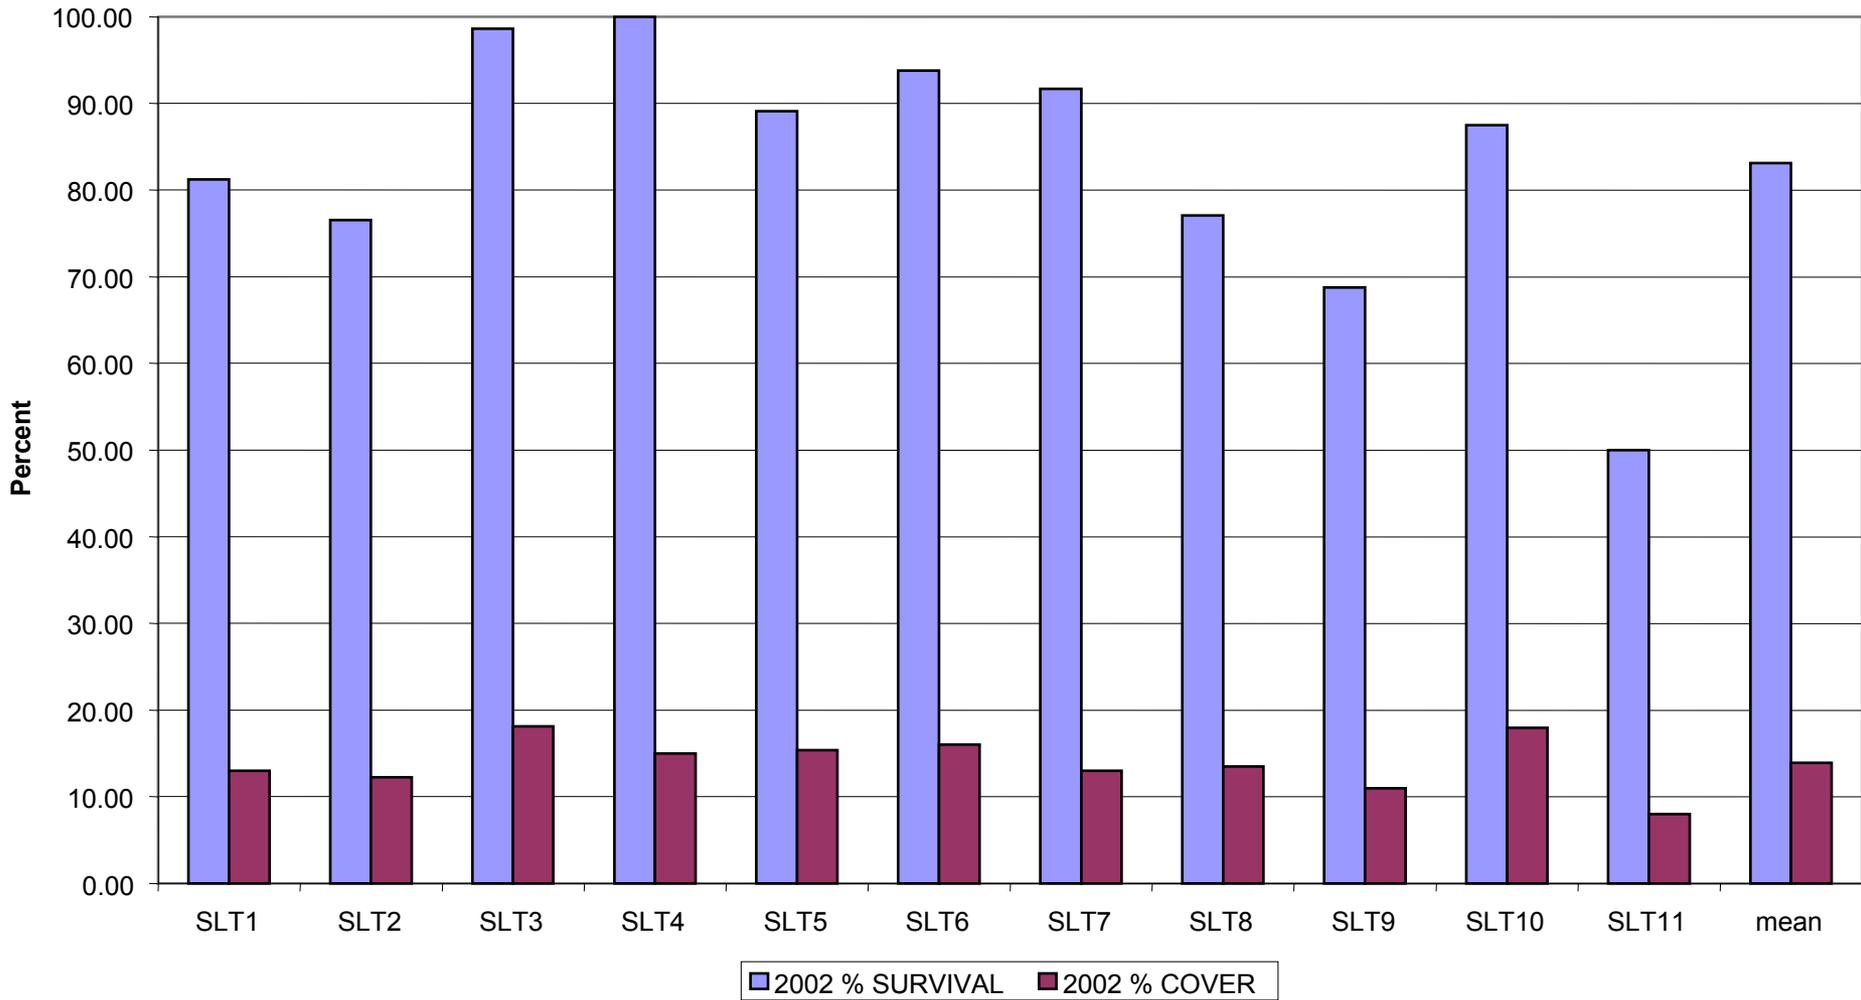
**2002 % Survival and % Cover of *Zizaniopsis miliacea*
planted along shoreline terraces within Sweet Lake project area.**

Figure 8. 2002 percent survival and percent cover of vegetative plantings along the Sweet Lake shoreline terraces located in the Sweet/Willow Lake Hydrologic Restoration (CS-11b) project area.

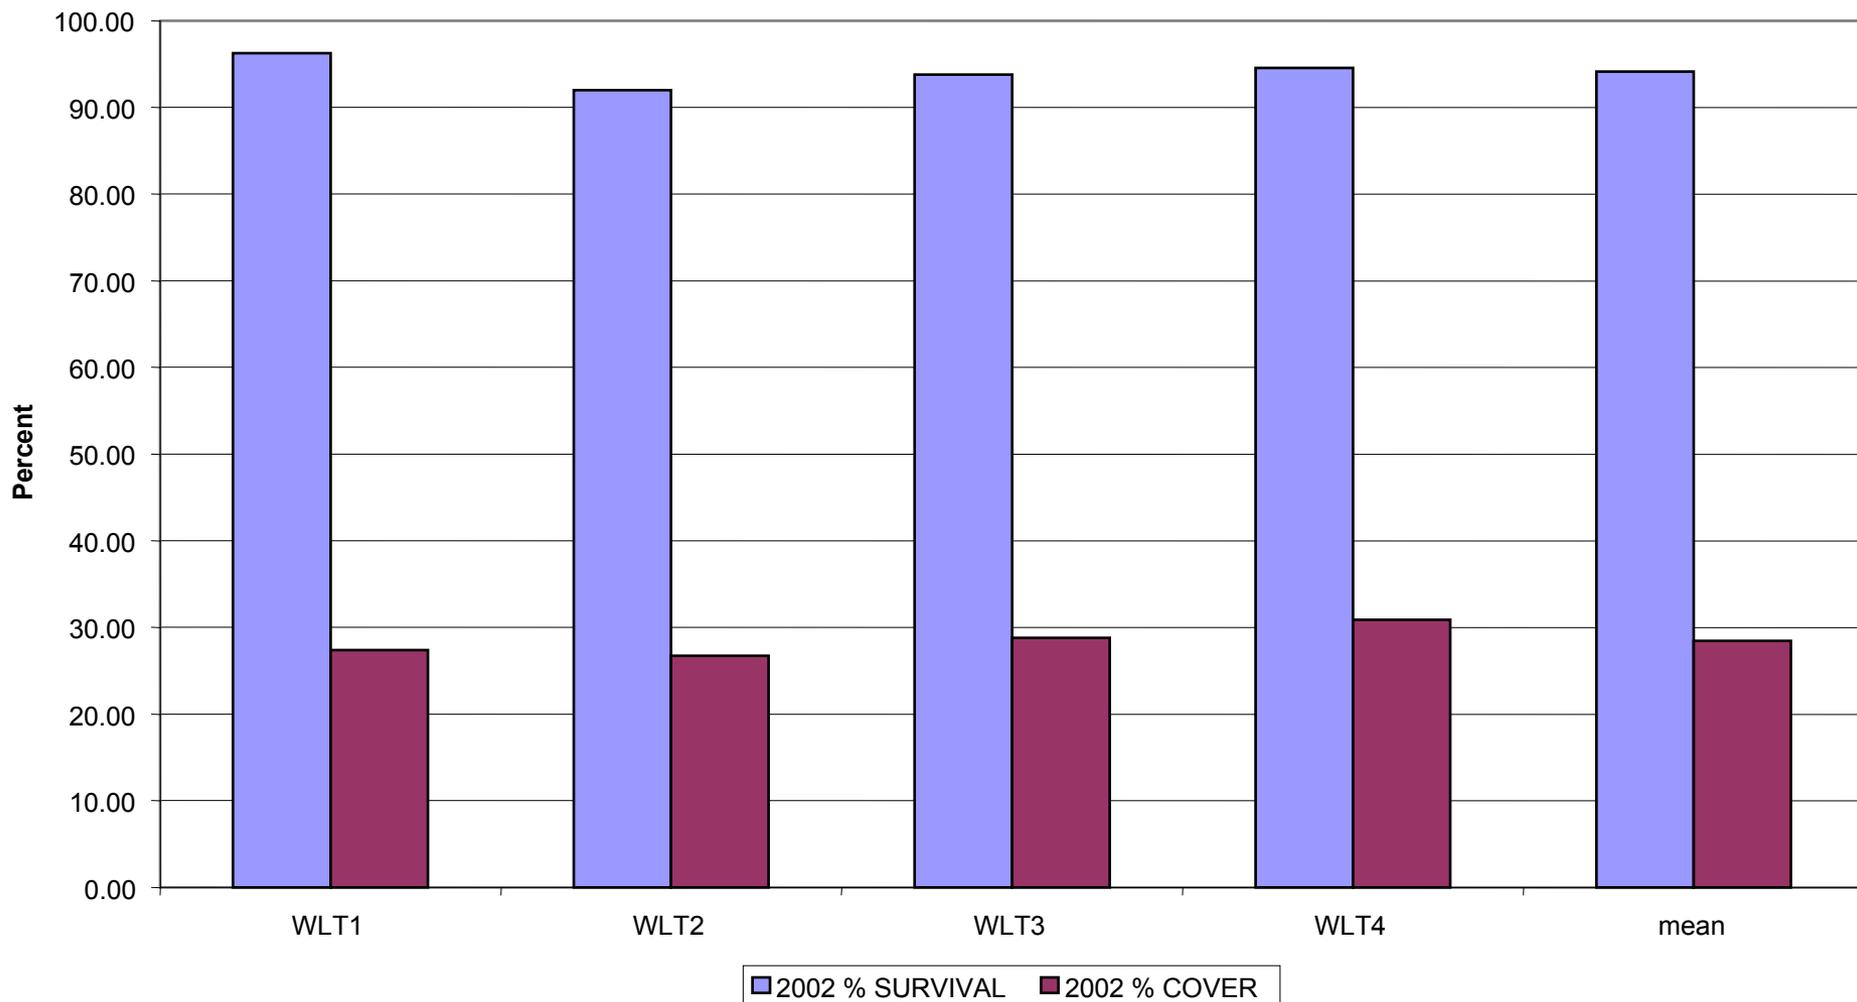
**2002 % Survival and % Cover of *Zizaniopsis miliacea*
planted along shoreline terraces within Willow Lake project area.**

Figure 9. 2002 percent survival and percent cover of vegetative plantings along the Willow Lake shoreline terraces located in the Sweet/Willow Lake Hydrologic Restoration (CS-11b) project area.

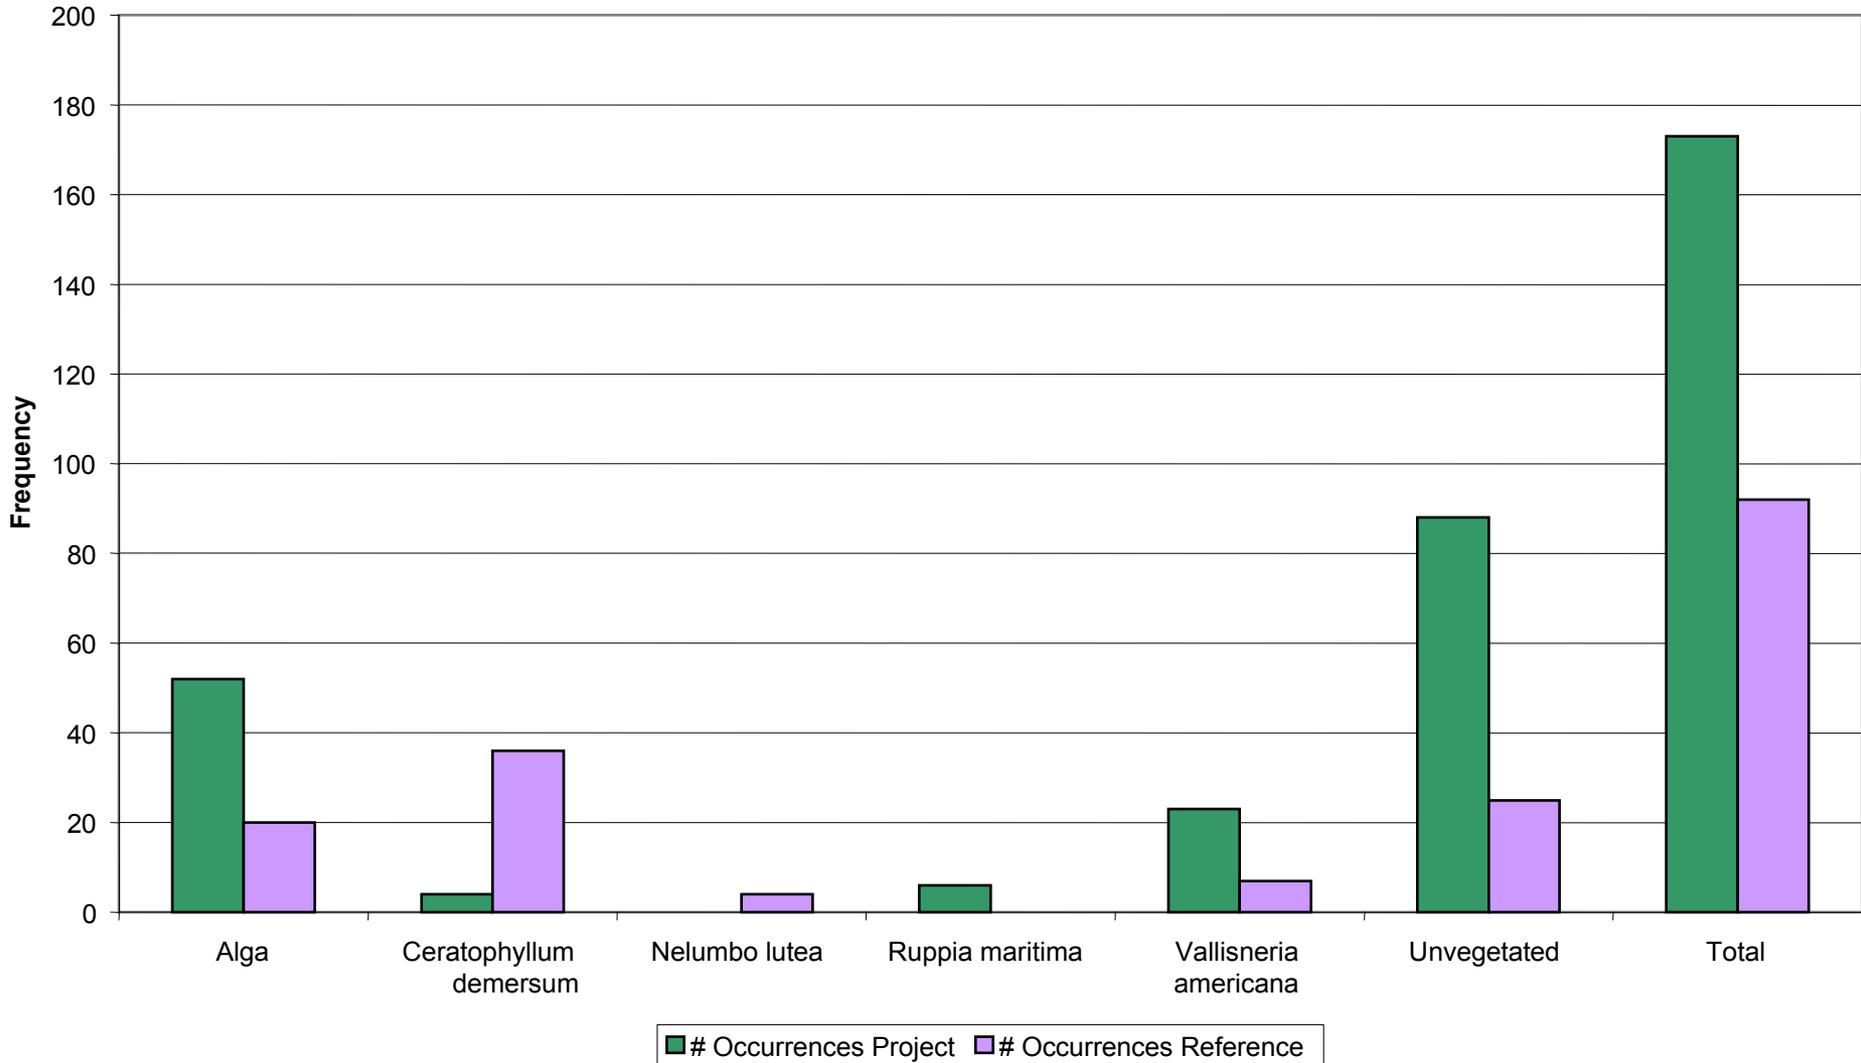
Frequency of Occurrences of SAV within the CS-11b Project and Reference areas from 05/2000.

Figure 10. 2000 preconstruction data for number of occurrences of submerged aquatic vegetation within the Sweet/Willow Lake Hydrologic Restoration (CS-11b) project and reference areas.

- Data were collected in May 2000 pre-construction. Initial data indicated that unvegetated areas within the project and reference areas were 50.87 and 27.17 percent respectively.

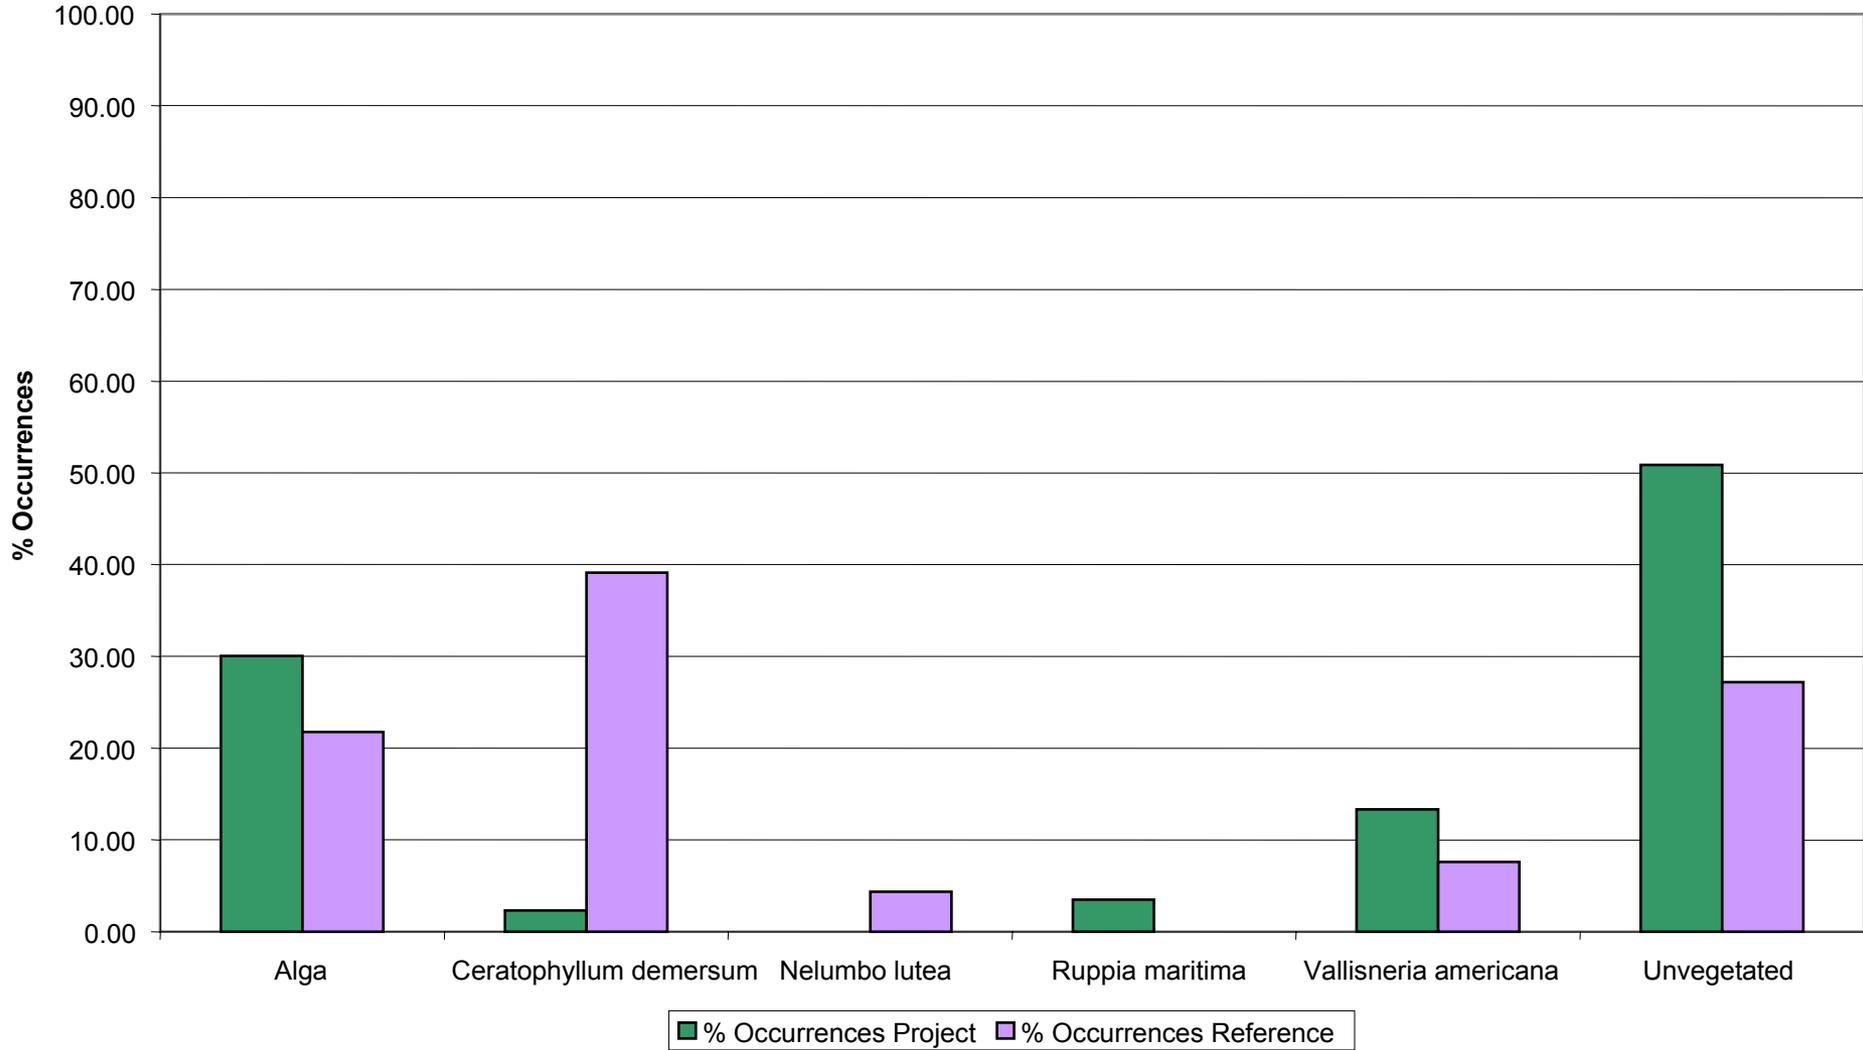
% Occurrences of SAV within the CS-11b Project and Reference areas from 05/2000.

Figure 11. 2000 preconstruction data for percent occurrences of submerged aquatic vegetation within the Sweet/Willow Lake Hydrologic Restoration (CS-11b) project and reference areas.
