## 2010 Operations, Maintenance, and Monitoring Report

### Little Lake Shoreline Protection/Dedicated Dredging Near Round Lake (BA-37)

State Project Number BA-37  
Priority Project List 11

September 2010  
Lafourche Parish

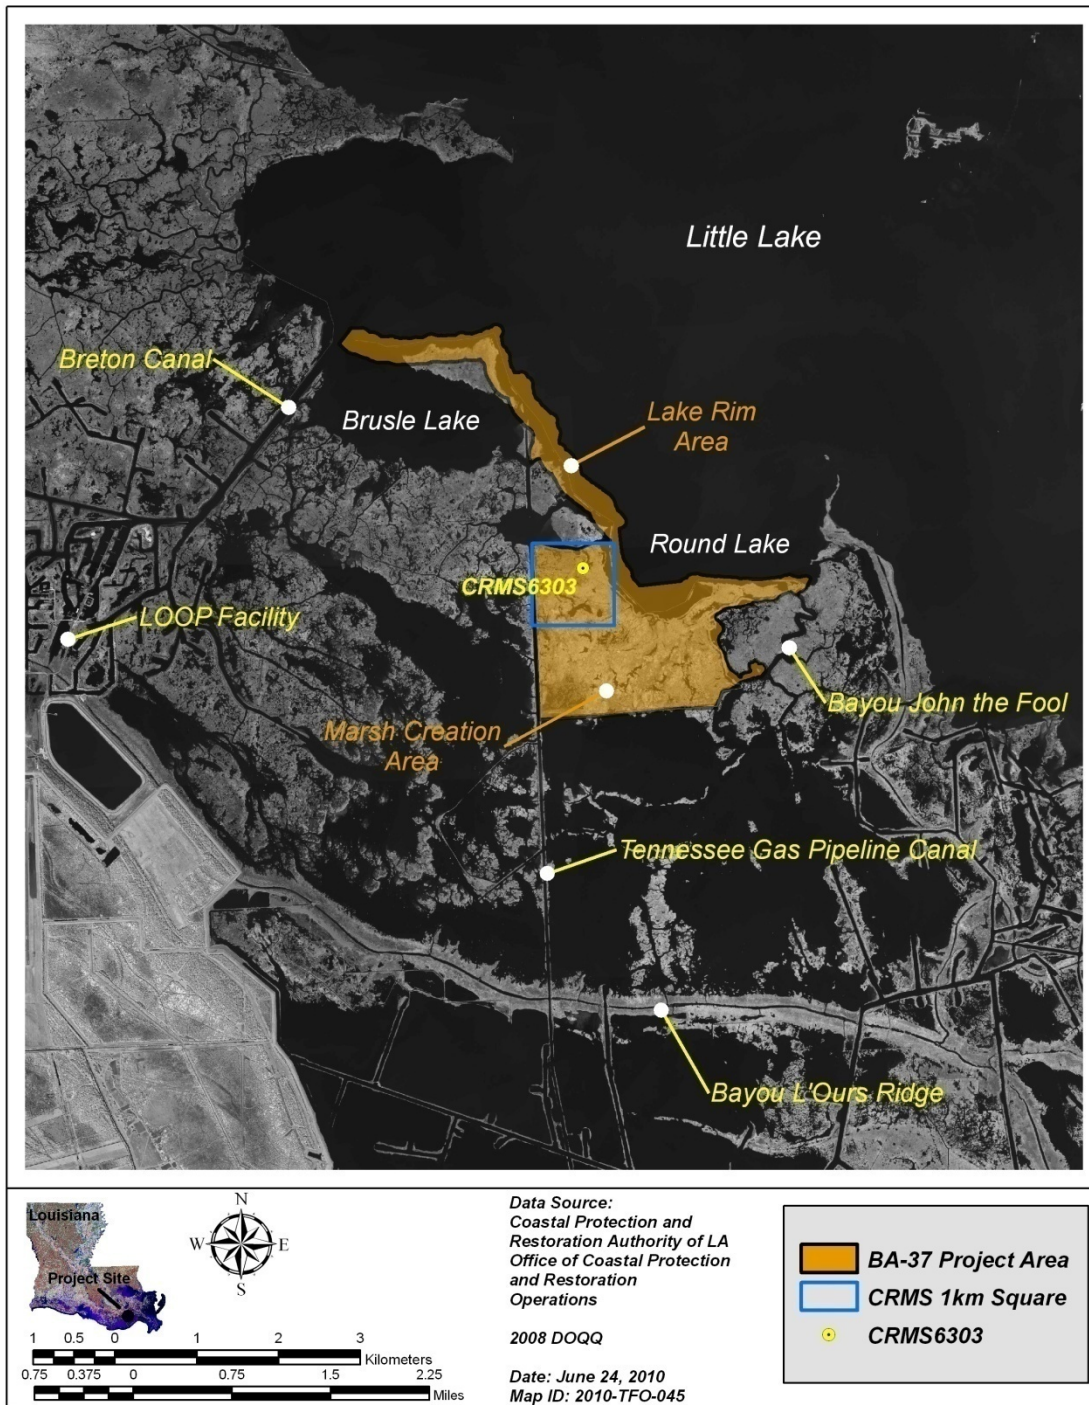
**Figure 2. Location of the Little Lake Shoreline Protection/Dedicated Dredging Near Round Lake (BA-37) project area.**

Because of the inclusion of a Coast-wide Reference Monitoring System-Wetlands (CRMS) site (CRMS6303) inside the Little Lake Shoreline Protection/Dedicated Dredging Near Round Lake (BA-37) project area (figures 2 and 7), land/water analysis was performed on a 1.0 km<sup>2</sup> (0.4 mi<sup>2</sup>) portion of the marsh creation area. The U.S. Geological Survey's National Wetlands Research Center (USGS/NWRC) obtained 1.0 m (3.3 ft) resolution color infrared (CIR) aerial photography to delineate land and water habitats over time. A pre-construction aerial image was captured on November 1, 2005. This image was analyzed, interpreted, processed, and verified for quality and accuracy using protocols established in Folse et al. (2008). Specifically, habitats in the 1 km<sup>2</sup> (0.4 mi<sup>2</sup>) were condensed to a land or water classification. Land was considered to be a combination of emergent marsh, scrub-shrub, wetland forested, and upland habitats. The open water, beach/bar/flat, and submerged aquatics (SAV) habitat classes were considered water. Once grouped into these two classes, the percentage of land and water and the land to water ratio for the pre-construction period were calculated. After the analysis was complete, the classification data and the photomosaic were mapped to spatially view the data.

Because of the inclusion of a Coast-wide Reference Monitoring System-Wetlands (CRMS) site (CRMS6303) inside the Little Lake Shoreline Protection/Dedicated Dredging Near Round Lake (BA-37) project area (figures 2 and 7), vegetation data was collected in the marsh creation area. Vegetation stations were established in the BA-37 marsh creation area to document species composition and percent cover over time. Ten (10) plots were placed inside the 200 m<sup>2</sup> (239 yd<sup>2</sup>) square, which is nested within the 1.0 km<sup>2</sup> (0.4 mi<sup>2</sup>) square, as per Folse et al. (2008) (figure 7). Vegetation data were collected in October 2008 (2 year post-construction) and July 2009 (3 years

Because of the inclusion of a Coast-wide Reference Monitoring System-Wetlands (CRMS) site (CRMS6303) inside the Little Lake Shoreline Protection/Dedicated Dredging Near Round Lake (BA-37) project area (figures 2 and 7), hydrologic data is being collected in the marsh creation area. One (1) continuous recorder station was installed north of the 200 m<sup>2</sup> (239 yd<sup>2</sup>) square and on the inner perimeter of the 1.0 km<sup>2</sup> (0.4 mi<sup>2</sup>) square and the BA-37 project area using procedures established in Folse et al. (2008). The continuous recorder was adjusted to collect date/time (MM/DD/YYYY, hh:mm:ss) in central standard time (CST), temperature (°C), specific conductance (µS/cm), salinity (ppt), water level (ft), and battery voltage (V) data on an hourly interval. The station was deployed and serviced, and the data was processed and verified for quality and accuracy in accordance with the Folse et al. (2008) protocol. The continuous recorder station was established on October 24, 2008 and has been under constant operation since that time. Monthly mean water level and salinity data were calculated to summarize the data collected from this hydrologic monitoring station during the period from October 2008 to January 2010.

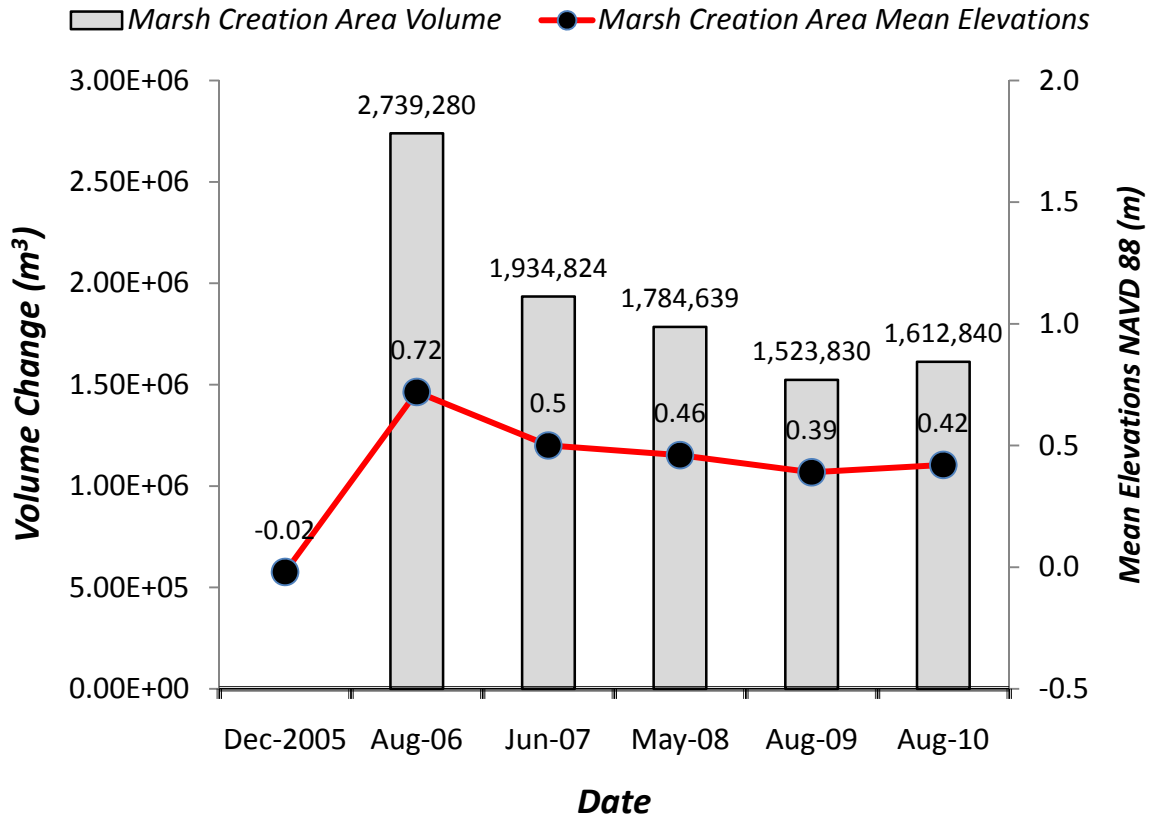
**Figure 13. Sediment volumes and mean elevations over time inside the Little Lake Shoreline Protection/Dedicated Dredging Near Round Lake (BA-37) marsh creation and nourishment area.**

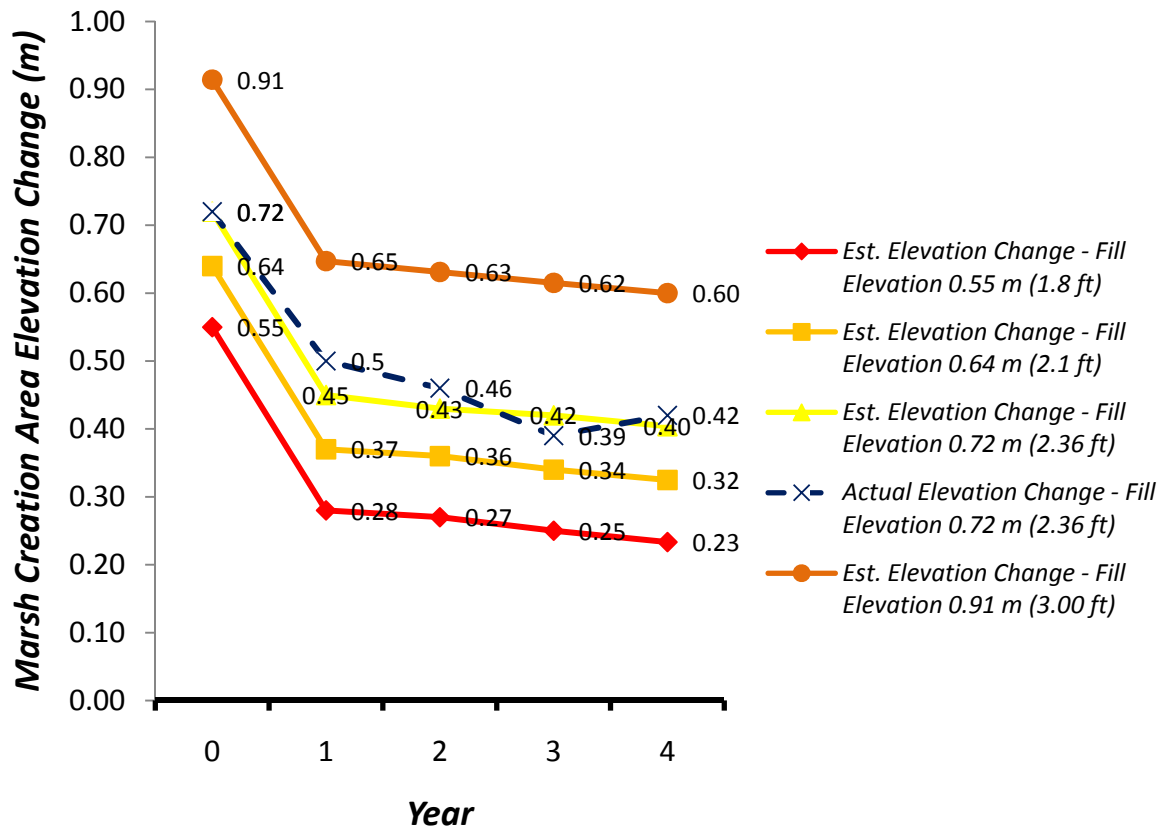
**Figure 14. Estimated and actual sediment consolidation inside the Little Lake Shoreline Protection/Dedicated Dredging Near Round Lake (BA-37) marsh creation and nourishment area.**

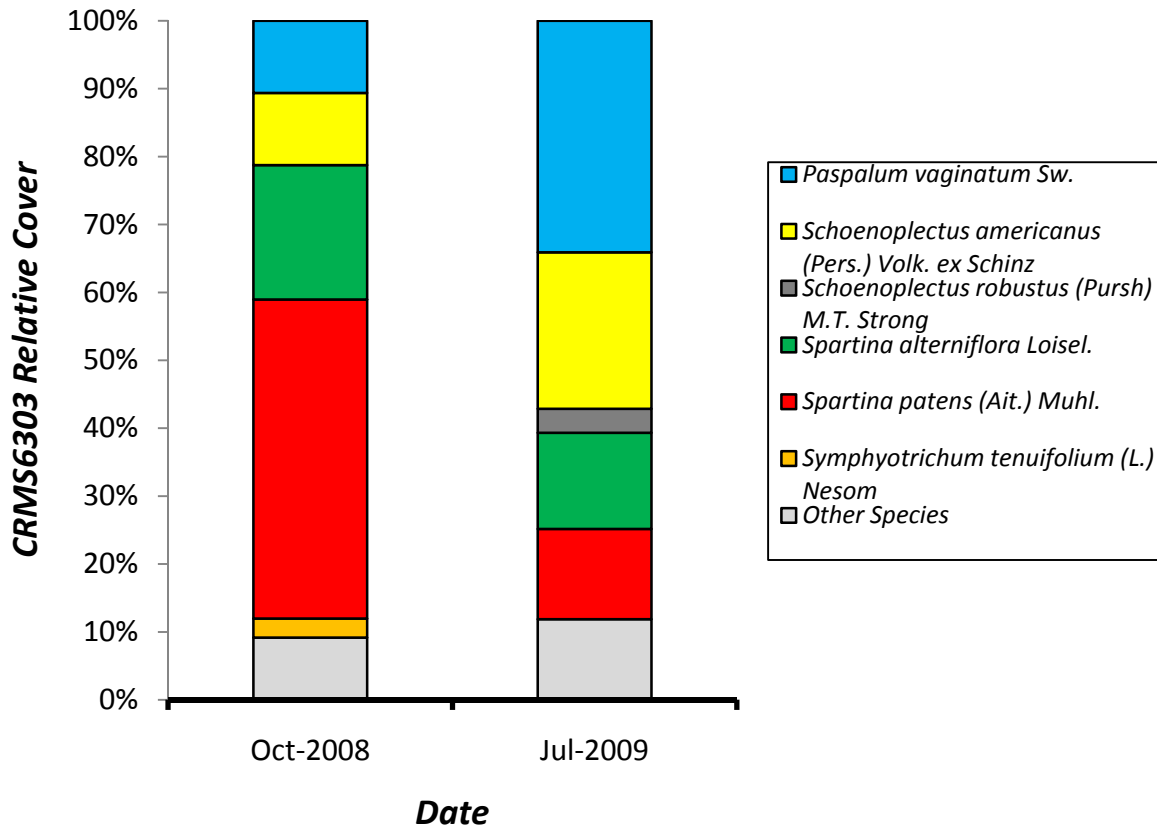
**Figure 24.** Relative cover of the top five vegetation species populating the CRMS6303 200 m square inside the Little Lake Shoreline Protection/Dedicated Dredging Near Round Lake (BA-37) marsh creation and nourishment area in 2007 to 2008. Ocular vegetation data were grouped by year.

The CRMS6303 vegetation data confirms the classification of Little Lake Shoreline Protection/Dedicated Dredging Near Round Lake (BA-37) marsh creation area as intermediate marsh. The dominant species found during both sampling events were *Spartina patens* (Ait.) Muhl. (saltmeadow cordgrass), *Paspalum vaginatum* Sw. (seashore paspalum), *Schoenoplectus americanus* (Pers.) Volk. ex Schinz & R. Keller (chairmaker's bulrush), and *Spartina alterniflora* Loisel. (smooth cordgrass) (figure

24). *S. patens*, *P. vaginatum*, and *S. americanus* are common inhabitants and indicator species for intermediate marsh. While *S. alterniflora* is ubiquitous in salt marsh communities, this species is also known to populate brackish and intermediate communities (Chabreck and Condrey 1979). The relative cover disparities between the two sampling events are probably due to seasonal variations in species growth. The 2008 vegetation sampling occurred in October and the 2009 data were collected in July (figure 24). Some *Spartina* species have been shown to have seasonal standing crops (Kirby and Grosselink 1976). As a result, their cover values are also cyclic and vary by season. In closing, the CRMS6303 vegetation data support the assumption that the BA-37 marsh creation and nourishment goals are being attained.

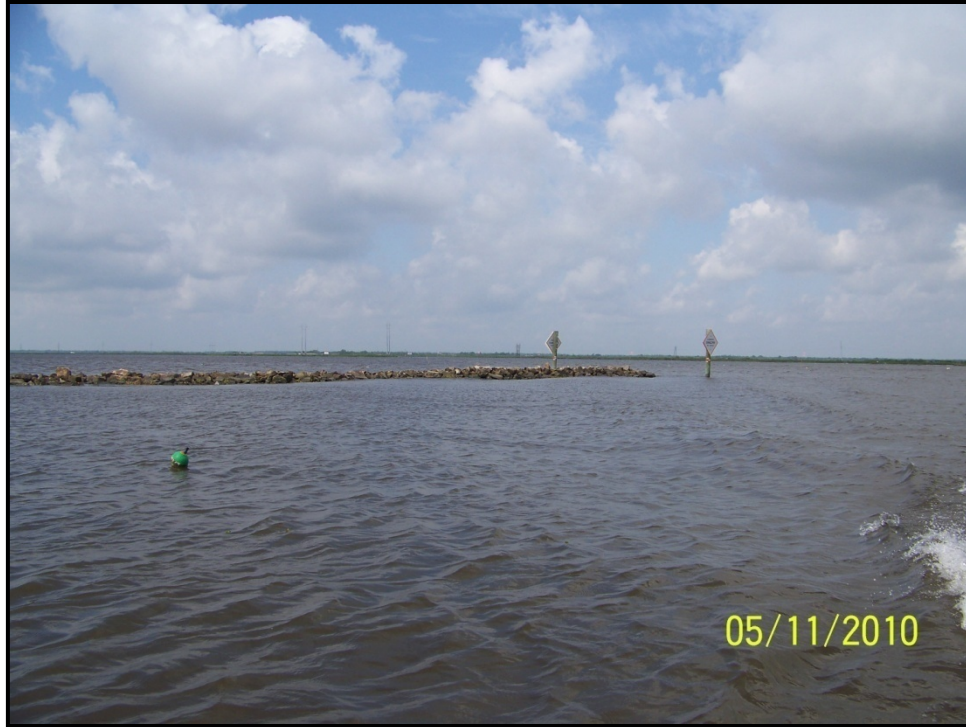
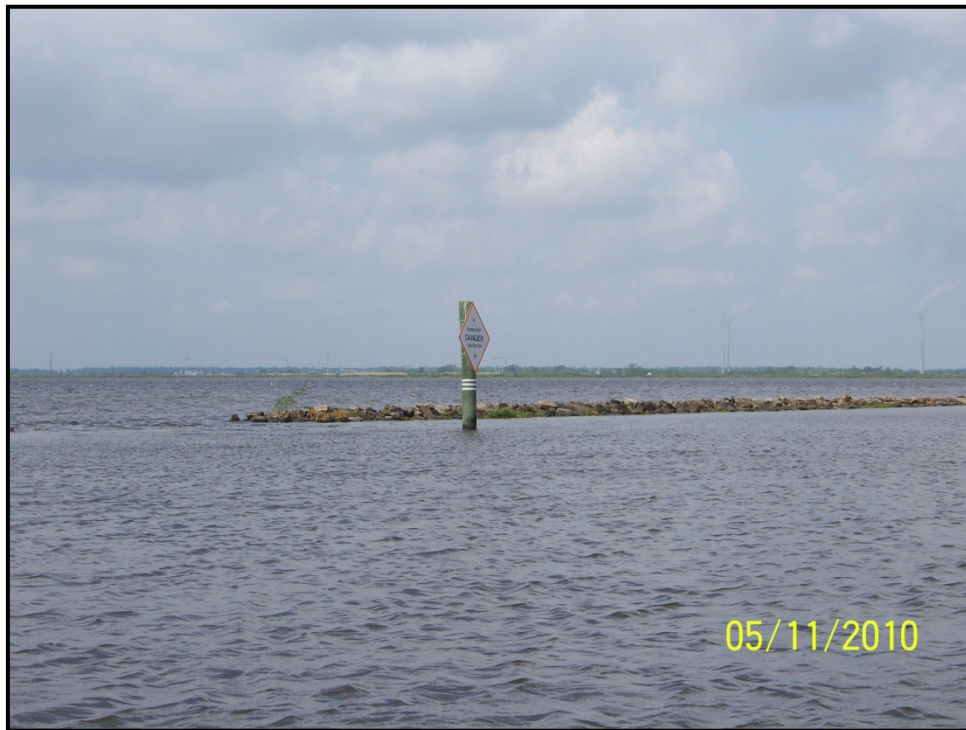
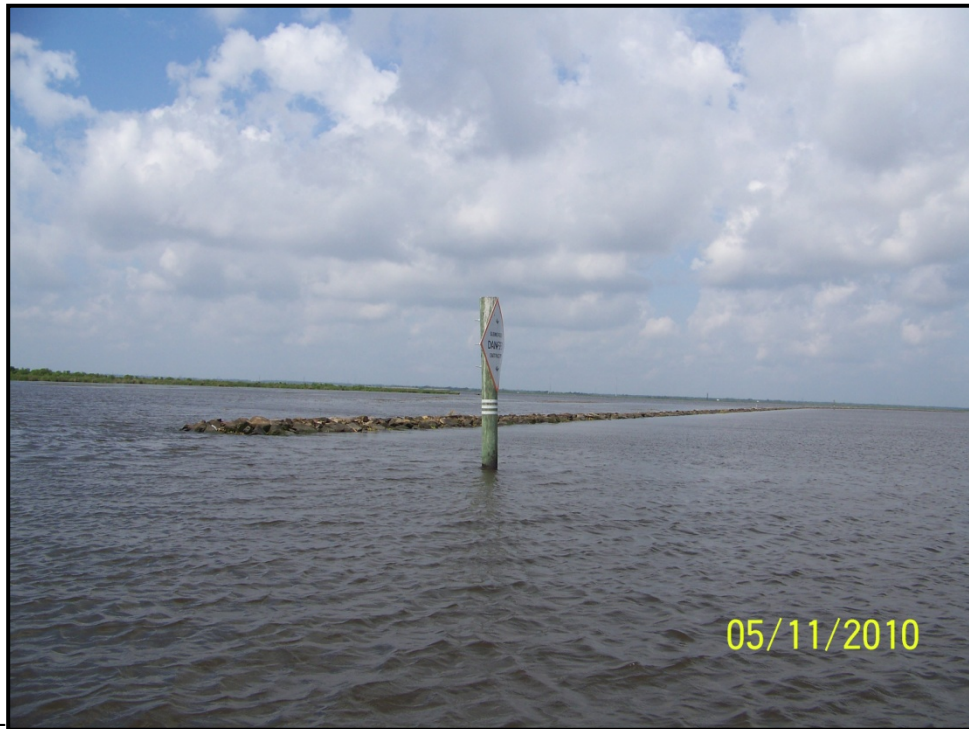
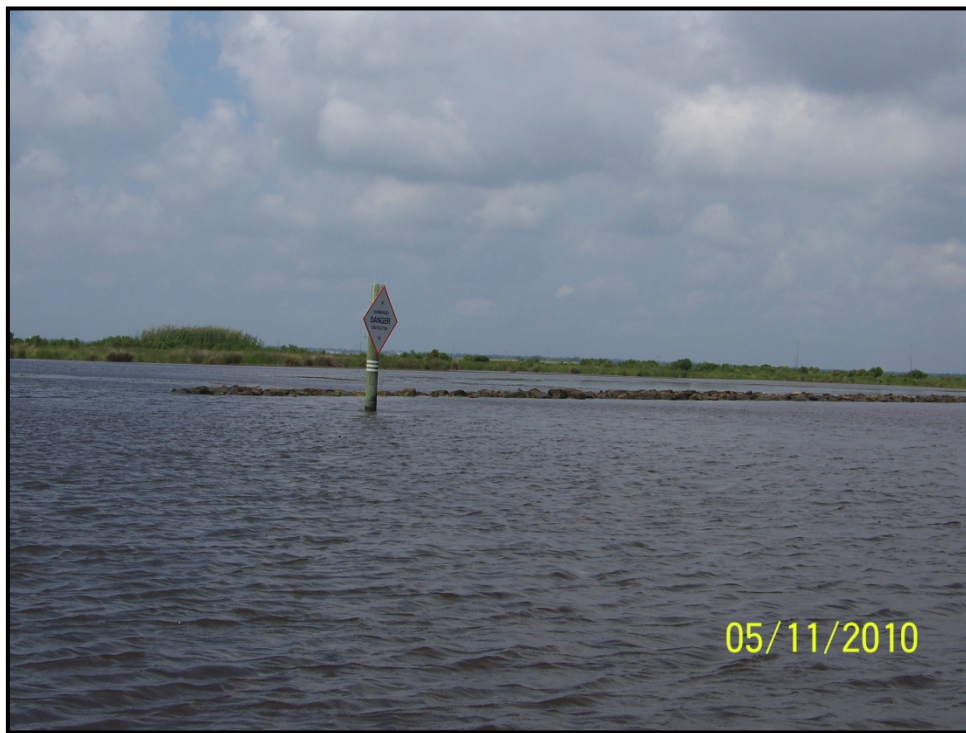
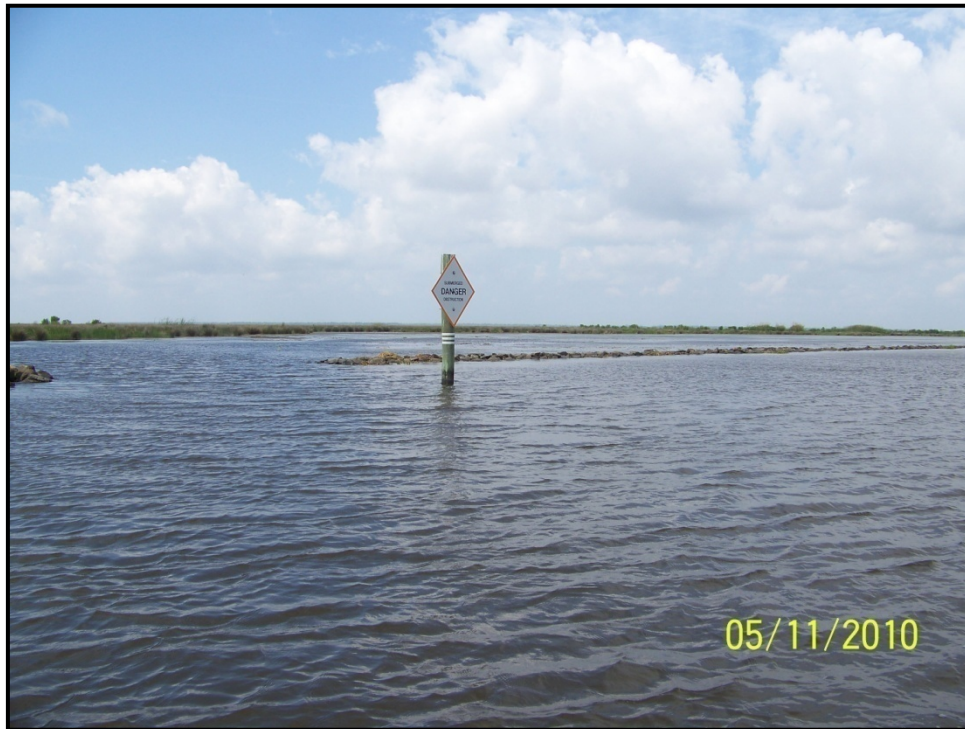
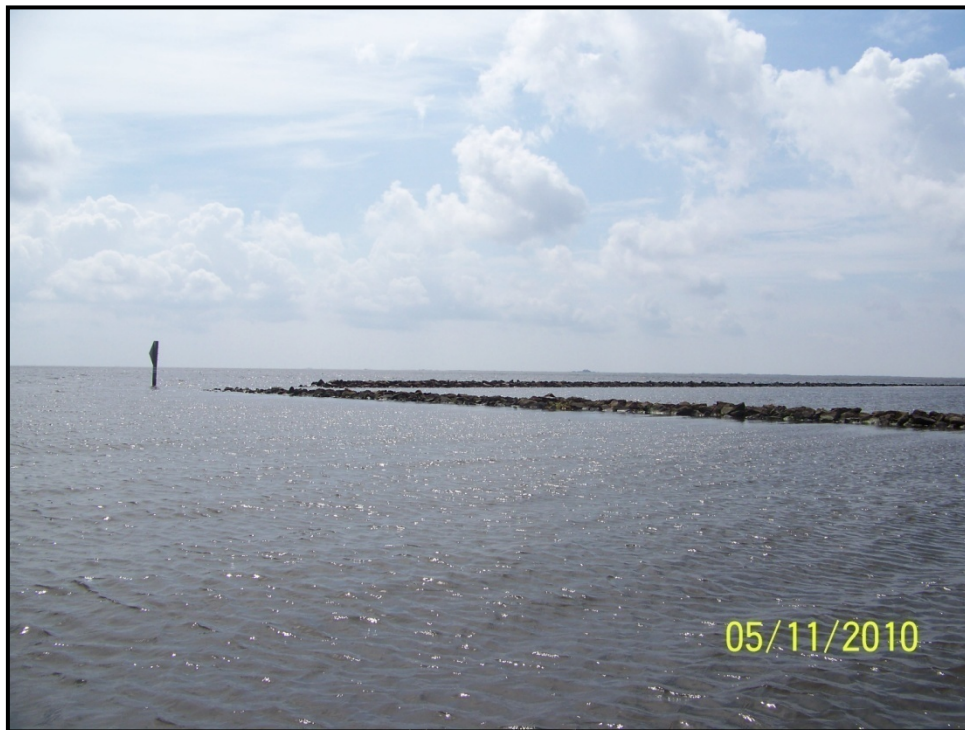
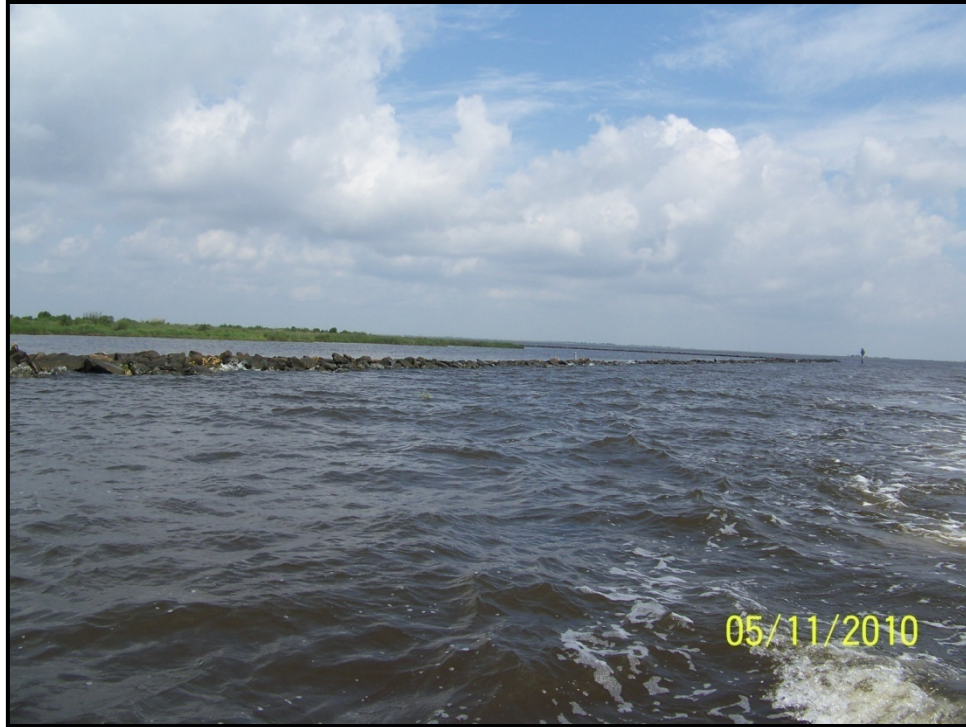
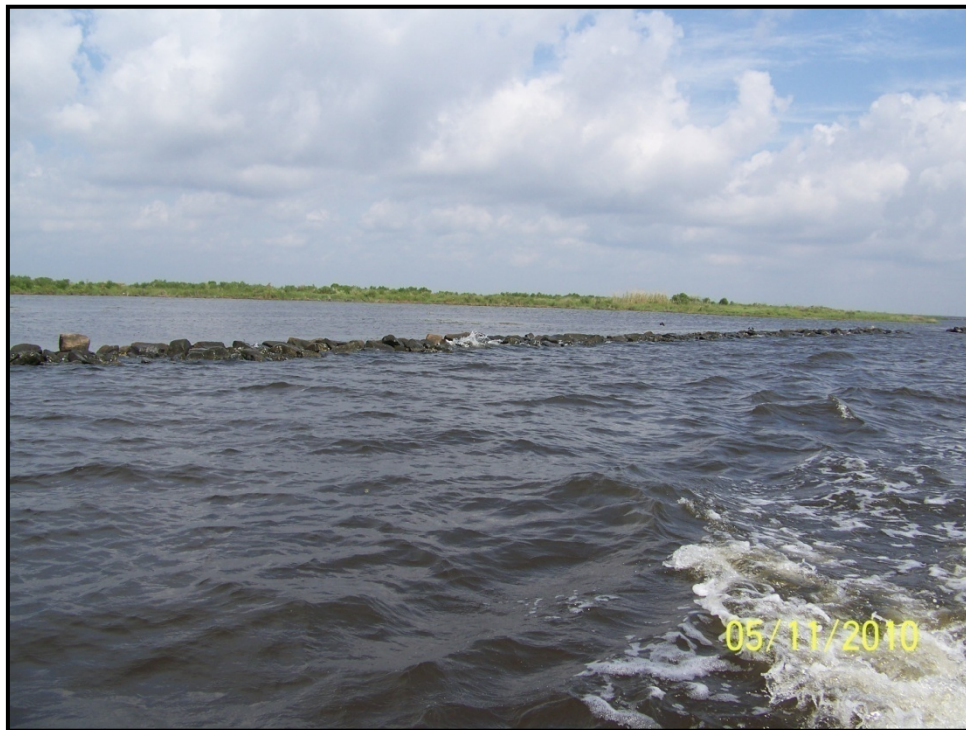
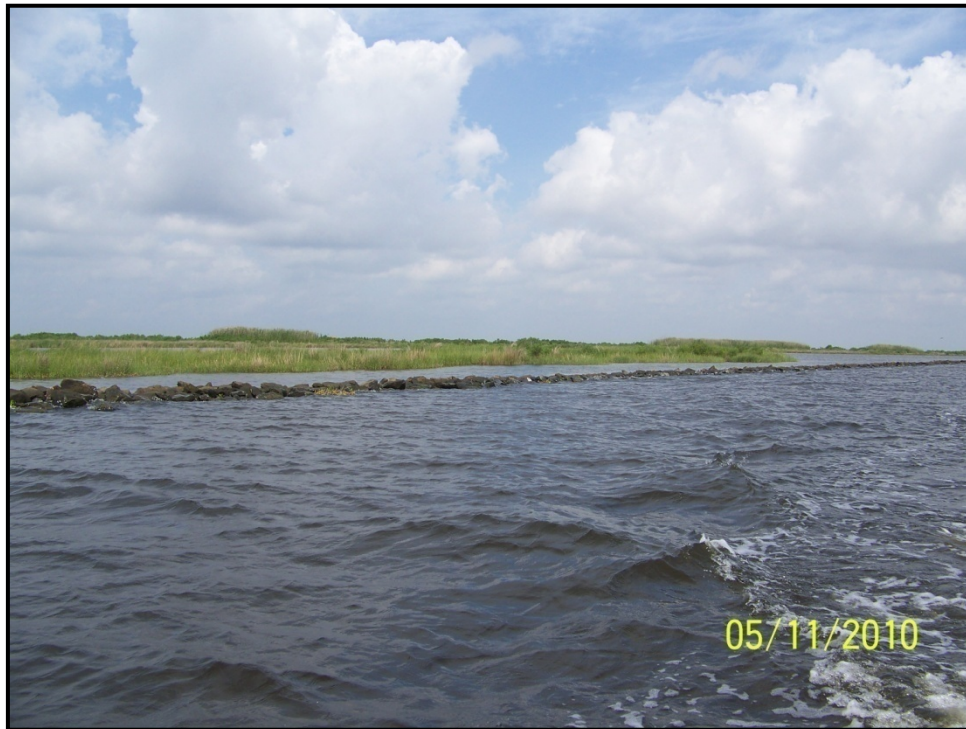
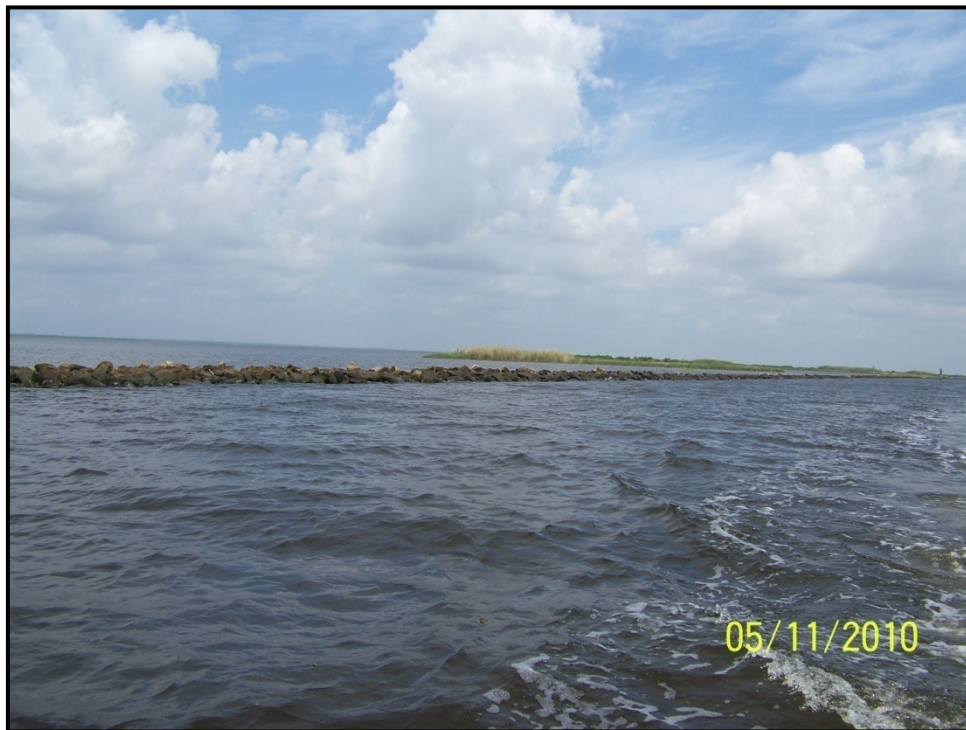
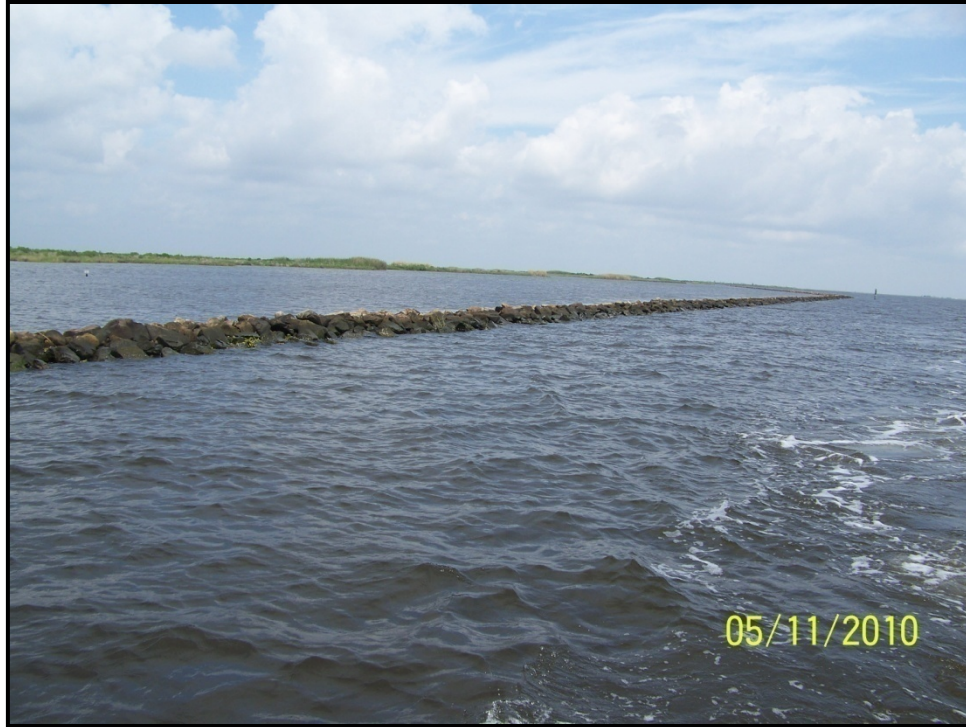
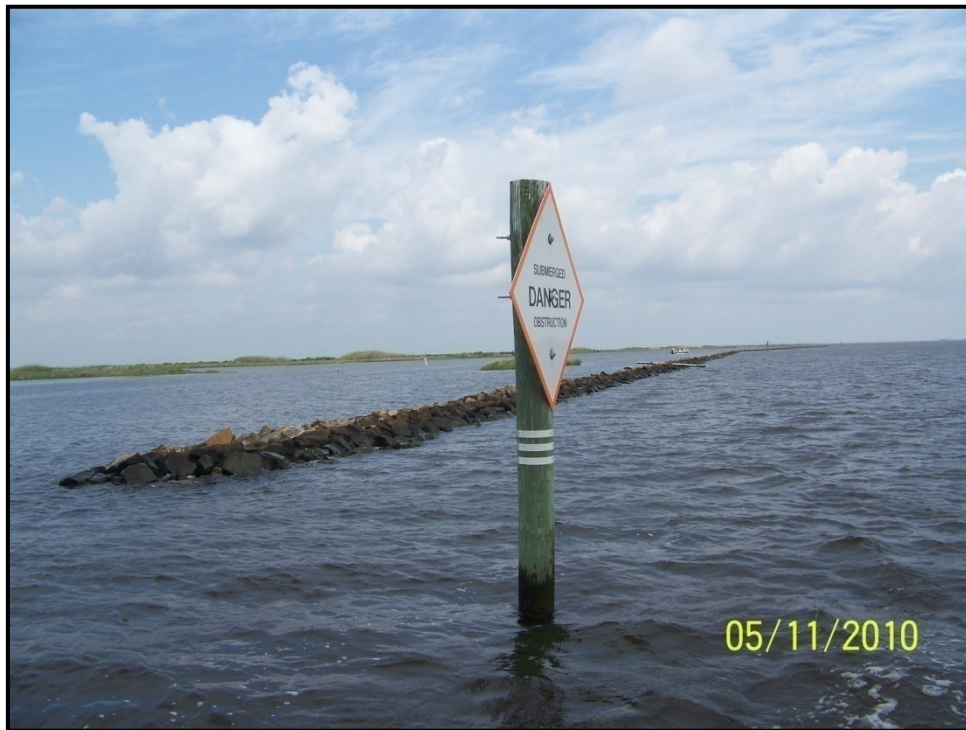
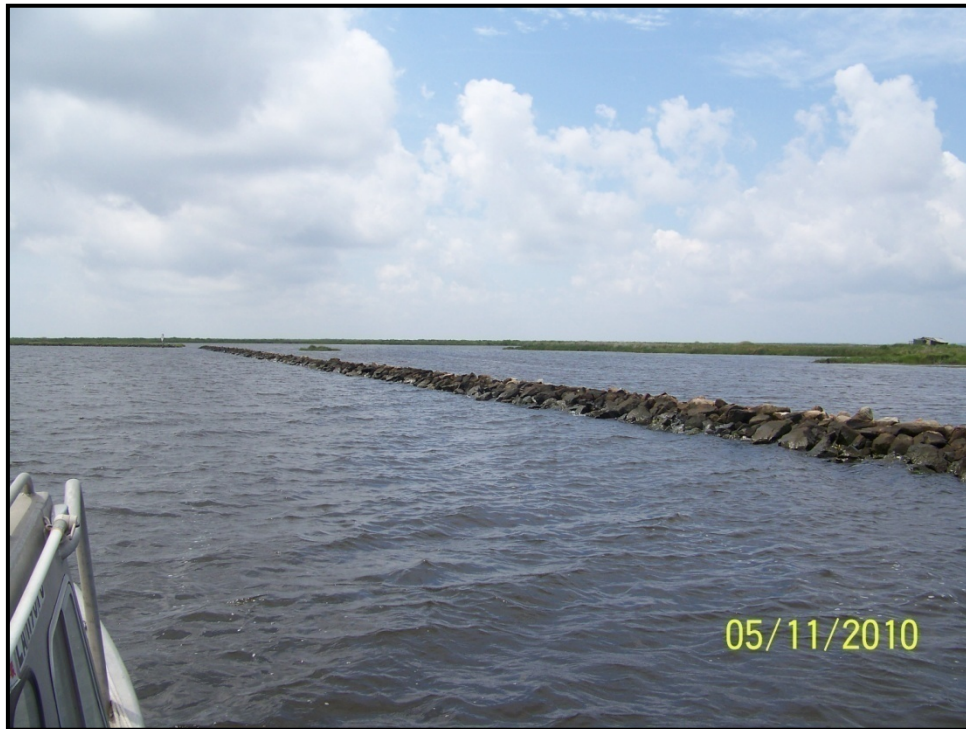
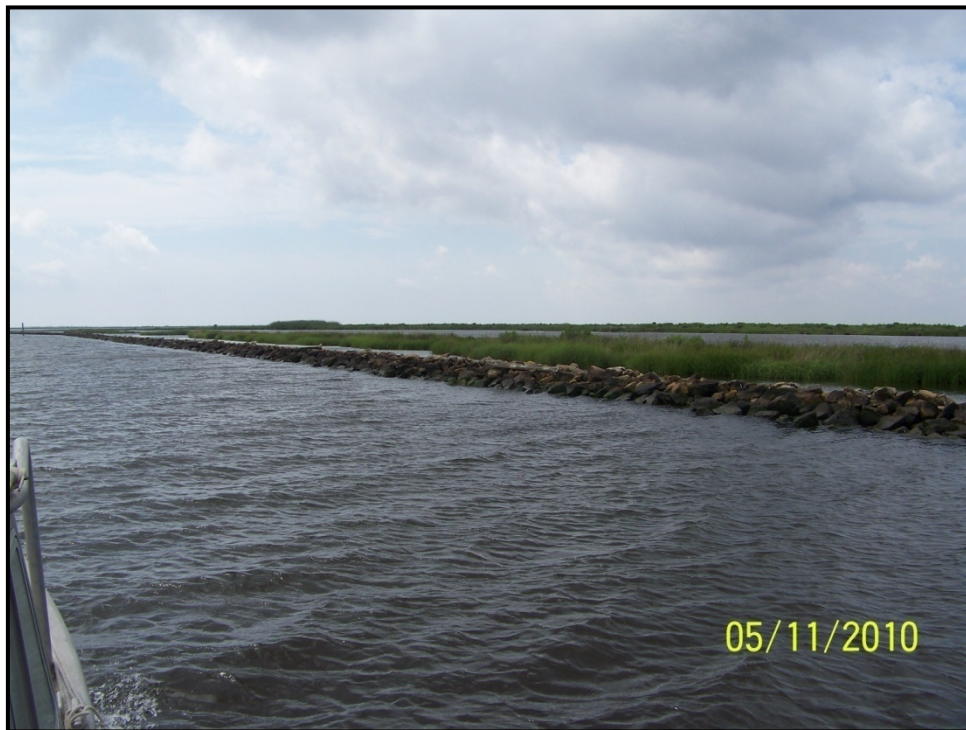
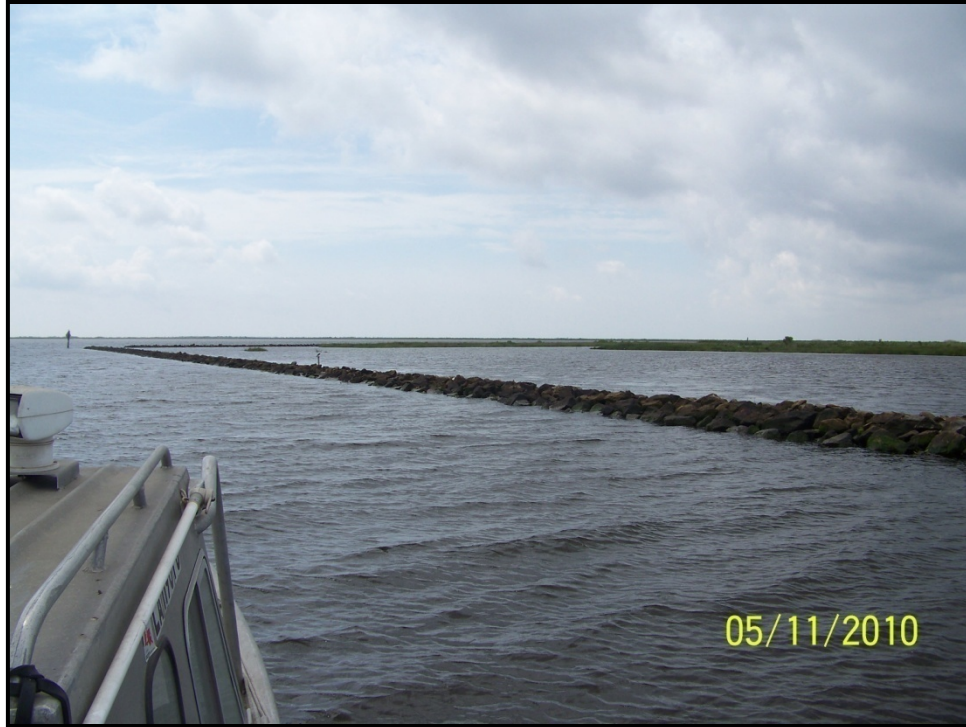
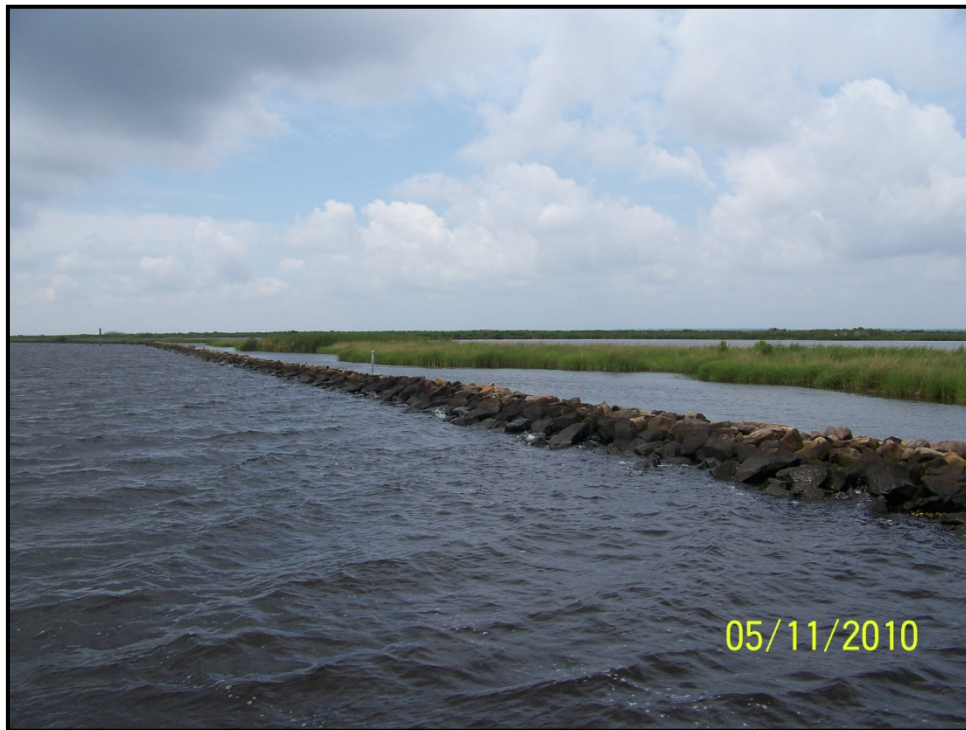
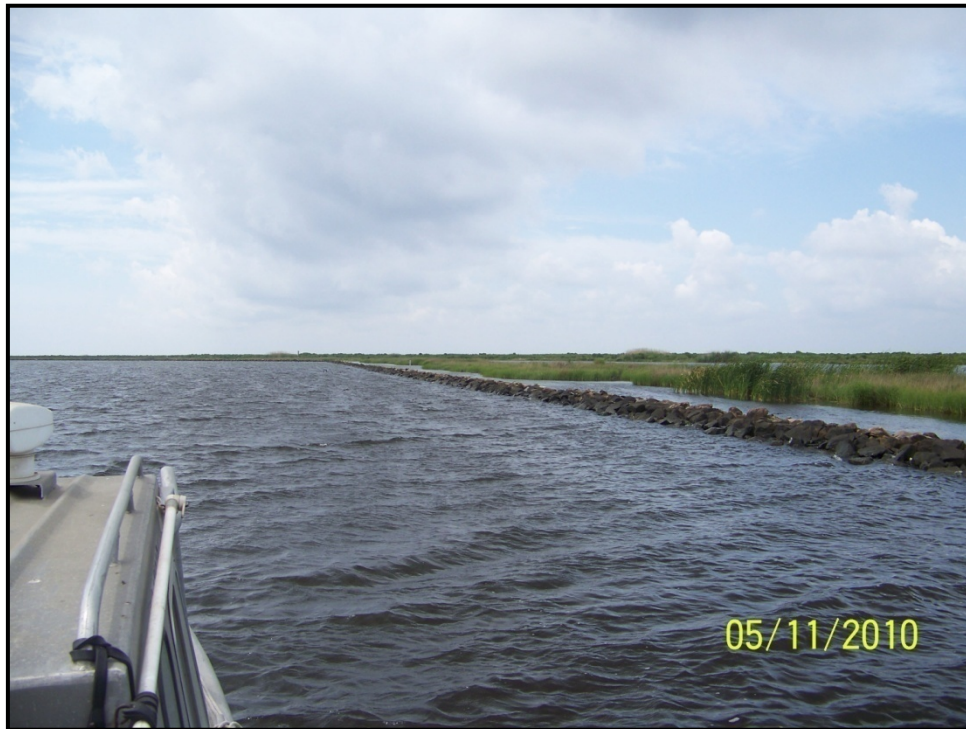
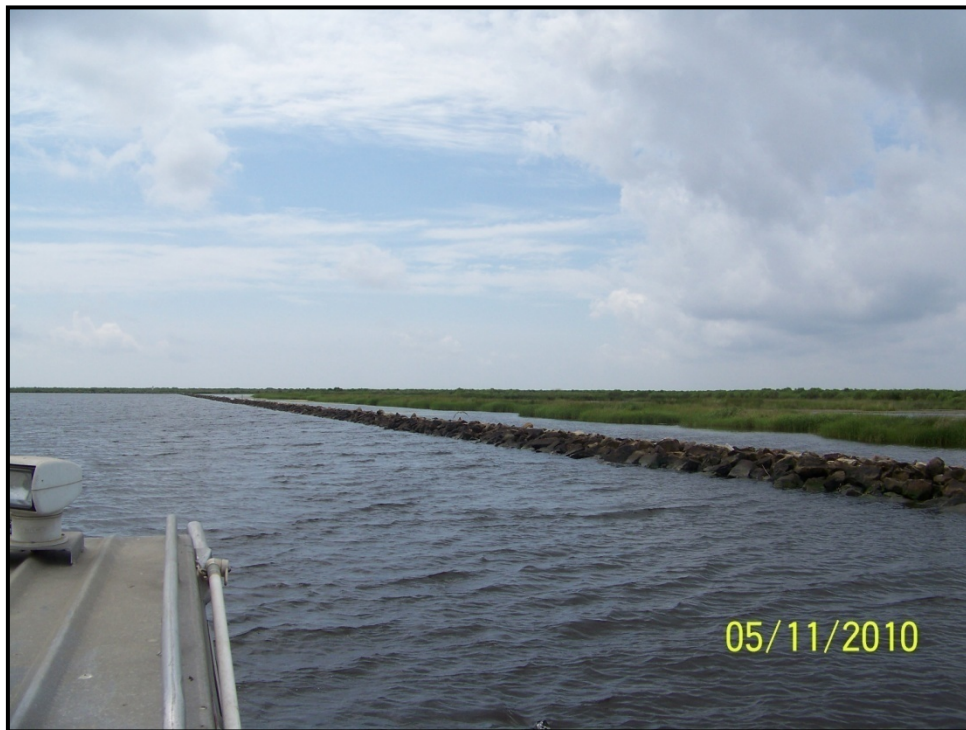
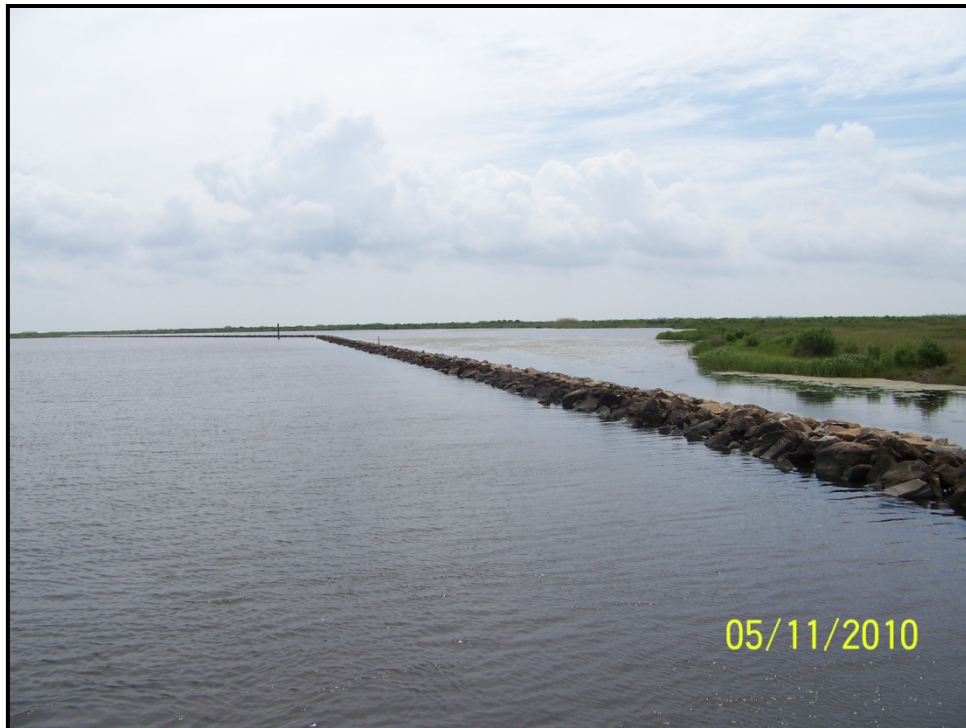
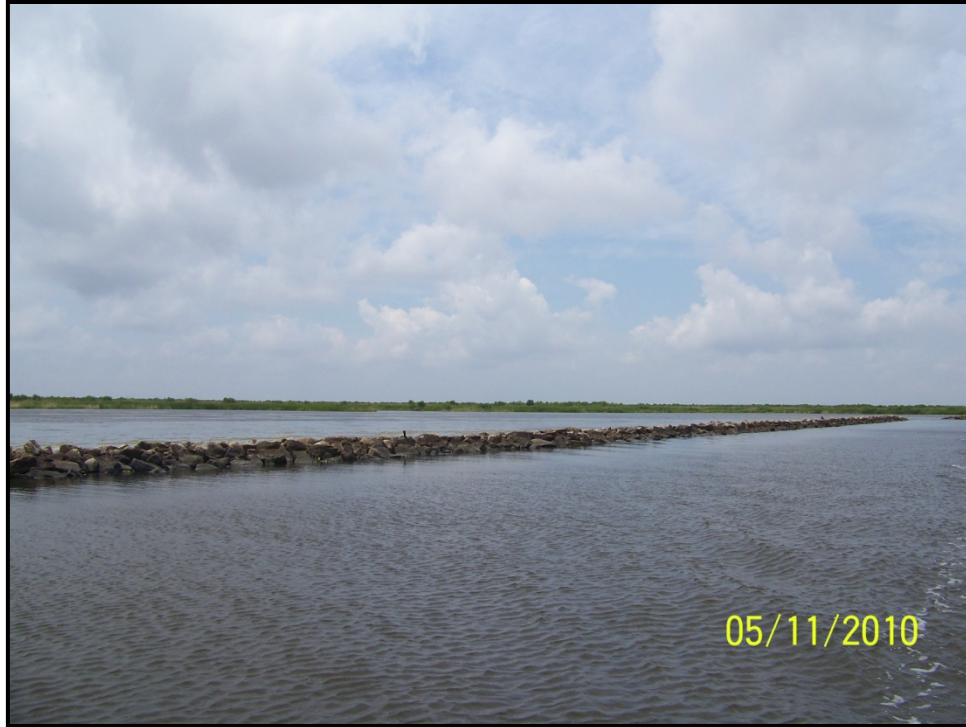
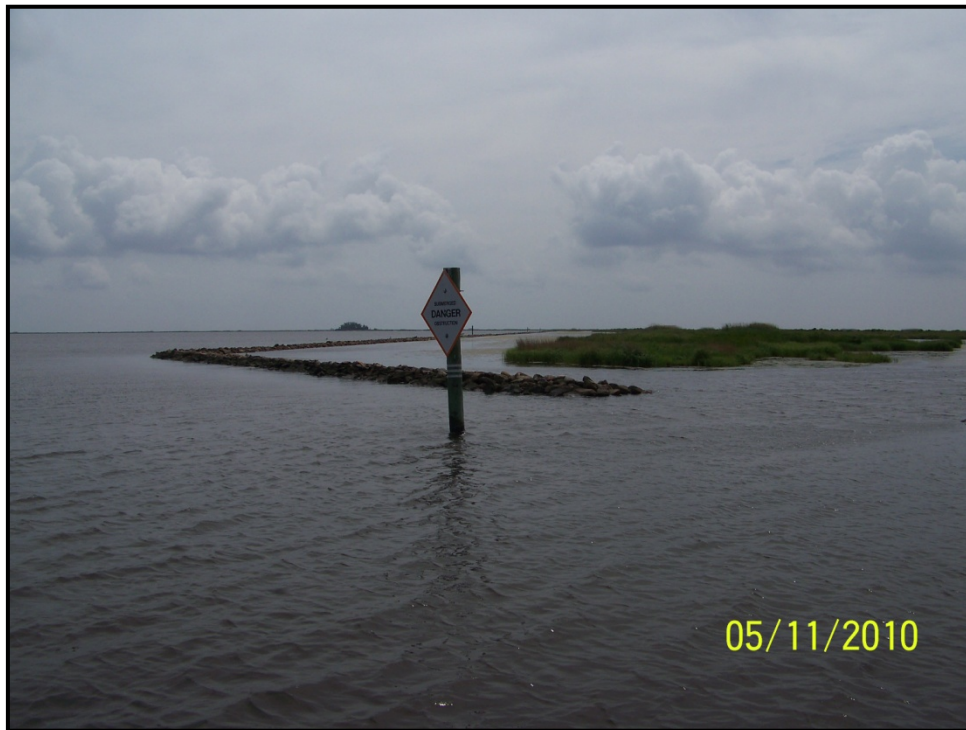
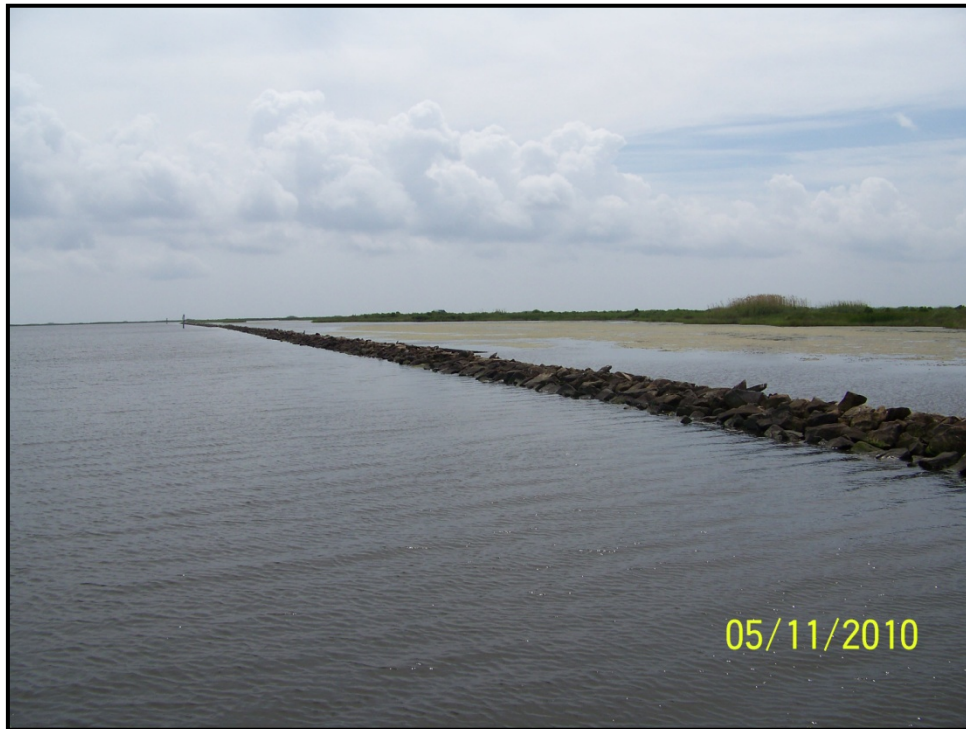
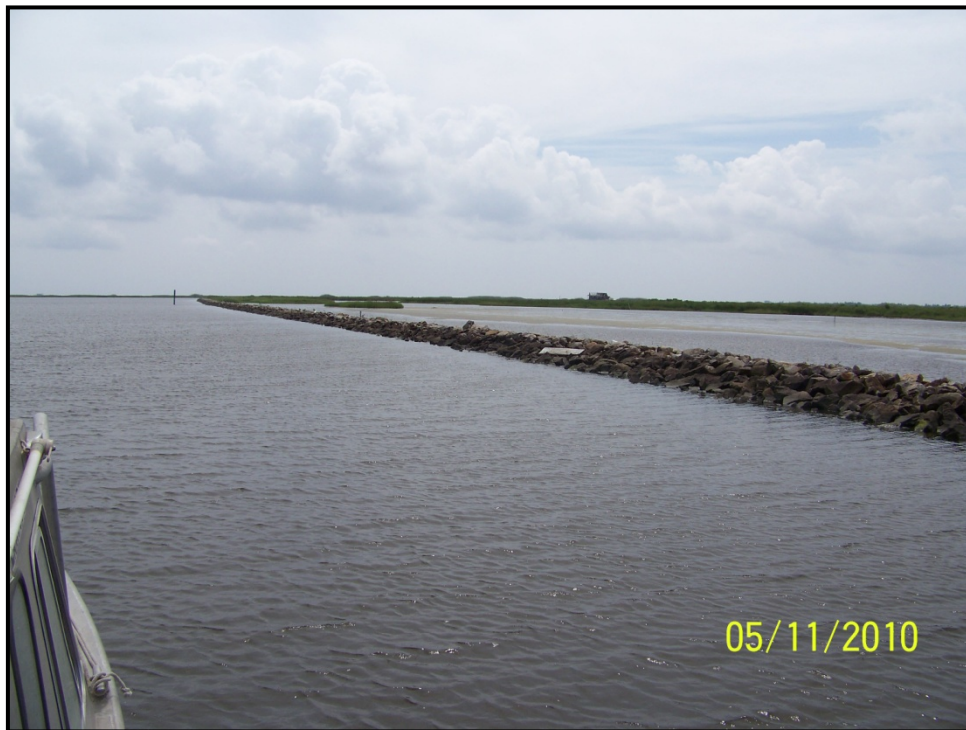
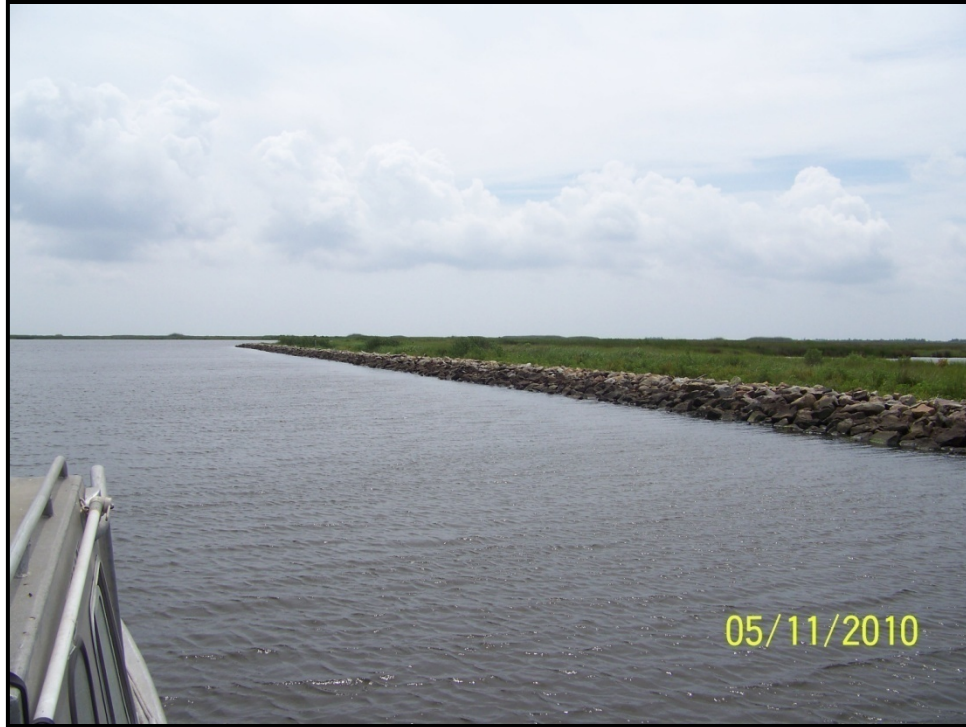
**Rock Segments 1 – 24** (Photos 1 – 18, 20 - 25, Appendix B)

All rock segments were inspected by boat. During the time the rock segments were inspected, the water elevation was approximately EL 1.7 ft. NAVD88 according to the construction project tide gage at Bayou John the Fool. Using the water elevation as a reference, the following approximate rock segment elevations were estimated by observations:

Rock Segment	Approximate Estimated Elevation (FT, NAVD88)	As-Built Elevations (FT, NAVD88)
Segments 3, 4, 5, 8, and 9*	< EL 2.5*	EL 2.5 – 3.0
Segments 1, 2, 6 and 7	≈ EL 2.5 – 3.0	EL 2.5 – 3.0
Segments 10 – 24	≥ EL 3.0	EL 3.2 – 4.0

\* Portions of these segments are at or below EL 2.5 ft. NAVD88 but not less than EL 2.0 ft. NAVD88 based on observed tide gage readings.

It appears that all segments have experienced some amount of settlement as is expected. Clearly the segments that did not receive a third lift during construction (1 - 5, 8, and 9) are the lowest elevation segments with some portions of the segments below EL 2.5 ft. Check points along the rock segments will be collected during the 2011 O&M survey to verify the rock segment elevations observed. No maintenance will be required along the rock dike at this time. The segments should continue to be monitored for settlement.
