## 2010 Operations, Maintenance, and Monitoring Report

### Little Lake Shoreline Protection/Dedicated Dredging Near Round Lake (BA-37)

State Project Number BA-37  
Priority Project List 11

September 2010  
Lafourche Parish

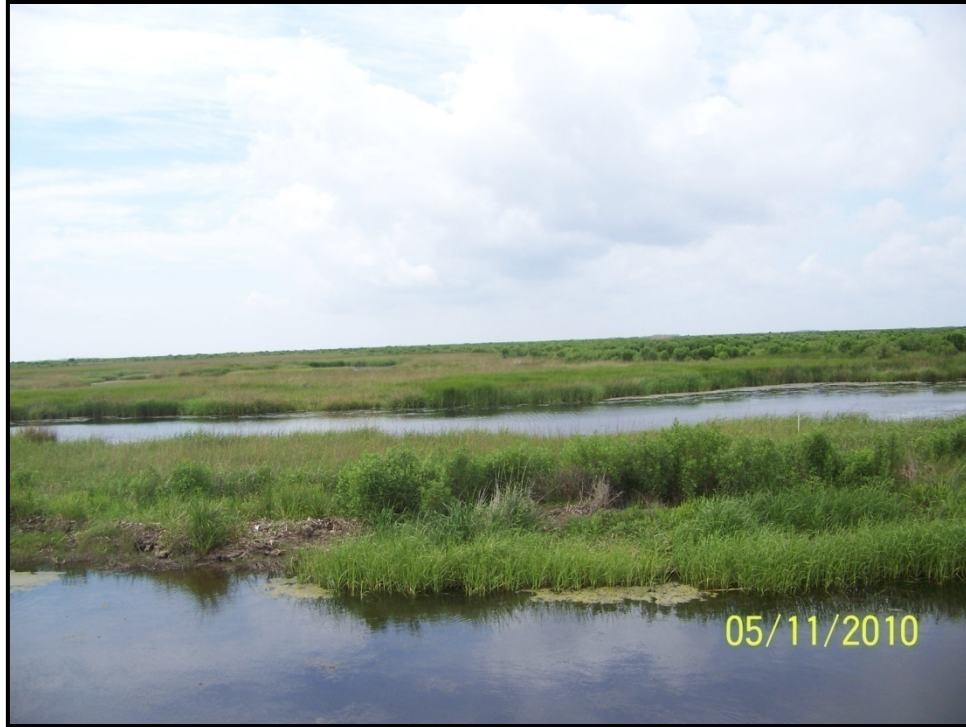
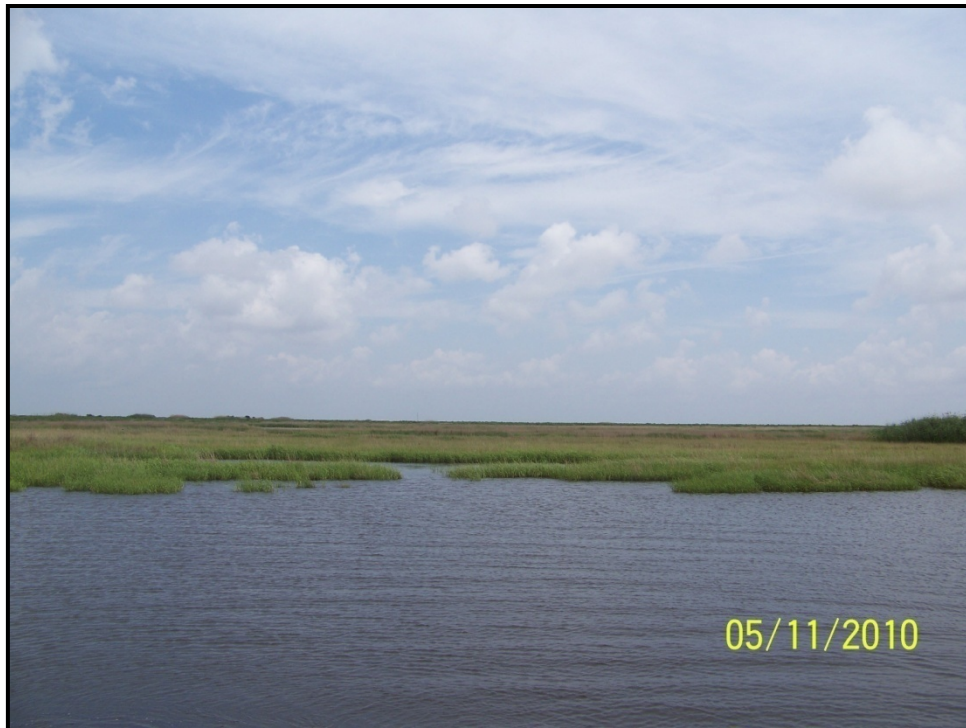
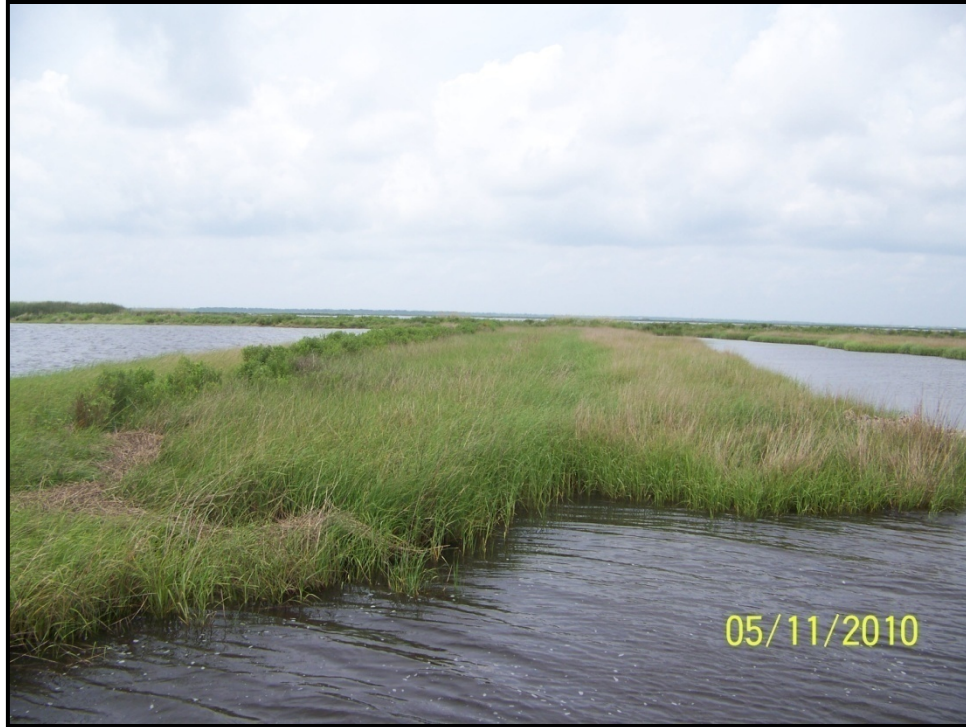
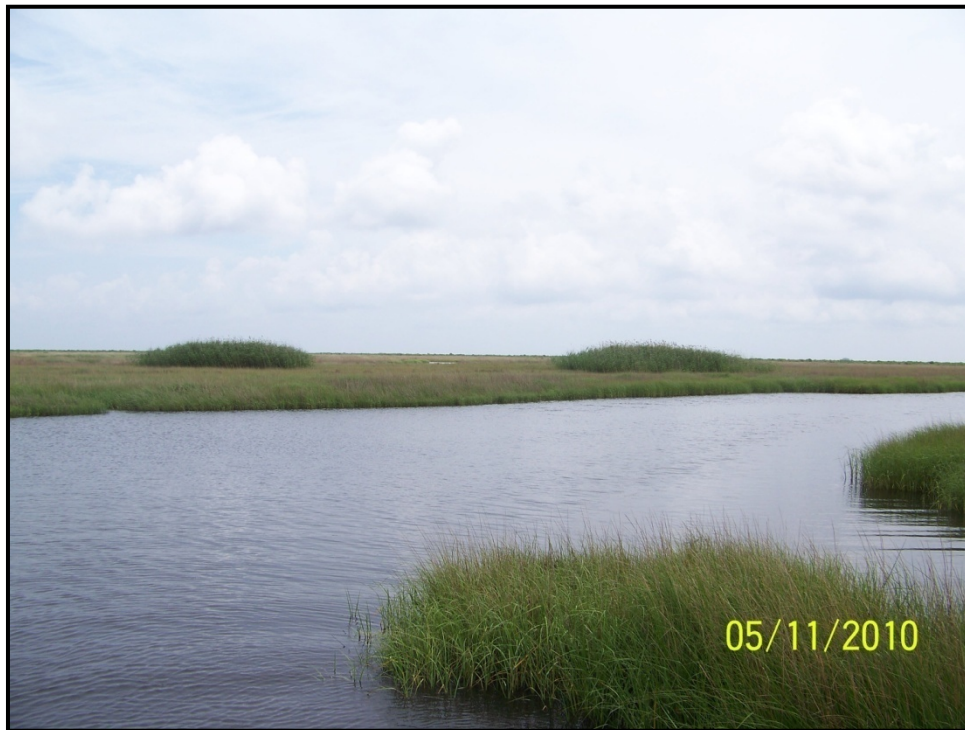
**Marsh Creation Area** (Photos 19, 26 – 28, Appendix B)

The fill material in the marsh creation area has fully vegetated. As mentioned above, marsh creation area grid point “O&M” surveys were performed in May 2008, June 2009, and July 2010 as well as “as-built” and 9-month post-placement (May 2007) surveys. Figure 5 is a map showing the elevations associated with the “as-built”, 9-month post-placement (May 2007), and May 2008 surveys of the marsh creation area. Additionally, Figure 6 is a map showing elevations from the last two surveys (2009 and 2010). The average grid elevations for the marsh creation area surveys are shown in the table below.

**Photo 26 - Marsh creation area SW corner looking north from south dike. Tide Reading ~ 1.7 ft NAVD88.**

**Photo 27 - Marsh creation area SW corner looking west along south dike. Tide Reading ~ 1.7 ft NAVD88.**

**Photo 28 - Marsh creation area SW corner looking northeast from south dike. Tide Reading ~ 1.7 ft NAVD88.**

Although there are two additional “O&M” surveys scheduled (of the five annual surveys for the first five years), we recommend only one of the remaining surveys be performed. A survey was performed in May 2007 with remaining construction funds, and this data serves as the first of the five annual surveys after construction completion. There will also be “O&M” surveys of the marsh creation area in Years 10 and 15 as per the O&M Plan.
