## **2022 Operations, Maintenance, and Monitoring Report**

### **Grand Liard Marsh and Ridge Restoration (BA-0068)**

State Project Number BA-0068  
Priority Project List 18

April 2022

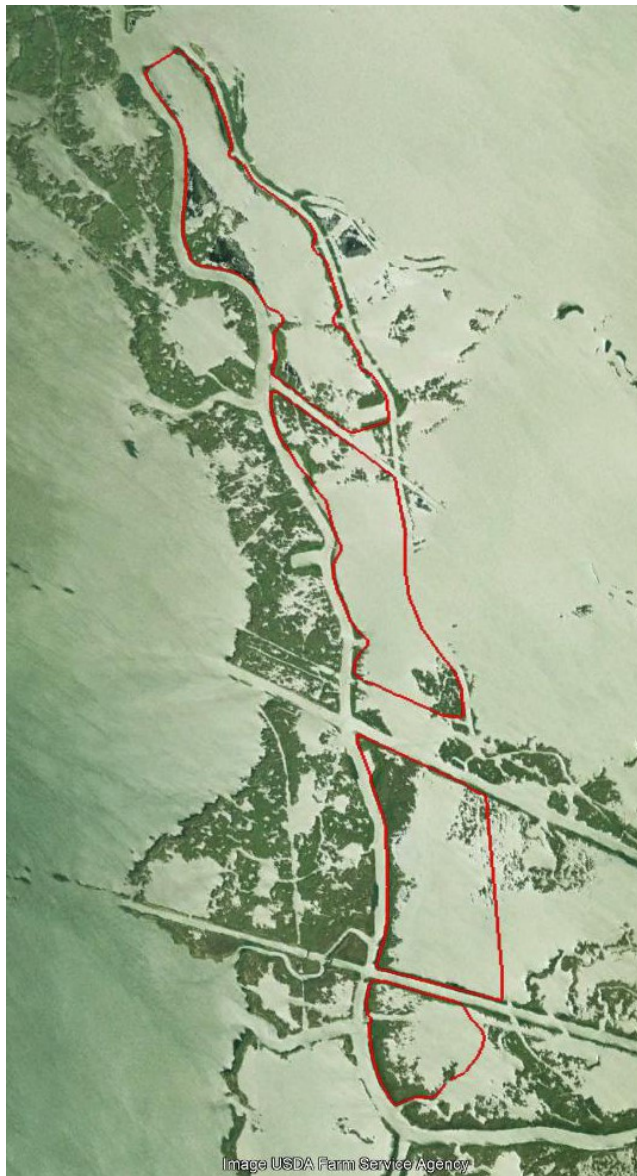
**Figure 2.** True color imagery from 12/31/2009 showing remaining land within the BA-0068 boundary (indicated in red) (Source: Google Earth, USDA Farm Service Agency).

The Grand Liard Marsh and Ridge Restoration project (BA-0068) is located within lower Plaquemines Parish, Louisiana, immediately adjacent to Bayou Grand Liard (Figure 1). Extensive wetland loss in this area has resulted from a variety of factors including subsidence, salt-water intrusion, a lack of sediment supply, and oil and gas activities (NMFS 2012). Over recent decades, a series of north-south oriented bayous (i.e., Bayou Long, Dry Cypress Bayou) and their associated ridges have deteriorated, resulting in large expanses of open water. The Bayou Grand Liard ridge, which separates the open bays of the Bastian Bay and Grand Liard mapping units, is the most prominent remaining ridge. The Coast 2050 land loss rate from 1983 to 1990 in the Grand Liard mapping unit was -1.7% per year and future land loss in the project area is estimated to be -1.43% per year (NMFS 2011). These projections suggested that the remaining land would be completely converted to open water by 2050 if restoration did not occur (Figure 2).

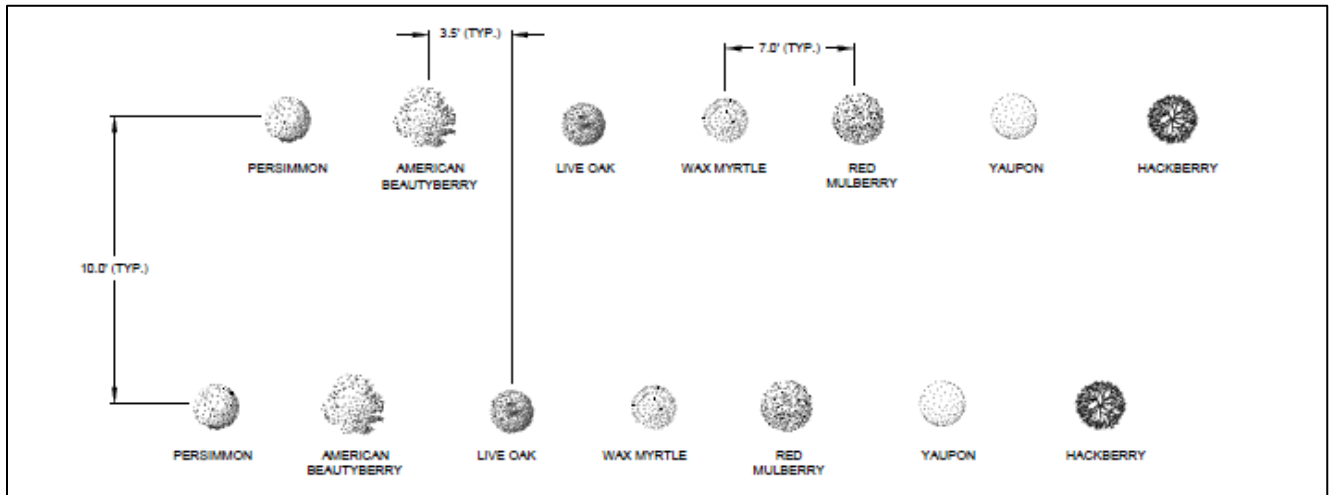
**Figure 4.** Layout of the woody seedling planting conducted along the BA-0068 ridge in June 2020.

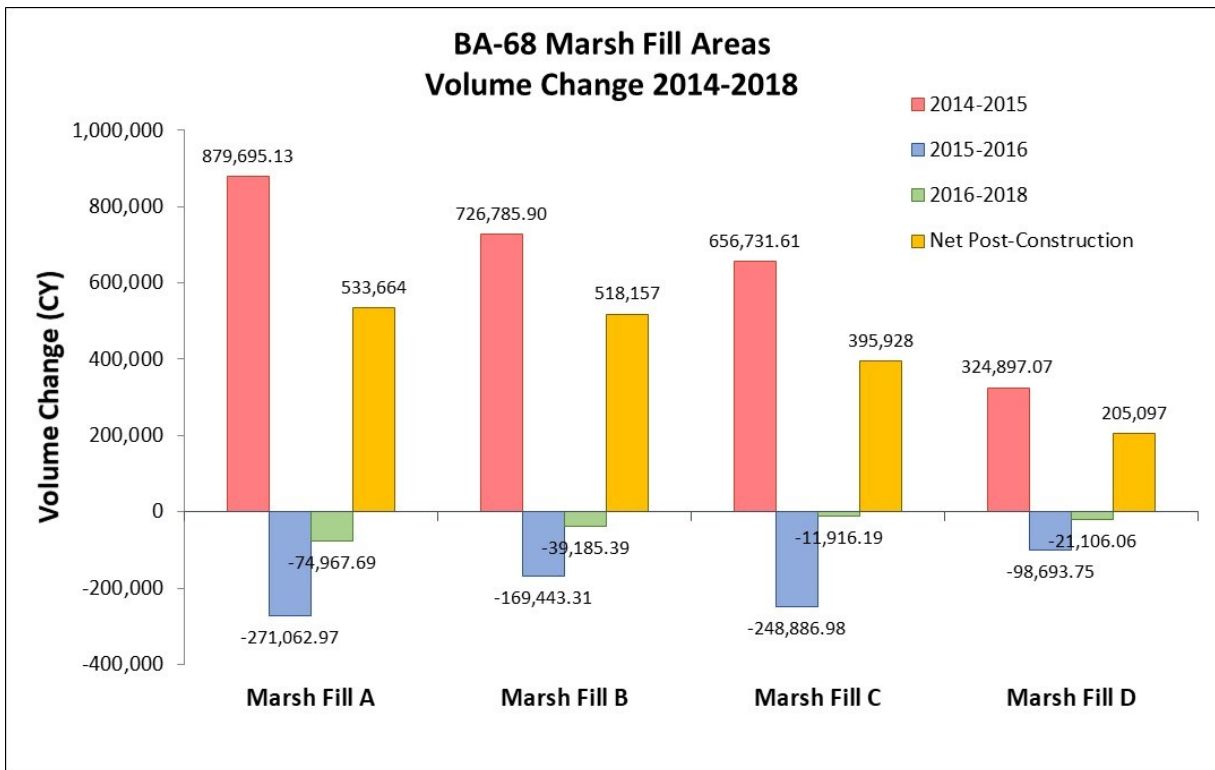
**Figure 13.** Volume change (CY) over time within the BA-0068 fill areas.

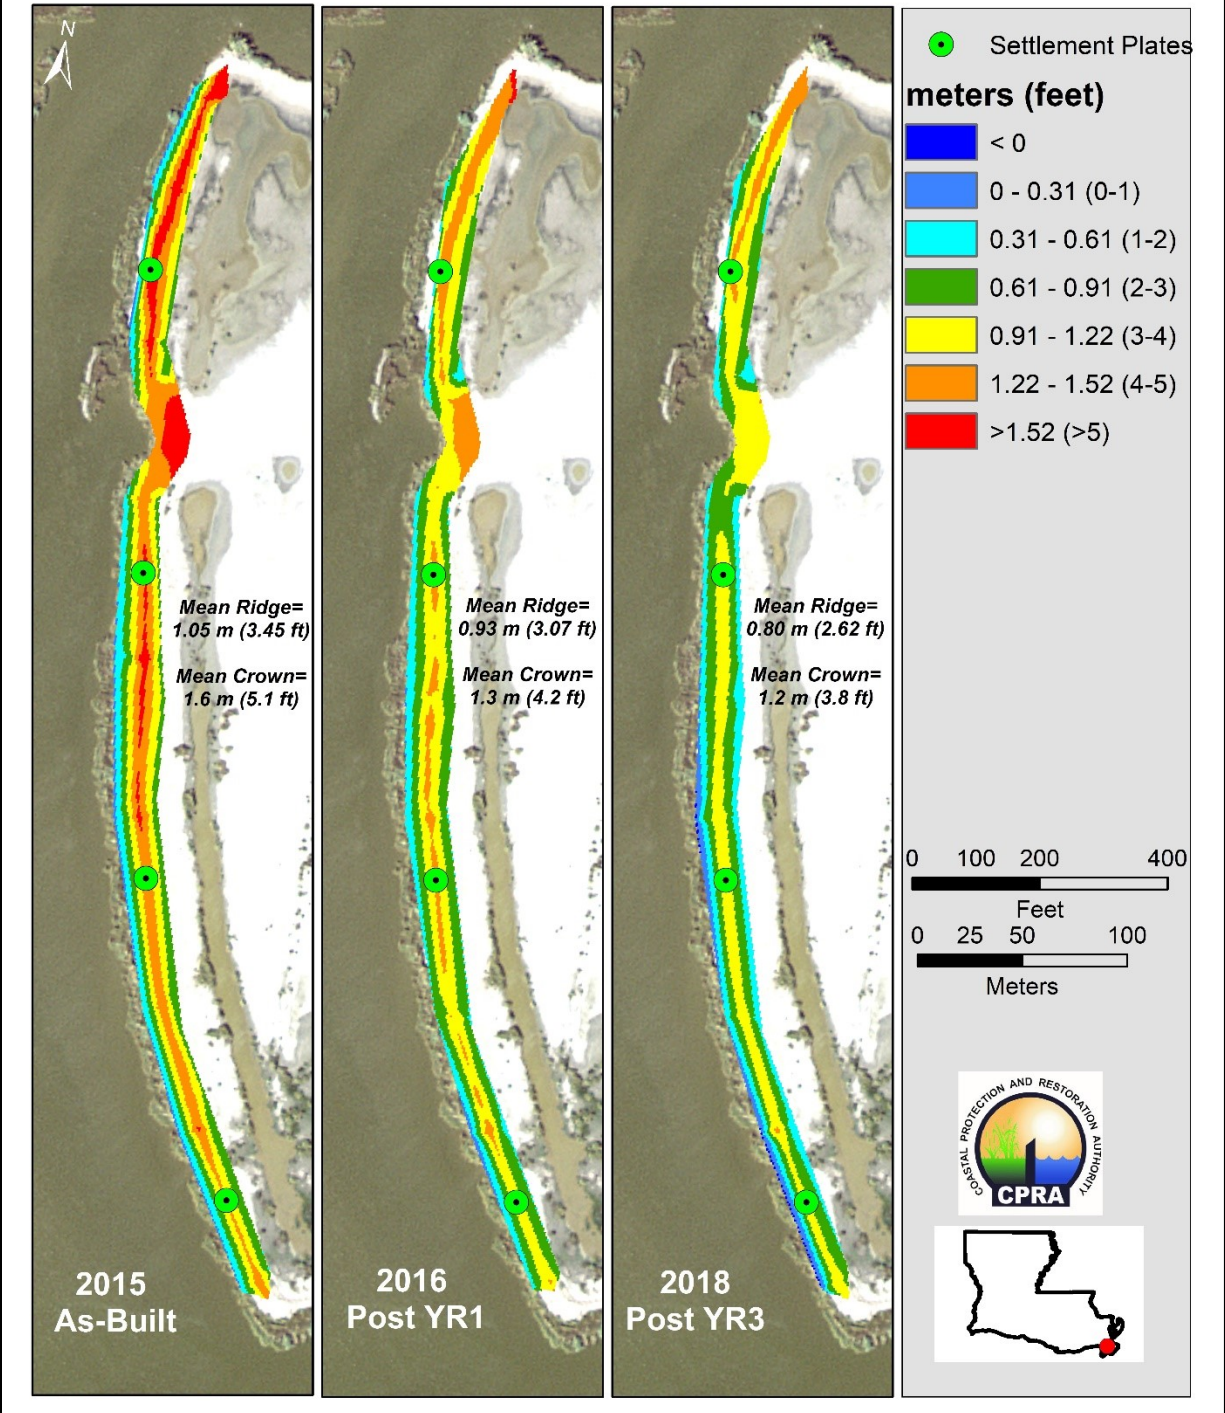
**Grand Liard Marsh and Ridge Restoration (BA-0068)  
Ridge Creation Area D  
2015-2018 Elevation Grid Models (NAVD88 m (ft), Geoid12B)**

Before construction, seven settlement plates were installed along the ridge area to monitor vertical consolidation of the underlying sediments during construction (Figures 17-20). Below fill settlement observed during construction was reported to be much higher in Areas C and D (2.2 and 2.8 ft) than in Areas A and B (0.6 and 1.2 ft) (AECOM Technology Services 2016); however, it appears that the construction settlement reported for Areas A and B does not include an immediate pre-fill elevation reading which would have captured the initial (greatest) period of settlement immediately following fill placement. The settlement plates were also measured in Years +1 and +3 to quantify the amount of below fill settlement occurring during the post-construction period. The observed below fill settlement was subtracted from the total crown settlement to obtain an assumed settlement within the fill material. The quantity of below fill settlement is shown in Table 6 and compared graphically to the within fill settlement in Figure 22. Results showed that mean below fill settlement of the ridge areas accounted for 50% of observed settlement by Year 1 and 89% of the observed settlement between Years 1 and 3. For the total post-construction period, below fill settlement accounted for a majority of the observed settlement in all ridge areas except for Area A; however, the placement of the settlement plate in Area A is off center from the ridge crown which may have resulted in reduced below-fill compaction due to

**Figure 20.** Elevation grid models of Ridge Creation Area D associated with the Grand Liard Marsh and Ridge Restoration (BA-0068) project in 2015, 2016, and 2018.

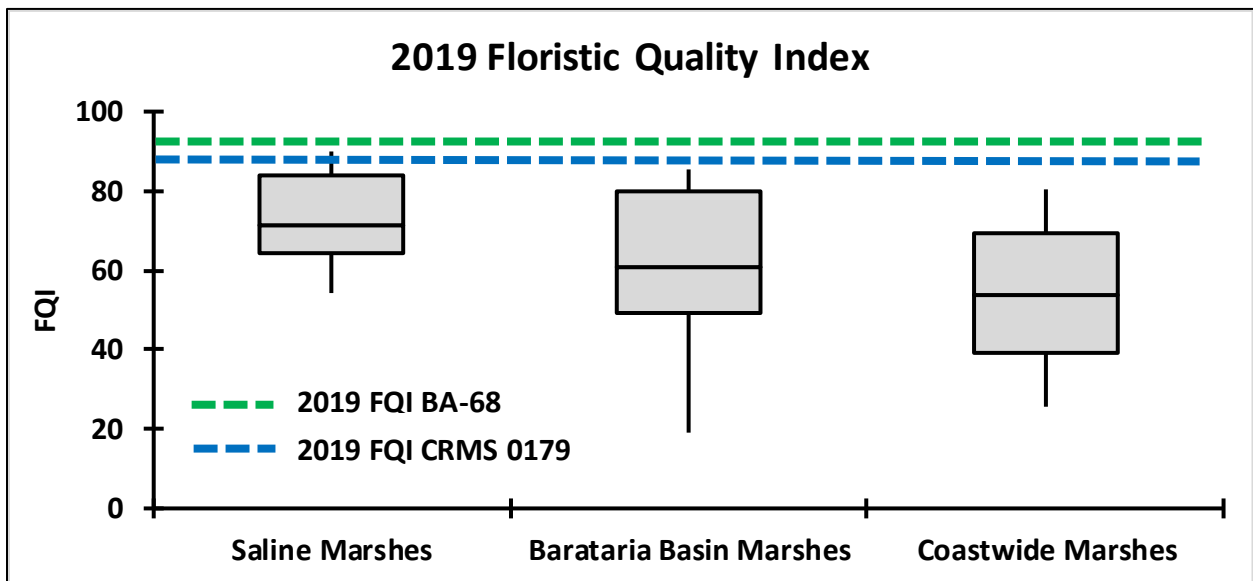
**Figure 25.** The 2019 Floristic Quality Index (FQI) for BA-0068 and CRMS0179 compared to the FQI for all saline marshes, all marshes in Barataria Basin, and all marshes coast-wide. The boxplots represent the 10<sup>th</sup>, 25<sup>th</sup>, mean, 75<sup>th</sup>, and 90<sup>th</sup> percentiles.

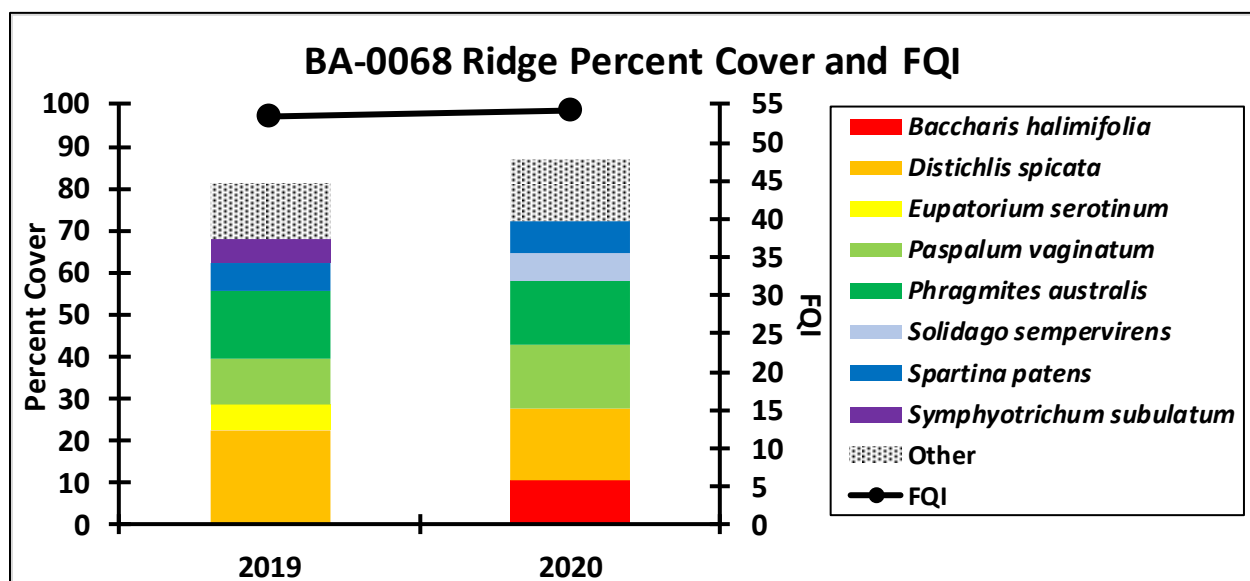
**Figure 26.** Percent cover and FQI of the herbaceous vegetation on the ridge in 2019 and 2020 at the BA-0068 project.

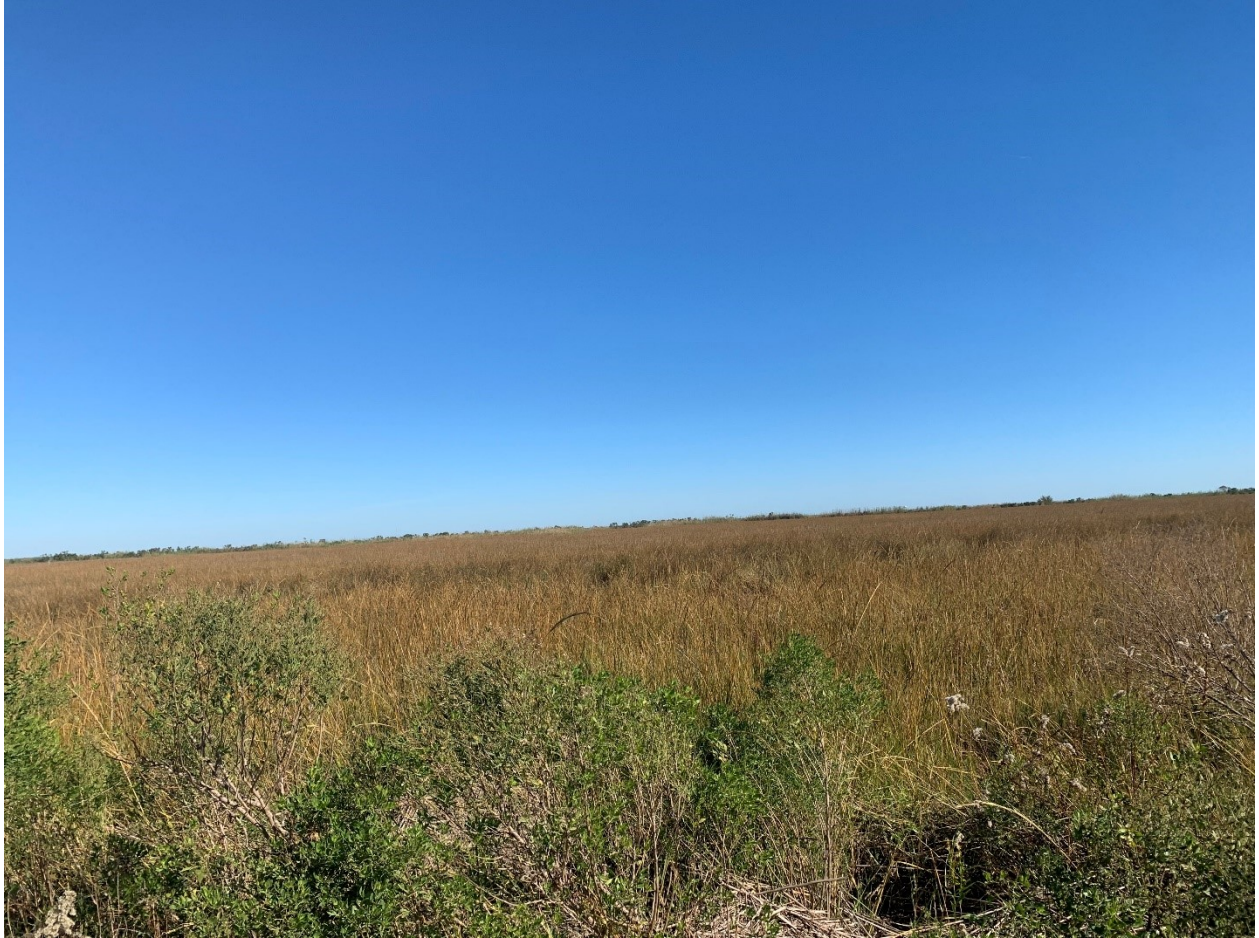
**Marsh in Cell A from the Ridge (11/30/2021)**

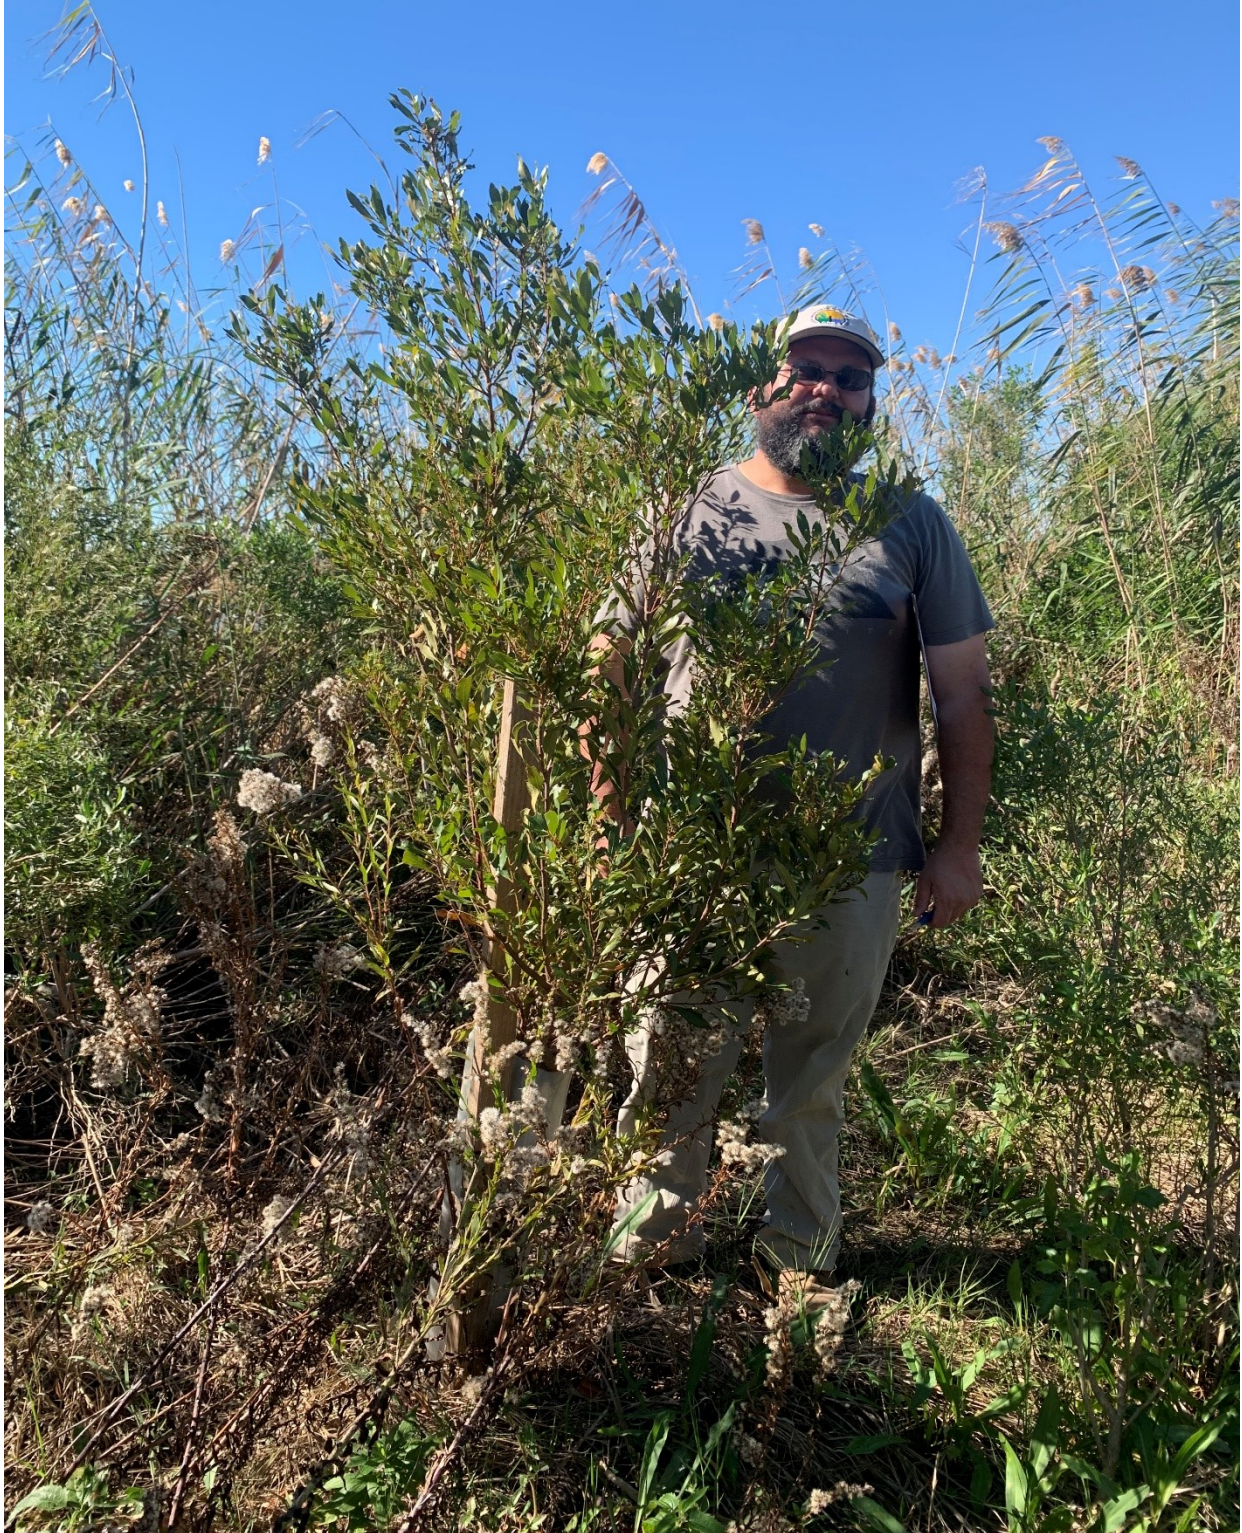
**Tree planted on ridge in Cell B (Engineer for scale) (11/30/2021)**

An effort should be made in the near future to remove the tree protectors from the planted trees. The surviving trees are large enough that some are becoming hindered by the protectors and are now at lower risk of predation due to their size. Also, some protectors are coming loose and littering the project area. Although the cost of removing the protectors was not included in the original O&M budget, there should be sufficient O&M funds to complete this task.

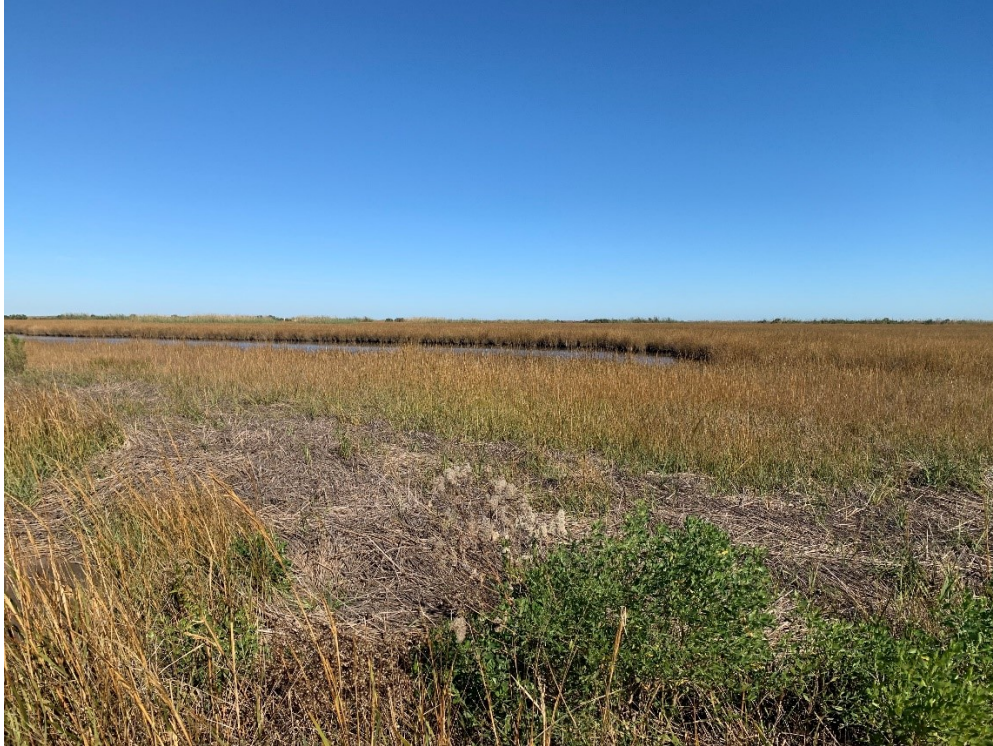
**Marsh in Cell B from the Ridge (11/30/2021)**

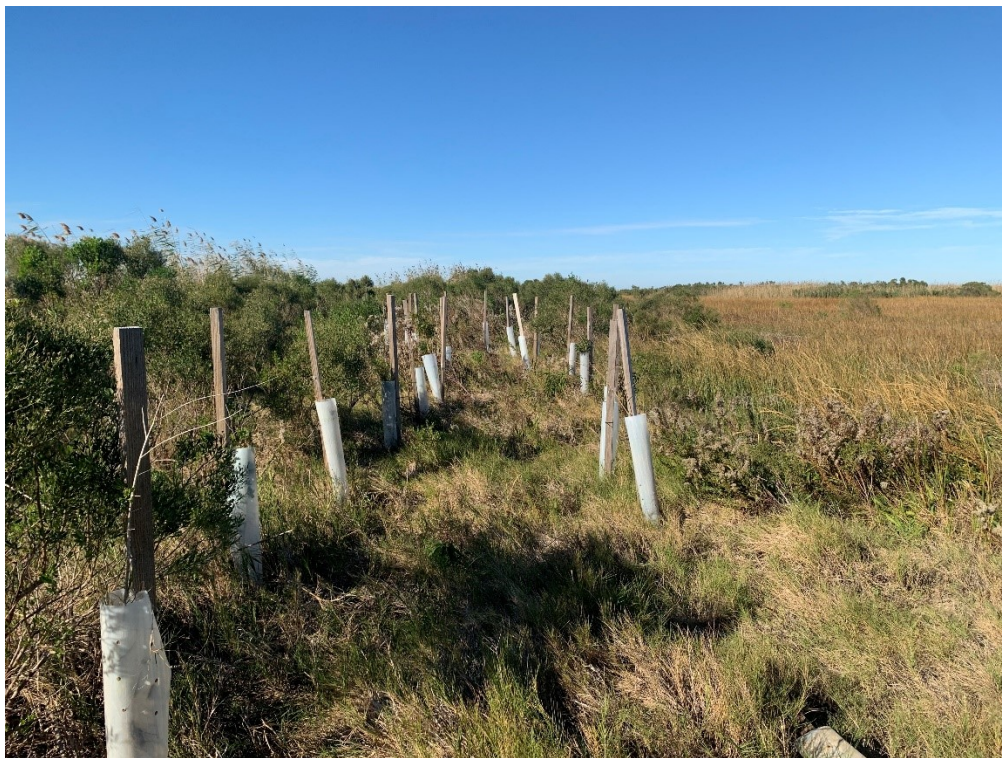
The ridge restoration area shows only minor erosion along Bayou Grand Liard. The woody vegetation planting performance is being evaluated and results are presented in the Vegetation section (Section IV.c.) of this report. Two hurricane events (Zeta in 2020, Ida in 2021) have impacted the ridge since the plants were installed. A significant amount of rack, primarily consisting of *P. australis* (roseau cane) reeds, from the hurricane events was noted along all portions of the ridge but this did not appear to significantly impact the plantings.

**Cell C Ridge looking north (11/30/2021)**

- Continue to monitor the condition of the ridge and fill areas.

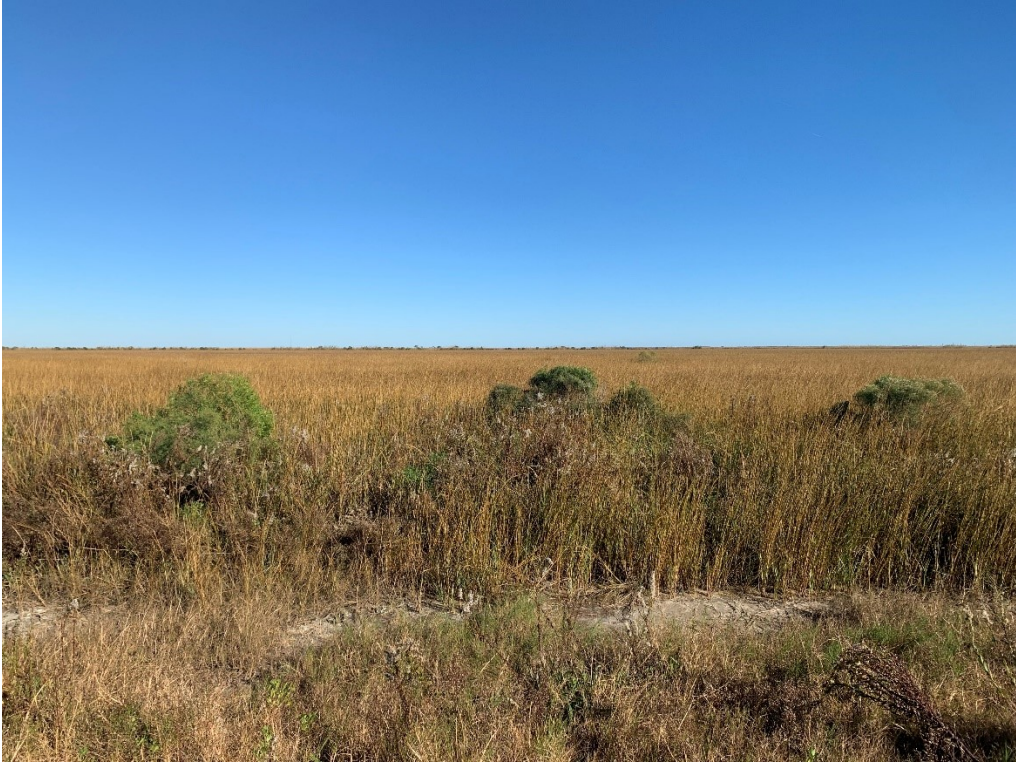
**Marsh in Cell C from the Ridge (11/30/2021)**

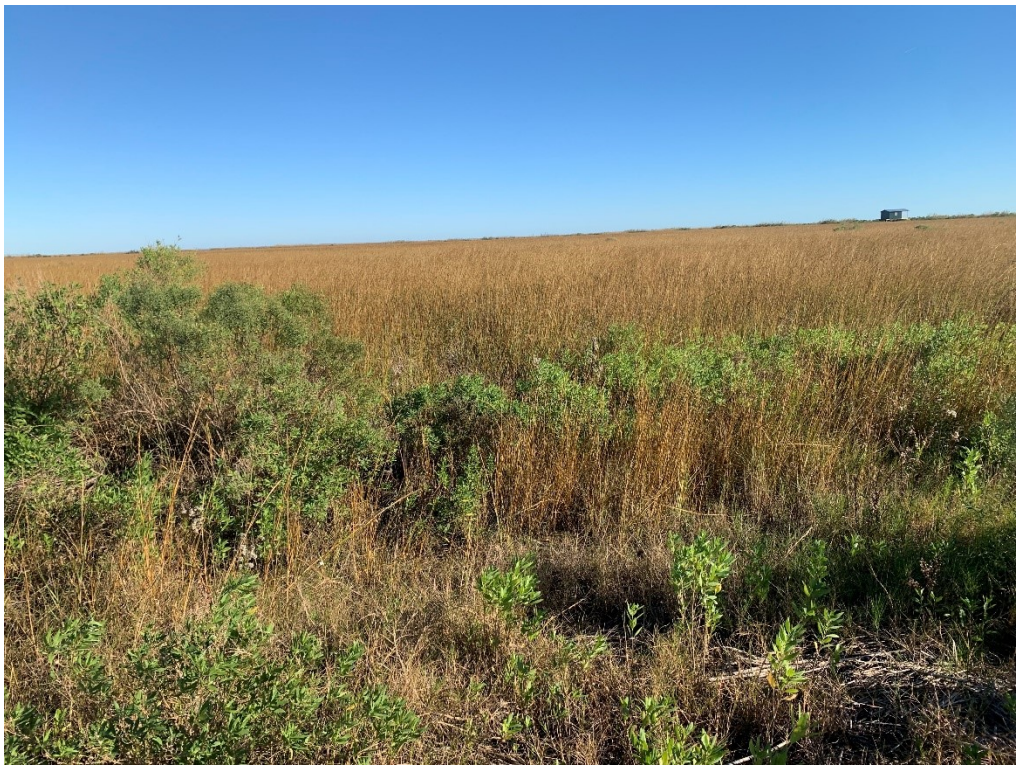
**Marsh in Cell D from the Ridge (11/30/2021)**

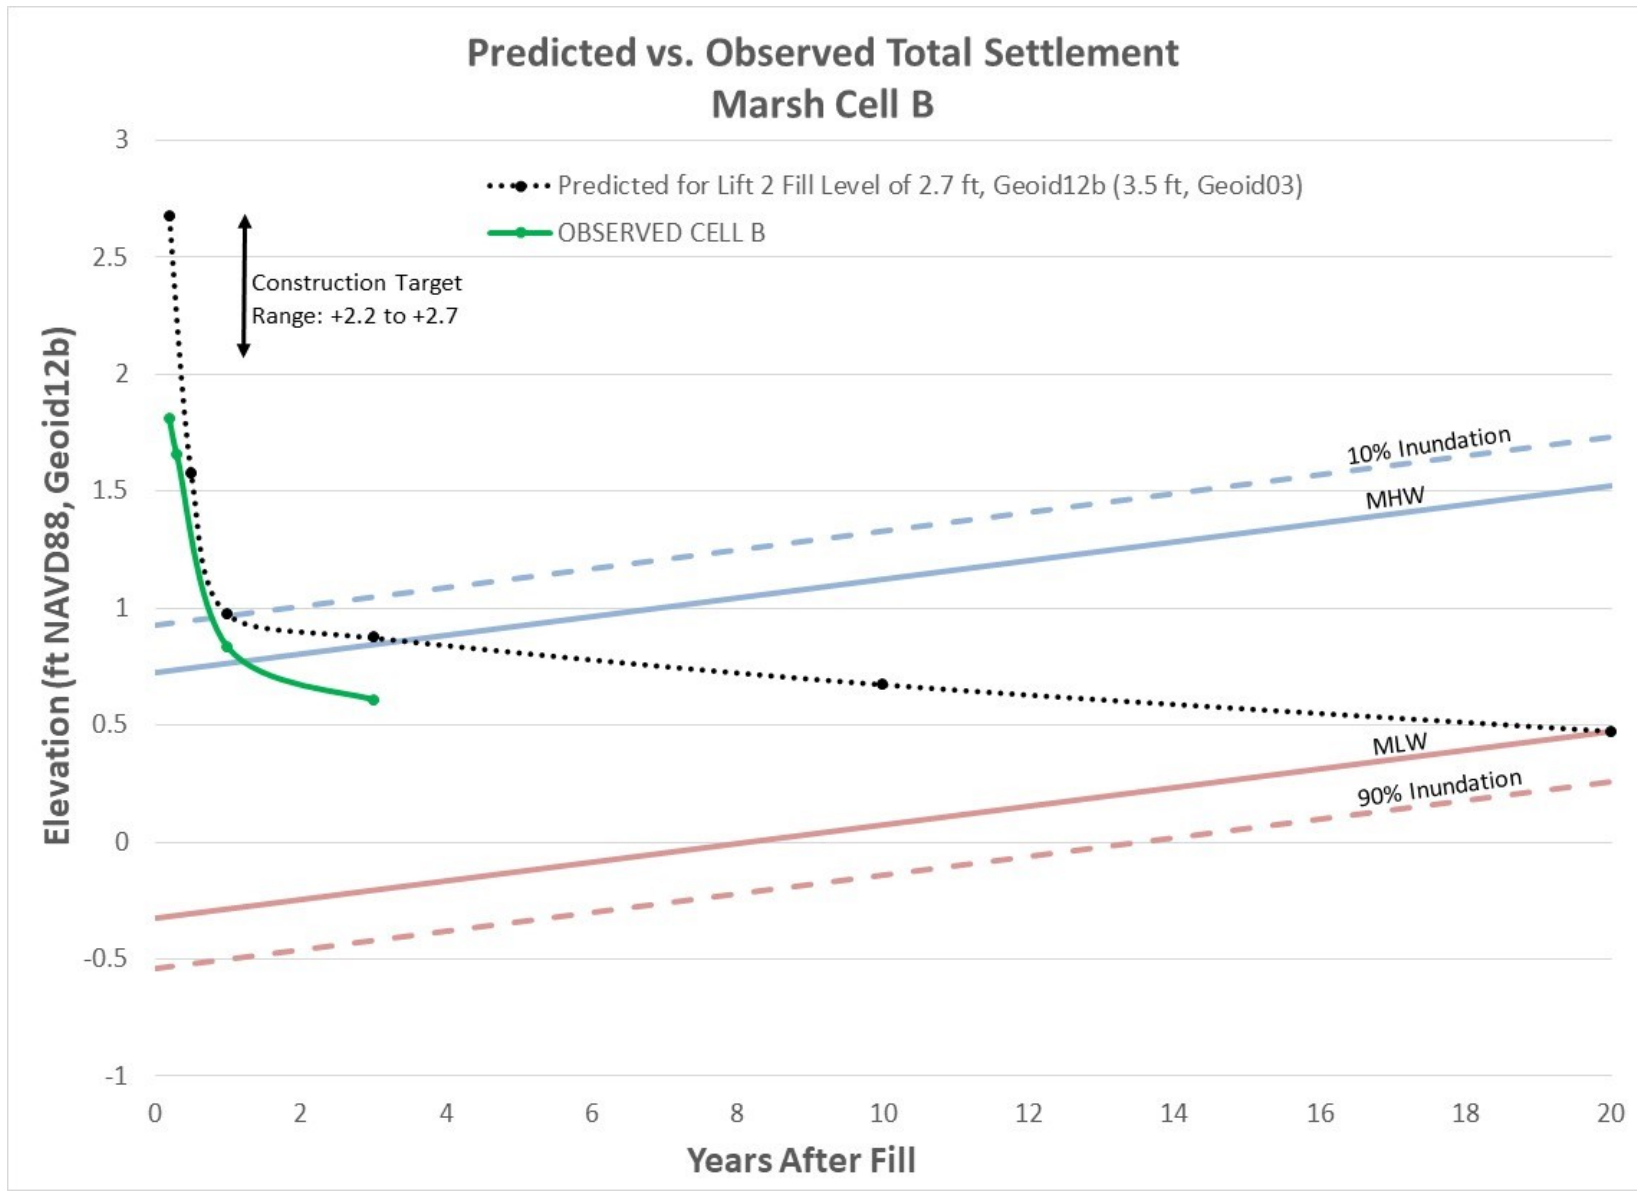
Appendix C-2. Predicted vs. observed mean elevation in BA-0068 Marsh Cell B.

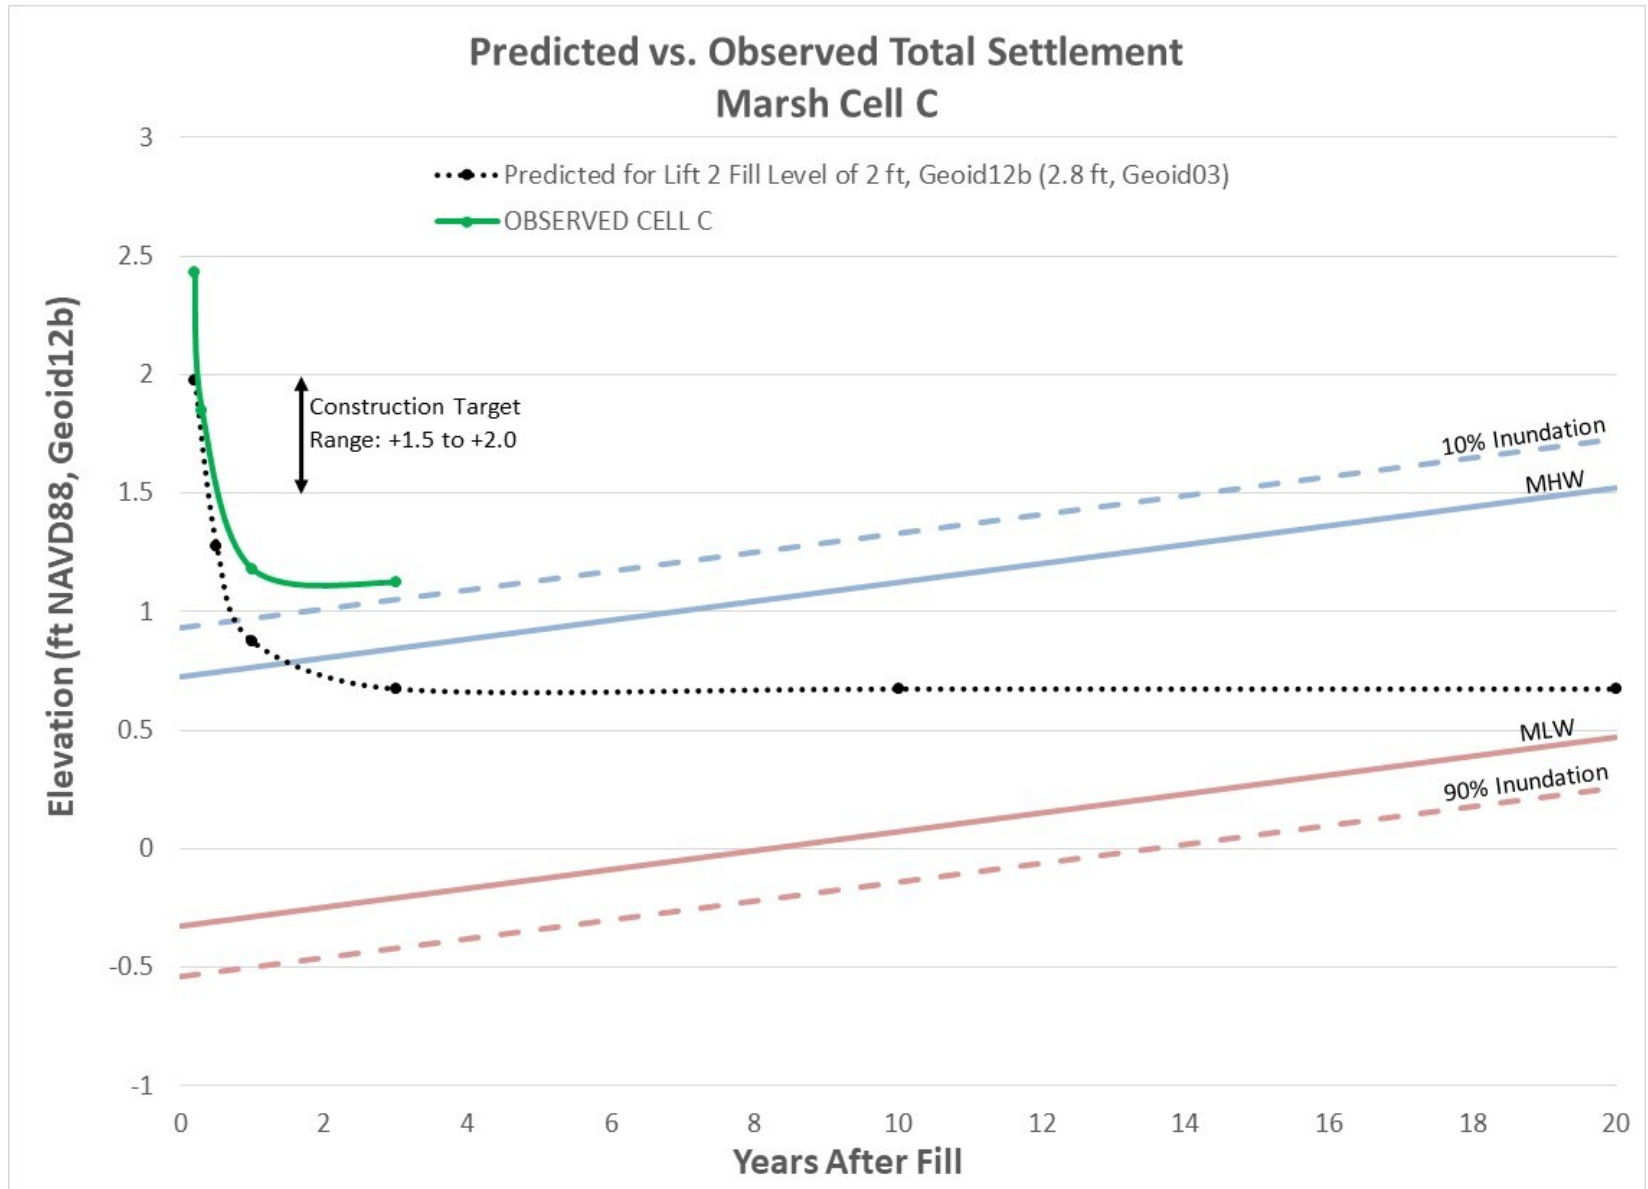
Observed mean elevation within Area C was above the predicted curve; however, the total amount of settlement by Year 3 (-1.2 ft) was the same as predicted (Appendix C-3). Mean as-built fill elevation was 0.4 ft above the maximum fill target of +2.0 ft following the third lift, and the design curve was based on only two lifts. Although the overall amount of settlement was the same as predicted by Year 3, it was greater than expected within the first year and lower than expected between Years 1 and 3, and therefore did not follow the predicted curve. The mean elevation at Year 3 was just approaching the 10% inundation level and mean elevation by Year 20 will be expected to remain within the optimum range for the duration of the 20-year life. Despite also receiving a third lift, the observed settlement within Area D was similar to the predicted curve (Appendix C-4). The mean as-built fill elevation was 0.2 ft above the fill target and the Year 3 mean elevation was 0.1 ft higher than predicted. Marsh at the Year 3 elevation would be expected to be flooded between 10-20% of the time, and the elevation by Year 20 is expected to still be within the optimum range.

Appendix C-3. Predicted vs. observed mean elevation in BA-0068 Marsh Cell C.

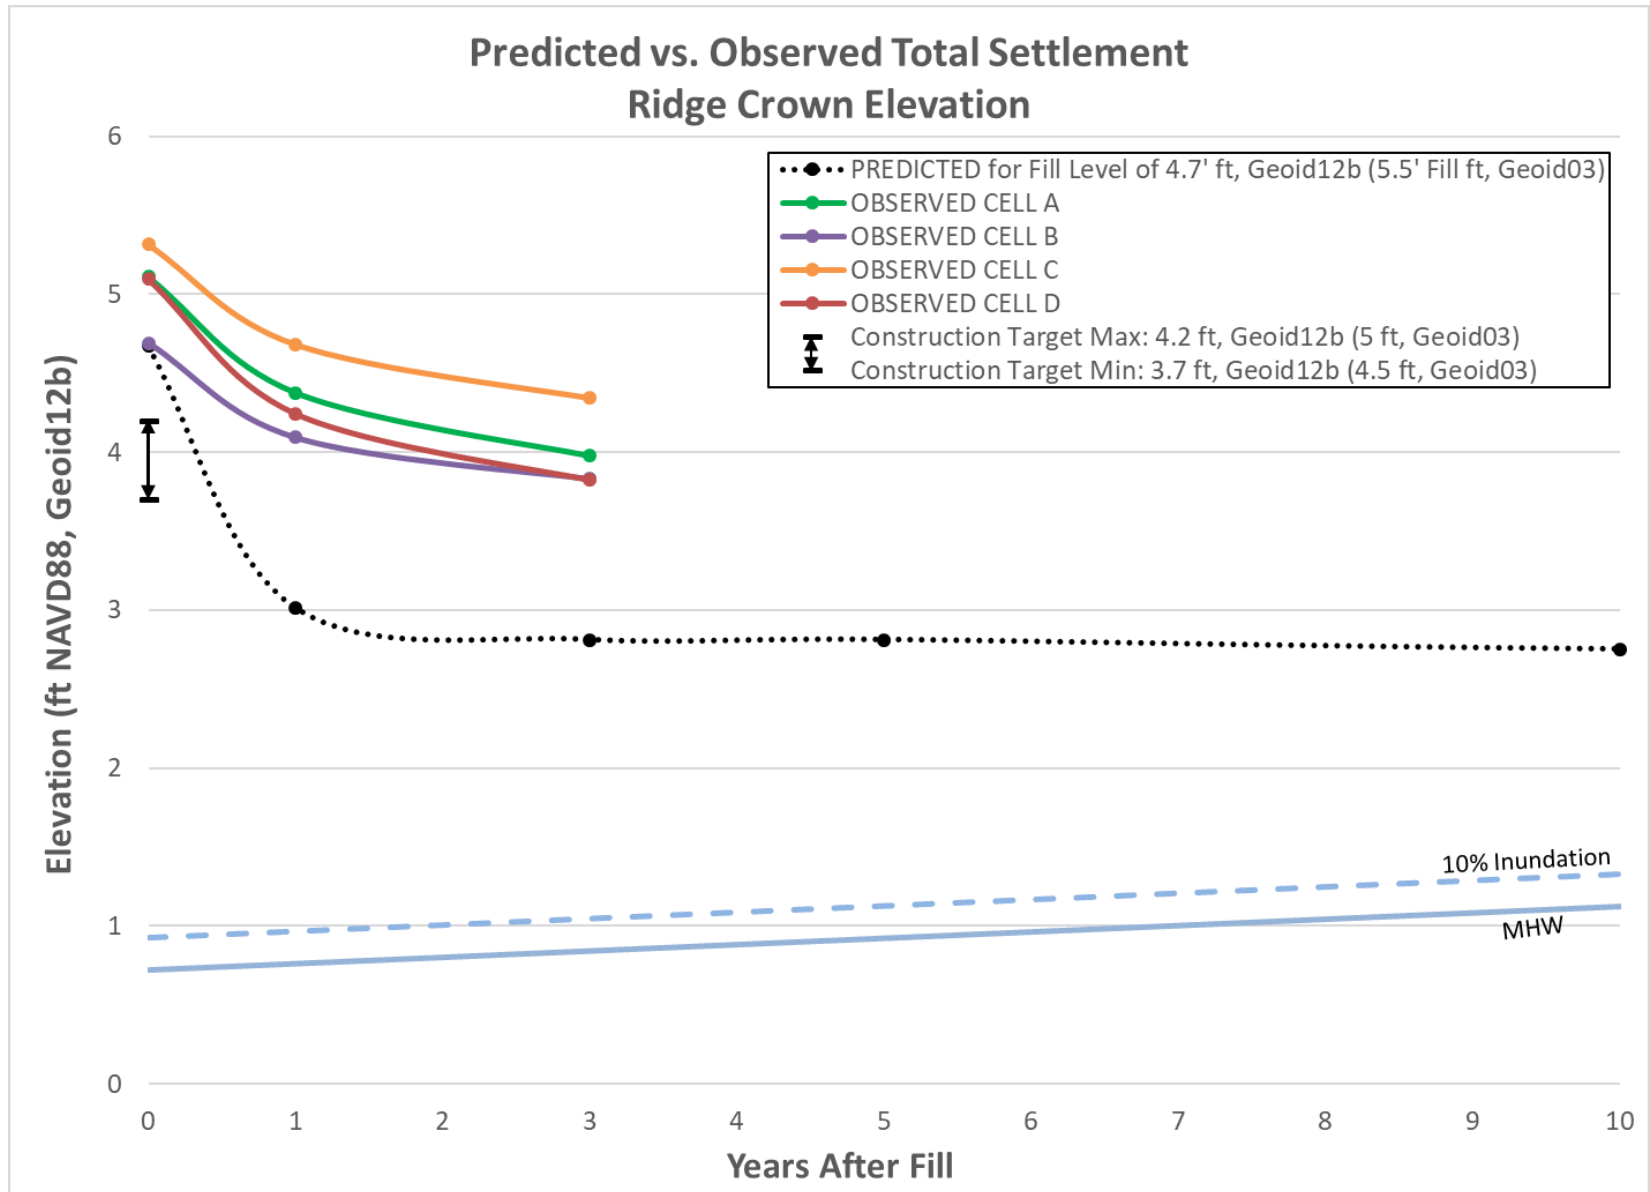
The predicted settlement curve for the original +4.7 ft target fill height design is plotted along with the observed mean crown elevation through post-construction Year 3 for each of the four fill areas in Appendix C-5. The as-built crown elevation of the ridge in Area B (+4.7 ft) was the same as the target fill height used for the predicted curve, while the fill elevation of the other ridge areas were slightly higher. The comparison shows that observed mean crown elevations within the four ridge areas at Year +3 were 1.0-1.5 ft higher than the predicted elevation for Year +3 (+2.8 ft) based on a +4.7' fill height. Almost 2 feet of crown settlement had been predicted by Year +3, while only 1.1 feet of settlement was observed for the combined ridge areas. This lower than predicted settlement rate observed within the ridge creation areas is likely due to additional 'dressing' of the ridges which occurred after the as-built process surveys of the ridge were taken and while marsh fill placement was occurring. Although ridge construction was considered complete as of 3/24/2015 (AECOM Technology Services 2016), daily contractor notes indicate that marsh buggies continued to reshape and add material to the ridge areas to meet project specifications through August 2015. Therefore, as initial fill settlement occurred along the ridge areas, crews made up for these losses by adding new material to meet design specs over several months. This significantly reduced the resulting observed settlement rate of the fill material, but likely increased the below-fill settlement due to the weight of additional material.

**Appendix C-5.** Predicted vs. observed mean elevation of the BA-0068 ridge crown.
