**2018 Operations, Maintenance, and
Monitoring Report**

Holly Beach Sand Management

State Project Number CS-31
Priority Project List 11

June 2018
Cameron Parish

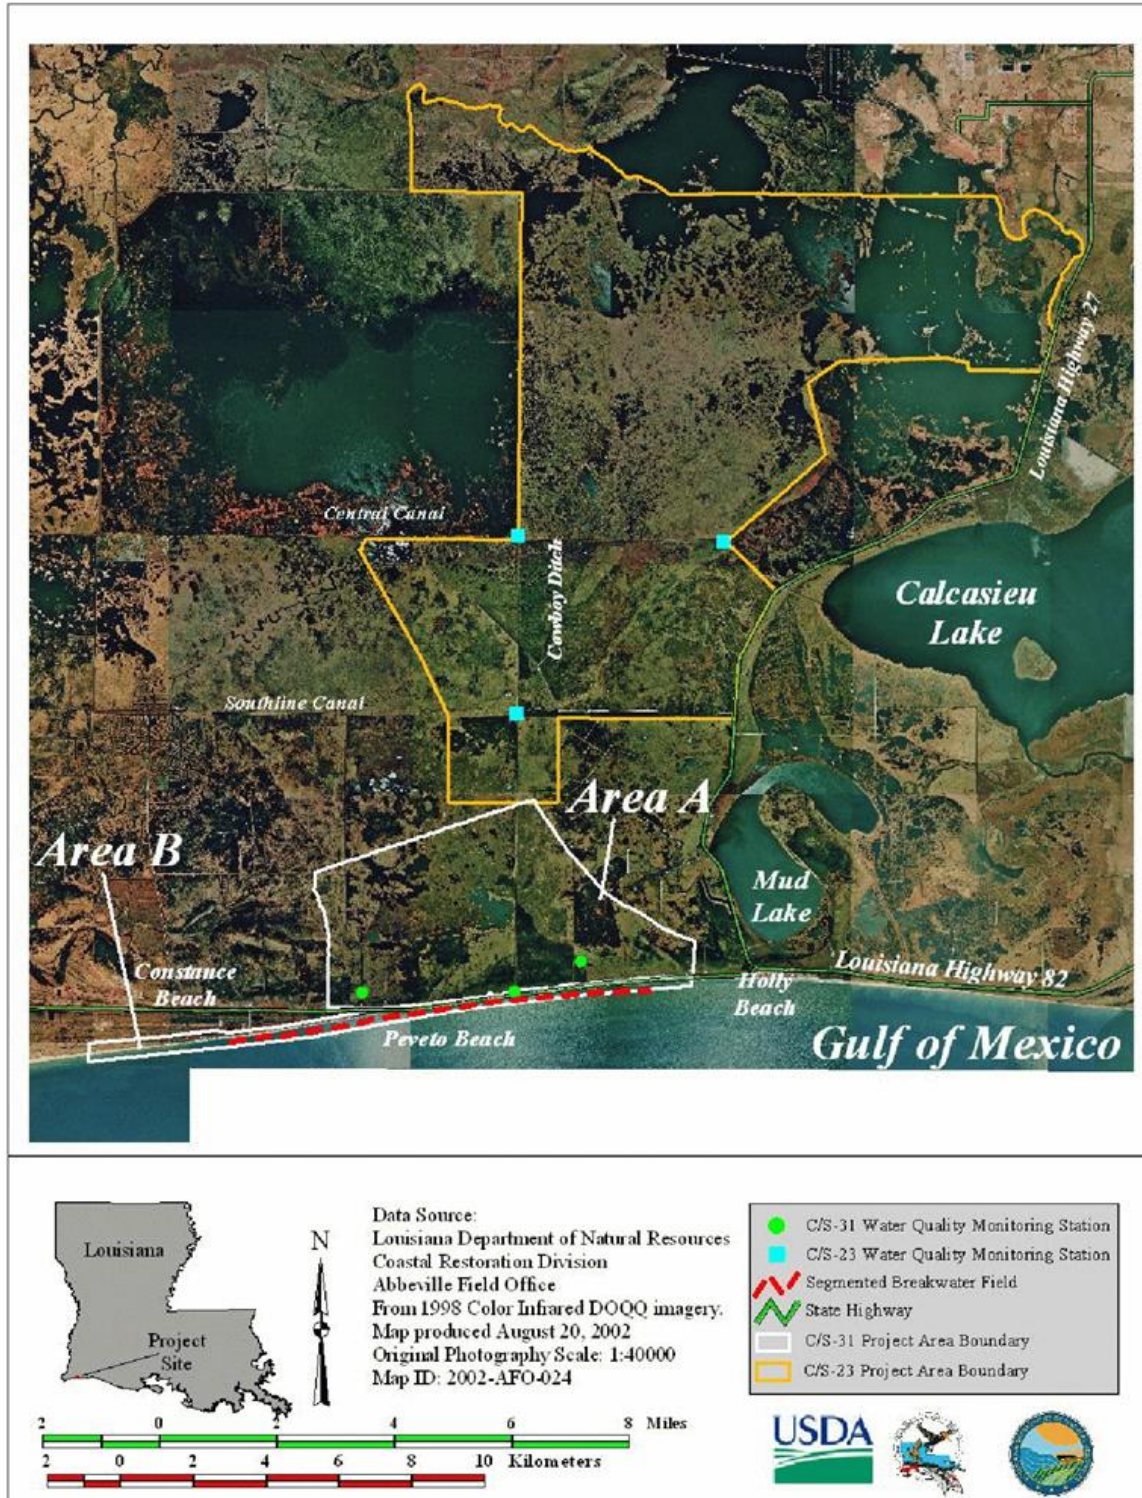
Figure 1. Holly Beach Sand Management (CS-31) project area boundaries.

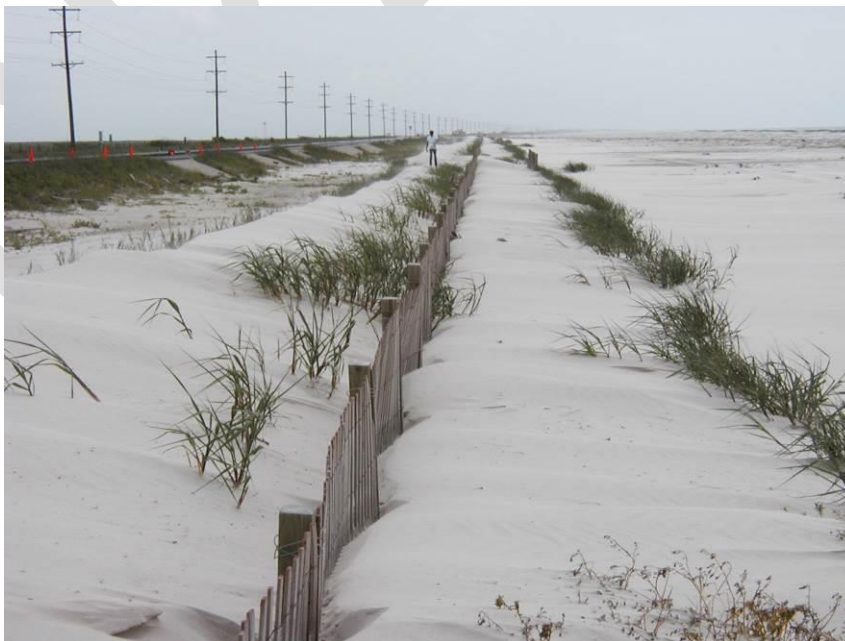
Figure 8a. View of the sand fencing and Vegetation Plantings at Station CS31-108 taken in April 2004. Note the dune formation almost covering the fences. The photograph is facing east.

Data were collected on October 6, 2003, April 20, 2004 and October 12, 2004 (Table 2, Figure 8). Mean percent survival and mean percent cover in the fall of 2003 were 82.5% and 13.07%, respectively. In the spring of 2004 mean percent survival was 81.1% and mean percent cover was 26.7%. Mean percent survival dropped to 76.7% in the fall of 2004, while mean percent cover increased to 46.4% (Figure 9). Many of the original plants were actually covered by the dune that formed behind the fences. The dunes were becoming colonized by both *Panicum amarum* and other species as well. The last scheduled monitoring of the vegetation plantings occurred in the fall of 2004. As documented in the inspection report, though, the plantings were severely impacted by Hurricane Rita and were replanted by the La Dept. of Agriculture and Forestry. These plantings were again severely impacted by Hurricane Ike and were replanted in the fall of 2011. During the 2016 O&M inspection, it was noted that very little of the plantings remained. The remaining vegetation was flourishing in areas along the beach front which were not impacted by beach retreat and direct wave action. There was minimal to no vegetation remaining where the beach was severely eroded and experiencing constant wave energy.

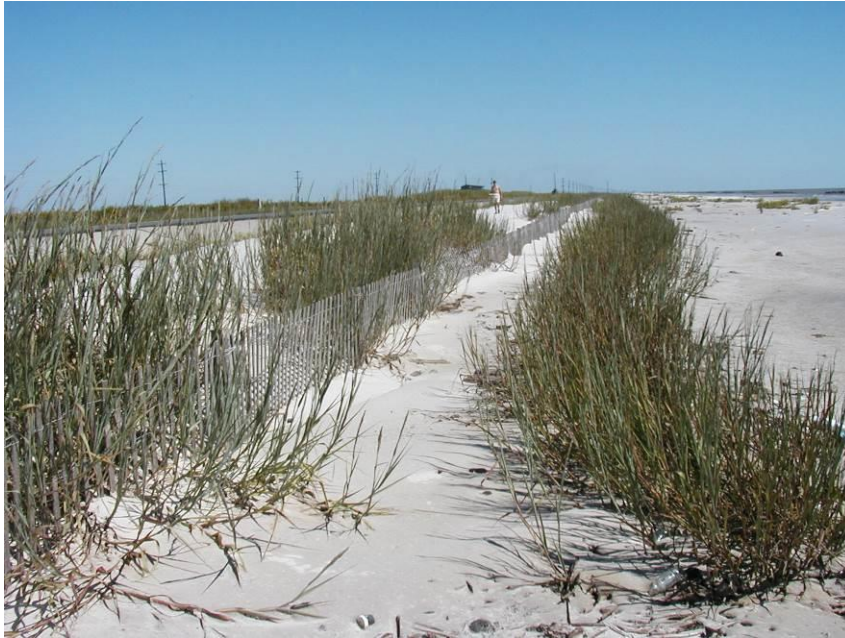
Figure 8b. View of the Sand Fencing and Vegetation Plantings at Station CS31-150 taken in October 2004. The photograph is facing east.

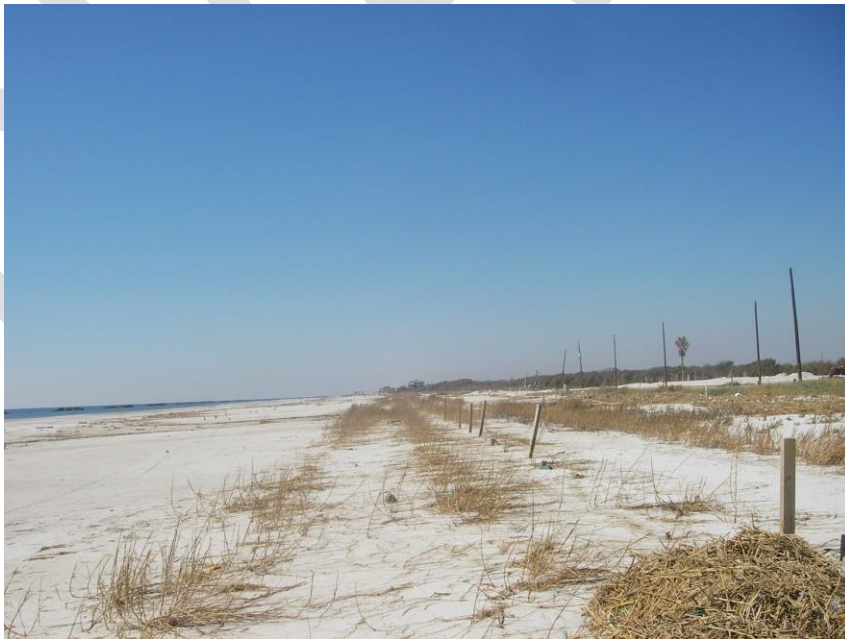
Figure 8c. View of a section of the sand fencing and vegetation plantings taken October 2005, following Hurricane Rita. The photograph is facing west.

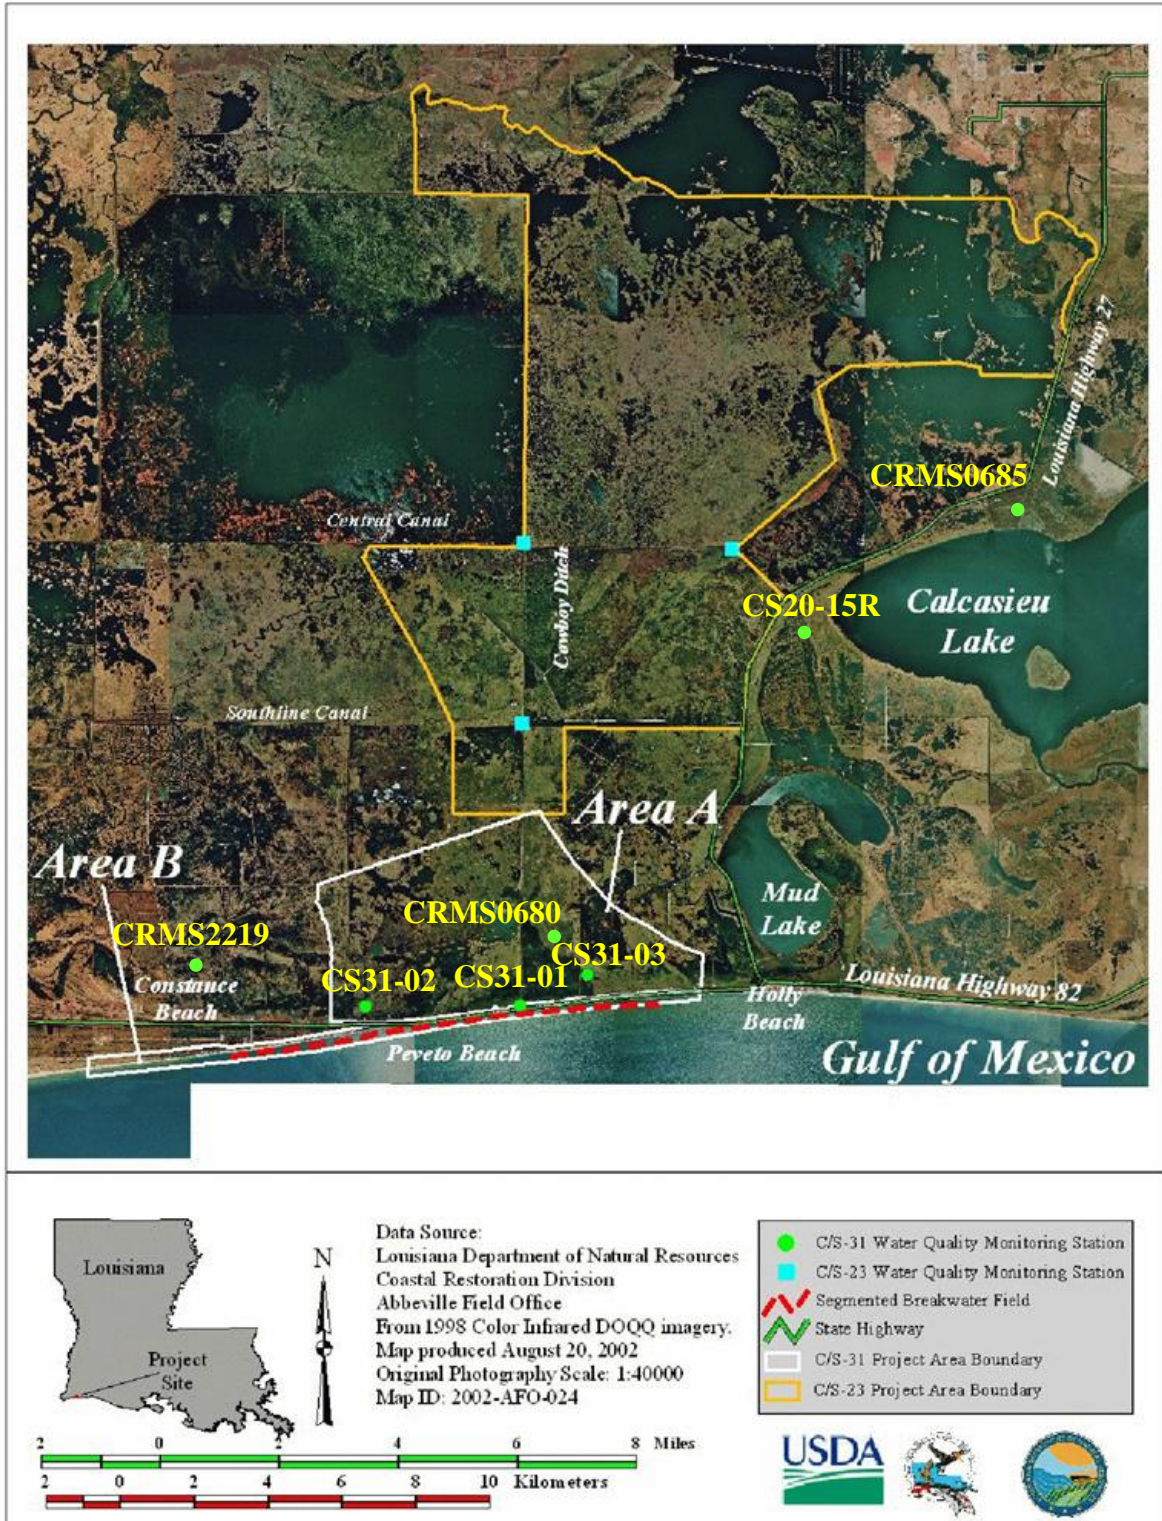
Hourly salinity data were collected at the following continuous recorder stations (Figures 12 and 13a-c).

Figure 12. Location of continuous recorder stations at Holly Beach Sand Management (CS-31) project.

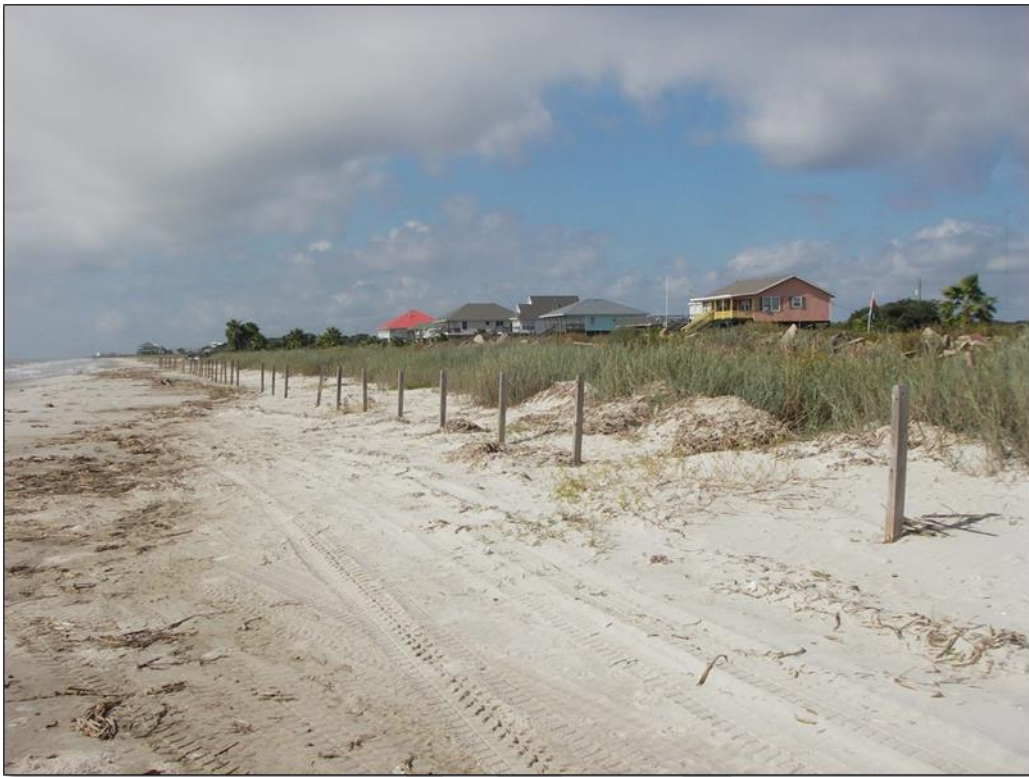
The sand fence has suffered extensive damage due to wave and tidal action, and loss of beachhead. There is very little fence remaining. It is estimated that 10 percent of fence is intact and functioning as intended, in areas where there is significant beachhead to prevent wave and tidal encroachment. (Photos: Appendix A, Photos 1 - 4).

Photo No. 1, Double section of sand fence on western end of project. The section of fence closest to the water is no longer intact, due to tidal action, while the section further away from the water has successfully created a dune.

The project team will make a site visit to inspect the remaining sand fence and determine whether a maintenance event is required to remove remaining fence posts where the sand fence has been damaged.

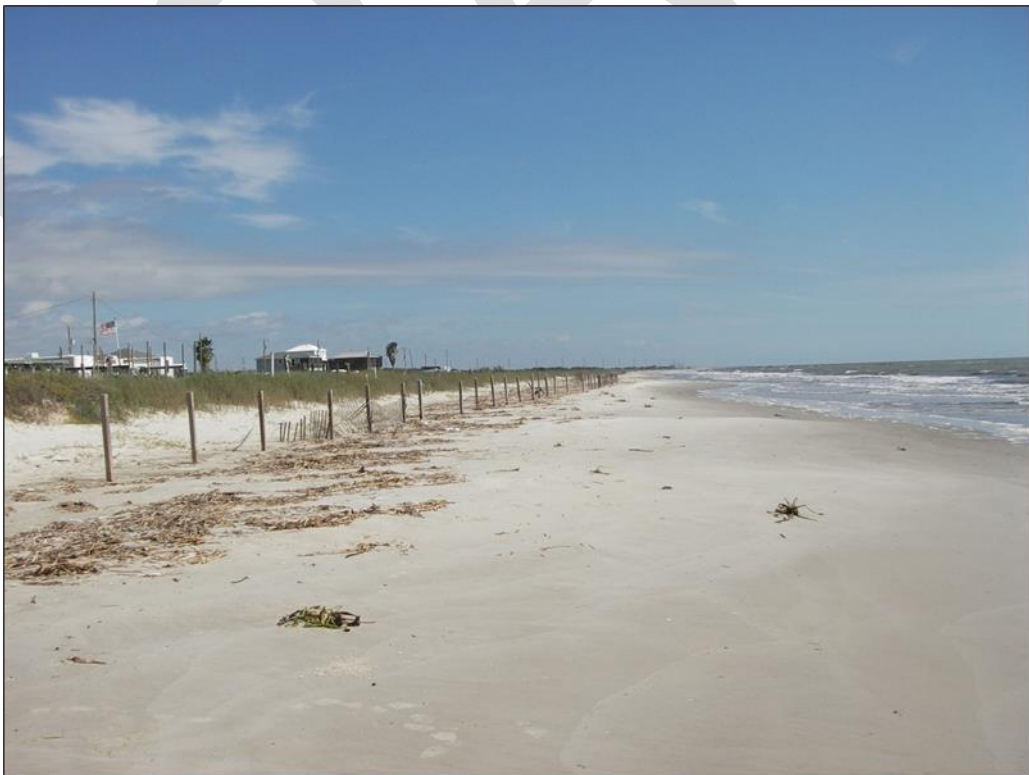
Photo No. 2, Double section of sand fence on western end of project. The section of fence closest to the water is no longer intact, due to tidal action, while the section further away from the water has successfully created a dune.

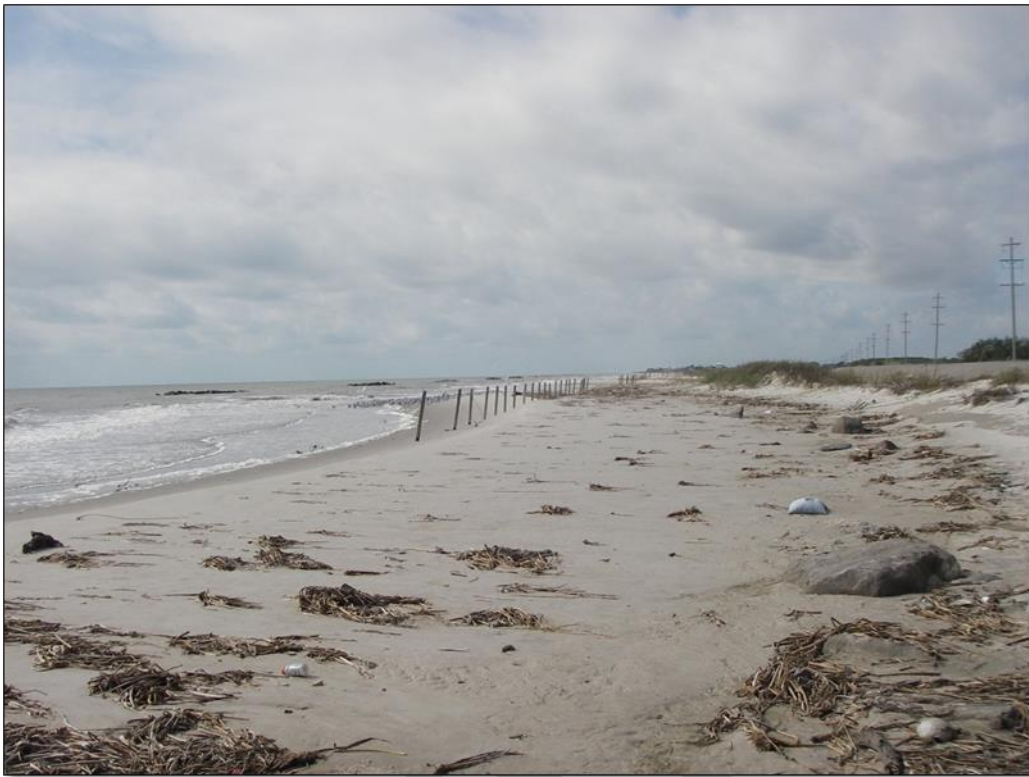
There has been substantial loss of beachhead. There is a need for more beach nourishment, however the borrow area utilized for the previous nourishment project (2003), has been consumed and there is no known economical borrow source in the project area. (Photos: Appendix A, Photos 1 – 4).

Photo No. 3, Little to no sand fence remains on the eastern end of the project.

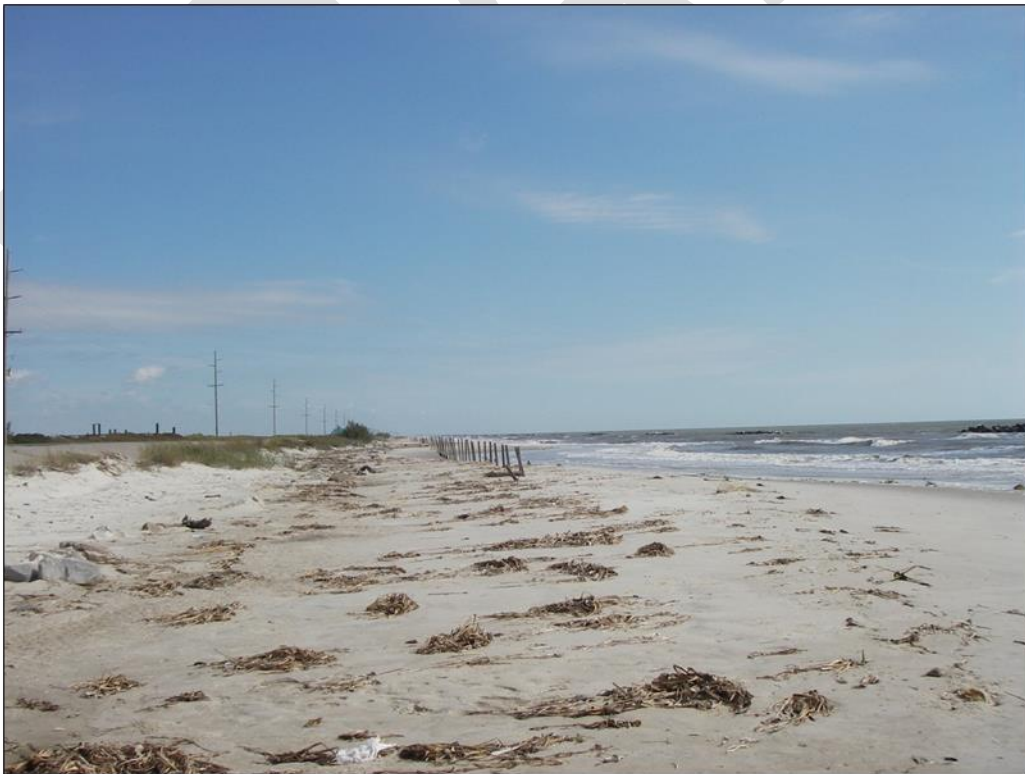
Photo No. 4, Little to no sand fence remains on the eastern end of the project.
