# 2021 Operations, Maintenance, and Monitoring Report

## Sabine Refuge Marsh Creation Cycles – 3, 4 & 5

State Project Number CS-28-3 and CS-28-4-5  
Priority Project List 8

May 2022  
Cameron Parish

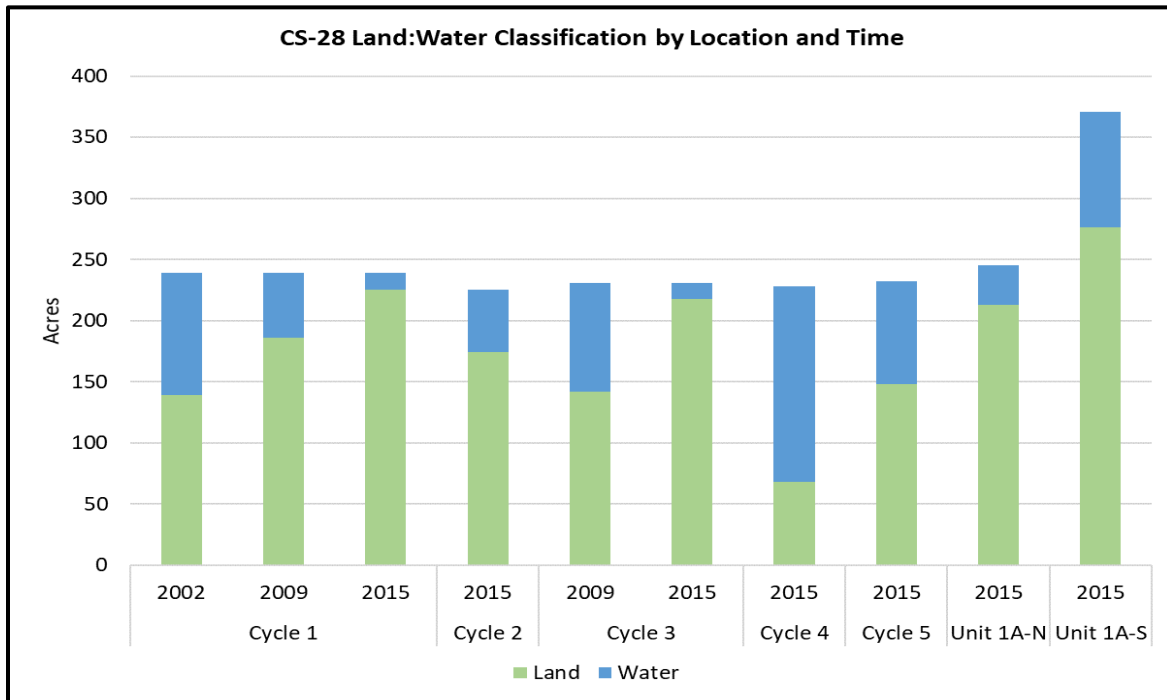
Aerial photography collected one year post-construction of Cycle 1 (2002) showed unvegetated dredged material or mudflat in about 58% of the marsh (Figures 3-4). All other marsh creation areas were open water at that time. Between 2002 and 2009 in Cycle 1, 171 additional acres became vegetated, increasing the percent land to 77% (Figures 3, 5, and 6). By 2015, 94% of the Cycle 1 marsh creation area was vegetated wetland (Figures 3 and 7).

Aerial photography collected two years post-constructions of Cycle 3 (2009) show Cycle 3 percent land around 62% (Figures 3 and 5). Land in the Cycle 3 marsh creation area increased to 94% by 2015 (Figures 3 and 7). Cycle 2 consisted of 77% percent land in 2015 (Figure 7).

**Figure 3.** Acreages for land:water classifications from aerial photography collected in 2002, 2009 and 2015.

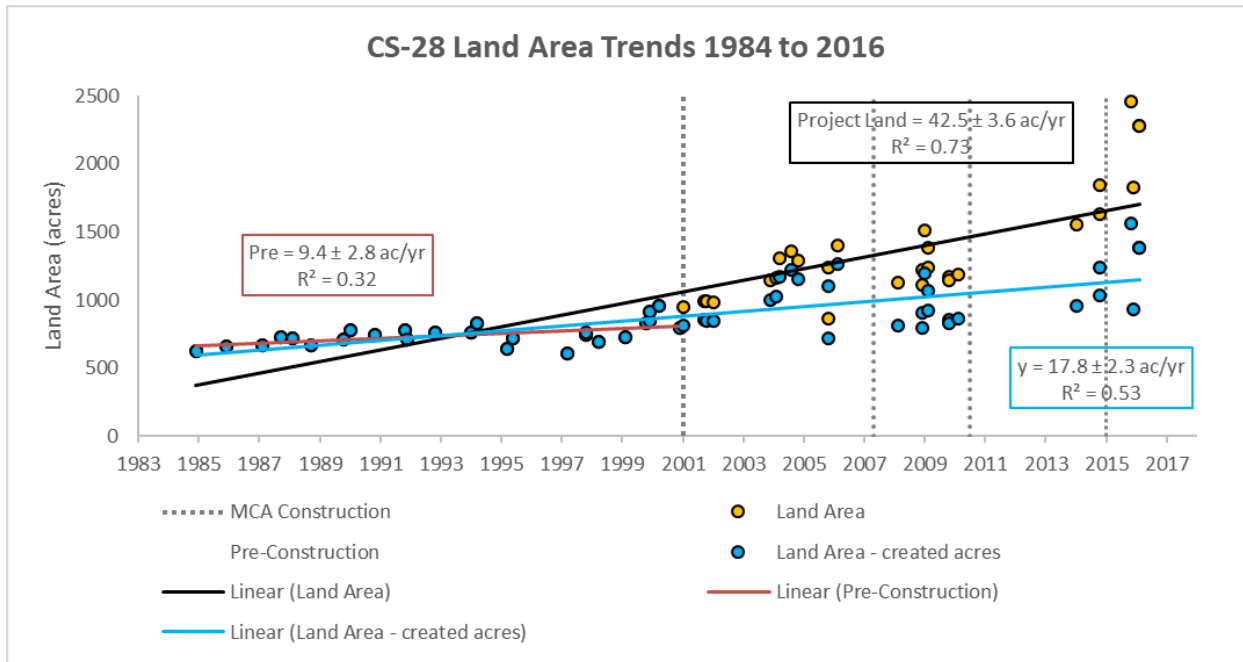
The general land change trend in the CS-28 project area prior to construction was slightly positive with an increase of 9 ac/yr (0.2%/yr) from 1984 to 2001 (Figure 9). From 1984 to present, the land gain rate has increased to 42.5 ac/yr (0.9%/yr). The increase reflects both created marsh area and any effect that the project may have had on slowing landloss in the pre-existing marsh in the project area. In order to assess whether the project has met its goal of reducing landloss in existing surrounding marshes, created marsh area quantified through spatial analysis was subtracted from project land acreage and the rate of change was assessed. Excluding created marsh area, the land change rate from 1984 to 2016 would be 17.8 ac/yr (0.4%/yr). The project does appear to have provided some protection to adjacent marshes though differences between pre and post construction, excluding created marsh, are slight and within the range of error for the estimates.

**Figure 9:** Land area trends in acres for the CS-28 project area for years 1984 to 2016. The blue line depicts the land area trend prior to the construction of CS-28. The green line depicts the land area trend for the post-construction time period. The red line depicts the post-construction land area trend with the CS-28 project acreage removed.

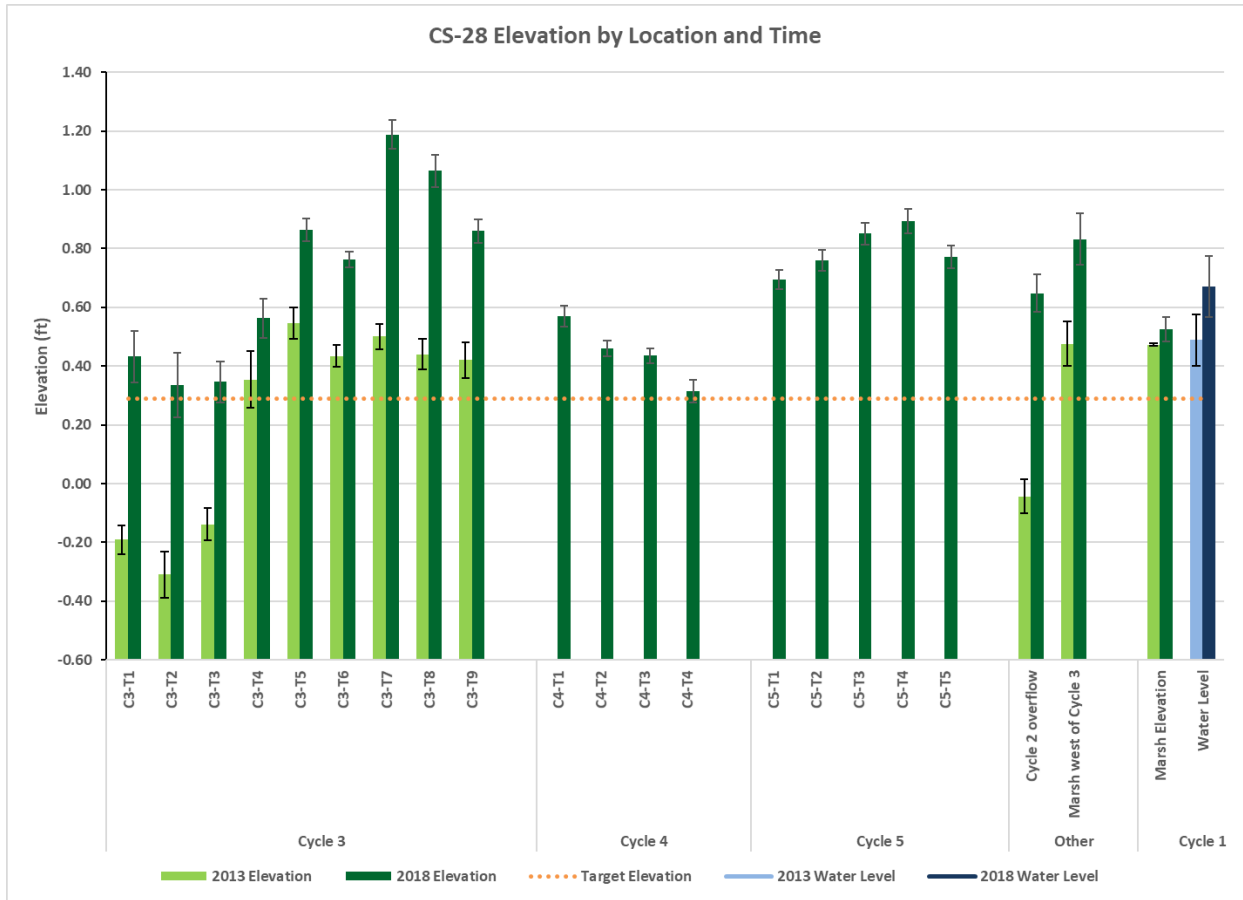
**Figure 11.** Survey elevation data and target elevation from 2013 and 2018 for Cycles 1, 3, 4 and 5 containment areas and Cycle 2 overflow. Mean water elevation was recorded at CRMS6301 in the Cycle 1 containment area.

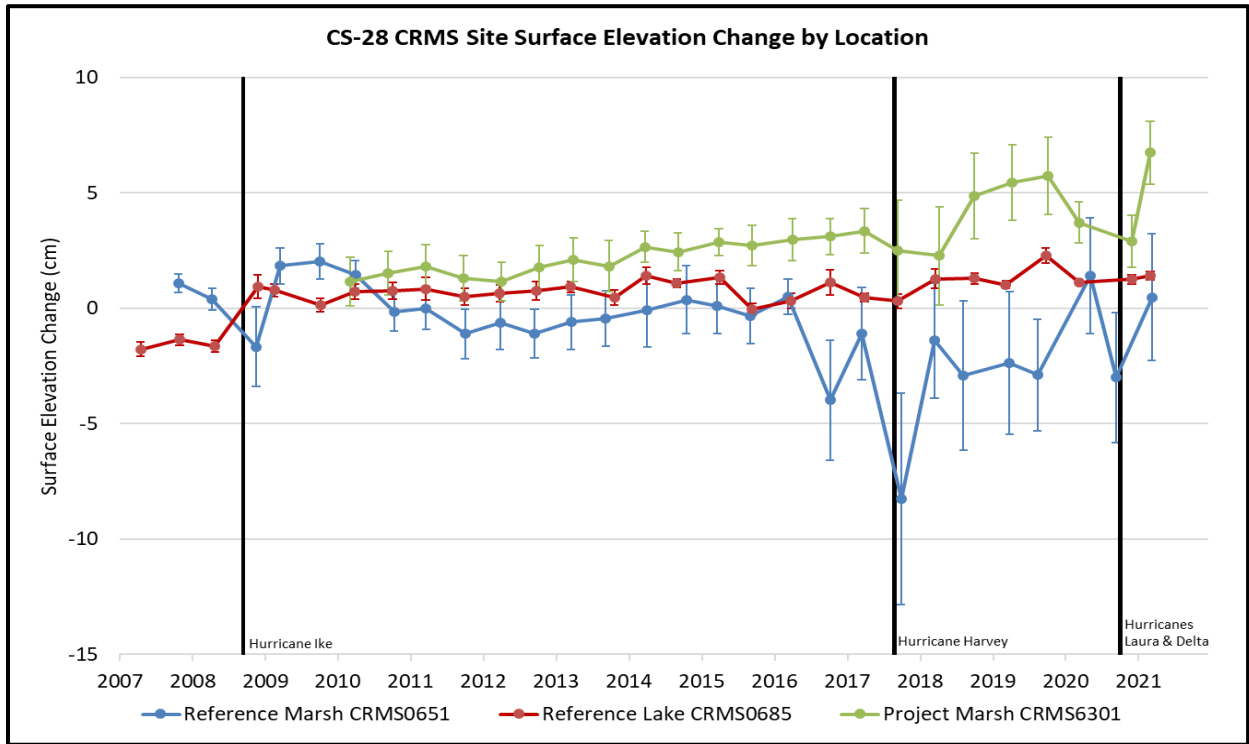
Elevation change data are available from CRMS sites. Elevation within Cycle 1 has increased steadily from 2010 through 2021, with 2020 (post hurricanes) showing the only negative elevation change (Figure 12). The elevation gain between 2018 and early 2020 is notable at CRMS6301. The trend was seen in the marsh creation area but not at nearby reference sites (Figure 12). There was a drought in the spring of 2018 that was observed to stimulate vegetative production and produce elevation gain at some CRMS sites in the region including CRMS6301. This process may explain some of the elevation gain in Cycle 3 between 2013 and 2018.

**Figure 12.** Yearly means and standard errors of surface elevation change collected in the project and reference locations from 2010-2021.

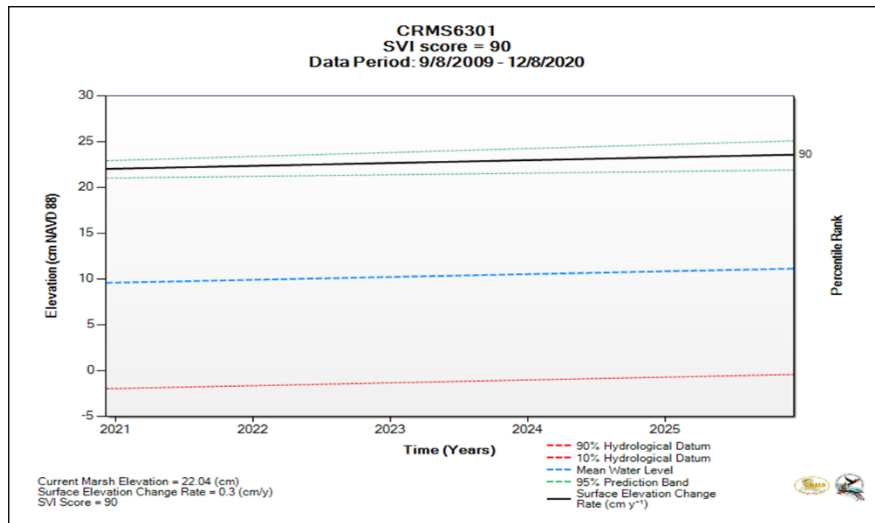
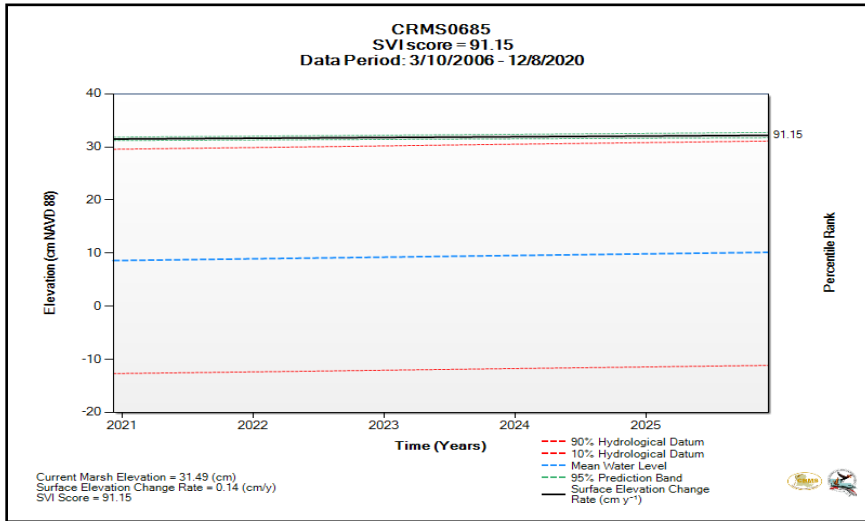
Of the CRMS sites utilized for this report, surface elevation trajectories are highest at CRMS6301 (3.6 cm/yr), are stable adjacent to the lake at CRMS0685 (0.14 cm/yr) and are negative in the marsh at CRMS0651 (-0.29 cm/yr). The Submergence Vulnerability Index (SVI) provides information on elevations relative to water levels and helps interpret these rates. SVI scores for CRMS6301 in Cycle 1 and CRMS0685 near the lake are high (>90) indicating that the sites are high in the tidal frame (Figures 13a and b). Current elevation change rates should prevent submergence over the next five years at current trajectories. CRMS0651 is losing elevation and becoming more submerged (Figure 13c).

Figures 13a, b and c . Submergence Vulnerability Index 2020.

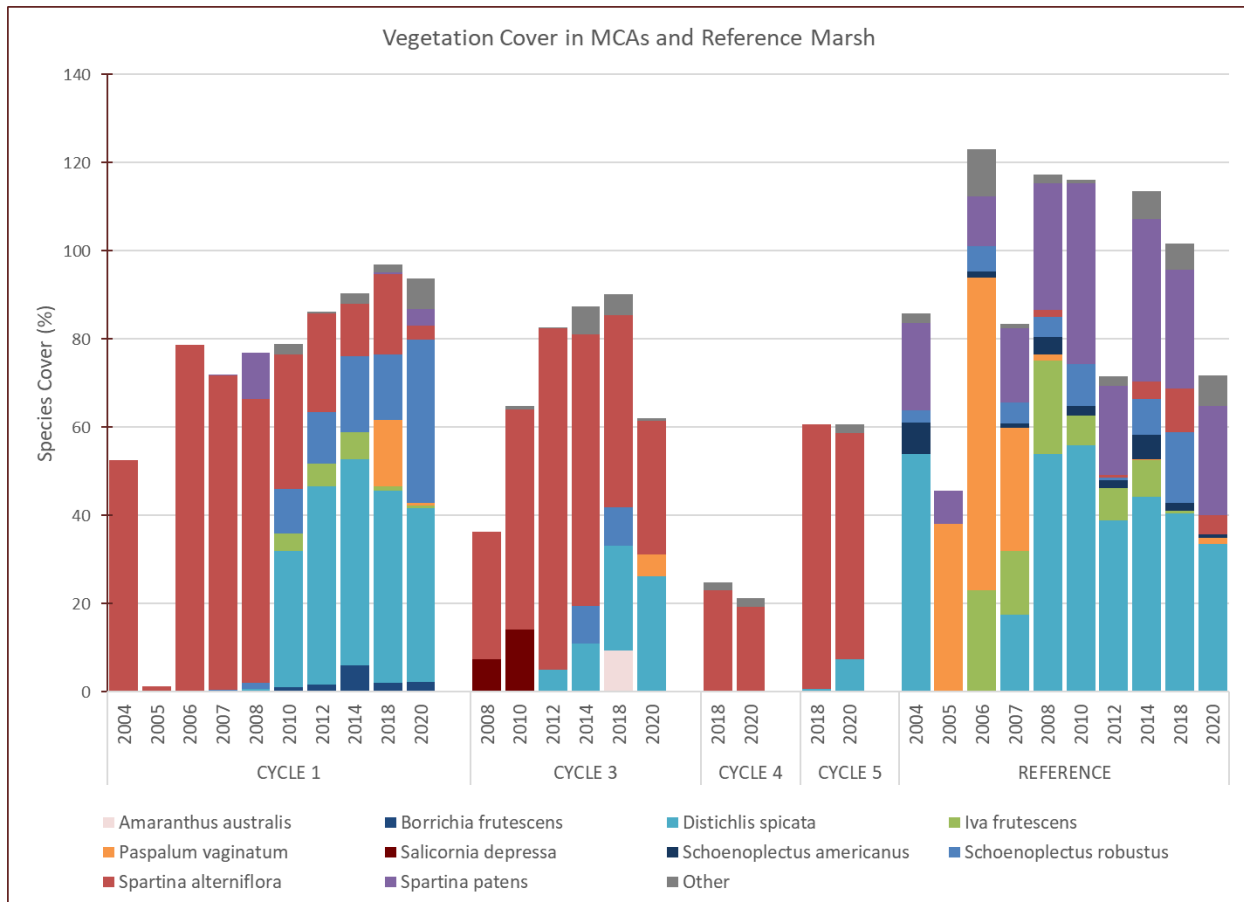
These vegetation data allow for an assessment of early succession in marsh creation areas. All CS-28 MCAs are colonized first by *Spartina alterniflora* and salt tolerant succulents like *Salicornia depressa* and *Batis maritima* (Figure 18; Batis included in the “Other” class). After a few years, more salt tolerant grasses and sedges emerge including *Distichlis spicata* and *Shoenoplectus robustus*. *Spartina patens*, which is one of the most commonly found species in the reference marsh has not become established in the Cycle 1 marsh creation area after 20 years. *Distichlis spicata*, which is a salt tolerant grass, is co-dominant in both the Reference area and the Cycle 1 marsh creation area but otherwise, the vegetation communities remain distinctly different from one another.

**Figure 18.** Percent cover of individual vegetation species by years within CS-28 cycles 3, 4, 5 and reference area.

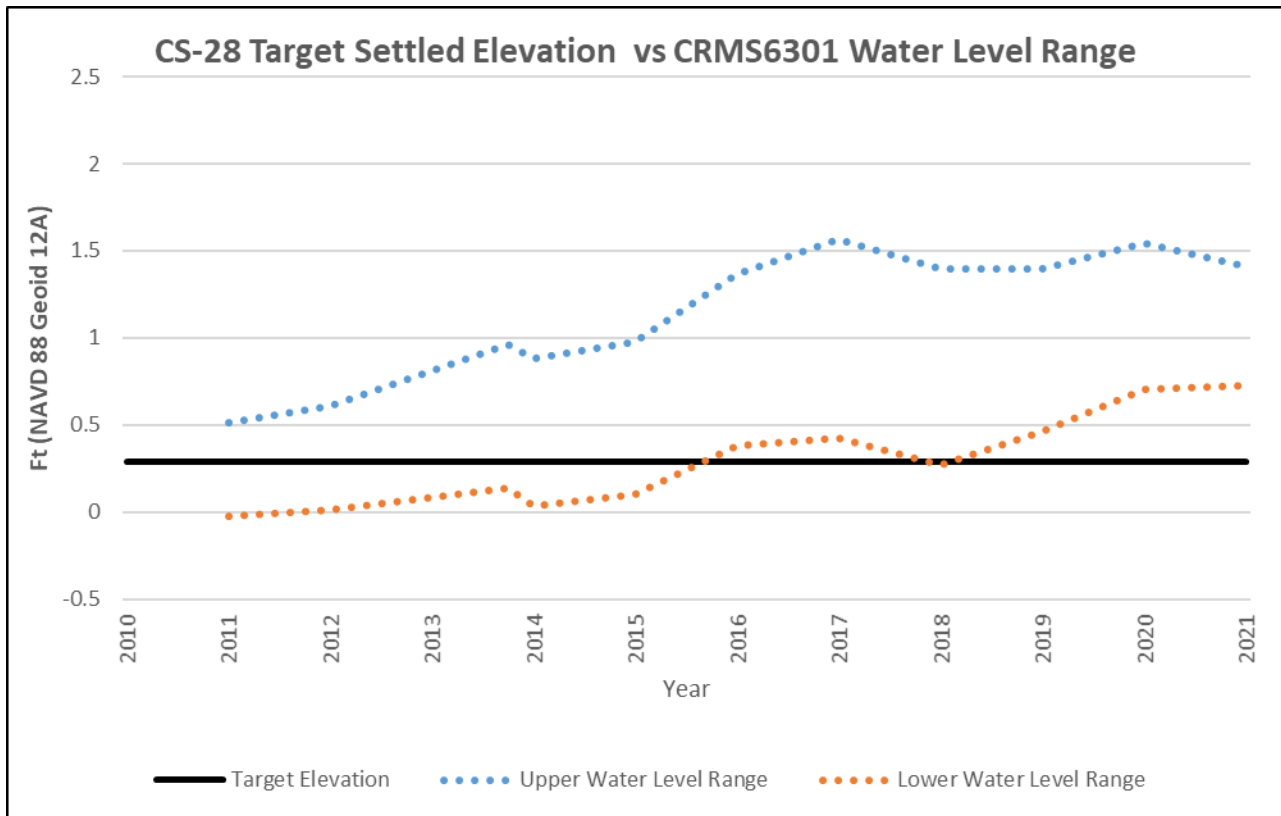
**Figure 21.** Annual water level range collected in the Cycle 1 marsh creation cycle plotted against the target settled elevation goal for the CS-28 marsh creation areas.

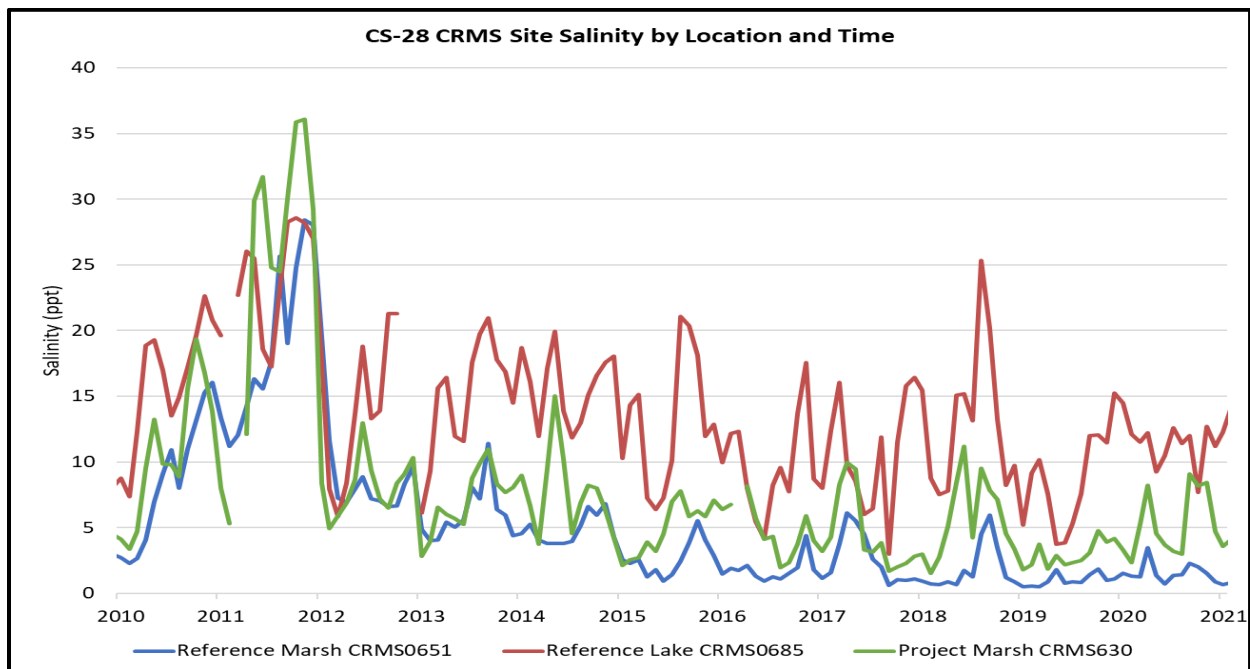
Monthly water surface salinity was calculated from CRMS hourly data from 2006-2021. Salinity was highest during the 2011 drought and has decreased since (Figure 22). There was another, much shorter drought in 2018 that did not have the same effect as the 2010/2011 drought. CRMS0685 has consistently had the highest salinities as it is directly connected to the Gulf of Mexico. The project area salinities are higher than those found in the marsh to the east of the project area. This consistent decrease in salinity can, in part, be attributed to the effects of the CS-23 Sabine control structures, which became operational in 2013, and ponding due to drainage limitations caused by sea level rise.

**Figure 22.** Monthly means of surface water salinity collected in the project and reference area locations from 2010-2021.

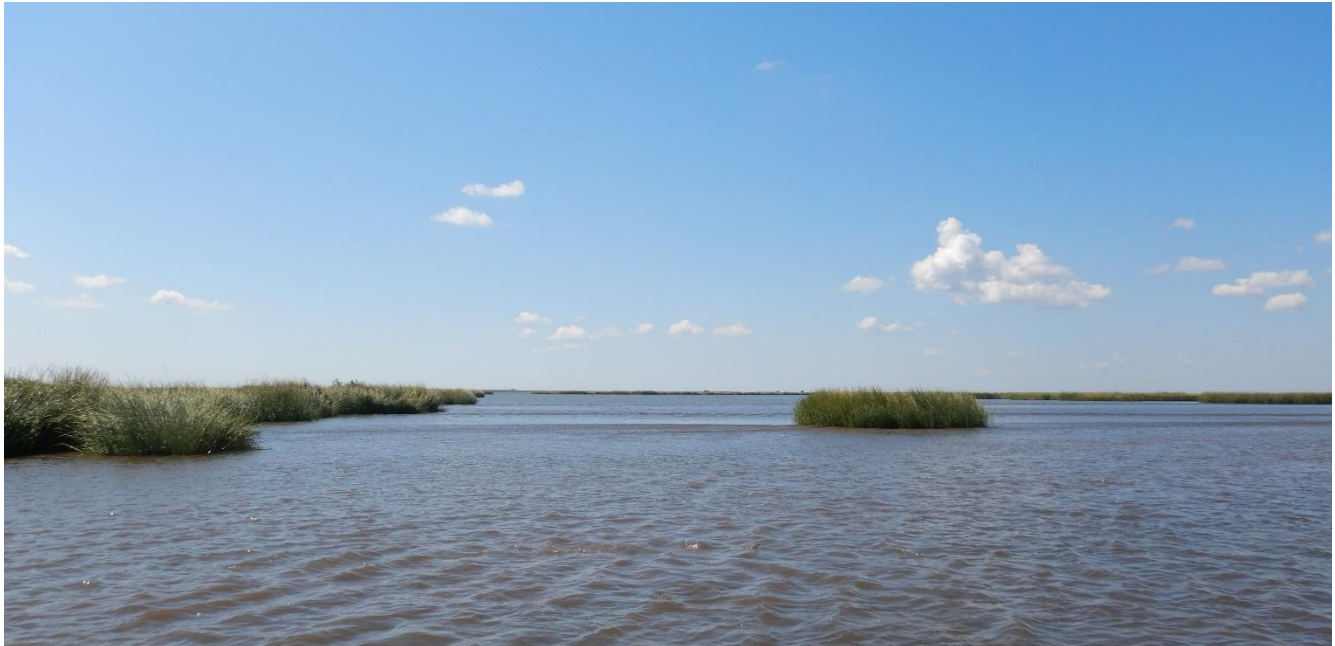
The emergent marsh platform has good vegetation coverage. However, the western and southern side of the cell has shallow open water that will be addressed with the forthcoming CS-81 Sabine Cycles 6 & 7 project. The containment dikes are sufficiently gapped where post-construction gapping was not required. (Photos: Appendix A, Photos 2 - 4)

**Photo No. 2**, Cycle No. 4, Southern Containment Dike, Looking Southwest

No O&M related maintenance work is required at this time for the marsh creation cycles. However, it is agreed by the project team that the additional fill material placed during the construction of the CS-81 Cycles 6 & 7 phase will dramatically benefit the performance of Cell No. 4.

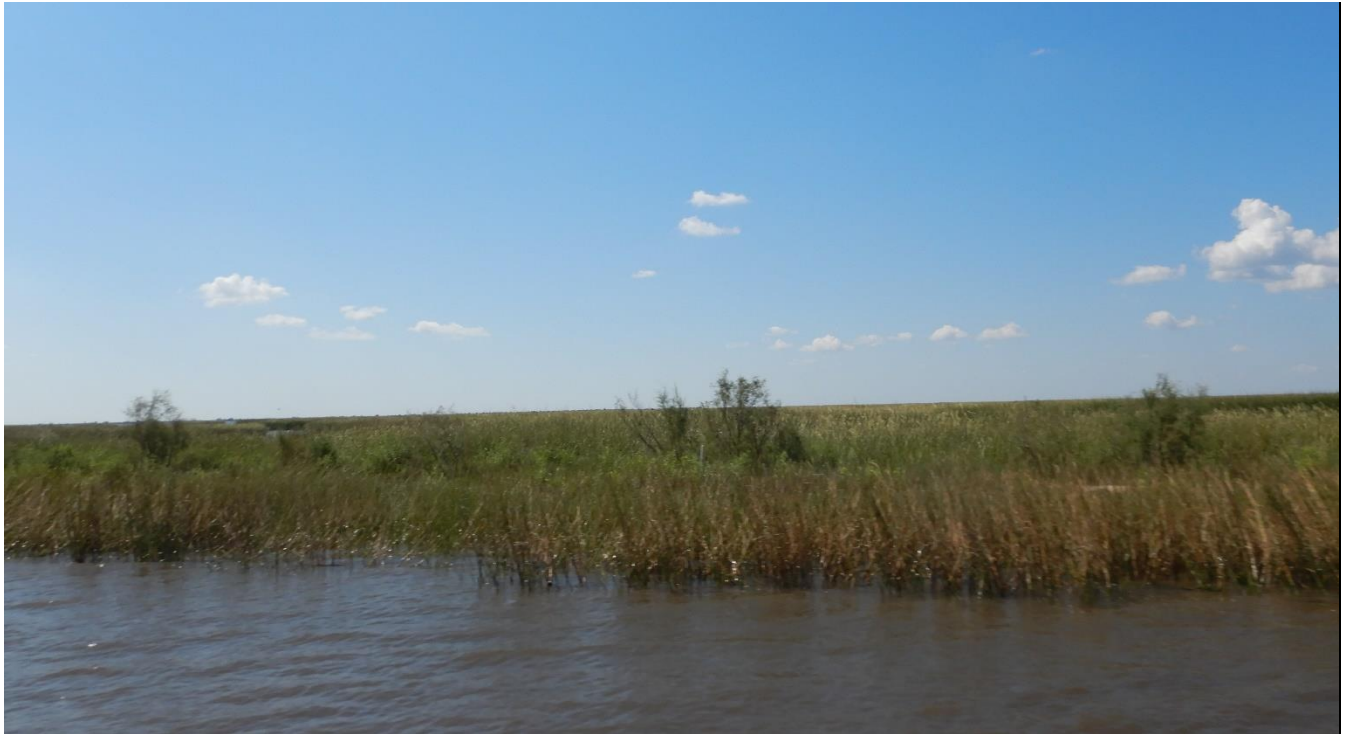
**Photo No. 3**, Cycle No. 4, Vegetation where Established on north end

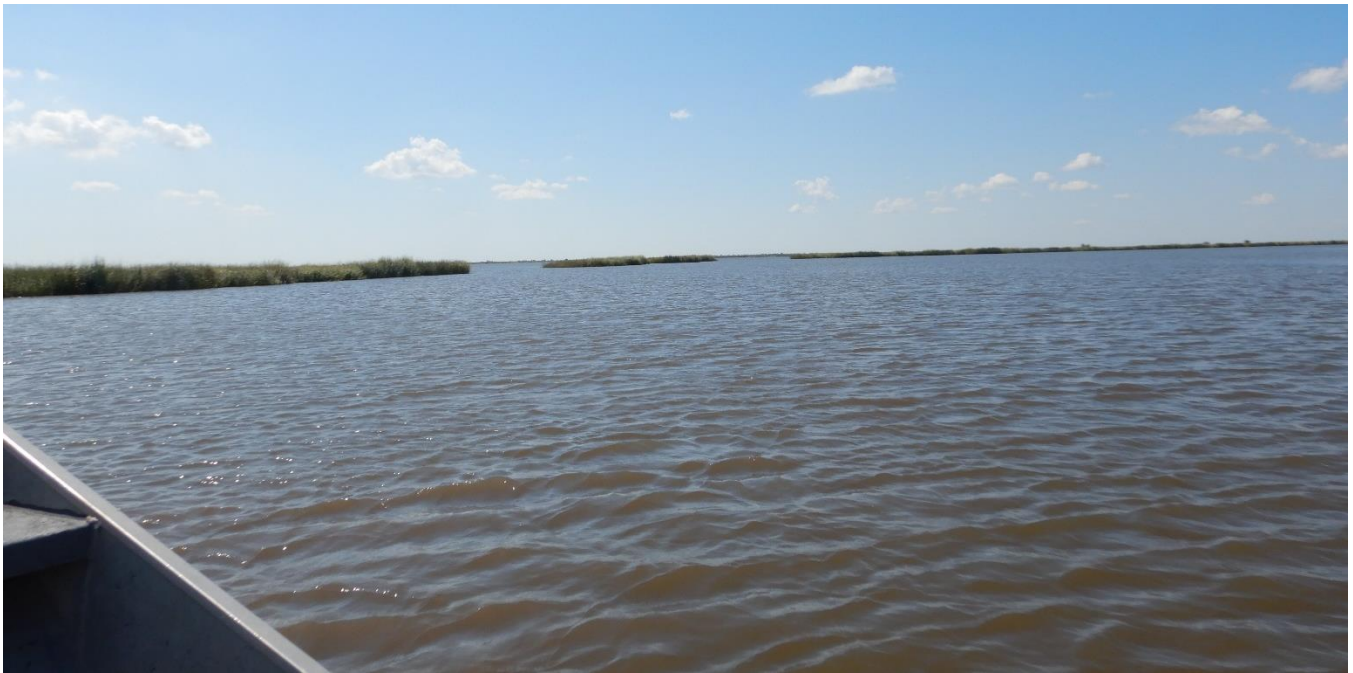
**Photo No. 4**, Interior of Marsh Creation Cycle No. 4, South East End

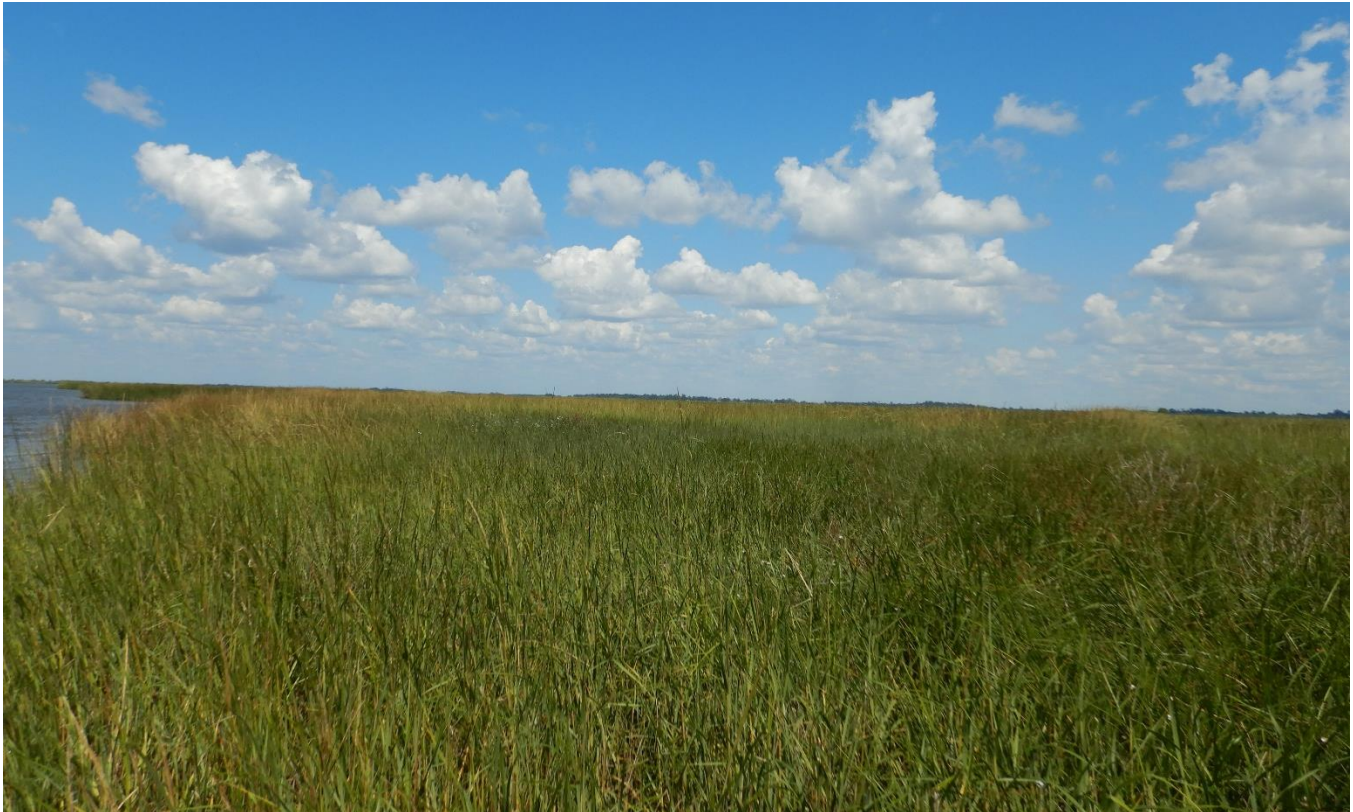
The emergent marsh platform has thick stands of vegetation, more so than Cycle No. 4. The containment dikes are sufficiently gapped where post-construction gapping was not required. (Photos: Appendix A, Photos 5 - 6)

**Photo No. 5**, Marsh Interior West Side of Cycle No. 5, well established vegetation

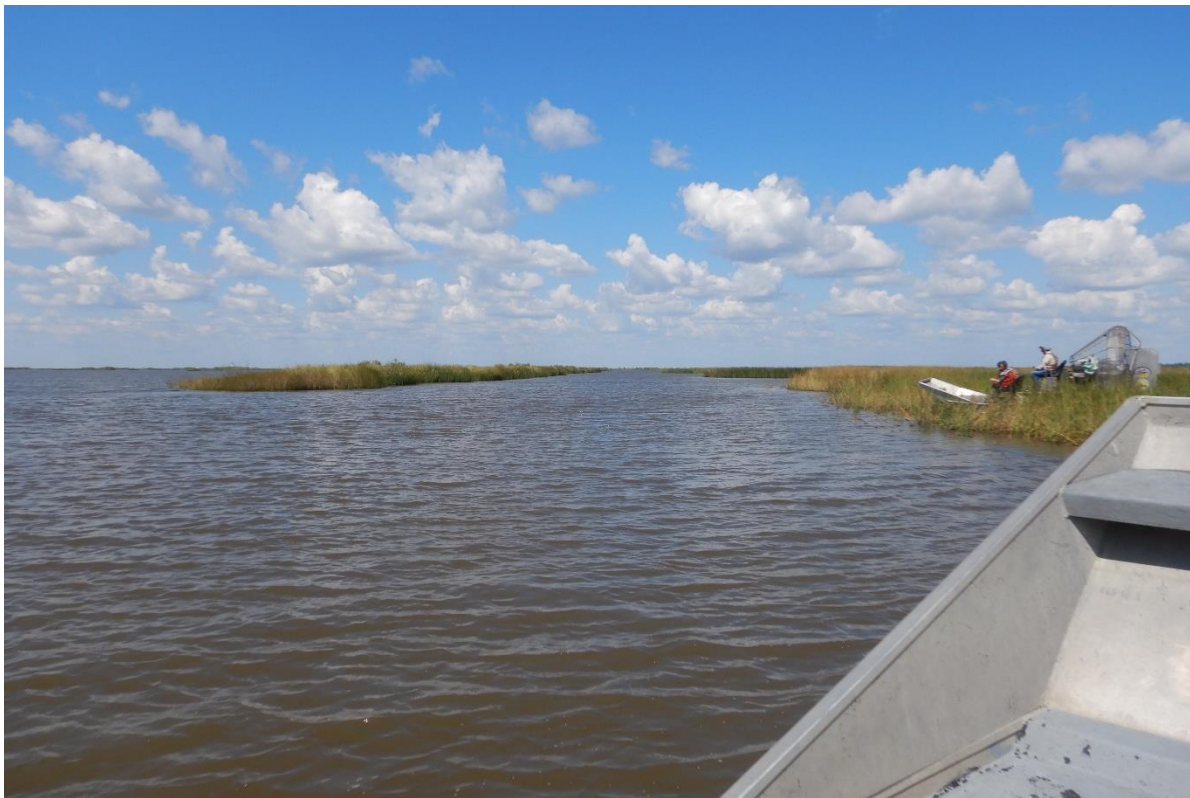
**Photo No. 6**, Marsh Creation Cycle No. 5 – West side containment dike
