2023 Operations, Maintenance, and Monitoring Closeout Report

Hopedale Hydrologic Restoration (PO-0024) Project

State Project Number PO-0024
Priority Project List 8

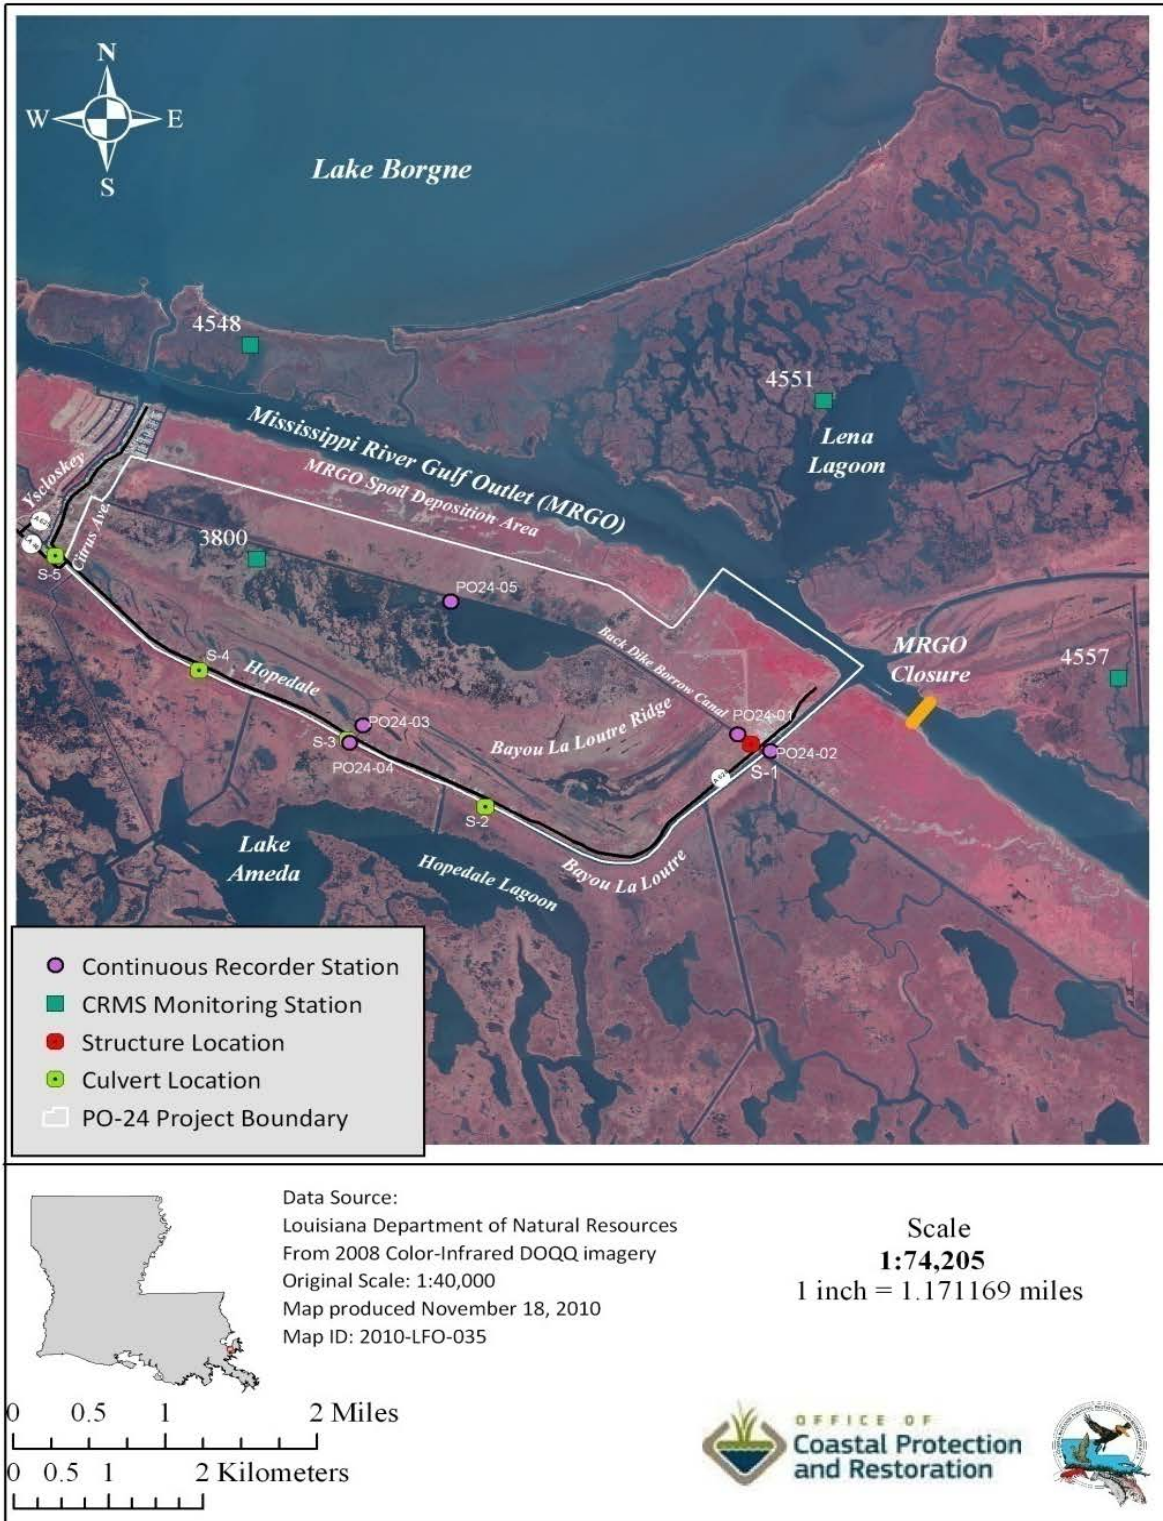
Figure 1: Hopedale Hydrologic Restoration (PO-0024) project location and features.

During construction of LA Hwy 624, the Louisiana Department of Transportation and Development (LDOTD) installed four sets of non-gated culverts (S-2 through S-5, Figure 1) under the roadway. Those structures allowed uncontrolled high salinity influx from Bayou La Loutre into the project area. As part of an LDOTD reconstruction project to increase the elevation of LA Hwy 624, those culverts were replaced in 2000. The replacement structures consisted of three, plastic, 36-inch culverts at S-2 through S-4 and two, plastic, 36-inch culverts at S-5.

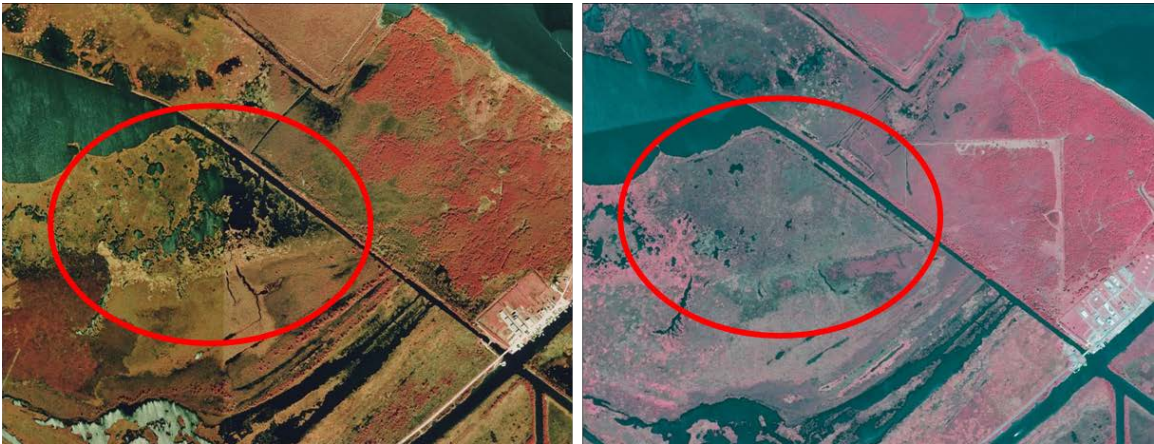
Figure 5: Location of MRGO spoil deposition within the PO-0024 project area in 1998 (left) and 2012 (right).

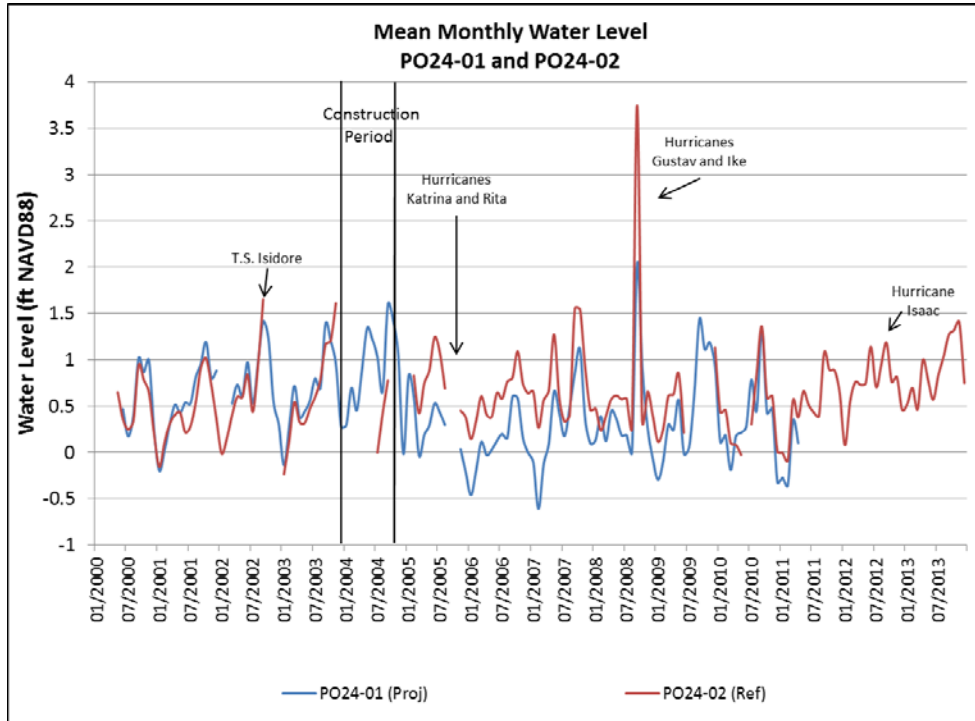
Figure 14: Mean monthly water level for project station PO24-01 and reference station PO24-02 for the Hopedale Hydrologic Restoration project.

Visual observation of mean monthly water level shows project stations, PO24-01 and PO24-05, tracking closely with reference stations during the pre-construction period and then maintaining lower water elevations than reference stations during the post-construction period (Figures 14 and 15). The exception is PO24-03, which tracks closely with nearby reference station PO24-04 before and after construction. Figure 16 shows project and reference stations during the period of CRMS data collection from 2008 to 2022. Project stations PO24-01, PO24-05, and CRMS3800 generally track lower than the other stations during this data period, including project station PO24-03. The CRMS 4548 hydrological station was discontinued in 2014. It also appears that water levels increase over time through 2022 at the CRMS stations.

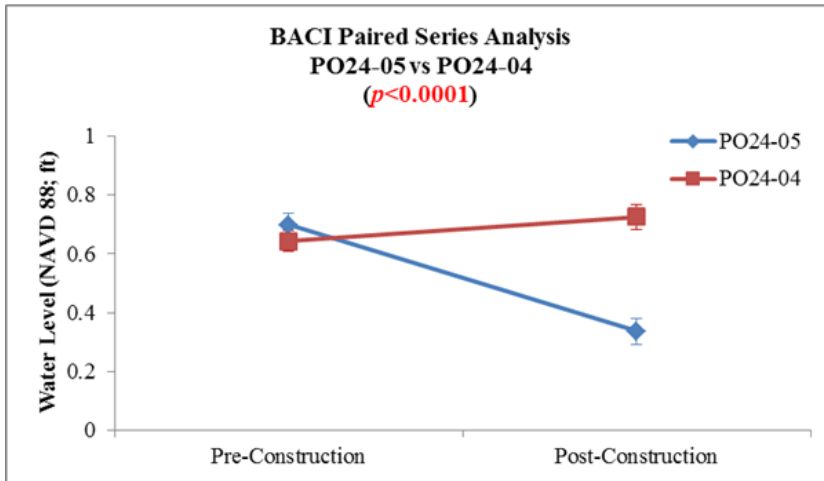
Figure 20: BACI paired series analysis graphs for water level.

To test the interaction between project and reference sites in pre-construction and post-construction time periods, mean weekly water level measurements were analyzed by the same method described for salinity data in the previous section. Results of the paired sites were significant for all comparisons (Figure 20) with water levels at PO24-01 and PO24-05 approximately 0.4 feet lower than what would be expected if the project had no impact. The project impact was reduced at PO24-03, yet still significant. When averaged, the project site water levels decreased from 0.70 ft to 0.41 ft, while reference site water levels increased from 0.58 ft to 0.71 ft between pre- and post-construction.

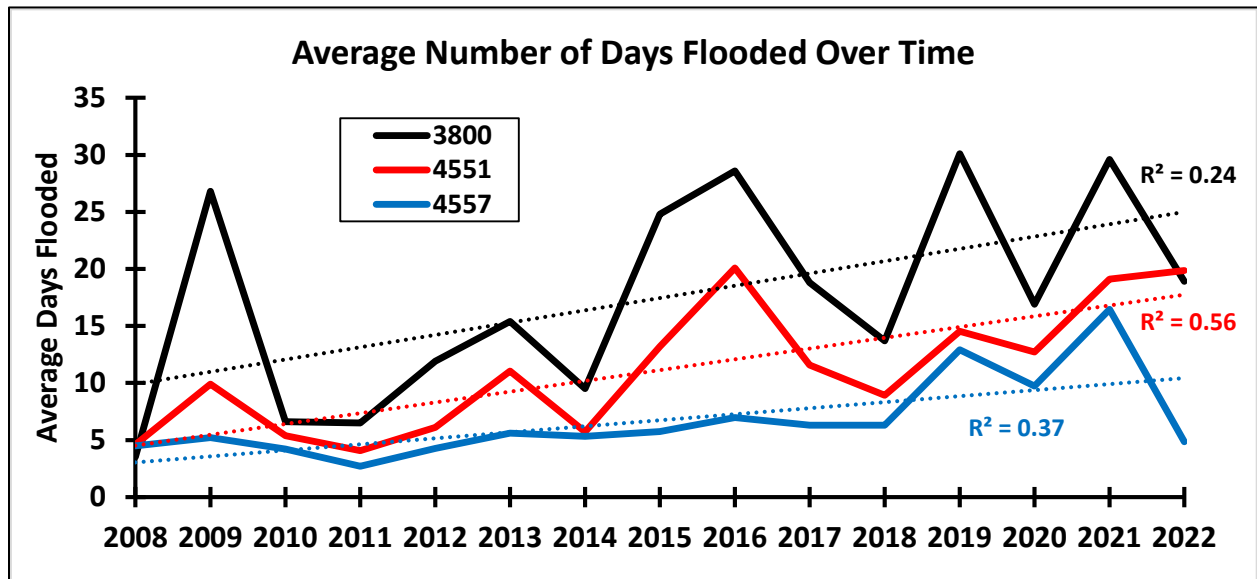
Figure 22: Average length of flood event over time at project (CRMS3800) and reference (CRMS4551 and 4557) CRMS sites.

Although the project specific gauges were removed, further analysis of flooding at three of the CRMS stations through 2022 was possible (CRMS 4548 was eliminated with data only available through 2014). To investigate the regional trends discussed above, CRMS 3800, CRMS 4551, and CRMS4557 were analyzed for number average number of days of flooding in a year (i.e. how long did flood events last when flooded), average inundation depth, and total number of days flooded per year (which is a similar metric to percent annual flooding in Figure 21). Average number of days flooded was variable from year to year but did show a significant increase over time at all three sites (CRMS3800 = $p=0.38$, $F_{(1,13)}=5.3$, $r^2=0.23$; CRMS4551 = $p<0.001$, $F_{(1,13)}=18.6$, $r^2=0.56$; CRMS4557 = $p=0.009$, $F_{(1,13)}=9.3$, $r^2=0.37$). CRMS3800, which is in the project area (impoundment) was flooded the most average days throughout the time period (had the longest lasting flooding events), and CRMS4557, which is outside of the MRGO closure was flooded the least average days (had shorter flooding events) (Figure 22).

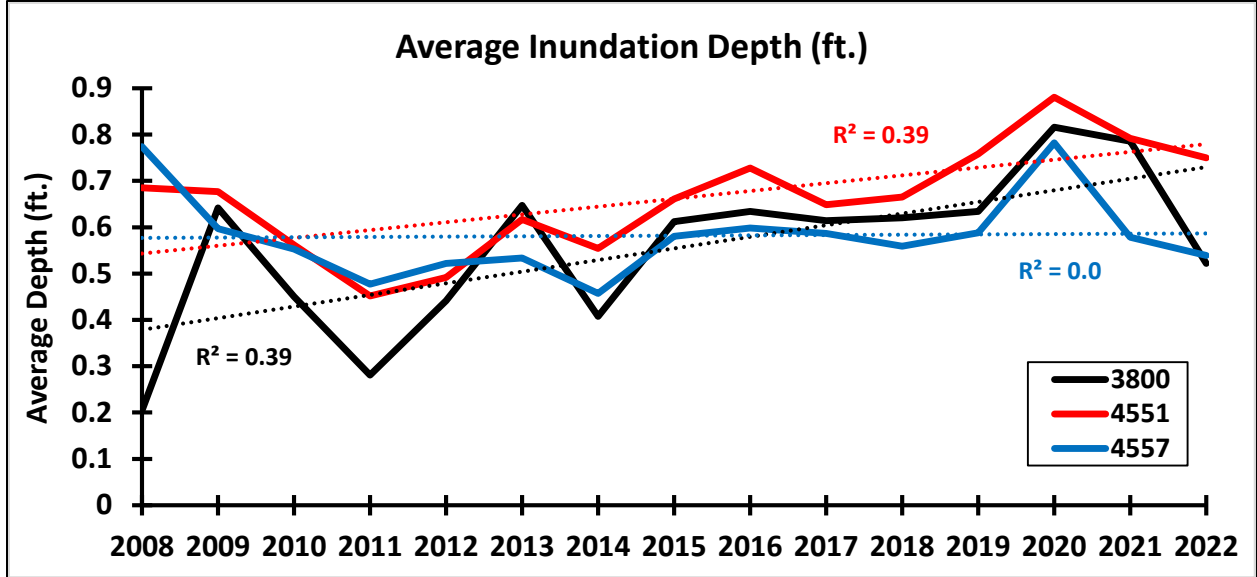
Figure 23: Average inundation depth over time at project (CRMS3800) and reference (CRMS4551 and 4557) CRMS sites.

Average annual inundation depth at the same three CRMS sites demonstrated a different pattern, with CRMS3800 and CRMS4551 showing a significant increase in average flooding depth over time (CRMS3800 = $p=0.007$, $F_{(1,13)}=10.0$, $r^2=0.39$; CRMS4551 = $p=0.008$, $F_{(1,13)}=9.9$, $r^2=0.39$) and CRMS4557 showing no trend in flooding depth (Figure 23).

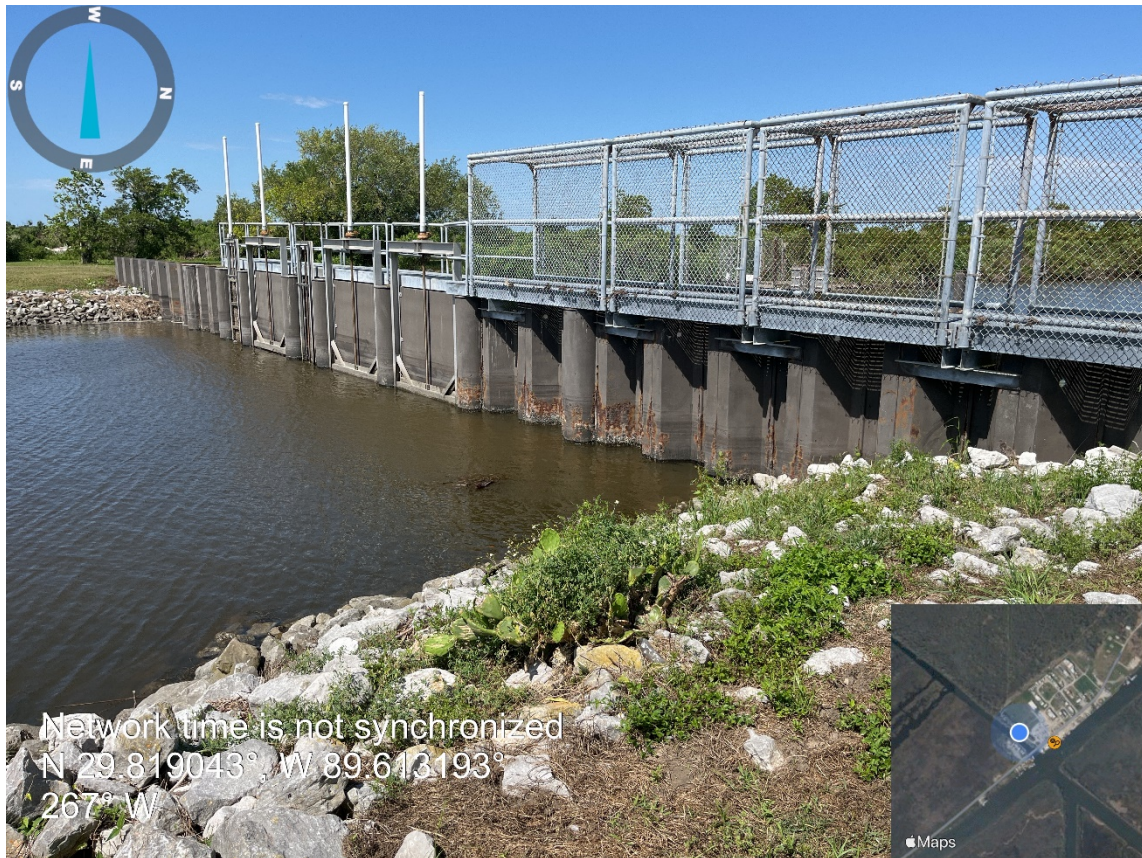
Corrosion was observed at joints between sheet piles and pipe piles near the apparent mean water level at both the main structure as well as the two pipe pile barriers flanking the structure (See photos 1 and 2 in Appendix A). The project team attempted to locate the sacrificial anodes previously placed on the structure but was unable to locate them. The anodes are presumably exhausted.

Photo 1. Structure viewed from project exterior (downstream) on northern bank depicting corrosion of the sheet pile structure.

| FIELD INSPECTION CHECK SHEET | | | | | |
|--|---|---|---|---|--|
| Sheet pile Structure | Some corrosion noted | Some corrosion | Yes | 1 | Surficial corrosion observed, especially near the apparent mean water level at joints between sheet piles and pipe piles. Anodes are likely exhausted. |

- Repair or replacement of broken fish gate gearbox.
- Replacing 26 anodes on the entire structure.
- Clean and treat surficial rust with epoxy coating.

1. Upgrade or replace the anodes at the structure with magnesium anodes.
2. Install an epoxy coating in order to treat and prevent surficial rust on the structure.
3. Install reflective tape on the structure's guardrails in order to improve visibility.

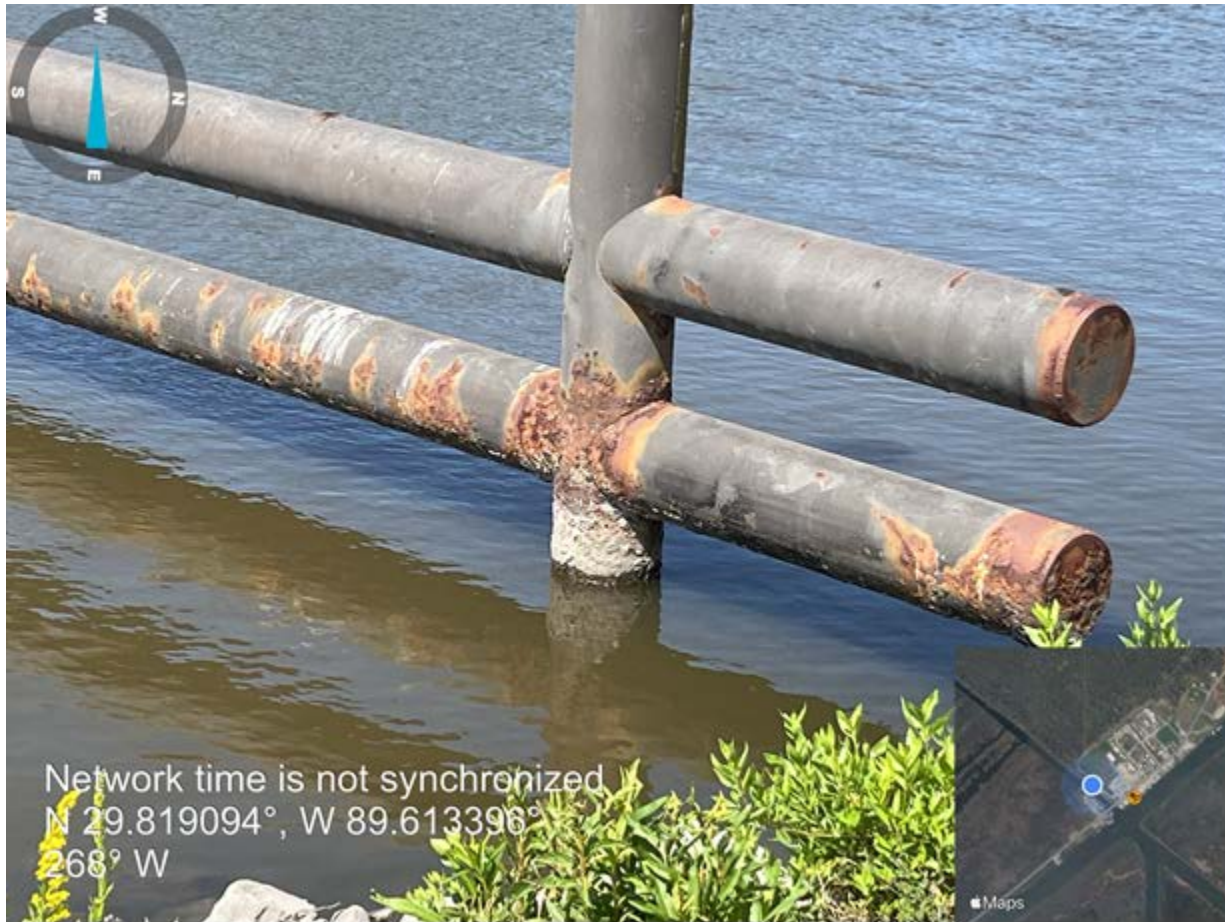
Photo 2. Pipe barrier viewed from project exterior (downstream) on northern bank depicting corrosion.

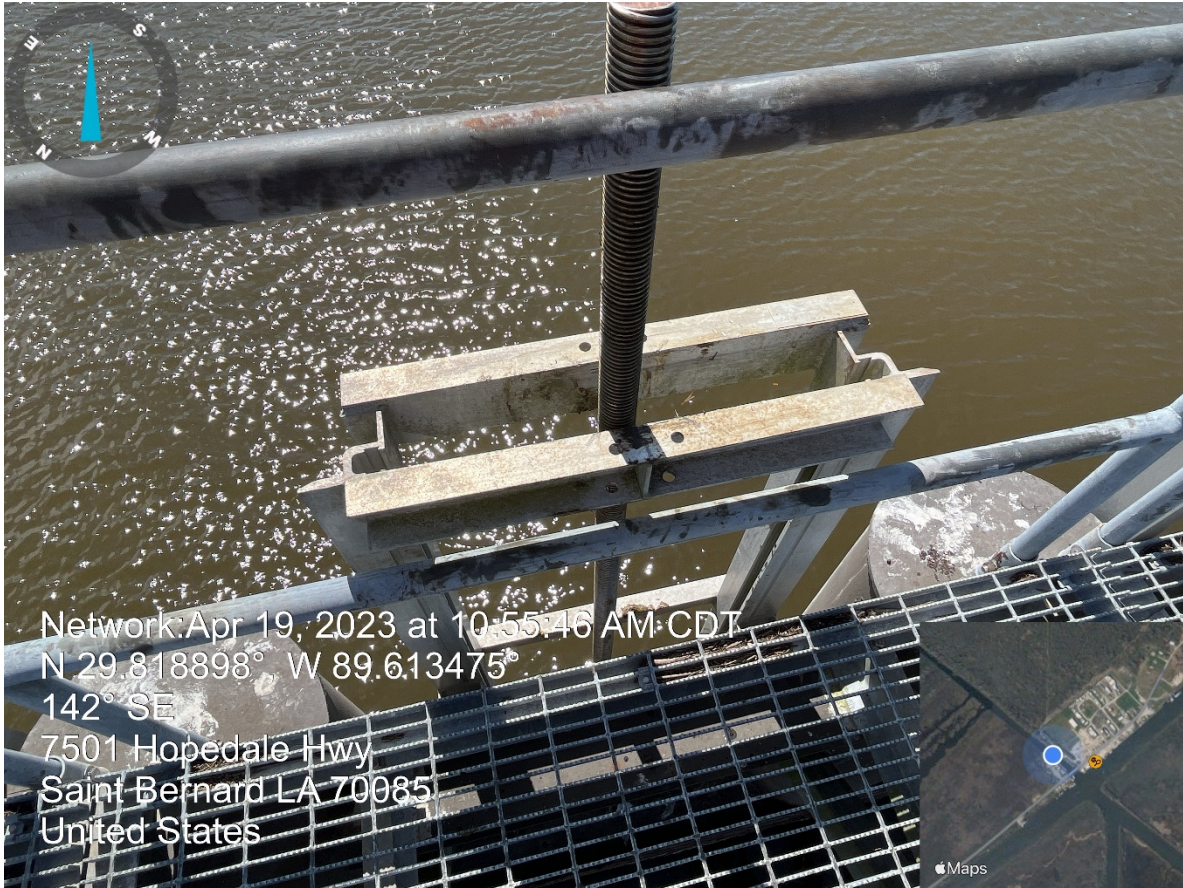
The fish gates were open at the time of the inspection. During the exercise of one of the gates the gearbox suffered damage rendering it inoperable. The representative with SBPG removed the broken gearbox from the top of the gate to have it repaired (See photo 3 in Appendix A). The gate associated with the broken gearbox will remain closed until the gearbox is repaired and re-installed. CPRA will coordinate with SBPG to ensure the gearbox is repaired and re-installed.

Photo 3: Fish gate viewed from atop the structure. (Gearbox removed for repairs).

| FIELD INSPECTION CHECK SHEET | | | | | |
|--|---|---|---|---|--|
| Fish Gates 24" x 84" | Good (1 missing gearbox) | None visible over water surface | None visible over water surface | 1 & 3 | Gates were exercised and open during time of inspection except for one which remains closed due to broken gearbox. |
