2004 Operations, Maintenance, and Monitoring Report

Perry Ridge Shore Protection

State Project Number CS-24
Priority Project List 4

May 2007
Calcasieu Parish

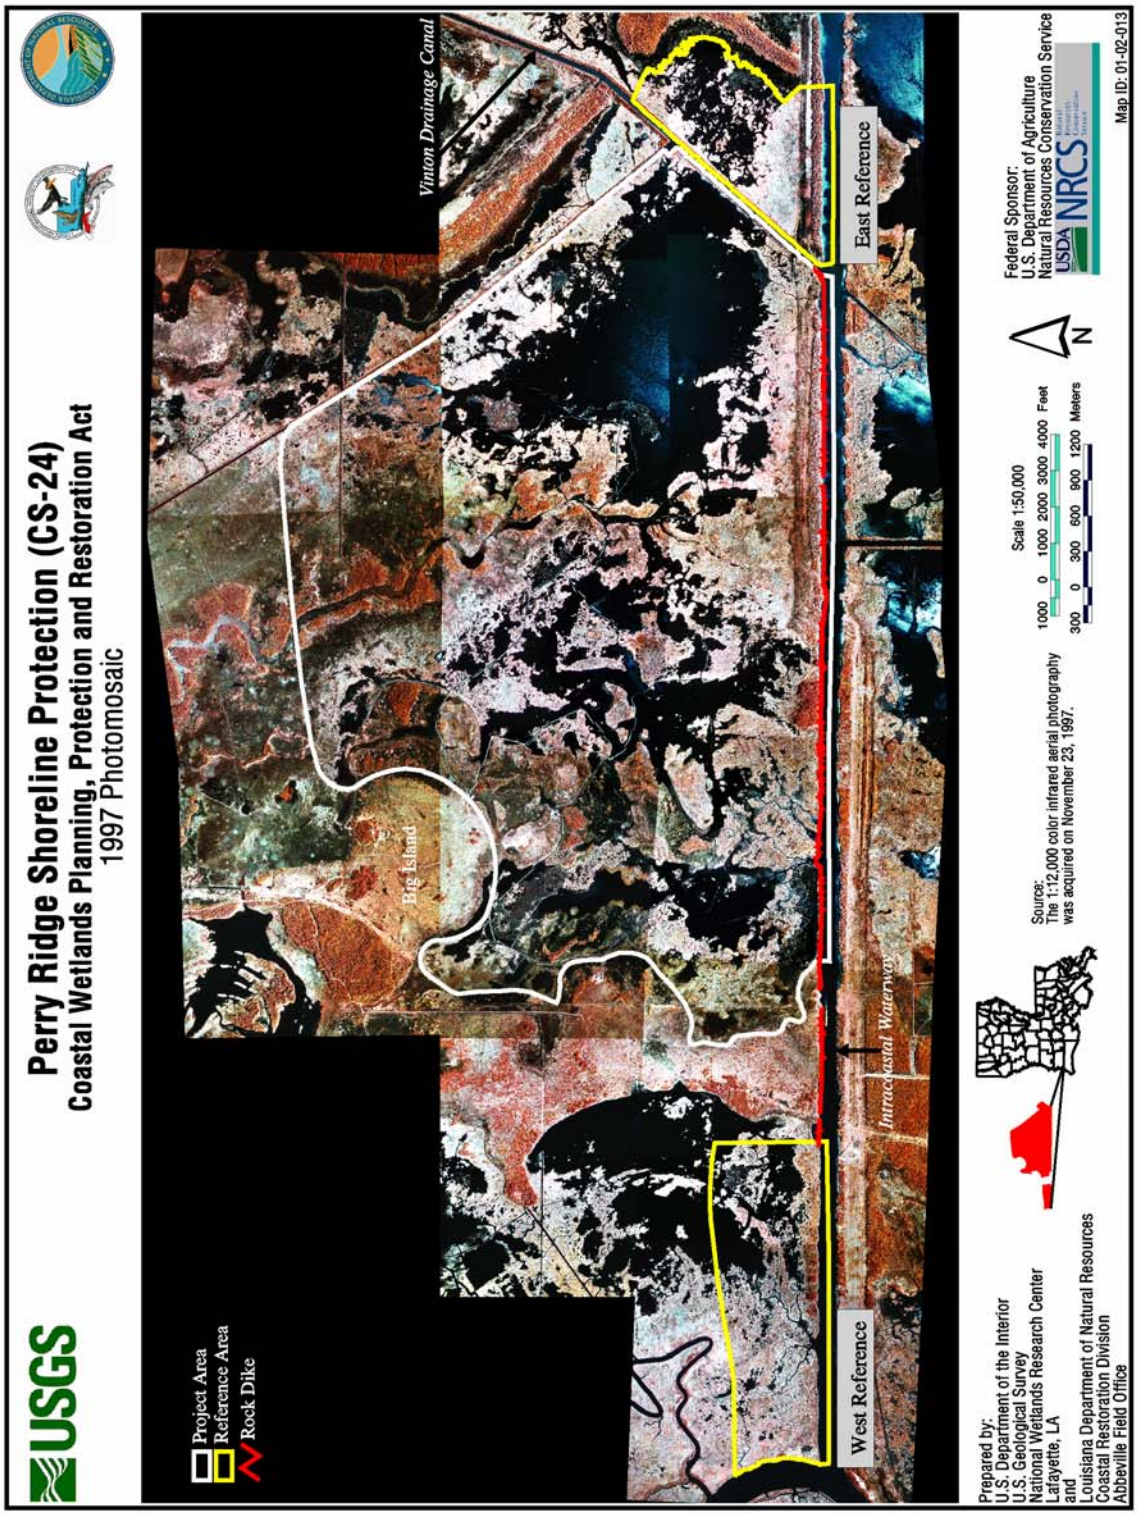
Figure 2. Photomosaic of the Perry Ridge Shore Protection (CS-24) project and reference areas from aerial photography flown November 23, 1997.

Aerial Photography:
Pre-construction photography, flown on November 23, 1997, indicated land to water ratios were 60.6% land and 39.4% water in the project area (figures 2 and 3). Reference area data from 1997 will be included with the next analysis which includes 2001 photography. Aerial photography flown on November 17, 2001 is currently being processed by NWRC.
