# 2004 Operations, Maintenance, and Monitoring Report

# Black Bayou Hydrologic Restoration

State Project Number CS-27
Priority Project List 2

May 2007
Calcasieu and Cameron Parishes

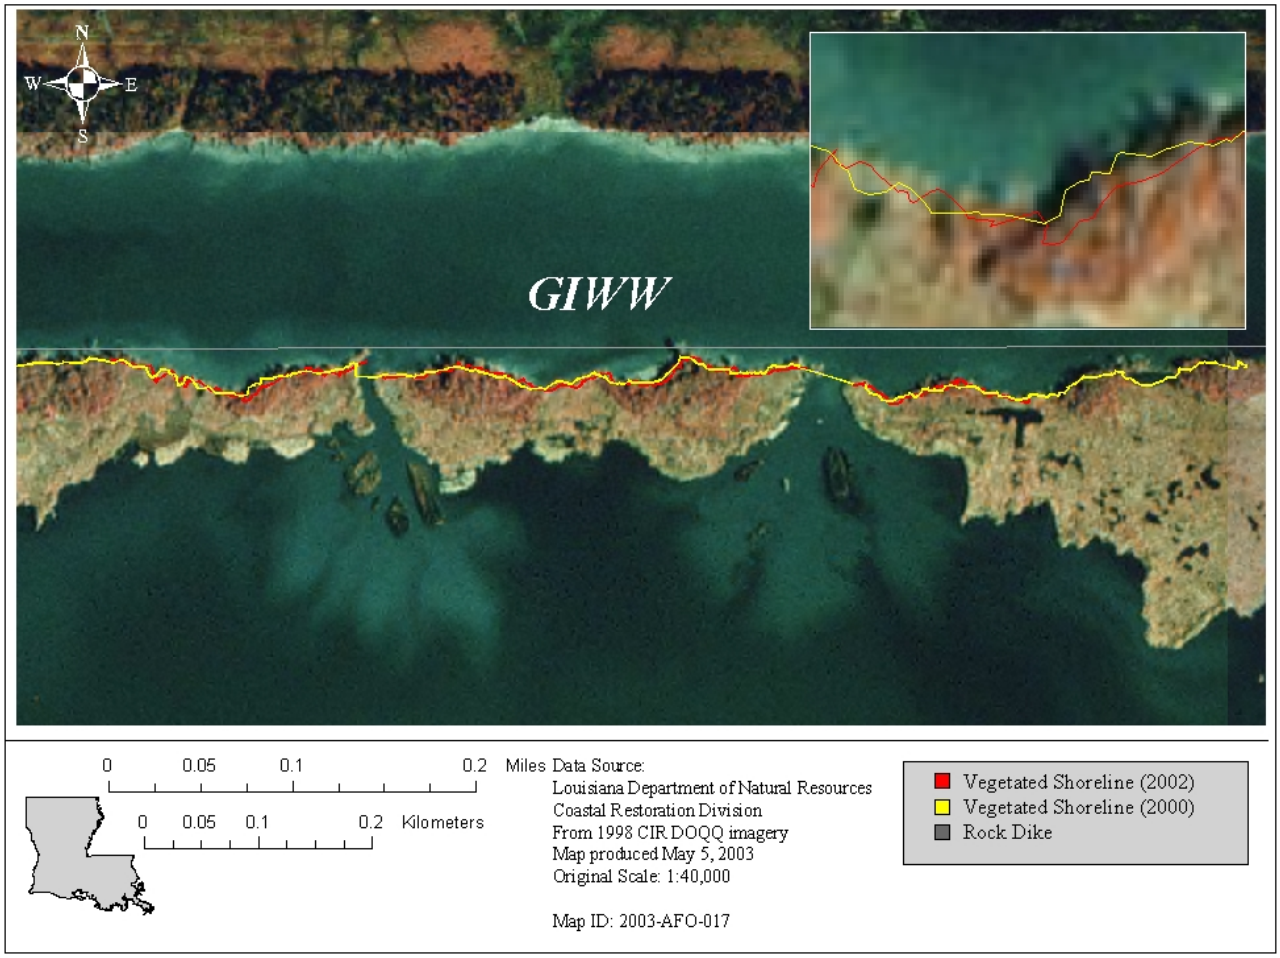
**Figure 4.** GPS surveys preconstruction (2000) and immediately postconstruction 2002 at the project section of GIWW bank. Picture inset shows a magnified view of the survey tracks.

A DGPS survey of a portion of the GIWW shoreline within the project boundary was conducted preconstruction (2000) and in spring 2002 after the rock dike feature was constructed. The reference area for this monitoring element was compromised because of another rock dike construction and therefore no meaningful comparisons can be made between project and reference. The GPS system we used is considered to have submeter accuracy. This means that each physical point should be within 3ft of the corresponding point on the map. An areal analysis of loss / gain was not conducted, but linear gains and losses as measured roughly in ArcMap were as much as 17ft and 27ft respectively (figure 4).

Reduce mean erosion rate of protected shoreline along GIWW: The March 2002 postconstruction shoreline survey is considered as "immediately post construction" and was compared to the first survey to estimate preconstruction erosion conditions. Therefore, the erosion rate reduction potential of the rock dike will be evaluated after the 2004 shoreline survey is analyzed. Other shoreline protection projects using rock dikes near the CS-27 project along the GIWW have been successful in reducing shoreline erosion and we expect the same results.

A structural assessment survey performed by a licensed engineering/ land surveying firm is recommended to evaluate settlement and stability of the rock structure along with any evidence of accretion on the land side of the rock structure.
