2009 Operations, Maintenance and Monitoring Report

DELTA WIDE CREVASSES

State Project Number MR-09
Priority Project List 6

August 1, 2009
Plaquemines Parish

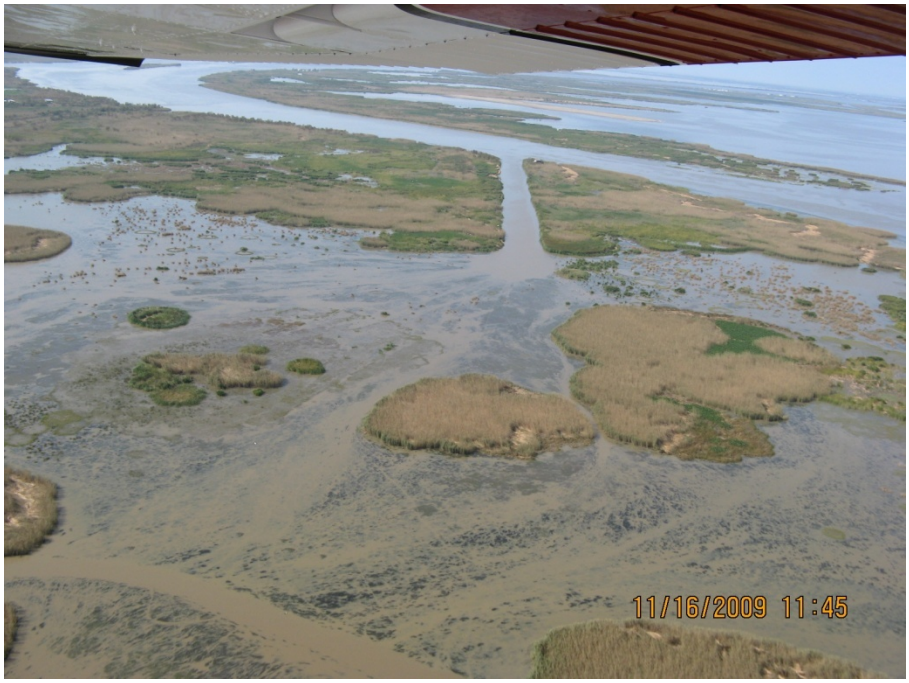
There is no current maintenance on this project; however the project area is inspected annually by personnel from OCPR, LDWF, and NMFS. The 2008 and 2009 annual inspections examined the 6 crevasses constructed or maintained during Phase II. These inspection reports indicate that the project is functioning successfully. Aerial inspection during a high river phase in November, 2009 indicated high amounts of water and sediment flowing through the crevasse channels into the receiving areas (figs. 2 and 3). Depth soundings of the channel at crevasse 81 during the 2008 inspection suggest that the channel is silting in, although flow through the crevasse was still strong.

Figure 3. View of Crevasse 11 and receiving area during the 2009 annual inspection, November, 2009. Note the heavy sediment load.

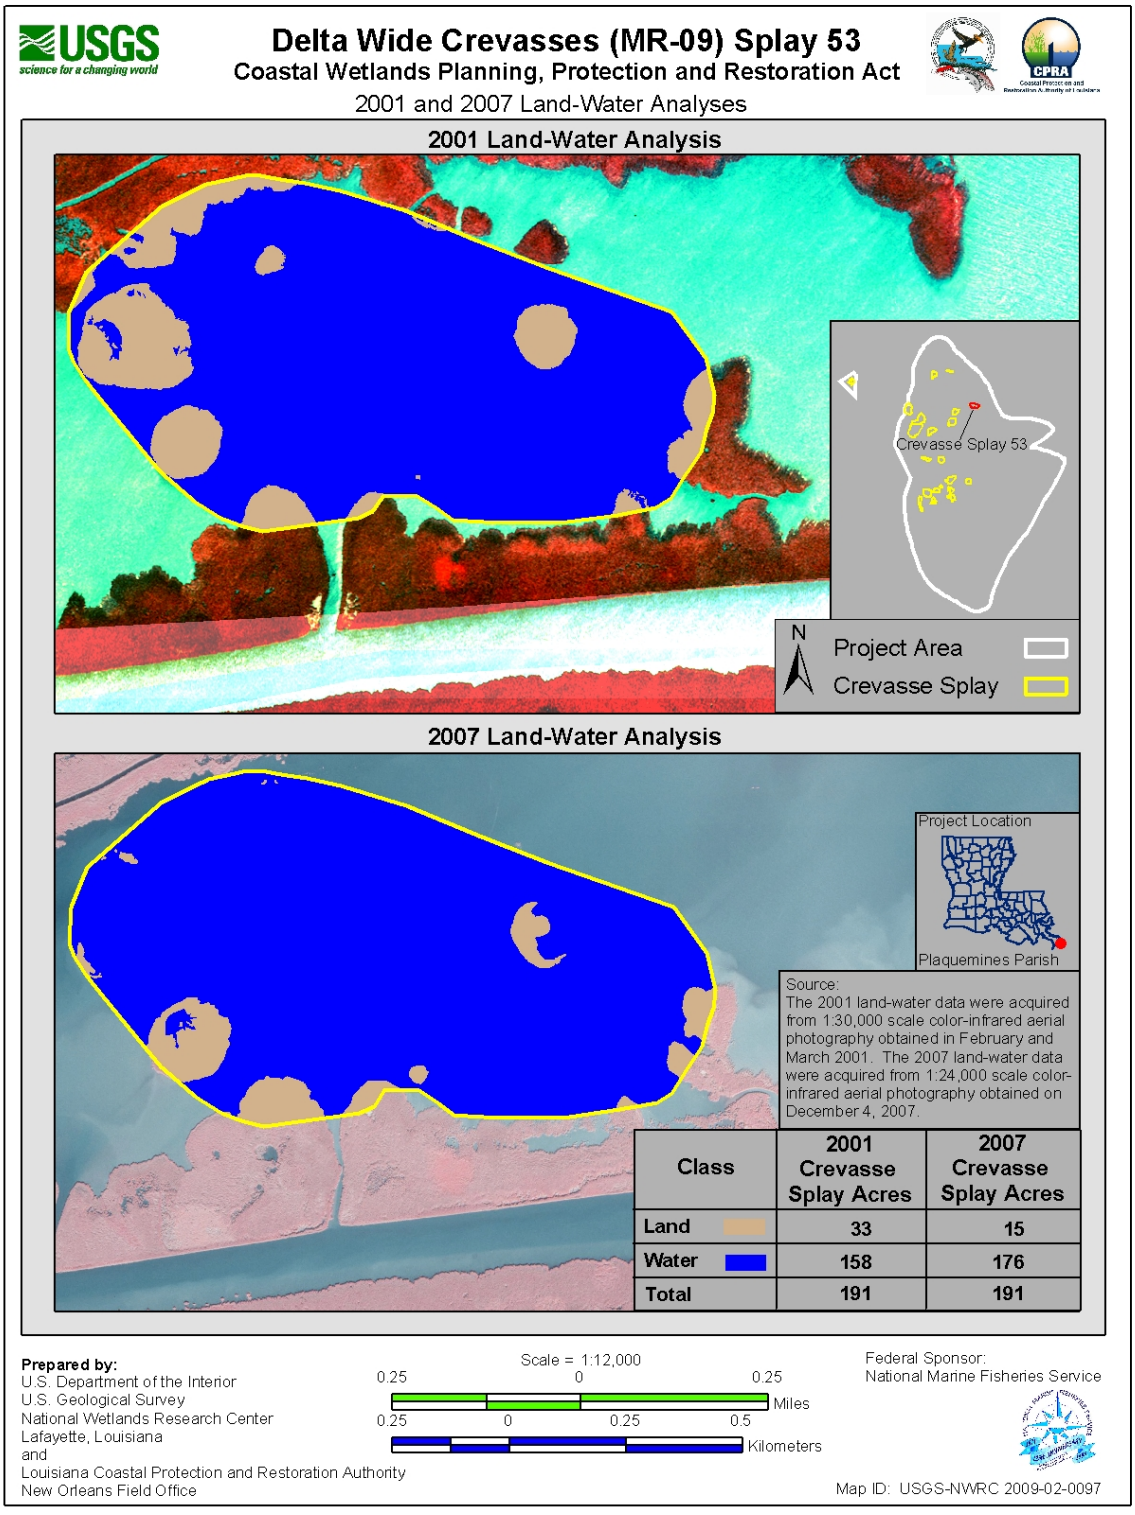
Color infrared aerial photography obtained in 2000 (as-built), 2002, and 2007 has been analyzed by the USGS and are presented as land-water analysis. There were a total of 22 crevasses analyzed including the six used for vegetation data. Table 1 shows a summary of land gain/loss in acres including the relative change and rate (per year). The total land gain recorded for the MR-09 project area since construction is 499 ac. with an average land gain of 23 ac. per crevasse. This translates to a total land gain of 59.4% across the project area. The largest land gain for a single crevasse occurred at Crevasse 31 (fig. 6) with a land gain of 124 ac. (185.1%). The largest relative gain occurred at Crevasse CO-2 (fig.7) with an increase of 850% (17 ac). One crevasse experienced land loss. Crevasse 53 (fig. 8) lost 18 ac of land between 2001 and 2007.

Figure 8. Land-water analysis for Crevasse 53 in 2001 and 2007.

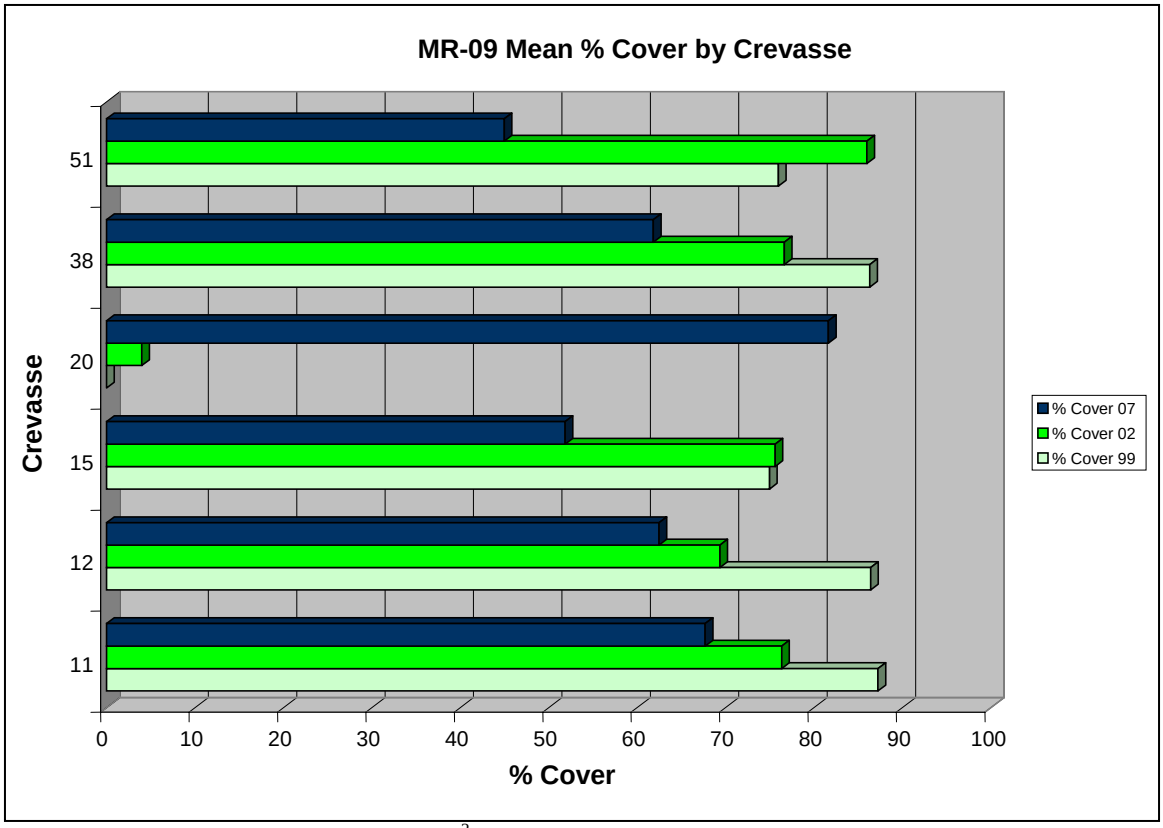
Vegetation surveys were conducted in August 1999 (N=46), August 2002 (N=49), and August 2007 (N=50) during the post-construction period. Total percent cover was lower in 2007 than in previous years at 5 of the 6 crevasses surveyed (Fig. 9). The exception is Crevasse 20 where total percent cover increased from 4% in 2002 to 82% in 2007.

Figure 9. Mean percent cover of all 4-m^2 plots for six selected crevasses within the MR-09 project area August 1999, August 2002, and August 2007. Vegetation was sampled using the Braun-Blanquet method.

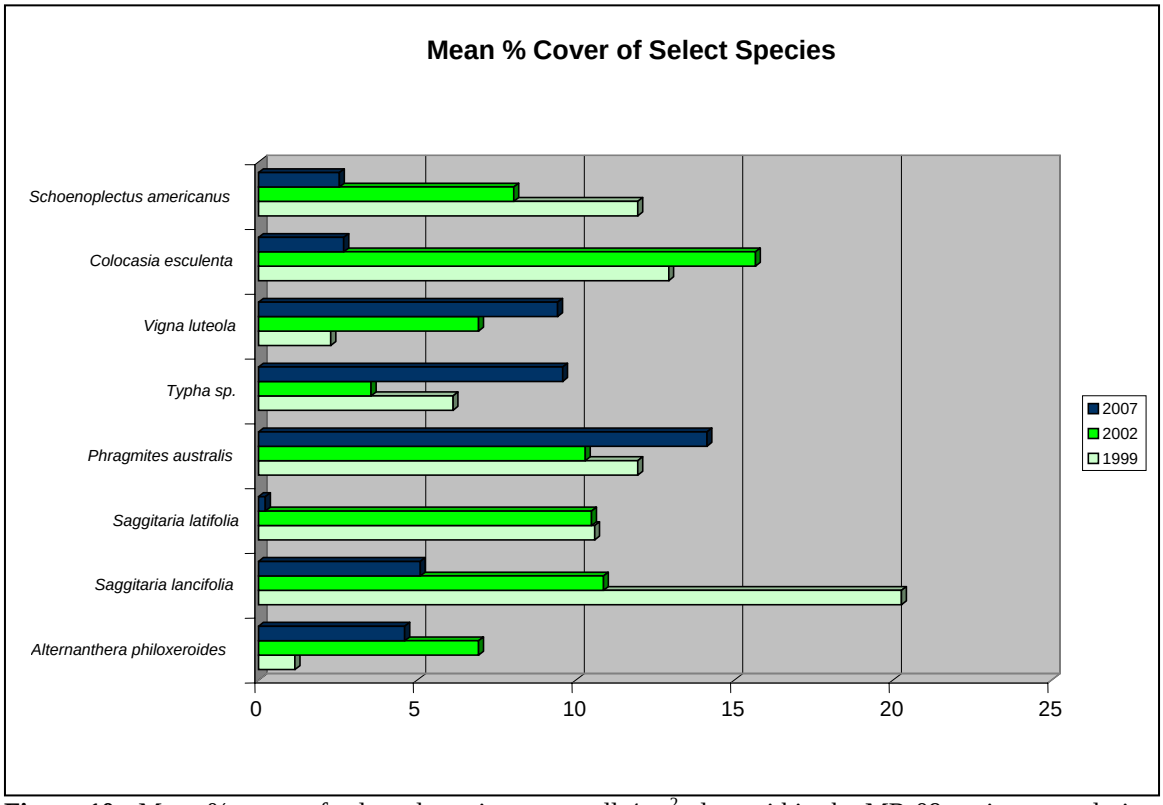
Percent cover data of individual species across all plots in the MR-09 project area suggest a shift in species composition (Fig. 10). Percent cover of species such as *Sagittaria lancifolia*, *Sagittaria latifolia*, *Colocasia esculenta*, and *Schoenoplectus americanus*, which dominated the 1999 and 2002 surveys decreased in the 2007 survey. Meanwhile, percent cover of other species has increased. *Phragmites australis*, *Vigna luteola*, and *Typha* sp. have all increased from 1999 to 2007.

Figure 10. Mean % cover of selected species across all 4-m^2 plots within the MR-09 project area during August 1999 (N=46 plots), August 2002 (N=49 plots), and August 2007 (N=50 plots). Vegetation was sampled using the Braun-Blanquet method.

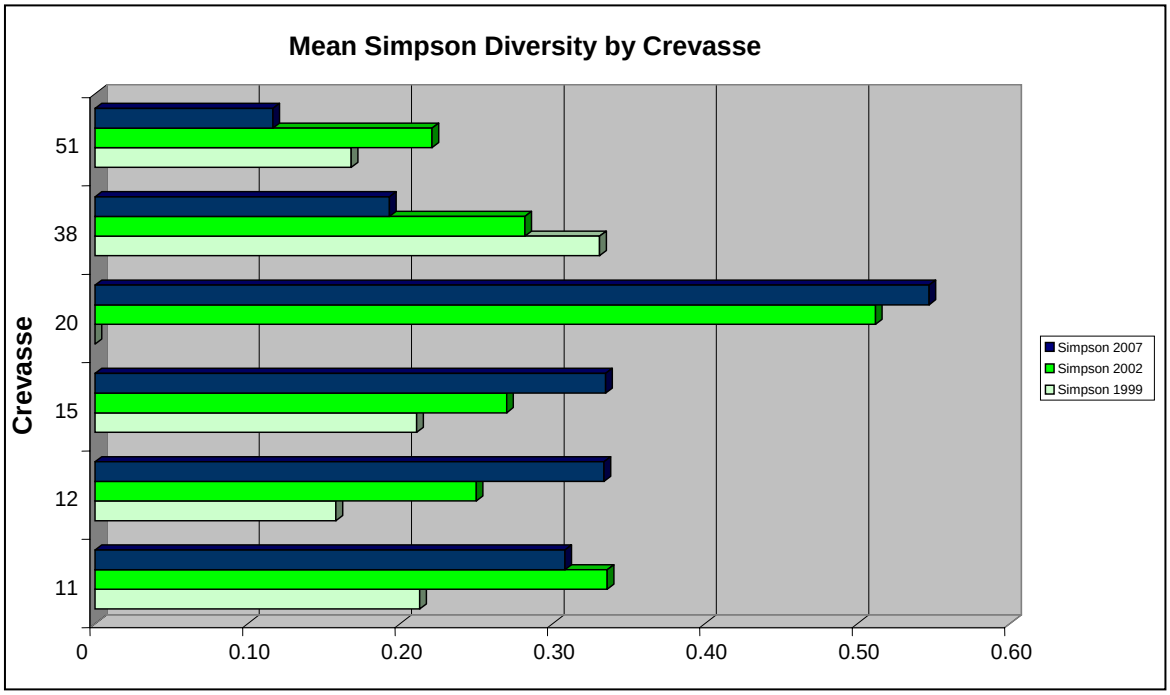
Diversity, as measured by Simpson's Diversity Index, increased at 4 of the 6 crevasses surveyed from 1999 to 2007 (Fig. 11). Diversity decreased at crevasses 38 and 51.

Figure 11. Comparison of diversity between sampling years 1999 (N=46 plots), 2002 (N=48 plots), and 2007 (N=50 plots) across each crevasse using the Simpson index of diversity. Note: diversity index values have no unit values and are used for comparative purposes only.

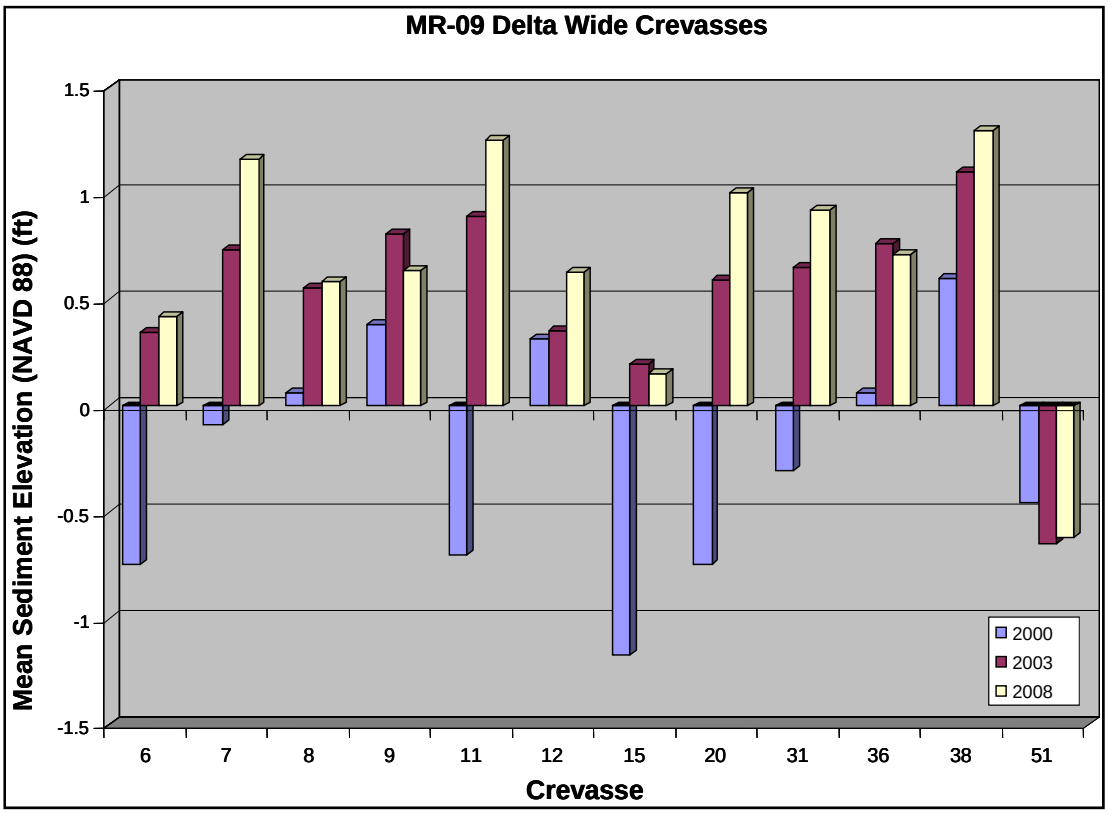
Elevation surveys were conducted in 2000 (as-built), 2003 and 2008 (post-construction) on 12 crevasses in the MR-09 project area (Figure 12). Analysis of the elevation data in the receiving areas shows a trend in elevation gain across all crevasses except 51 (Figures 13 and 14) since construction of the project. When analyzed across all 12 crevasses, there has been a mean gain in elevation of 0.91 ft in the project area from construction to 2008 (Table 2). However it is worth noting that much of that elevation gain occurred in the first few years after construction. Mean elevation gain from 2000 to 2003 was 0.76 ft., while from 2003 to 2008 mean elevation gain was 0.15 ft. Elevation gain was impacted by crevasse angle of orientation and width. Mean elevation gain from 2000 to 2008 for crevasses oriented 60° from the parent channel was 1.22 ft, twice the elevation gain of crevasses oriented at 90°, 0.60 ft. Similarly, wide crevasses (>150 ft across) outgained narrow crevasses (<100 ft across) 1.17 ft to 0.65 ft for the same time period. The greatest elevation gains were observed in wide, 60° crevasses (1.28 ft), while the least gains were observed in the narrow, 90° crevasses (0.14 ft).

Figure 13. Mean sediment elevation (NAVD 88) in the project area (by crevasse) in 2000 (as-built), 2003 and 2008 (post-construction) for the twelve crevasses of Phase I of Delta Wide Crevasses (MR-09).

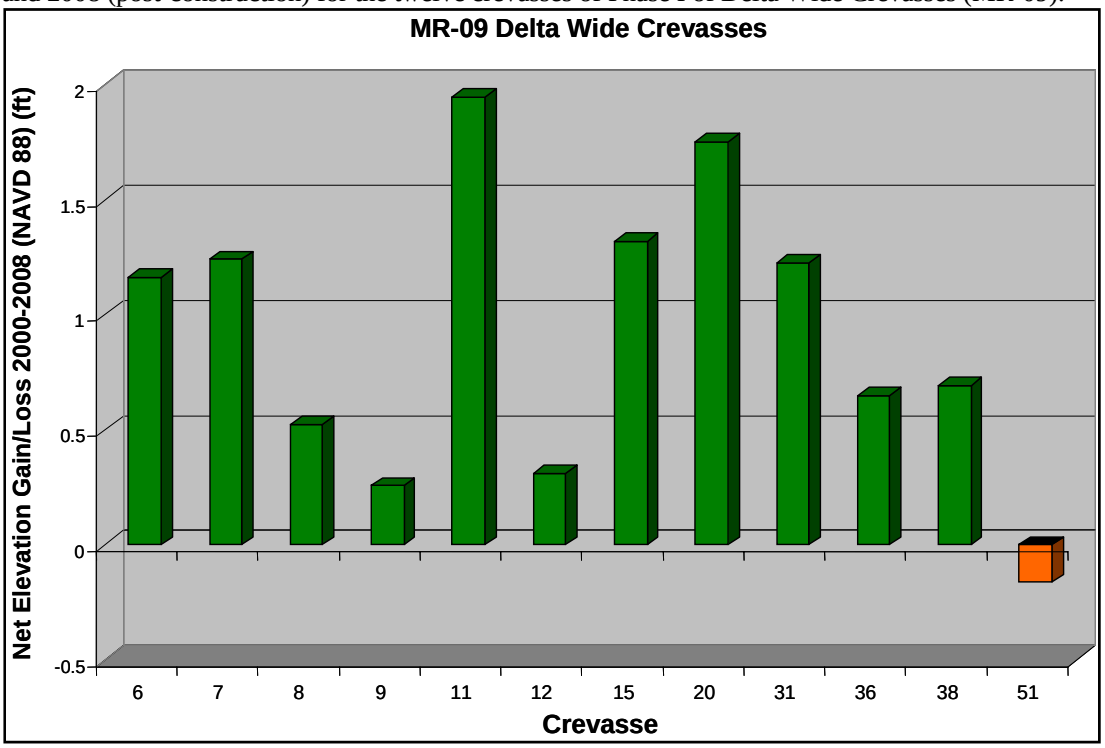
Figure 14. Elevation gain/loss between 2000 and 2008 for each of the twelve crevasses in Phase I of Delta Wide Crevasses (MR-09). Green bars represent an overall increase in mean elevation while orange bars represent an overall decrease in mean elevation.

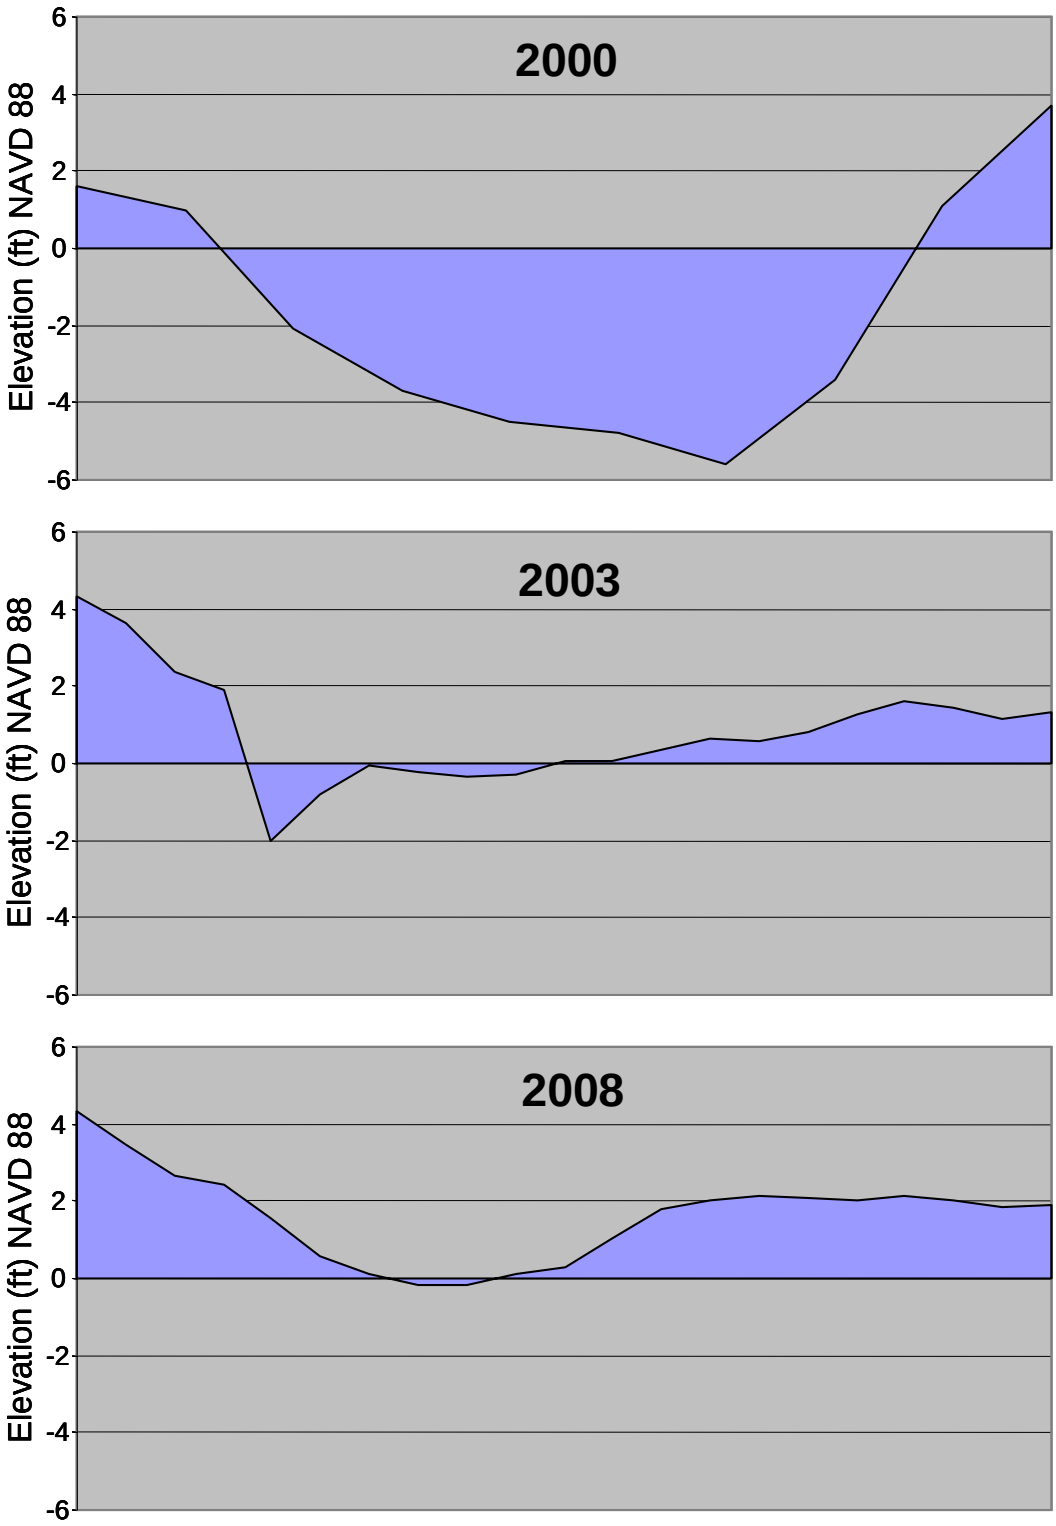
Elevation loss in the Crevasse 51 receiving area may be due to sedimentation of the crevasse channel (fig 15). The elevation survey of the crevasse channel and the land-water analysis of the aerial photography suggest that the channel may be filling in with sediment. Sedimentation in the crevasse channel prevents water and sediments from passing through the crevasse into the receiving area.

Figure 15. Elevation cross-section of crevasse channel for Crevasse 51 in 2000, 2003, and 2008.

Channel cross sections are needed on other crevasses (other than crevasses that are currently surveyed) to document whether the crevasse channels are remaining open or whether they are filling in and are in need of maintenance. Operation and Maintenance

project managers can use the increase or decrease of average elevation as the determining factor on when and where to dredge to re-open channels.
