2012 Operations, Maintenance, and Monitoring Report

East Timbalier Island Sediment Restoration, Phase 1 & 2 (TE-25 & TE-30)

State Project Number TE-25 & TE-30
Priority Project List 3 & 4

July 2012
Lafourche Parish

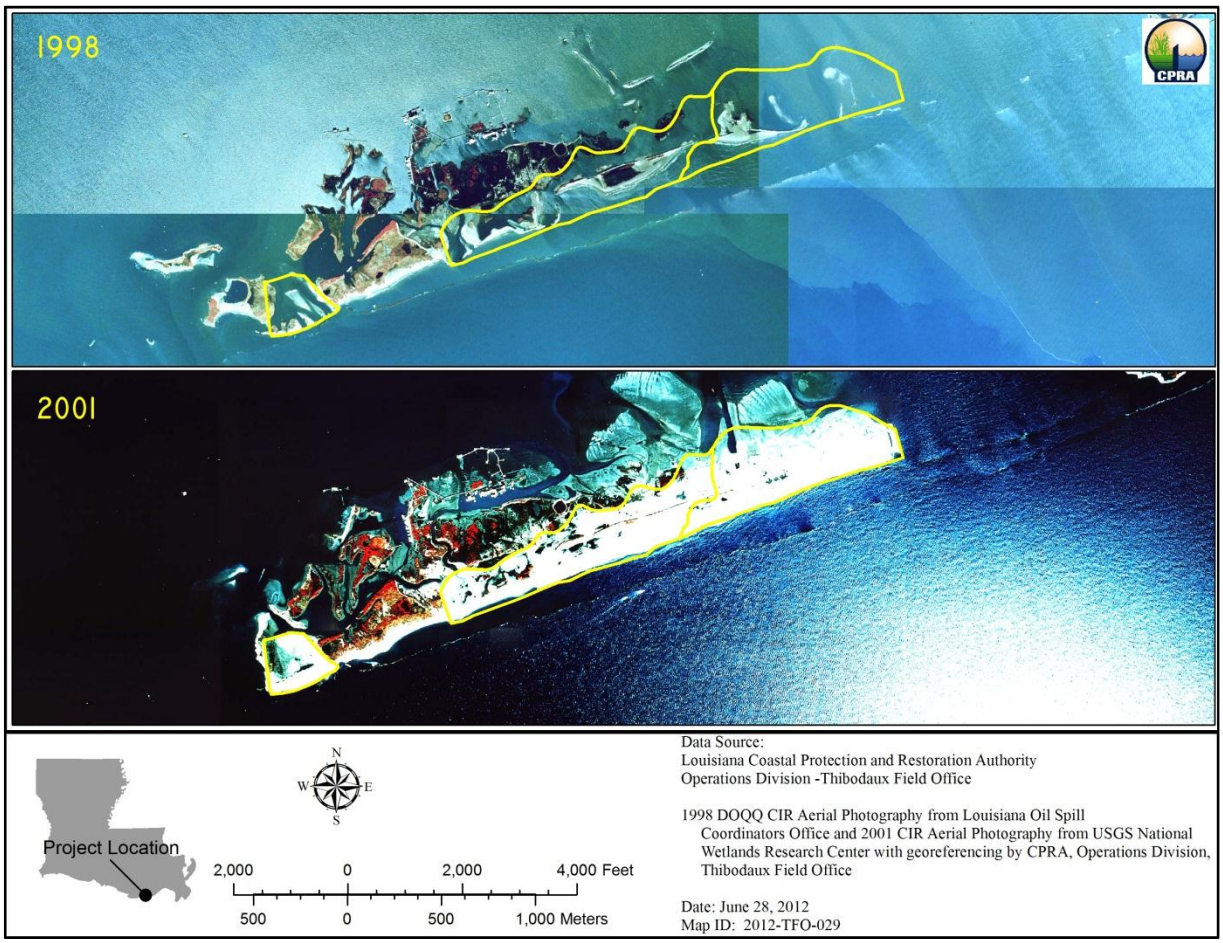
These results are consistent with aerial photography and observations made during site visits. Aerial photography taken in the first half of 2001 (Figure 13) shows visible degradation of the eastern portion of the island. In particular, the southeast corner of the island is heavily eroded, with an apparent breach in the sand dune at the southeastern corner (corresponding to the right hand side of the 114+00 and 114+00-5m plots in Figure 12). By May 2002 this breach had greatly expanded and the far eastern portion of the project had partially degraded (Figure 14). In addition, the bay side of the island (and the project) experienced substantial loss along the eastern half of the combined project area. Post-hurricane season aerial photography from 2002 (Figure 14) shows that Hurricane Isidore and Hurricane Lili, both of which passed in 2002, had profound impacts on the island, again with substantial loss of sediment at the eastern end. The island remained relatively stable from November 2002 to 2004, but again saw substantial degradation during the hurricane season of 2005 when hurricanes Cindy, Katrina and Rita came ashore (Figure 15).

Figure 13. **Aerial photography (1998 and 2001) for East Timbalier Island. Note the addition of sand and sediment resources to East Timbalier Island by construction of the TE-25 and TE-30 projects.**

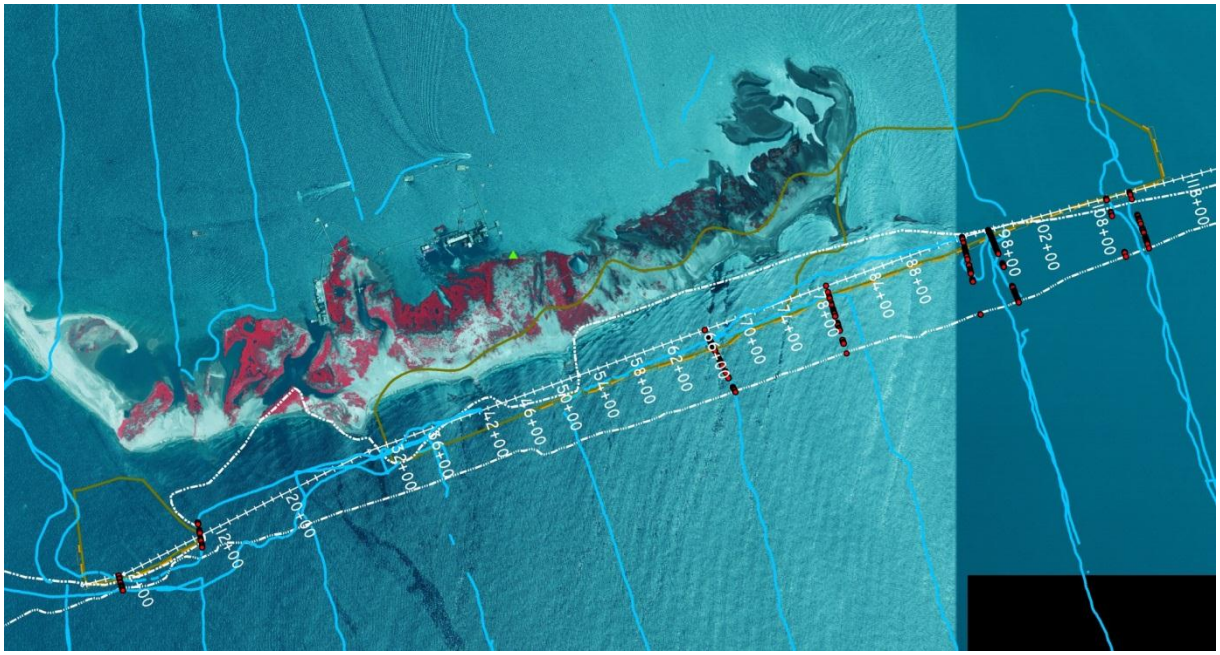
BICM 2006 bathymetry data (blue lines) was used to develop elevation profiles at selected project stations (red dots) to determine the status of East Timbalier Sediment Restoration Phase 1 (TE-25) and Phase 2 (TE-30) project rock shoreline protection features. All elevations are NAVD88 in meters.

BICM 2006 elevation profile at project station -1+00. Rock feature would be located at approximately 17 m along the profile.
