**State of Louisiana
Department of Natural Resources
Coastal Restoration Division**

**2006/2007 Annual Inspection
Report**

**CAERNARVON OUTFALL
MANAGEMENT
(BS-03a)**

State Project Number BS-03a
Priority Project List 2

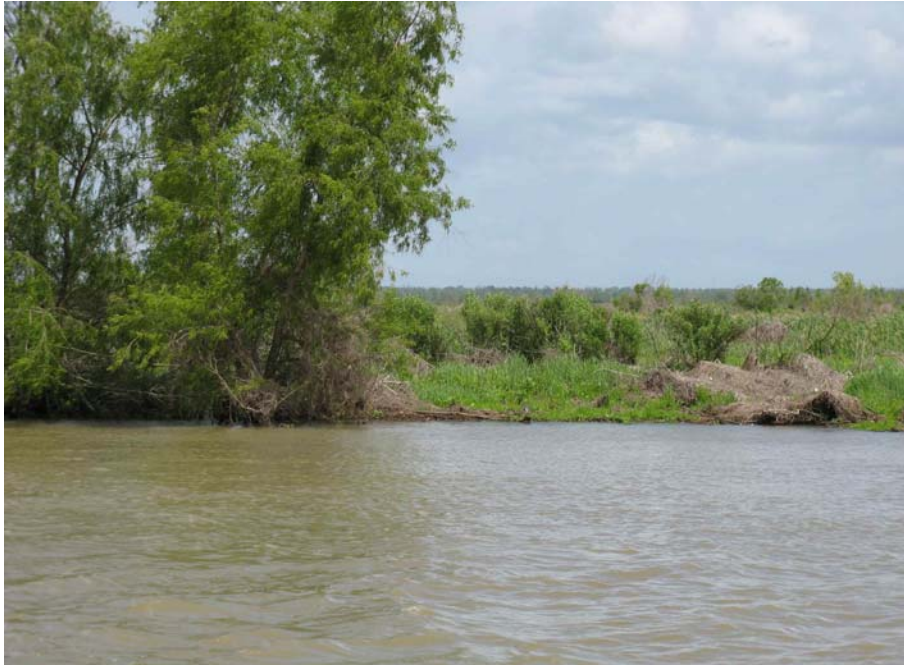
Photo # 19 Site 58 (view 3) Bayou Mandeville spoil bank.

- J. Site # 57** –It appears that the vegetation on the spoil bank along the sides of the Reggio Canal that was damaged by the storm is recovering although many sparse areas remain.
- K. Site # 58** –The vegetation on the spoil bank along the sides of the Bayou Mandeville that was damaged by the storm is recovering although many sparse areas remain.
- L. Site/Structure # 60** – The gate structure is still covered with storm debris. The gates were in the open position at the time of the inspection. Water flow was slightly visible, therefore it was not known just how much blockage remains due to storm debris.
