**2005 Operations, Maintenance,
and Monitoring Report**

**BRADY CANAL HYDROLOGIC
RESTORATION**

State Project Number TE-28
Priority Project List 3

June 2005
Terrebonne Parish

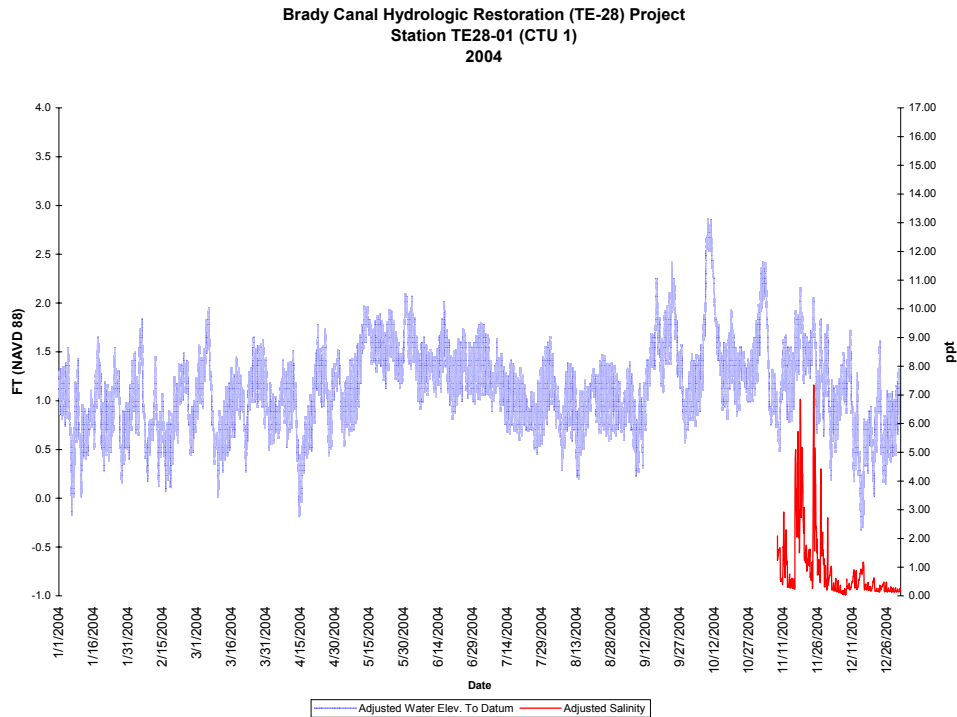
Figure 6: Water level and salinity data collected at station TE28-01 during 2004. The salinity data that is missing is attributed to a mat of decaying water hyacinth that has skewed the data.
