**State of Louisiana  
Department of Natural Resources  
Coastal Restoration Division and  
Coastal Engineering Division**

**2005 Operations, Maintenance,  
and Monitoring Report**

**Boston Canal/ Vermilion Bay  
Shoreline Stabilization**

State Project Number TV-09  
Priority Project List 2

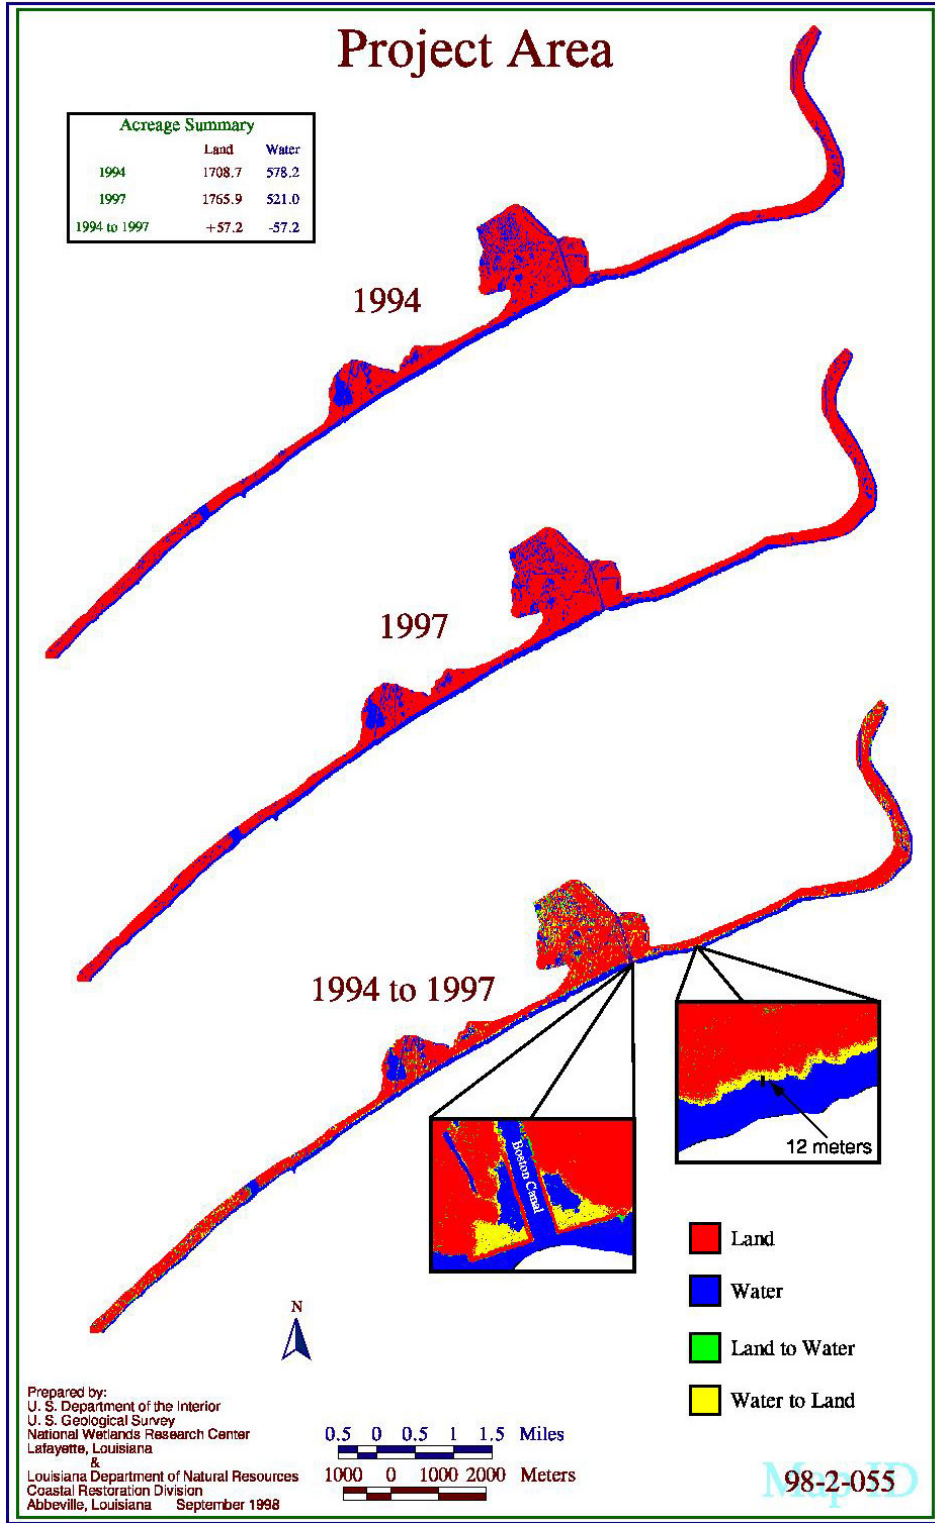
Land/water analysis of the project area indicated an increase of 57.4 ac (23.2 ha) from 1994 to 1997 (figures 2-4). Some of the land gain is in the interior part of the project area, unrelated to project features; however the plantings on the bay shoreline indicated effective protection and sediment trapping (figure 2), and there were gains in the areas behind the rock dikes (figure 3). Also, there were no breaches in the shoreline indicating that the interior marsh has remained protected from potential bay wave erosion.

**Figure 2.** Boston Canal/Vermilion Bay Shoreline Stabilization (T/V-09) GIS land/water analysis of project area.

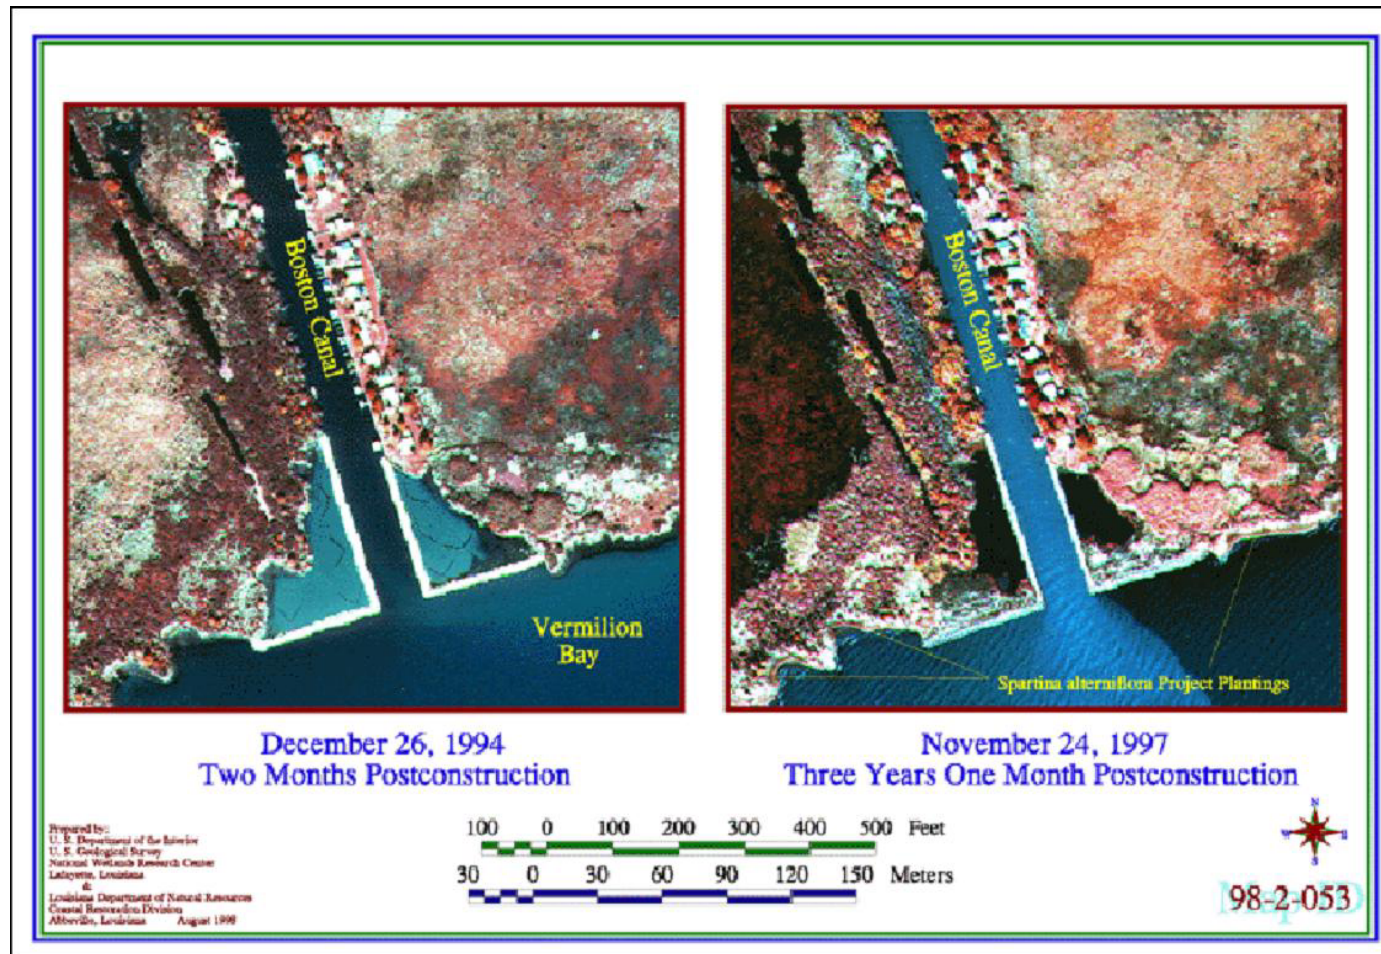
**Figure 3.** Aerial photography comparison of Boston Canal Shoreline Stabilization (TV-09) project at two months post-construction (December 26, 1994) and three years, one month post-construction (November 24, 1997).

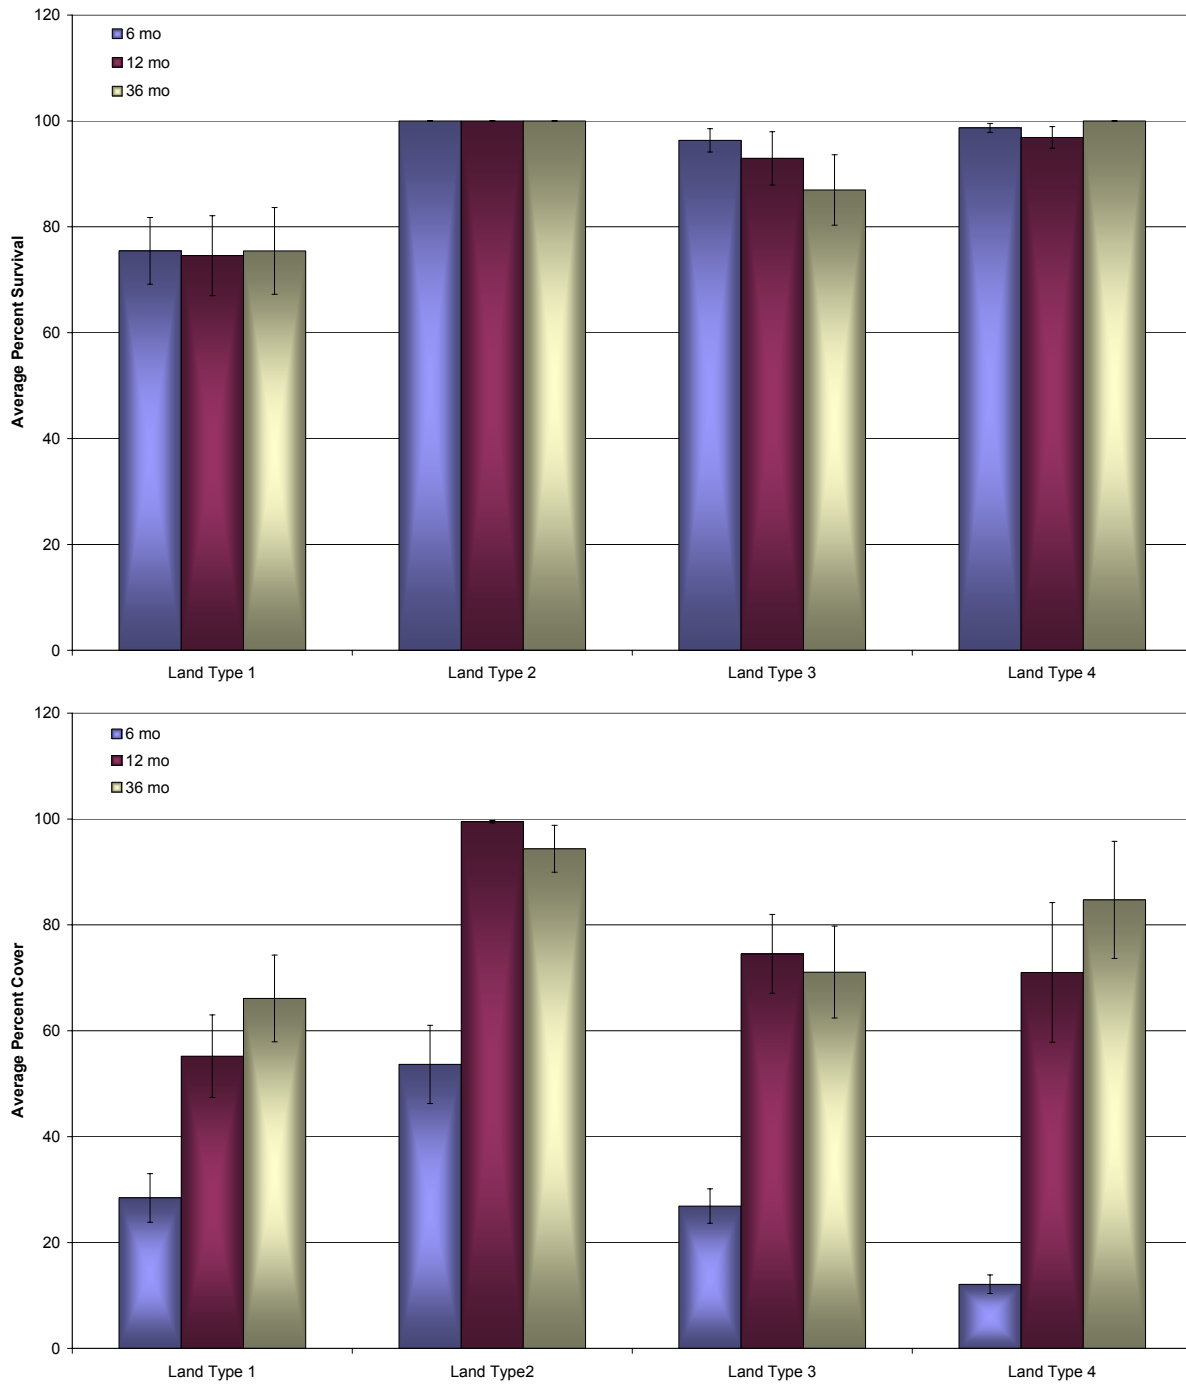
**Figure 4.** Boston Canal/Vermilion Bay Shoreline Stabilization (TV-09) average percent survival (upper) and average percent cover (lower) of *Spartina alterniflora* plantings in land types 1-4 observed at 6, 12, and 36 months post-planting, 1995, 1996, and 1999 means  $\pm$  SE.

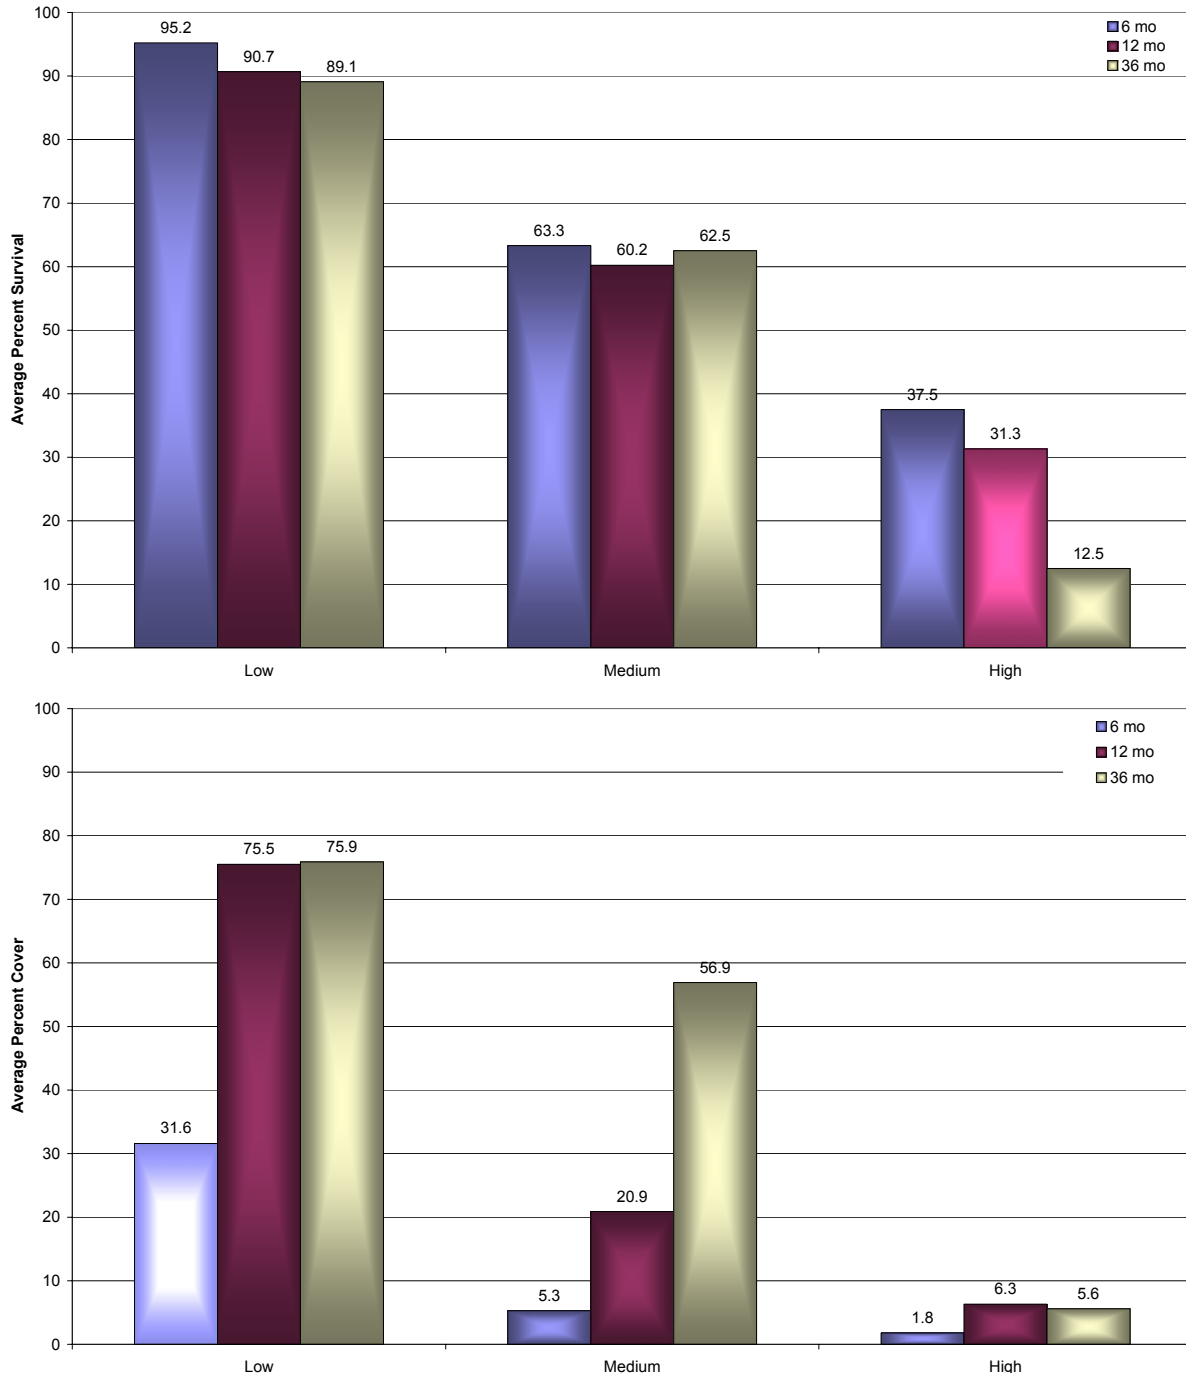
**Figure 5.** Boston Canal/Vermilion Bay Shoreline Stabilization (TV-09) average percent survival (upper) and average percent cover (lower) of *Spartina alterniflora* plantings at 6, 12, and 36 months post-planting in low, medium, and high levels of *Phragmites australis* coverage.

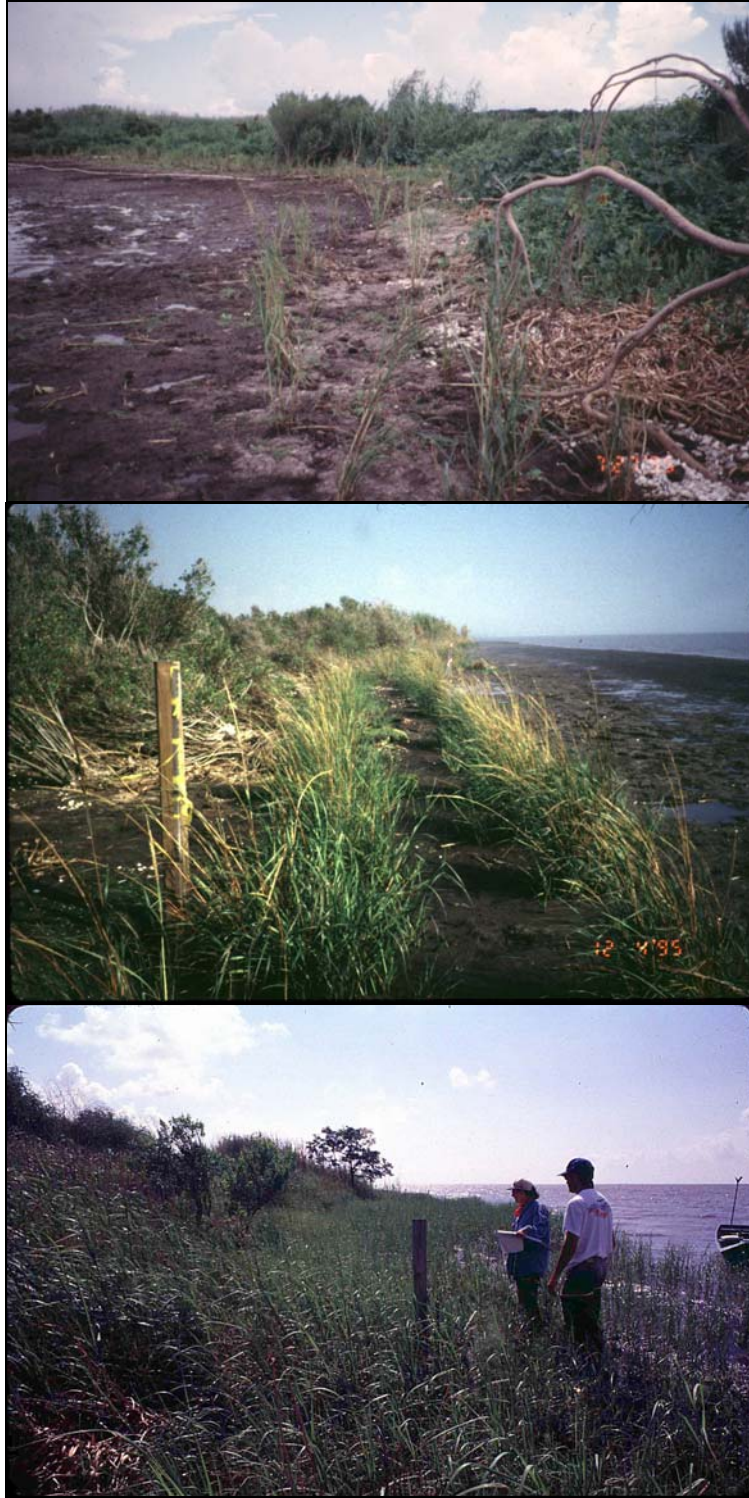
**Figure 6.** *Spartina alterniflora* planting at 6 (upper), 12 (center), and 36 (lower) months post-planting monitoring.

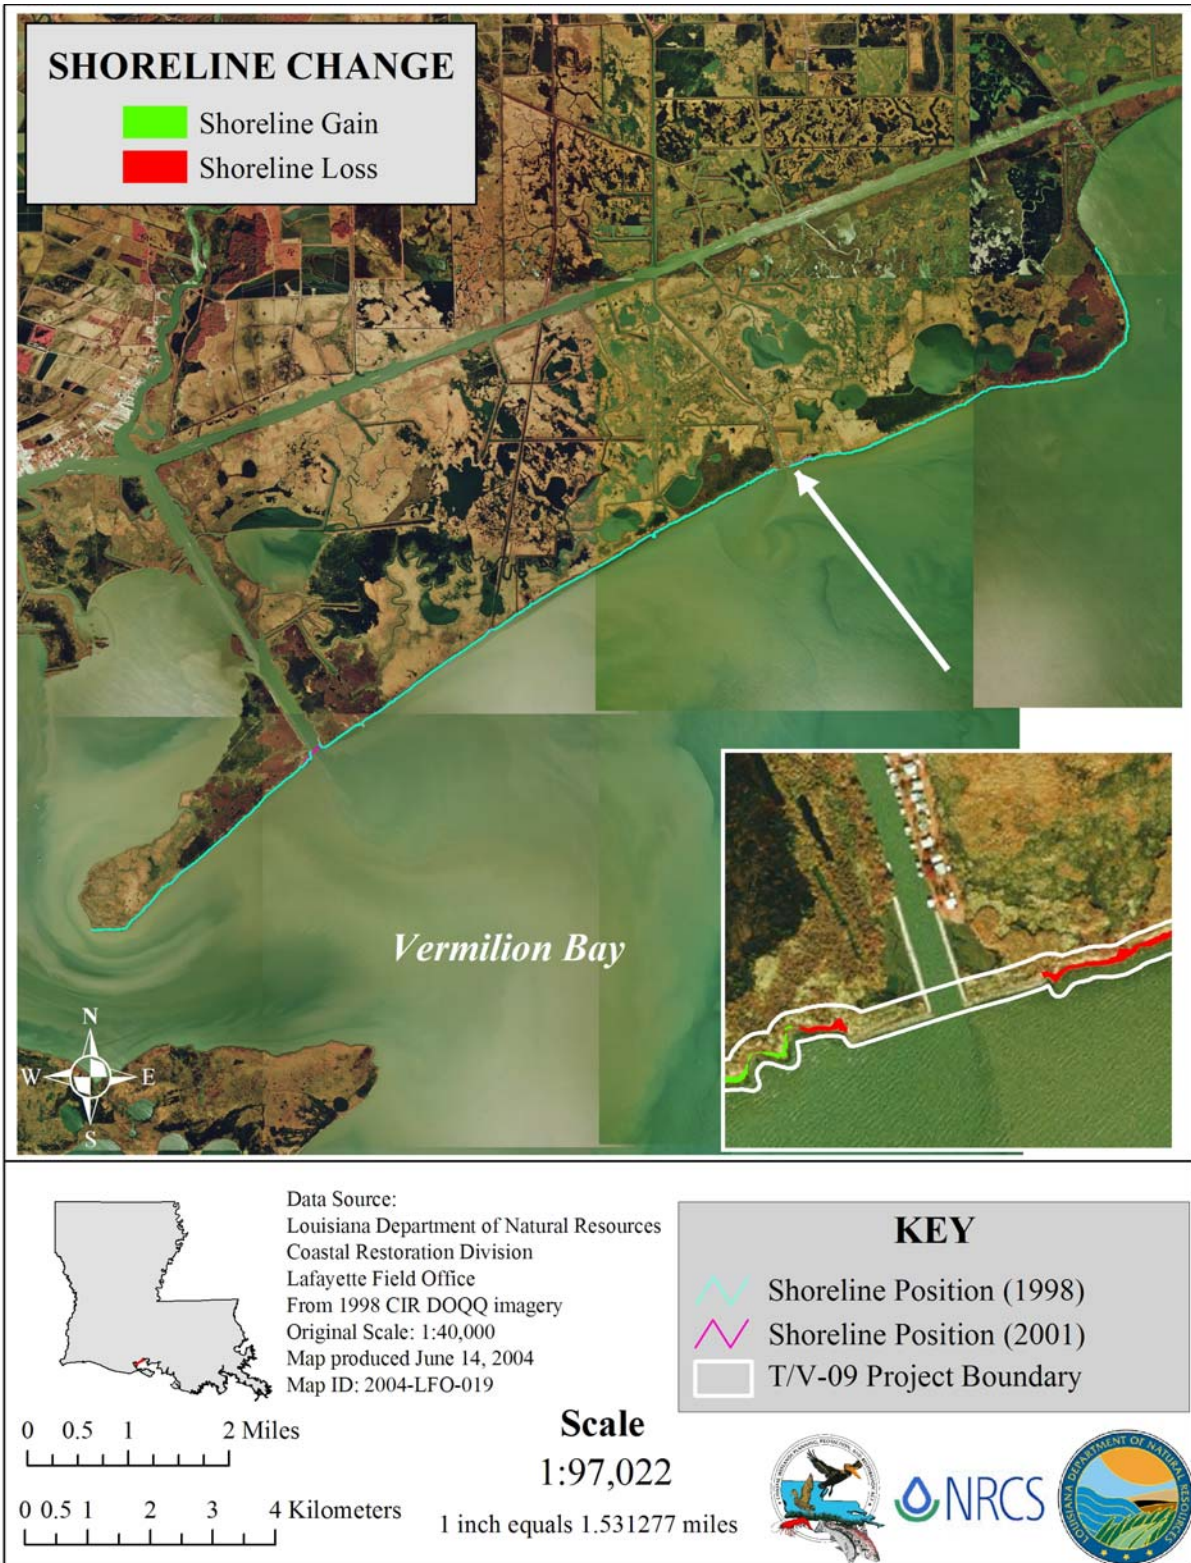
A comparison of DGPS mapping of the 13.25-mi (21.3-km) project shoreline in 1998 and 2001 indicated total losses of 6.4 ac (2.6 ha) and total gains of 13.46 ac (5.45 ha) for a net gain of 7.06 ac (3.1 ha) (figure 8). Between 2001 and 2004, total shoreline losses were 22.68 ac (9.18 ha) and total gains were 0.8 ac (0.3 ha) for a net loss of 21.88 ac (8.85 ha) (figure 9). Hurricane Lili, which passed over the area in 2002, likely accounted for much of the loss through wave-induced erosion. Although not mapped in this effort, the shoreline areas behind the rock dikes were completely protected and have accumulated sediment (figure 10). The reference area originally chosen for the project was later determined to be invalid when it was discovered that the landowner had installed a series of vegetative plantings beginning prior to the completion of the Boston Canal project.

**Figure 8.** Shoreline position change for Boston Canal/Vermilion Bay Shoreline Stabilization (TV-09) project using 1998 and 2001 differential global positioning system mapping data.

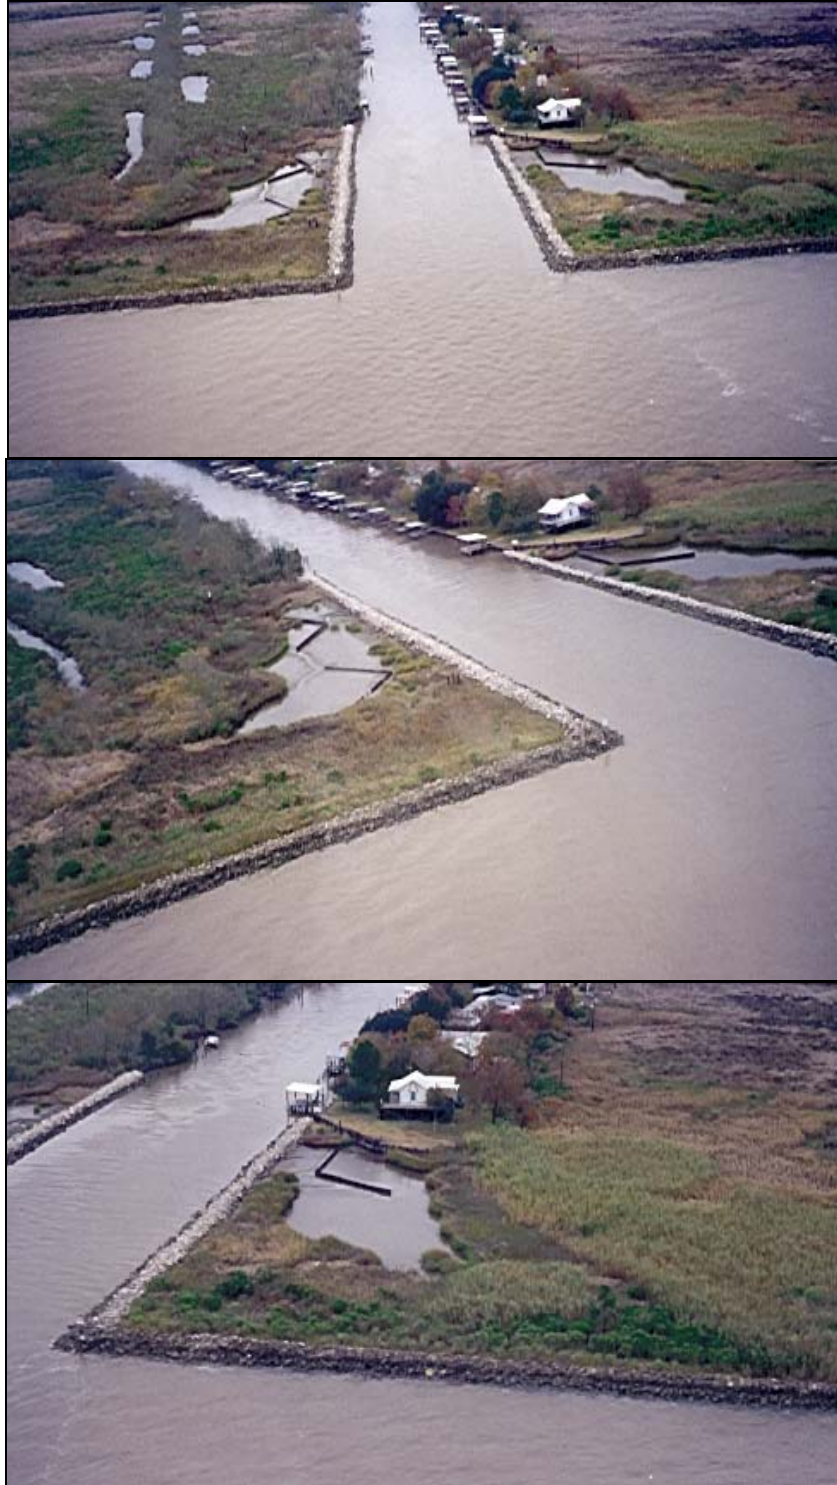
**Figure 10.** Boston Canal/Vermilion Bay Shoreline Stabilization (TV-09) rock dike and sediment fences at the mouth of Boston Canal (January 2001).
