Coastal Protection and Restoration Authority of Louisiana

2011 Operations, Maintenance and Monitoring Report

Oaks/Avery Canals Hydrologic Restoration

State Project Number T/V-13a
Priority Project List 6

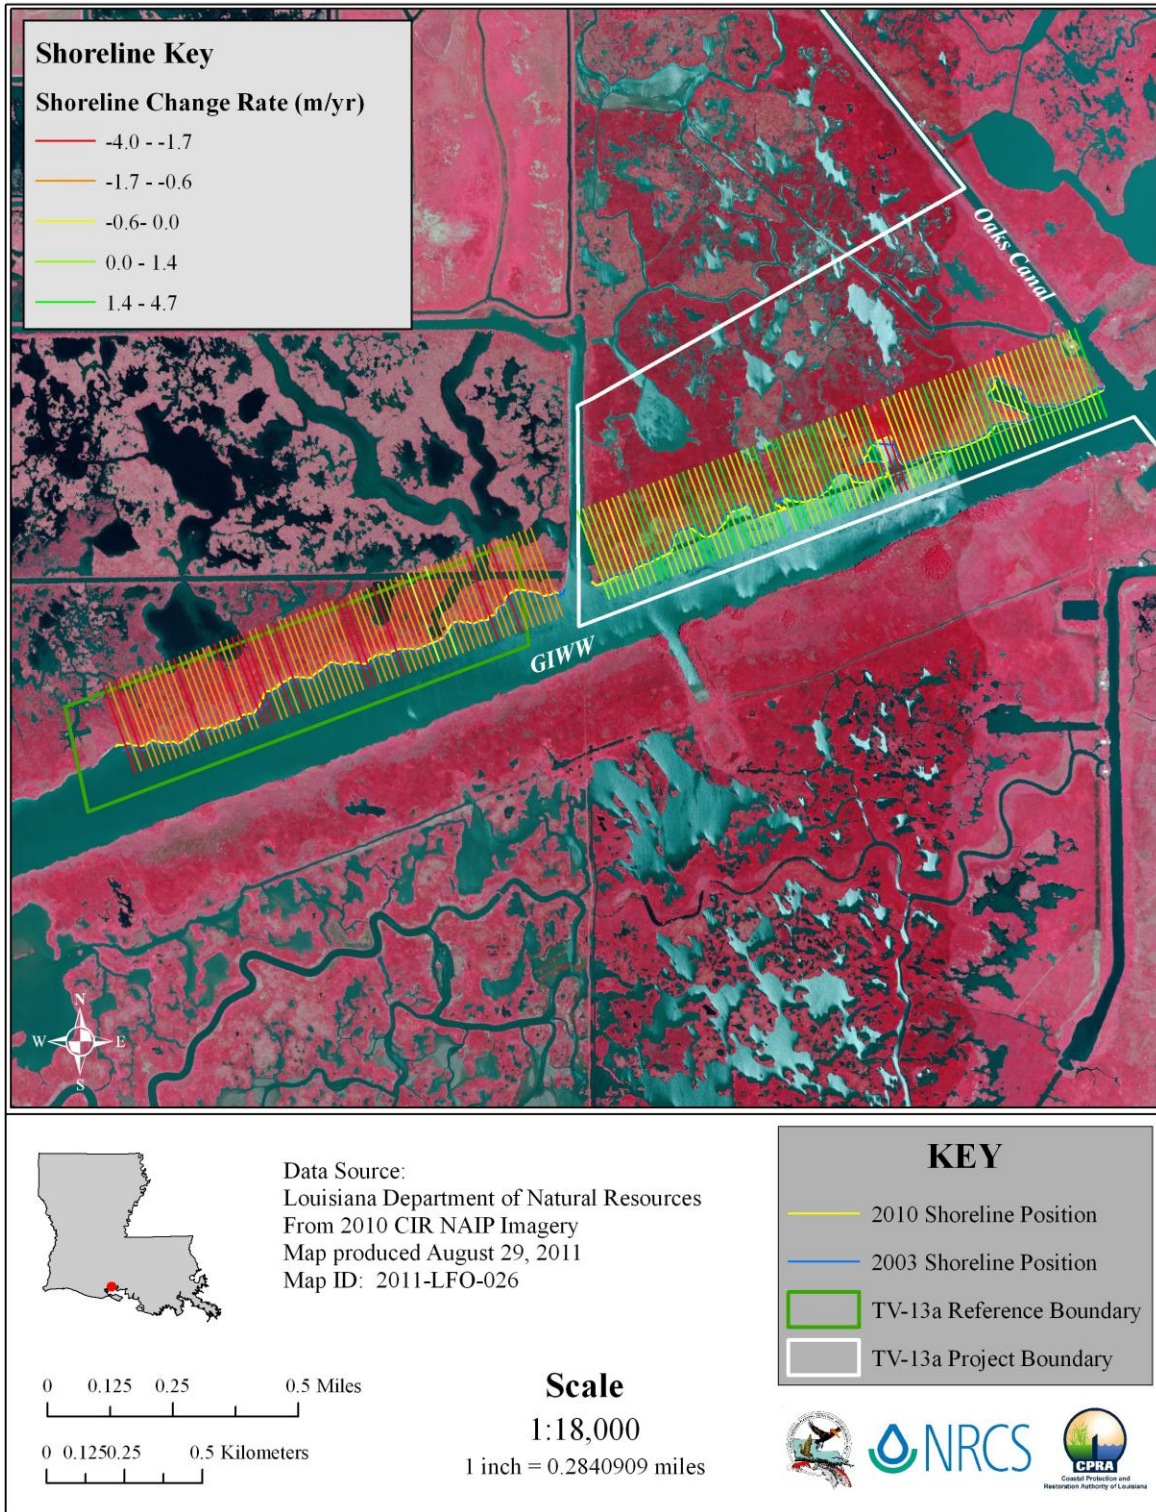
Figure 8. Shoreline change in the TV-13a project area along the GIWW for the period 2003-2010.

As-built (immediately post-construction) bankline positions for the project and reference areas along the GIWW were collected following rock dike construction and again in 2006/7 and 2010 (table 2). Overall, between 2003 and 2010, the project bankline prograded at a mean rate of 0.7 m/yr (2.3 ft/yr) and the unprotected reference area eroded at a rate of -1.4 m/yr (-4.6 ft/yr) (figure 8). These data are consistent with shoreline change in other rock dike projects built along the GIWW. Sediment appears to be accumulating between the shore and the rock dike, resulting in the progradation of the bankline.

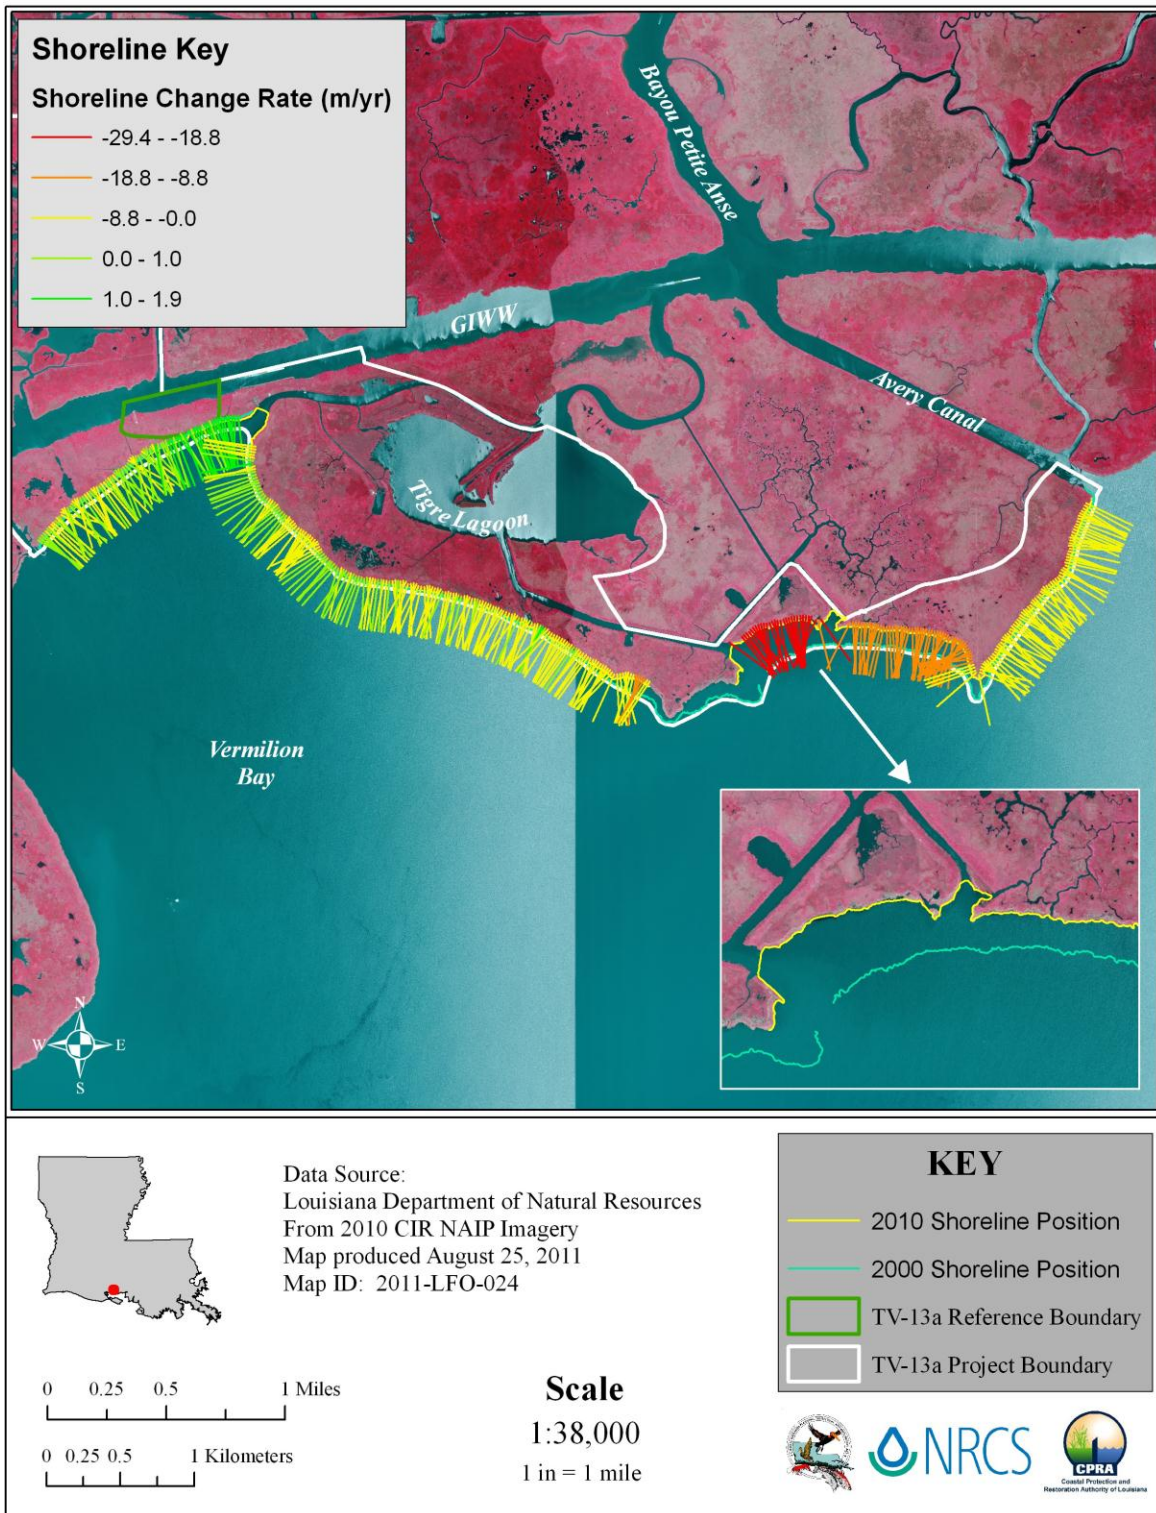
Figure 9. Shoreline change along the shore of Vermilion Bay during the period 2000-2010.

Data were collected in 2000 (pre-construction), 2003 (post-planting), 2007, and 2010 for the Vermilion Bay shoreline (table 2, figure 9). Shoreline loss was minimal for the majority of the project area, with the exception of a 6000-ft long section southeast of Tigre Lagoon, which exhibited marked shoreline erosion. It is possible that erosion rates from 2003-2007 increased with time as plantings were lost, or remained consistent with 2000-2003, with the additional loss attributed to Hurricane Rita, which battered the shoreline of the project with high winds and a storm surge of as much as 11-12 ft. From 2007-2010, shoreline erosion in the 6000 ft section southeast of Tigre Lagoon decreased (table 2). It is not known why this decrease occurred. There could have been a change in soil composition as marsh was exposed, which could have reduced the erodibility of the soil. During the entire monitoring period (2000-2010), the shoreline retreated at a rate of -3.8 m/yr (-12.5 ft/yr). The 6000 ft long section southeast of Tigre Lagoon eroded at a mean rate of -15.8 m/yr (-51.8 ft/yr). Loss in this area was as much as -29.4 m/yr (-96.5 ft/yr) (figure 9).

Replanting vegetation or another suitable shoreline protection measure is strongly recommended for those portions of the Vermilion Bay shoreline exhibiting erosion rates in excess of 100 ft/yr. In addition, it is imperative to have a better understanding of the factors causing the observed shoreline loss in this area of the project.
