# 2013 Operations, Maintenance, and Monitoring Report

## East Marsh Island Marsh Creation

State Project Number TV-21  
Priority Project List 14

June 2013  
Iberia Parish

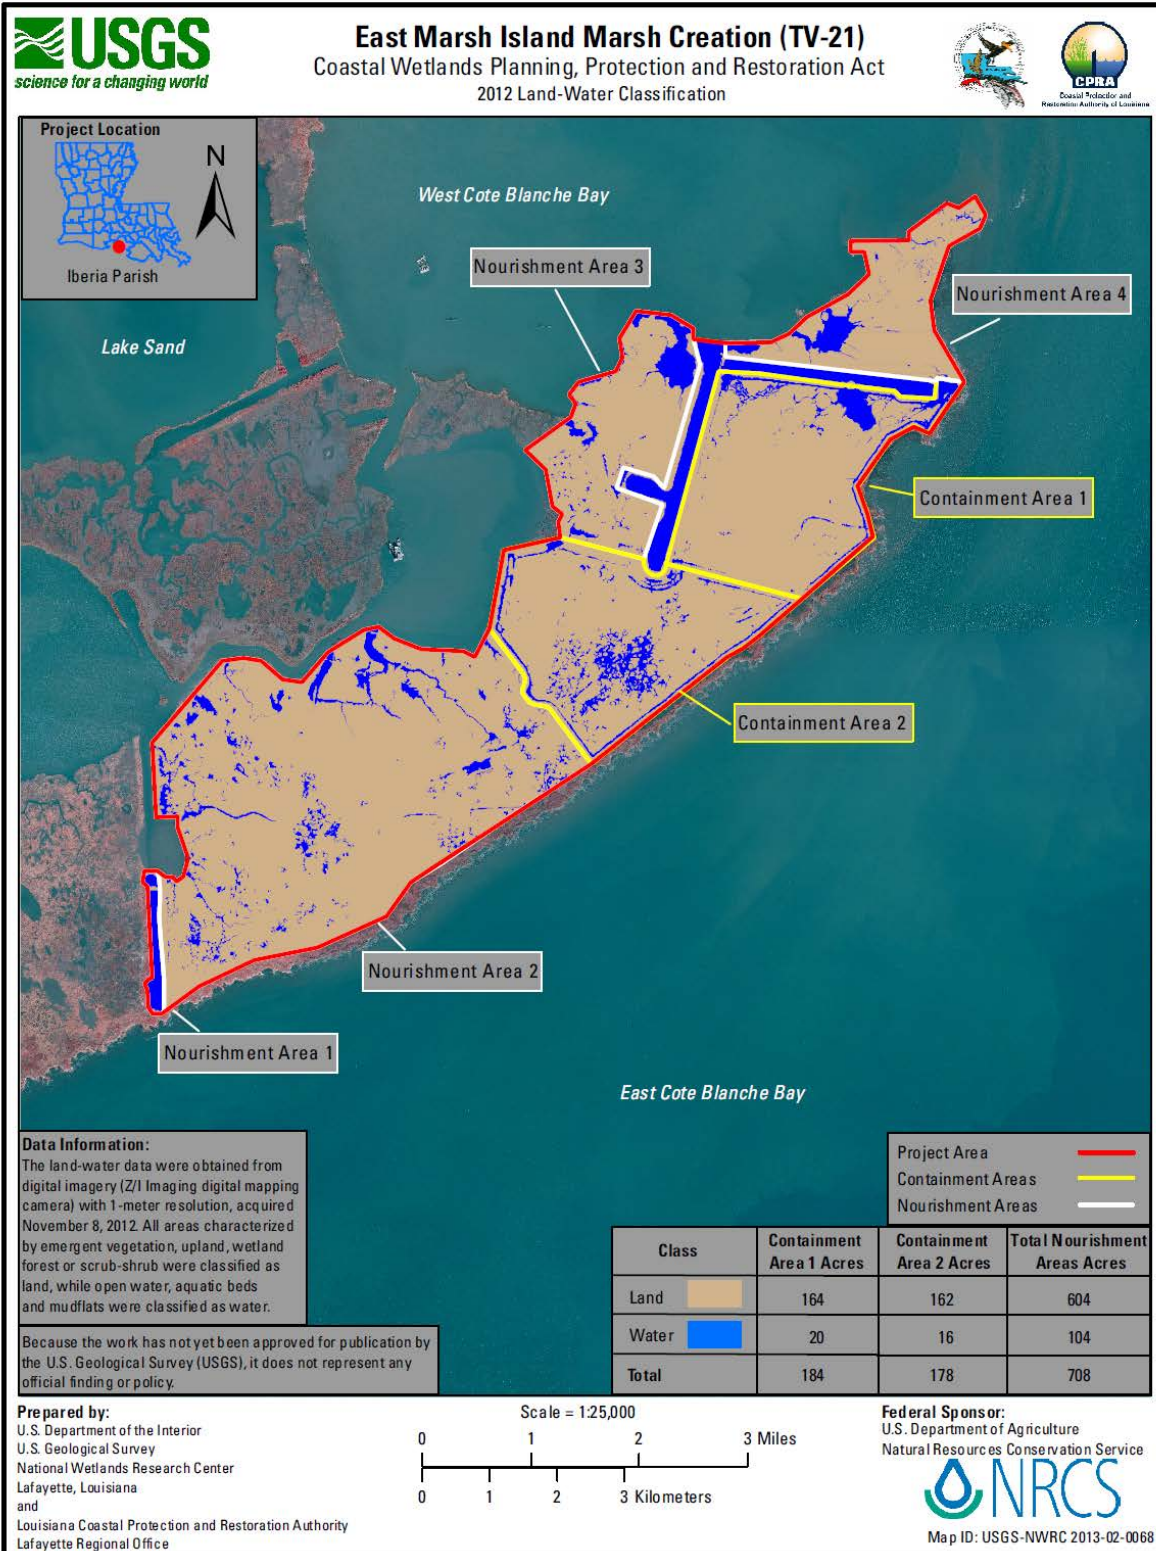
**Figure 3.** East Marsh Island Marsh Creation (TV-21) project 2012 land/water analysis.

Post-construction land/water analysis was completed for the 2012 aerial photography (figure 3). Results indicated 89.13% land and 10.87% water within containment area 1, 91.01% land and 8.99% water within containment area 2, and 85.31% land and 14.69% water within the nourishment areas. Future analysis will help to determine the project's effect on land change.

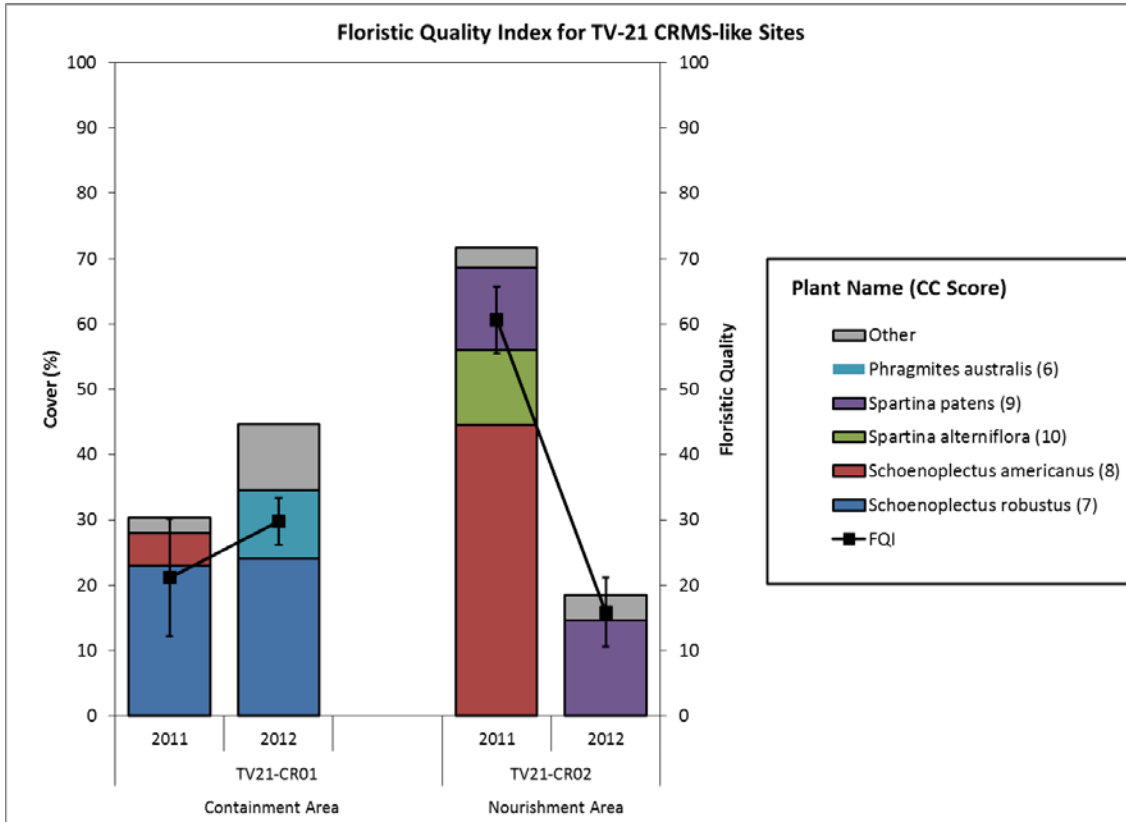
Containment area 2 had begun to vegetate by late summer of 2011 (TV21-CR01) and increased in cover to near 50% by 2012 (figure 6a). Vegetation in nourishment area 2 (TV21-CR02) was doing quite well in the first year after construction, but declined drastically in both cover and FQI in 2012 due to heavy herbivory damage from nutria. By 2012, the nutria had eliminated almost all of the *Schoenoplectus americanus* (a preferred food source) and *Spartina alterniflora* from the area, which were dominant species in the 2011 survey. Minor herbivory was noted in containment area 2, but the nutria weren't as prolific as in the nourishment area. This could be due to a smaller percentage of *S. americanus*.

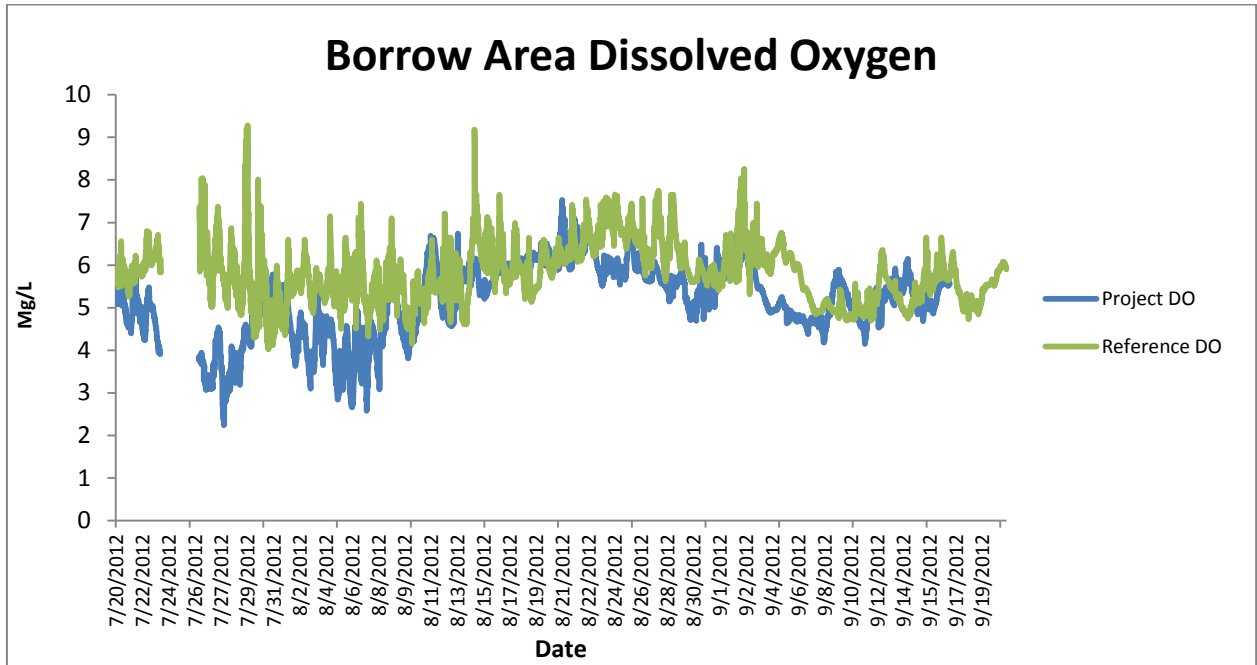
**Figure 9.** Dissolved oxygen levels (Mg/L) in the TV-21 borrow and reference areas from July-September 2012.

Dissolved oxygen levels were monitored in the borrow area and a reference area, just outside of the borrow area, in July through September 2012 (figure 9). Data was not collected in 2011 due to an equipment malfunction. A non-parametric one way median analysis was run to compare the 2012 data from both areas. It was found that dissolved oxygen levels were significantly lower in the borrow area than the reference area, particularly during the beginning of the sampling period ( $\chi^2=10.54$ ,  $p=0.0012$ ). Slightly higher water temperatures were recorded during the beginning of the sampling period, when compared to mid-August through September which may have caused this effect. Hypoxic conditions (<2 mg/L) did not occur in either area, though. The lowest dissolved oxygen levels occurred on July 28 in the borrow area and were 2.24 mg/L. The post-construction surveys completed in March 2012 showed significant infilling of the borrow area during the first year since construction.
