**Coastal Protection and Restoration Authority
of Louisiana (CPRA)**

**2015 Operations, Maintenance, and
Monitoring Report**

**East Mud Lake Marsh Management
(CS-20)**

State Project Number CS-20
Priority Project List 2

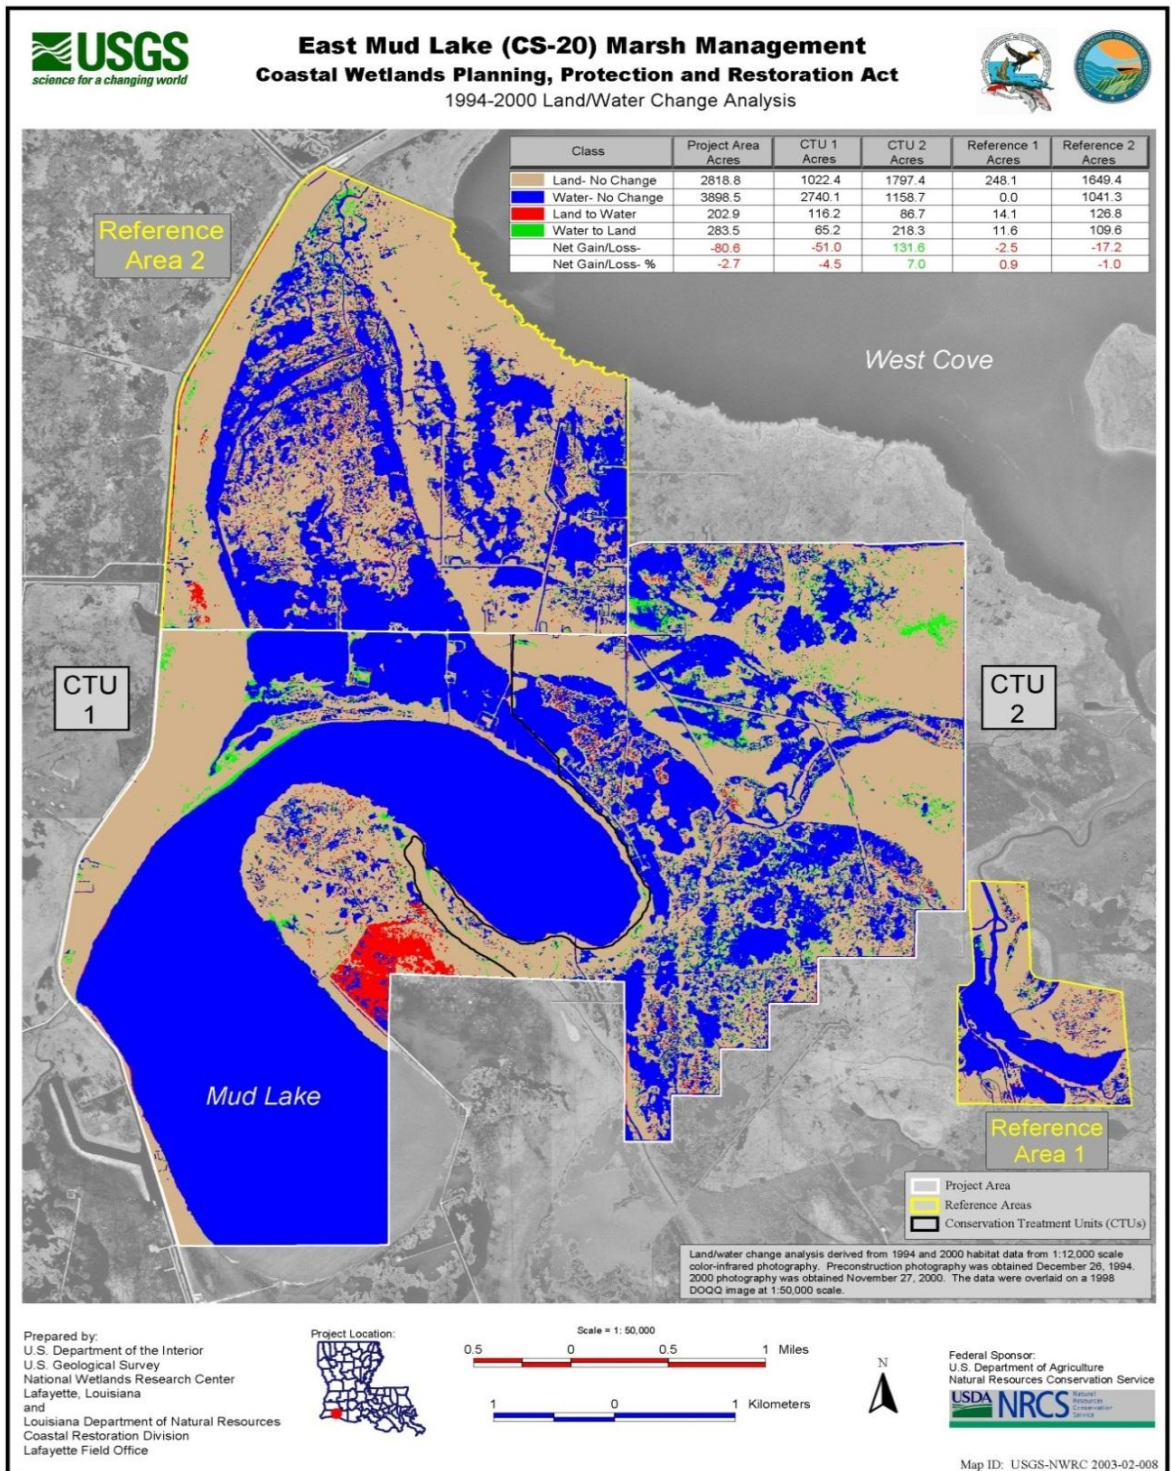
Figure 5A. Land to water change analysis from 1994-2000 at CS-20. Note marsh gains (green) within broken marsh and along larger ponds in CTU 2. The large swath of marsh loss (red) in CTU 1 was caused by a marsh fire that mostly recovered by 2006.

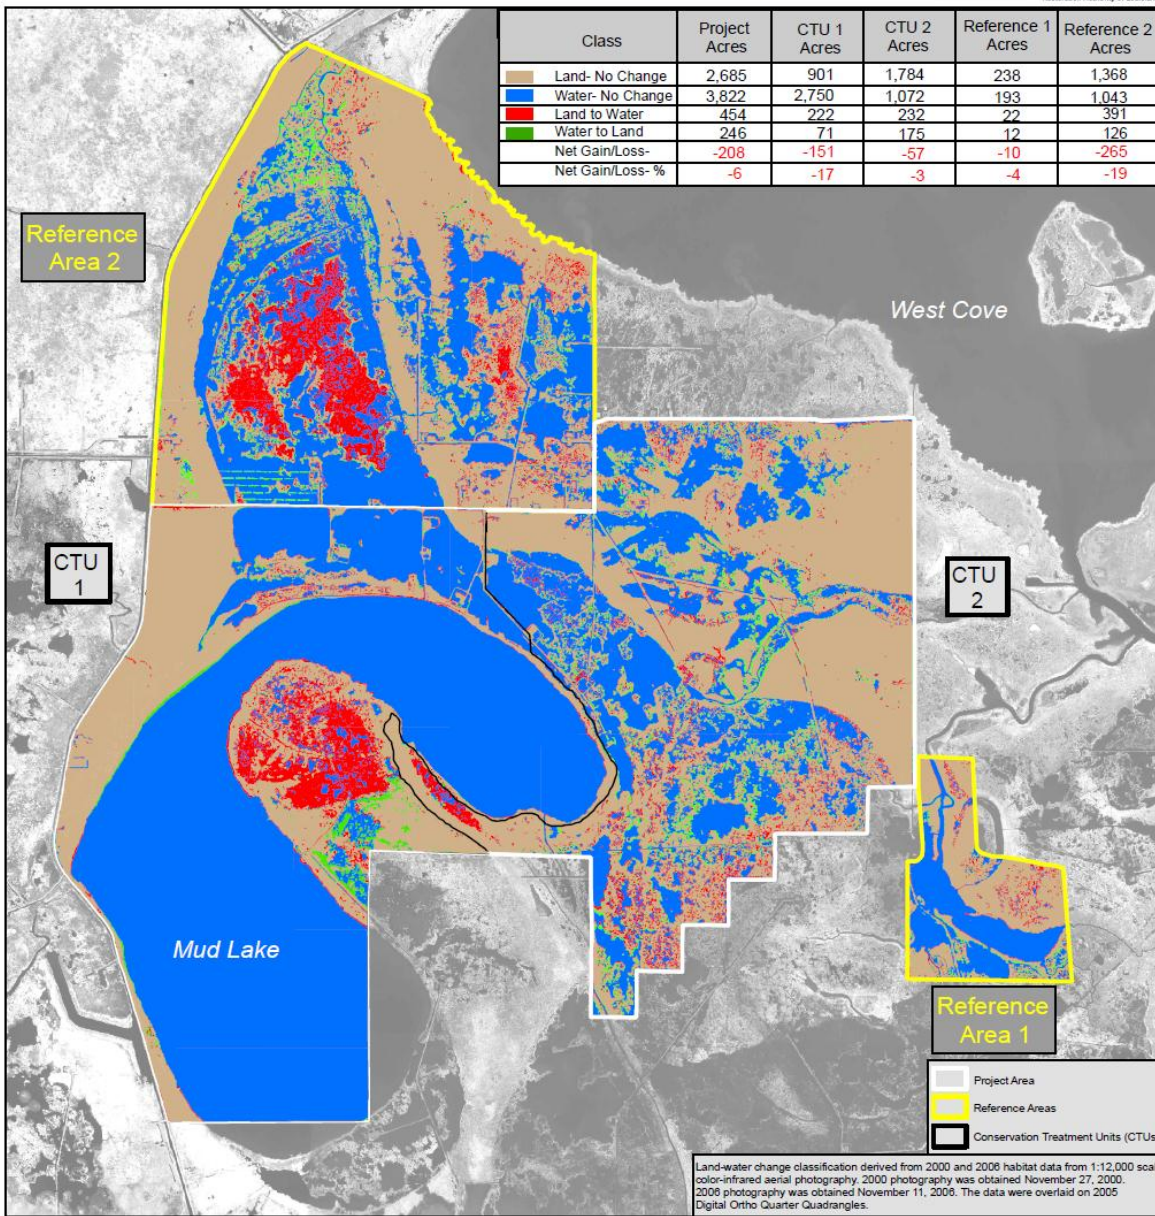
Figure 5B. Land to water change analysis at CS-20 from 2000-2006. Note marsh gains (green) within broken marsh and along larger ponds in CTU 2. The large swaths of marsh loss (red) were the result of Hurricane Rita in 2005.

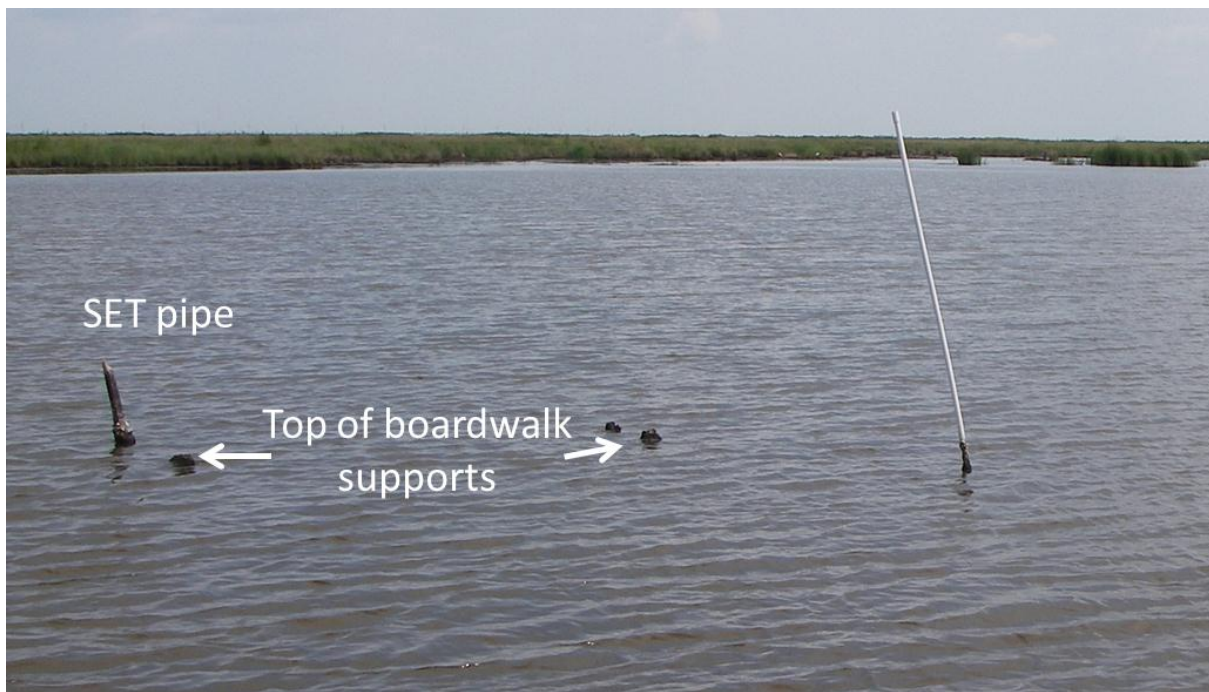
Picture 1. Picture of Station CS20-52R taken in Aug 2009 following Hurricanes Rita (2005) and Ike (2008). Most of the open water was marsh prior to the hurricane storm-surge scour (see figure 5B for extent of damage in Reference Area 1).

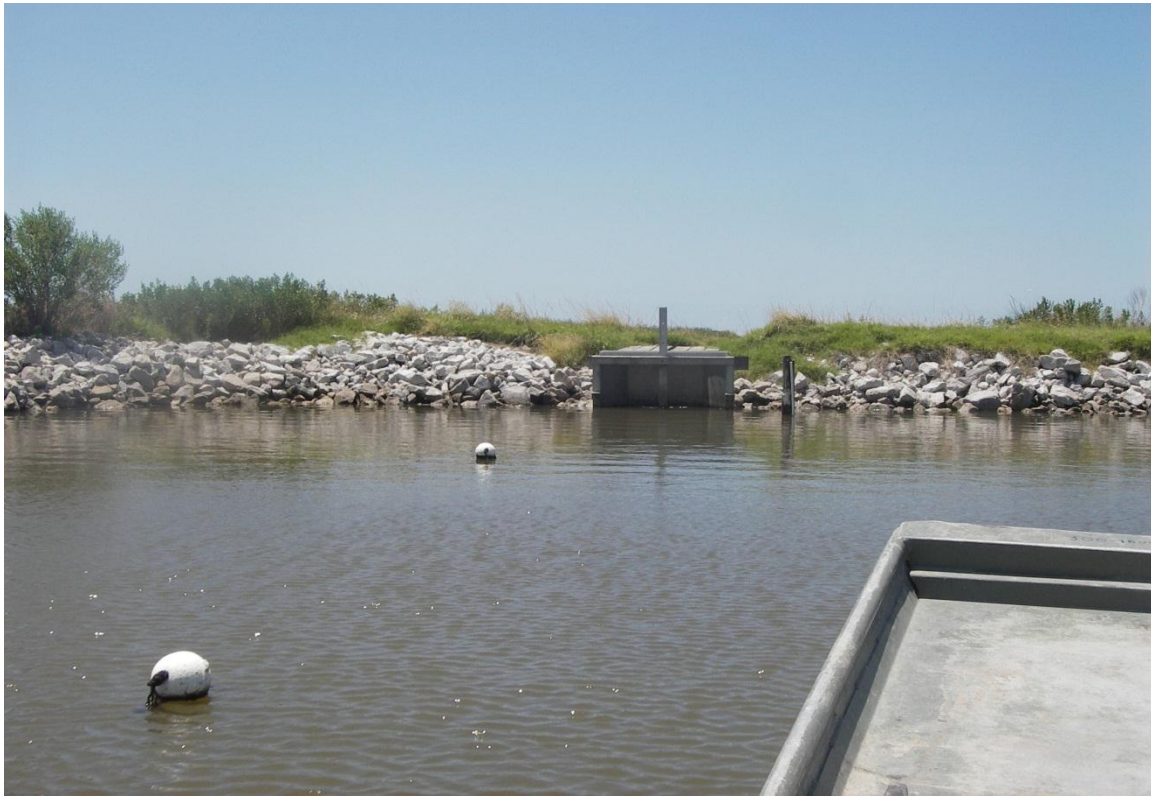
Photo 15, Structure 3

This is also a pre-existing structure that was incorporated into the CS-20 Project. Walkways are in excellent shape. Rock placed around the structure has stabilized the banks. (Photos: Appendix A, Photos 15 & 16).

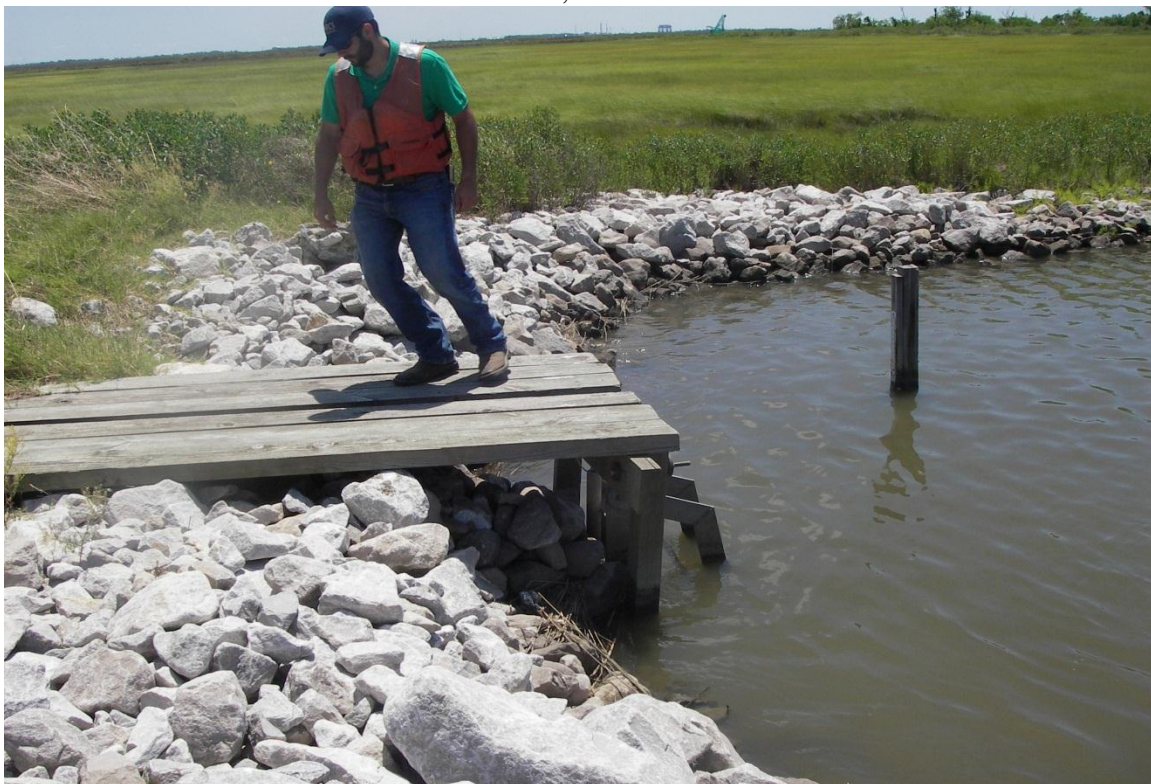
Photo 16, flap side, Structure 3
