2014 Operations, Maintenance, and Monitoring Report

Cote Blanche Hydrologic Restoration

State Project Number TV-04
Priority Project List 3

June 2014
St. Mary Parish

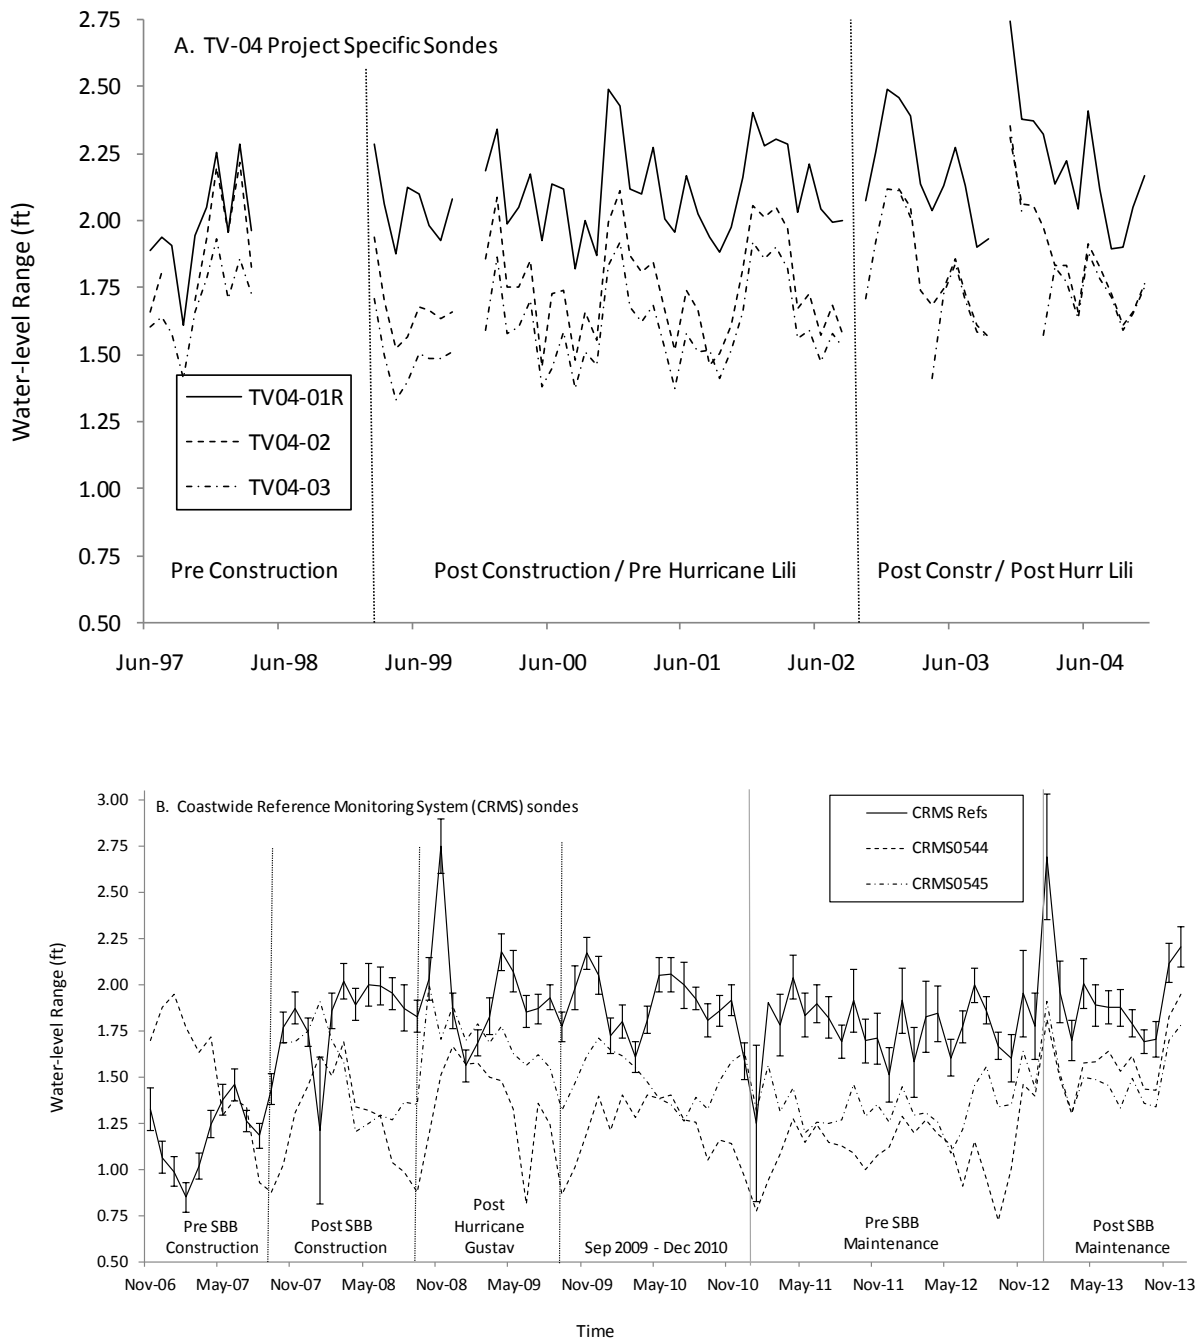
The low-level weirs are reducing water level variability within the TV-04 area when free from hurricanes and hydrologic bypassing around the weirs. Monthly averages of daily water level range were plotted for project and reference sondes for project-specific (TV-04) and CRMS sets with delineations for time intervals of interest (Figure 2). In the TV-04 sonde set, reference (TV04-01R) and project (Humble Canal sonde at TV-02/22 and Humble B Canal/Mud Bayou sonde at TV04-03) ranges were closer together during pre-construction than in later time intervals as the water level range decreased at the project sondes (Figure 2A). To demonstrate changes in water level ranges within the project area relative to reference conditions, the daily water level range of the reference was subtracted from the project sondes. The range differences from each project sonde were averaged over the time intervals of interest and compared; their interaction was statistically significant (sonde \times time interval, $F_{1,2}=23.7$, $p<0.0001$). Prior to project construction, water level ranges within the project area were less than along ECBB; subsequently, the differences grew after project construction (Figure 3A). In the time interval following project construction, the range difference in water level range tripled at the Humble Canal sonde (TV-02/22) and doubled at the Humble B Canal/Mud Bayou sonde (TV04-03). The range difference at TV04-03 increased by ~25% after Hurricane Lili (Figure 3A). Between November 2004 and November 2006, ECBB had breached into School Bus Bayou (SBB) allowing tidal water to bypass the weir located on Humble Canal which prompted construction of the SBB structures (weirs at intersection with Humble Canal and a foreshore rock dike).

Figure 2. Water level ranges (maximum – minimum per day) collected over time from reference and project sondes (A. TV-04 Project Specific and B. CRMS) at the Cote Blanche Hydrologic Restoration project (TV-04). Values are monthly means of daily ranges. The

reference sonde has the solid line (error bars represent variability among CRMS reference sondes), and the project sondes have dashed lines.

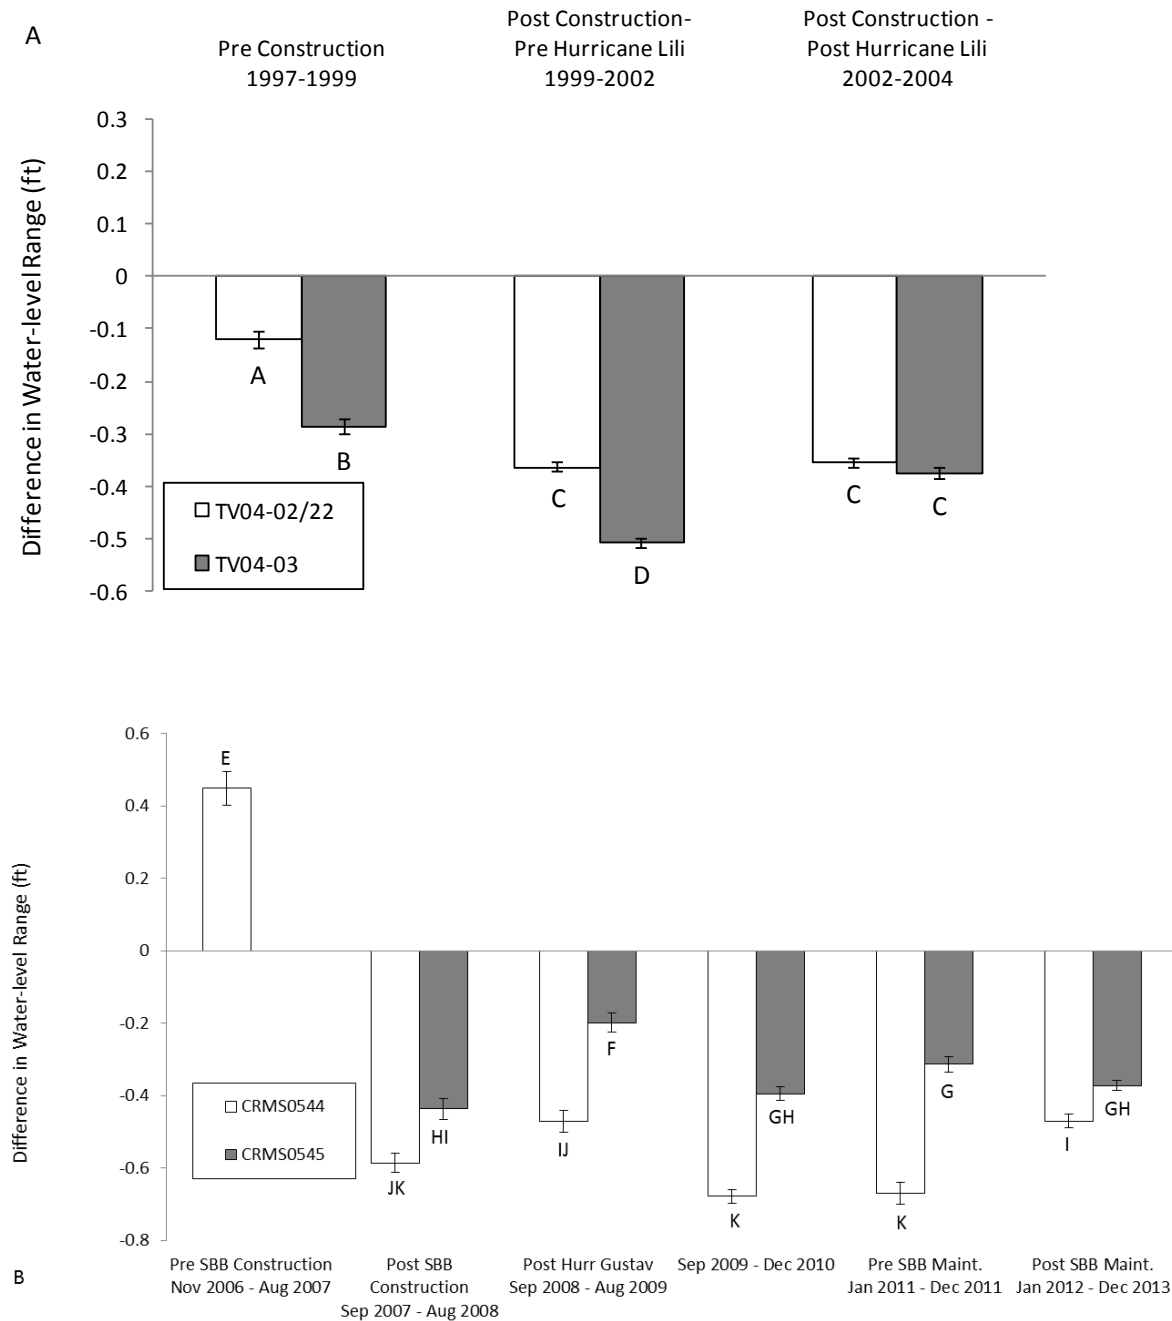
Within the CRMS sonde set, range differences between project area sondes over time intervals were statistically significant as an interactive effect (sonde \times time interval, $F_{1,4}=12.1$, $p=0.0001$) (Figure 3B). Water level range averaged greater at the Humble Canal (CRMS0544) sonde than the reference sondes (CRMS_{Refs}) prior to construction of the SBB structures as water was bypassing the Humble Canal weir. Water level ranges were typically less at project sondes than the reference following the installation of the SBB structures with the Humble Canal sonde (CRMS0544) having larger range differences than the Humble B Canal/Mud Bayou sonde (CRMS0545) (Figure 3B). While CRMS0545 is influenced by Humble B Canal and Mud Bayou weirs, it is open to WCBB to the north via Bayou Mascot (Figure 1) which allowed for increased ranges relative to the reference for a brief time following Hurricane Gustav (Figure 2B). Following recovery from Hurricane Gustav, CRMS544 water level ranges averaged ~0.6ft below CRMS_{Refs} prior to the SBB Maintenance.

The SBB foreshore rock dike was lifted and SBB/Humble Canal weir replaced by January 2013; thereafter, water level ranges at CRMS0544 increased and were more comparable to those at CRMS0545 (Figure 3B). The late increase in water level range at CRMS0544 may be caused by a breach around the Jackson Bayou weir identified during the last OM&M event on May 30, 2012 (Aucoin 2012).

Figure 3. Difference in water level range ($\text{Range}_{\text{proj } i} - \text{Range}_{\text{ref}}$) collected over time intervals from (A) TV-04 Project Specific and (B) Coastwide Reference Monitoring System (CRMS) sondes at the Cote Blanche Hydrologic Restoration project (TV-04). Values are means and standard errors of daily range differences for a time interval. Each sonde set (A and B) was analyzed separately, and both had significant interaction (sonde \times time interval) effects; the different letters indicate significant differences among columns within a set

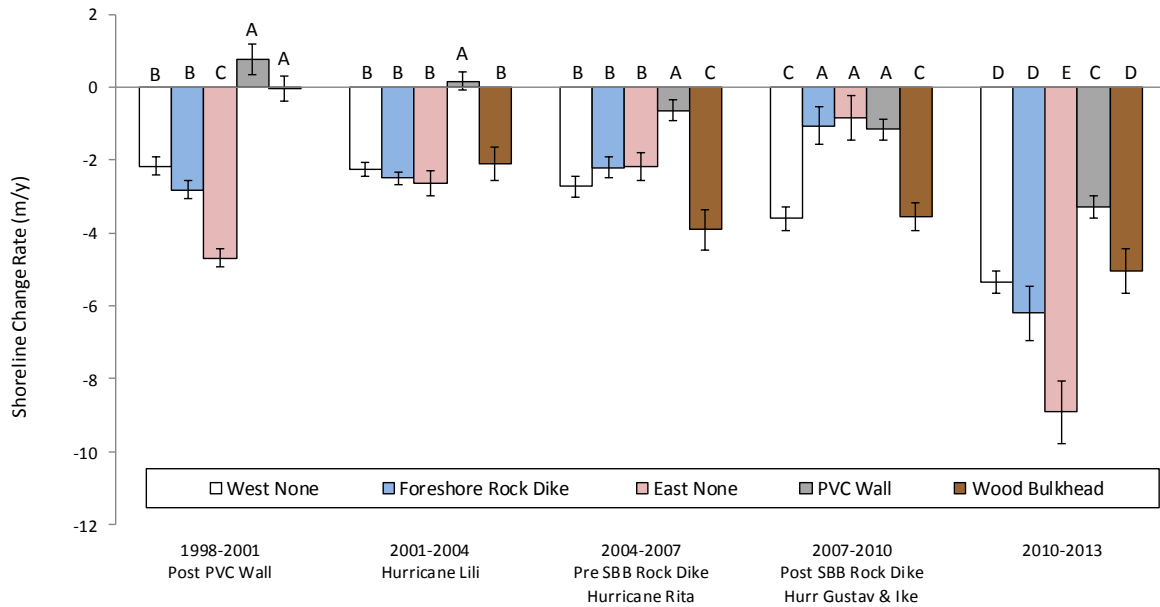
Figure 4. Intervals of shoreline change rates were calculated from shoreline mapping conducted along protected and unprotected shoreline of East Cote Blanche Bay within the TV-04 project area from 1998-2013. Significant events affecting the shoreline in the time intervals were: 1998-2001, initial post construction of the PVC wall east of Humble Canal; 2001-2004, Hurricane Lili; 2004-2007, pre-construction of the foreshore rock dike parallel to School Bus Bayou and Hurricane Rita; 2007-2010, post construction of the SBB rock dike and Hurricanes Gustav and Ike; 2010-2013, SBB rock dike lifted and SBB/Humble Canal weir replaced. Significant differences among shoreline protection types within each time interval are indicated by different letters (Tukey's HSD post test).

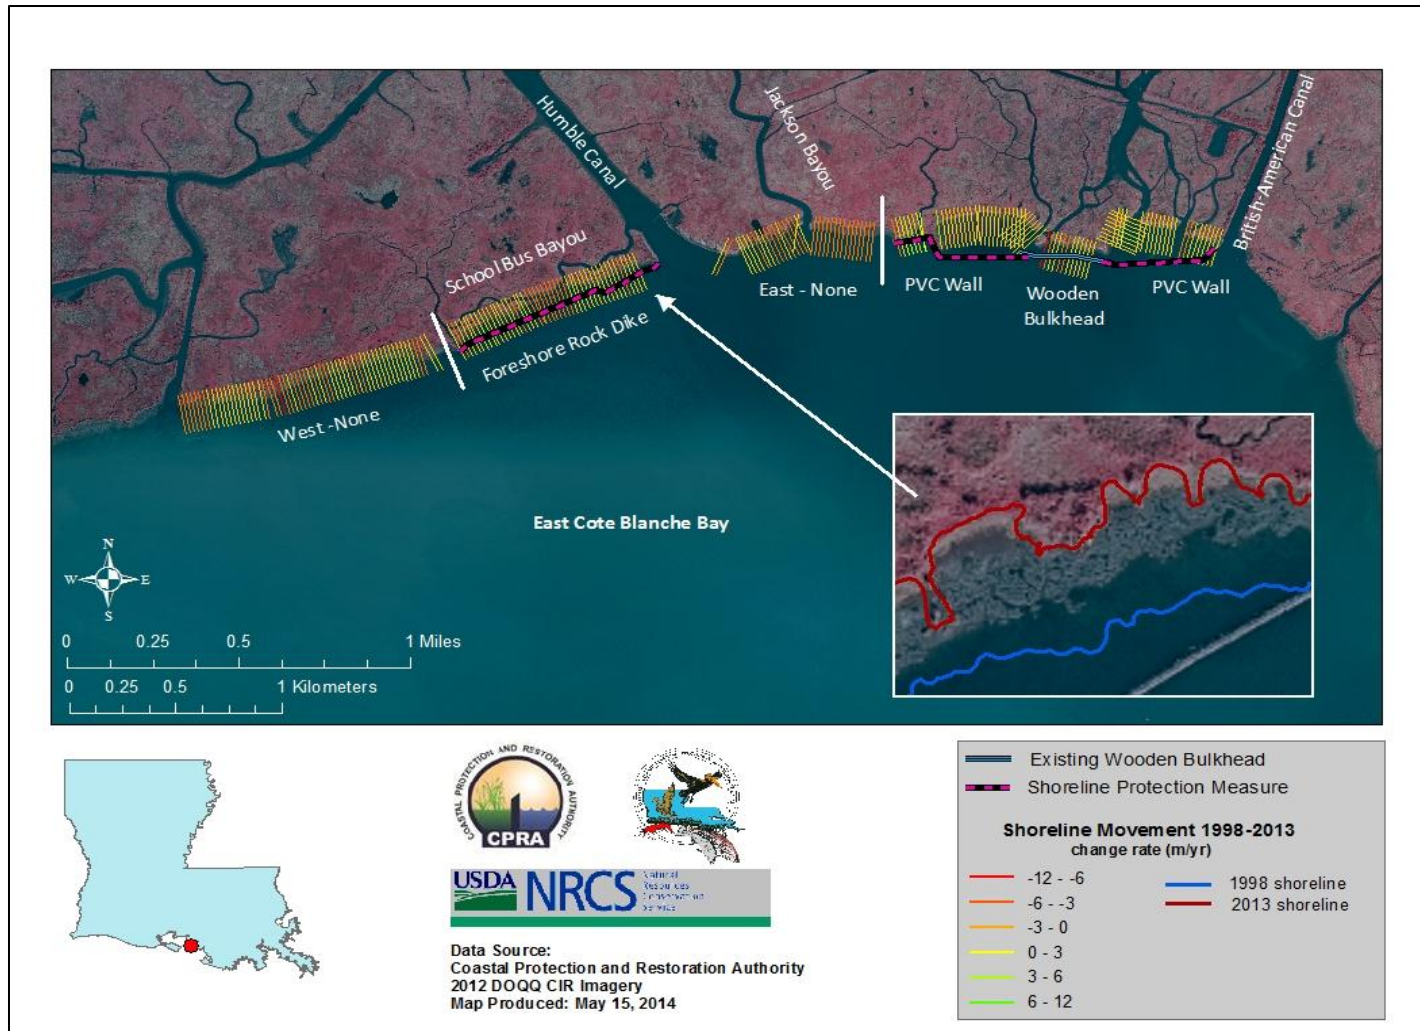
Figure 5. Cote Blanche Hydrologic Restoration (TV-04) shoreline change over the life of the project (1998-2013). The Foreshore Rock Dike was not constructed until 2007, and the Wooden Bulkhead was a pre-existing structure constructed in the late 1950s.

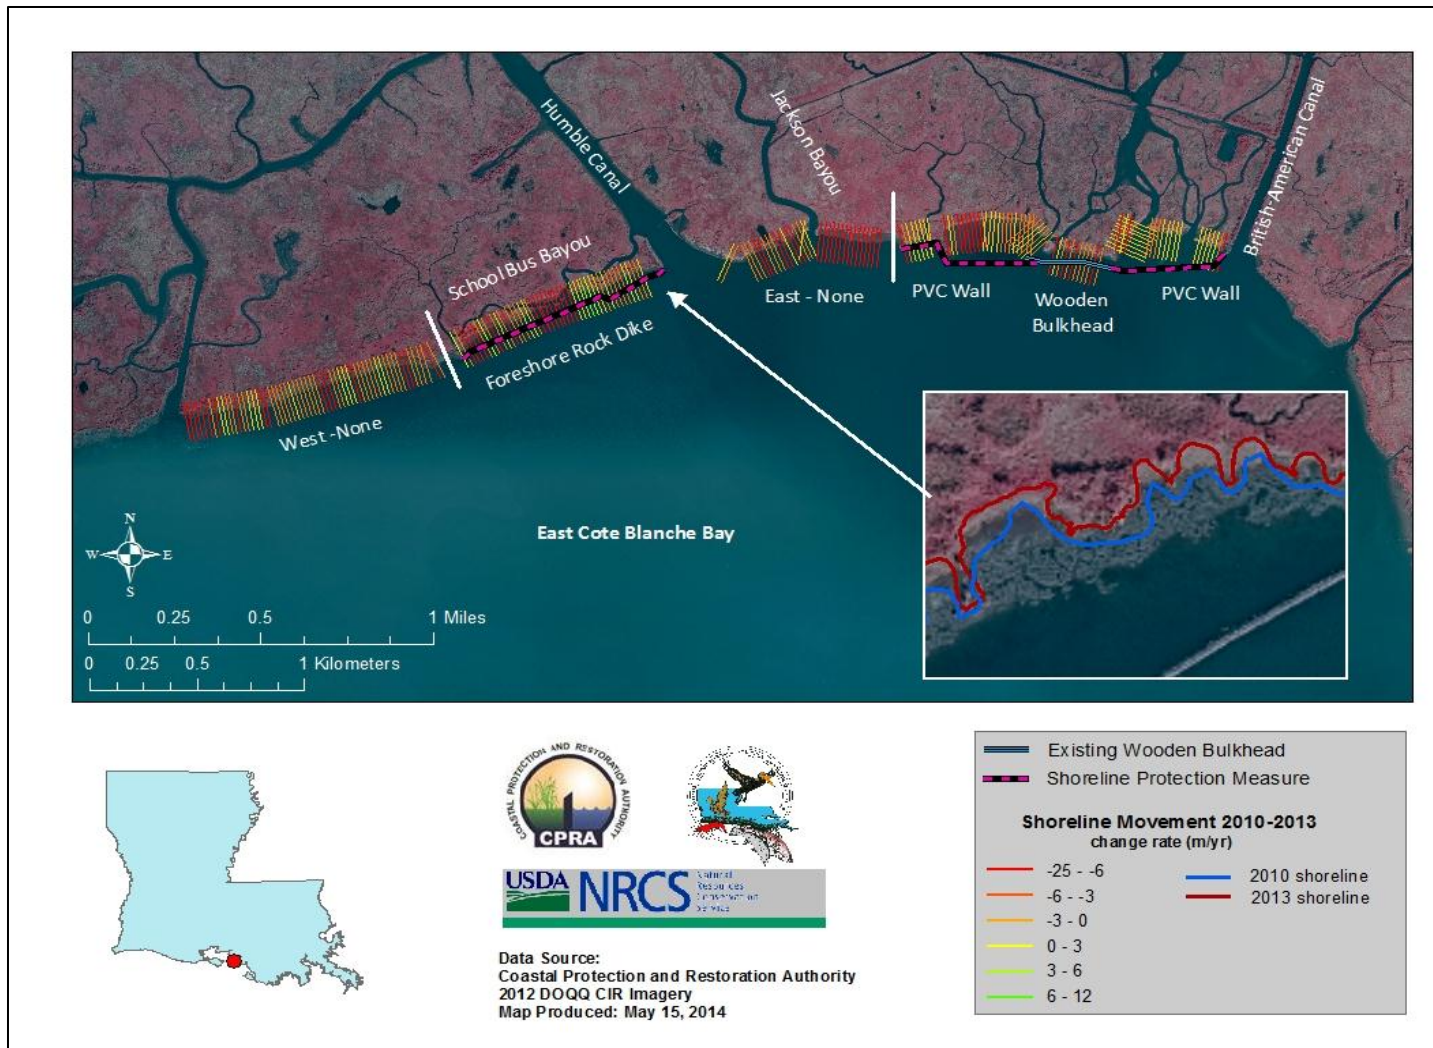
Figure 6. Cote Blanche Hydrologic Restoration (TV-04) shoreline change from 2010 to 2013. The Foreshore Rock Dike was constructed in 2007, and the Wooden Bulkhead was a pre-existing structure constructed in the late 1950s.

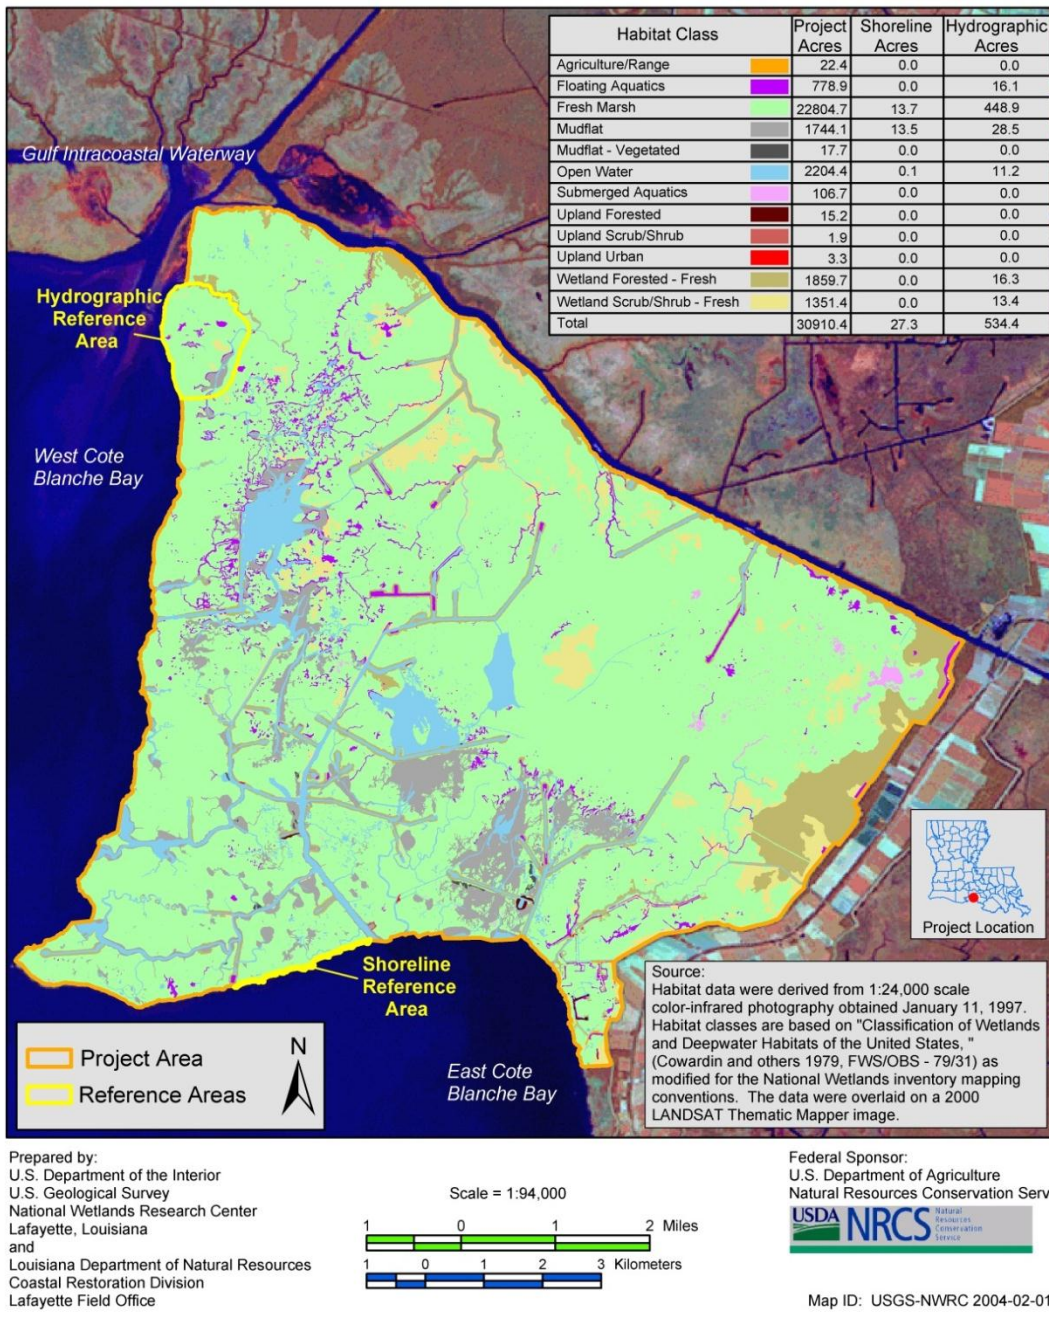
Figure 7. Cote Blanche Hydrologic Restoration (TV-04) 1997 GIS habitat analysis from photography taken January 1997.

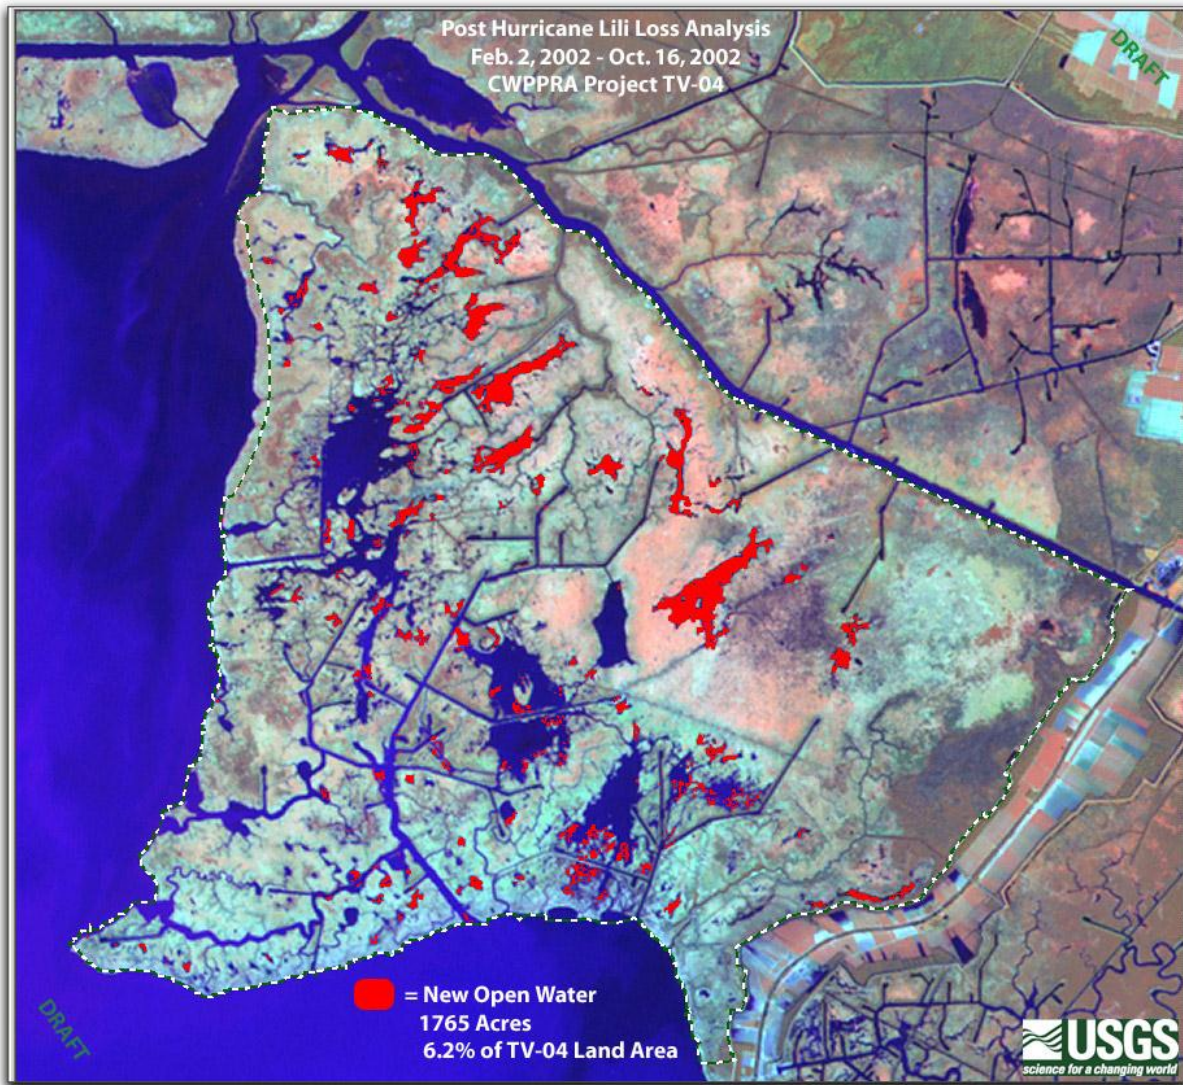
Figure 8. Land to Water change analysis (February 2002 – October 2002) resulting from Hurricane Lili (10/3/02). Satellite imagery and analysis provided by U. S. Geological Survey.

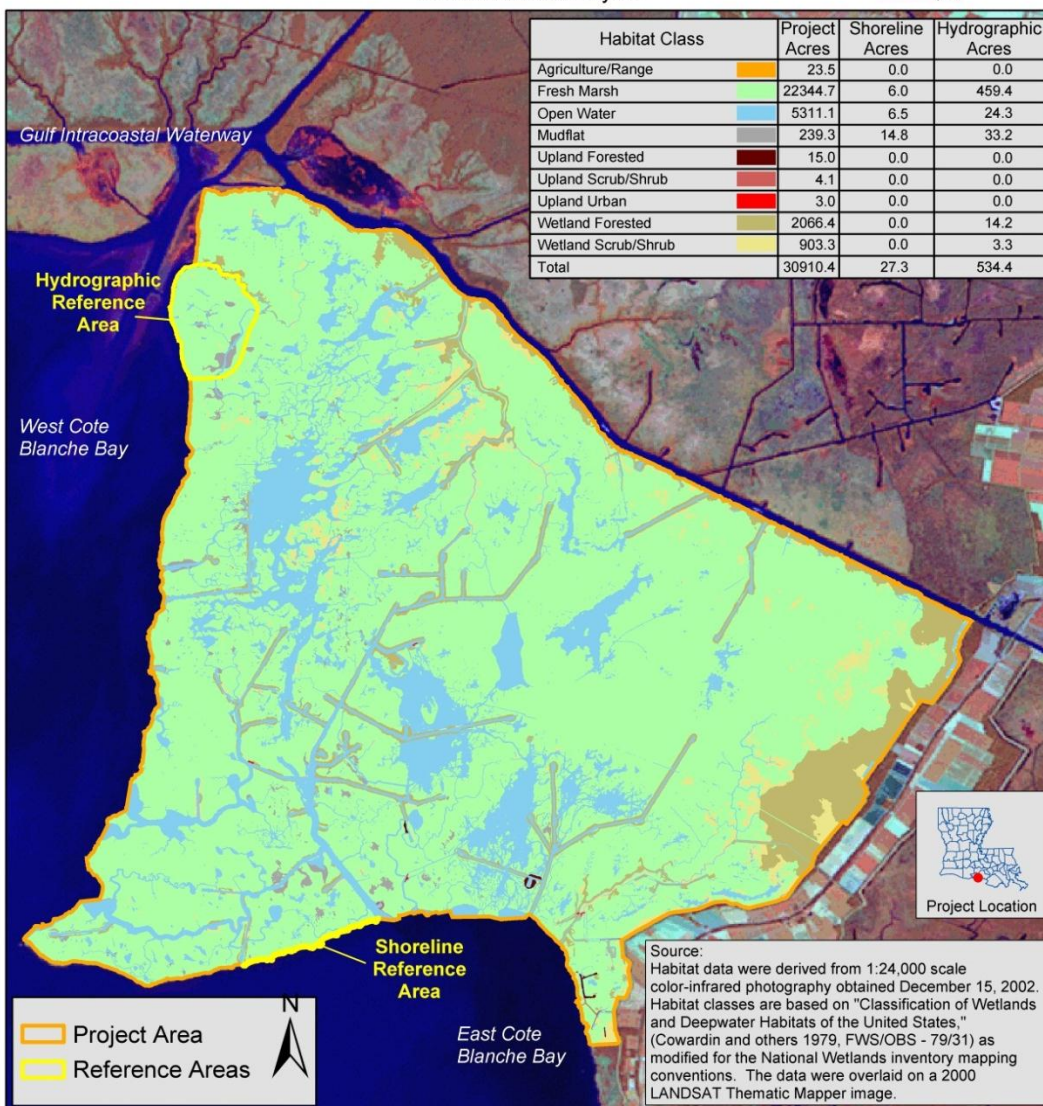
Figure 9. Cote Blanche Hydrologic Restoration (TV-04) 2002 GIS habitat analysis from photography taken December 2002 (after Hurricane Lili).

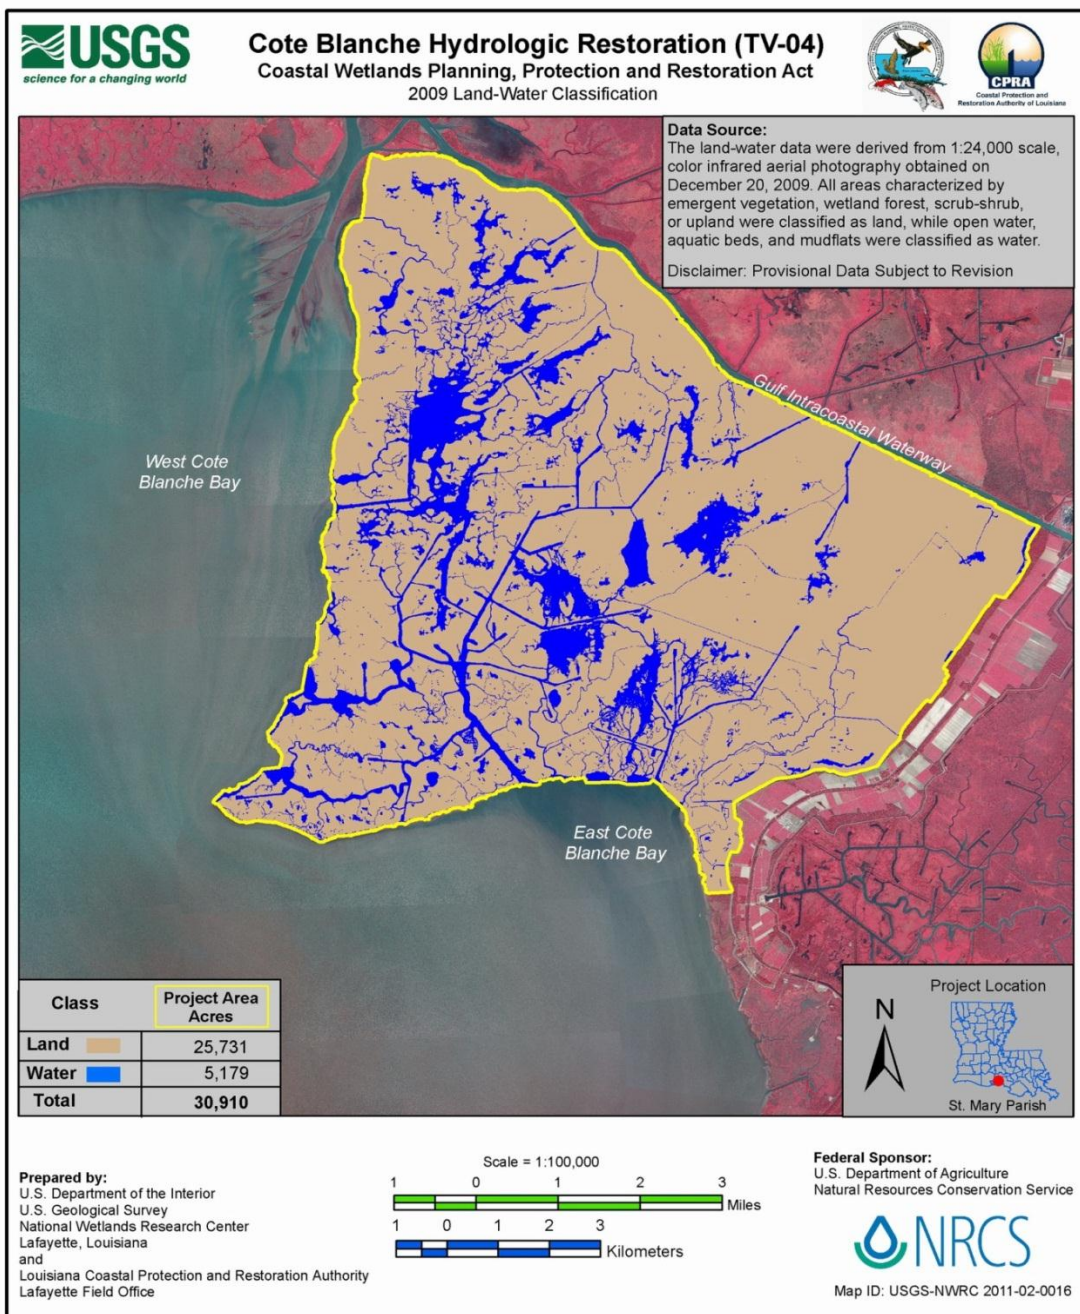
Figure 10. Cote Blanche Hydrologic Restoration (TV-04) 2009 land and water analysis from photography taken December 2009.
