Coastal Protection and Restoration Authority of Louisiana (CPRA)

2016 Operations, Maintenance and Monitoring Report

Oaks/Avery Canals Hydrologic Restoration

State Project Number T/V-13a
Priority Project List 6

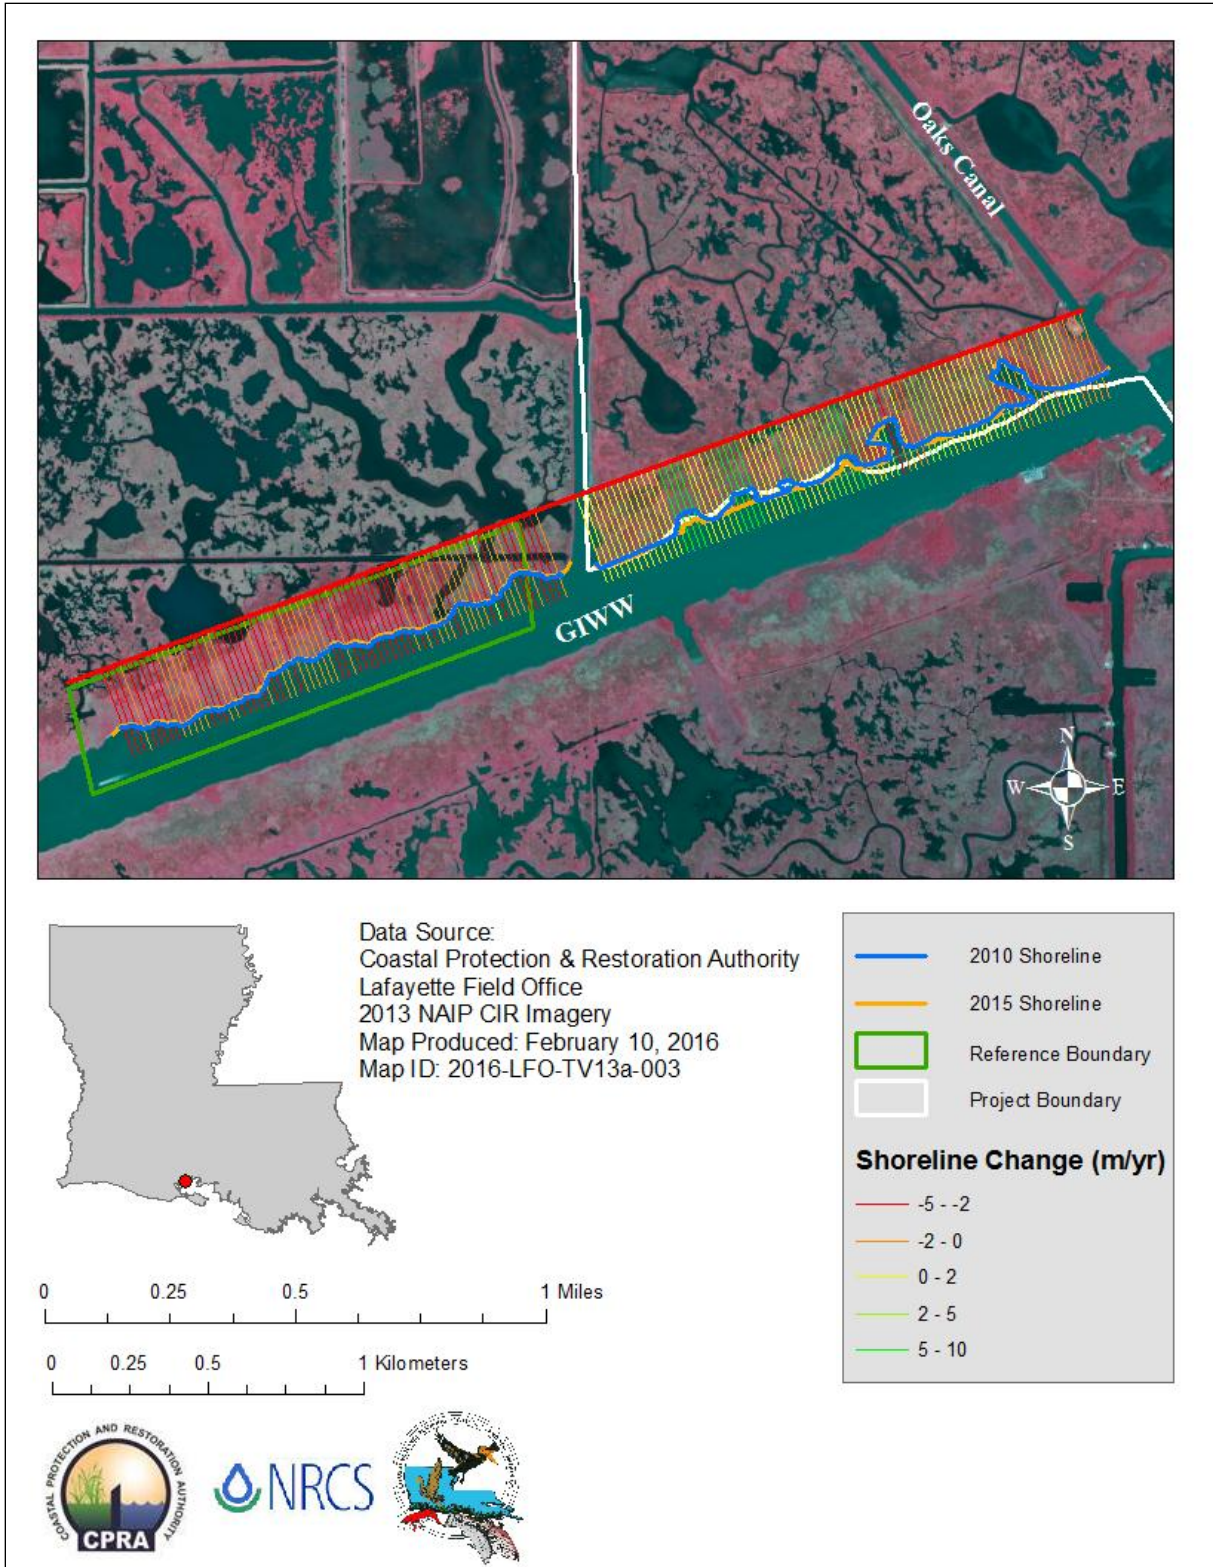
Figure 10. Shoreline change in the TV-13a project area along the GIWW for the period 2010-2015.

Shoreline protection along the GIWW prevented erosion and allowed for bank expansion. As-built (immediately post-construction) bankline positions for the project and reference areas along the GIWW were collected following rock dike construction and again in 2006/7, 2010 and 2015 (Table 1). Since, 2010, the project bankline prograded at a mean rate of 1.7 m/yr (5.6 ft/yr) and the unprotected reference area eroded at a rate of -0.9 m/yr (-3 ft/yr) (Figure 10). These data are consistent with shoreline change in other rock dike projects built along the GIWW. Sediment appears to be accumulating between the shore and the rock dike, resulting in the progradation of the bankline, successfully reducing the erosion rate along the GIWW.

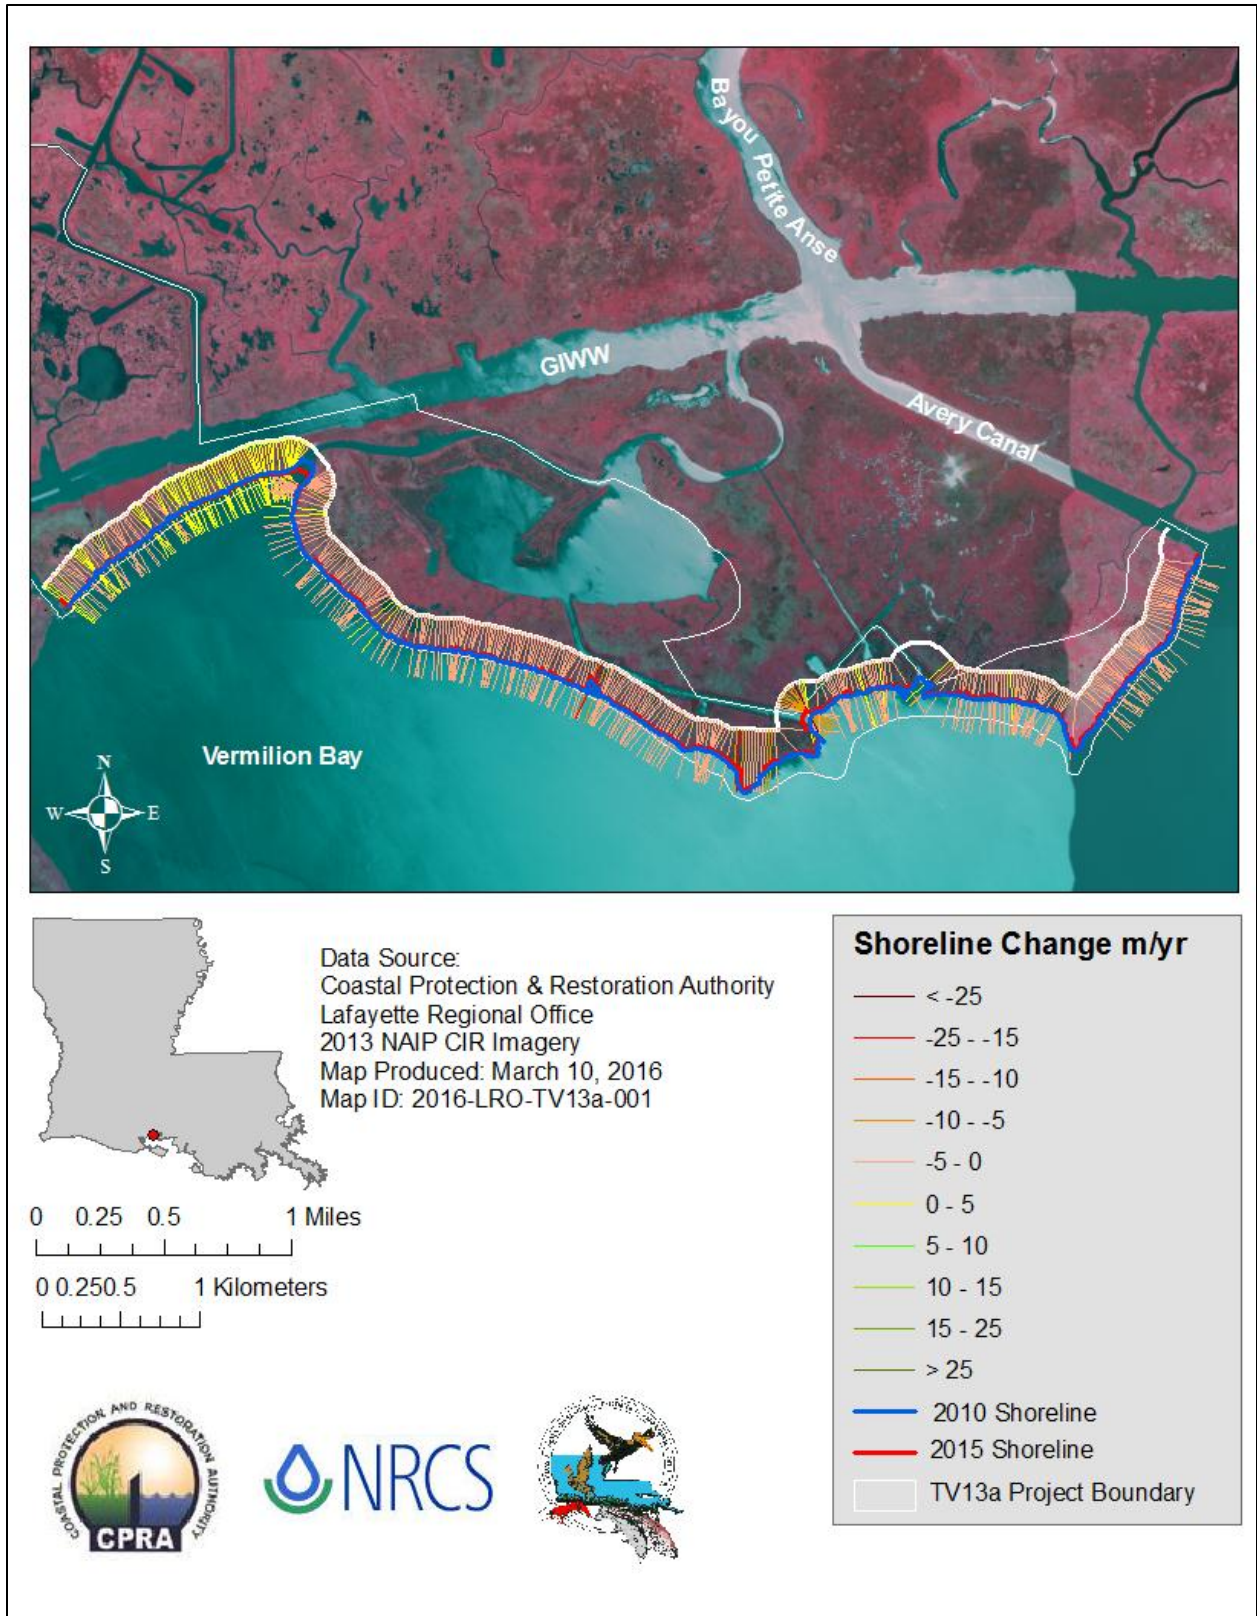
Figure 11. Shoreline change along the shore of Vermilion Bay during the period 2010-2015.

The Vermilion Bay shoreline continued to erode throughout the project area with the most erosion seen in periods that included hurricanes. Data were collected in 2000 (pre-construction), 2003 (post-planting), 2007, 2010 and 2015 for the Vermilion Bay shoreline (Table 1, Figures 10 and 11). Shoreline loss was minimal, -2.7 m/yr since 2010, for the majority of the project area, with the exception of the area near the mouth of the canal connecting Tigre Lagoon to Vermilion Bay (-6.7 m/yr). It is highly possible that erosion rates from 2003-2007 increased due to Hurricane Rita, which battered the shoreline of the project with high winds and a storm surge of as much as 11-12 ft. During the entire monitoring period (2000-2015), the shoreline retreated at a rate of -2.7 m/yr (-8.9 ft/yr). The area near the mouth of the canal connecting Tigre Lagoon to Vermilion Bay eroded at a mean rate of -15.9 m/yr (-52.2 ft/yr). Loss in this area was as much as -19.82 m/yr (-65.0 ft/yr) (Figure 11).

Shoreline protection measures are recommended for those portions of the Vermilion Bay shoreline exhibiting the highest erosion rates in excess. In addition, it is imperative to have a better understanding of the factors causing the observed shoreline loss in this area of the project.
